**Re: Indiana-Kentucky Electric Corporation
Clifty Creek Station's CCR 2016 Annual Landfill Inspection**

**Reference: 2016 CCR Rule Inspection
Annual Landfill Inspection
Clifty Creek Generating Station
Madison, Indiana**

**2016 CCR Rule Inspection
Clifty Creek Landfill**

Clifty Creek Generating Station
Madison, Indiana
Jefferson County

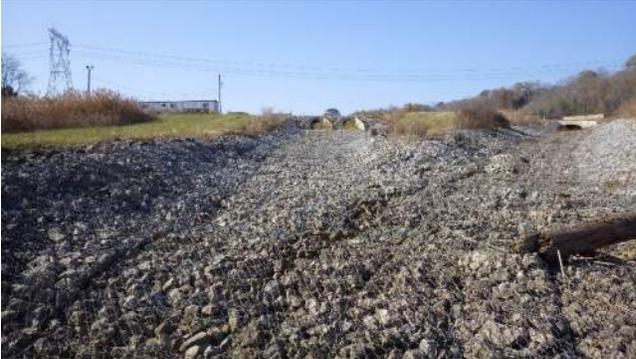
**Photo 1**

Northwest final grade surface water channel (right) and final grade surface/storm water channel looking west.

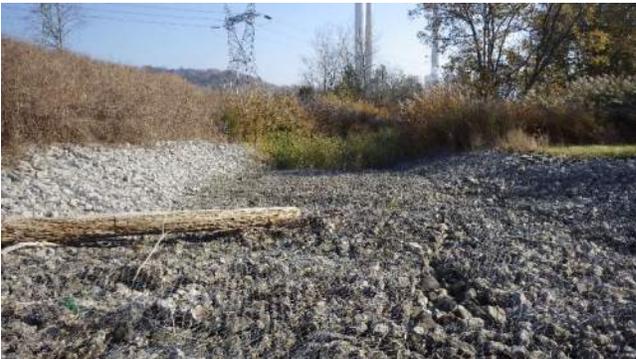
**Photo 2**

- A log was noted in the combined channel east of the construction trailer and upstream of the Conspan outlet flowing into the West Boiler Slag Pond (Photo 2). The Conspan is a precast concrete culvert and foundation represented on reference Drawing No. 16-30870-05 in Appendix C and is 72-lf long and 20' wide by 5' tall culvert at a 1.25% slope.

- Some grass and vegetation was present in the channel on the upstream side of the West Boiler Slag Pond Conspan outlet. The vegetation present did not impede proper function of the channel. (Photo 2)

The combined surface/storm water channel flowing east to the West Boiler Slag Pond. The log is in the foreground. The vegetation and low area are in the background near the tree line.

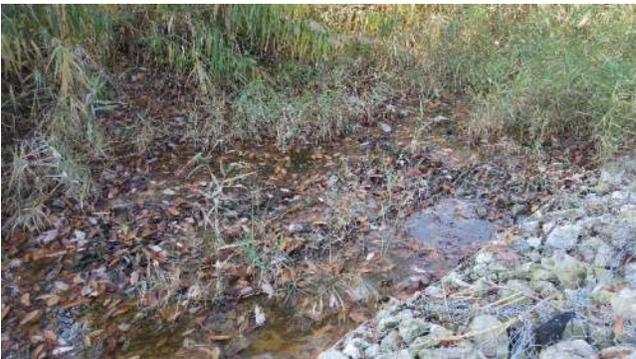
**Photo 3**

- The area of the channel near the tree line appears to be low and holding some water. Vegetation obscures inspection. Flow does not seem impeded, but the area should be monitored for changes. (Photo 3)

A low area in the combined surface/storm water channel upstream of the Conspan flowing into the West Boiler Slag Pond.

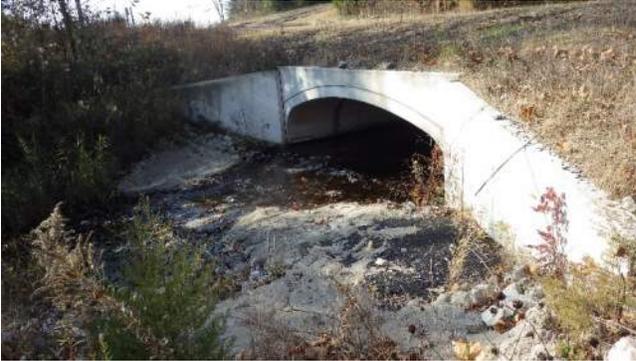
Photo 4

- The West Boiler Slag Pond Conspan flow appears unrestricted with slight vegetation growing. (Photos 4 and 5)

West Boiler Slag Pond Conspan downstream headwall.

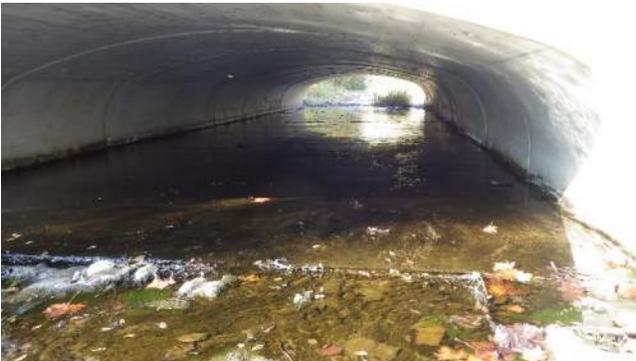
Photo 5

West Boiler Slag Pond Conspan looking upstream.

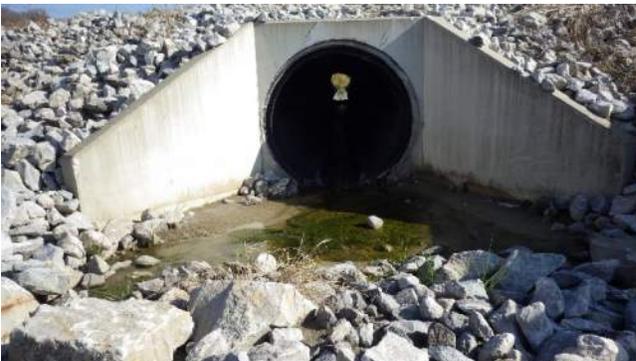
Photo 6

- The final grade surface/storm water channels include two headwalls passing under the access road past the temporary construction office trailers. A slight bow in the crown of the southern of the two pipes was observed in 2015 and 2016; however, no depression was noticed in the road, and flow is not impeded. The bow did not appear to change between 2015 and 2016. (Photo 6)

The southern of two final grade surface/storm water channel culverts passing beneath the access road to the temporary construction office trailers. A slight bow was observed in the crown.

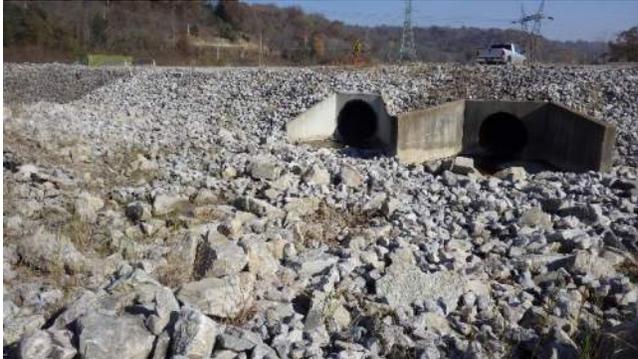
**Photo 7**

- The reeds and vegetation within the final grade surface/storm water channel northeast of the closed Type III landfill, which were noted in 2015, were markedly reduced near the construction trailer area culverts. Riprap and gabions were in place. Observations of the headwalls for the leachate pipes were obscured by grasses, though flow did not appear to be impeded. (Photos 7 and 8; Point 1, Appendix A)

The two headwalls for the final grade surface/storm water channels upstream of the temporary construction office trailer area. Vegetation and reeds near the construction trailer area culverts were minimal for 2016 visit.

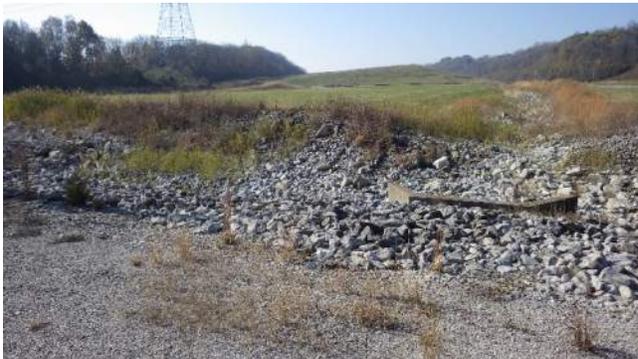
**Photo 8**

Vegetation visible in final grade surface/storm water channels west of the temporary construction office trailer area, obscuring observation of the leachate piping headwalls. Discharge flow did not appear to be impeded.

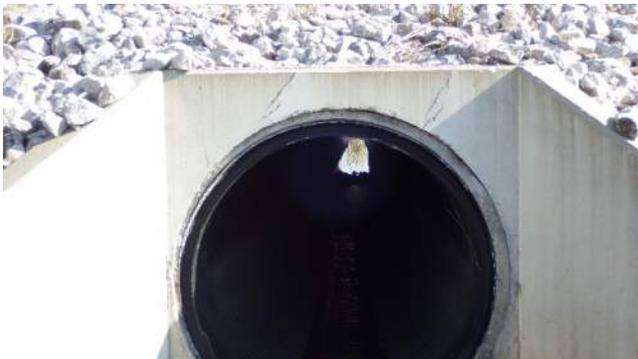
**Photo 9**

- The cracks noted on the surface of the inlet headwall for the northwest final grade channel appears unchanged from 2015. Flow is not impeded; this is a maintenance observation for continued monitoring. (Photo 9)

The cracks in the inlet headwall for the northwest final grade channel appears unchanged from the 2015 visit.

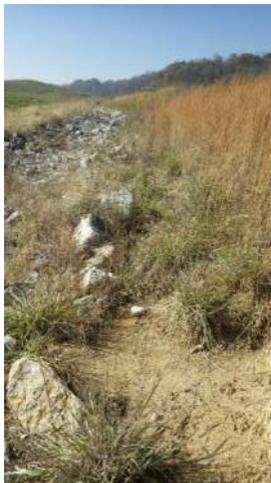
**Photo 10**

- A bare zone was observed along the northwestern final grade surface/storm water channel. It lies near the channel bottom along the riprap zone. (Photo 10; Points 2 and 3, Appendix A)

A bare zone was observed in the northwest surface/storm water channel in the channel bottom along the riprap.

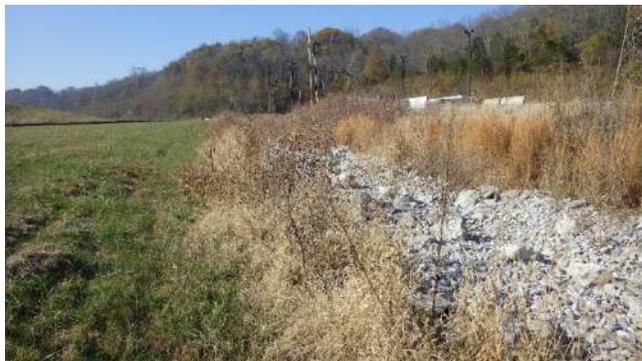
**Photo 11**

- The side slopes along the northern final grade surface/storm water channel were covered with grasses between 1 to 3 feet tall. (Photo 11)
- A low spot was noted in the southern final grade surface/storm water channel with possible erosion of the riprap. Visual observation was obscured by vegetation. (Photo 12; Point 4, Appendix A)

Grasses along the northwestern final grade surface/storm water channel.

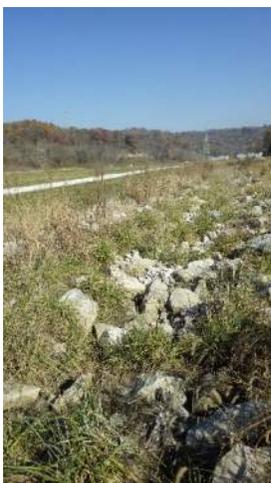
**Photo 12**

Low spot and riprap erosion in southwestern final grade surface/storm water channel.

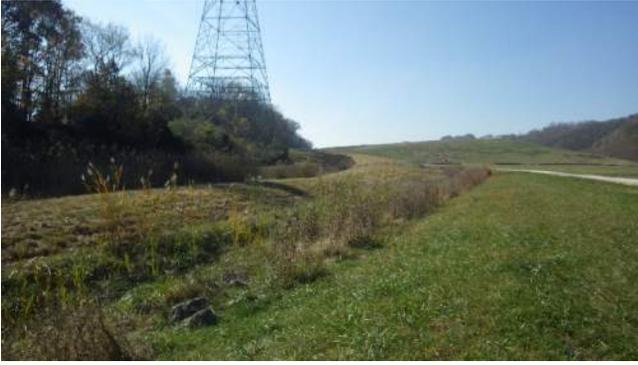
Photo 13

- Vegetation obscures observation of the southern final grade surface/storm water channel near its junction with the southern storm water channel. (Photo 13)

Vegetation in southwestern final grade surface/storm water channel near its junction with the southern storm water channel.

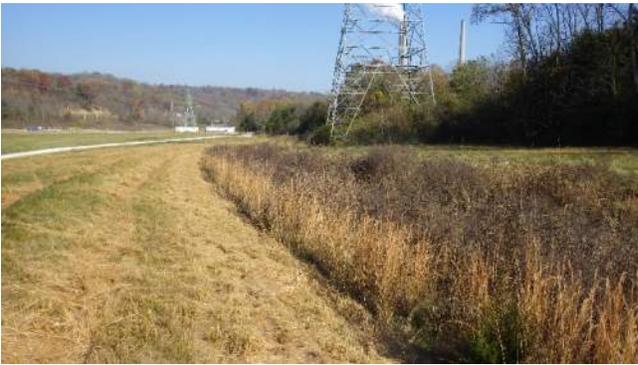
Photo 14

Vegetation in southern storm water channel.

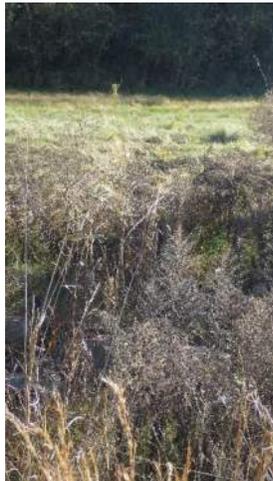
Photo 15

- Vegetation obscures observation of the southern storm water channel. (Photo 14)
- Several erosion rills were noted on the southern ridge side of the southern stormwater channel. These are located outside of the limits of waste and are noted as maintenance

concerns only for access to the southern ridge near the landfill. (Photo 15; Points 5 and 6, Appendix A)

Erosion rill on south side of southern storm water channel.

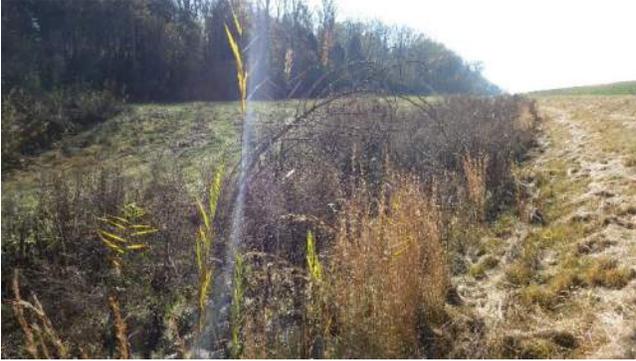
**Photo 16**

- Several trees one to three inches in diameter were observed near the base of the transmission line tower in the southern storm water channel. (Photo 16; Point 7, Appendix A)
- A low spot with possible erosion was noted in the southern storm water channel near the southeastern corner of Subphases 1A1 and 1B1. This channel is located on the southern ridge side of the maintenance road adjacent to the landfill, outside of the limits of waste. (Photo 17; Point 8, Appendix A)

Small tree in southern storm water channel.

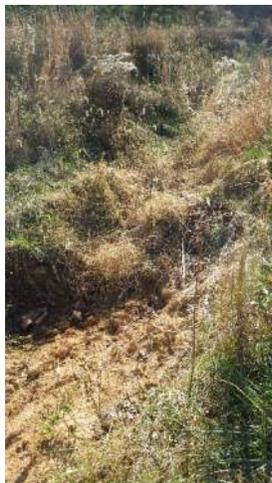
**Photo 17**

Low spot with possible erosion in the southern storm water channel near the southeastern corner of Subphases 1A1 and 1B1.

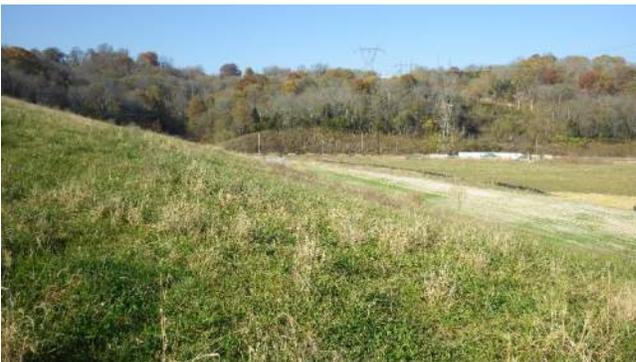
**Photo 18**

- The temporary cover vegetation on Subphases 1A1/1B1 was generally less than six inches tall and appeared to be maintained. Some taller grasses were present with a height of approximately two feet. (Photo 18)

Vegetative cover on northern slope of Subphases 1A1 and 1B1.

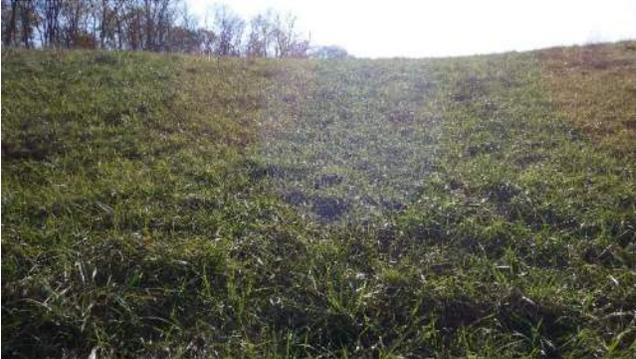
Photo 19

- Minor erosion rills were observed at the juncture of the northeastern landfill slope and the southwestern final cover surface/storm water channel. (Photo 19)

Minor erosion rills at juncture of northeastern landfill slope and the southwestern final cover surface/storm water channel.

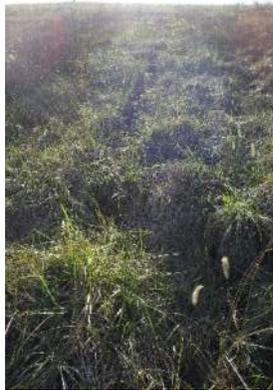
Photo 20

- An erosion rill runs from top to bottom of the northeastern slope of Subphases 1A1/1B1 near the north corner. It was approximately 12 inches deep and obscured by vegetation. (Photo 20; Point 9, Appendix A)

Erosion rill running top to bottom near northeast corner of Subphase 1A1.

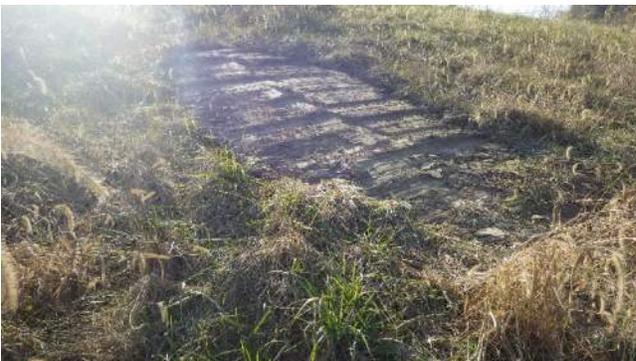
Photo 21

- A recent compacted soil repair on the northeastern slope was noted during the November field visit. (Photo 21; Point 10, Appendix A)
- Subphase 1A2 is nearing permitted final CCR grade. The northwestern slope along the haul road has temporary soil cover placed with established grass cover. The vegetation is less than six inches tall on a uniform slope. (Photo 22)

Repair of temporary cover on northeastern side of Subphases 1A1 and 1B1.

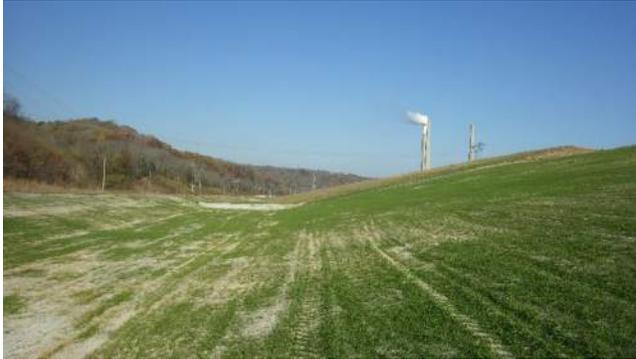
**Photo 22**

Northwestern slope of Subphase 1A2 with established vegetation and uniform slope.

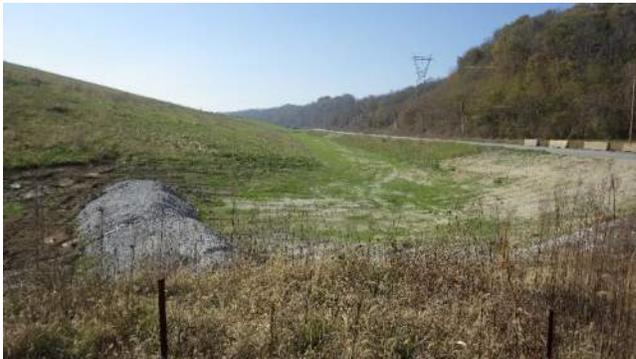
**Photo 23**

- The rock check dams appeared recently maintained with additional gravel placement, little to no silt buildup, and established vegetation in the regions flowing towards the check dams. (Photo 23)

Rock check dam and storm water channel at the northeast corner of Subphases 1A1 and 1B1.

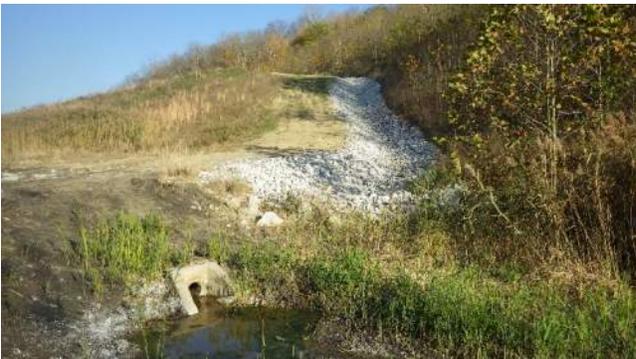
**Photo 24**

- The storm water channel along the southern ridge of Subphase 1C appears recently graded with additional riprap placement. (Photo 24)
- Storm water within the inactive Subphase 1C is collected from the temporary cover and directed towards the Landfill Runoff Collection Pond. The pipe outlet was located during the November site visit. (Photos 25 and 26; Point 11, Appendix A)

- The leachate pipe appeared unrestricted and actively flowing. Vegetation was maintained around the headwall to allow visual observation. (Photo 24; Point 12, Appendix A)

The storm water channel along the Devil's Backbone side of Subphase 1C1. The leachate pipe headwall is in the foreground.

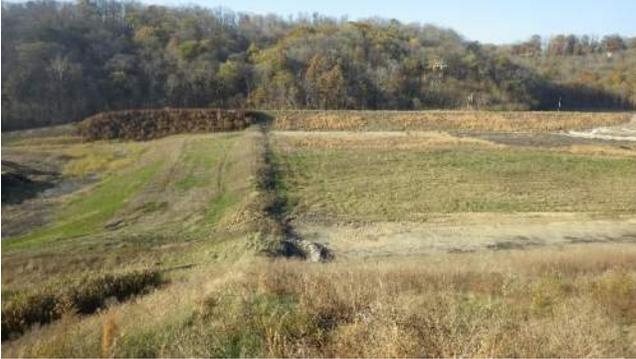
**Photo 25**

Southwestern edge of inactive Subphase 1C. Termination berm and sediment trap for storm water management.

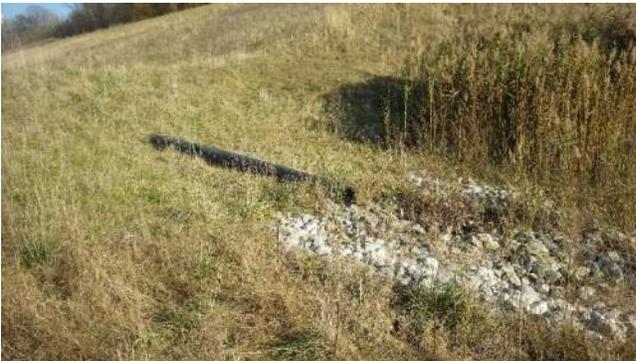
**Photo 26**

Storm water pipe outlet for Subphase 1C temporary cover area.

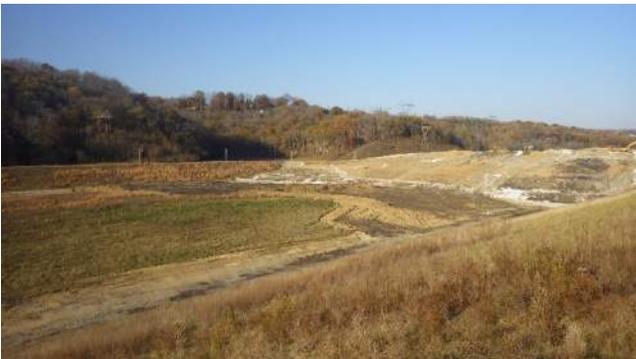
**Photo 27**

- The construction portions of Subphase 1C are being stripped of temporary cover in preparation for CCR placement. The southern slopes remain vegetated and appear unchanged from the 2015 report. (Photo 27)

Subphase 1C with temporary cover removal and active face of Subphase 1A2.
