2018 ANNUAL DAM AND DIKE INSPECTION REPORT

**West Boiler Slag Pond
&
Landfill Runoff Collection Pond**

**CLIFTY CREEK PLANT
Indiana-Kentucky Electric Corporation
MADISON, INDIANA**

October 22, 2018

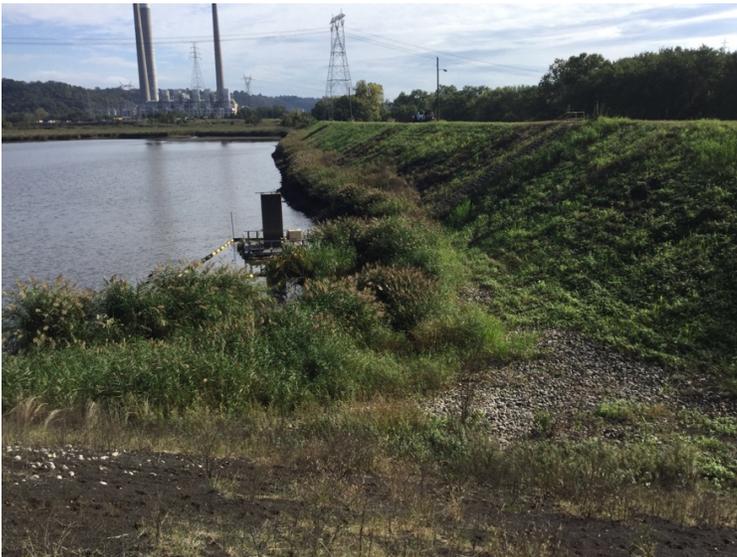
2. Photographs No. 3, and 4 illustrate the condition of the interior slopes at the settling end of the pond and the present extent of boiler slag buildup. The interior slope of the dike at this end of the pond appeared to be in satisfactory and stable condition.

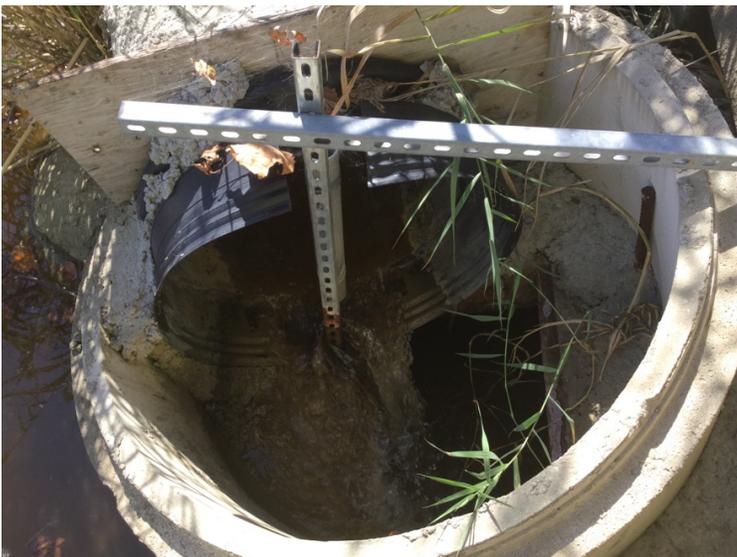
3. Photographs No. 5 and 6 are an overview of the principal spillway decant structure. Vegetation control was observed to be satisfactory. The decant structure and the access stairway appeared to be functioning properly and was free of obstructions. Photograph No.6 shows the recently added pipe to allow for treatment of discharged water.

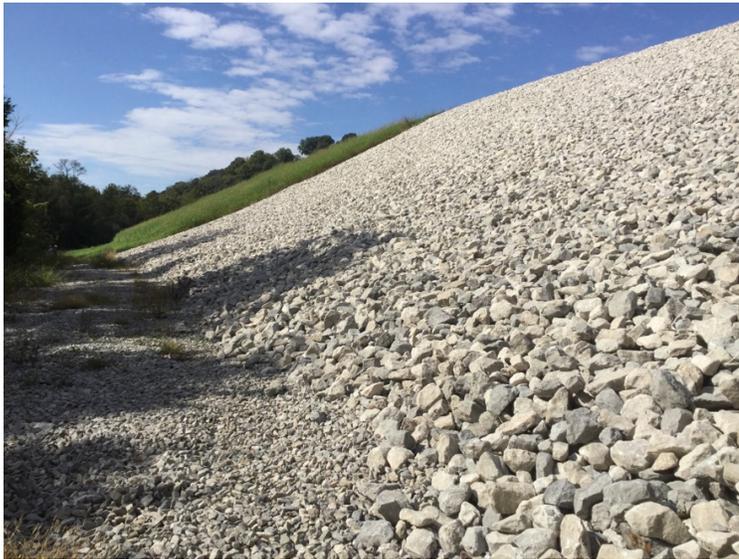
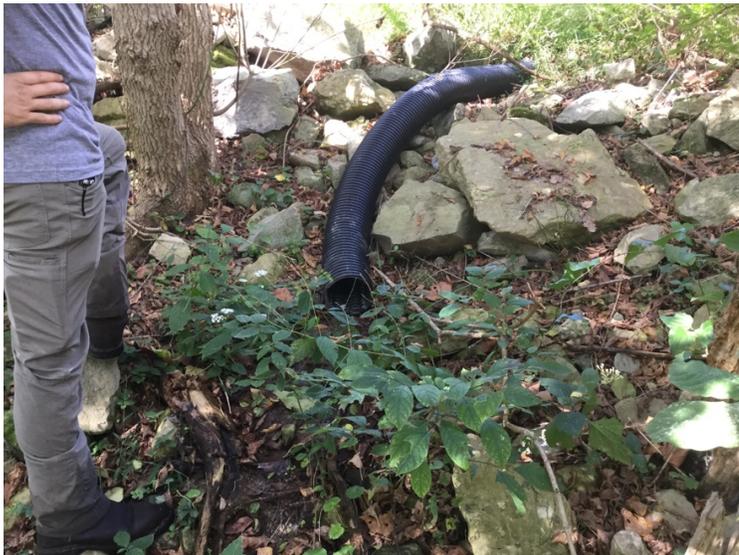
7. Photograph No.11 and No. 12 shows the previously repaired slope area that experienced sloughing/slip near the left abutment. The repair also included installing a seepage collection pipe at the toe of rip rap placement. The pipe showed minimal flow at the time of inspection.
