2019 ANNUAL DAM AND DIKE INSPECTION REPORT

**West Boiler Slag Pond
& Landfill Runoff Collection Pond**

**CLIFTY CREEK PLANT
Indiana-Kentucky Electric Corporation
MADISON, INDIANA**

Document ID: GERS-19-021

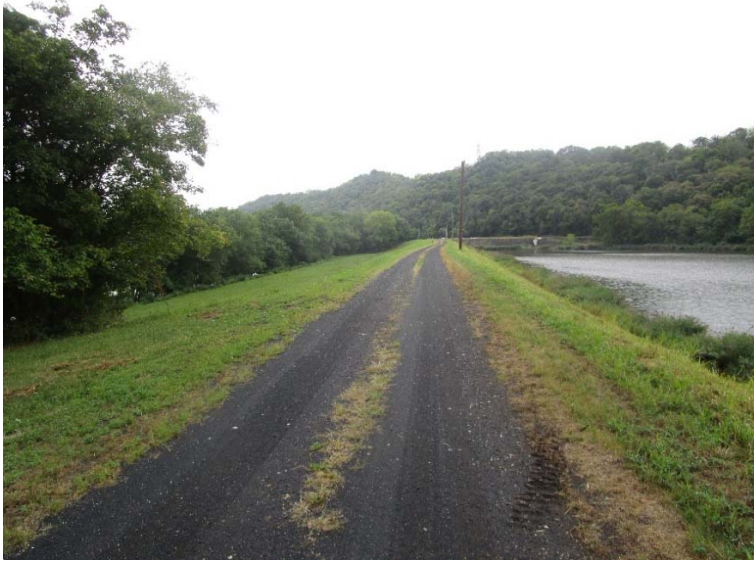
Photo No. 1

1. Photographs No. 1 and 2 illustrate a typical overview of the dike crest. The crest appears to be in good and stable condition. Signs of settlement, misalignment and cracking were not observed.

View of the erosion rills on the protective West Boiler Slag Pond Dike From Crest Looking Northeast

Overview of Crest

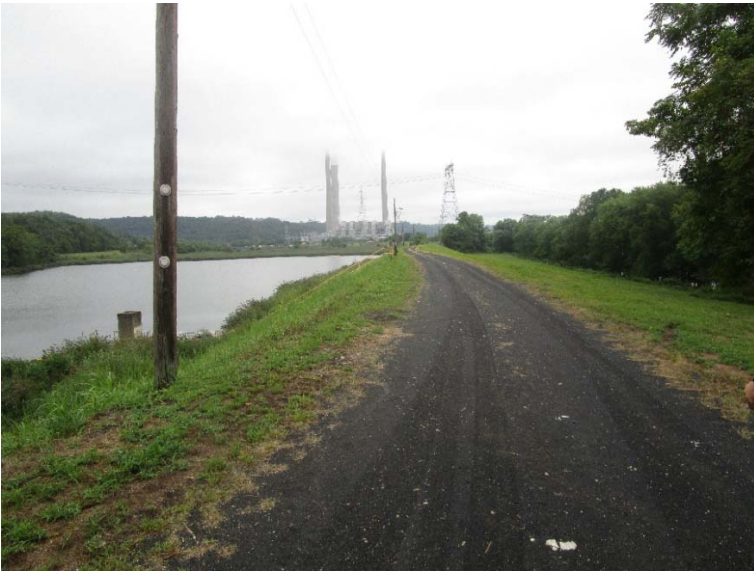
Photo No. 2

West Boiler Slag Pond Dike – Crest From Top Looking Northeast

General Condition

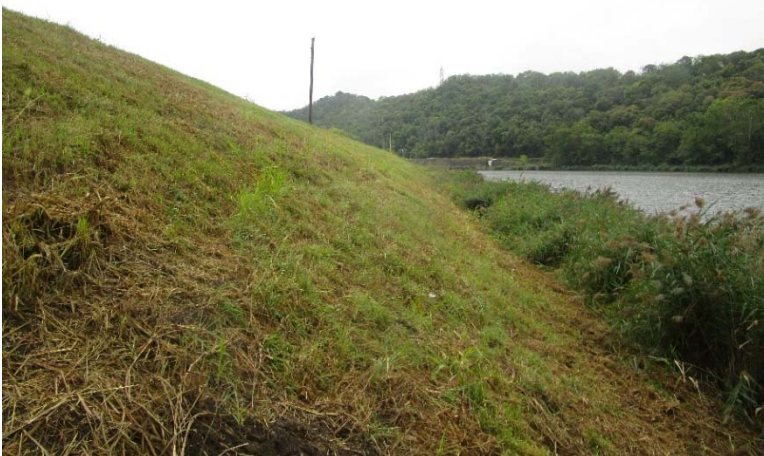
Photo No. 3

2. Photographs No. 3, and 4 illustrate the condition of the interior slopes at the settling end of the pond and the present extent of boiler slag buildup. The interior slope of the dike at this end of the pond appeared to be in satisfactory and stable condition.

3. There were a few locations where the use of the remotely controlled mower, appear to have caused disturbance to the inboard slope surfaces at areas where the soil is more granular.

West Boiler Slag Pond – Near South End of Interior Slope

Area where some surface disturbance caused by the remotely controlled mower

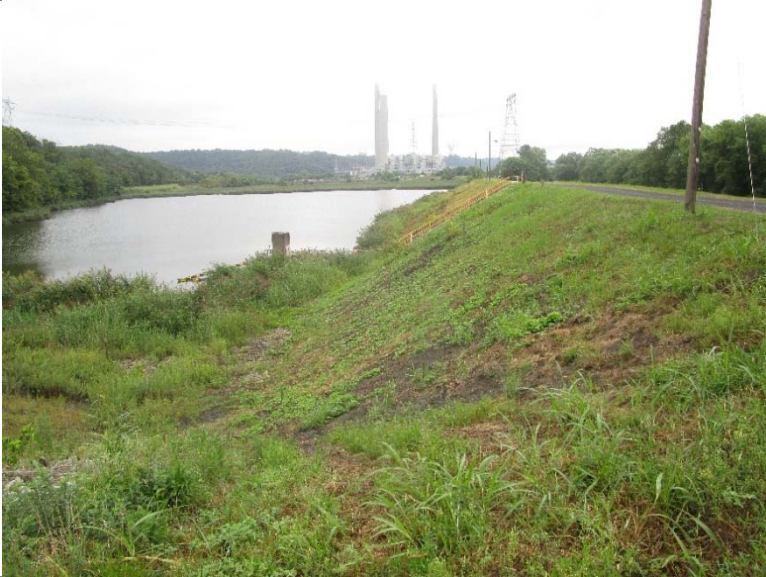
Photo No. 4

West Boiler Slag Pond Dike –
Interior Slope Looking Northeast
From Crest.

Overview of General Condition

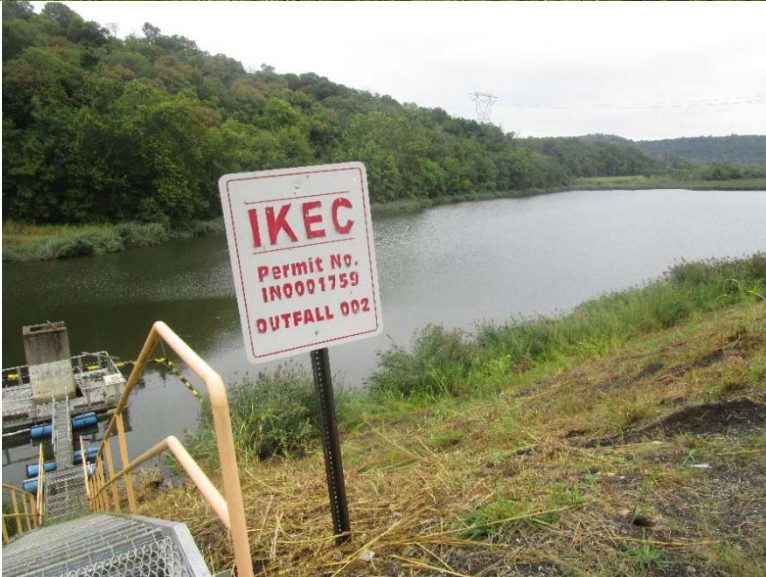
Photo No. 5

4. Photograph No. 5 shows the Principal Spillway and Decant Structure along with some localized overgrown vegetation near the access stairs and water line. The overflow structure appeared to be in satisfactory condition.

5. The overflow discharge structure walkway, railings, metal decking, and visible concrete were found to be in satisfactory, functional condition. However, there was some overgrown vegetation adjacent to the access stairs. Photographs No. 5 and 6 illustrate the access stairs, metal walkway, metal deck, and concrete structure of the overflow discharge structure.

West Boiler Slag Pond Principal
Spillway Access Stairs and Decant
Structure

Overview of General Condition

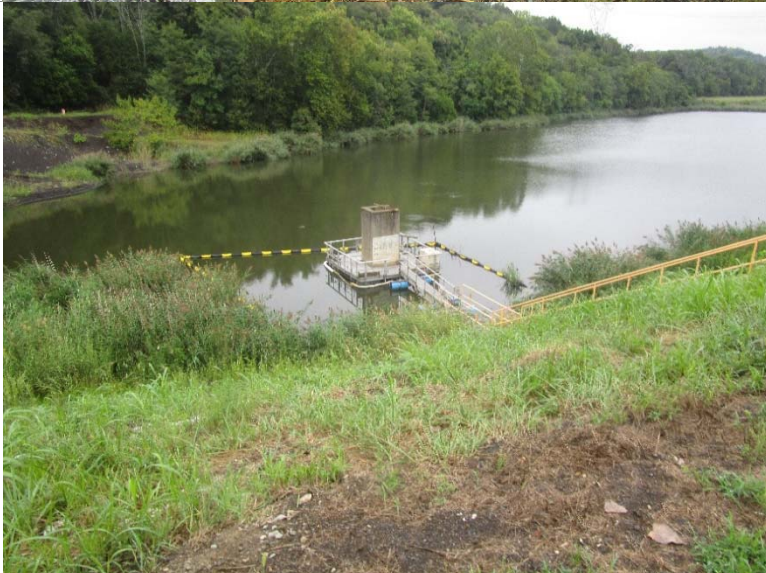
Photo No. 6

West Boiler Slag Pond Dike –
Interior Slope Looking Northwest
From Crest

Overview of General Condition
Local Vegetation growth

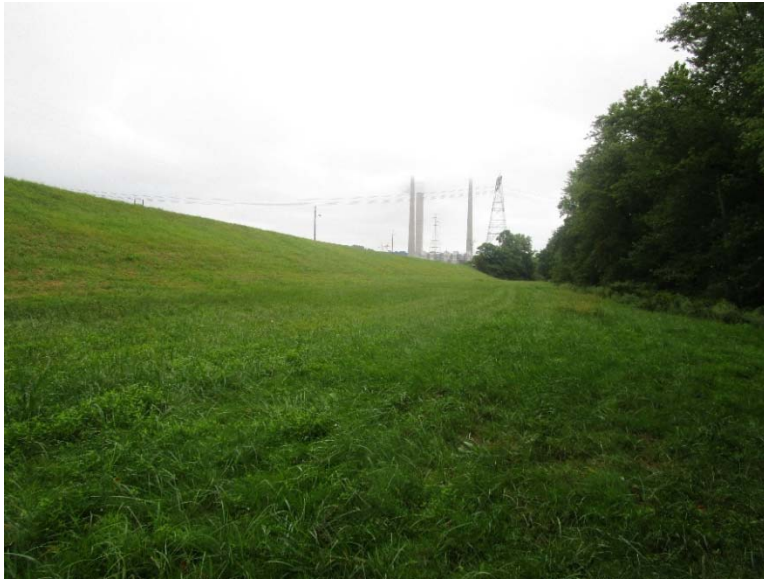
Photo No. 7

6. Photographs No. 7, 8 and 9 shows the general condition of the exterior slope and toe area of the south dike. The slope appeared in satisfactory and stable condition. There were no signs of settlement, misalignment, sloughing or erosion. No wet areas were noted during this inspection except along the toe area where it appears there was standing water in tire ruts caused from mowing activities.

West Boiler Slag Pond Dike –
Exterior Slope From Toe Looking
East

Overview of Vegetation and
General Condition

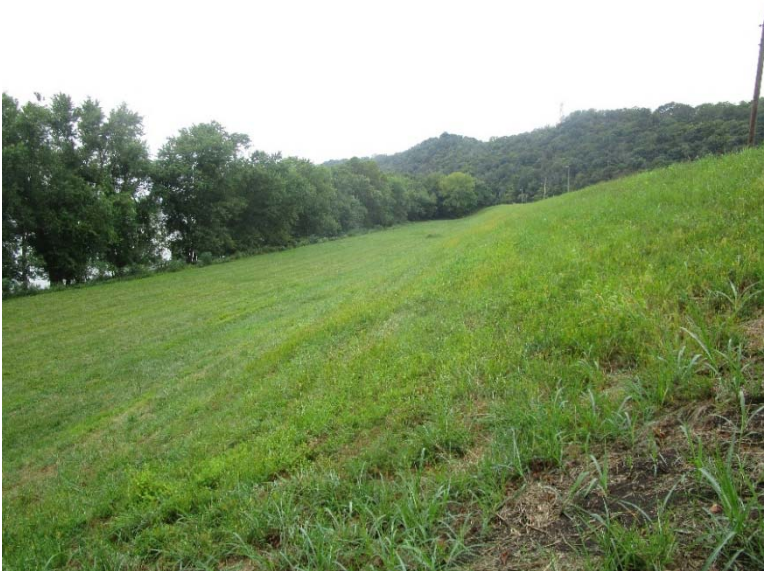
Photo No. 8

West Boiler Slag Pond Dike
Exterior Slope From Toe Looking
Southwest

Overview of Vegetation and
General Condition

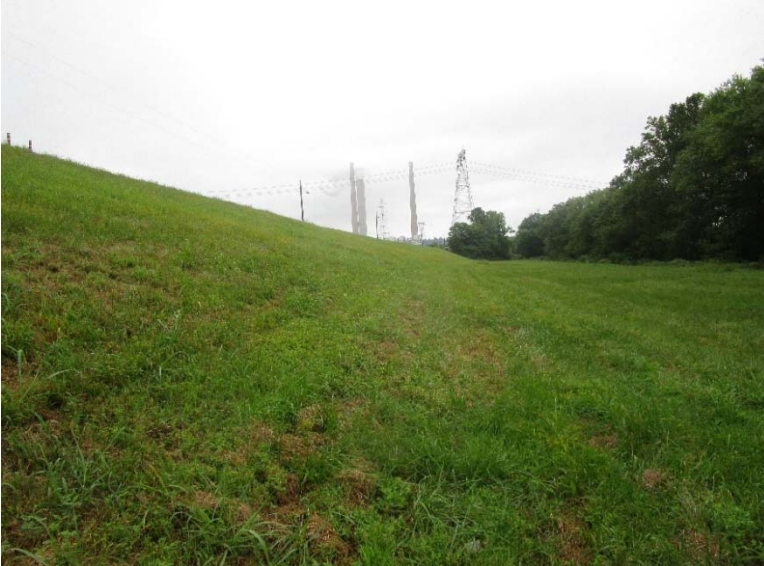
Photo No. 9

West Boiler Slag Pond Dike –
Exterior Slope From Toe Looking
East

Overview of Vegetation and
General Condition

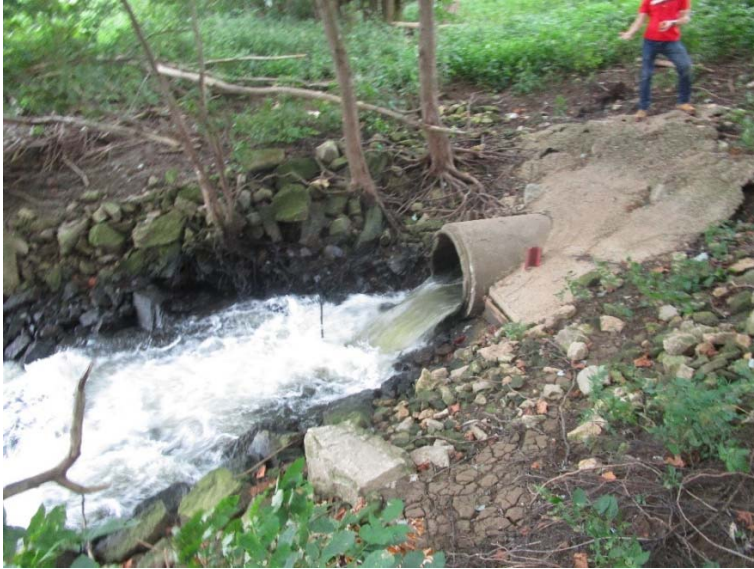
Photo No. 10

7. Photograph No. 10 shows the typical condition of the discharge pipe and outlet channel. Erosion at the confluence of the channel and the river was consistent with the conditions observed in past years. The channel and outlet pipe were observed to be in good condition and were unobstructed and flowing steadily.

West Boiler Slag Pond Principal Spillway Pipe Discharge

General Condition of End of Pipe and Outlet Channel

Some wood debris carried by the river during flooding events

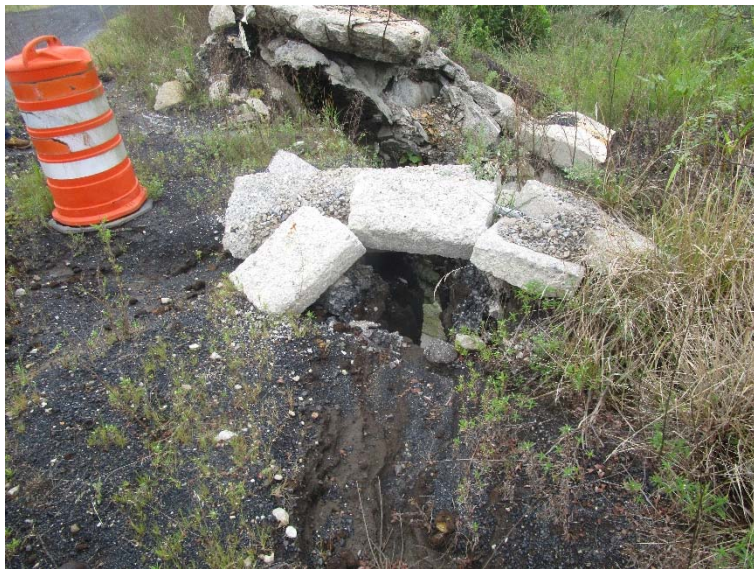
Photo No. 11

8. Significant Erosion along the Inboard slope few hundred feet from the inlet pipes. Erosion is taking place in an area with a very wide crest and does not constitute yet a detrimental condition to the integrity of the structure.

West Boiler Slag Inboard slope close to the Inlet Channel

Significant Erosion along the Inboard slope close to the Inlet Channel. Erosion is taking place in an area with a very wide crest and does not constitute detrimental conditions.

- An evaluation of the use of the remotely controlled mower, purchased by the plant indicates that the anchors in the tracks are apparently disturbing the inboard slopes at areas where soil is more granular. Weed wacking or other mowing techniques are suggested for these areas.
- Vegetation height was moderate at local areas on the inboard slopes of the WBSP (Photographs Nos. 4 and 6). These areas should be weed waked to prevent damage to the existing riprap.
- Erosion along the Inboard slope close to the Inlet Channel (Photographs No. 11) requires prompt maintenance.

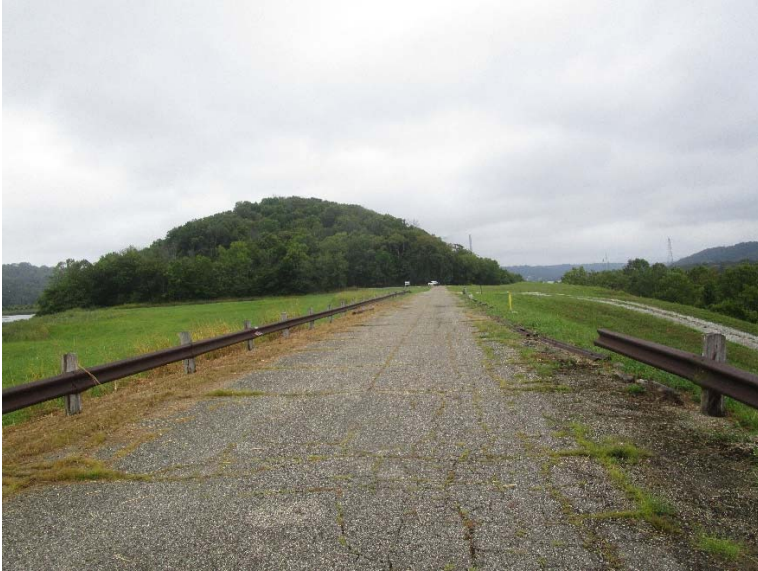
Photo No. 1

1. Photographs Nos. 1, and 2 show the generally condition of the crest of the dam. Signs of misalignment and settlement were not observed. Minor surface cracks in the pavement were observed. Those cracks are attributed to the age of the pavement and the results of weathering process.

Landfill Runoff Collection Pond Dam
From Crest Looking Northeast Across
Saddle Dam

General Overview

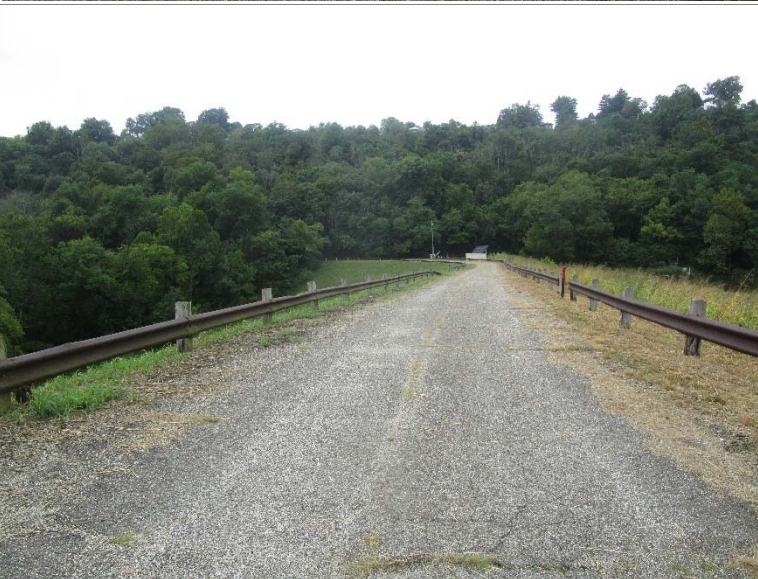
Photo No. 2

Landfill Runoff Collection Pond Dam
From Crest Looking Southwest

General Overview

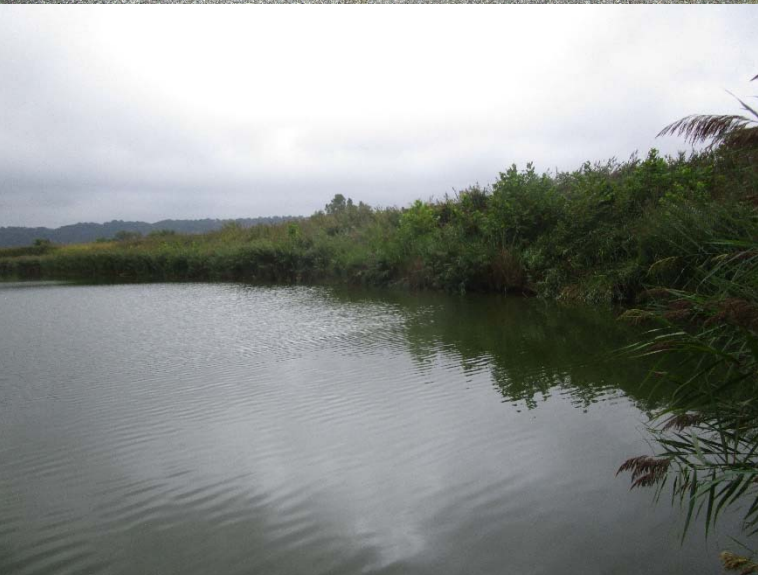
Photo No. 3

2. Photographs Nos. 3 and 4 provide overviews of the interior slope of the dam above the operating pool. Vegetation control near the water line and the upper slope areas is lacking, however, erosion due to wave action was not observed. Overall the slope was found to be in satisfactory and stable condition.

Landfill Runoff Collection Pond Dam
From Up Stream Slope

Overview of Current Operating Pool and
Vegetation Conditions on Interior Slope.

Significant vegetation Growth along the
Upstream of Dam

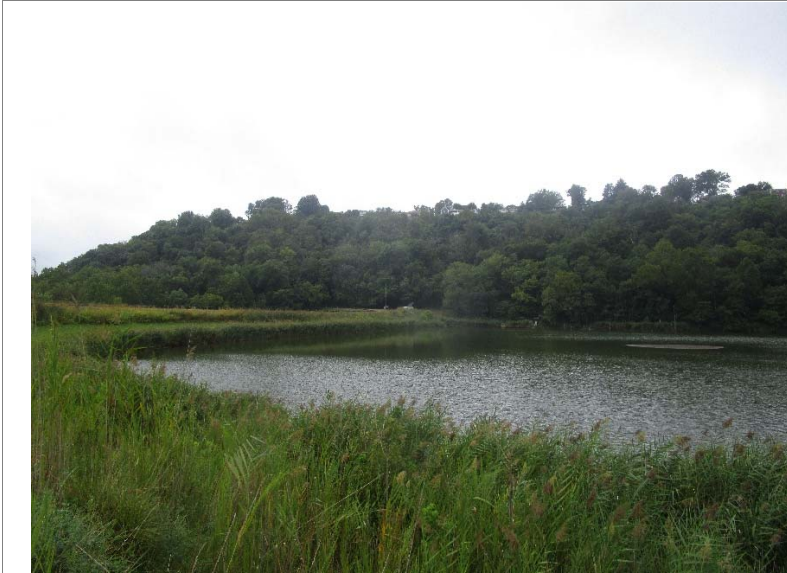
Photo No. 4

Landfill Runoff Collection Pond Dam
From Up Stream Slope

Overview of Vegetation and General
Conditions

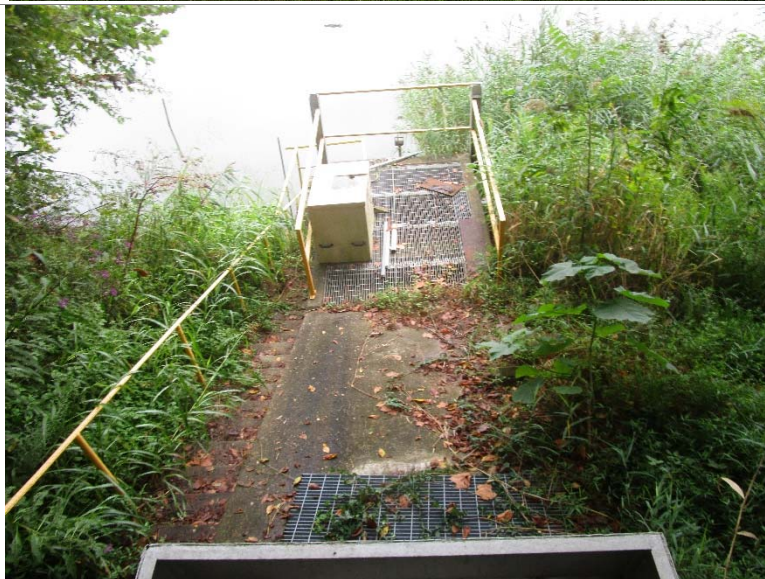
Photo No. 5

3. Photographs No. 5 and 6 are an overview of the principal spillway decant structure. Vegetation control was observed to be lacking. The decant structure and the access stairway appeared to be functioning properly and was free of obstructions. Photograph No.6 shows the recently added pipe to allow for treatment of discharged water.

Landfill Runoff Collection Pond Dam
From Roadway Leading to Crest Looking
Northeast

Overview of Vegetation Management and
General Condition-overgrown vegetation.

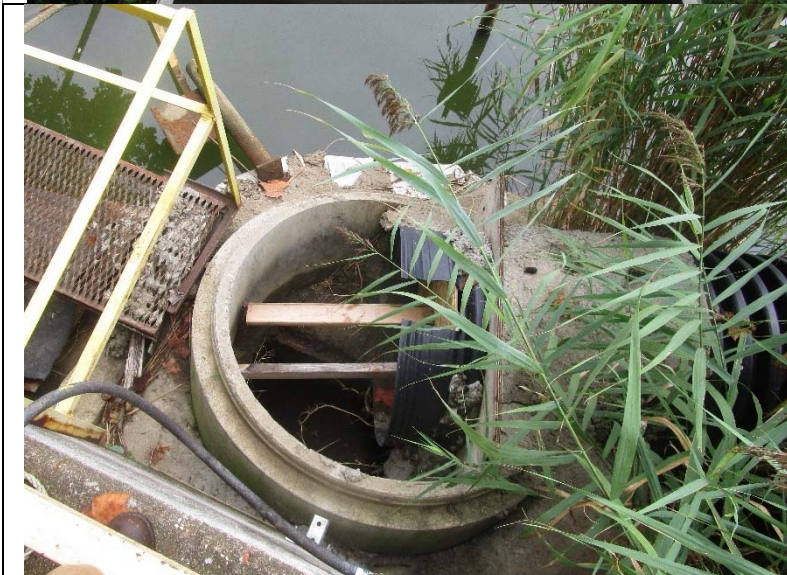
Photo No. 6

Landfill Runoff Collection Pond
Principal Spillway Structure

Looking at drop inlet for
treatment pipe.
-overgrown vegetation

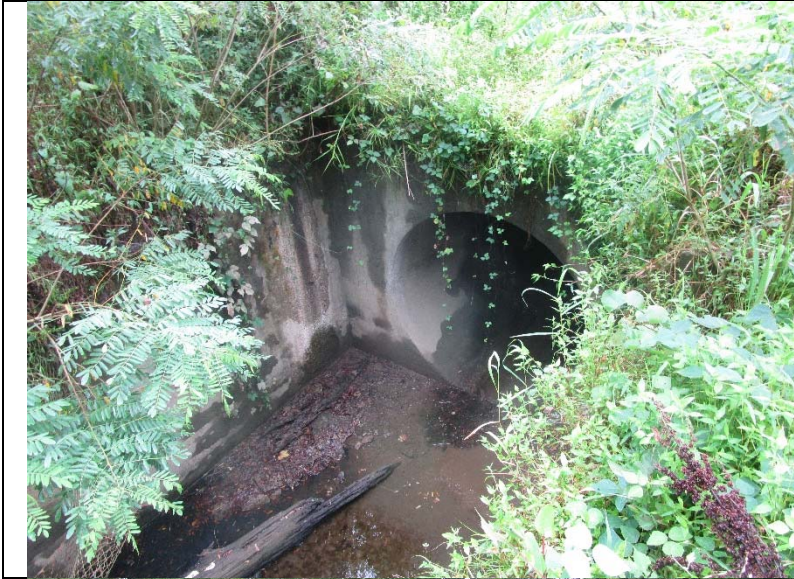
Photo No. 7

4. Photograph Nos. 7 and 8 is an overview of the principal spillway outlet channel. The channel is unobstructed with minimal flow at the time of the inspection. Vegetation control was observed to be lacking.

Landfill Runoff Collection Pond
Principal Spillway Outlet

General Overview –Backwater has been minimized since last inspection.
Overgrown vegetation

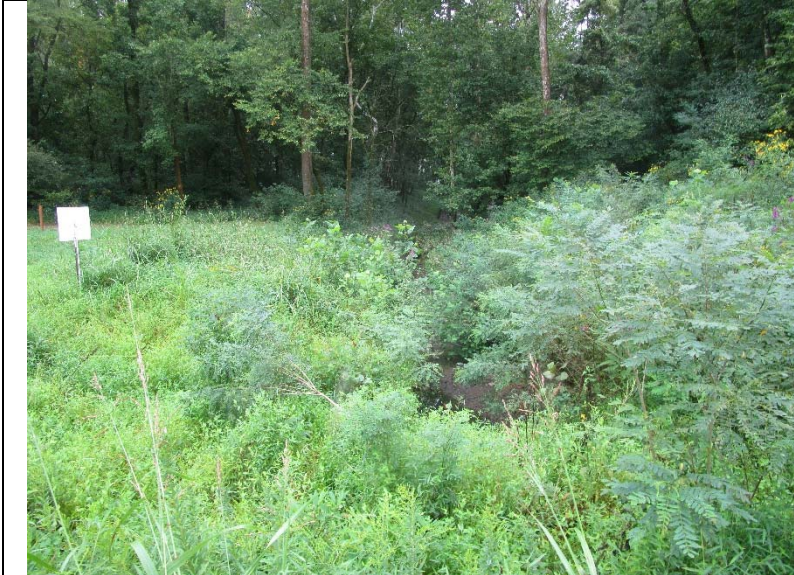
Photo No. 8

Landfill Runoff Collection Pond
Principal Spillway Outlet Channel
Looking Downstream

General Overview-overgrown vegetation

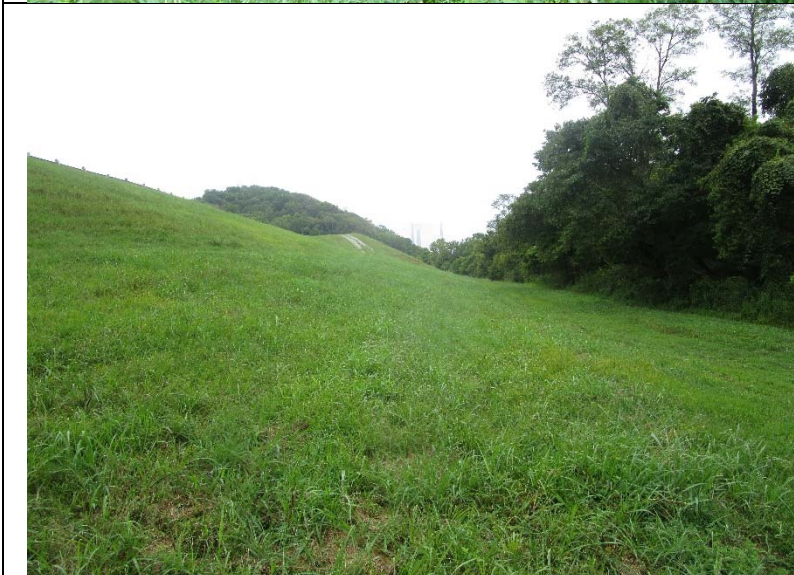
Photo No. 9

5. Photographs No's. 9 through 14 are all overviews of various areas of the exterior face of the dam as further described with each photograph. Throughout, vegetation control was adequate and there were no signs of sloughing, erosion or instability, except for the area adjacent to the previously repaired slope. No visible change was observed from previous inspections. In general, the exterior slope appeared to be in satisfactory and stable condition

Landfill Runoff Collection Pond Dam
Adjacent To Toe of Slope Looking East

Overview of Vegetation and General
Conditions

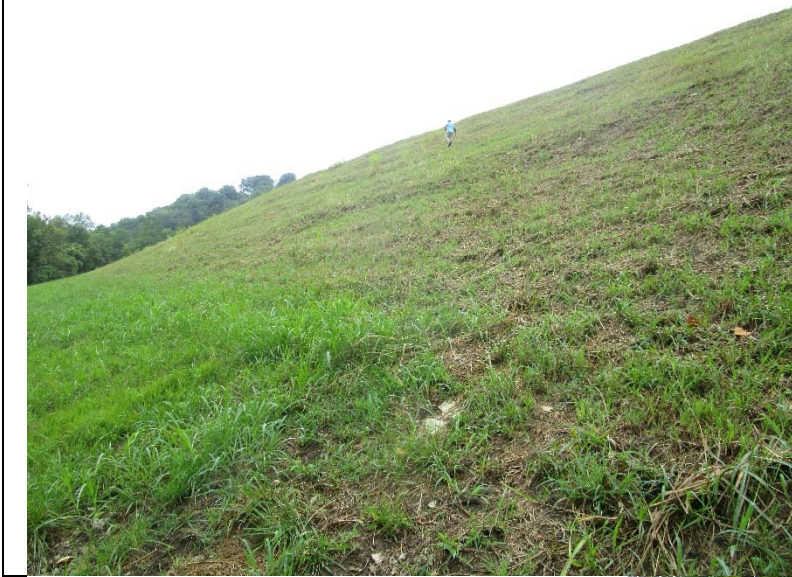
Photo No. 10

Landfill Runoff Collection Pond Dam
Adjacent To Toe of Slope Looking East

Overview of downstream slope adjacent
to rip rap repair area.

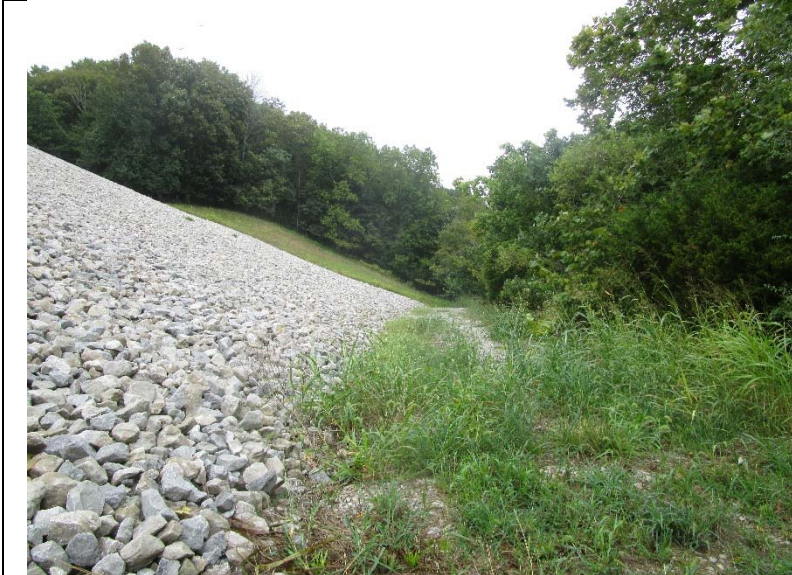
Photo No. 11

7. Photograph No.11 and No. 12 shows the previously repaired slope area that experienced sloughing/slip near the left abutment. The area appears to be in stable conditions. The repair also included installing a seepage collection pipe at the toe of rip rap placement. The pipe showed minimal flow at the time of inspection.

Landfill Runoff Collection Pond Dam
Adjacent To Toe of Slope Looking
Southwest

Overview of Vegetation and General
Conditions

- The soughing/slip area of the outboard slope needs to be repaired and stabilized in order to prevent additional damage to the slope area.

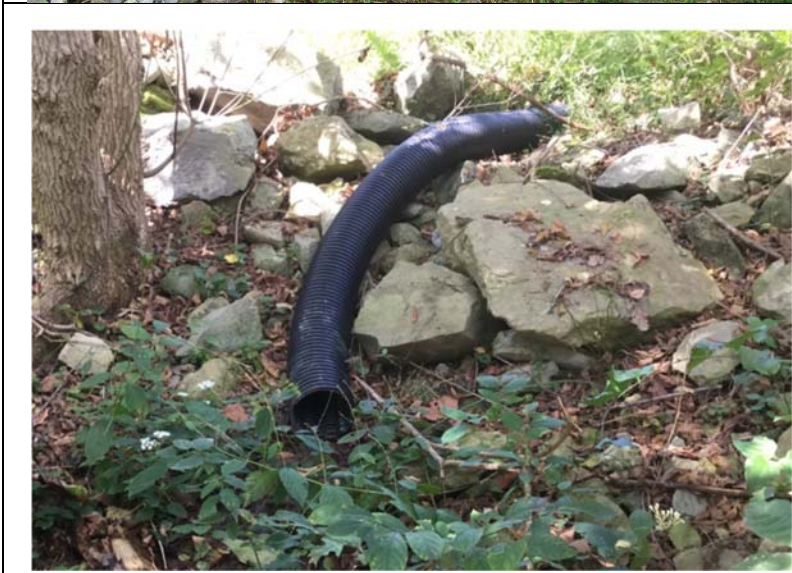
Photo No. 12

Overview of rip rap toe drain outlet pipe.
There was minor flow at time of
inspection. Looking west.

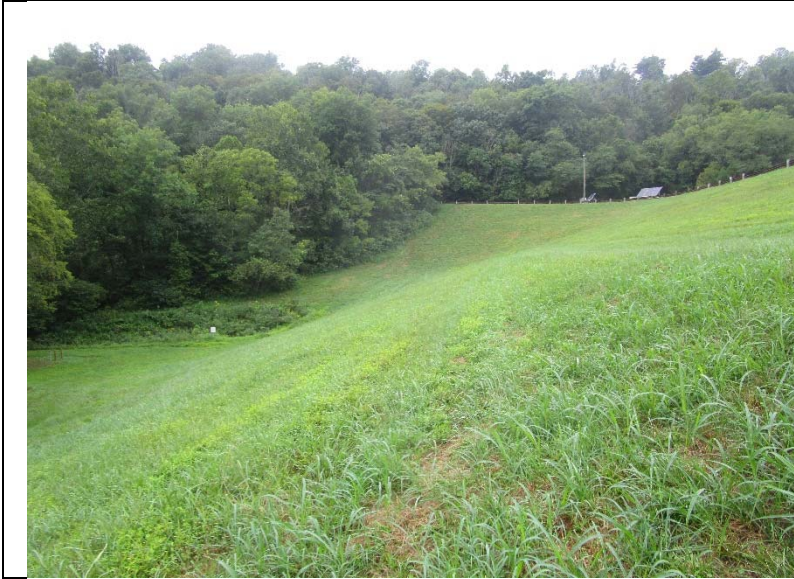
Photo No. 13

Overview of downstream slope area. Looking west.

General Overview

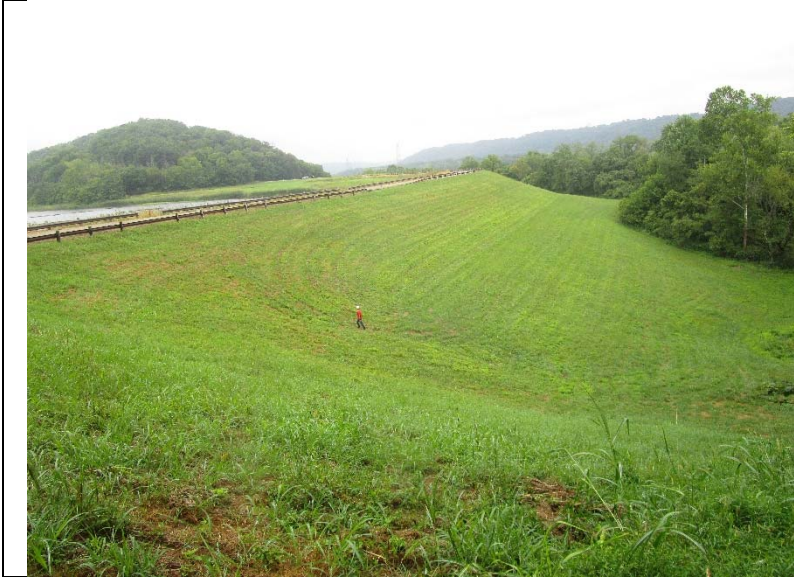
Photo No. 14

Landfill Runoff Collection Pond Dam From Top of Slope In Right Groin Looking East

Overview of Vegetation and General Conditions
