2020 ANNUAL DAM AND DIKE INSPECTION REPORT

**West Boiler Slag Pond
& Landfill Runoff Collection Pond**

**CLIFTY CREEK PLANT
Indiana-Kentucky Electric Corporation
MADISON, INDIANA**

INSPECTION DATE: December 09, 2020

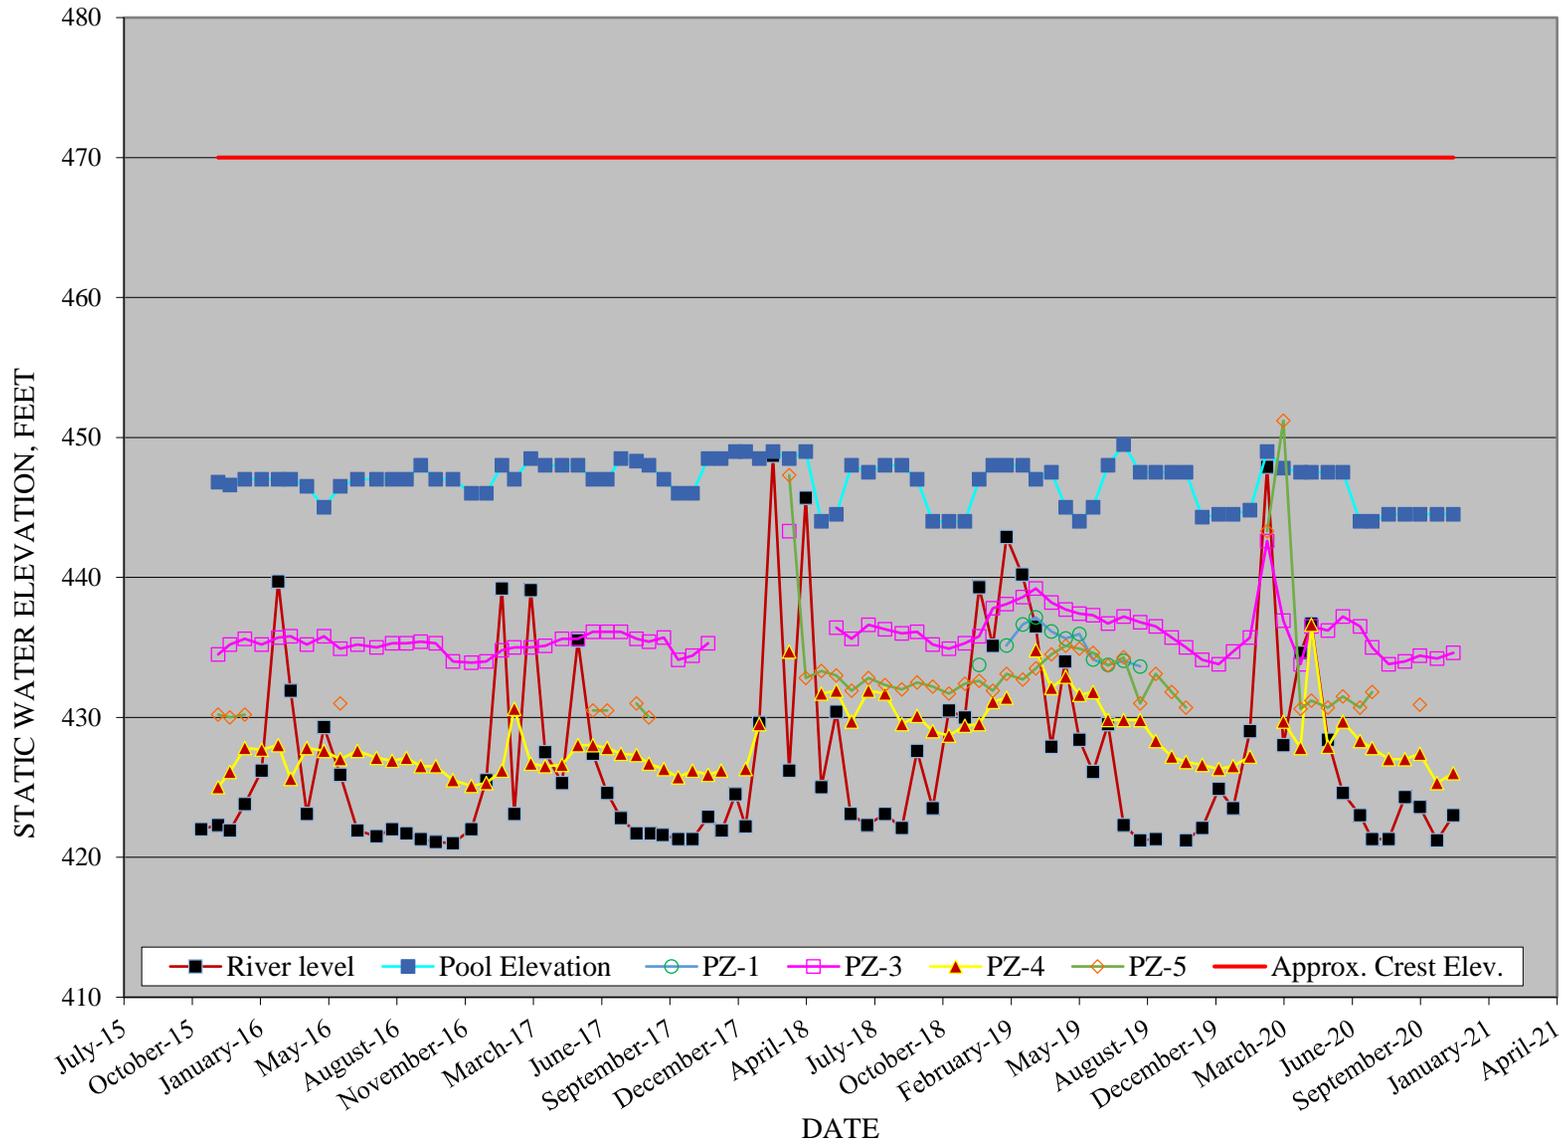
Figure 3 - West Boiler Slag Pond Piezometer Data.

A review of the data contained on the WBSP static water elevation plot showed that all piezometers exhibit consistent water elevations. The maximum readings in the piezometers since the last inspection are slightly higher. PZ-1 is a piezometer located at the crest of the constructed dike (shown as B-1 on location plan) which was found mostly in dry condition previously, but lately yielding readings in the early part of 2019 through middle of 2020. PZ-3 is a piezometer located at the crest of the constructed dike (shown as B-3 on location plan). PZ-4 is a piezometer located along a bench near the downstream toe of the constructed dike (shown as B-4 on location plan). PZ-5 is a piezometer located at the crest of the constructed dike (B-5 on location plan). Occasionally, PZ-5 was not yielding readings and found to be dry. Review of the static water elevation plot indicates that the static water levels for the piezometers generally fluctuate as a result of the water level fluctuations in the pool level (head water) and the river level (tail water), however, it appears that the river water level has more influence on all the piezometer’s water levels.

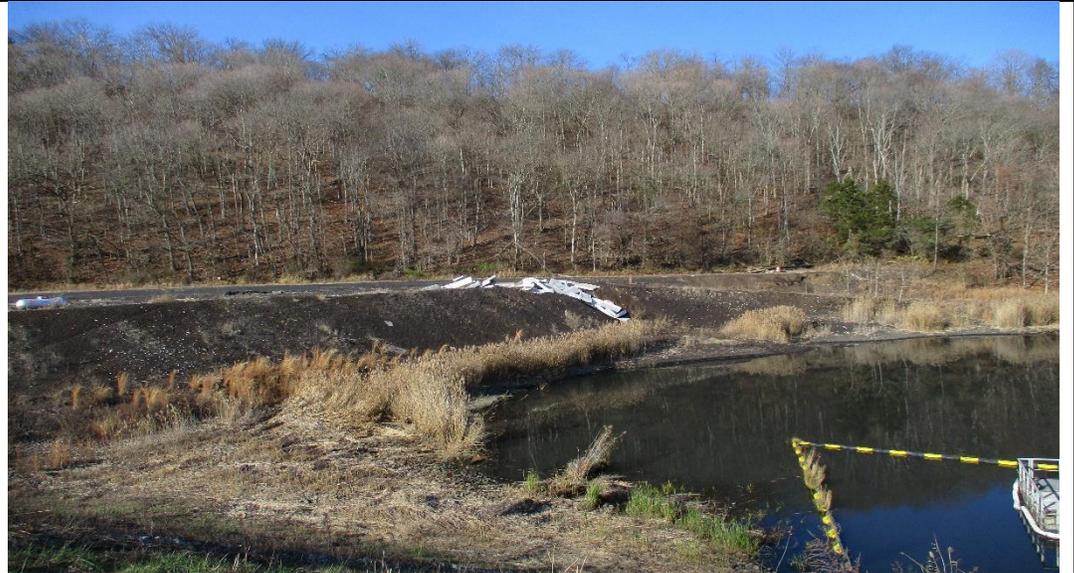
1. The northwest section of the dike and upstream slope are shown in Photograph No. 1. This slope consists of a layer of bottom ash. A small area on this slope appeared to have a depression or a large erosion gully that is filled with large size concrete debris (Photograph No. 2). The toe of the interior slope indicated slightly overgrown, dried vegetation.

<p>Photograph No. 1</p> <p>The northwest section of the upstream slope appears in fair condition with scattered vegetation.</p>

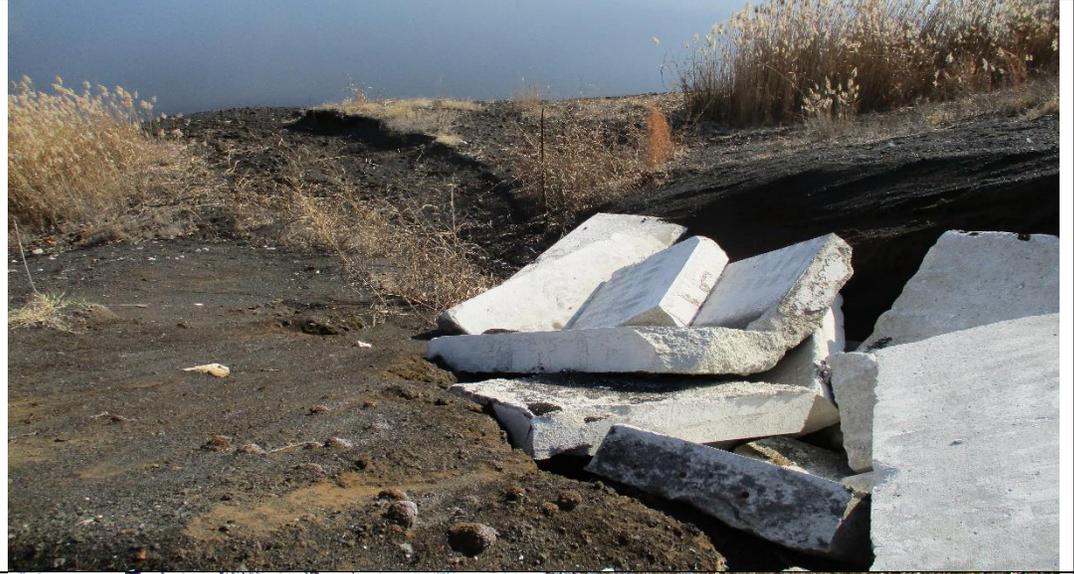
<p>Photograph No. 2</p> <p>A low area with concrete debris at the section of the dike.</p>

- > The two depressions (Photograph Nos. 2 and 11) identified at the upstream slope which are backfilled with hardened concrete or concrete debris shall be kept well maintained as part of the slope and should be backfilled further for stability.
- > Erosion gullies at the southeast upstream slope shall be repaired by backfilling with compatible material, regraded, and compacted.
- > Overgrown vegetation noticed along the interior slope should be mowed or cut down to minimum height so that it can be maintained on a regular basis.
- > Wet area, appeared to be minor seepage (Photograph No. 14) shall be monitored, reported with the plant inspection, followed by investigation and accordingly mitigated.

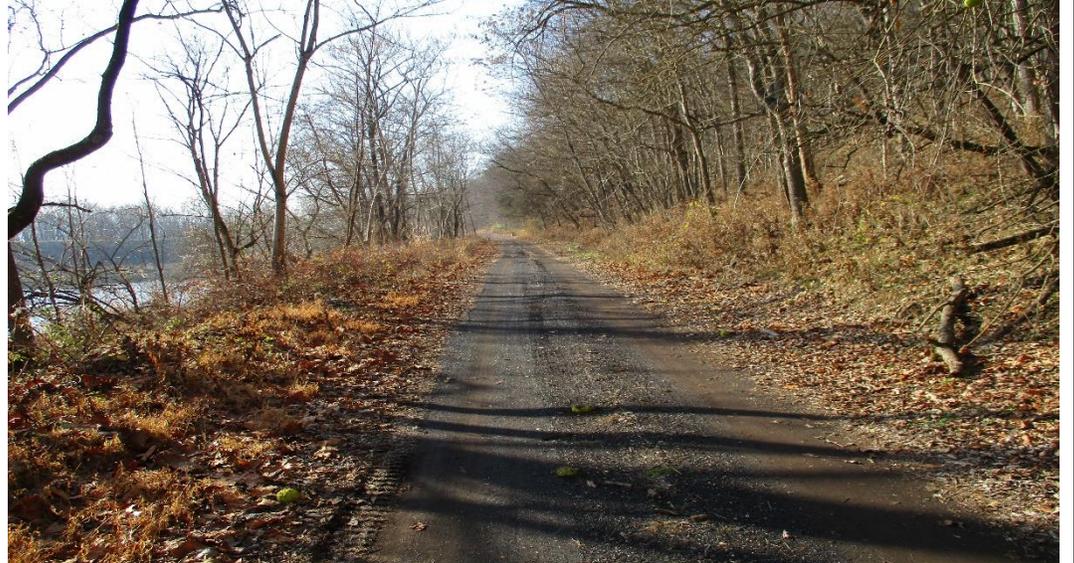
2. Photograph No. 3 illustrate a typical overview of the north dike crest. The crest appears to be in good and stable condition. Signs of settlement, misalignment and cracking were not observed. The upstream slope of this dike is illustrated in Photograph No. 4. The upstream is slightly steep, consists of trees and vegetation. The slope appeared to be in fair condition with some remnants of riprap still visible.

<p>Photograph No. 3</p> <p>This photograph illustrates typical condition of the crest also used as haul road.</p>

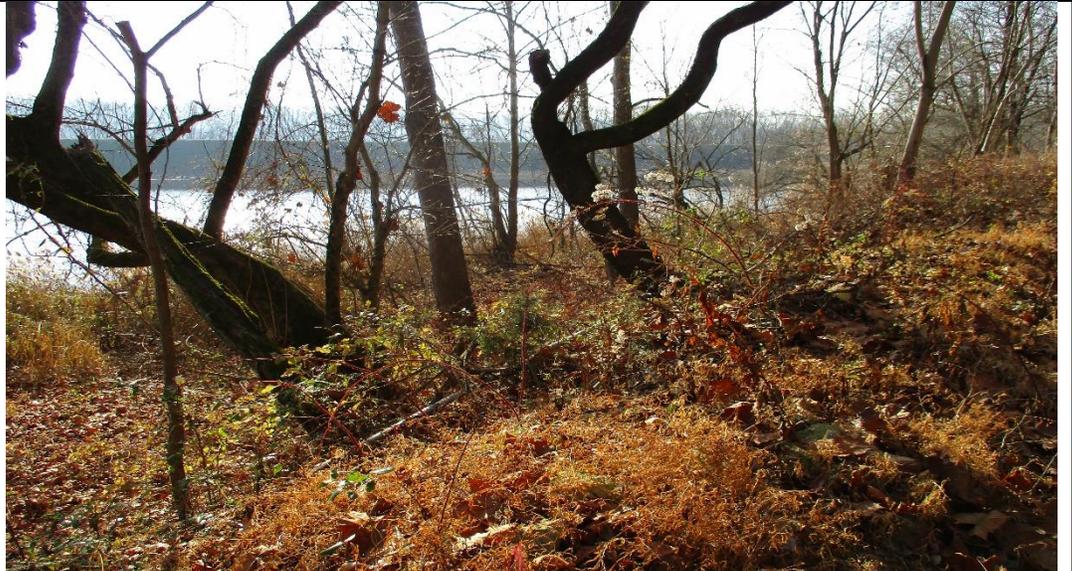
Photograph No. 4
The upstream slope of the north dike.

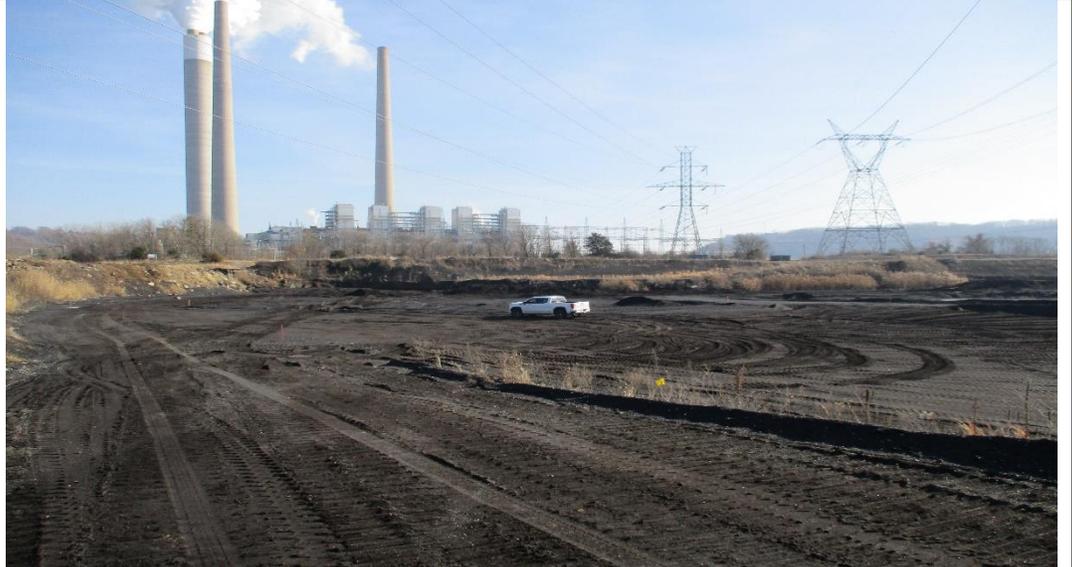
3. Photographs No. 5, and 6 illustrate the condition of the east end of pond that is used for settling and temporary storage of bottom ash. This area appeared to be in good condition, the upstream slope is slightly uneven but in fair and stable condition. Ash sluice pipes are located in this area of the pond (Photographs No. 6 and 7). The sluice pipes were in good functional condition and the access deck and support structure to the pipes were in good and stable condition.

Photograph No. 5
This photograph illustrate northeast area inside the pond used for temporary storage of bottom ash.

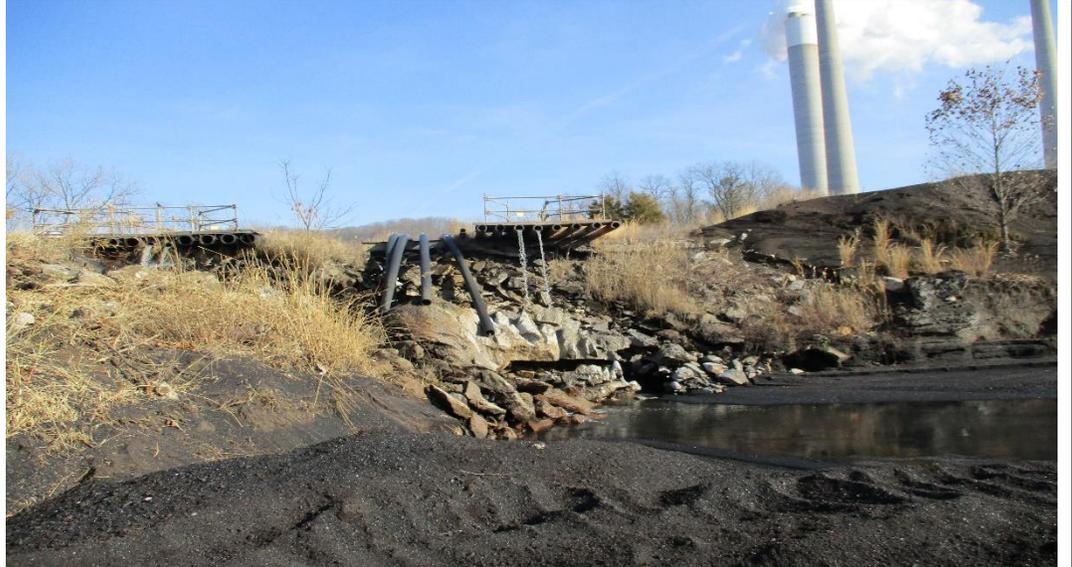
Photograph No. 6
This photograph illustrate bottom ash and other discharge pipes.

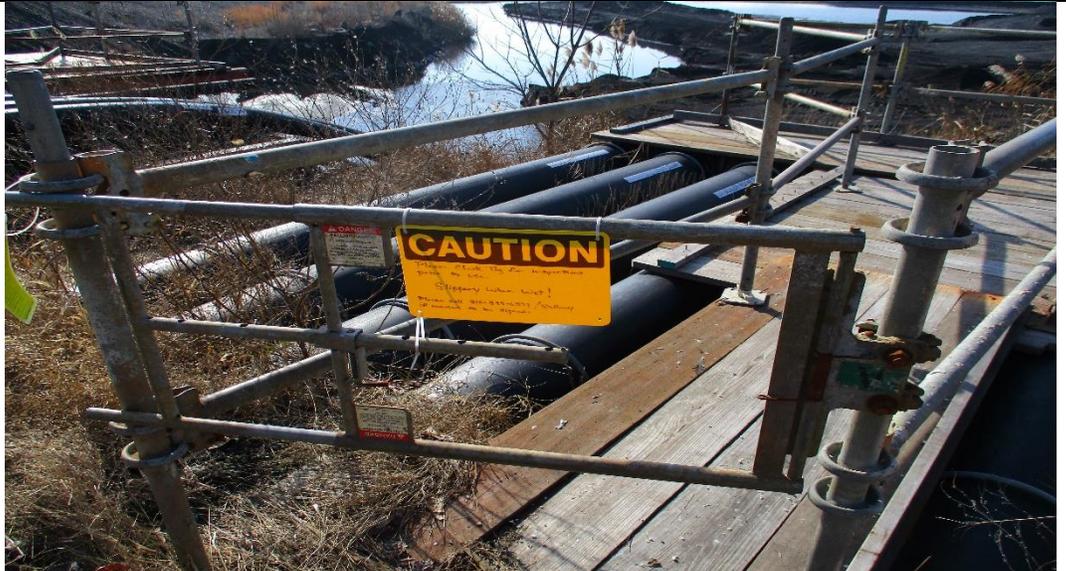
Photograph No. 7
The access wooden deck platform and support to the discharge pipes.

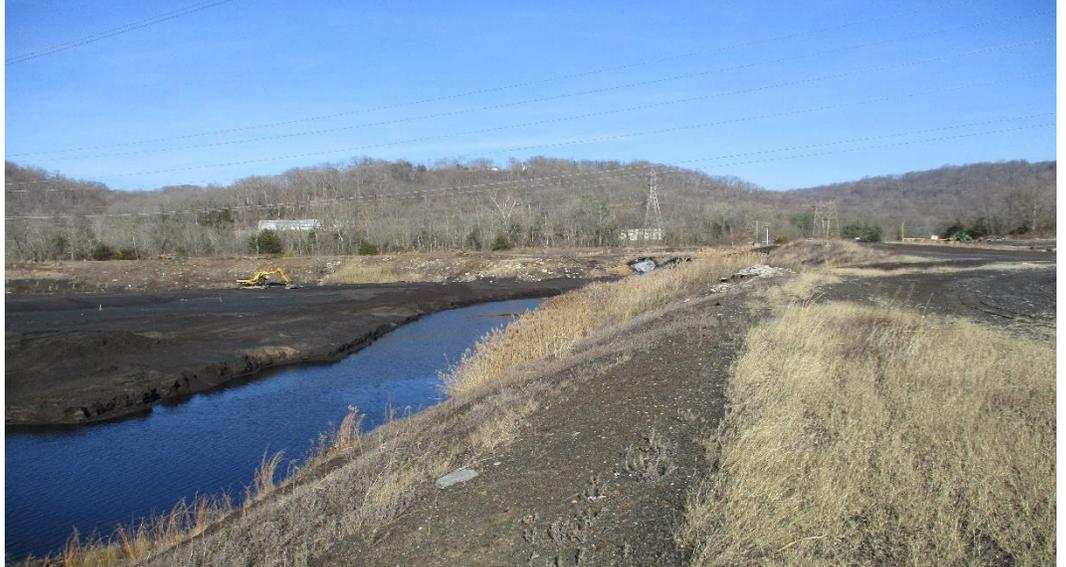
4. Photographs No. 8 and 9 illustrates the upstream slope of the northeast section of the dike. The upstream slope indicated minor erosion and some vegetation growth. This area of the pond interior consists substantial stockpiles of bottom ash. Erosion gullies were noticed along this section of the dike (Photographs No. 9 and 10). An area along the slope was spotted filled with dry concrete and concrete debris (Photograph No. 11).

Photograph No. 8
Typical view of the upstream slope (looking north).

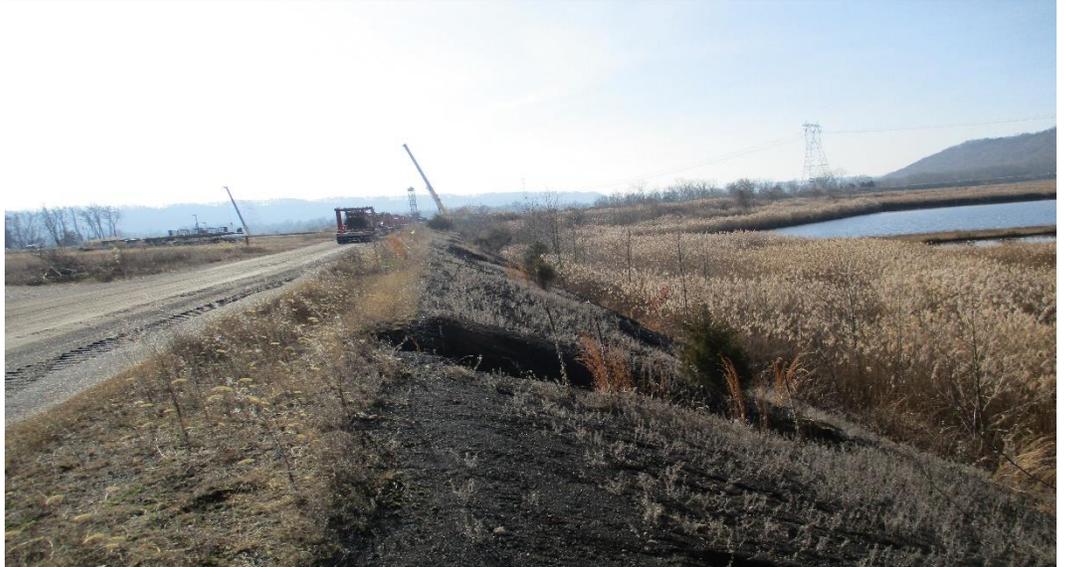
Photograph No. 9
This photograph illustrate general condition of the upstream slope of the east dike.

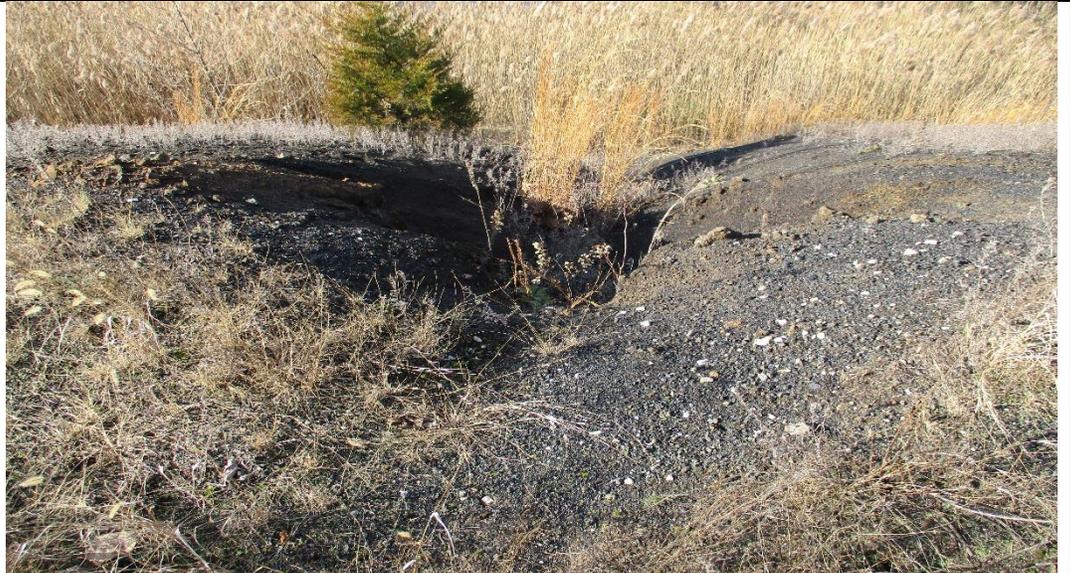
Photograph No. 10
Typical erosion gully.

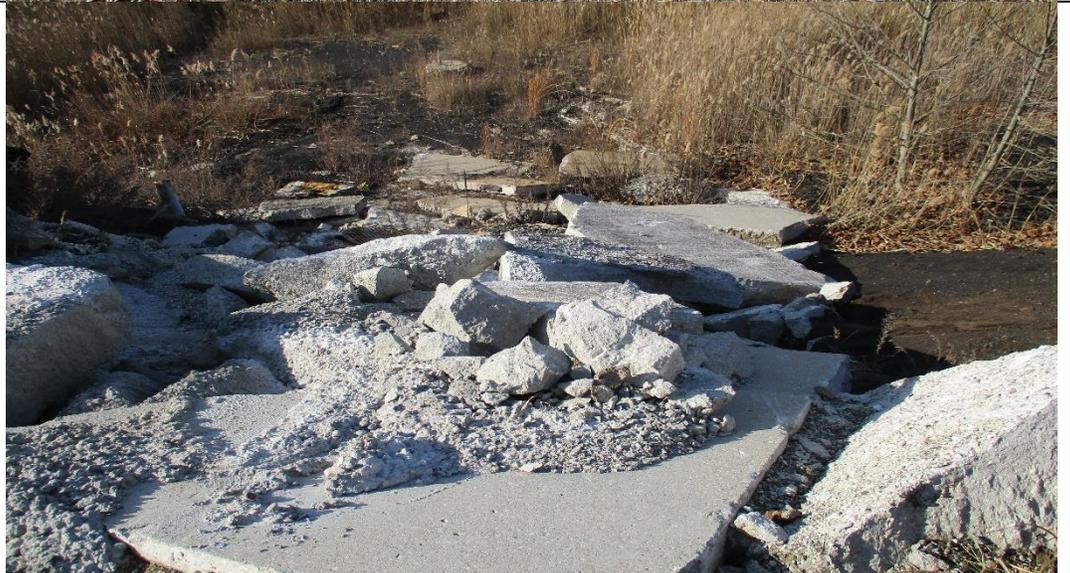
Photograph No. 11
Concrete debris dumped.

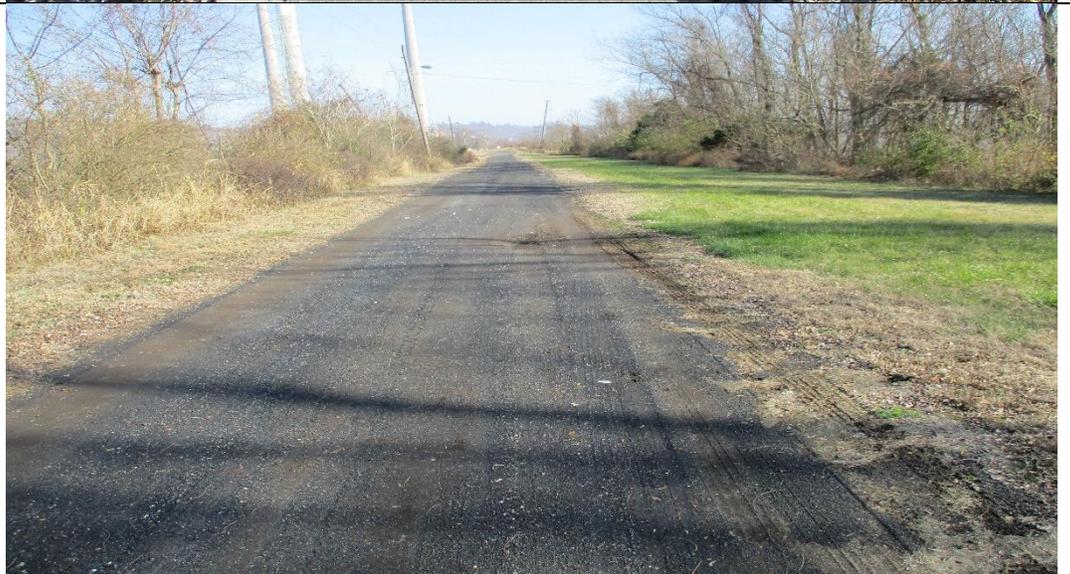
5. A typical condition of the south dike, east crest is illustrated in Photograph No. 12. The crest appeared in good and stable condition without no sign of significant settlement, depression, or misalignment.

Photograph No. 12
This photograph illustrate crest of the south dike.

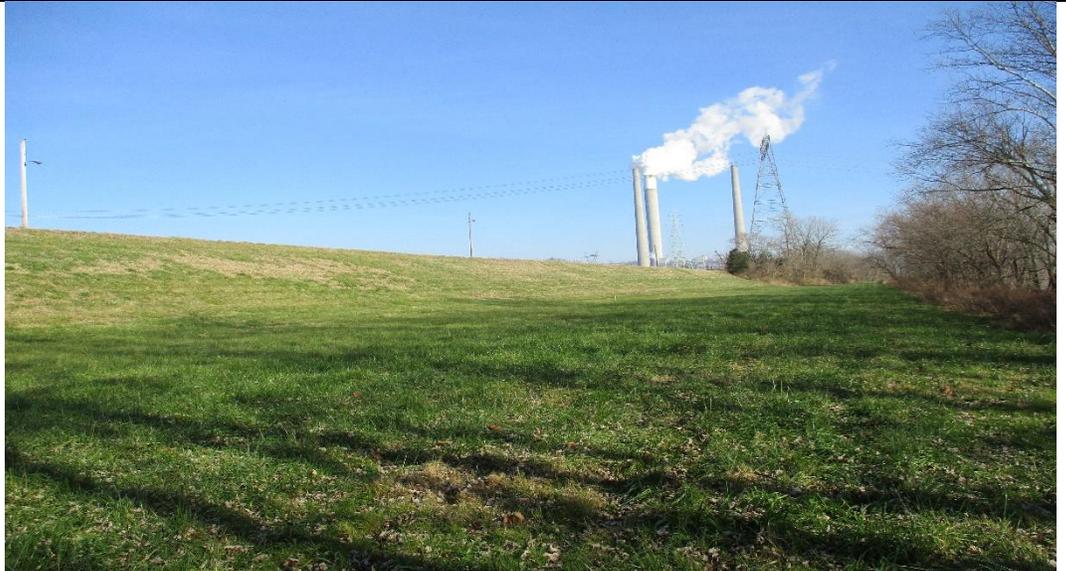
6. Photographs No. 13, 14, and 15 shows the general condition of the south dike upstream, downstream, and toe area. The slope appeared in good and stable condition. There were no signs of settlement, misalignment, sloughing or erosion. Wet area at the toe of this section of the dike was noticed with rutting and standing water.

Photograph No. 13
The downstream slope appears good.

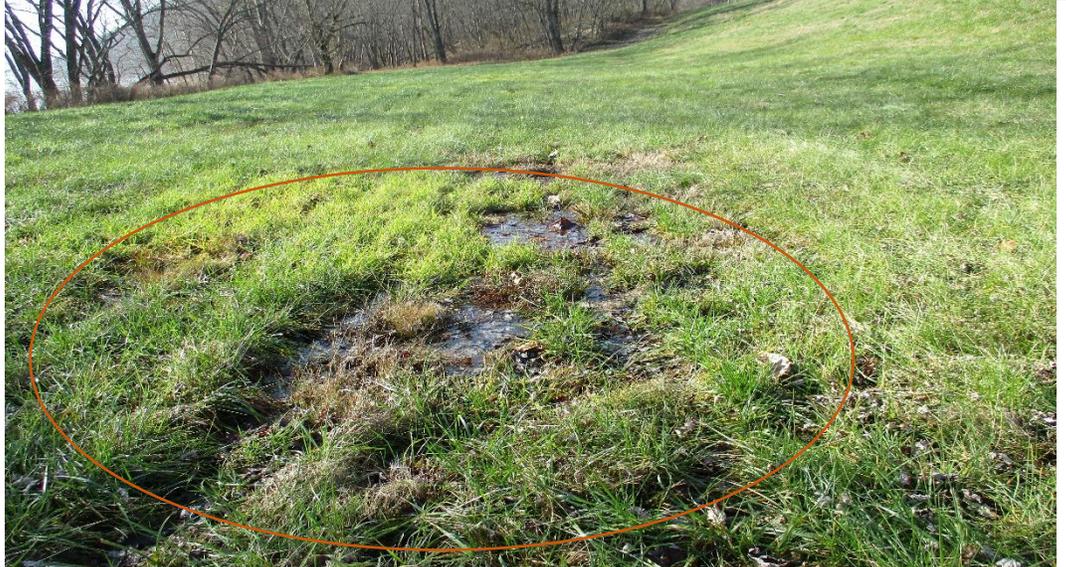
Photograph No. 14
Wet area.

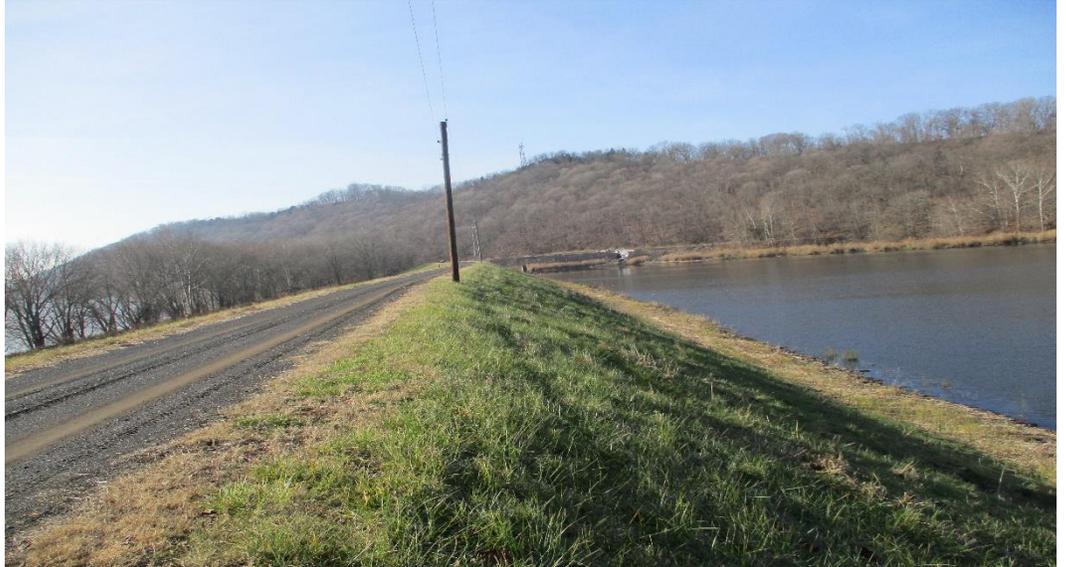
Photograph No. 15
Upstream slope of the south dike.

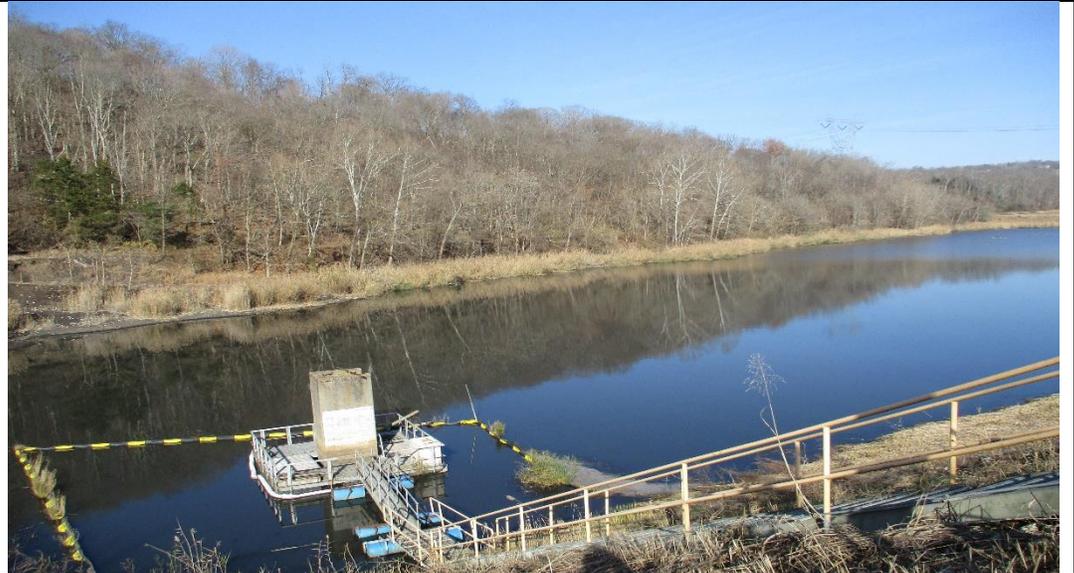
7. The overflow decant structure walkway, railings, metal decking, and visible concrete were found to be in satisfactory, functional condition. Photographs No. 16 and 17 illustrate the access stairs, metal walkway, metal deck, and concrete structure of the overflow decant structure. The Outfall # 002 pipe outflowing water to the Ohio River appeared in good condition without any obstruction to the flow (Photograph No. 18).

<p>Photograph No. 16</p> <p>The overflow decant structure, access stair, handrail, and deck appeared in functional condition.</p>

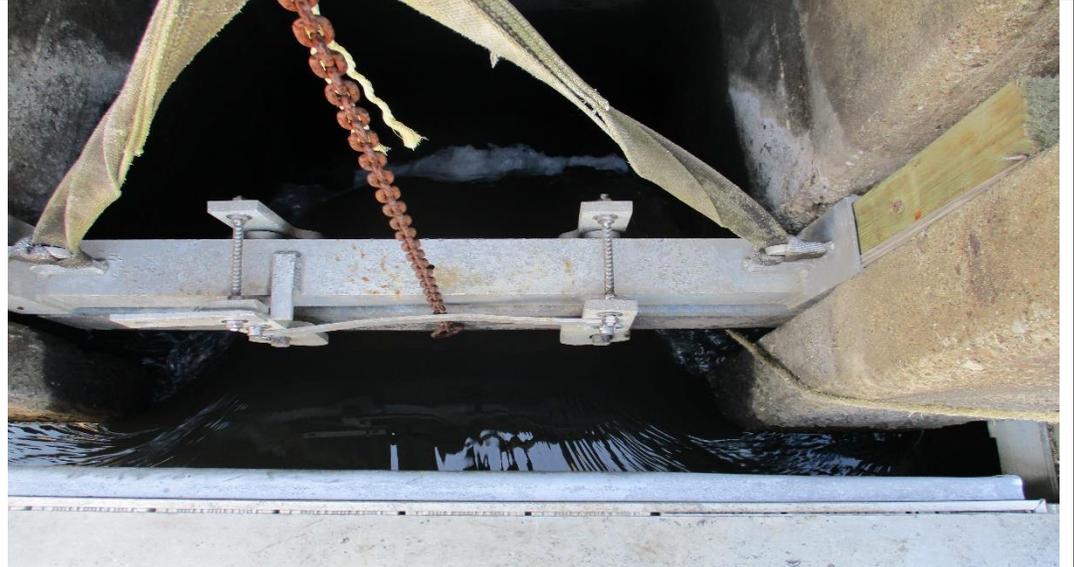
<p>Photograph No. 17</p> <p>The interior of the overflow decant structure, concrete, and appurtenances were in good functional condition.</p>

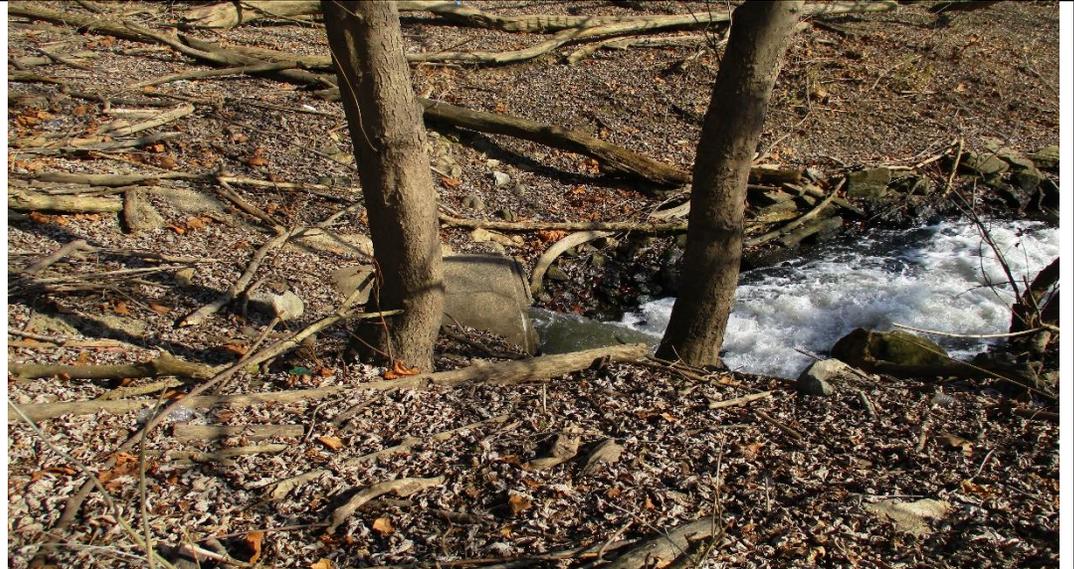
<p>Photograph No. 18</p> <p>The outfall appeared free of obstruction.</p>

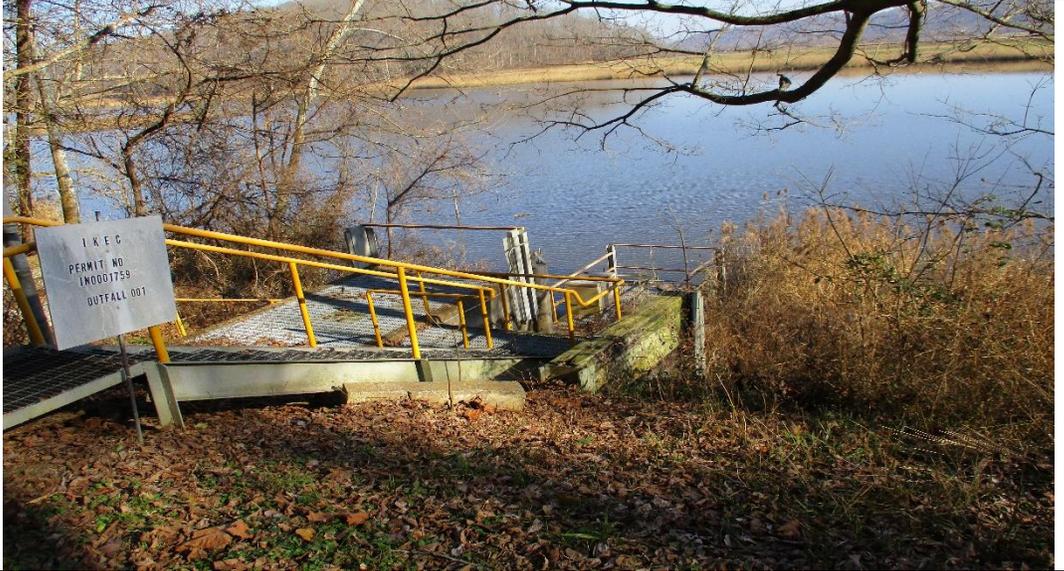
1. Photograph No. 19 illustrates an overview of the principal spillway decant structure. The decant structure and the access stairway appeared to be functioning properly and was free of obstructions. The recently added pipe (not shown in this photograph) to allow for treatment of discharged water was in functional condition. Slightly overgrown vegetation was notice along this dike upstream slope.

<p>Photograph No. 19</p> <p>The overflow decant structure visible concrete, railing, metal covers, side support, and stairs, were in operational condition.</p>

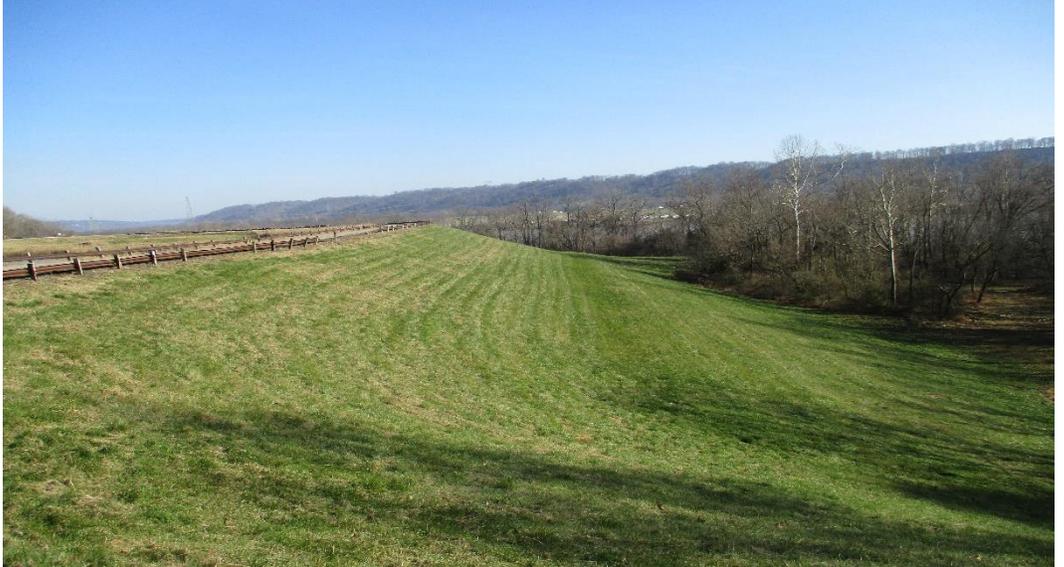
2. Photographs No. 20 and 21 show an overall view of the downstream slope of the dam. Throughout exterior slope vegetation control was good and there were no signs of sloughing, erosion or instability. In general, the exterior slope appeared to be in satisfactory and stable condition. A wet area encountered at the southwest corner of the slope (Photograph No. 21).

<p>Photograph No. 20</p> <p>This photograph illustrates typical view of the downstream slope (looking east).</p>

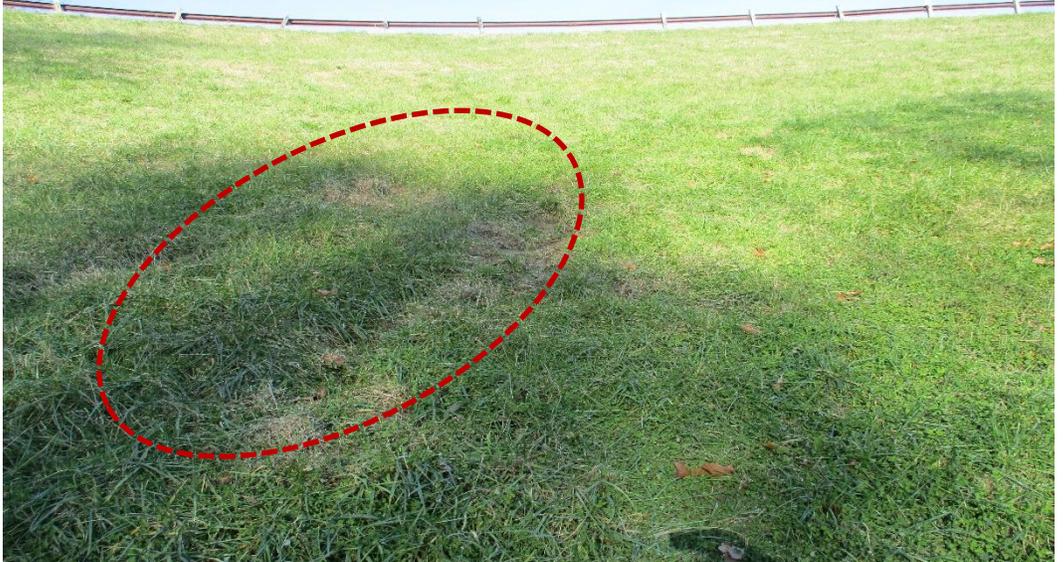
<p>Photograph No. 21</p> <p>Wet area at the downstream slope.</p>

- > Wet area, appeared to be minor seepage (Photograph No. 21) shall be monitored, reported with that plant inspection, followed by investigation and accordingly mitigated.
- > Piezometer those are consistently dry could be clogged at the screen level. These piezometers should be revive by flushing, recharging to make sure that those are in good working condition.

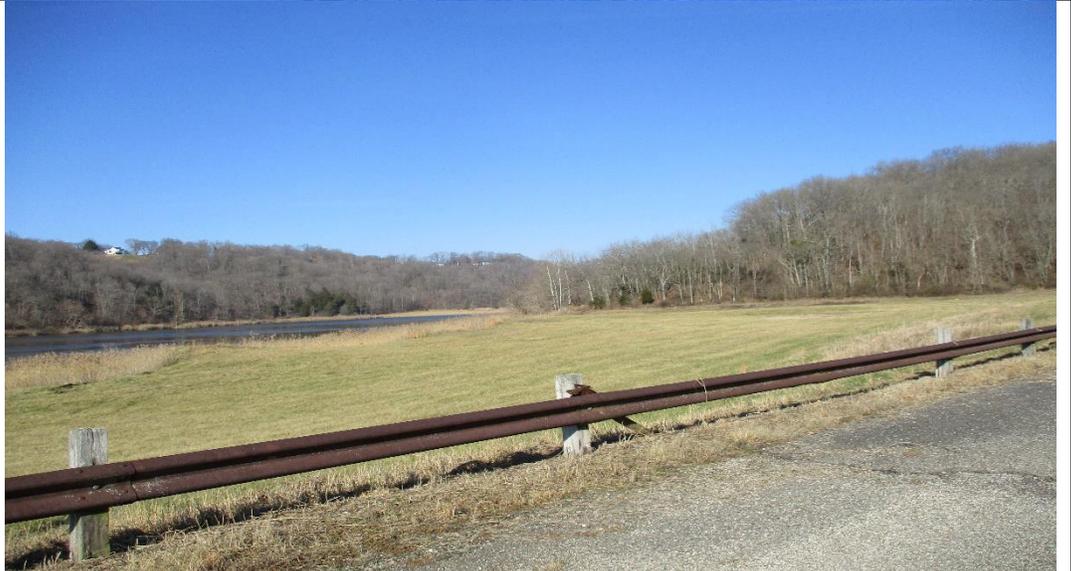
4. Photographs No. 23 illustrates typical condition of the crest and upstream slope of the dam. Signs of misalignment and settlement were not observed. Minor surface cracks in the pavement were observed. Those cracks are attributed to the age of the pavement and the results of weathering process. Vegetation control near the water line and the upper slope areas is lacking, however, erosion due to wave action was not observed. Overall the slope was found to be in satisfactory and stable condition

Photograph No. 23
The crest and upstream slope (looking northeast).
