2020 ANNUAL DAM AND DIKE INSPECTION REPORT

**West Boiler Slag Pond
& Landfill Runoff Collection Pond**

**CLIFTY CREEK PLANT
Indiana-Kentucky Electric Corporation
MADISON, INDIANA**

Document ID: GERS-20-041

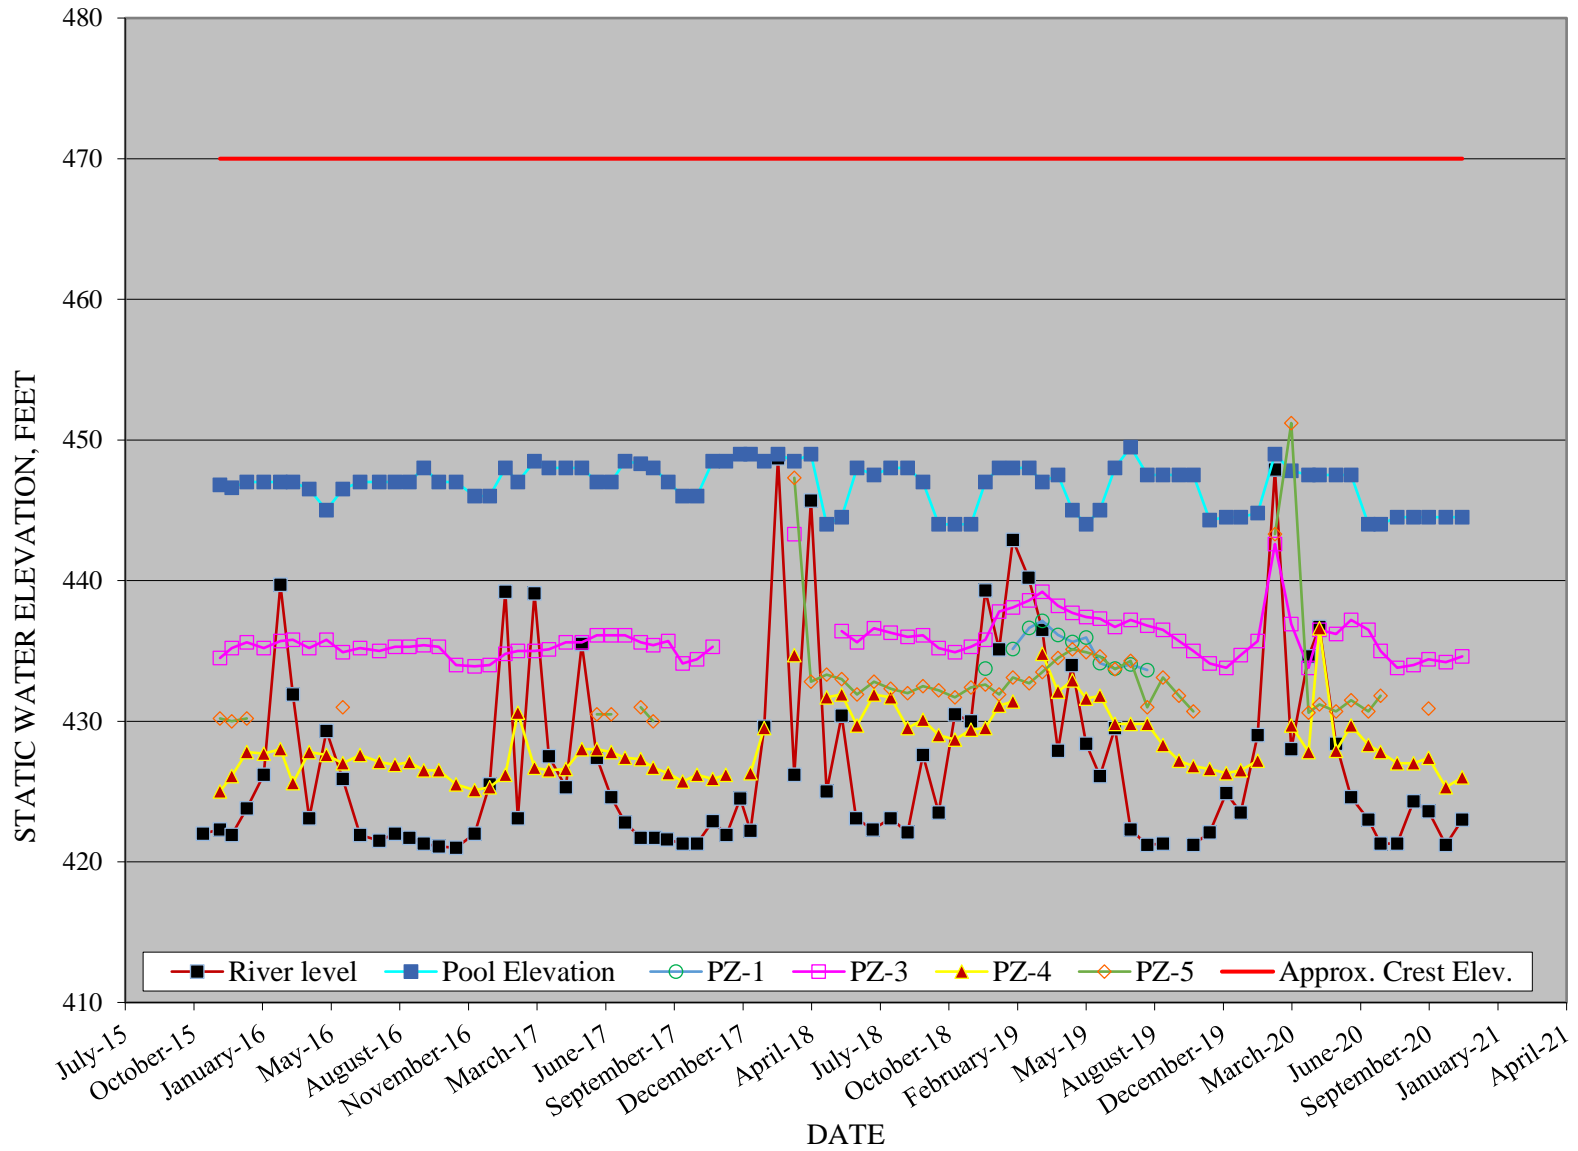
Figure 3 - West Boiler Slag Pond Piezometer Data.

A review of the data contained on the WBSP static water elevation plot showed that all piezometers exhibit consistent water elevations. The maximum readings in the piezometers since the last inspection are slightly higher. PZ-1 is a piezometer located at the crest of the constructed dike (shown as B-1 on location plan) which was found mostly in dry condition previously, but lately yielding readings in the early part of 2019 through middle of 2020. PZ-3 is a piezometer located at the crest of the constructed dike (shown as B-3 on location plan). PZ-4 is a piezometer located along a bench near the downstream toe of the constructed dike (shown as B-4 on location plan). PZ-5 is a piezometer located at the crest of the constructed dike (B-5 on location plan). Occasionally, PZ-5 was not yielding readings and found to be dry. Review of the static water elevation plot indicates that the static water levels for the piezometers generally fluctuate as a result of the water level fluctuations in the pool level (head water) and the river level (tail water), however, it appears that the river water level has more influence on all the piezometer's water levels.

- > Piezometer that are consistently dry could be clogged at the screen level. These piezometers should be revive by flushing, recharging to make sure that those are in good working condition.

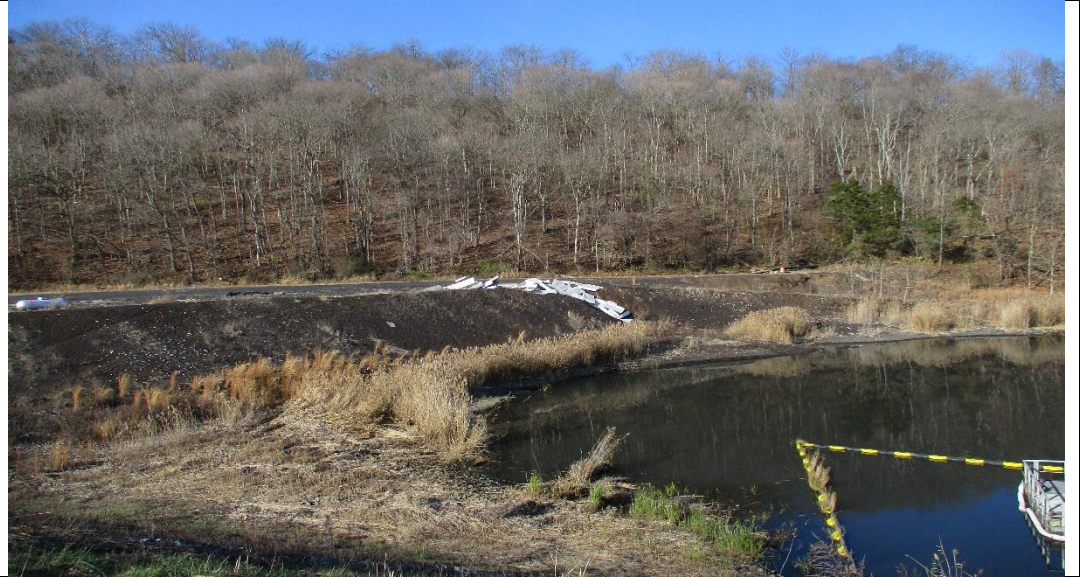
1. The northwest section of the dike and upstream slope are shown in Photograph No. 1. This slope consists of a layer of bottom ash. A small area on this slope appeared to have a depression or a large erosion gully that is filled with large size concrete debris (Photograph No. 2). The toe of the interior slope indicated slightly overgrown, dried vegetation.
2. Photograph No. 3 illustrate a typical overview of the north dike crest. The crest appears to be in good and stable condition. Signs of settlement, misalignment and cracking were not observed. The upstream slope of this dike is illustrated in

<p>Photograph No. 1</p> <p>The northwest section of the upstream slope appears in fair condition with scattered vegetation.</p>

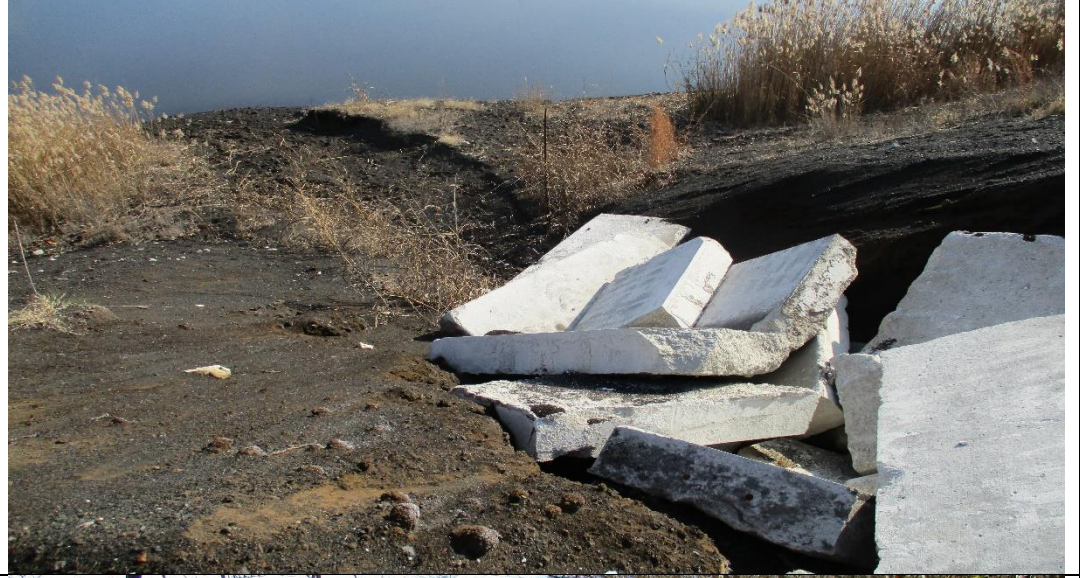
<p>Photograph No. 2</p> <p>A low area with concrete debris at the section of the dike.</p>

- > The two depressions (Photograph Nos. 2 and 11) identified at the upstream slope which are backfilled with hardened concrete or concrete debris shall be kept well maintained as part of the slope and should be backfilled further for stability.
- > Erosion gullies at the southeast upstream slope shall be repaired by backfilling with compatible material, regraded, and compacted.
- > Overgrown vegetation noticed along the interior slope should be mowed or cut down to minimum height so that it can be maintained on a regular basis.
- > Wet area, appeared to be minor seepage (Photograph No. 14) shall be monitored, reported with the plant inspection, followed by investigation and accordingly mitigated.

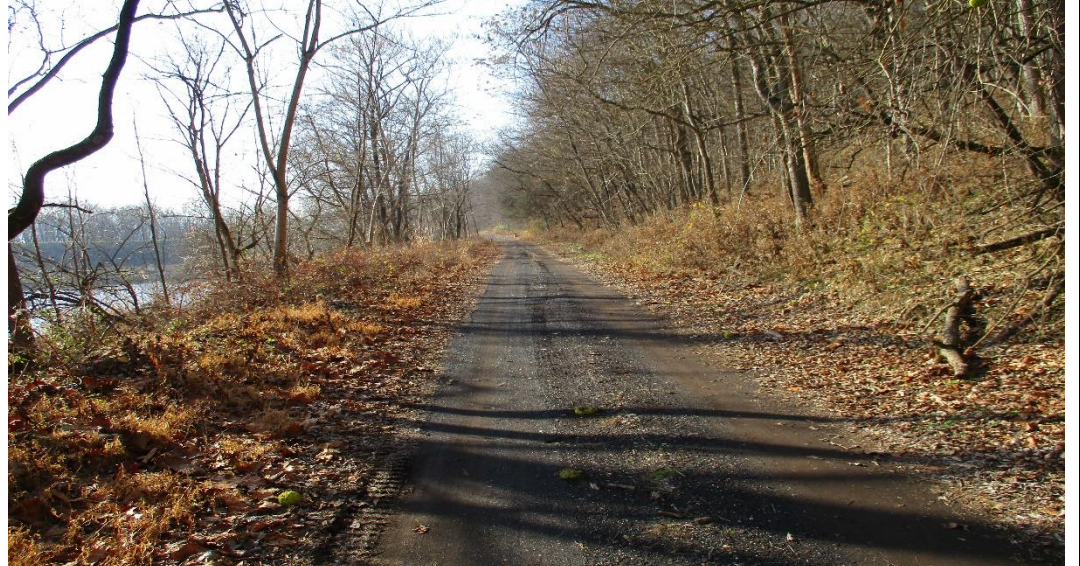
<p>Photograph No. 3</p> <p>This photograph illustrates typical condition of the crest also used as haul road.</p>

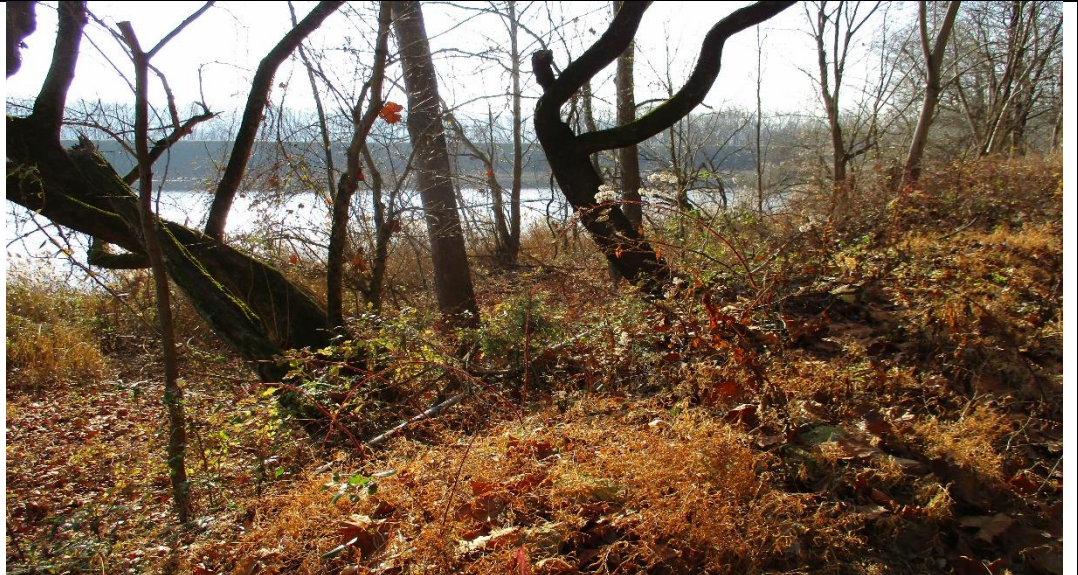
Photograph No. 4
The upstream slope of the north dike.

Photograph No. 4. The upstream is slightly steep, consists of trees and vegetation. The slope appeared to be in fair condition with some remnants of riprap still visible.

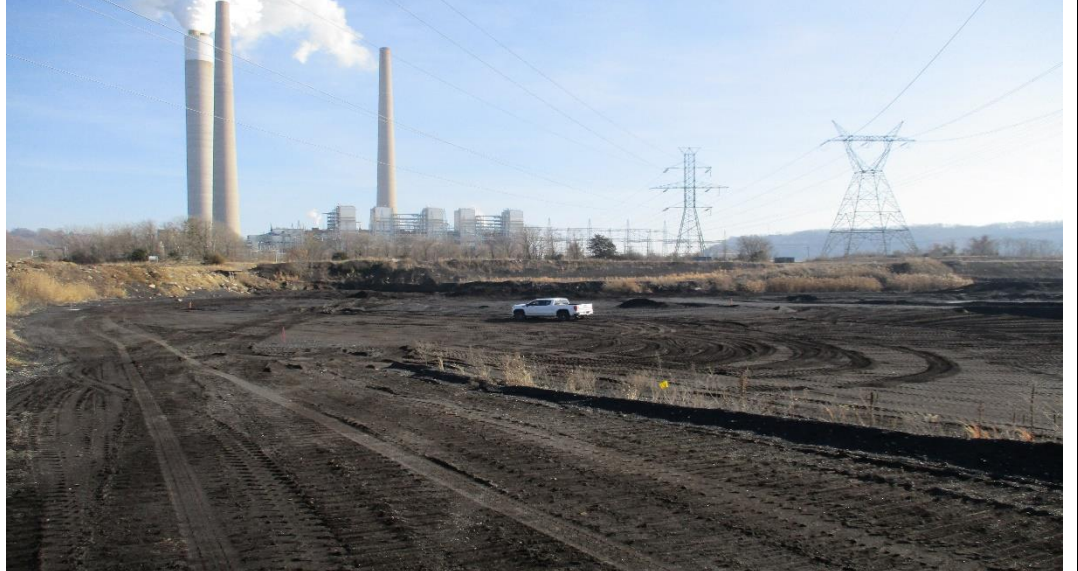
Photograph No. 5
This photograph illustrate northeast area inside the pond used for temporary storage of bottom ash.

3. Photographs No. 5, and 6 illustrate the condition of the east end of pond that is used for settling and temporary storage of bottom ash. This area appeared to be in good condition, the upstream slope is slightly uneven but in fair and stable condition. Ash sluice pipes are located in this area of the pond (Photographs No. 6 and 7). The sluice pipes were in good functional condition and the access deck and support structure to the pipes were in good and stable condition.

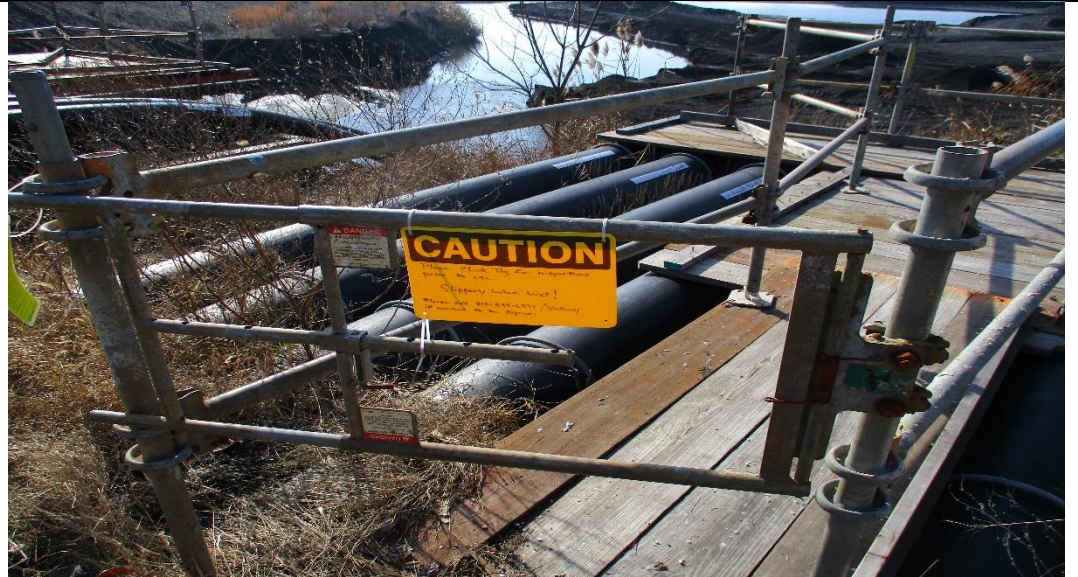
Photograph No. 7

The access wooden deck platform and support to the discharge pipes.

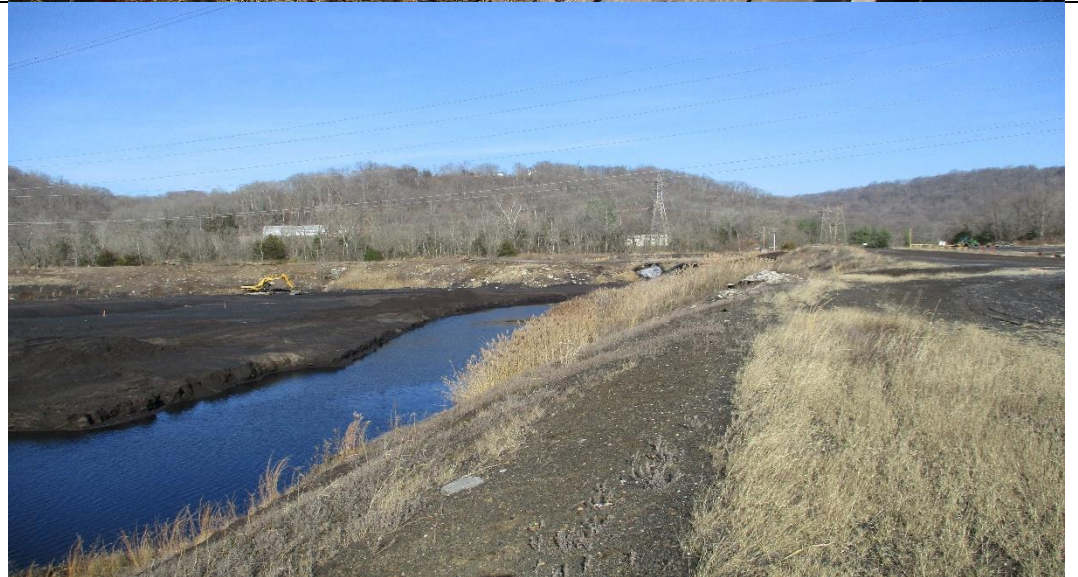
Photograph No. 8

4. Photographs No. 8 and 9 illustrates the upstream slope of the northeast section of the dike. The upstream slope indicated minor erosion and some vegetation growth. This area of the pond interior consists substantial stockpiles of bottom ash. Erosion gullies were noticed along this section of the dike (Photographs No. 9 and 10). An area along the slope was spotted filled with dry concrete and concrete debris (Photograph No. 11).

Typical view of the upstream slope (looking north).

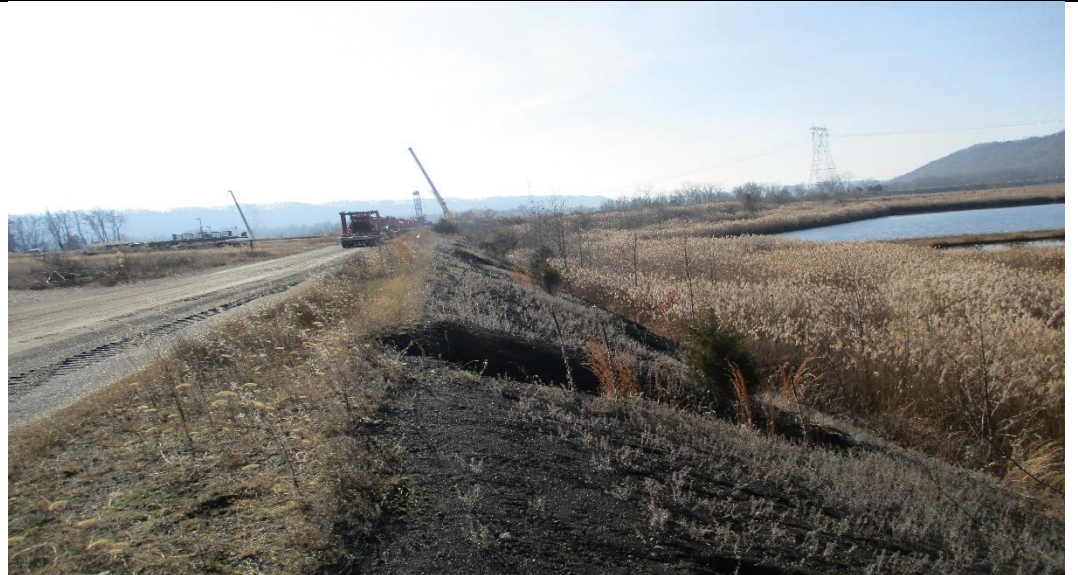
Photograph No. 9

This photograph illustrate general condition of the upstream slope of the east dike.

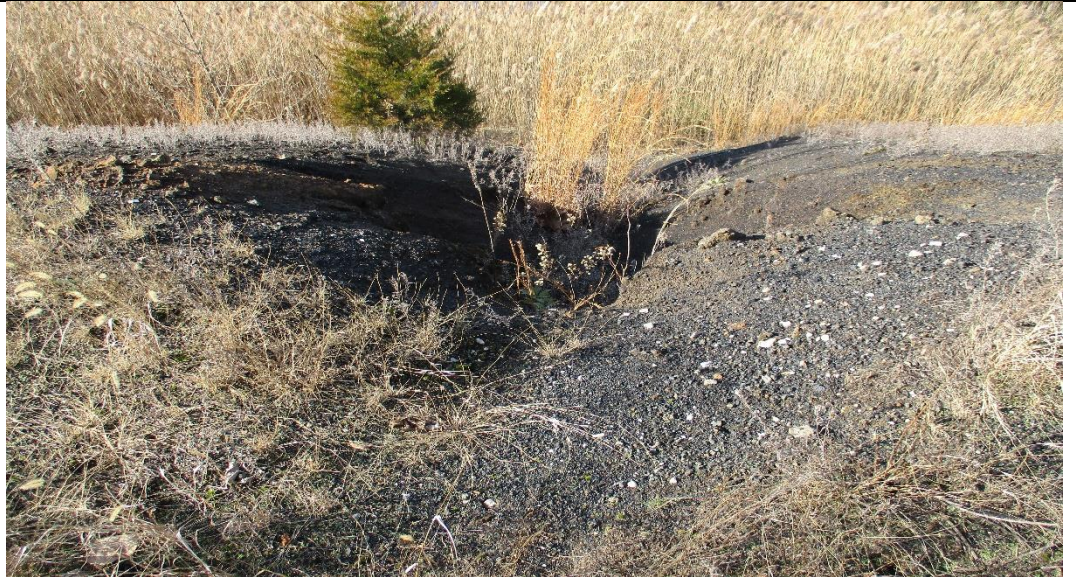
Photograph No. 10
Typical erosion gully.

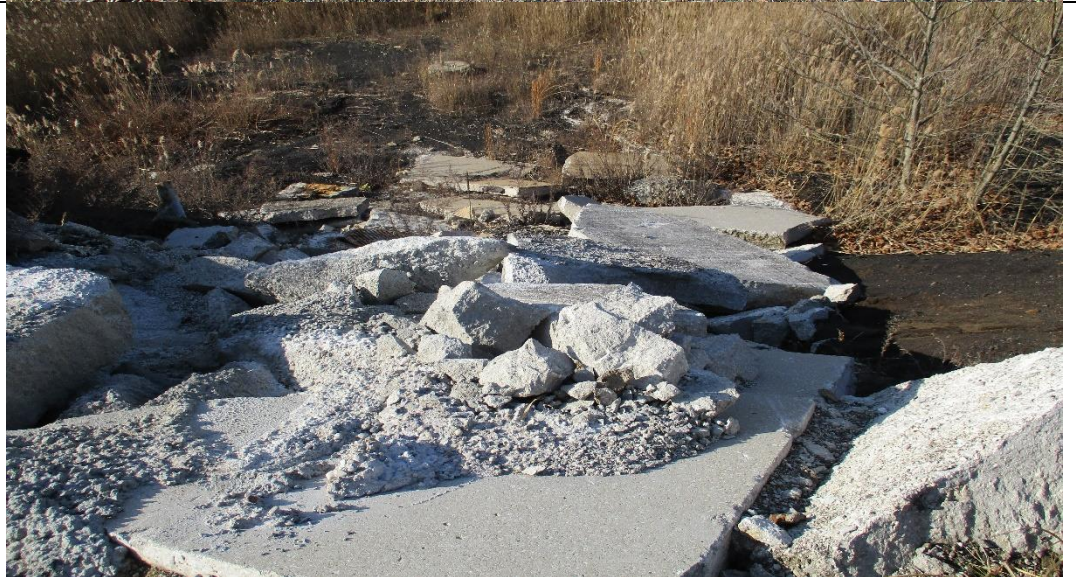
Photograph No. 11
Concrete debris dumped.

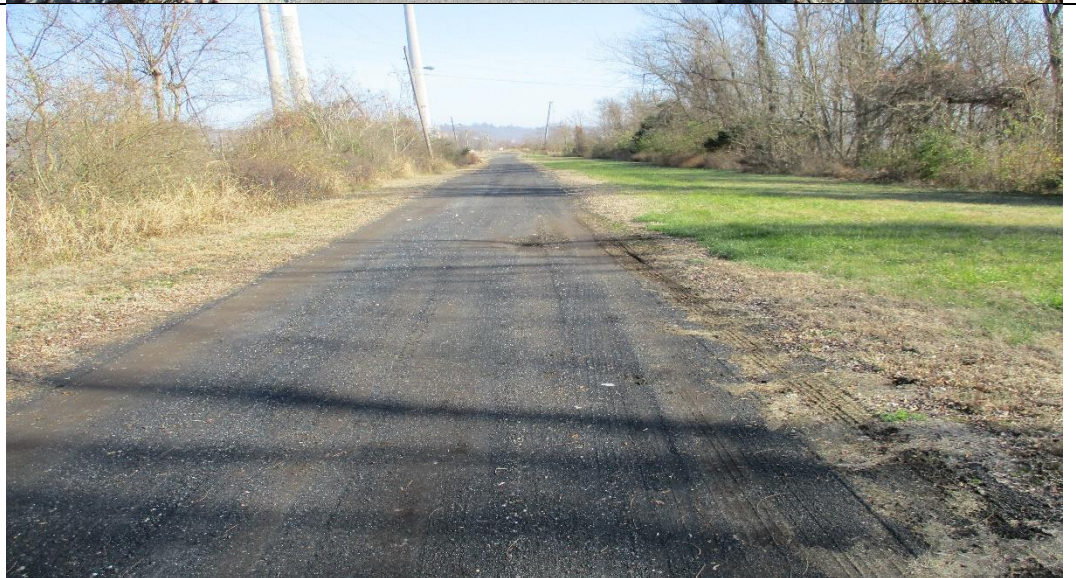
5. A typical condition of the south dike, east crest is illustrated in Photograph No. 12. The crest appeared in good and stable condition without no sign of significant settlement, depression, or misalignment.

Photograph No. 12
This photograph illustrate crest of the south dike.

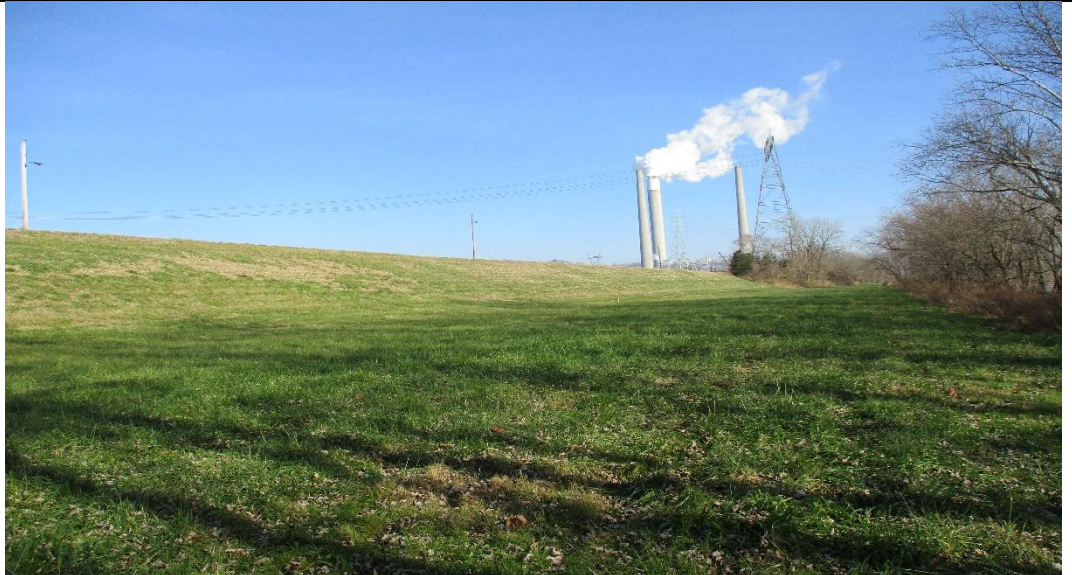
6. Photographs No. 13, 14, and 15 shows the general condition of the south dike upstream, downstream, and toe area. The slope appeared in good and stable condition. There were no signs of settlement, misalignment, sloughing or erosion. Wet area at the toe of this section of the dike was noticed with rutting and standing water.

Photograph No. 13
The downstream slope appears good.

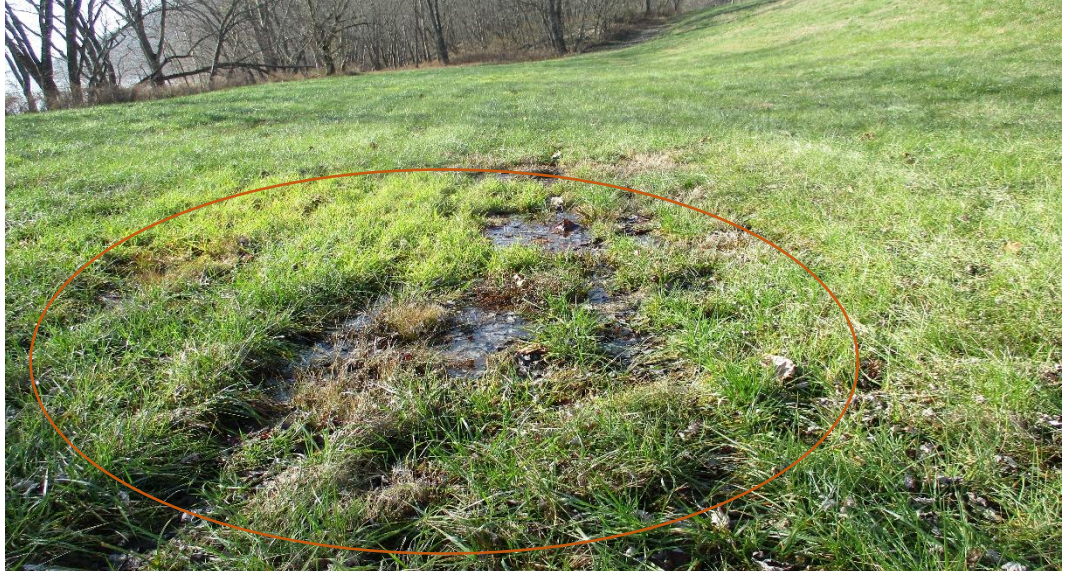
Photograph No. 14
Wet area.

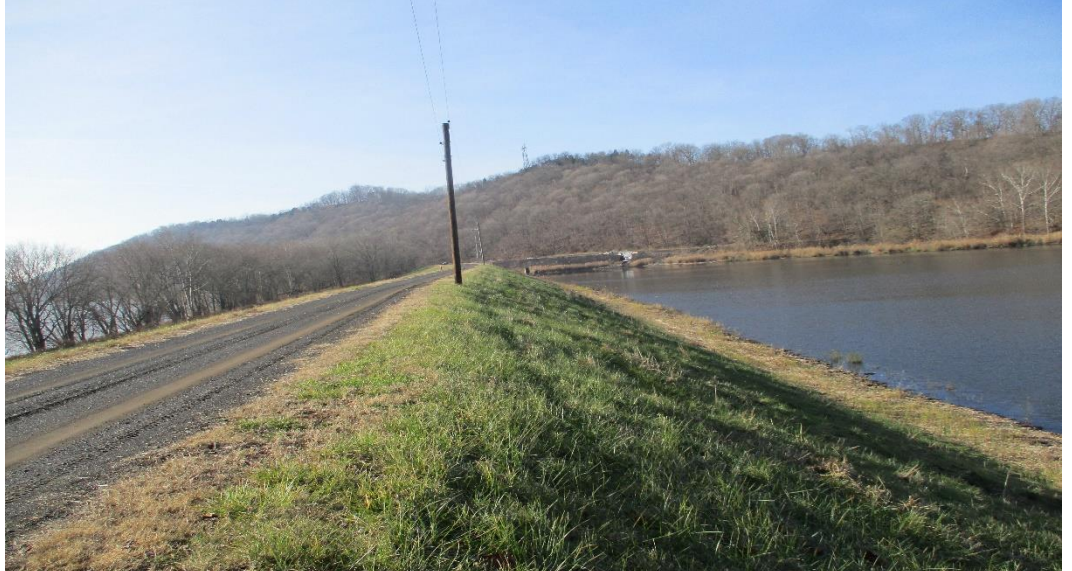
Photograph No. 15
Upstream slope of the south dike.

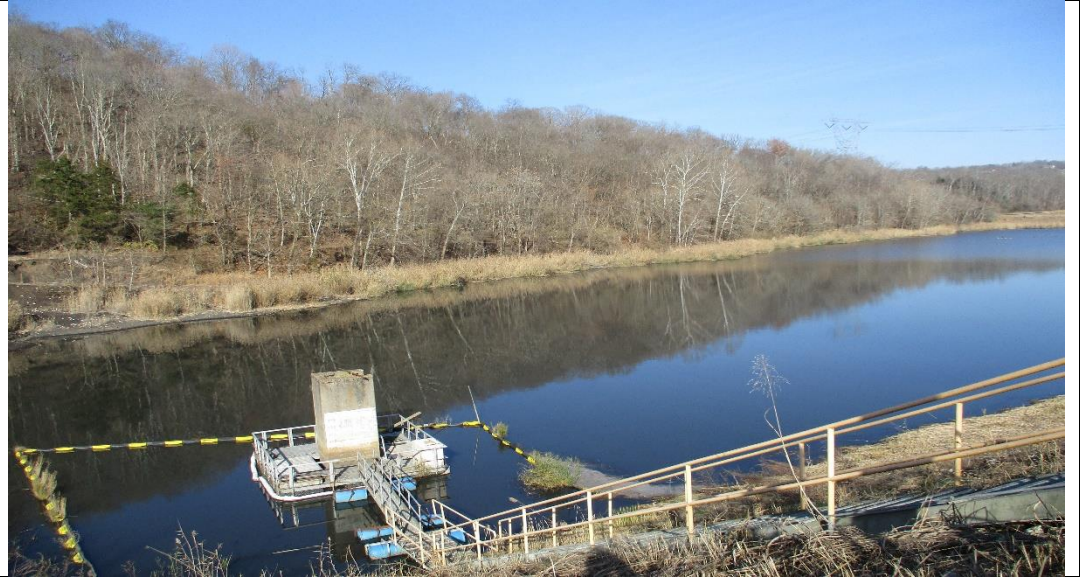
7. The overflow decant structure walkway, railings, metal decking, and visible concrete were found to be in satisfactory, functional condition. Photographs No. 16 and 17 illustrate the access stairs, metal walkway, metal deck, and concrete structure of the overflow decant structure. The Outfall # 002 pipe outflowing water to the Ohio River appeared in good condition without any obstruction to the flow (Photograph No. 18).

<p>Photograph No. 16</p> <p>The overflow decant structure, access stair, handrail, and deck appeared in functional condition.</p>

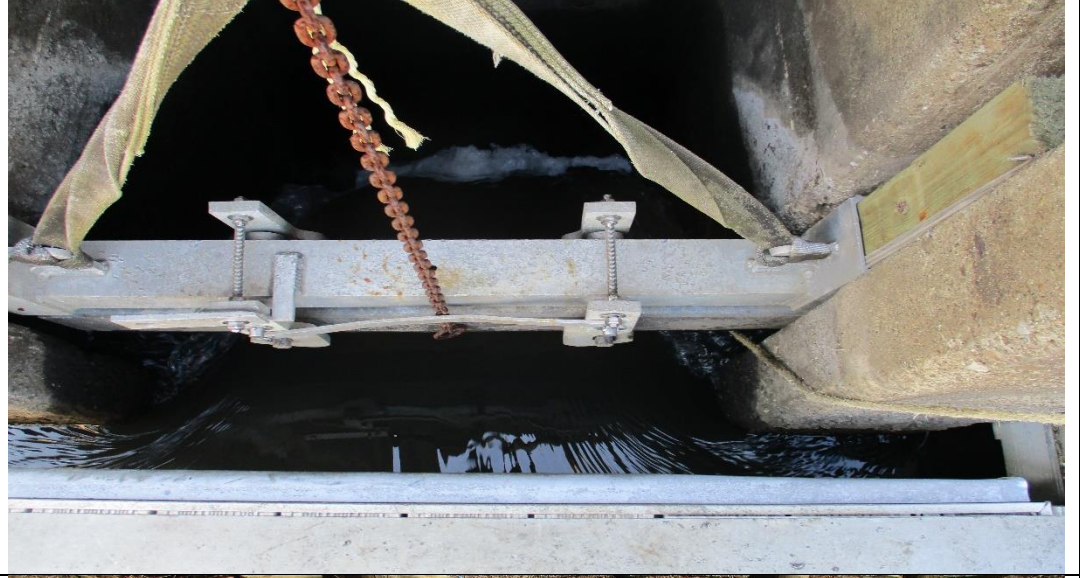
<p>Photograph No. 17</p> <p>The interior of the overflow decant structure, concrete, and appurtenances were in good functional condition.</p>

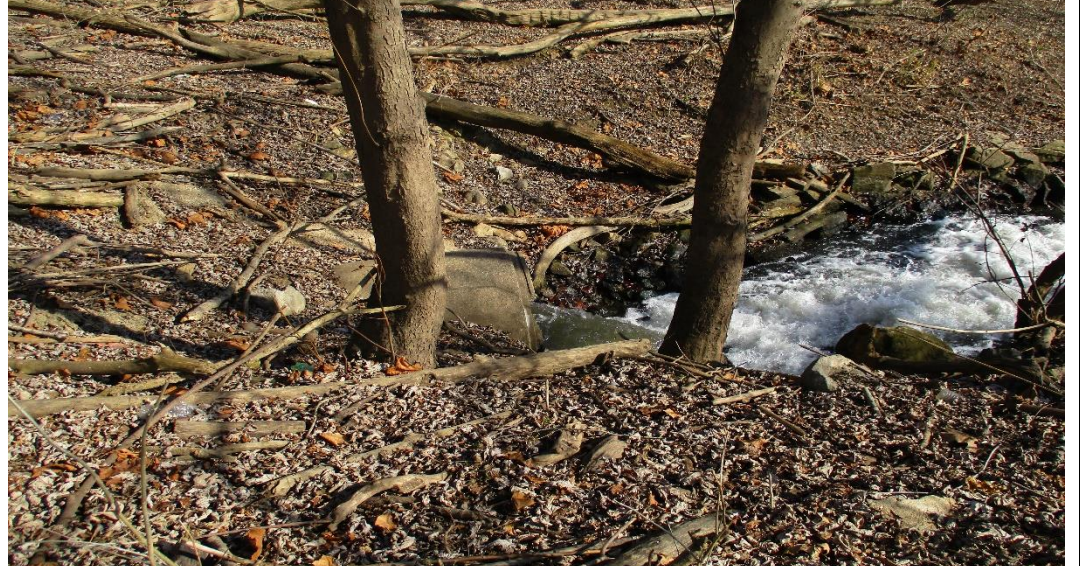
<p>Photograph No. 18</p> <p>The outfall appeared free of obstruction.</p>

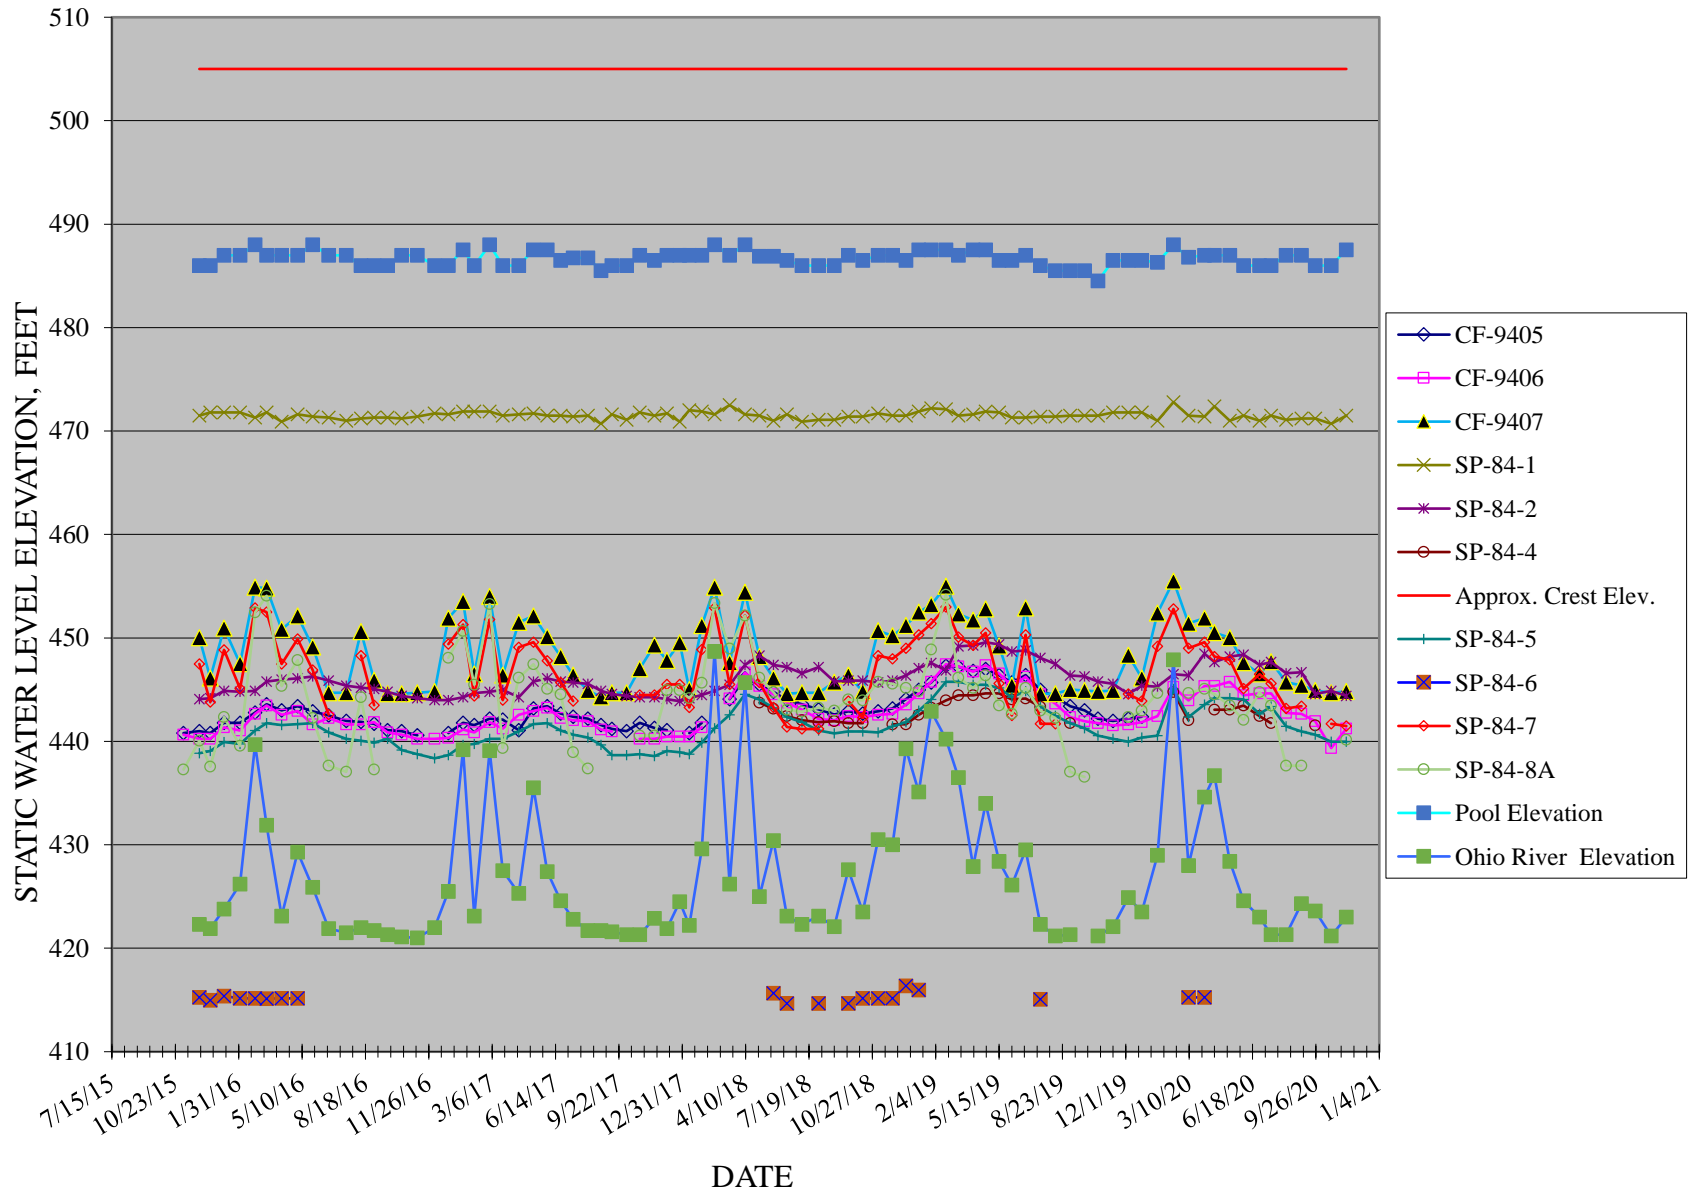
FIGURE 6 - Landfill Runoff Collection Pond Piezometers Data.

A review of the LRCP static water elevation plot indicates that two of the piezometers (SP-84-1 and SP-84-6) located along the crest of the dam historically exhibit consistent water elevations. Piezometer RP-84-6 was dry most of the time and not yielding measureable water. Review of the static water elevation plot indicates that the static water levels for the piezometers and monitoring wells generally fluctuate as a result of some variation in the pond water elevation and seasonal changes in the river water elevations, however, it appear that the river elevations has more influence on all the piezometers readings.

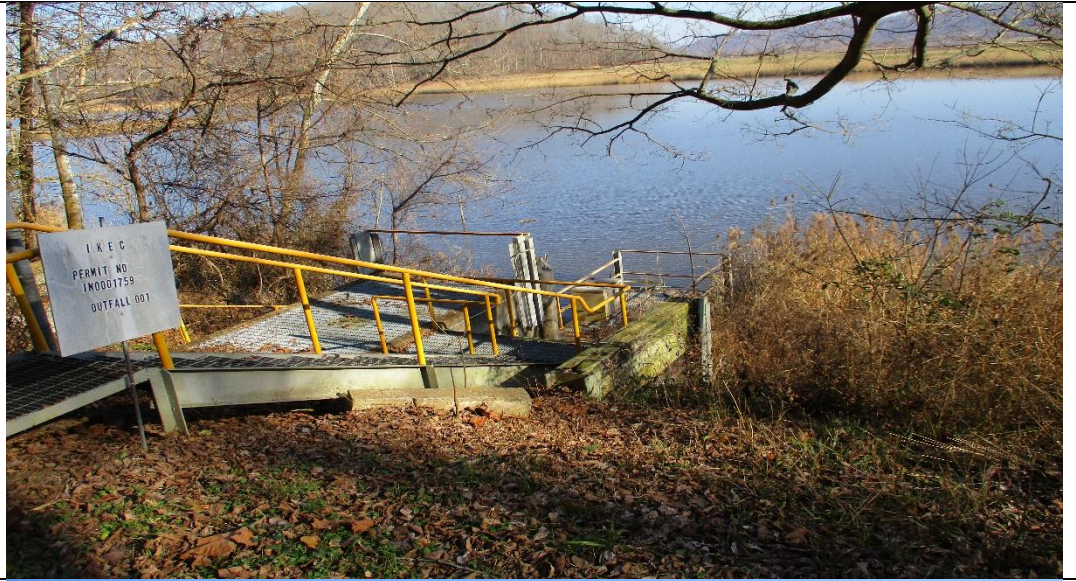
1. Photograph No. 19 illustrates an overview of the principal spillway decant structure. The decant structure and the access stairway appeared to be functioning properly and was free of obstructions. The recently added pipe (not shown in this photograph) to allow for treatment of discharged water was in functional condition. Slightly overgrown vegetation was notice along this dike upstream slope.

Photograph No. 19
The overflow decant structure visible concrete, railing, metal covers, side support, and stairs, were in operational condition.

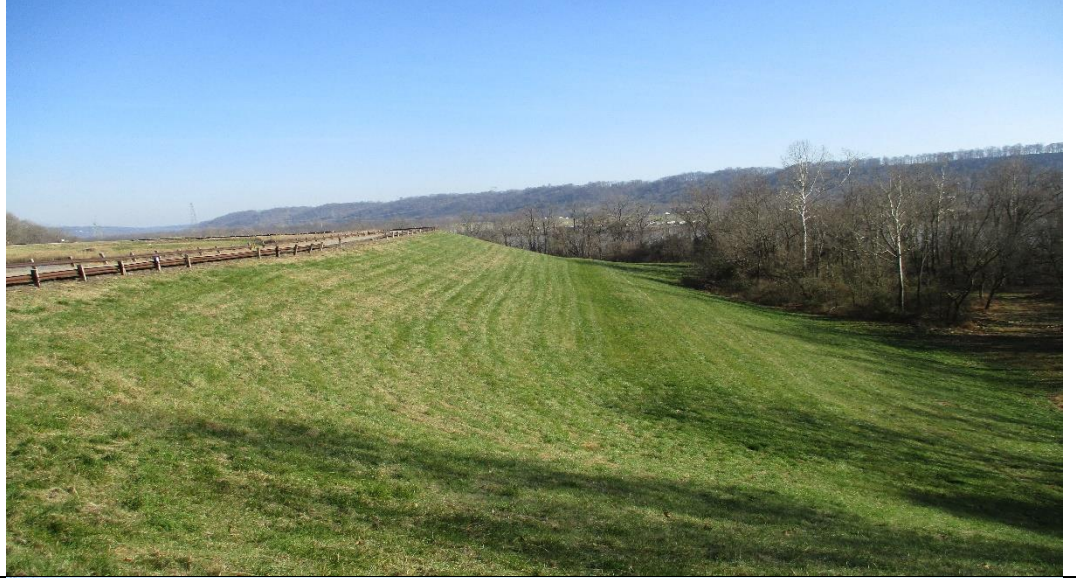
2. Photographs No. 20 and 21 show an overall view of the downstream slope of the dam. Throughout exterior slope vegetation control was good and there were no signs of sloughing, erosion or instability. In general, the exterior slope appeared to be in satisfactory and stable condition. A wet area encountered at the southwest corner of the slope (Photograph No. 21).

Photograph No. 20
This photograph illustrates typical view of the downstream slope (looking east).

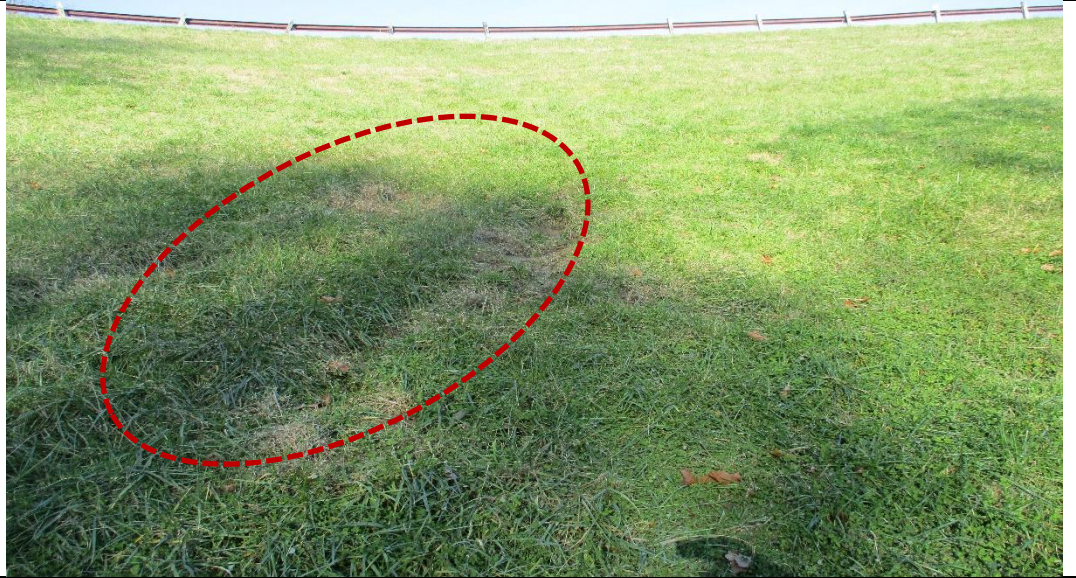
Photograph No. 21
Wet area at the downstream slope.

- > Wet area, appeared to be minor seepage (Photograph No. 21) shall be monitored, reported with that plant inspection, followed by investigation and accordingly mitigated.
- > Piezometer those are consistently dry could be clogged at the screen level. These piezometers should be revive by flushing, recharging to make sure that those are in good working condition.

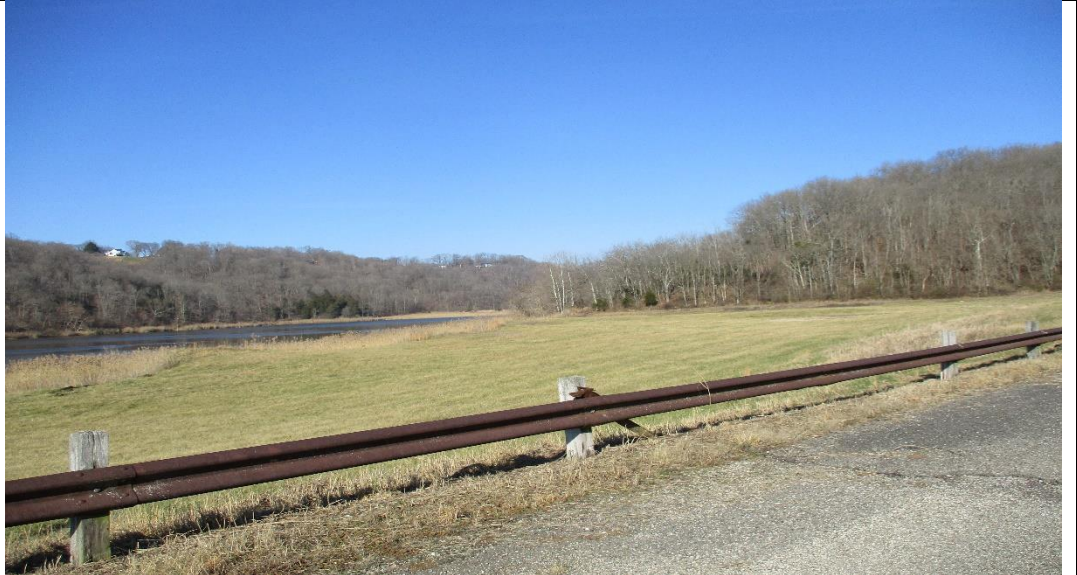
4. Photographs No. 23 illustrates typical condition of the crest and upstream slope of the dam. Signs of misalignment and settlement were not observed. Minor surface cracks in the pavement were observed. Those cracks are attributed to the age of the pavement and the results of weathering process. Vegetation control near the water line and the upper slope areas is lacking, however, erosion due to wave action was not observed. Overall the slope was found to be in satisfactory and stable condition

Photograph No. 23
The crest and upstream slope (looking northeast).
