2021 ANNUAL DAM AND DIKE INSPECTION REPORT

**West Boiler Slag Pond
& Landfill Runoff Collection Pond**

**CLIFTY CREEK PLANT
Indiana-Kentucky Electric Corporation
MADISON, INDIANA**

Document ID: GERS-22-002

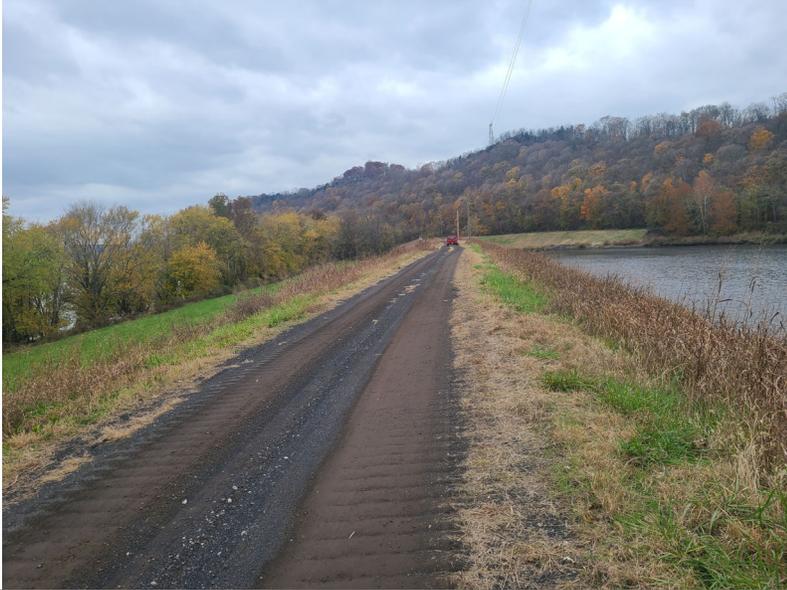
Photo No. 1

1. Photographs No. 1 and 2 illustrate a typical overview of the dike crest. The crest appears to be in good and stable condition. Signs of settlement, misalignment and cracking were not observed.
2. Photographs No. 3, 4 and 5 illustrate the condition of the interior slopes at the settling end of the pond and the present extent of boiler slag buildup. The interior slope of the dike at this end of the

~~View of the erosion rills on the protective~~
West Boiler Slag Pond Dike From Crest Looking Southwest

Overview of Crest

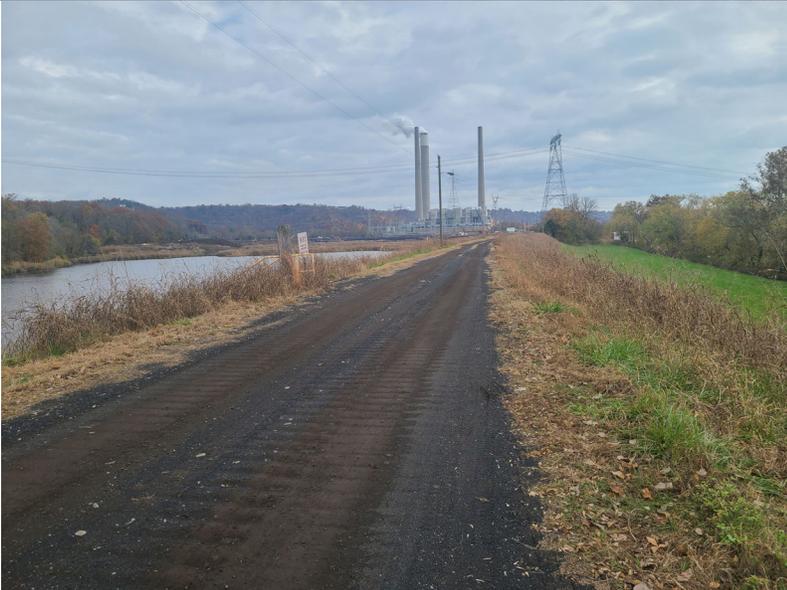
Photo No. 2

West Boiler Slag Pond Dike – Crest From Top Looking Northeast

General Condition

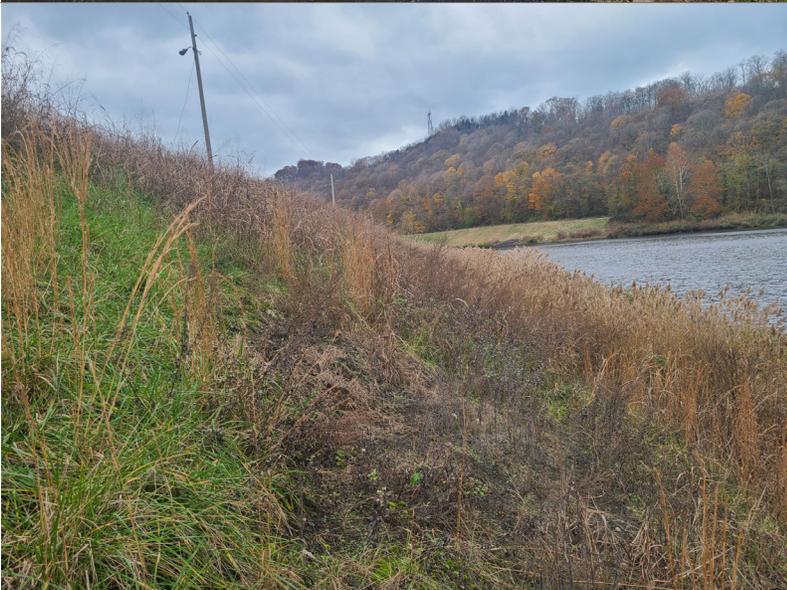
Photo No. 3

pond appeared to be in satisfactory and stable condition with some overgrown vegetation near the water line.

West Boiler Slag Pond – Near South End of Interior Slope

Area where some surface disturbance caused by the remotely controlled mower, Vegetation overgrowth

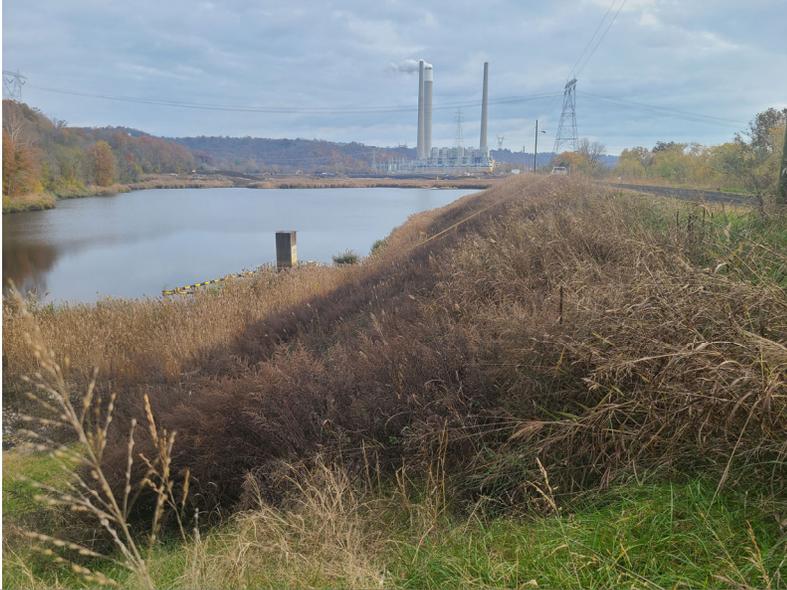
Photo No. 4

West Boiler Slag Pond Dike –
Interior Slope Looking Northeast
From Crest.

Overview of General Condition,
Vegetation overgrowth

- Vegetation height was moderate to high on the inboard slopes of the WBSP (Photographs Nos. 4 and 6). These areas should be weed waked to prevent damage to the existing riprap.

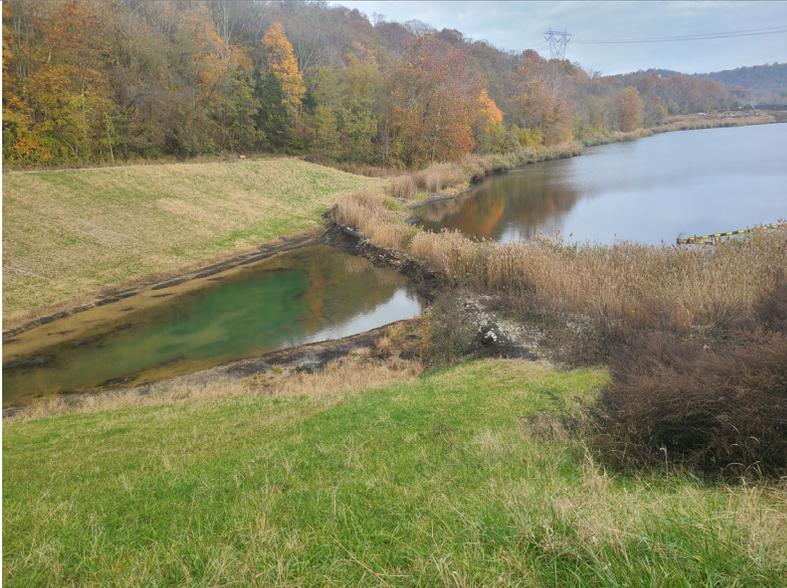
Photo No. 5

West Boiler Slag Pond Dike –
Interior Slope Looking Northwest
From Crest

Overview of General Condition
Local Vegetation growth

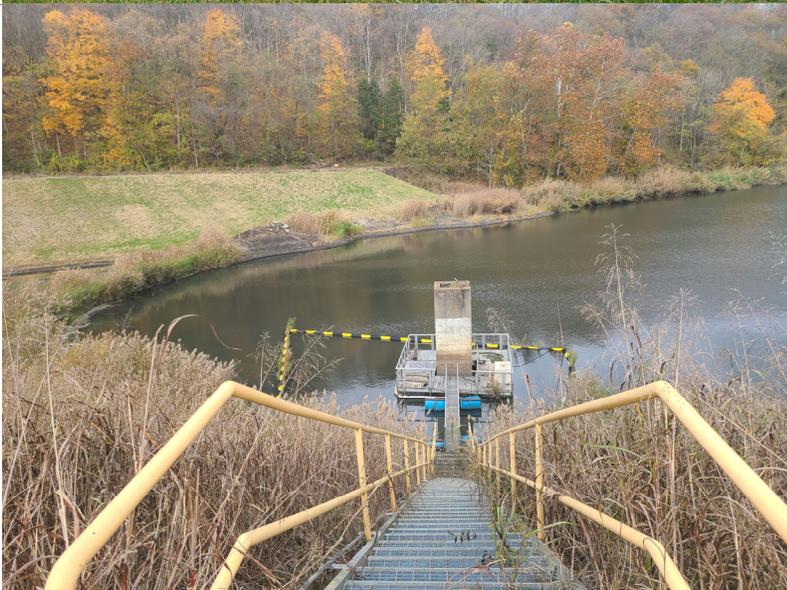
Photo No. 6

3. Photograph No. 6 shows the Principal Spillway and Decant Structure along with some overgrown vegetation near the access stairs and water line.
4. The overflow discharge structure walkway, railings, metal decking, and visible concrete were found to be in satisfactory, functional condition. However, there was some overgrown vegetation adjacent to the access stairs. Photographs No. 6 illustrate the access stairs, metal walkway, metal deck, and concrete structure of the overflow discharge structure. The overflow structure appeared to be in satisfactory condition.

West Boiler Slag Pond Principal
Spillway Access Stairs and Decant
Structure

Overview of General Condition,
Vegetation overgrowth

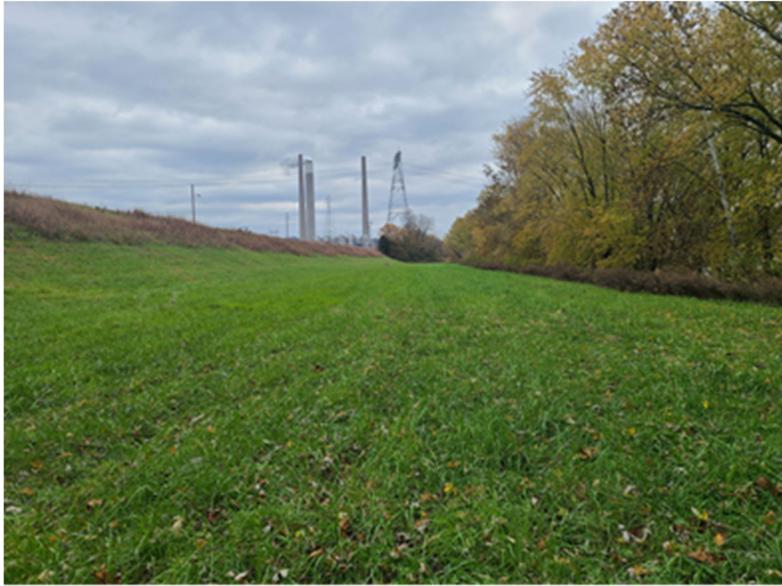
Photo No. 7

5. Photographs No. 7, 8 and 9 shows the general condition of the exterior slope and toe area of the south dike. The slope appeared in satisfactory and stable condition. There were no signs of settlement, misalignment, sloughing or erosion. Few wet areas were noted during this inspection along the toe area which appears to be caused by tire ruts from mowing activities.

West Boiler Slag Pond Dike –
Exterior Slope From Toe Looking
East

Overview of Vegetation and
General Condition

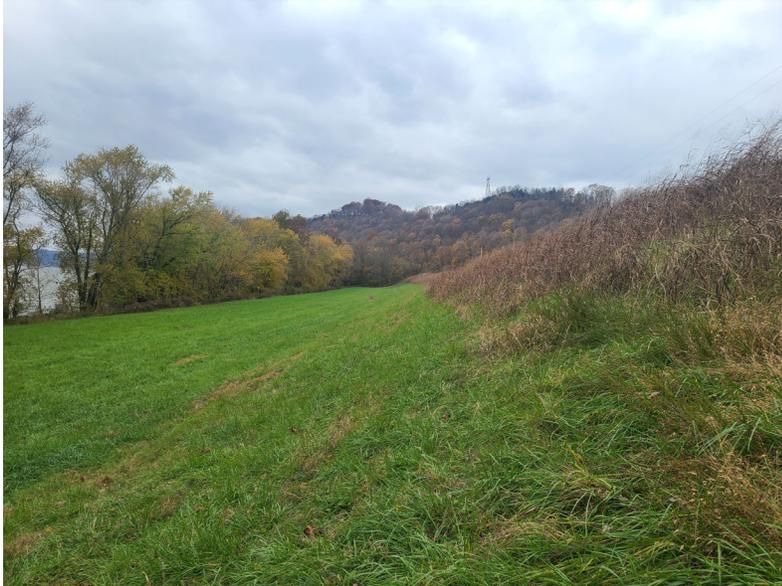
Photo No. 8

West Boiler Slag Pond Dike
Exterior Slope From Toe Looking
West

Overview of Vegetation
Overgrowth and General
Condition

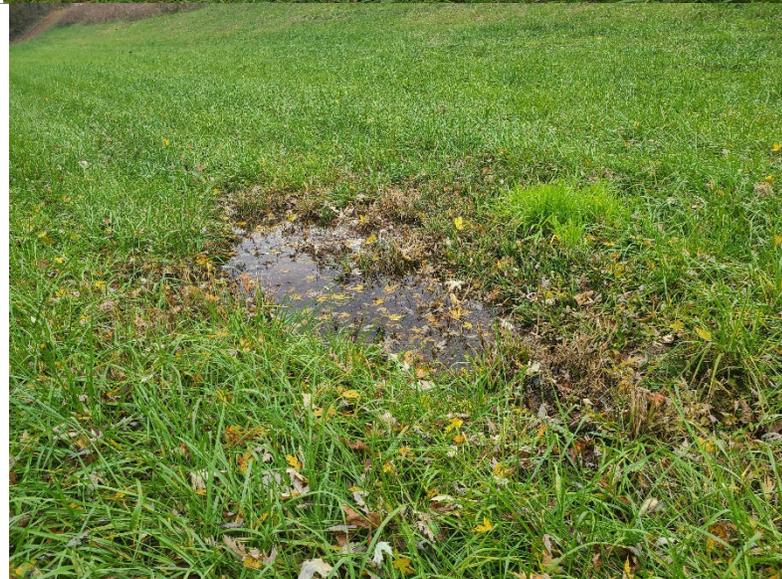
Photo No. 9

West Boiler Slag Pond Dike –
Exterior Slope From Toe Looking
East

Wet Area

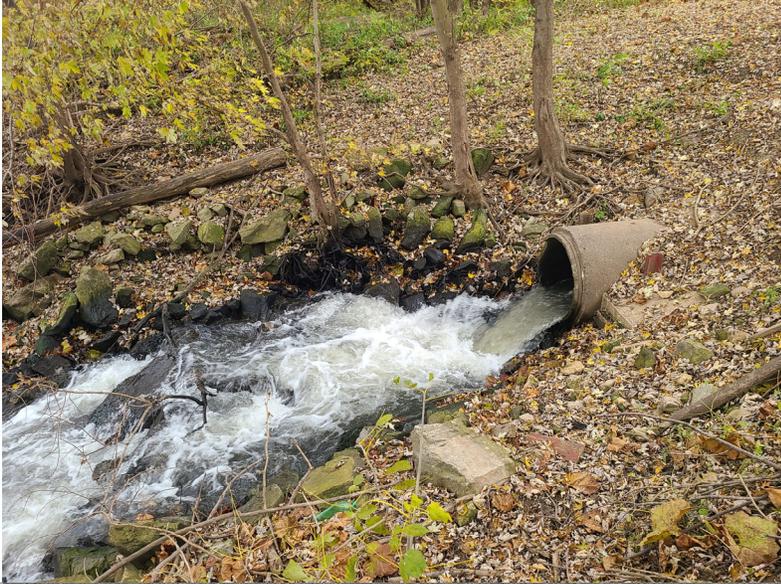
Photo No. 10

6. Photograph No. 10 shows the typical condition of the discharge pipe and outlet channel. The channel and outlet pipe were observed to be in good condition and were unobstructed and flowing steadily.

West Boiler Slag Pond Principal Spillway Pipe Discharge

General Condition of End of Pipe and Outlet Channel

Some wood debris carried by the river during flooding events

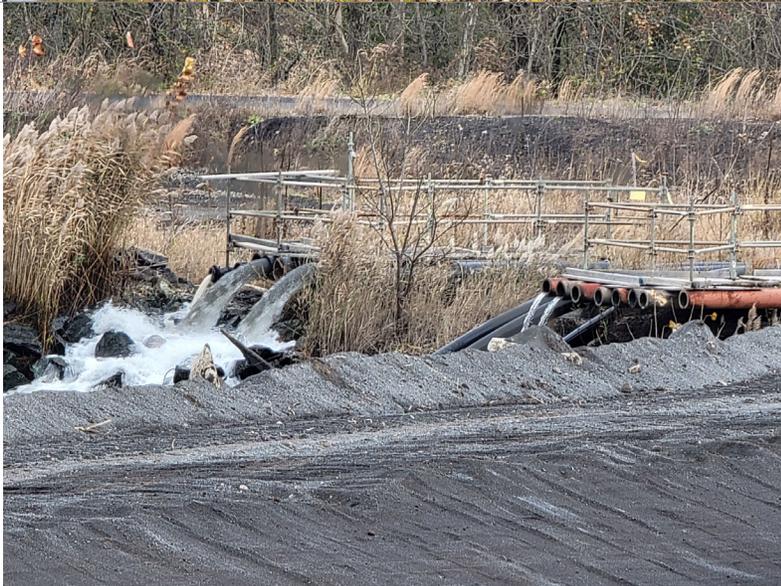
Photo No. 11

7. Photograph No. 11 shows the ash sluice pipes and other pipes.
8. Construction within the limit of the pond was ongoing during the site visit. The construction included regrading areas in the dry part of the pond to prepare for building the CCR compliant pond. Photos 12 through 14 show some of the construction activities.

West Boiler Slag Pond bottom ash and other discharge pipes

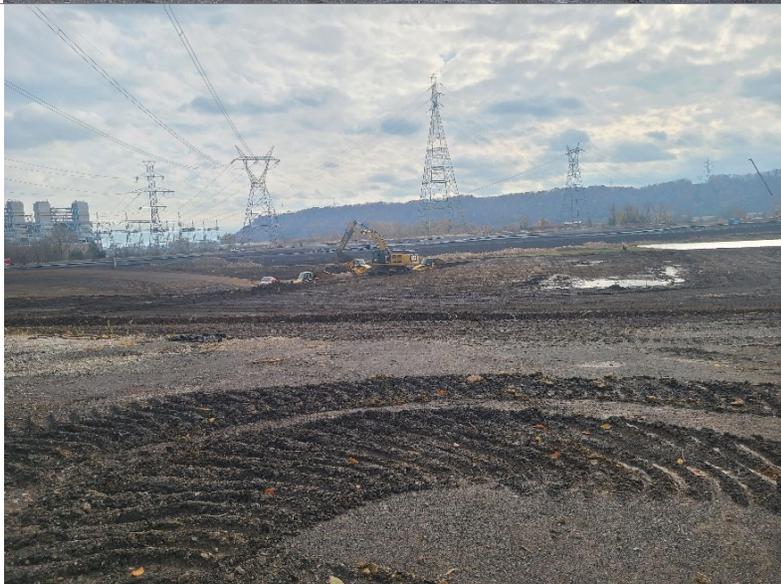
Photo No. 12

West Boiler Slag Pond

Construction within the limit of the pond.

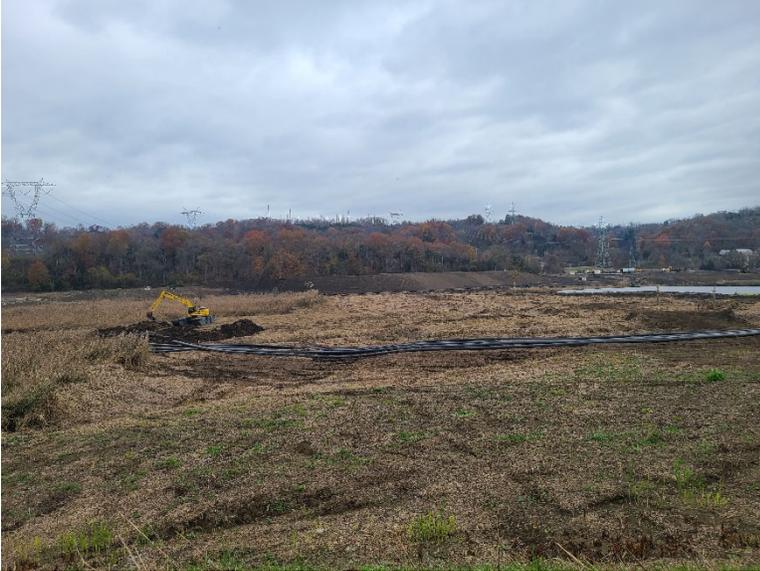
Photo No. 13

West Boiler Slag Pond

Construction within the limit of the pond.

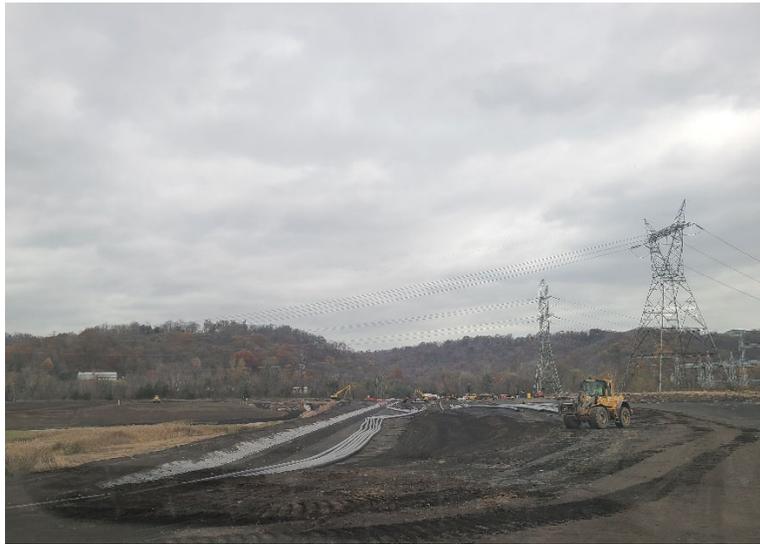
Photo No. 14

West Boiler Slag Pond

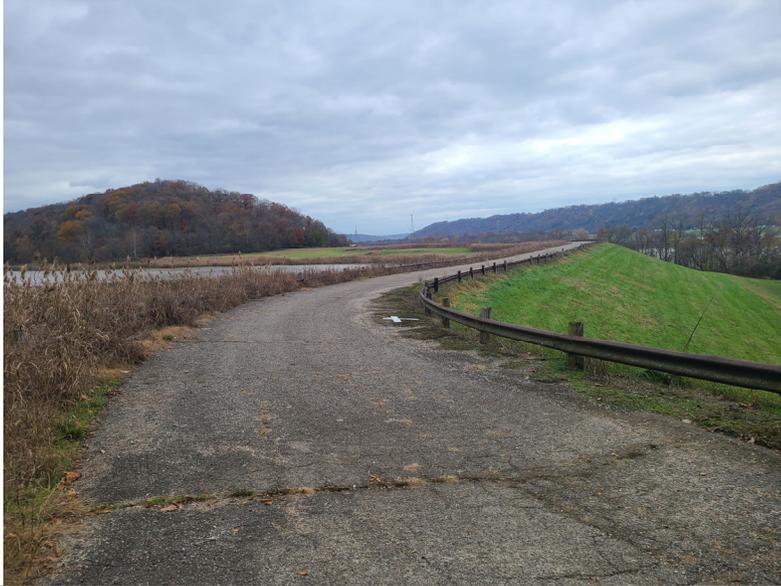
Photo No. 1

1. Photographs Nos. 1, and 2 show the generally condition of the crest of the dam. Signs of misalignment and settlement were not observed. Minor surface cracks in the pavement were observed. Those cracks are attributed to the age of the pavement and the results of weathering process.

Landfill Runoff Collection Pond Dam
From Crest Looking Northeast Across
Saddle Dam

General Overview

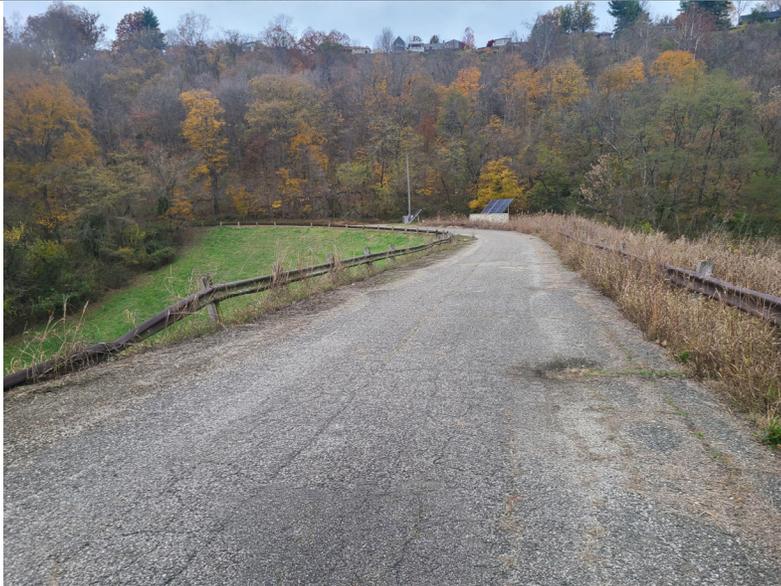
Photo No. 2

Landfill Runoff Collection Pond Dam
From Crest Looking Southwest

General Overview

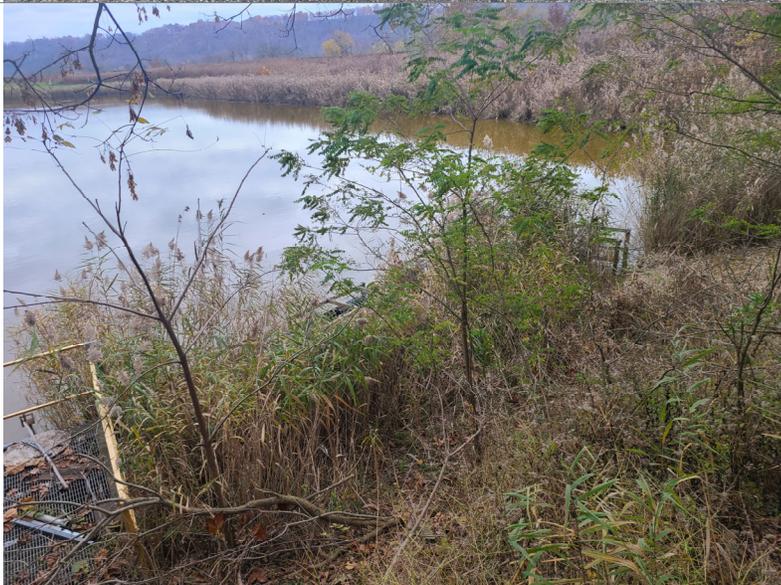
Photo No. 3

2. Photographs Nos. 3 and 4 provide overviews of the interior slope of the dam above the operating pool. Vegetation control near the water line and the upper slope areas is lacking, however, erosion due to wave action was not observed. Overall the slope was found to be in satisfactory and stable condition.

Landfill Runoff Collection Pond Dam
From Up Stream Slope

Overview of Current Operating Pool and
Vegetation Conditions on Interior Slope.

Significant vegetation Growth along the
Upstream of Dam

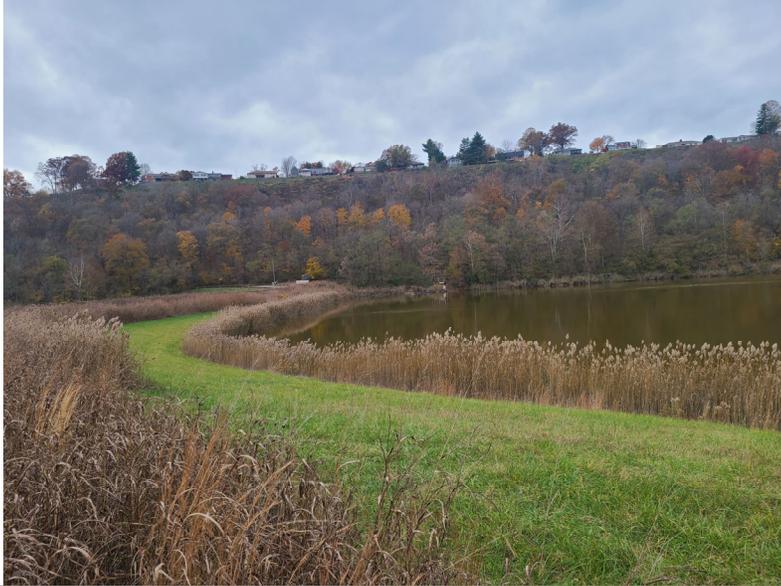
Photo No. 4

Landfill Runoff Collection Pond Dam
From Up Stream Slope

Overview of Vegetation and General
Conditions

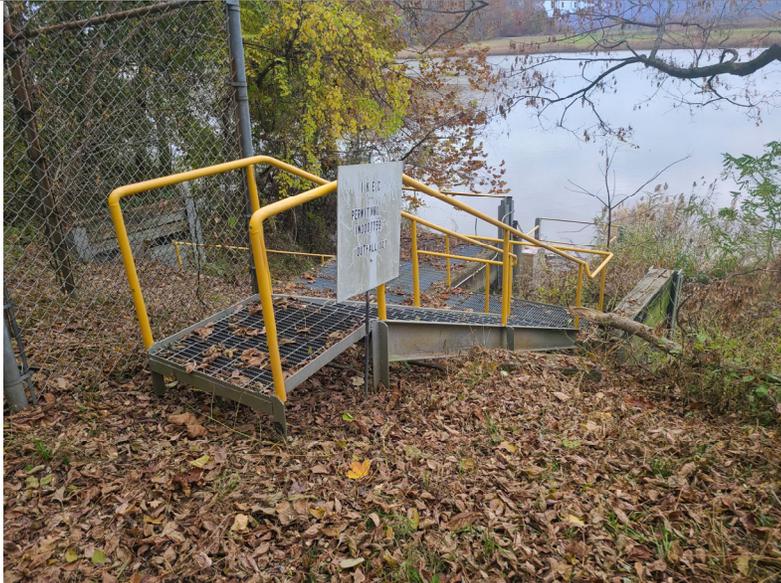
Photo No. 5

3. Photograph No. 5 shows an overview of the principal spillway decant structure. Vegetation control was observed to be lacking. The decant structure and the access stairway appeared to be functioning properly and was free of obstructions. Photograph No.6 shows the recently added pipe to allow for treatment of discharged water with few fallen wood sticks that doesn't appear to restrict the horizontal flow underneath.

Landfill Runoff Collection Pond Dam
Principal Spillway Access Stairs and
Decant Structure

Overview of Vegetation Management
and General Condition-overgrown
vegetation.

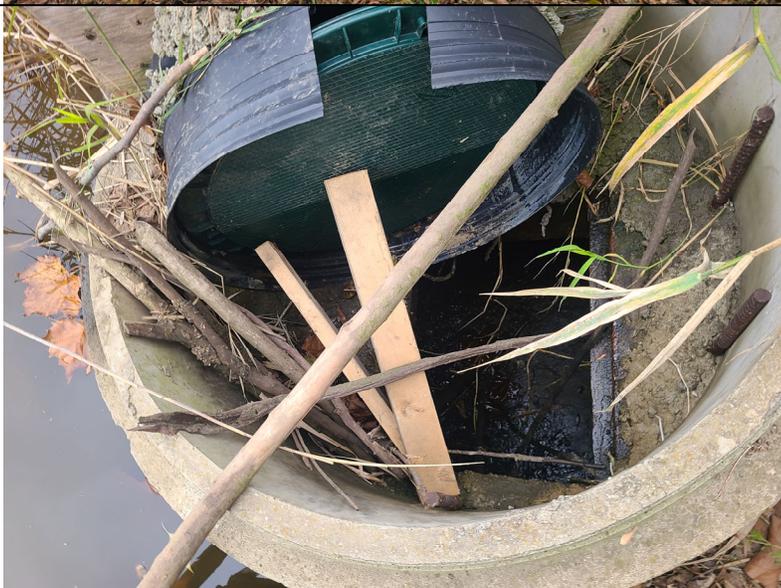
Photo No. 6

Landfill Runoff Collection Pond
Principal Spillway Structure

Looking at drop inlet for
treatment pipe. Fallen wood
sticks above the flow line.

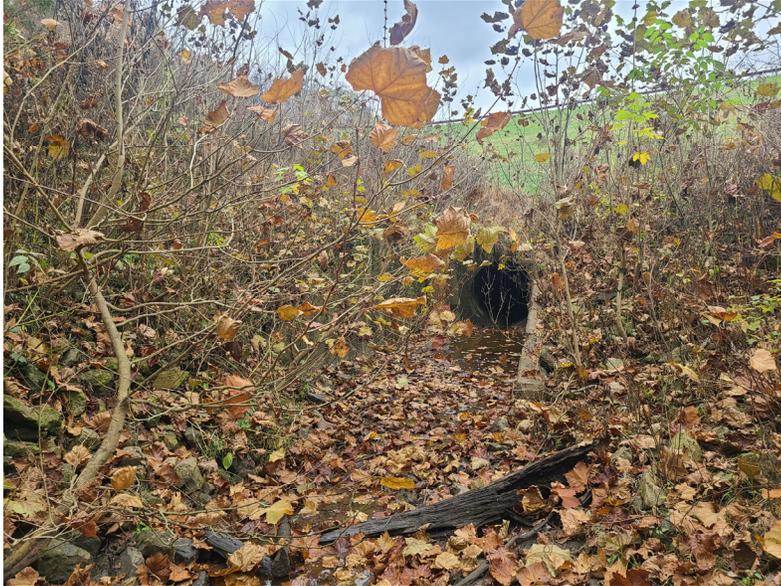
Photo No. 7

4. Photograph Nos. 7 and 8 is an overview of the principal spillway outlet channel. The channel is unobstructed with minimal flow at the time of the inspection. Vegetation control was observed to be lacking.

Landfill Runoff Collection Pond
Principal Spillway Outlet

General Overview-Overgrown vegetation

Fallen tree trunk needs remove

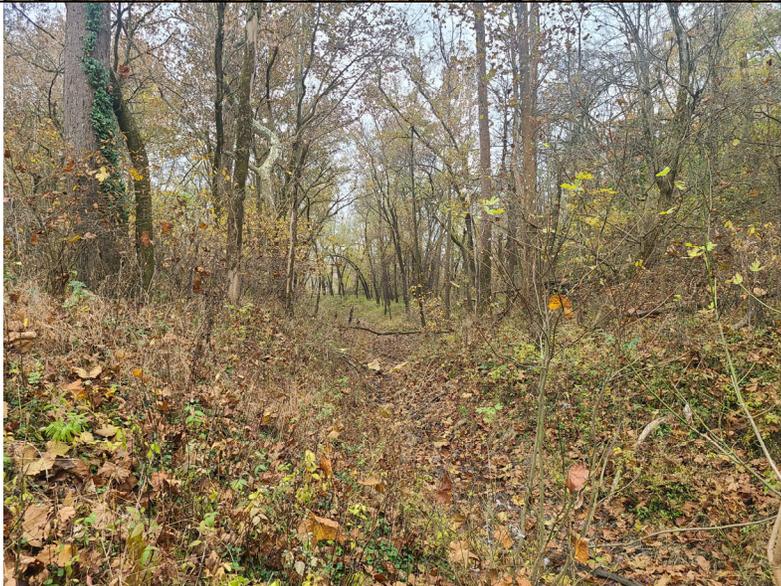
Photo No. 8

Landfill Runoff Collection Pond
Principal Spillway Outlet Channel
Looking Downstream

General Overview-overgrown vegetation

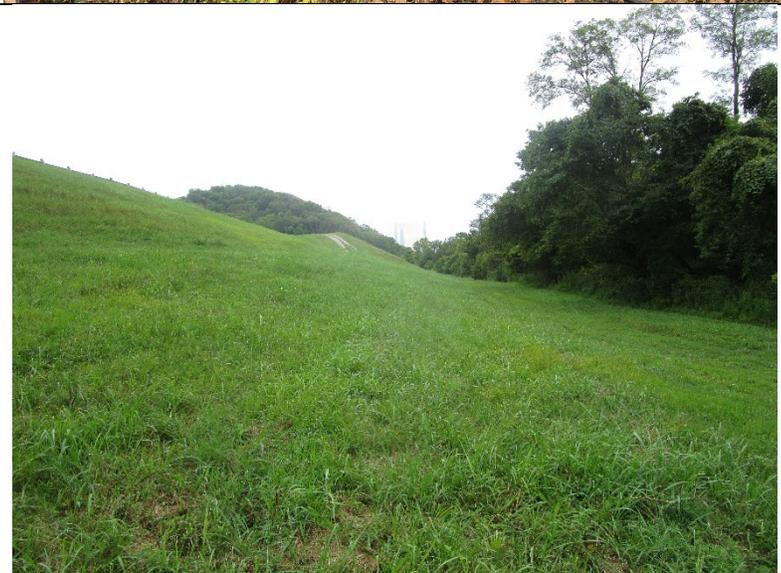
Photo No. 9

5. Photographs Nos. 9 through 14 are all overviews of various areas of the exterior face of the dam as further described with each photograph. Throughout, vegetation control was adequate and there were no signs of sloughing, erosion or instability, except for the area adjacent to the previously repaired slope. No visible change was observed from previous inspections. In general, the exterior slope appeared to be in satisfactory and stable condition

Landfill Runoff Collection Pond Dam
Adjacent To Toe of Slope Looking East

Overview of Vegetation and General
Conditions

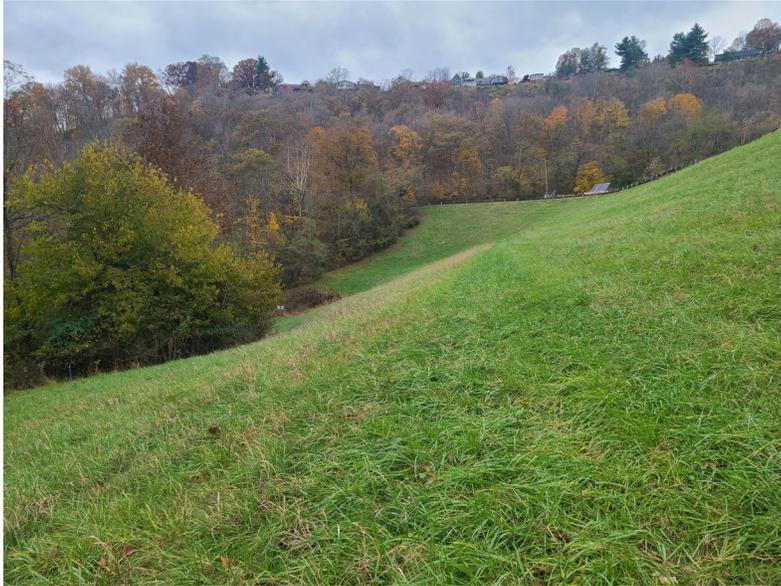
Photo No. 10

6. The one area of concern is the slope adjacent to the previously repaired area in 2017. This area apparently did not experience additional sloughing/slip activity. A repair detail has been approved the state and ready for implementation.

Landfill Runoff Collection Pond Dam
Adjacent To Toe of Slope Looking East

Overview of downstream slope adjacent
to rip rap repair area.

- The southing/slip area of the outboard slope needs to be monitored in order to prevent additional damage to the slope area.

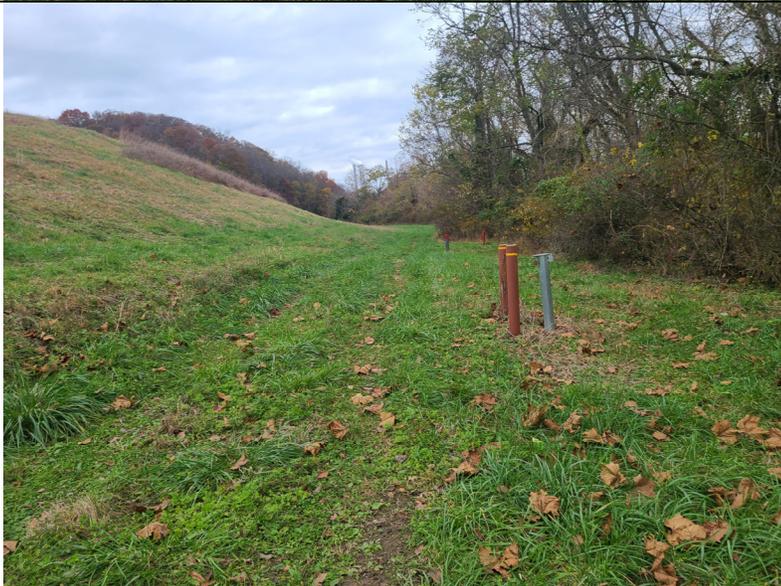
Photo No. 11

Landfill Runoff Collection Pond Dam
Adjacent To Toe of Slope Looking
Southwest

Overview of Vegetation and General
Conditions

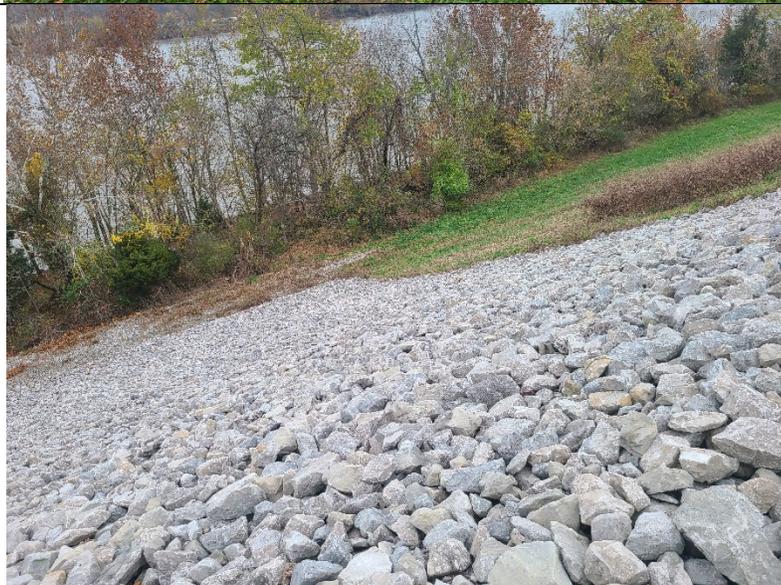
Photo No. 12

Landfill Runoff Collection Pond Dam
Adjacent To Toe of Slope Looking
Southwest

Overview of rip rap,
Looking west.

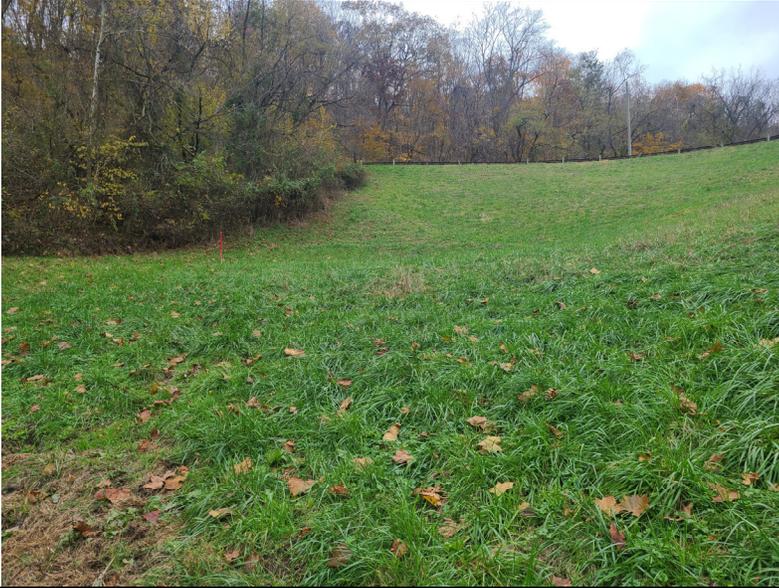
Photo No. 13

Overview of downstream slope area. Looking west.

General Overview

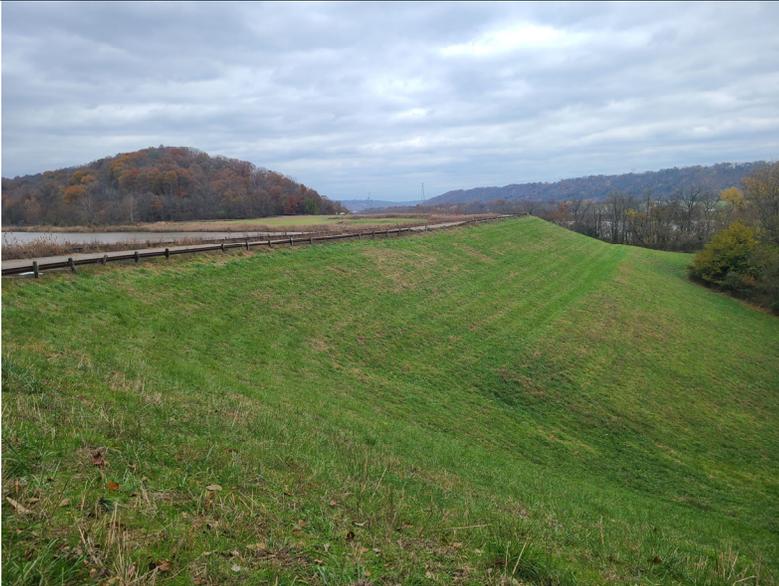
Photo No. 14

Landfill Runoff Collection Pond Dam
From Top of Slope In Right Groin
Looking East

Overview of Vegetation and General
Conditions
