2021 ANNUAL DAM AND DIKE INSPECTION REPORT

**West Boiler Slag Pond
& Landfill Runoff Collection Pond**

**CLIFTY CREEK PLANT
Indiana-Kentucky Electric Corporation
MADISON, INDIANA**

GERS-21-080

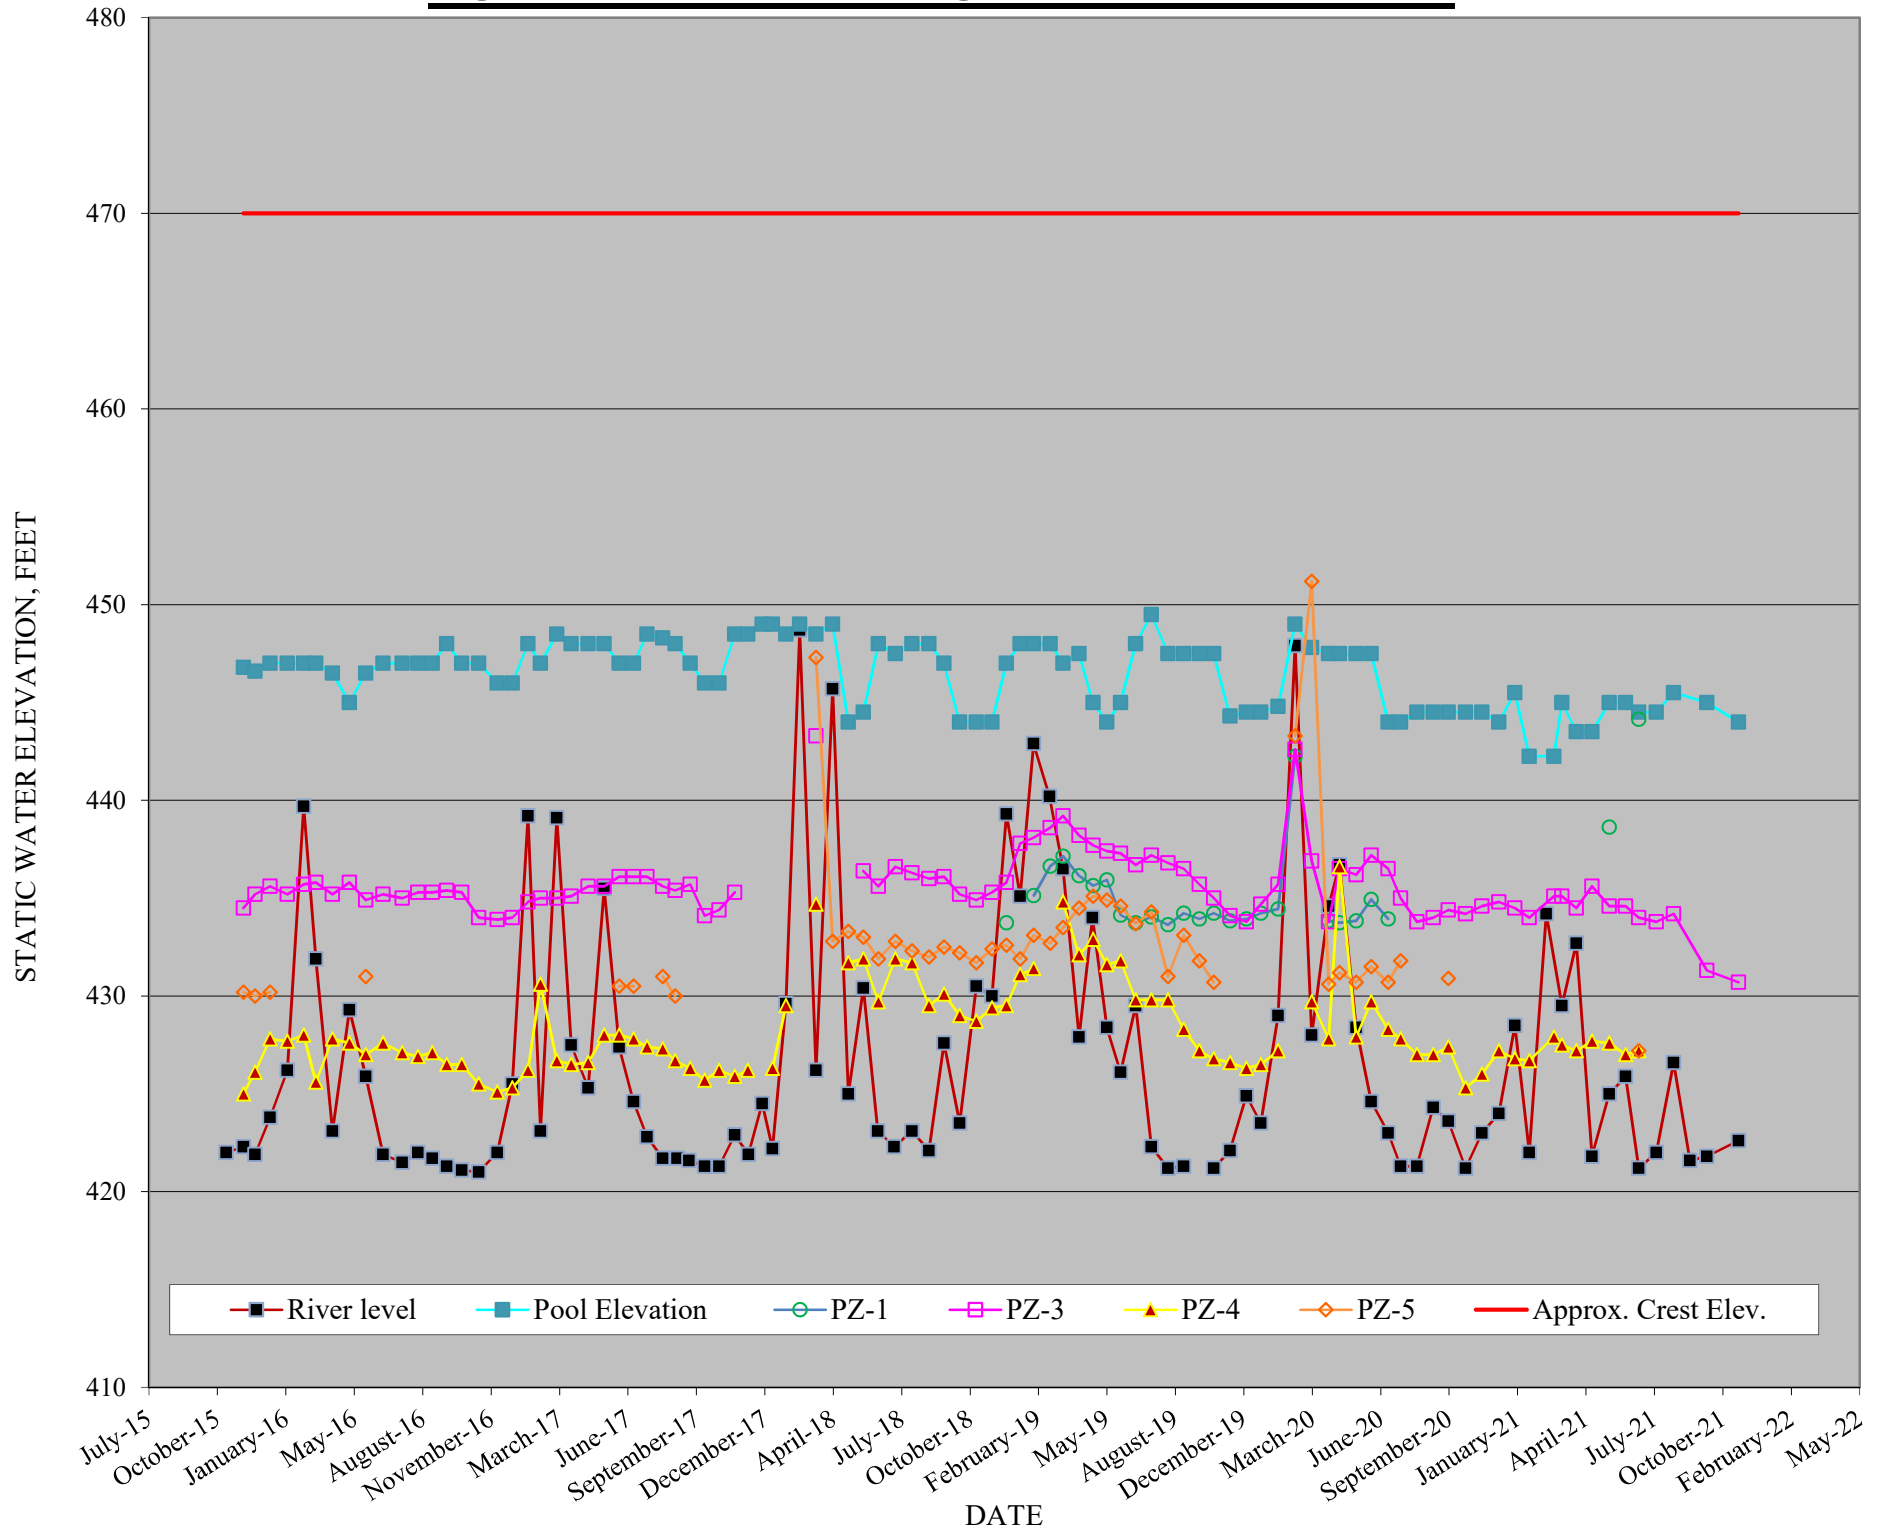
Figure 2 - West Boiler Slag Pond Piezometer Data.

A review of the data contained on the WBSP static water elevation plot showed that all piezometers exhibit consistent water elevations. PZ-1 is a piezometer located at the crest of the constructed dike (shown as B-1 on location plan) which was dry most of the year 2021 with potentially erroneous readings (higher than the pond and the river levels). PZ-3 is a piezometer located at the crest of the constructed dike (shown as B-3 on location plan). PZ-4 is a piezometer located along a bench near the downstream toe of the constructed dike (shown as B-4 on location plan). PZ-5 is a piezometer located at the crest of the constructed dike (B-5 on location plan) which was also dry most of the year 2021. Review of the static water elevation plot indicates that the static water levels for the piezometers generally fluctuate as a result of the fluctuations in the pool level (head water) and the river level (tail water), however, it appears that the river water level has more influence on all the piezometer's water levels.

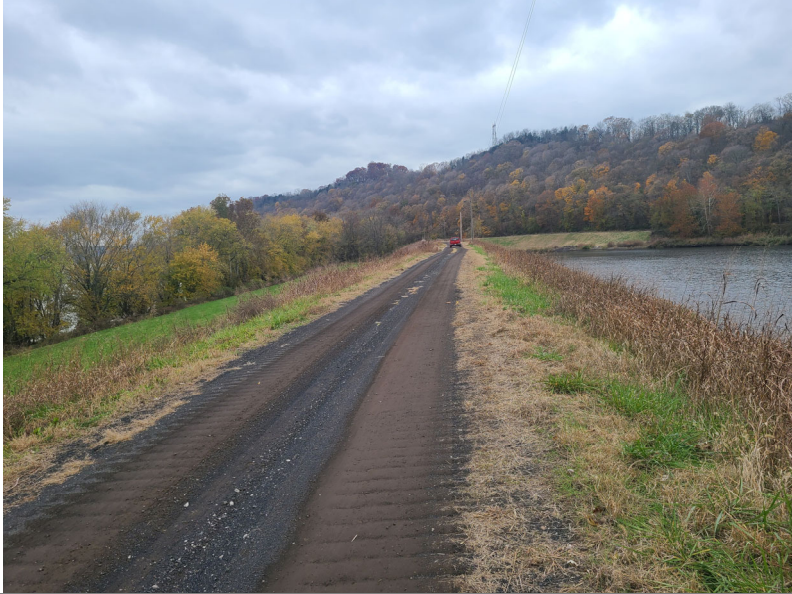
Photo No. 1

1. Photographs No. 1 and 2 illustrate a typical overview of the dike crest. The crest appears to be in good and stable condition. Signs of settlement, misalignment and cracking were not observed.

View of the erosion rills on the protective West Boiler Slag Pond Dike From Crest Looking Southwest

Overview of Crest

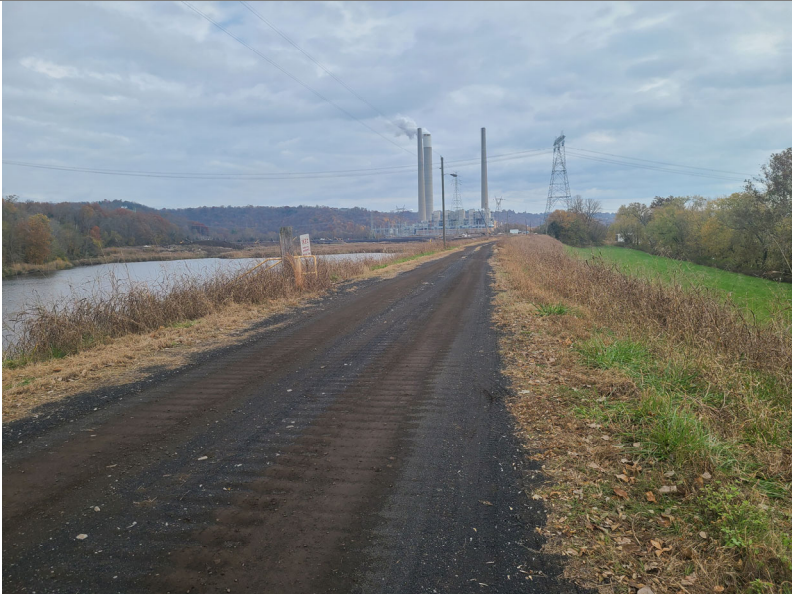
Photo No. 2

West Boiler Slag Pond Dike – Crest From Top Looking Northeast

General Condition

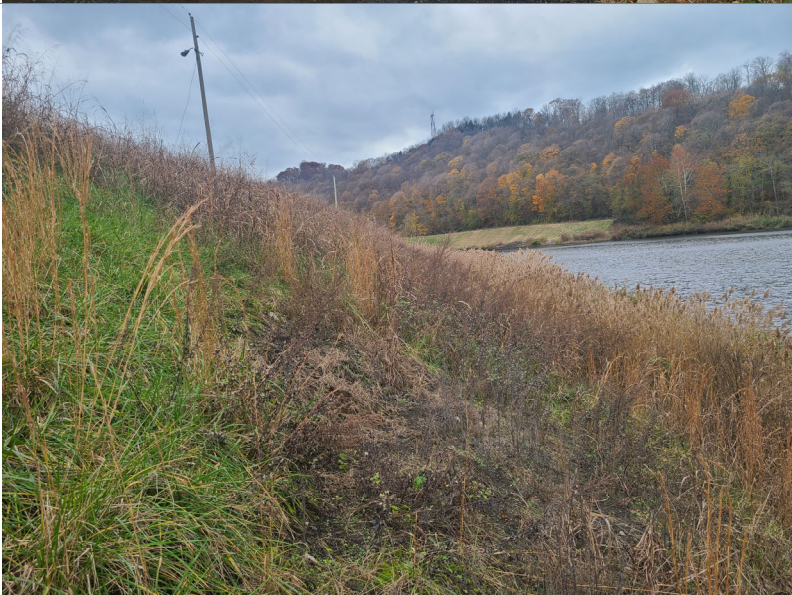
Photo No. 3

2. Photographs No. 3, and 4 illustrate the condition of the interior slopes at the settling end of the pond and the present extent of boiler slag buildup. The interior slope of the dike at this end of the pond appeared to be in satisfactory and stable condition with some overgrown vegetation near the water line.

West Boiler Slag Pond – Near South End of Interior Slope

Area where some surface disturbance caused by the remotely controlled mower, Vegetation overgrowth

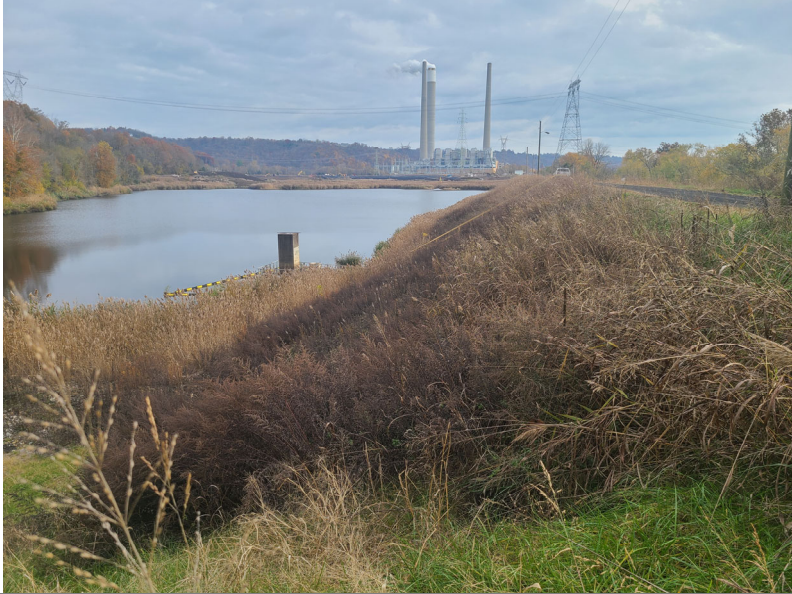
Photo No. 4

West Boiler Slag Pond Dike –
Interior Slope Looking Northeast
From Crest.

Overview of General Condition,
Vegetation overgrowth

- Vegetation height was moderate to high on the inboard slopes of the WBSP (Photographs Nos. 4 and 6). These areas should be weed waked to prevent damage to the existing riprap.

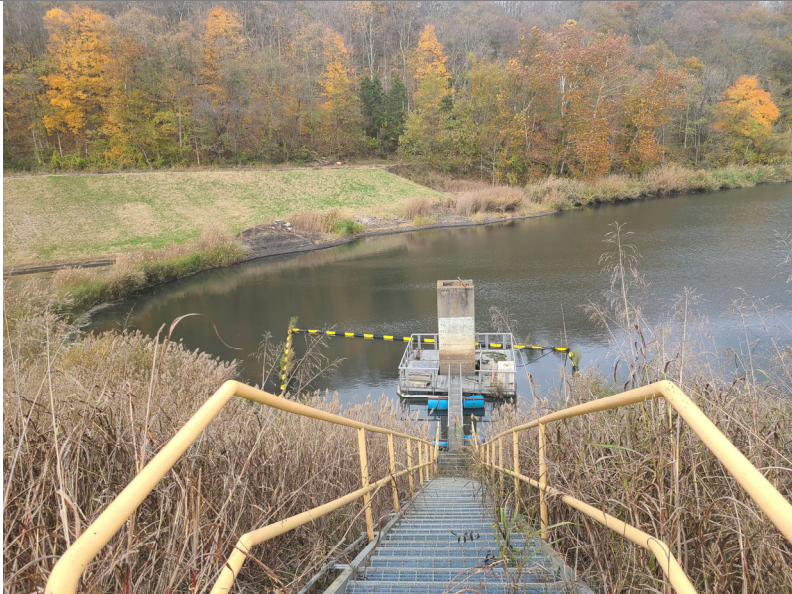
Photo No. 5

3. Photograph No. 5 shows the Principal Spillway and Decant Structure along with some overgrown vegetation near the access stairs and water line. The overflow structure appeared to be in satisfactory condition.

West Boiler Slag Pond Principal
Spillway Access Stairs and Decant
Structure

Overview of General Condition,
Vegetation overgrowth

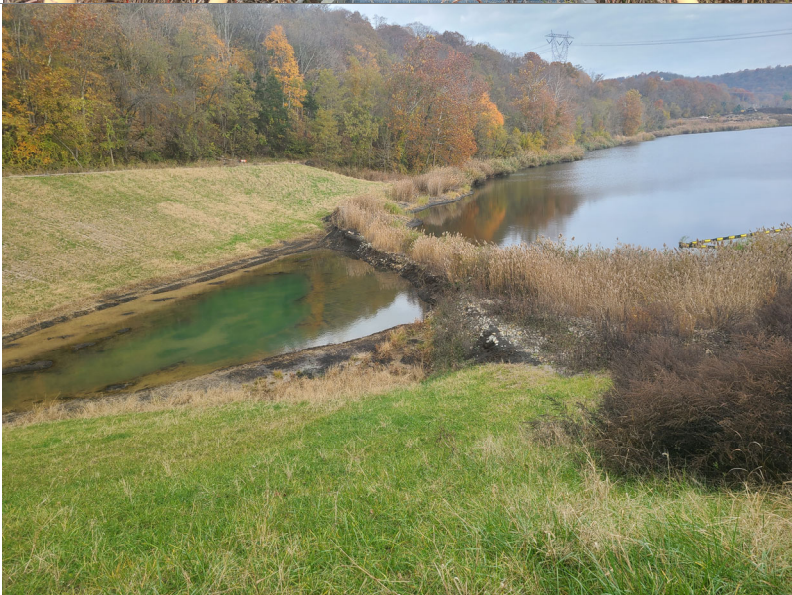
Photo No. 6

adjacent to the access stairs. Photographs No. 5 and 6 illustrate the access stairs, metal walkway, metal deck, and concrete structure of the overflow discharge structure.

West Boiler Slag Pond Dike –
Interior Slope Looking Northwest
From Crest

Overview of General Condition
Local Vegetation growth

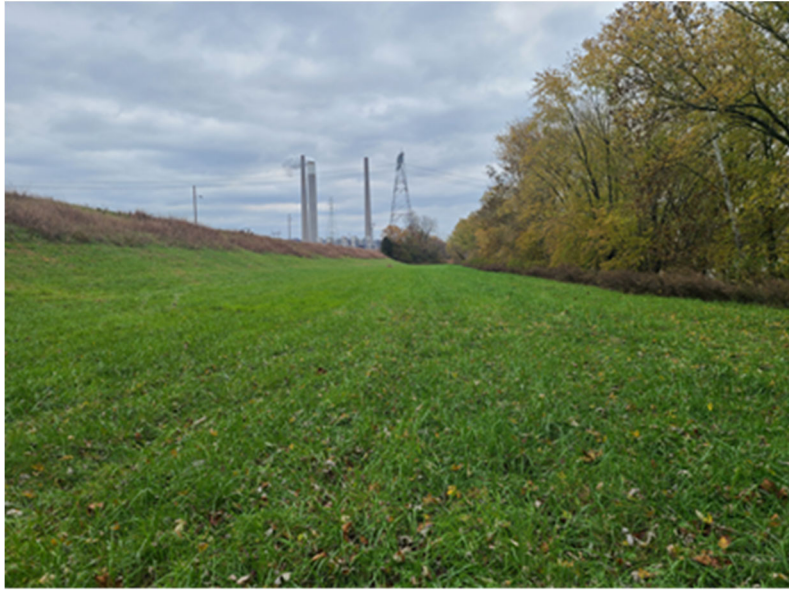
Photo No. 7

5. Photographs No. 7, 8 and 9 shows the general condition of the exterior slope and toe area of the south dike. The slope appeared in satisfactory and stable condition. There were no signs of settlement, misalignment, sloughing or erosion. Few wet areas were noted during this inspection along the toe area which appears to be caused by tire ruts from mowing activities.
6. Photograph No. 10 shows the typical condition of the discharge pipe and outlet channel. The channel and outlet pipe were observed to be in good condition and were unobstructed and flowing steadily.
7. Photograph No. 11 shows the ash sluice pipes and other pipes.
8. Construction within the limit of the pond was ongoing during the site visit. The construction included regrading areas in the dry part of the pond to prepare for building the CCR compliant pond. Photos 12 through 14 show some of the construction activities.

West Boiler Slag Pond Dike –
Exterior Slope From Toe Looking
East

Overview of Vegetation and
General Condition

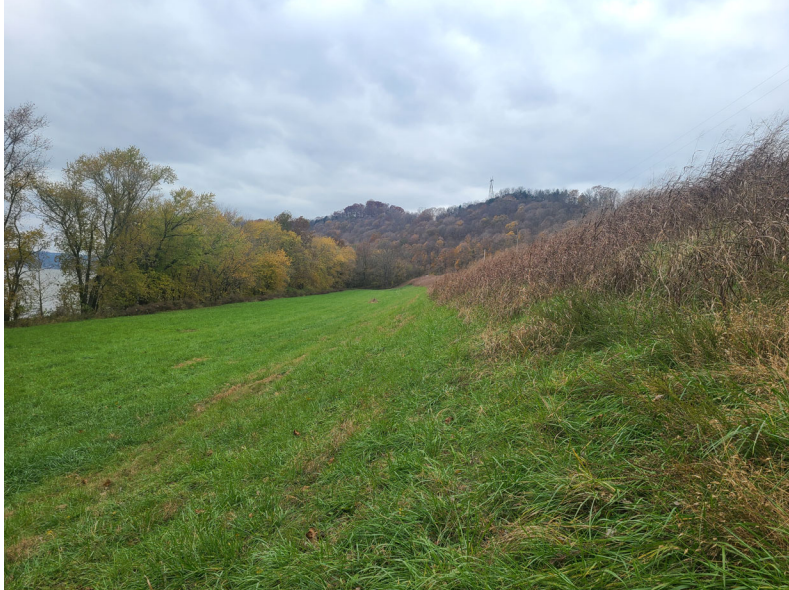
Photo No. 8

West Boiler Slag Pond Dike
Exterior Slope From Toe Looking
West

Overview of Vegetation
Overgrowth and General
Condition

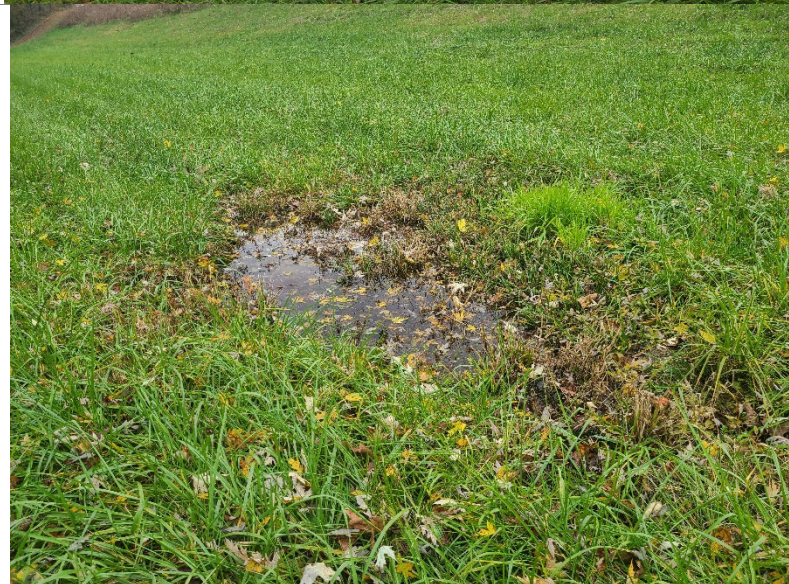
Photo No. 9

West Boiler Slag Pond Dike –
Exterior Slope From Toe Looking
East

Wet Area

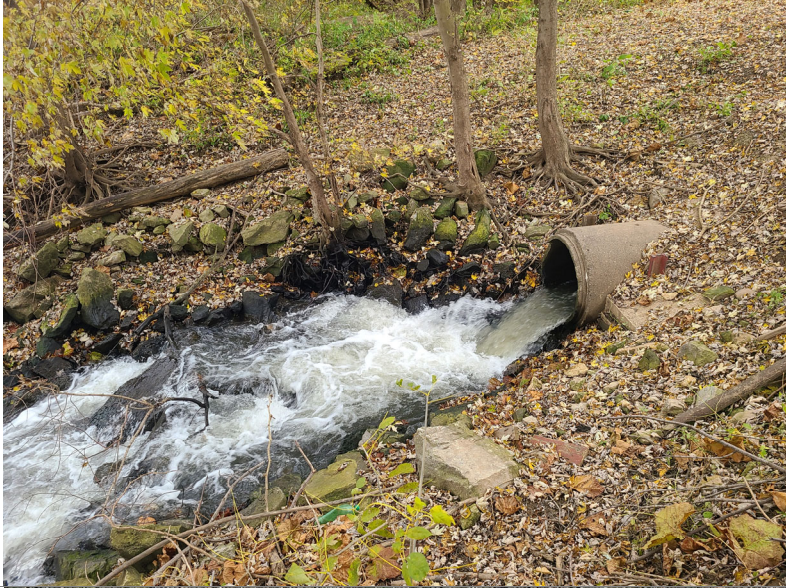
Photo No. 10

West Boiler Slag Pond Principal Spillway Pipe Discharge

General Condition of End of Pipe and Outlet Channel

Some wood debris carried by the river during flooding events

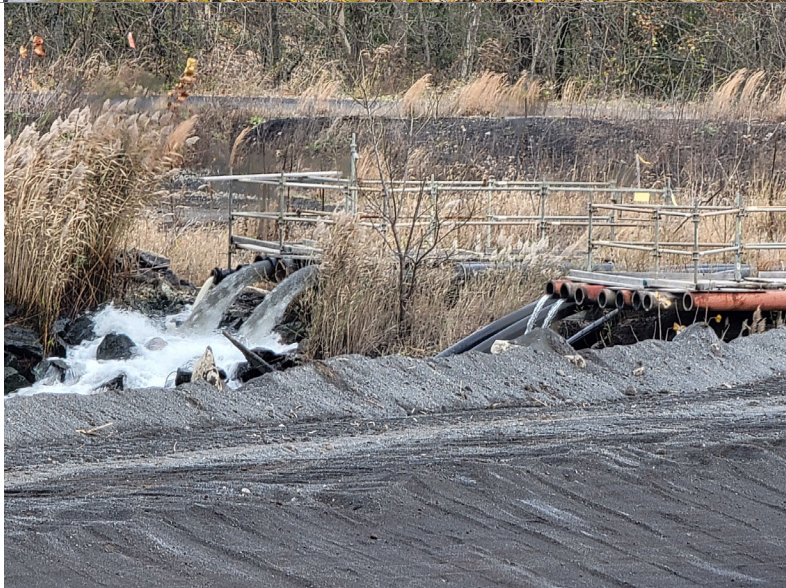
Photo No. 11

West Boiler Slag Pond bottom ash and other discharge pipes

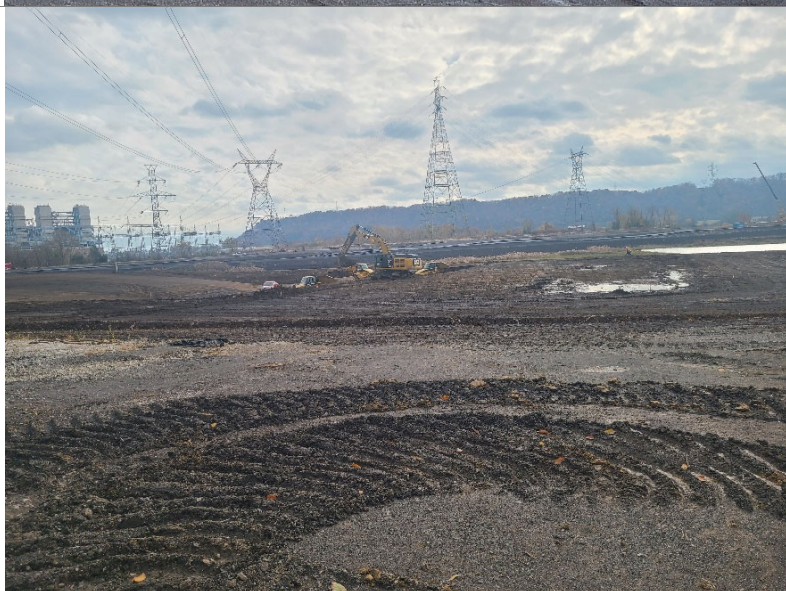
Photo No. 12

West Boiler Slag Pond

Construction within the limit of the pond.

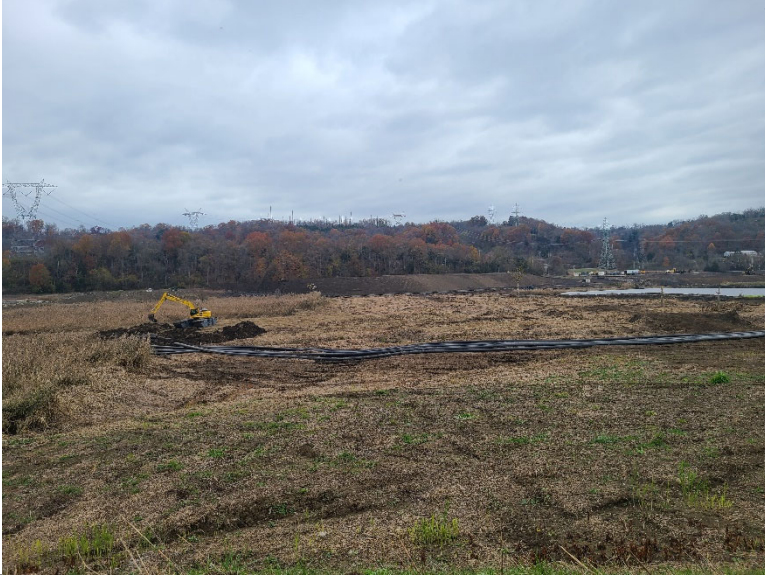
Photo No. 13

West Boiler Slag Pond Principal
Spillway Pipe Discharge

Construction within the limit of
the pond.

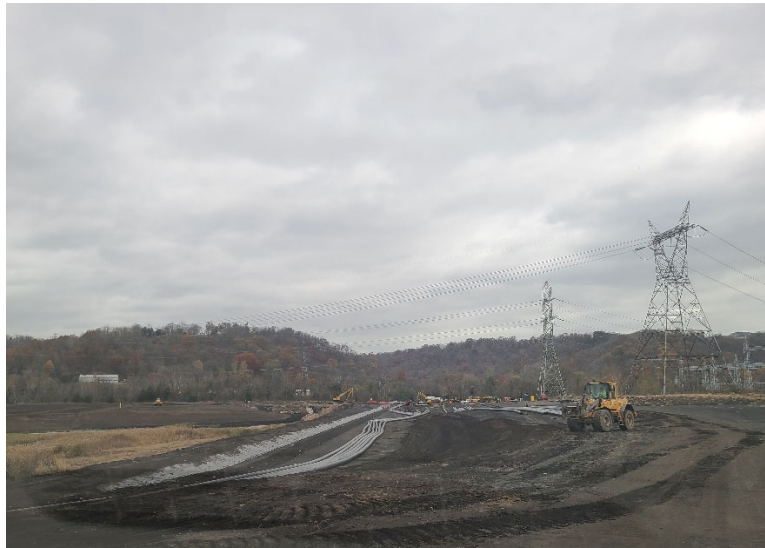
Photo No. 14

West Boiler Slag Pond Principal
Spillway Pipe Discharge

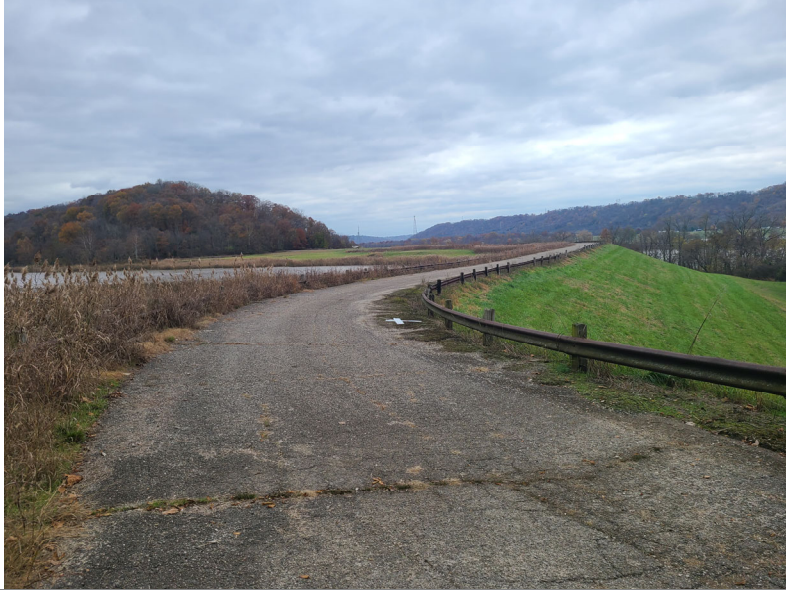
Photo No. 1

1. Photographs Nos. 1, and 2 show the generally condition of the crest of the dam. Signs of misalignment and settlement were not observed. Minor surface cracks in the pavement were observed. Those cracks are attributed to the age of the pavement and the results of weathering process.

Landfill Runoff Collection Pond Dam
From Crest Looking Northeast Across
Saddle Dam

General Overview

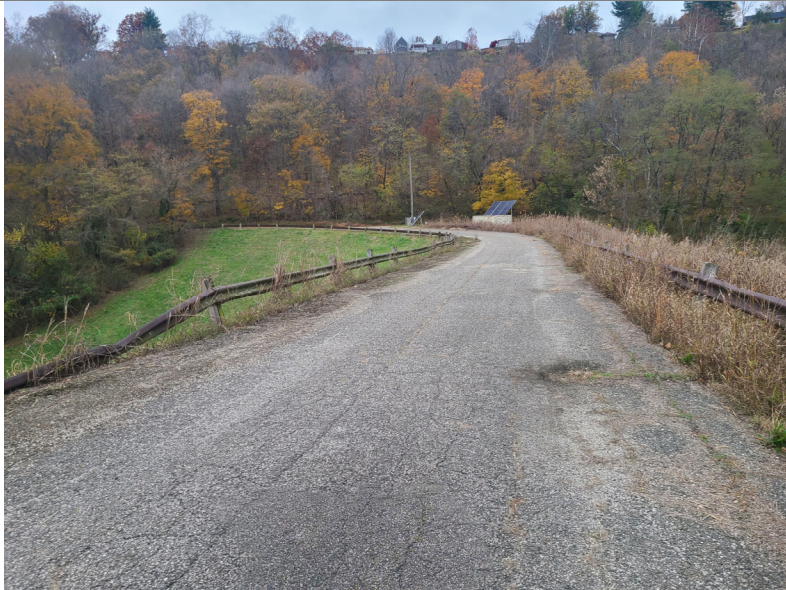
Photo No. 2

Landfill Runoff Collection Pond Dam
From Crest Looking Southwest

General Overview

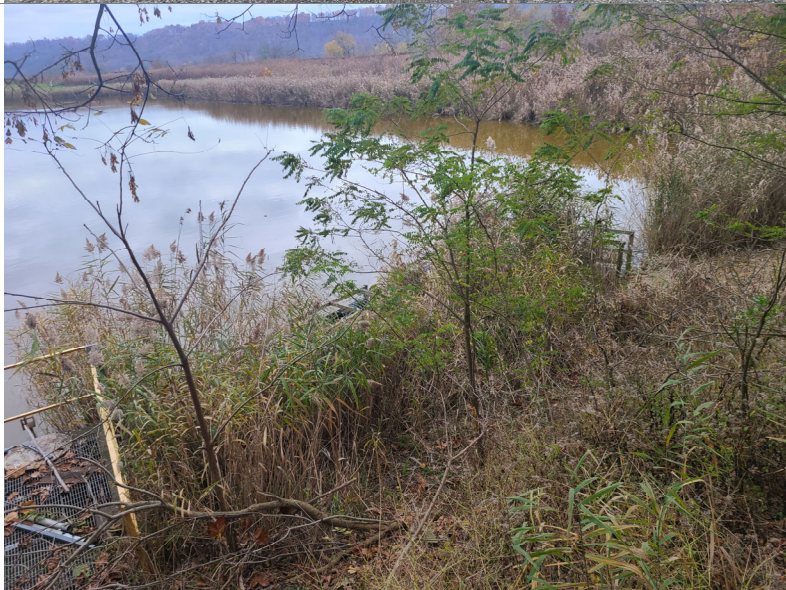
Photo No. 3

2. Photographs Nos. 3 and 4 provide overviews of the interior slope of the dam above the operating pool. Vegetation control near the water line and the upper slope areas is lacking, however, erosion due to wave action was not observed. Overall the slope was found to be in satisfactory and stable condition.

Landfill Runoff Collection Pond Dam
From Up Stream Slope

Overview of Current Operating Pool and
Vegetation Conditions on Interior Slope.

Significant vegetation Growth along the
Upstream of Dam

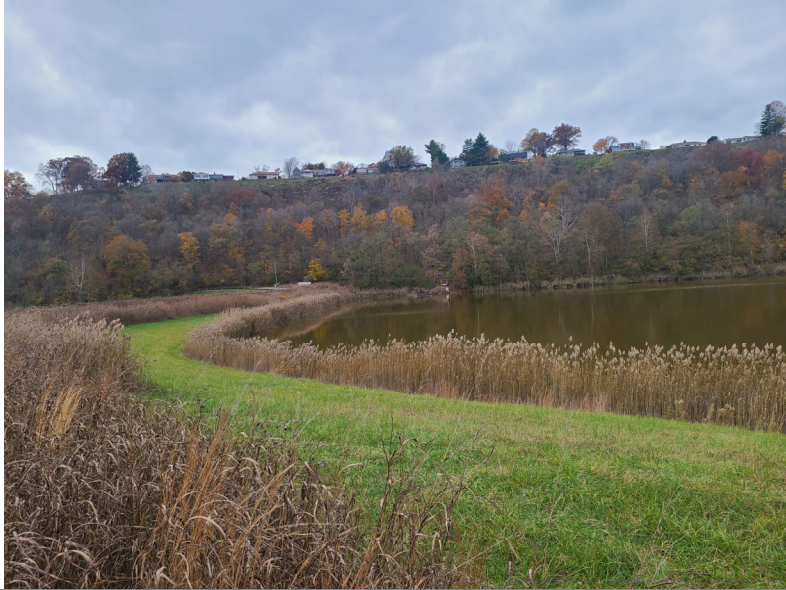
Photo No. 4

Landfill Runoff Collection Pond Dam
From Up Stream Slope

Overview of Vegetation and General
Conditions

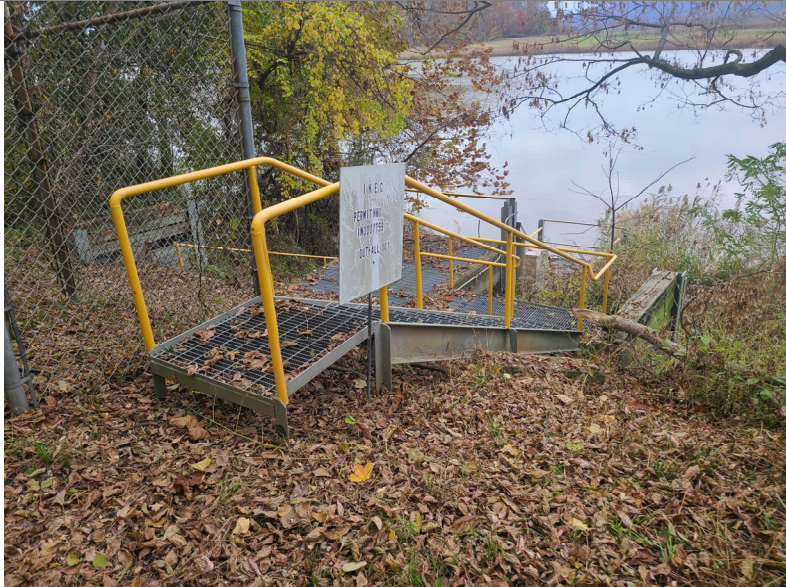
Photo No. 5

3. Photograph No. 5 shows an overview of the principal spillway decant structure. Vegetation control was observed to be lacking. The decant structure and the access stairway appeared to be functioning properly and was free of obstructions. Photograph No.6 shows the recently added pipe to allow for treatment of discharged water with few fallen wood sticks that doesn't appear to restrict the horizontal flow underneath.

Landfill Runoff Collection Pond Dam
From Roadway Leading to Crest Looking
Northeast

Overview of Vegetation Management and
General Condition-overgrown vegetation.

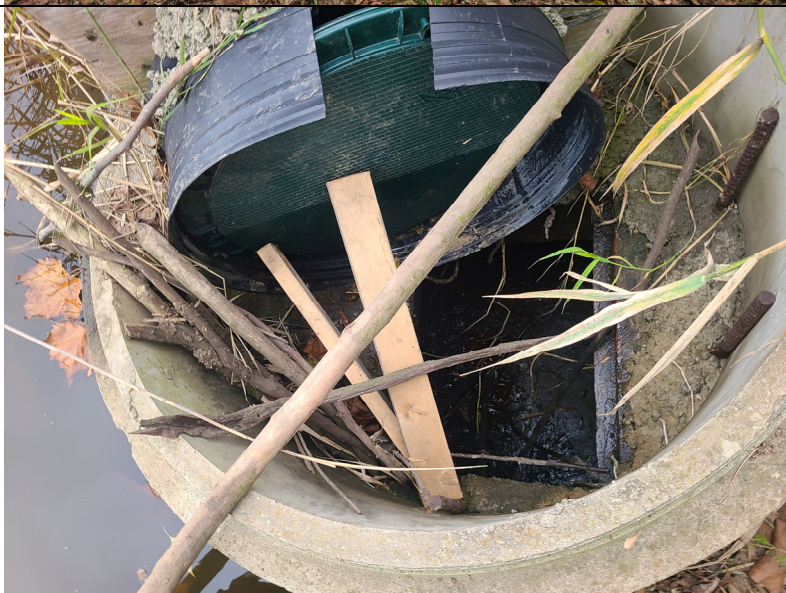
Photo No. 6

Landfill Runoff Collection Pond
Principal Spillway Structure

Looking at drop inlet for
treatment pipe. Fallen wood
sticks above the flow line.

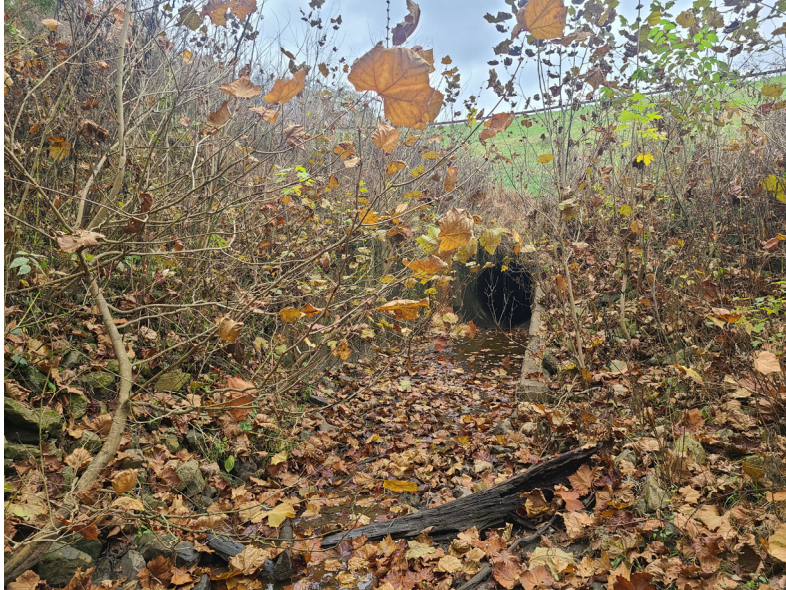
Photo No. 7

4. Photograph Nos. 7 and 8 is an overview of the principal spillway outlet channel. The channel is unobstructed with minimal flow at the time of the inspection. Vegetation control was observed to be lacking.

Landfill Runoff Collection Pond
Principal Spillway Outlet

General Overview-Overgrown vegetation

Fallen tree trunk needs remove

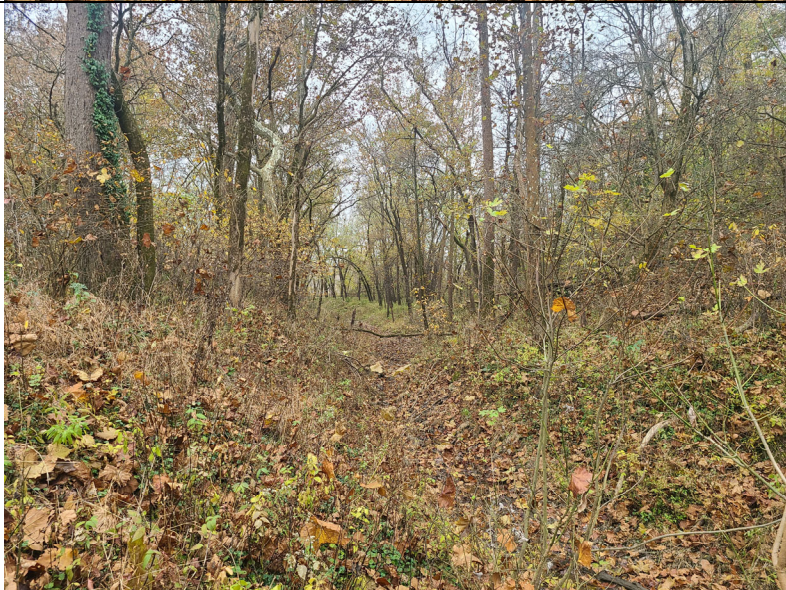
Photo No. 8

Landfill Runoff Collection Pond
Principal Spillway Outlet Channel
Looking Downstream

General Overview-overgrown vegetation

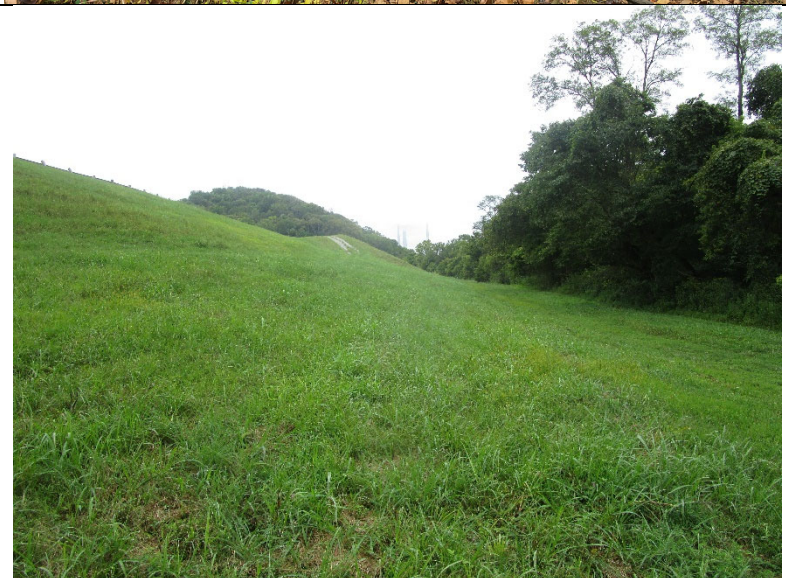
Photo No. 9

5. Photographs Nos. 9 through 14 are all overviews of various areas of the exterior face of the dam as further described with each photograph. Throughout, vegetation control was adequate and there were no signs of sloughing, erosion or instability, except for the area adjacent to the previously repaired slope. No visible change was observed from previous inspections. In general, the exterior slope appeared to be in satisfactory and stable condition

Landfill Runoff Collection Pond Dam
Adjacent To Toe of Slope Looking East

Overview of Vegetation and General
Conditions

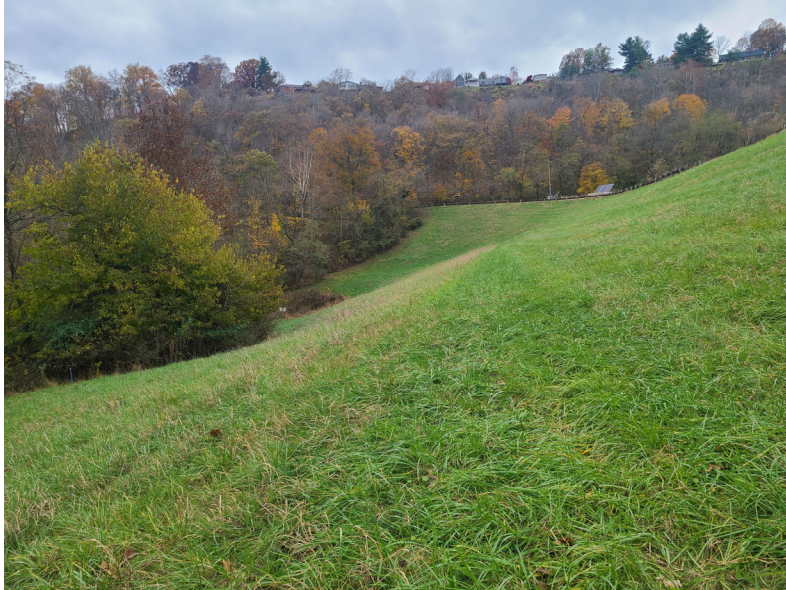
Photo No. 10

6. The one area of concern is the slope adjacent to the previously repaired area in 2017. This area apparently did not experience additional sloughing/slip activity. A repair detail has been approved the state and ready for implementation.

Landfill Runoff Collection Pond Dam
Adjacent To Toe of Slope Looking East

Overview of downstream slope adjacent
to rip rap repair area.

- The southing/slip area of the outboard slope needs to be monitored in order to prevent additional damage to the slope area.

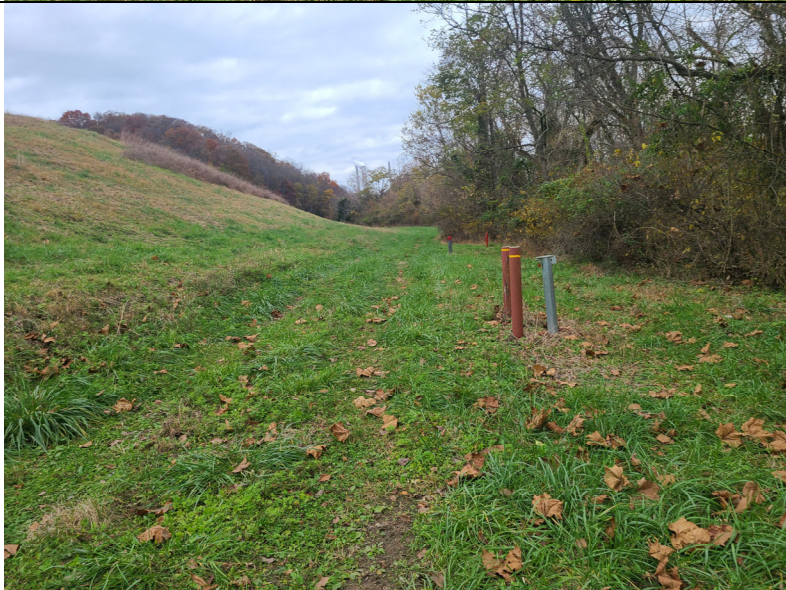
Photo No. 11

Landfill Runoff Collection Pond Dam
Adjacent To Toe of Slope Looking
Southwest

Overview of Vegetation and General
Conditions

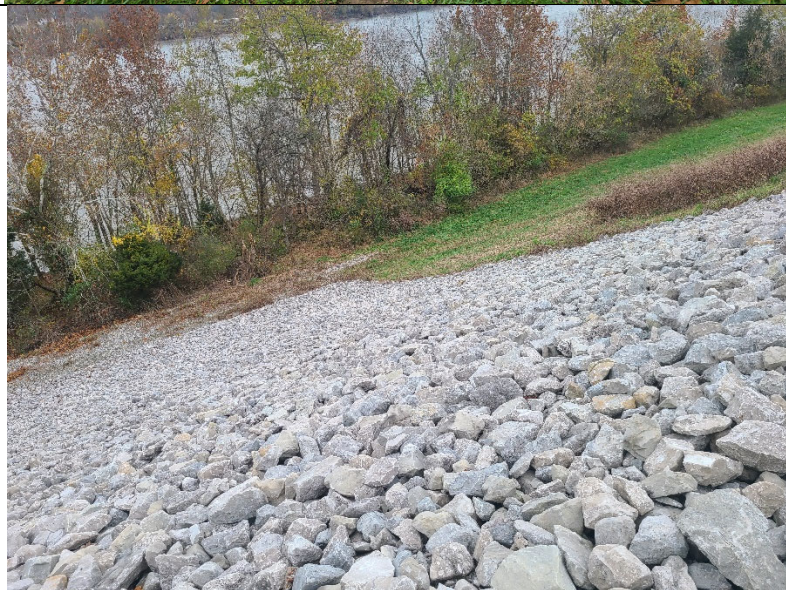
Photo No. 12

Landfill Runoff Collection Pond Dam
Adjacent To Toe of Slope Looking
Southwest

Overview of rip rap,
Looking west.

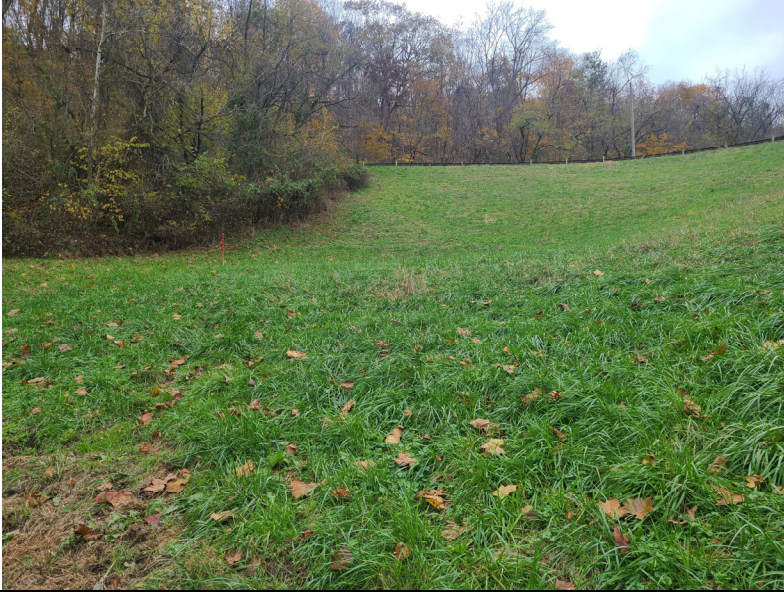
Photo No. 13

Overview of downstream slope area. Looking west.

General Overview

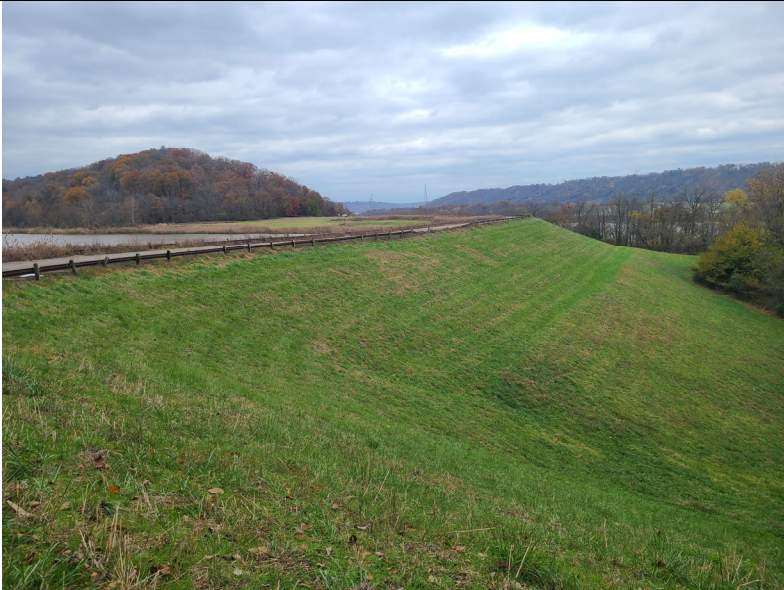
Photo No. 14

Landfill Runoff Collection Pond Dam
From Top of Slope In Right Groin
Looking East

Overview of Vegetation and General
Conditions
