2022 ANNUAL DAM AND DIKE INSPECTION REPORT

**West Boiler Slag Pond
& Landfill Runoff Collection Pond**

**CLIFTY CREEK PLANT
Indiana-Kentucky Electric Corporation
MADISON, INDIANA**

Document ID: GERS-22-045

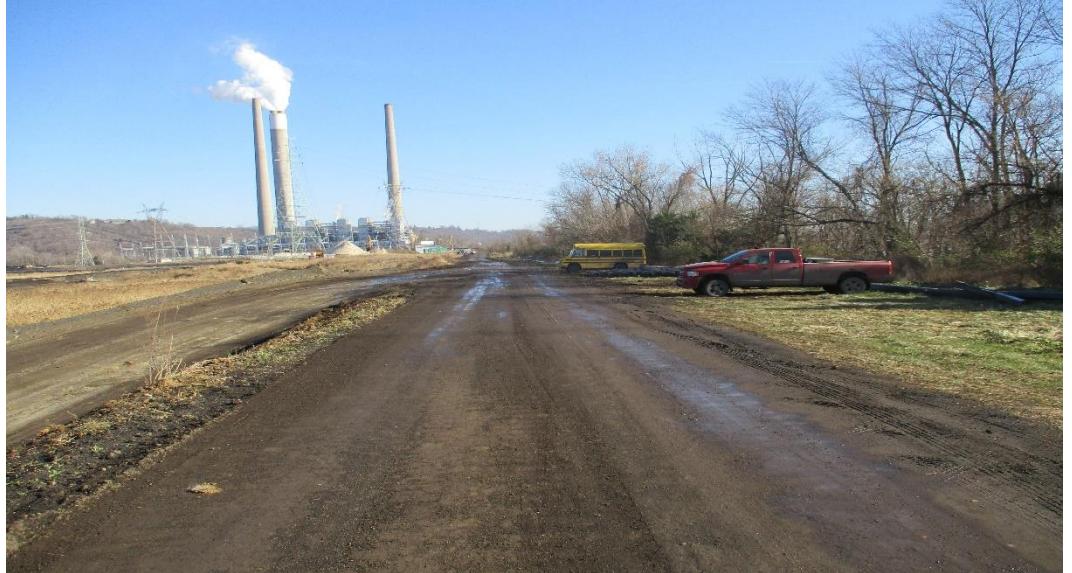
1. Photographs No. 1 and 2 illustrates a typical overview of the south dike crest. The crest appears to be in good and stable condition. Signs of settlement, misalignment and cracking were not observed. Minor surface erosion at the southwest corner of the crest was observed (Photograph No. 3).
2. The interior slope of the west section of the dike is illustrated in Photograph No. 4. This slope is currently graded for the construction of the new pond. The interim slope condition appeared fair. The overflow decant structure is not in use due to construction activities in this area of the pond.

<p>Photograph No. 1</p> <p>This photograph illustrates crest of the south dike (looking northeast).</p>

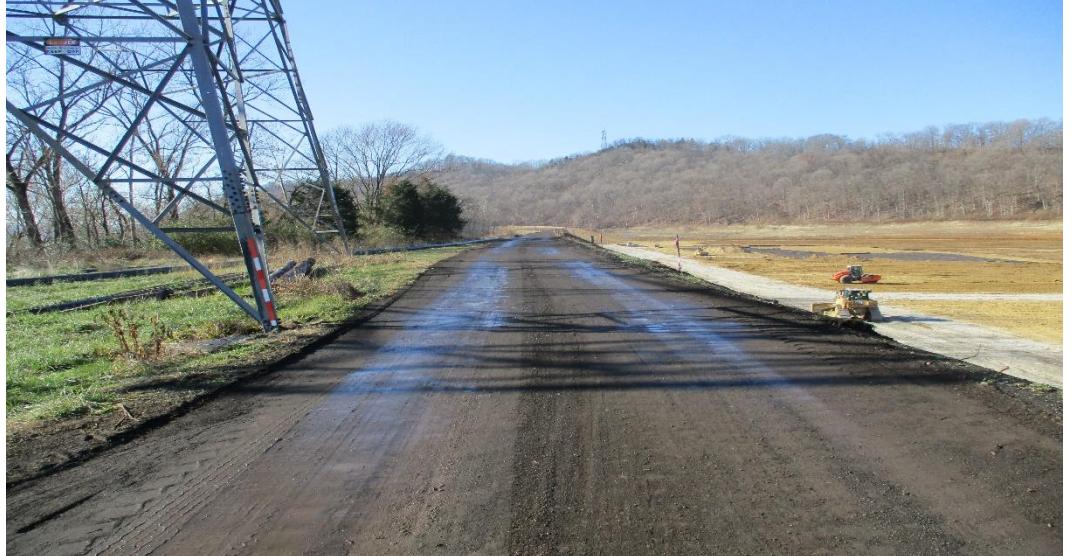
<p>Photograph No. 2</p> <p>This photograph illustrates crest of the south dike (looking southwest).</p>

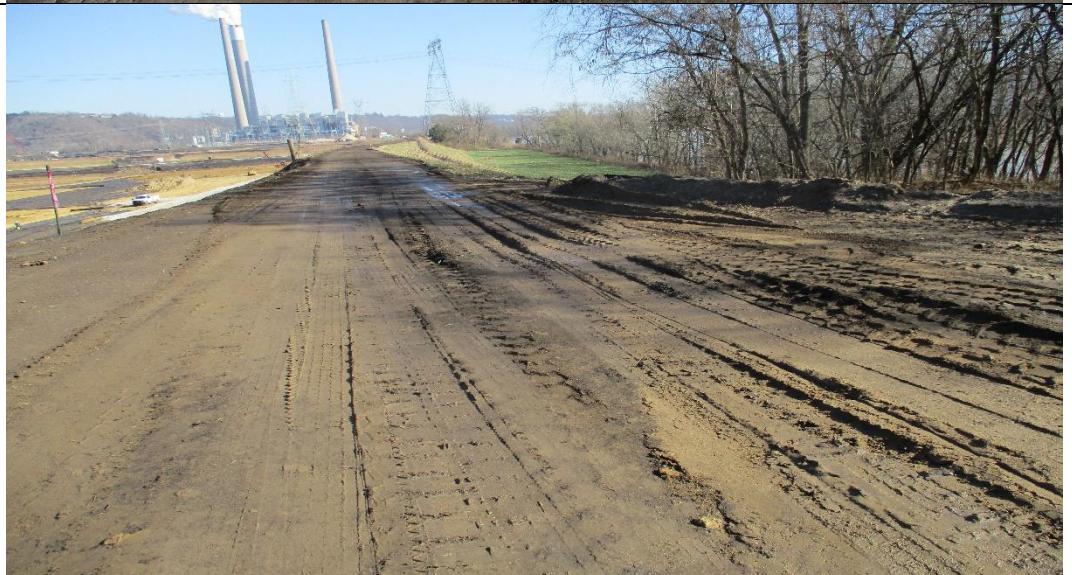
<p>Photograph No. 3</p> <p>Minor erosion on the south side of the crest.</p>

- Minor rutting of the south dike crest shall be repaired by backfilling/regrading with compatible material.
- Structural integrity of dikes and components of pond should be maintained during the course of closure by removal and installation of new pond activities.

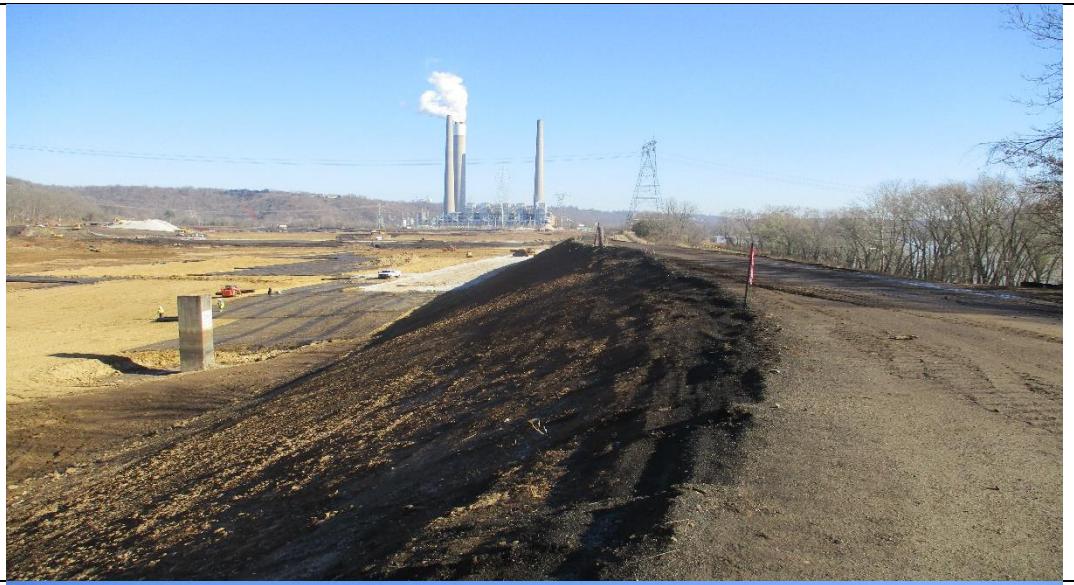
<p>Photograph No. 4 Typical condition of the south dike interior slope.</p>

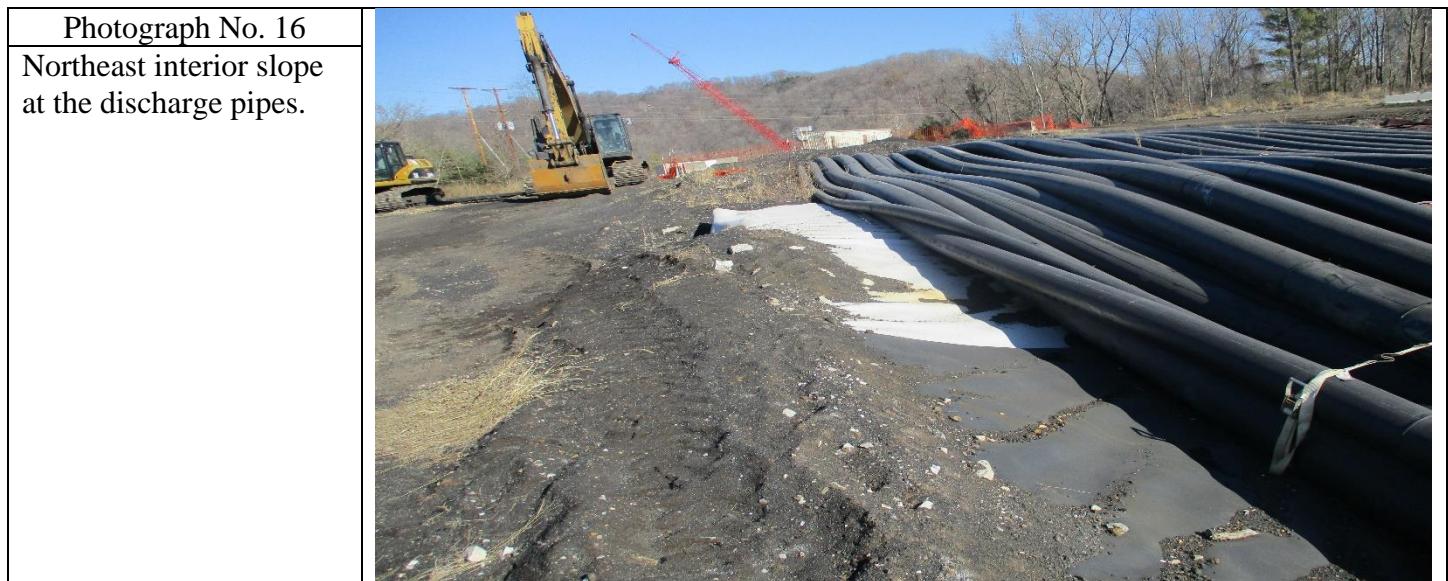
8. Photographs No. 14 and 15 illustrates the interior slope of the northeast section of the dike. The interior slope appeared in fair condition. This area of the pond interior consists substantial stockpiles of bottom ash. Minor erosion gullies were noticed along this section of the dike. Ash and other plant operational stream discharge pipes are also located in this section of the dike (Photograph No. 16). The discharge pipes, protective liner, and side slope appeared in fair and stable condition.

<p>Photograph No. 13 Northeast interior area of the pond.</p>	
<p>Photograph No. 14 Typical northeast interior slope.</p>	
<p>Photograph No. 15 Bottom ash and plant operations discharge pipes.</p>

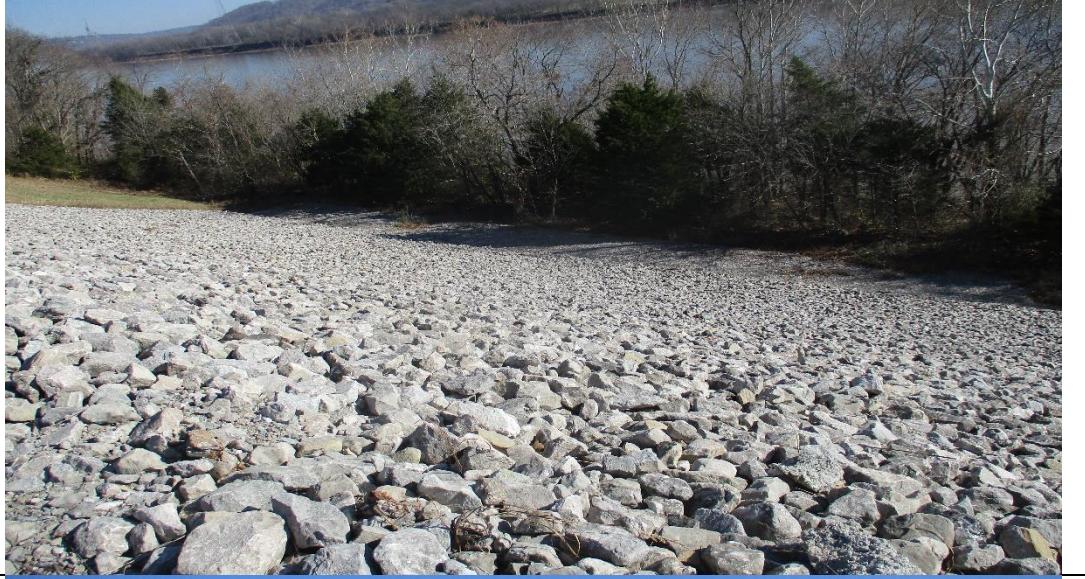
1. Photographs No. 17 and 18 illustrates the seepage control blanket previously installed. No visible seepage was observed during the inspection. The riprap cover was in good condition and no vegetation was seen protruding within the blanket.
2. Photographs No. 19 and 20 shows an overall view of the east exterior slope of the dam. Throughout exterior slope vegetation control was good and there were no signs of sloughing, erosion or instability. In general, the exterior slope appeared to be in satisfactory and stable condition.
3. A minor depression (Photograph No. 21) was encountered at the southeast area of the exterior slope along the toe. The access road from the crest of the dam to the toe area appeared in good condition (Photograph No. 22). Minor rutting along the sides were noticed (Photograph No. 23).

<p>Photograph No. 17 Overall view of the riprap blanket (looking east).</p>

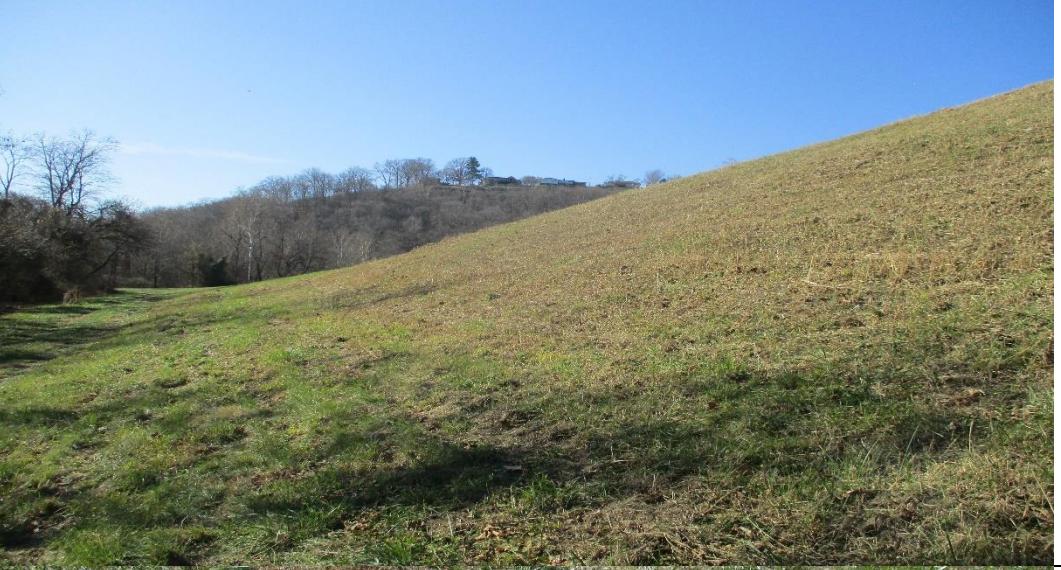
<p>Photograph No. 20</p> <p>Exterior slope (looking south).</p>

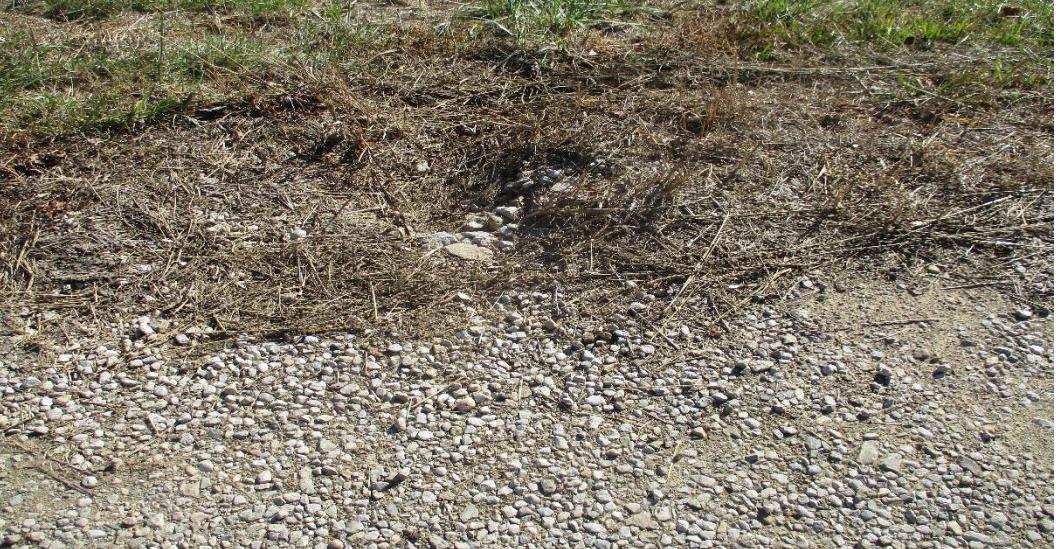
<p>Photograph No. 21</p> <p>Minor depression.</p>

- Minor rutting at the access road shall be repaired by backfilling/regrading with compatible material. A minor depression (Photograph No. 21) shall be backfilled with soil and compacted.

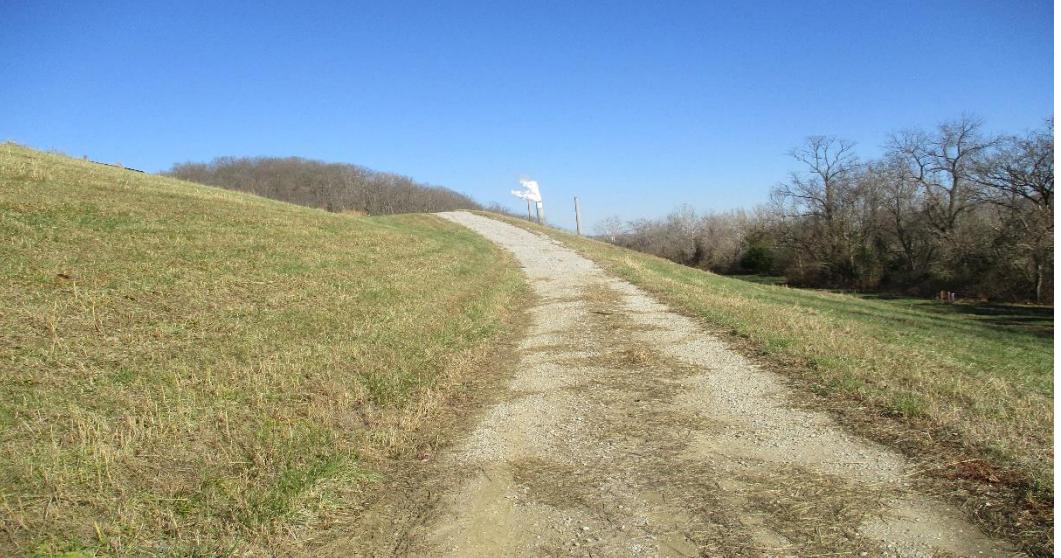
<p>Photograph No. 22</p> <p>Access road along the slope.</p>

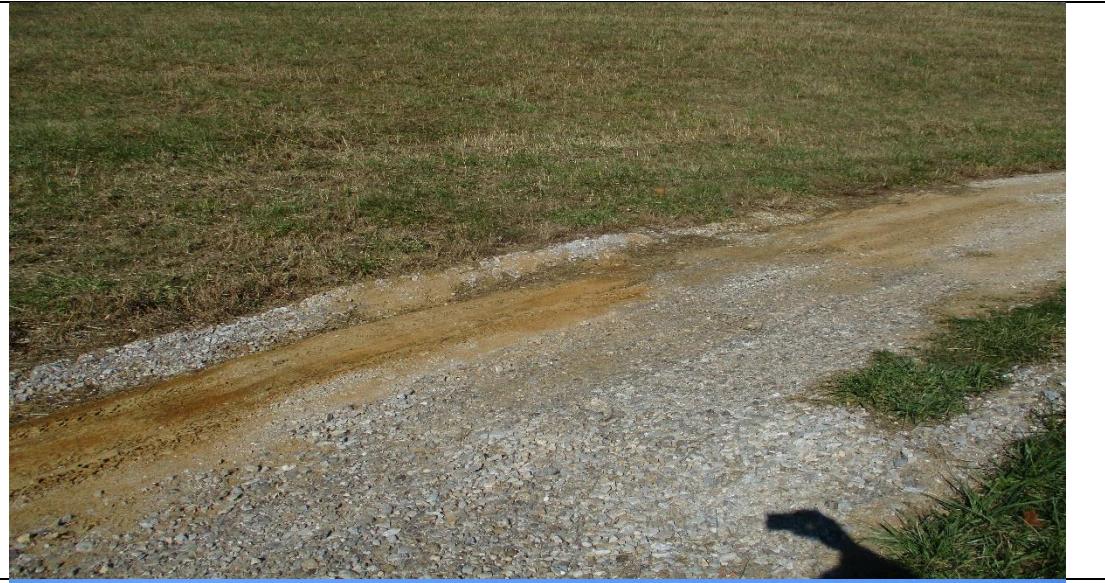
<p>Photograph No. 23</p> <p>Minor erosion.</p>

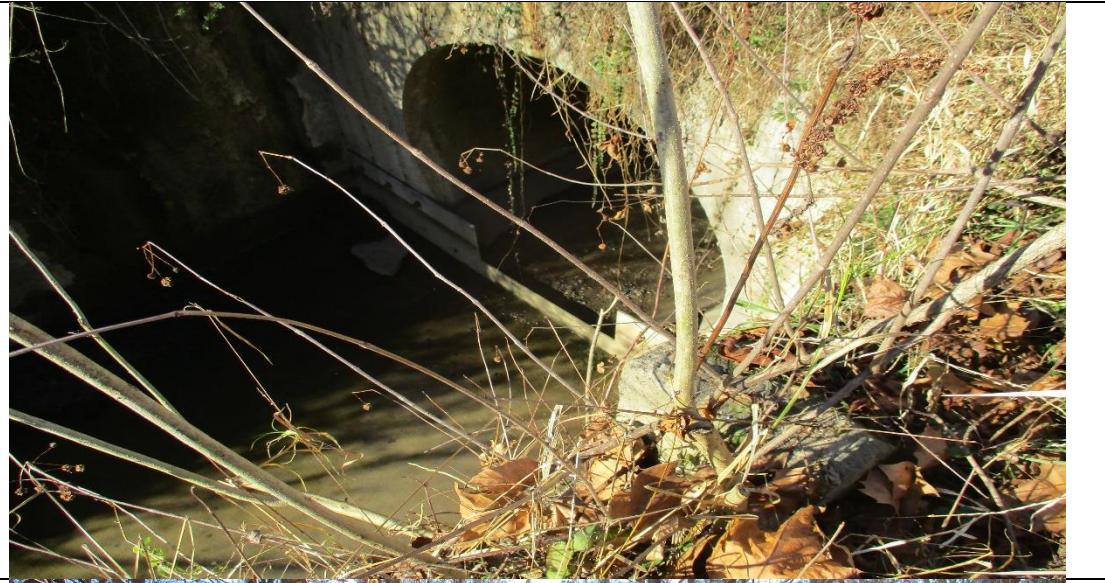
<p>Photograph No. 26 Outfall to the outlet channel and Ohio River.</p>

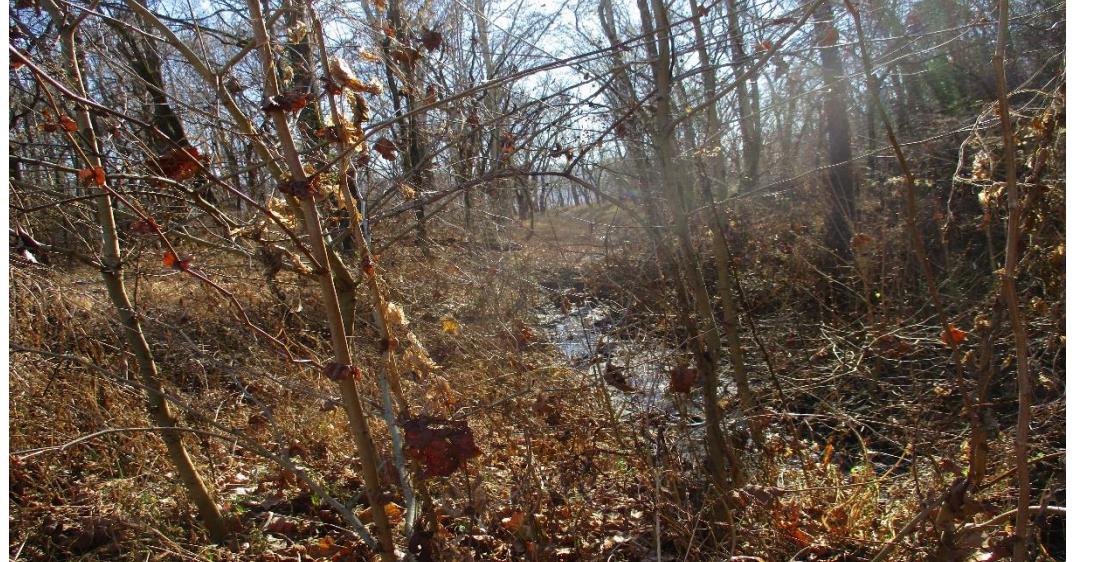
<p>Photograph No. 27 View of the outlet channel.</p>

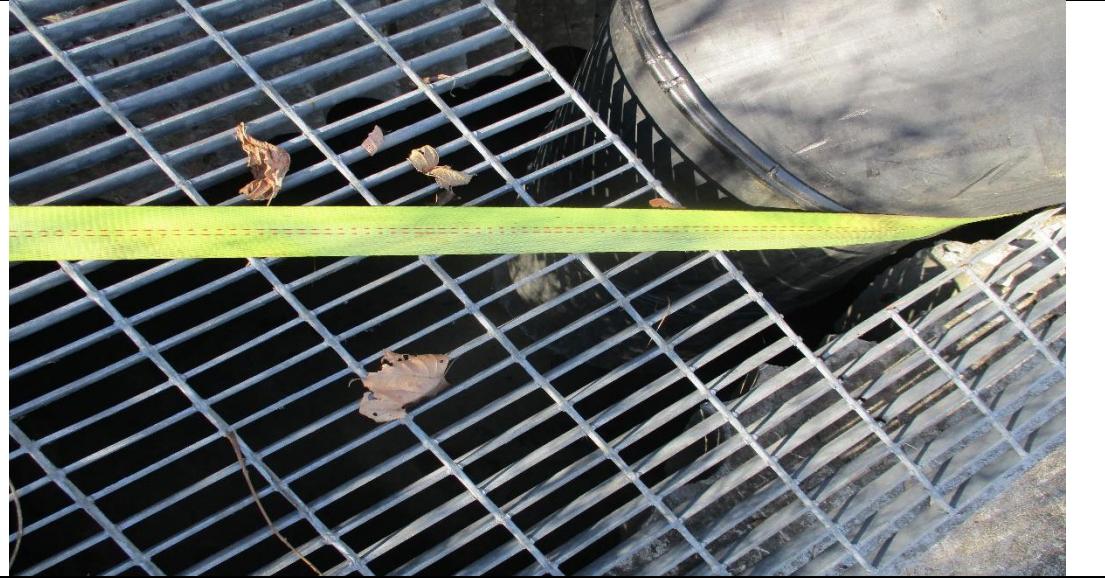
6. Photograph No. 28 illustrates an overview of the principal spillway decant structure. The decant structure and the access stairway appeared to be functioning properly and was free of obstructions. The recently added pipe (not shown in this photograph) to allow for treatment of discharged water was in functional condition. No water was flowing in the decant structures at the time of inspection.

<p>Photograph No. 28 Principal spillway structure.</p>

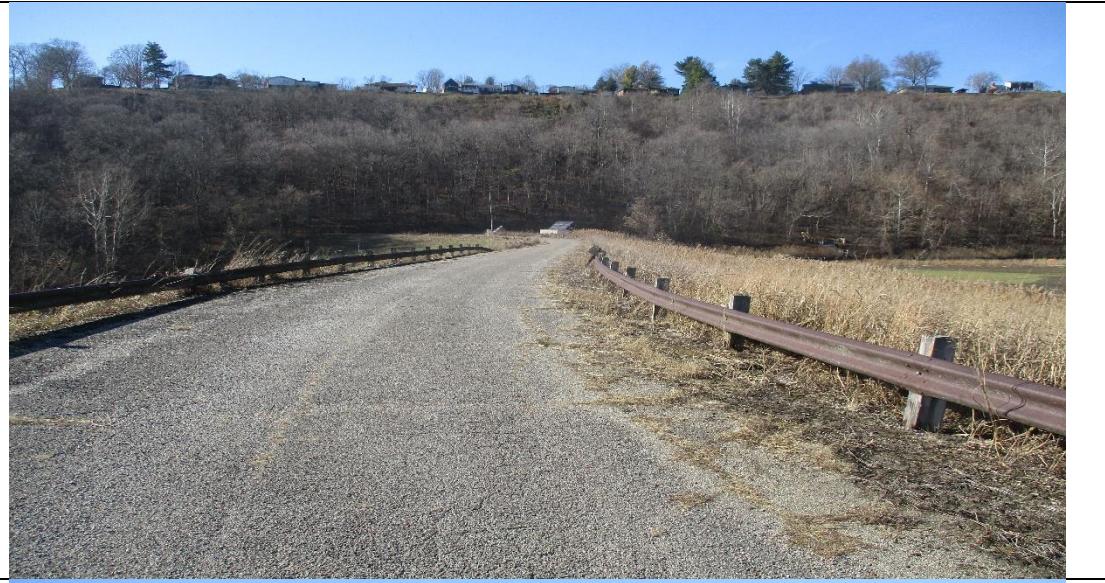
7. Photographs No. 29 and 30 illustrates typical condition of the crest and interior slope of the dam. Saddle dam is also part of this section of the dam. Signs of misalignment and settlement were not observed. Minor surface cracks in the pavement were observed. Those cracks are attributed to the age of the pavement and the results of weathering process. Overall, the slope was found to be in satisfactory and stable condition

<p>Photograph No. 29 Crest and saddle dam (looking west).</p>

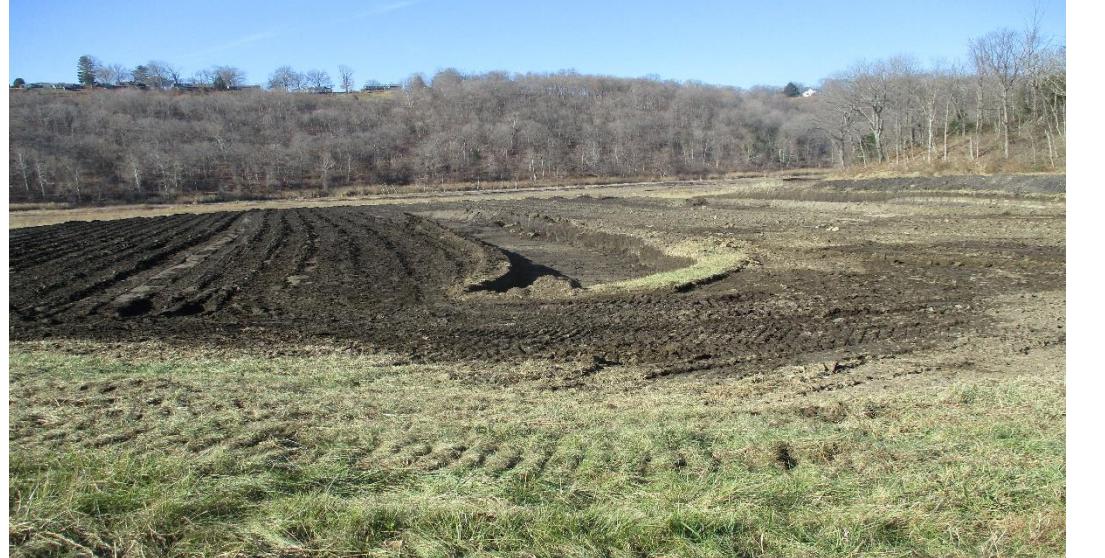
<p>Photograph No. 30 Interior slope (looking west).</p>
