Clifty Creek Station

2023 CCR Rule – Surface Impoundments Clifty Creek Dam/Dike Inspections

Clifty Creek Generating Station Madison, Indiana Jefferson County

January 19, 2024

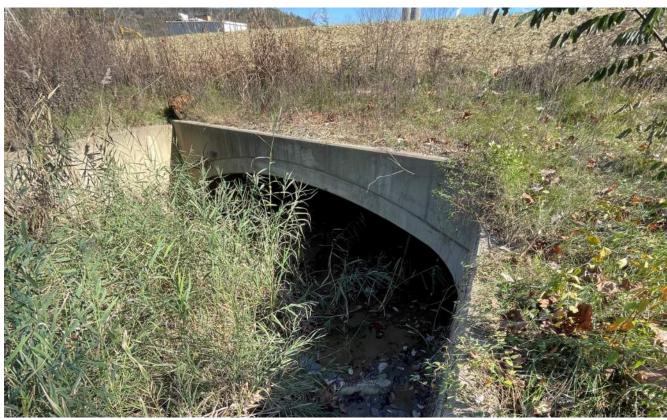
The existing culvert appears to be in satisfactory condition with negligible inflow. Flow appears to be limited to the area immediately adjacent to the culvert. The CCR sluice piping in the northeast corner of the WBSP has been terminated at the perimeter of the pond, and the pipes removed from within the pond.

Photograph 1 – Northwest (upstream) side of inlet culvert structure, northwest side of WBSP

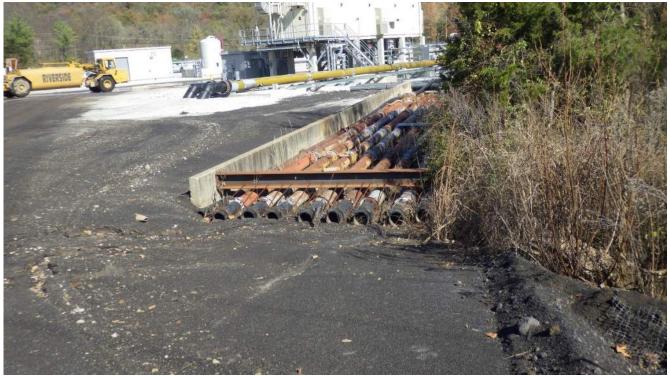
Photograph 2 – Former CCR sluice pipes, terminated, northeast side of WBSP.

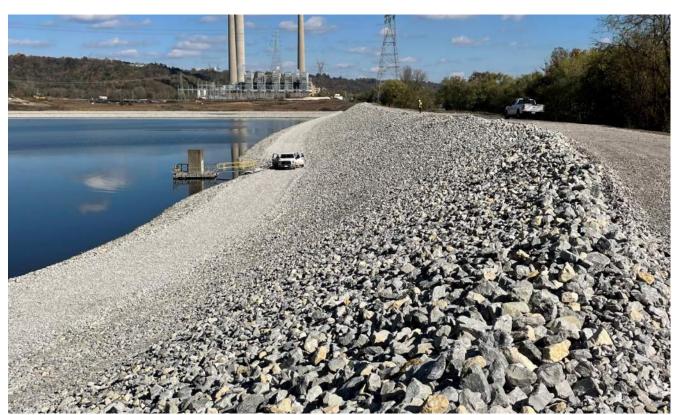
Photograph 3 – South dike embankment, upstream side looking east. Crew repairing railing around outfall structure.

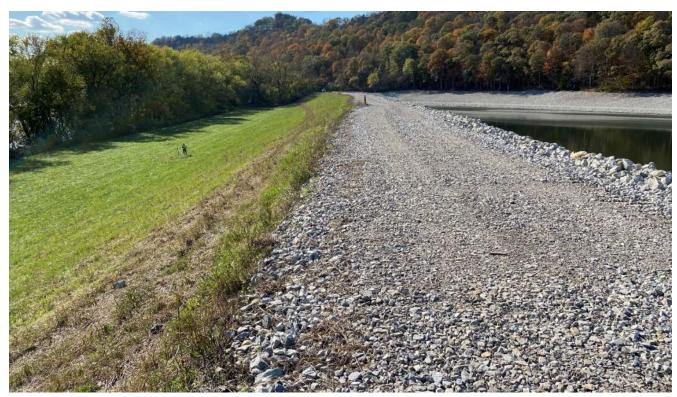
Photograph 4 – South dike embankment crest, looking west. Note the brown damaged vegetation parallel to the top of the slope.

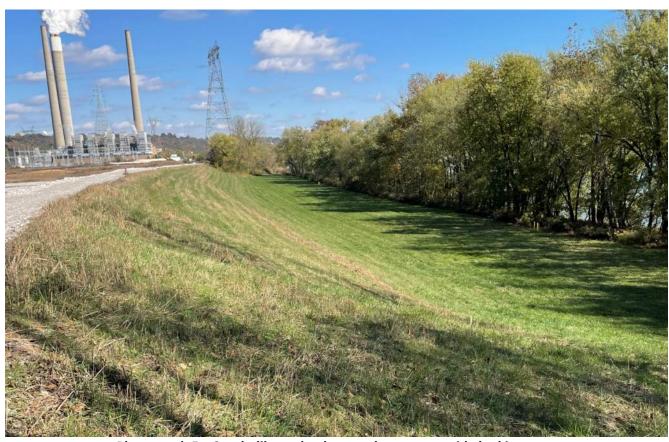
Photograph 5 – South dike embankment, downstream side looking east.

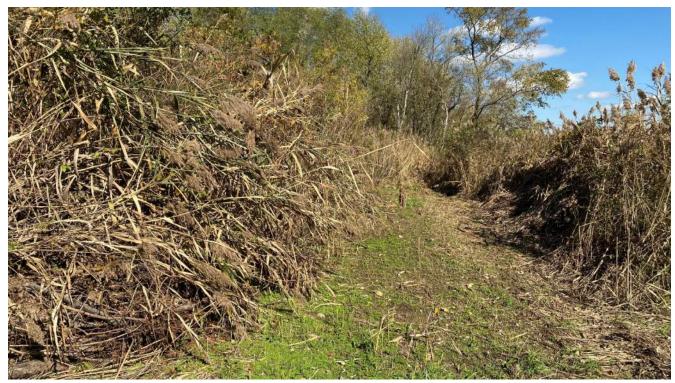
The upstream and downstream dike slopes and crest areas, east of the LVWTS, are overgrown with small to large trees and heavy brush (Photographs 6, 7, and 8 in Appendix D). These conditions make it virtually impossible to inspect the slopes. The trees and larger brush can also provide seepage pathways as the larger foliage dies off. Trees that topple in windstorms can leave large holes exposed in the face of the dam. Stantec recommends that the overgrown crest and downstream side of the dam be stripped of foliage, graded for ease of maintenance, and seeded with grass to protect it from erosion. This will allow for future inspections to be conducted on this portion of the dam.

Photograph 6 – Southern dike embankment downstream side, overgrown section with trail cut in, looking east.

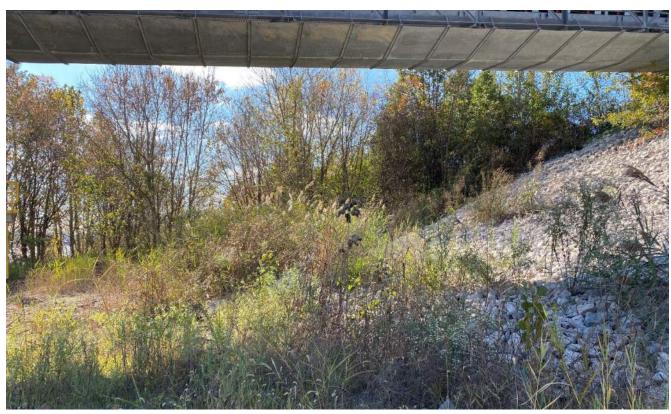
Photograph 7 – Southern dike embankment downstream side, overgrown section looking west beneath the gypsum conveyor.

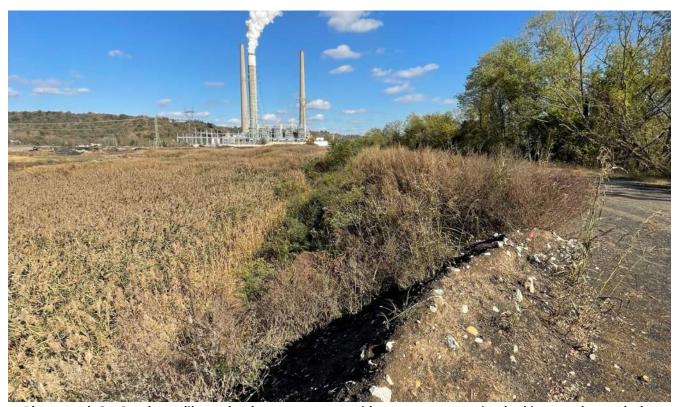
Photograph 8 – Southern dike embankment upstream side, overgrown section looking east beneath the power lines.

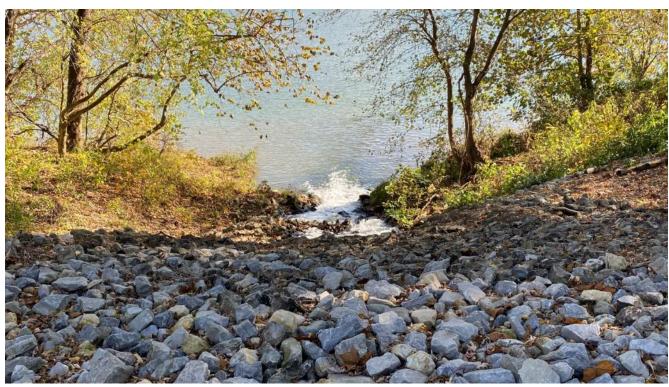
Photograph 9 – WBSP Outfall outlet to the Ohio River.

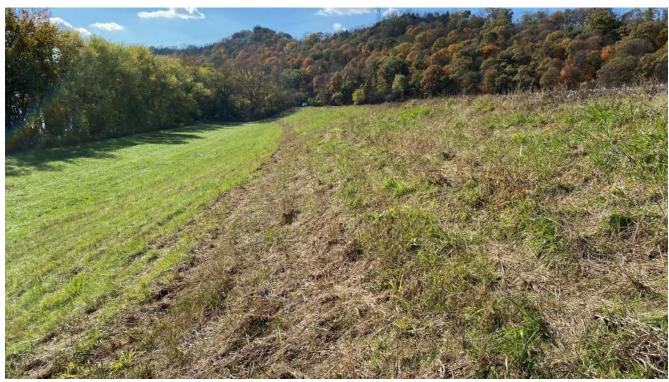
Photograph 10 – Southern dike embankment downstream side, showing damaged vegetation from vehicle traversing slope.

On the downstream face of the dam near the LVWTS, the minor rutting should be backfilled, graded, and reseeded. It appears that minor rutting of the south dike crest mentioned in the 2022 inspection report was repaired.

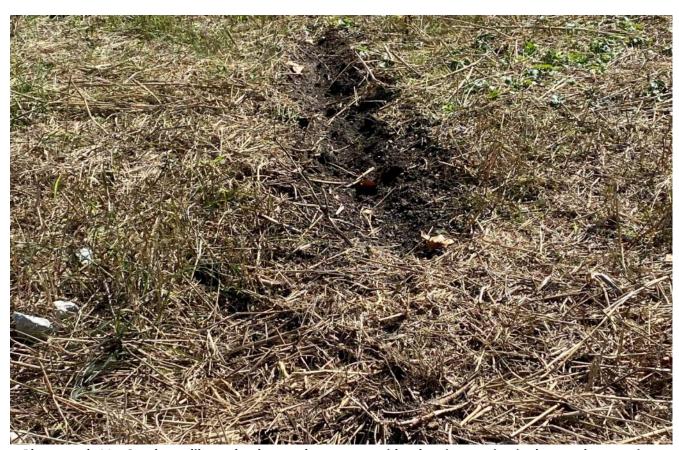
Photograph 11 – Southern dike embankment downstream side, showing erosion in damaged vegetation.

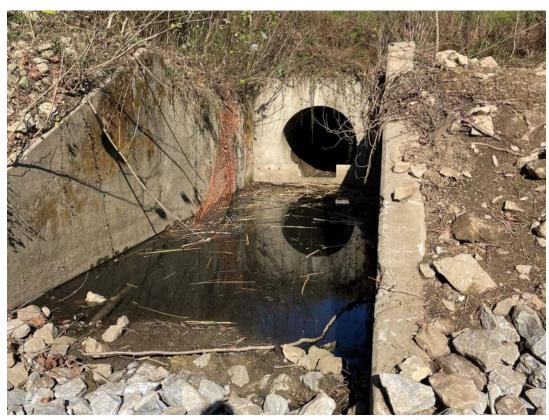
Photograph 5 – Outfall 001 outlet structure at toe of dam.

At the outlet for Outfall 001, we recommend that all brush and tall foliage around the wingwalls be removed to a distance of about 20 feet and replaced with either grass or riprap to aid in observation of the outlet structure. A railing around the top of the head and wing walls could also be considered. Debris left over from previous clearing activities should be removed from inside the culvert outlet box (Photograph 5). Since water will no longer be impounded in the LRCP, we recommend that an area at a distance of 20 feet around the inlet structure be cleared of all tall grasses and brush (Photographs 6 and 7). In addition, railings should be replaced or reinstalled around the inlet structure. A portion of the metal grating that covers one of the old inlets has been cut away leaving an open hole (Photograph 7). The grating should be replaced or the hole covered. Any superfluous materials or fixtures associated with the inlet structure should be removed. It is understood that the inlet elevation will be adjusted as part of the Phase 2 construction (Photograph 8).

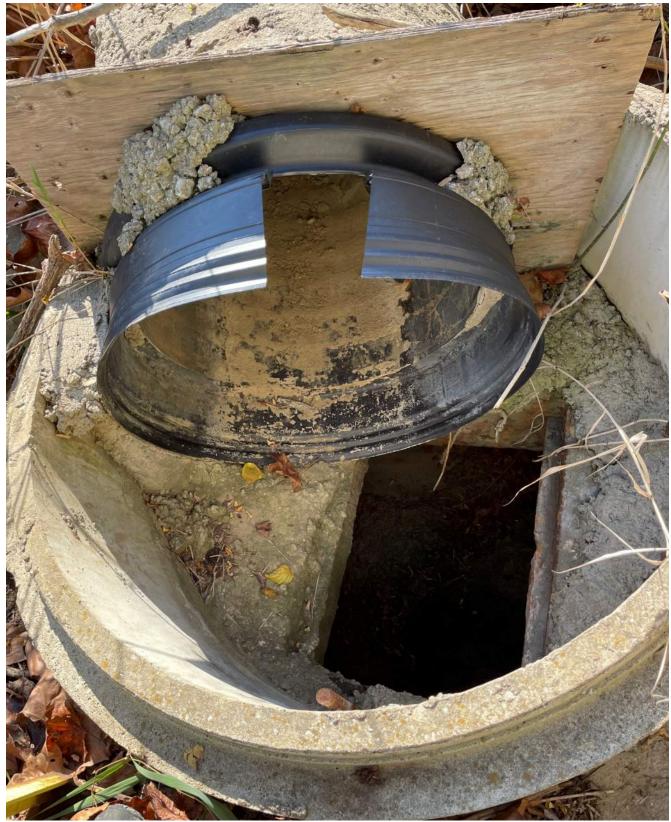
Photograph 8 – Current inlet structure for Outfall 001.

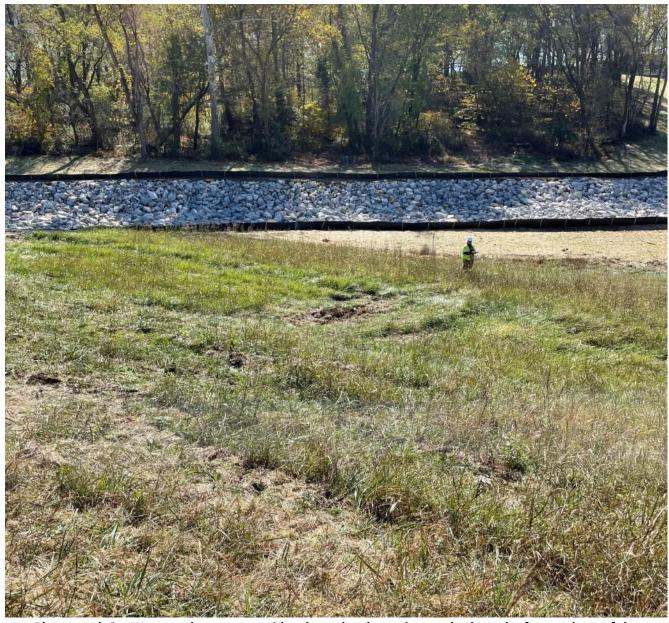
Photograph 9 – Western downstream side where the channel extends along the face and toe of the embankment. Note disturbed spots in grass from equipment.

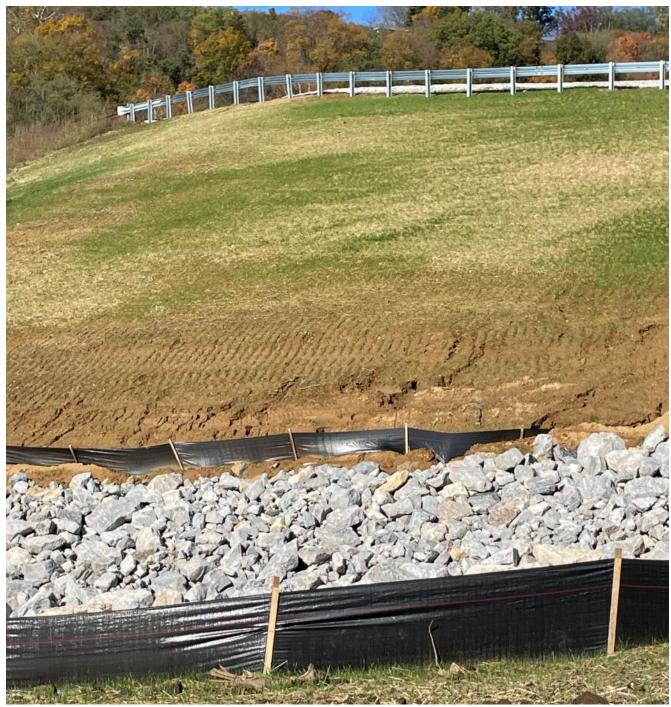
along the north edge of the new channel where erosion rills had started to form and one location below the access road to the toe where the seeded surface had sloughed off the slope. On the downstream slope between the access road to the toe and the riprap-covered slope are several areas where minor grading occurred. In these areas the bulldozer trampled the grass and may require reseeding to prevent erosion. Overall, the dam and associated structures appear to be in satisfactory condition.

Photograph 10 – Western part of regraded downstream side of dam. Note the erosion rills forming above the channel.

Minor maintenance for the LRCP includes mowing of the dam slopes to observe potential issues or concerns, repairing the erosion rills above the downstream channel (Photograph 10) and the disturbed areas on the western downstream slope just west of the newly graded slope (Photograph 9). The surface-sloughed area beneath the access road to the toe (Photograph 12) and the thinly vegetated slopes east of the access road (Photograph 13) will likely require attention as well.

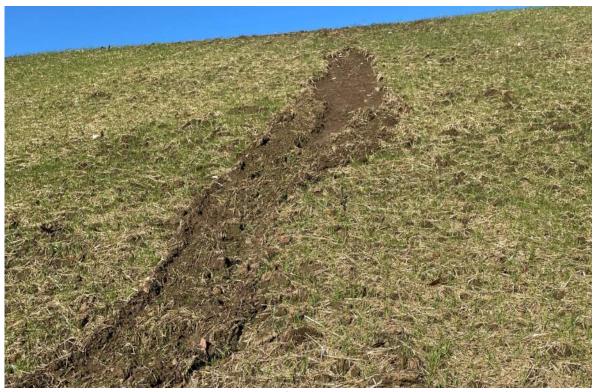
Photograph 12 – Regraded downstream side of dam below access road. Minor surface sloughing.

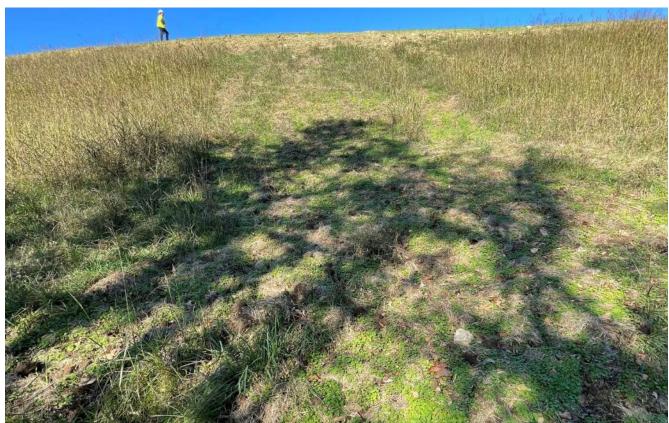
Photograph 13 – Downstream side of dam east of access road. Several areas of sparse vegetation where the bulldozer traversed the slope.

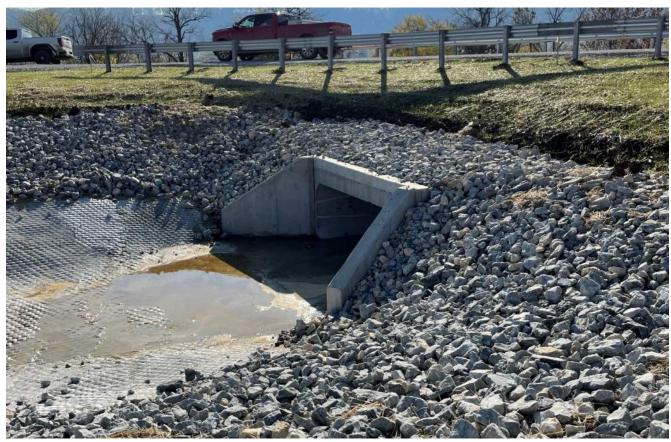
Dam degradation and the addition of the 12-foot by 4-foot box culvert to allow routing of run-on stormwater around the LRCP have potential for affecting the stability of the dam. Placement of a structure in or below an earthen dam provides the potential for seepage around the structure. Stantec provided a professional engineer to provide quality assurance during construction activities on the LRCP dam. Based on review of the construction observation reports, clay fill was adequately placed and compacted around the outside of the culvert structure. Shortly after completion of construction, the culvert appeared to adequately convey water from the upstream side to the downstream channel. Grass should help protect the slopes from erosion once the newly seeded slopes have matured.

Photograph 17 – Usptream side of dam at new 12x4 culvert.

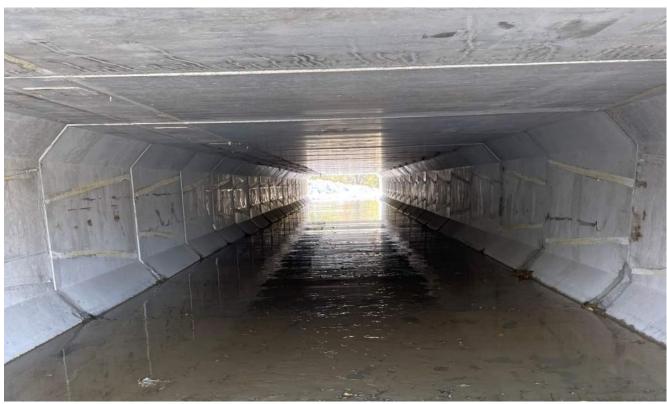
Photograph 18 – Usptream side of dam at new 12x4 culvert, looking south west through the culvert.

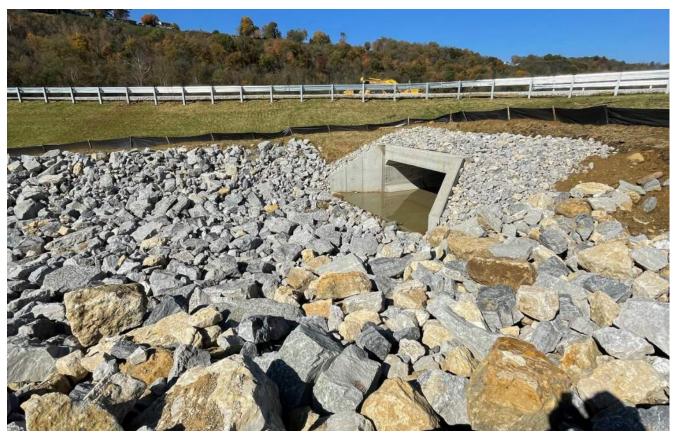
Photograph 19 – Downtream side of dam at new 12x4 culvert.
