October 11, 2016
File: 175534018
Revision 0

**RE: Initial Hazard Potential Classification Assessment
West Boiler Slag Pond and Landfill Runoff Collection Pond
EPA Final Coal Combustion Residuals (CCR) Rule
Clifty Creek Station
Madison, Jefferson County, Indiana**

Initial Hazard Potential Classification Assessment

Clifty Creek Station
West Boiler Slag Pond and Landfill
Runoff Collection Pond
Madison, Jefferson County, Indiana

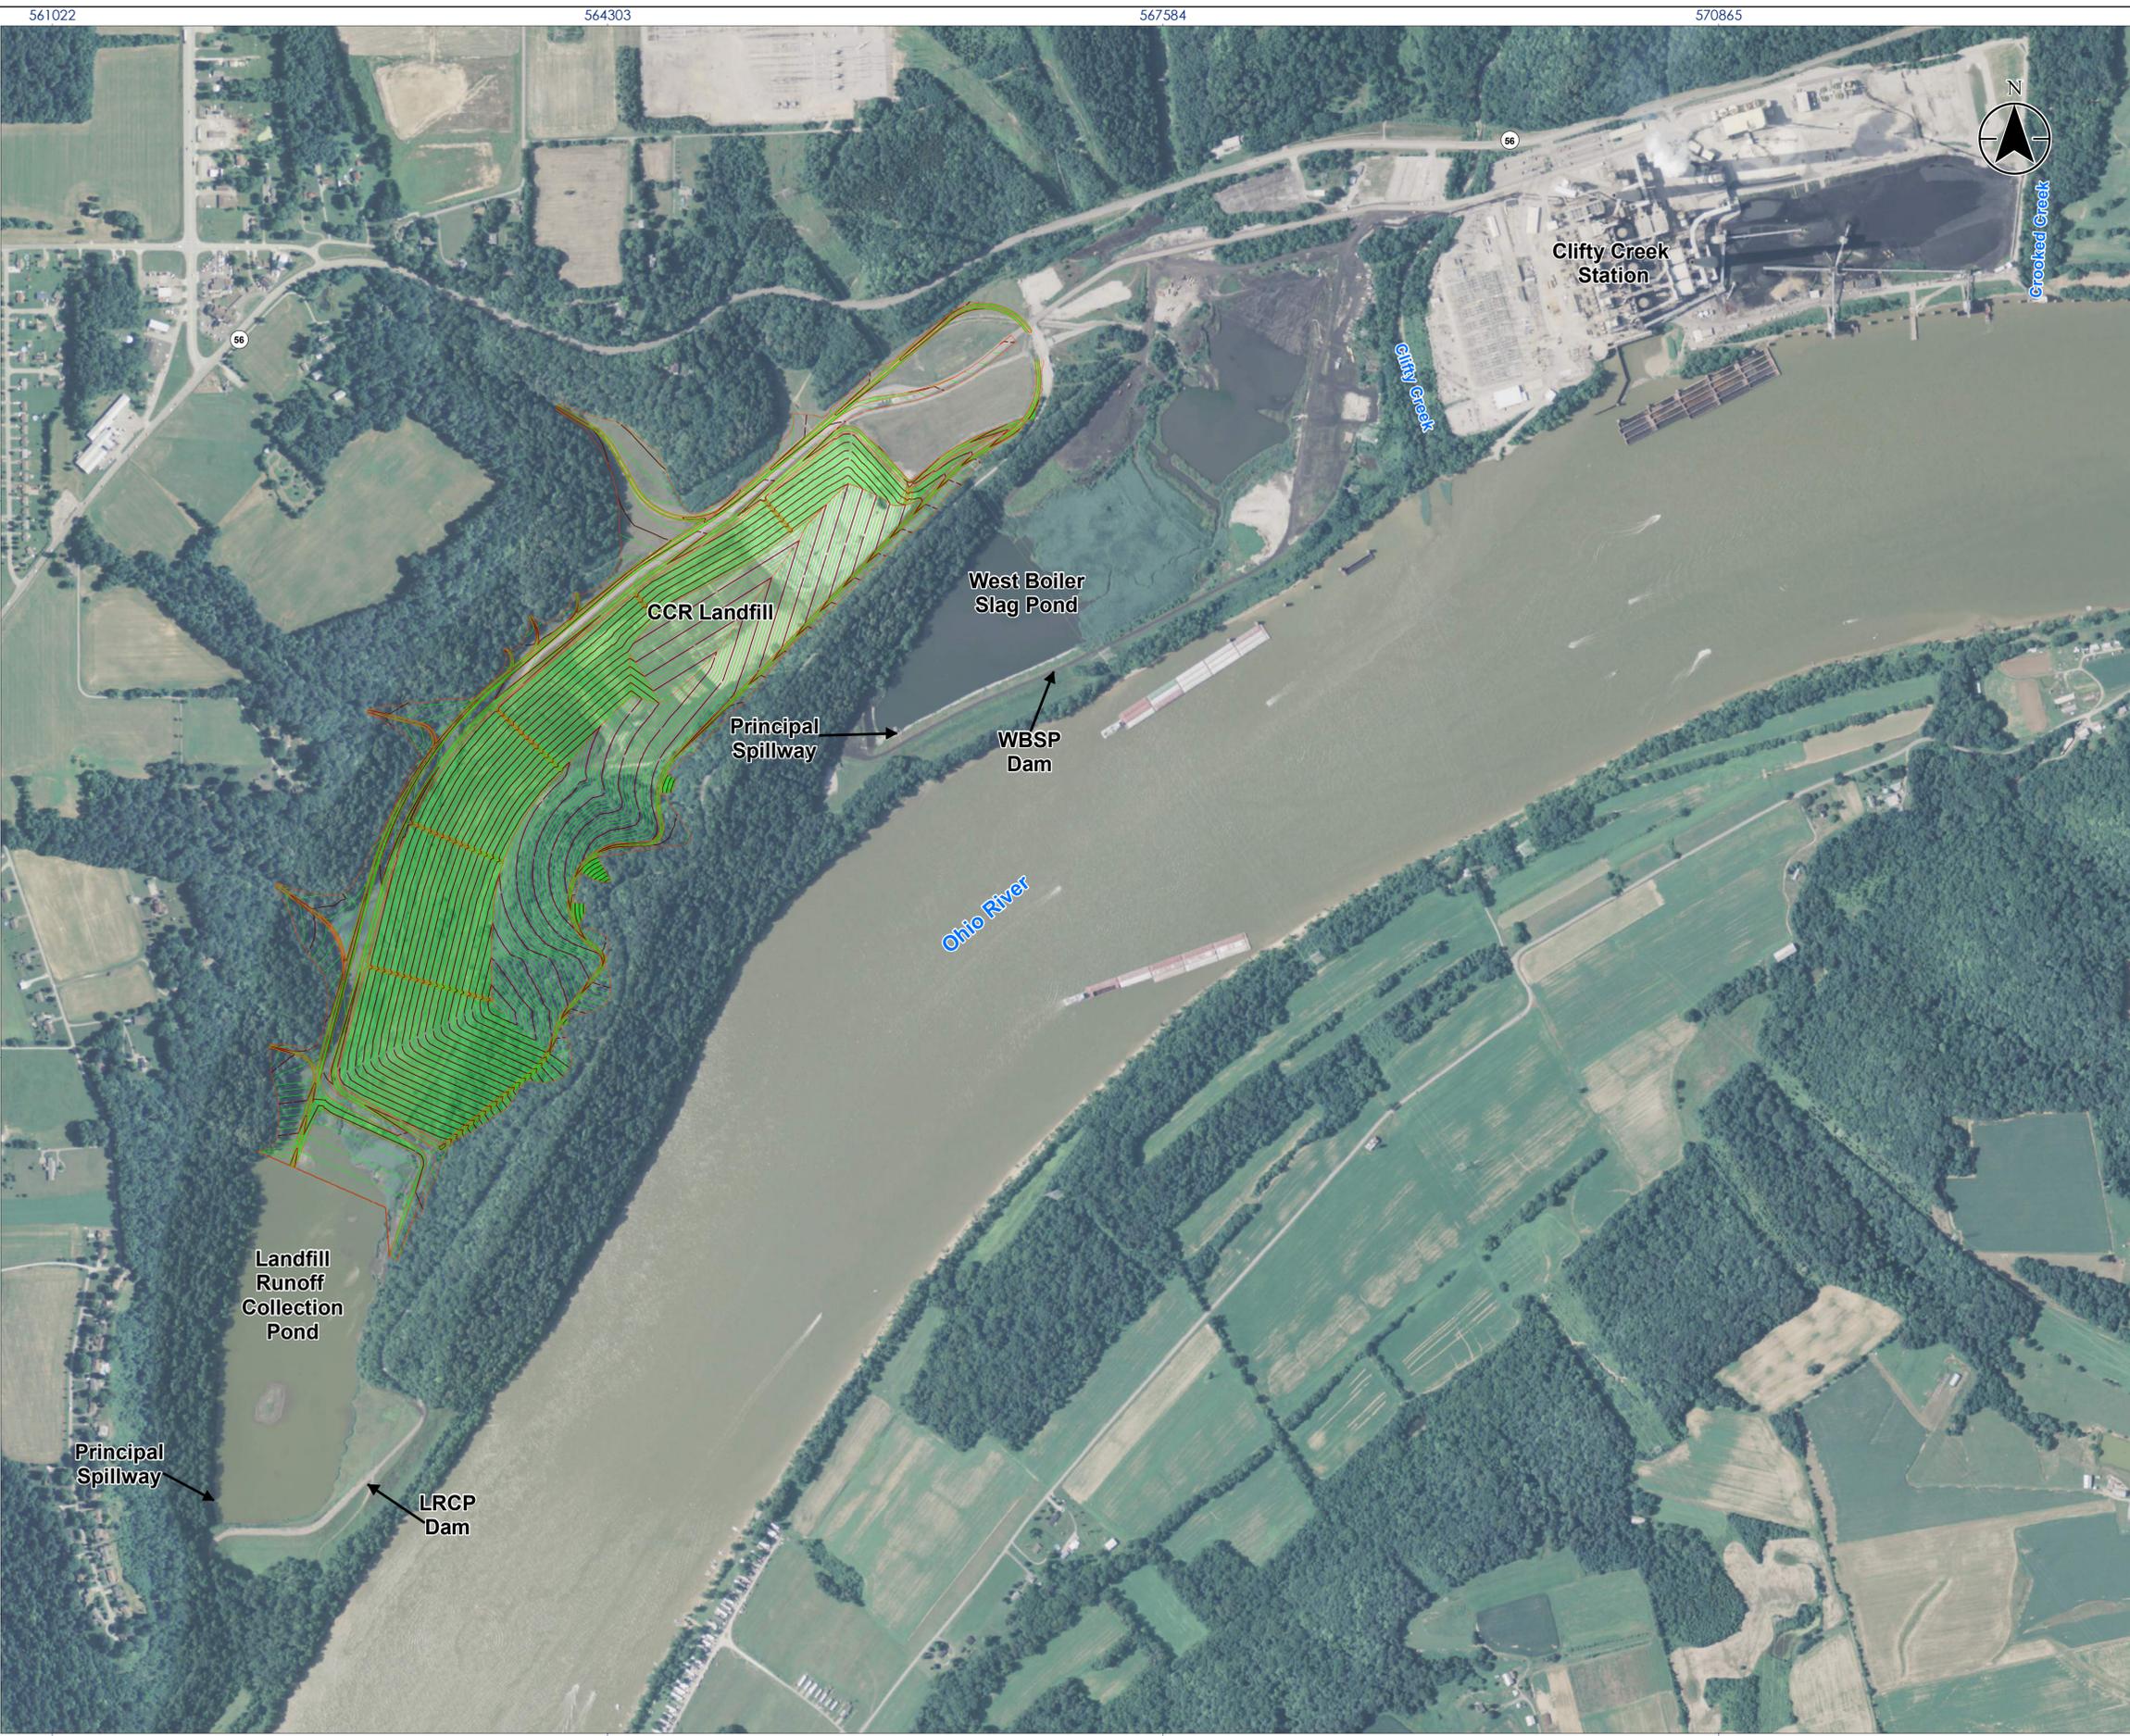
Figure No. **A-1**
 Title **Plan View of Clifty Creek Station**

The Clifty Creek Station WBSP and LRCP are owned and operated by IKEC. They are located in Madison, Indiana along the northern bank of the Ohio River. The WBSP currently serves as a settling facility for sluiced boiler slag produced at the station. In addition to the process flows from the station, stormwater from approximately 510 acres drains to the facility. The LRCP is being converted into a runoff collection pond through the ongoing construction of the Type 1 Restricted Waste Site CCR Landfill. An approximately 508-acre area, including both contact water and stormwater runoff, currently drains to the LRCP. Upon the completion of the CCR Landfill, the area draining to the LRCP will be reduced to approximately 443 acres. Both ponds are formed by natural grade to the north, east, and west and to the south by a dam that runs along the bank of the Ohio River. Figure A-1 provides a plan view of the Clifty Creek Station and its surface impoundments.
