**RE: Initial Structural Stability Assessment
Landfill Runoff Collection Pond
EPA Final Coal Combustion Residuals (CCR) Rule
Clifty Creek Station
Madison, Jefferson County, Indiana**

Initial Structural Stability Assessment

Clifty Creek Station
Landfill Runoff Collection Pond
Madison, Jefferson County, Indiana

October 17, 2016

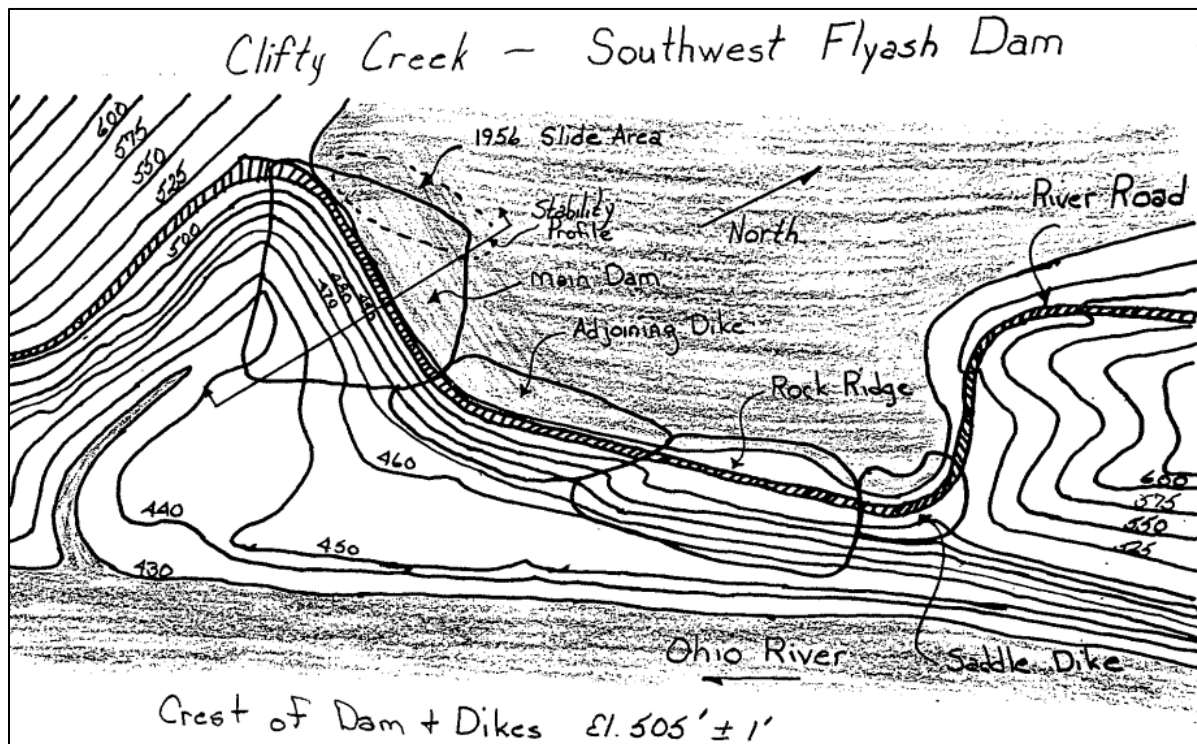
Figure 1 LRCP Dam Construction Detail (AEPSC, 1985)

The LRCP Dam consists of the main 70-foot high dam, a 25-foot high dike on top of an adjoining ridge, a natural rock ridge, and a 15-foot high saddle dike between the rock ridge and the east abutment (AEPSC, 1985). Figure 1 provides a sketch of the components of the LRCP Dam. The main dam has a constructed downstream slope of approximately 2.7H:1V above elevation 474 feet and 3.3H:1V below elevation 474 feet and an upstream slope of about 4.4H:1V. The saddle dike has a downstream slope of 2H:1V and a length of 250 feet (GZA, 2009).

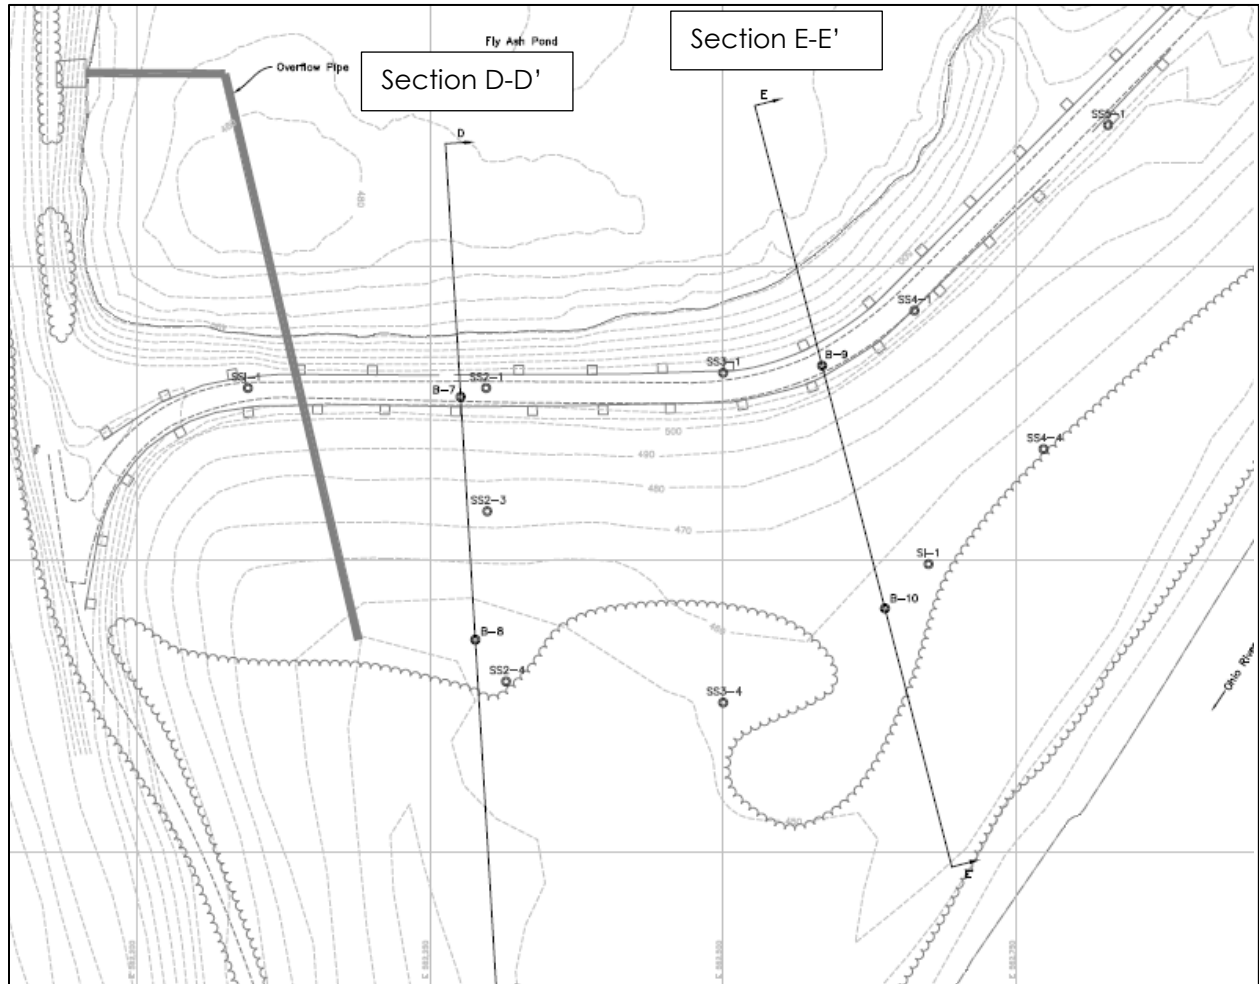
Figure 2 Clifty Creek LRCP Dam – Plan View of Cross Sections

surcharge pool. The two sections that were analyzed are labeled Sections D-D' and E-E' and are shown below in Figure 2.

The summary of the slope stability results from Stantec (2016a) is listed in Table 2. The pond levels were set at the 50% PMP elevation (501.4 feet for the Landfill Runoff Collection Pond). The tailwater was set near the elevation of the Ohio River.

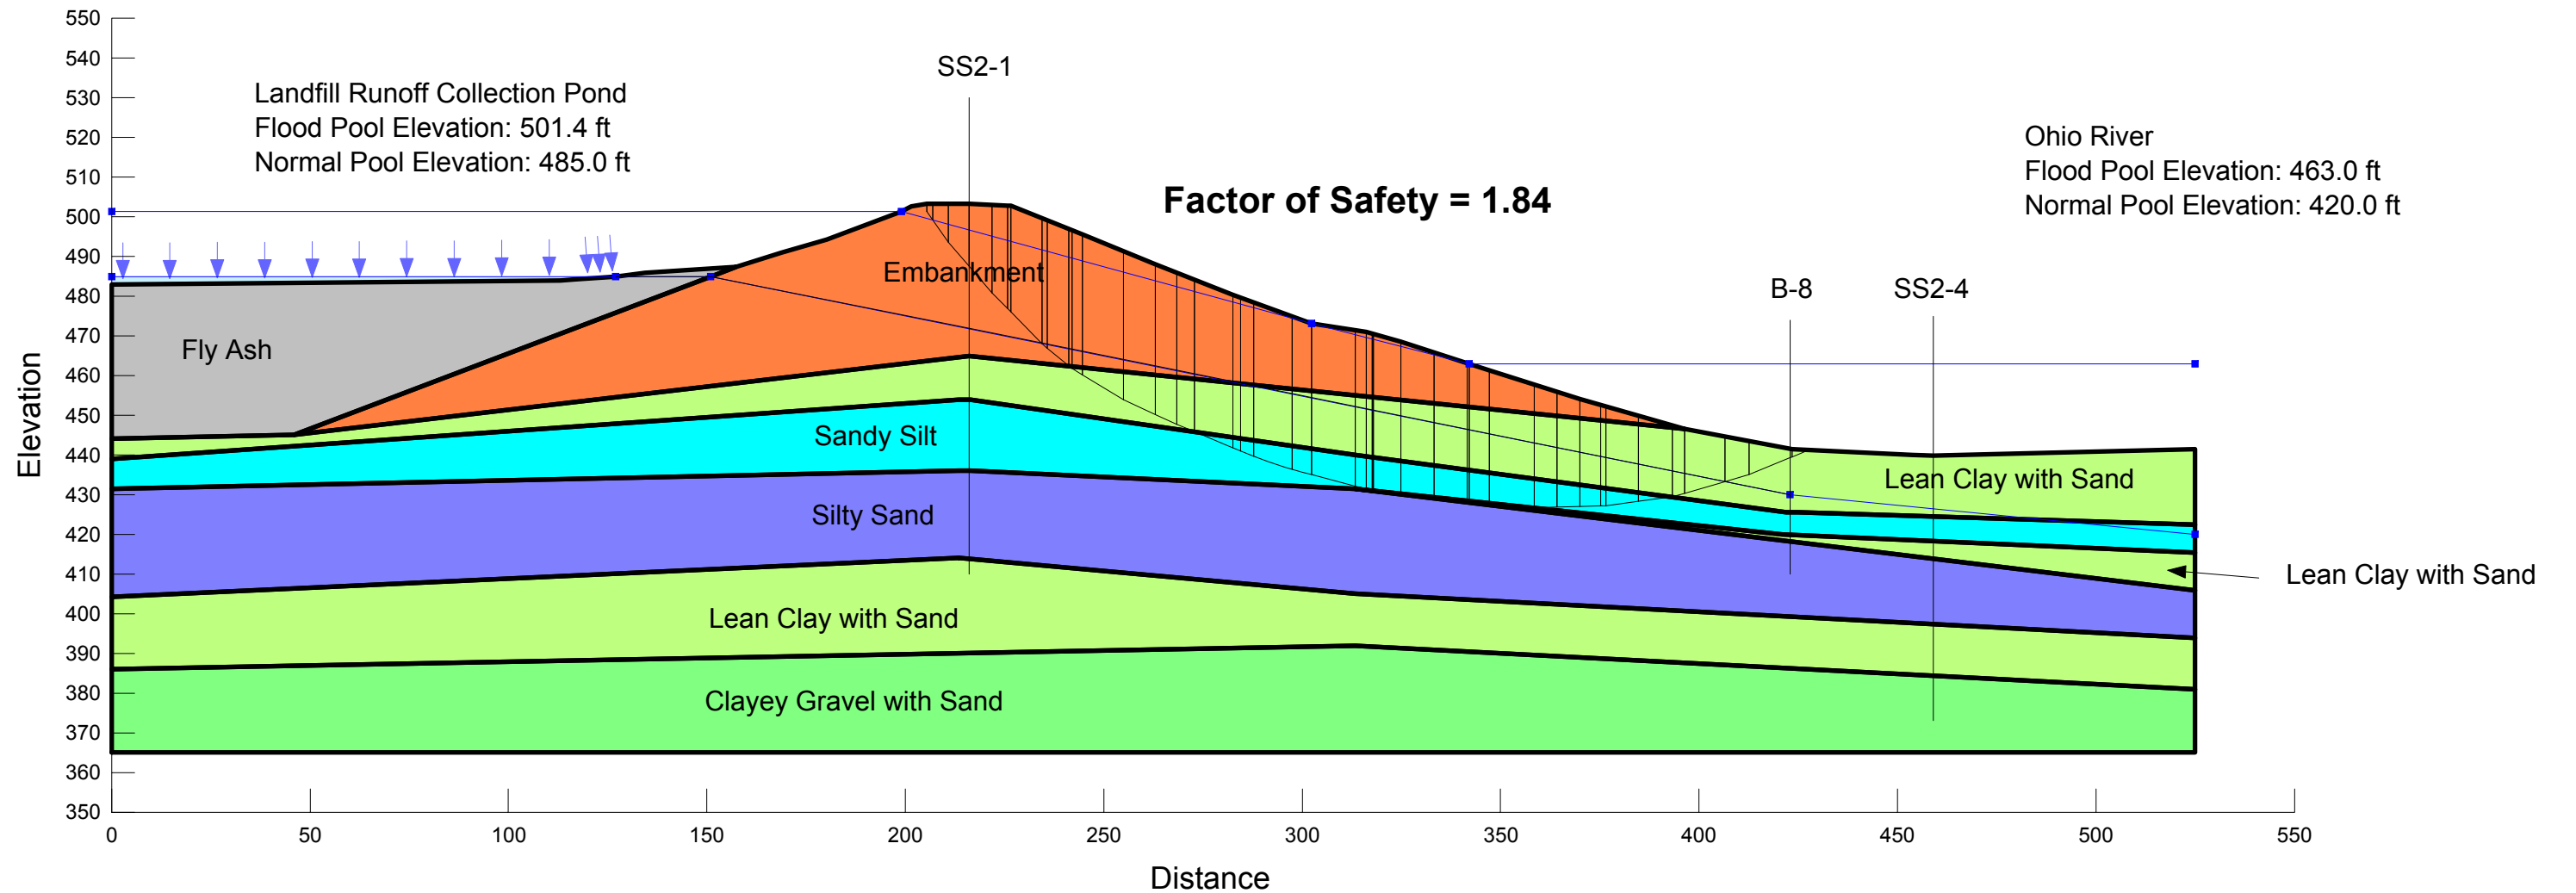
The slope stability assessment presented in this report is focused on the potential for slope failures of significant mass, which could directly impact potential release of water and CCR materials from the Landfill Runoff Collection Pond. The search for a critical slip surface in the slope stability assessment is thus restricted to consider only potential surfaces where the depth (measured at the base of at least one slice) is more than ten feet vertically below the ground surface. Table 4 summarizes the sudden drawdown safety factor evaluation results at the LRCP Dam Section D-D'. The results of the analysis are included in Appendix B.

Facility	Cross Section	EPA Final CCR Rule Criteria	Recommended Factor of Safety Criteria	Calculated Factor of Safety
Landfill Runoff Collection Pond	D-D'	Sudden Drawdown	1.1	1.8
