**RE: Initial Structural Stability Assessment
West Boiler Slag Pond
EPA Final Coal Combustion Residuals (CCR) Rule
Clifty Creek Station
Madison, Jefferson County, Indiana**

Initial Structural Stability Assessment

Clifty Creek Station
West Boiler Slag Pond
Madison, Jefferson County, Indiana

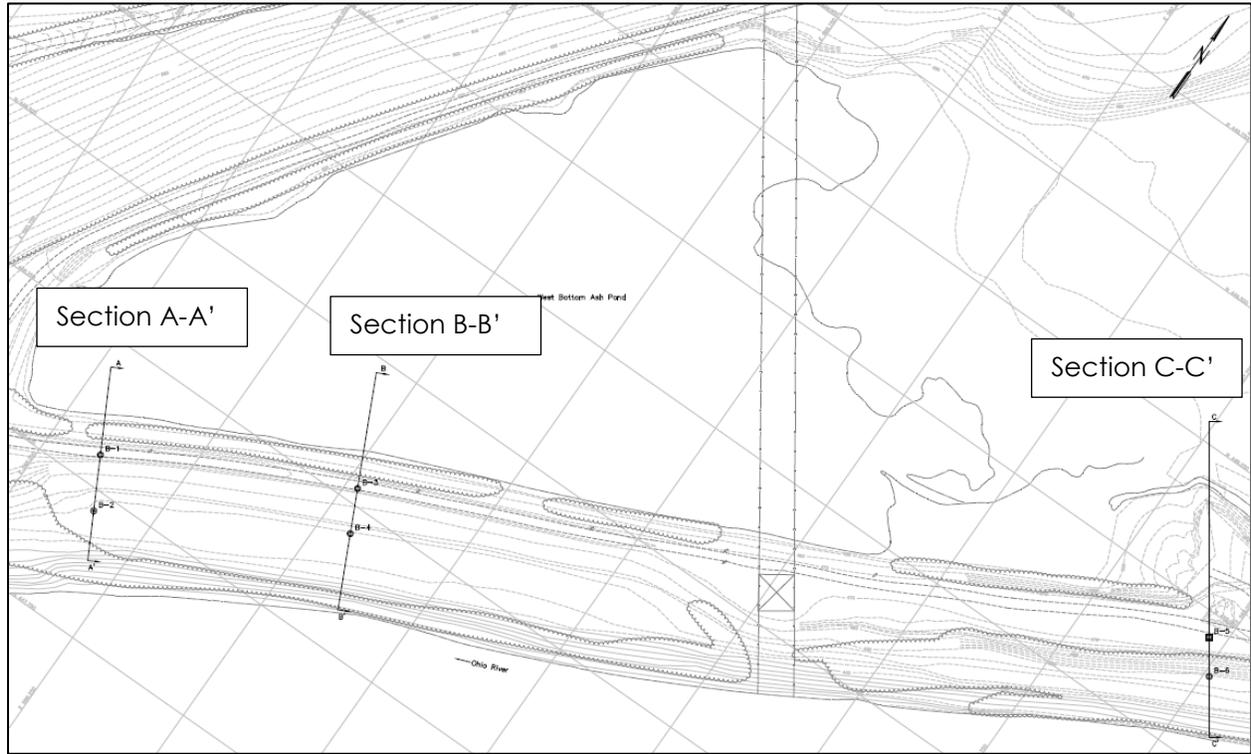
Figure 1 Clifty Creek Power Plant West Boiler Slag Pond – Plan View of Cross Sections

Slope stability analyses were available from Stantec (2010a and 2016). Three cross sections from the WBSP Dam were analyzed under static, long-term, steady-state conditions using the maximum surcharge pool. The three sections that were analyzed are labeled Sections A-A', B-B', and C-C' and are shown in Figure 1.
