**Re: Indiana-Kentucky Electric Corporation  
Clifty Creek Station's 2017 Annual Landfill Inspection**

**Reference: 2017 CCR Rule Inspection  
Annual Landfill Inspection  
Clifty Creek Generating Station  
Madison, Indiana**

**2017 CCR Rule Inspection  
Clifty Creek Landfill**

Clifty Creek Generating Station  
Madison, Indiana  
Jefferson County

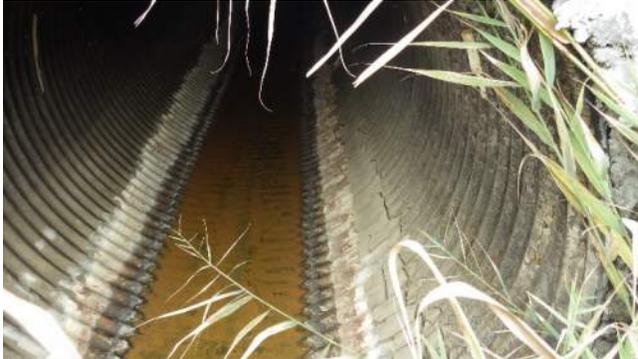
**Photo 1**

- Cracking, spalling, and deterioration was observed affecting the interior lining of the southernmost of the two culverts passing under the access road on the east end of the closed Type III landfill (Point 2, Appendix A; Photo 1, Appendix B). The deterioration has caused the corrugated metal to be exposed to flow. Both culverts were slightly obscured by vegetation (Point 1, Appendix A).

Cracking, spalling, and deterioration of pipe lining in culvert. Photo looking west, from downstream to upstream in pipe.

- Continue to repair erosion features, reestablish vegetation, and monitor in future inspections.
- Continue to monitor the surface water channel headwalls and culverts east of the landfill. Repair as needed.

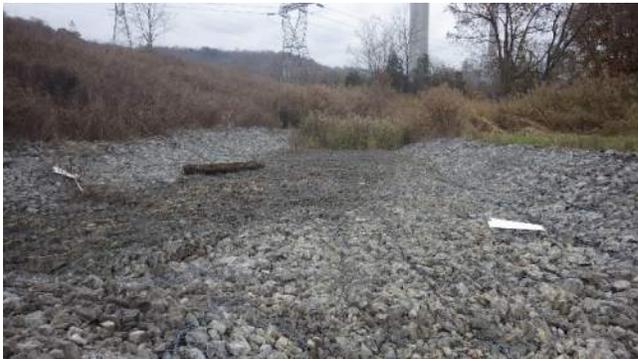
**Photo 2**

- A log was noted in the combined channel east of the construction trailer and upstream of the Conspan outlet flowing into the West Boiler Slag Pond (Photo 2, Appendix B).

The combined surface/storm water channel flowing east to the West Boiler Slag Pond. The log is in the foreground. The vegetation and low area are in the background near the tree line. Photo looking northeast, from upstream to downstream.

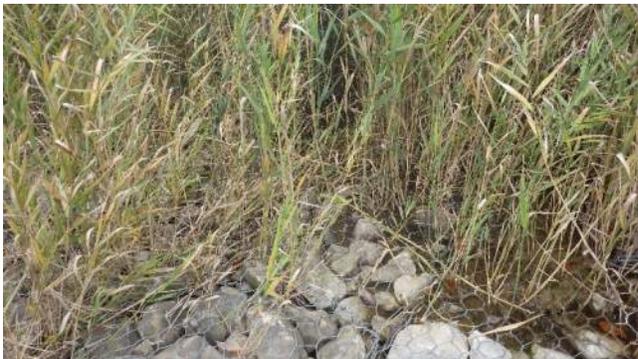
**Photo 3**

- Within the riprap channel, approximately halfway between the culverts and the Conspan near the West Boiler Slag Pond, a low spot with standing water was observed (Point 3, Appendix A; Photo 3, Appendix B). Heavy vegetation extended from the low spot toward the upstream side of the Conspan (Point 3 to Point 5, Appendix A). The vegetation present did not appear to impact functionality of the channel, but hindered visual inspection.

A low area in the combined surface/storm water channel upstream of the Conspan flowing into the West Boiler Slag Pond. Photo looking east, toward West Boiler Slag Pond.

- Remove excess vegetation from drainage channels, pipe inlets, and outlets. Flow was visible at the pipes observed by Stantec during the November site visit.

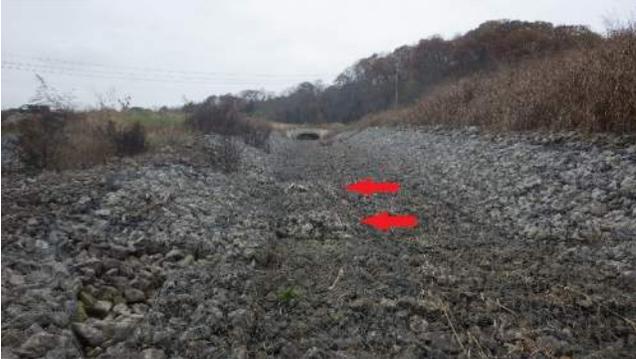
**Photo 4**

- The riprap mattress in the north stormwater channel near the haul road was observed to be slightly displaced with bulging and was wavy in appearance (Point 4, Appendix A; Photo 4, Appendix B). This did not appear to impact functionality.

Slight displacement of riprap mattress in combined storm/surface water channel. Bulging of mattress and wavy in appearance. Photo looking west, from downstream to upstream.

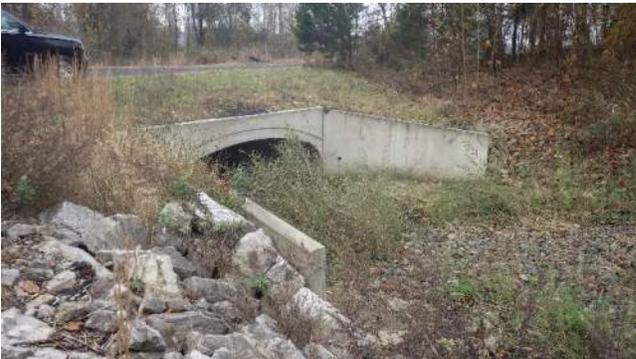
**Photo 5**

- The gabion and riprap mattresses appear to be functioning as designed and in acceptable condition.
- Some grass and vegetation was present in the channel on the upstream side of the West Boiler Slag Pond Conspan outlet. The vegetation present did not impede proper function of the channel. (Photo 5, Appendix B)

Grass and vegetation in the channel upstream of the Conspan near the West Boiler Slag Pond. Photo looking southeast from upstream side of Conspan.

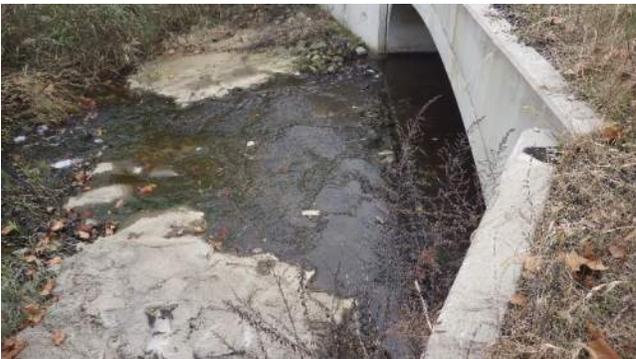
**Photo 6**

Flow from Conspan toward West Boiler Slag Pond. Vegetation did not appear to affect flow. Photo looking down at Conspan outlet.

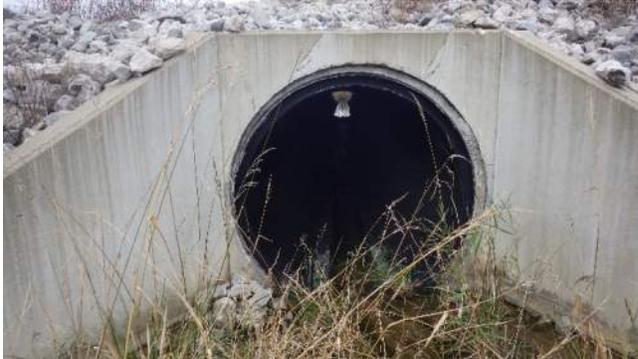
**Photo 7**

- The final grade surface/storm water channels include two headwalls and pipes passing under the access road past the temporary construction office trailers. A slight bow in the crown of the southern of the two pipes has been observed since 2015; however, no depression was noticed in the road, and flow is not impeded. The bow did not appear to have changed between 2015 and 2017.
- The cracks noted on the surface of the inlet headwall for the northwest final grade channel appear unchanged since 2015. Flow is not impeded; this is a maintenance observation for continued monitoring (Photo 7, Appendix B).

The cracks in the inlet headwall for the northwest final grade channel appears unchanged since the 2015 visit. Photo looking east at upstream headwall.

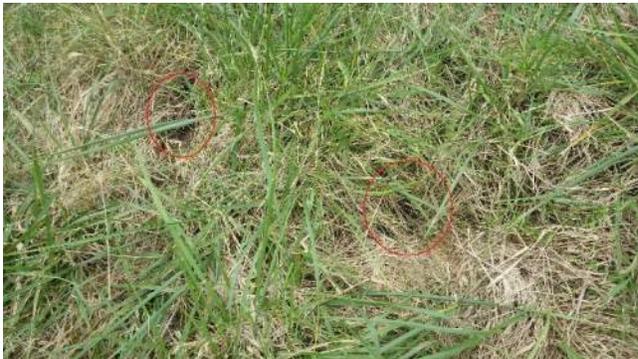
**Photo 8**

- A cluster of vermin burrows was observed in the Type III landfill cover, adjacent to the south side of the final cover north storm/surface water channel. The burrows were approximately two- to three-inches in diameter. (Points 8 and 11, Appendix A; Photo 8, Appendix B).

Cluster of vermin burrows in Type III landfill cover, adjacent to the south side of the final cover north storm/surface water channel. See Points 8 and 11 in Appendix A. Photo looking north.

- Monitor the vermin burrows in the cover of the Type III landfill, and repair as needed.
- Monitor the potential slough near the haul road on the north side of the Type III landfill. If the slough progresses toward the haul road and/or truck wash facility, a remediation could be considered.

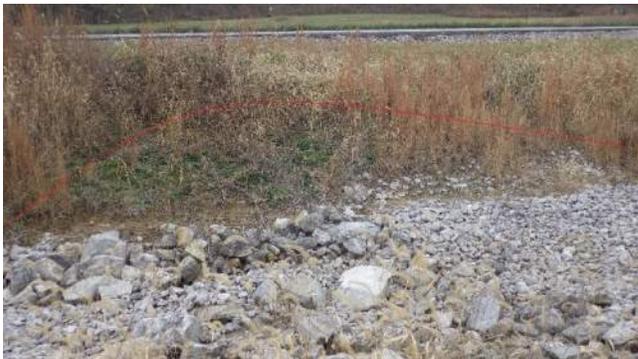
**Photo 9**

- A potential slough was observed on the south side of the haul road at the toe of slope toward the northeast corner of the Type III landfill (Point 10, Appendix A; Photo 9, Appendix B). The scarp appeared to be semi-circular, approximately 15-20 feet in diameter. It did not appear to impact the integrity of the haul road.

Potential slough observed on south side of haul road at toe of slope. Approximately 15-20 feet diameter, and did not appear to impact the haul road. See Point 10 in Appendix A. Photo looking north.

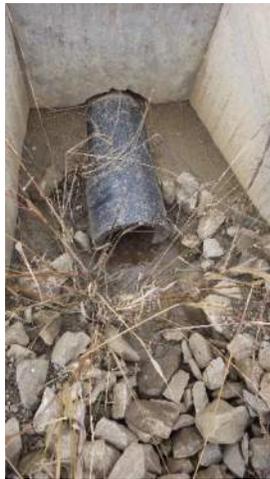
**Photo 10**

The surface drainage pipe from the truck wash station into the northern storm/surface water drainage channel on the Type III landfill cover was partially obstructed by sediment. See Point 7 in Appendix A. Photo looking north.

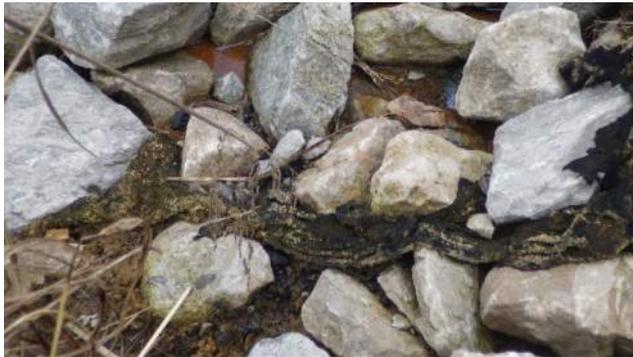
**Photo 14**

Seep, approximately 15 feet north of northern leachate pipe outlet. See Point 14 in Appendix A.

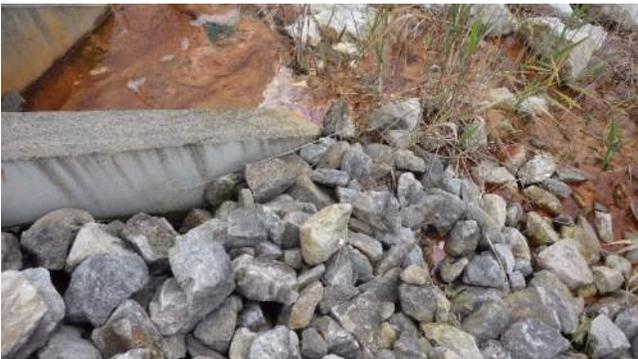
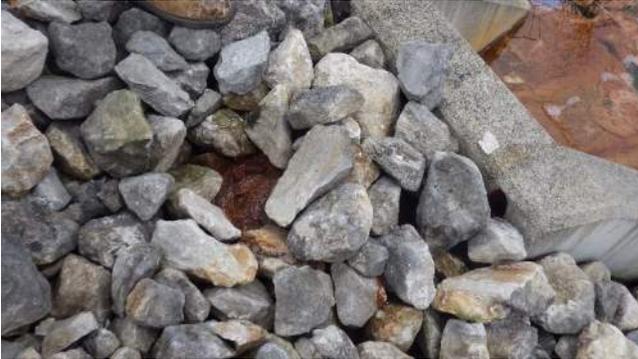
- A sheen was seen above and beside the southern leachate pipe headwall (Point 15, Appendix A; Photos 15 and 16, Appendix B).
- Several areas with thin vegetation were observed from the southeast corner extending to the southwest corner of the Type III landfill area. Sizes of the bare areas are indicated in Appendix A in the descriptions for Points 16 through 20.

Seep adjacent to outlet of southern leachate pipe. Sheen beside headwall. See Point 15 in Appendix A.

Seep at outlet of southern leachate pipe. Standing water and sheen above headwall. See Point 15 in Appendix A.

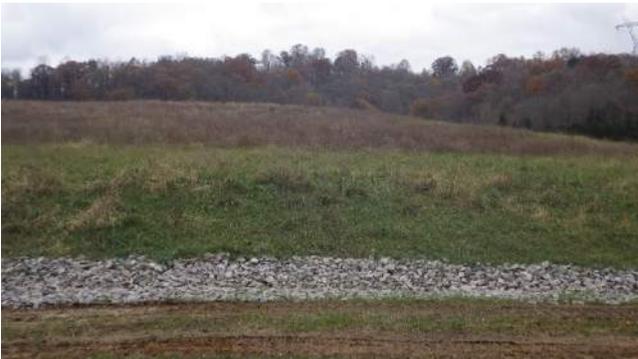
**Photo 17**

- The temporary cover vegetation on the top of Subphases 1A1/1B1 (Photo 17, Appendix B) was generally in one of two conditions: 1 to 1.5 feet tall grasses that were typically laying down, or 3 to 3.5 feet tall brushy vegetation.

Vegetated temporary cover on Subphases 1A1/1B1. Cover was either 1 to 1.5 feet tall grasses or 3 to 2.5 feet tall hardy/brushy vegetation. Photo looking north from outside of southern waste boundary.

- Conduct field surveys to measure current topography and compare to design geometry. Regrade surface as needed to conform to design. Areas near to permitted CCR grades are recommended to be capped, closed, and vegetated (Subphases 1A1, 1B1, 1A2, and 1B2).
- An Operations and Maintenance Manual should be developed that includes provisions for the placement of materials within the landfill, the maintenance of the landfill, and the procedure to follow if issues arise during the operation of the landfill.
- Monitor seeps from the northeast corner of the Type III landfill. Consider ways to segregate and reduce the various source of flows into the eastward stormwater and leachate collection channel.

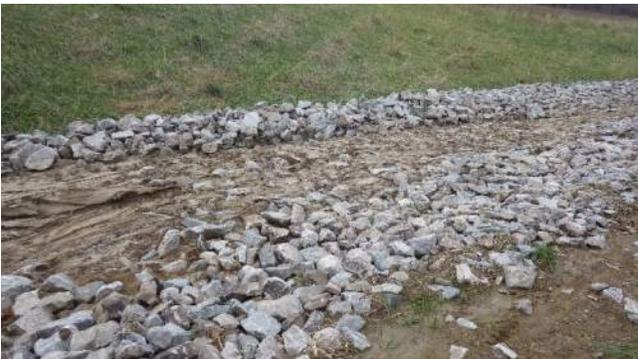
**Photo 18**

Sediment buildup and an area bare of vegetation near the edge of the working area of temporary cover on the south side of landfill. See Points 23 and 24 in Appendix A. Photo looking north.

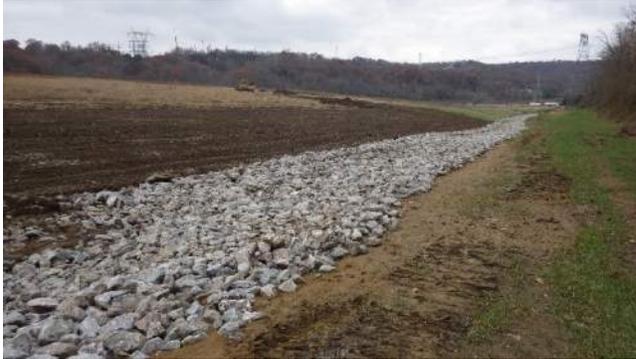
**Photo 19**

- The end of the currently placed temporary cover on the south side of Cell 1B2 was observed and marked in Appendix A as Point 26. The temporary cover limits are approximately 15 feet north of the stone-lined surface water channel (the end of which is marked as Point 27 in Appendix A; Photo 20 in Appendix B). An area of temporary cover extending about 40 feet further north feet was being regraded during the inspection (Point 26, Appendix A; Photo 19, Appendix B).

Working area of temporary cover on south side of landfill. See Points 25 and 26 in Appendix A. Photo looking northeast.

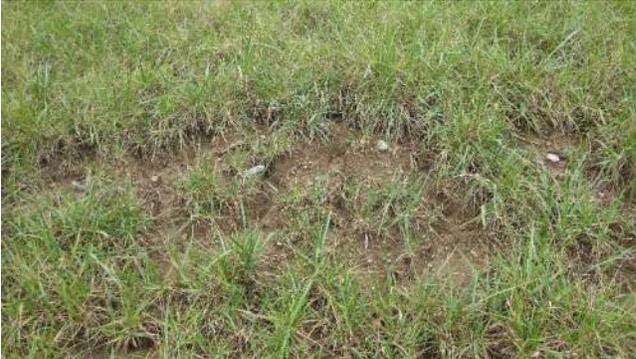
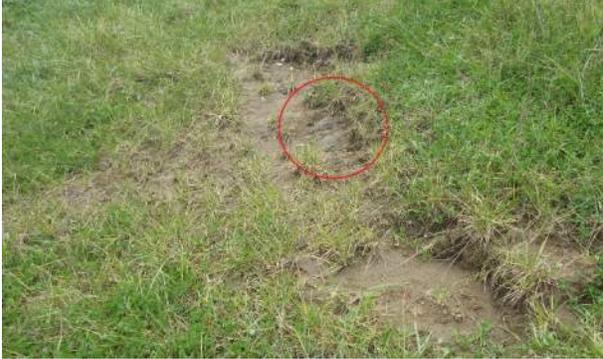
- Several bare or rocky areas were observed on the northern slope of the temporary cover in Cells 1A2/1B2. These were located as Points 30, 31, 32, 33, 34, 36, and 42 in Appendix A. The edges of a large area of rocky, minimally vegetated temporary cover near the top of the slope was located with Points 37 and 38 in Appendix A. These areas appear to follow dozer tracks and may be a function of the temporary cover fill consisting of excessive amounts of gravel/cobbles. Photo 22 in Appendix B represents a typical area of thin vegetation and rocky cover. Several erosion rills were observed in the grassed areas downslope from the rocky/bare areas.

Typical image of several areas of temporary cover on Cells 1A2/1B2 where vegetation was thin and cover soil contained gravel/cobbles. See Points 30, 31, 32-34, 36-38, and 42 in Appendix A. Photo looking east along the north slope of the landfill.

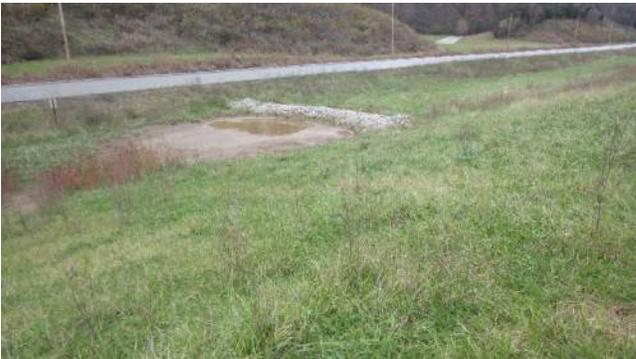
**Photo 23**

Sediment collected in the rock check dam near the boundary of Cells 1A1 and 1A2. Photo looking northeast.

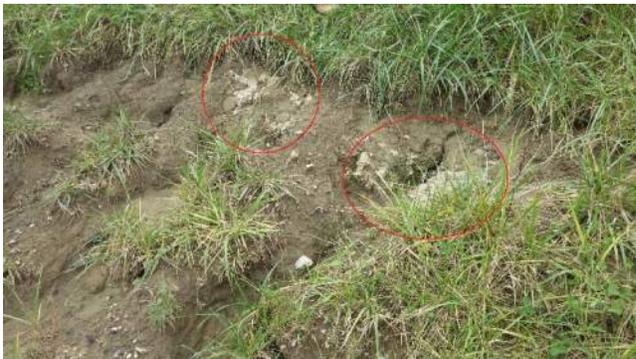
**Photo 24**

- An erosion rill with thin vegetation and a bare area was observed on the lower 1/3 of the northern slope of the landfill. The area was approximately 30 feet by 15 feet, and gypsum was exposed at the surface (Point 35, Appendix A; Photo 24, Appendix B).

Bare/rocky area of temporary cover, approximately 30 feet by 15 feet, with exposed gypsum. See Point 35 in Appendix A. Photo looking east along northern slope of landfill.

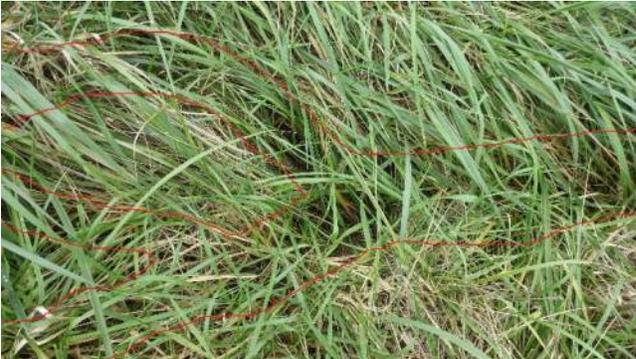
**Photo 26**

Minor erosion rills above the check dam on the northern slope of the landfill. See Point 41 in Appendix A.

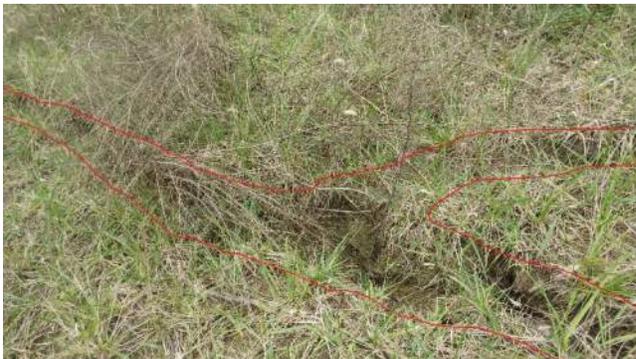
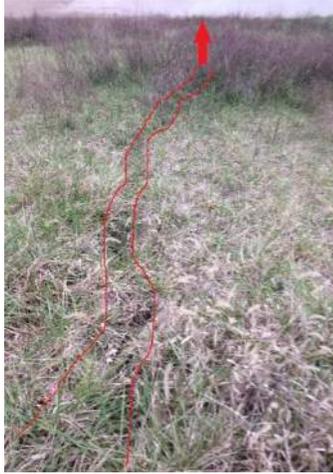
- Minor erosion rills (approximately 6 inches wide and 6 inches deep) were observed above the check dam (Point 41, Appendix A; Photo 26, Appendix B).
- An erosion rill runs from top to bottom of the northeastern slope of Subphases 1A1/1B1 near the north corner. It was approximately 12 inches deep and obscured by vegetation. This rill has been monitored since the 2016 inspection (Point 40, Appendix A; Photos 27 and 28, Appendix B).

Erosion rill from top to bottom of northeastern slope of Subphases 1A1/1B1 near the north corner. Has been monitored since 2016 inspection. This rill runs downhill from Point 40 as shown in Appendix A.

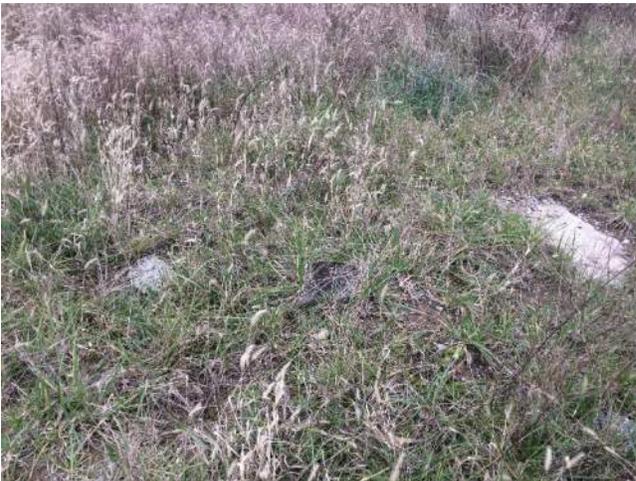
**Photo 29**

- Several large concrete chunks were observed within the temporary cover at the top of the slope near the northeast corner of the landfill (Point 39, Appendix A; Photo 29, Appendix B).

Concrete chunks within the temporary cover at the top of the slope near the northeast corner of the landfill. See Point 39 in Appendix A.

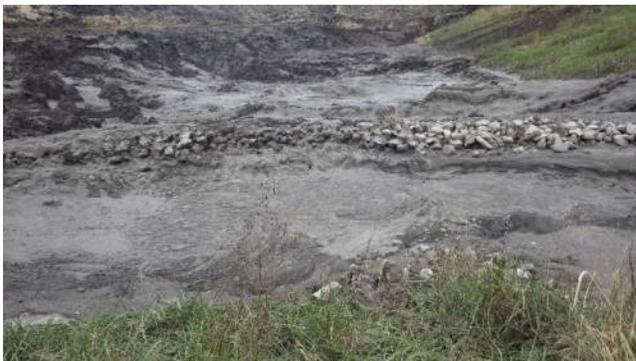
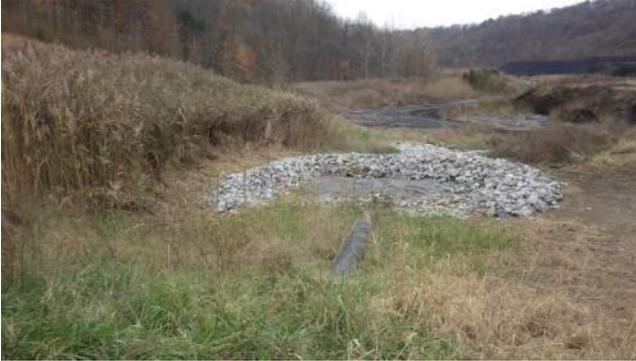
- Storm water within Subphase 1C is collected and directed towards the Landfill Runoff Collection Pond. The pipe inlets and outlets were located during the November site visit and were observed to be blocked with sediment. (Photos 30 and 31; Point 29, Appendix A)

Stormwater collection inlet on south side of Subphase 1C, blocked by sediment. See Point 29 in Appendix A. Photo looking east.

Stormwater collection outlet on south side of Subphase 1C. Sediment collected at outlet. Photo looking west.
