**Re: Indiana-Kentucky Electric Corporation**  
**Clifty Creek Station's 2020 Annual Landfill Inspection**

**Reference:** 2020 CCR Rule Inspection  
Annual Landfill Inspection  
Clifty Creek Generating Station  
Madison, Indiana

2020 CCR Rule Inspection  
Clifty Creek Landfill

Clifty Creek Generating Station  
Madison, Indiana  
Jefferson County

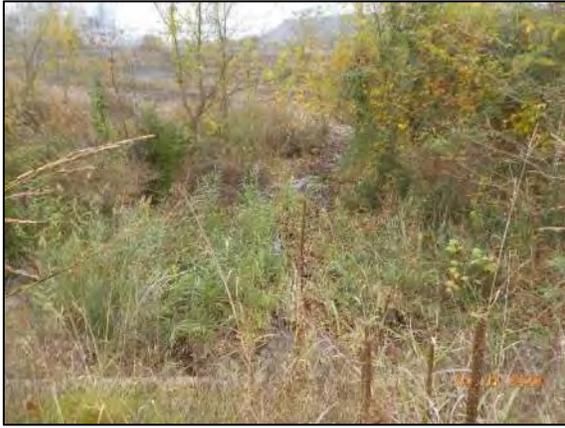
Photo 1

- The channel downstream of the east Conspan headwall is fairly clear of vegetation. Refer to Point 89, Appendix A and Photos 1-3, Appendix B.
- The channel upstream of the east Conspan headwall is fairly clear of vegetation to the next headwalls upstream (near the trailer area).
- The rock fill of the gabion mattress of the north stormwater channel near the confluence with the south channel was observed to be somewhat displaced and bulging beneath the wire gabion fabric (Point 90, Appendix A; Photos 4 and 5, Appendix B). The condition of this rock lining has not changed since 2019 and does not appear to impact functionality.

Some dense vegetation growing in stormwater drainage ditch that flows to West Boiler Slag Pond. Photo taken at access road Conspan and looking east from downstream headwall. (Point 89, Appendix A)

- Remove excess vegetation from drainage channels, pipe inlets, and outlets. Flow was visible at the pipes observed by Stantec during the October site visit.

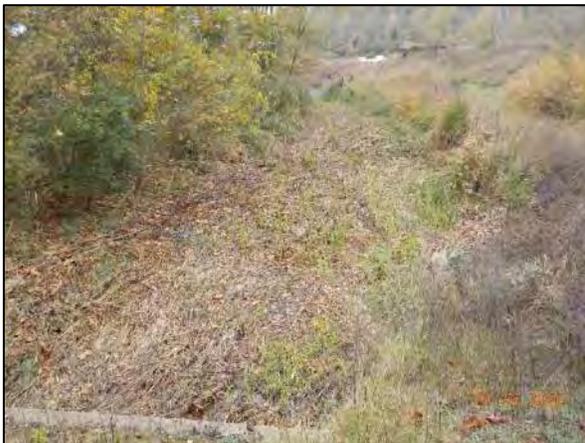
Photo 2

Controlled vegetation growing in front of west face of Conspan in stormwater drainage ditch from landfill to West Boiler Slag Pond. Photo taken atop access road Conspan and looking west (upstream) toward landfill. Ditch is in center of photograph. (Point 89, Appendix A)

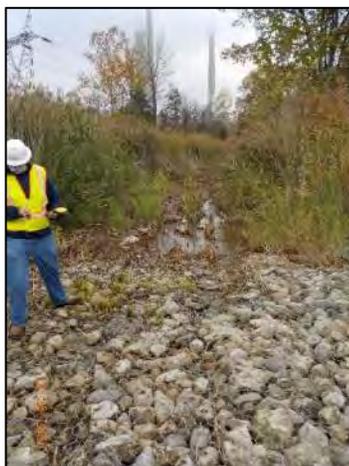
Photo 3

Looking east (downstream) between access road and landfill at controlled vegetation in stormwater drainage ditch from landfill to West Boiler Slag Pond. Log and other debris are also present. (Point 90, Appendix A)

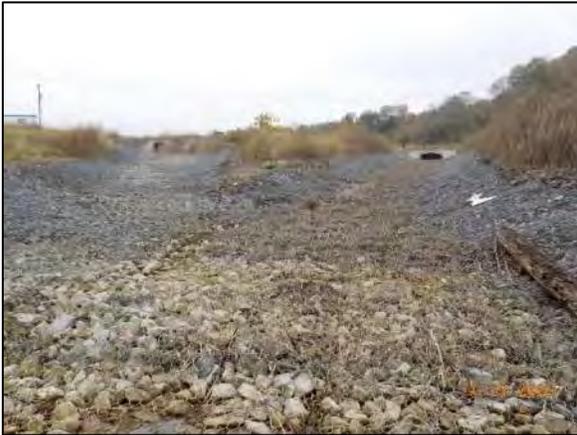
Photo 4

Looking west at stormwater drainage ditch confluence between access road and landfill. Gabion fill rock has shifted within baskets creating uneven channel lining. Condition is unchanged from previous year. (Point 90, Appendix A)

- Continue to repair erosion features, reestablish vegetation, and monitor in future inspections.
- Continue to monitor the surface water channel headwalls and culverts east of the landfill. Repair as needed.

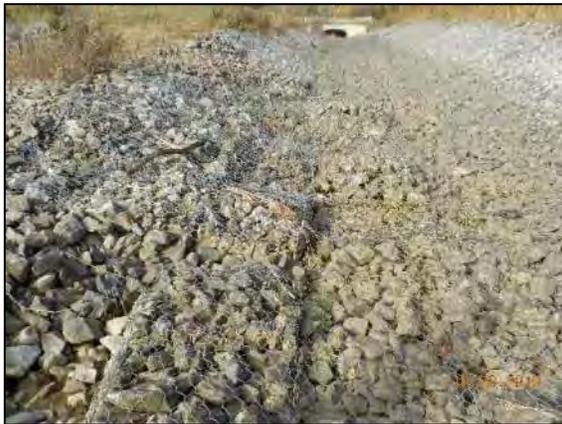
Photo 5

Looking west at uneven gabion fill rock in north stormwater drainage ditch. Condition is unchanged from previous year.

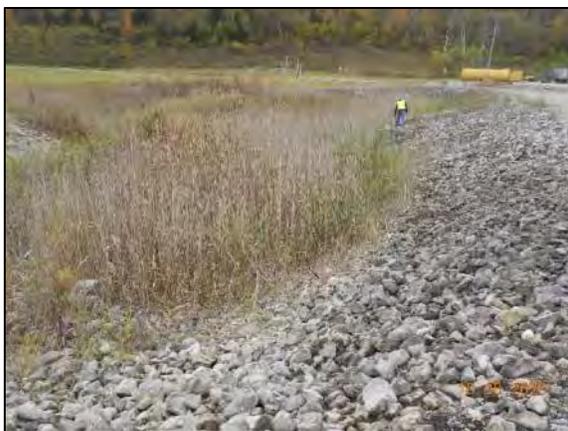
Photo 6

- The northern, southern, and eastern channels appear to be fairly clear of vegetation and maintained. Vegetation at one location (Point 91, Appendix A; Photo 6, Appendix B.) appears to have been sprayed for control but is dense.
- The Type III landfill cap appears uniform, mowed, and maintained.
- An inlet of a small pipe culvert beneath an access road on the south side of the Type III landfill is nearly buried in channel lining (Point 94, Appendix A)
- An outlet pipe from the truck wash is lower than the invert of the ditch (Point 92, Appendix A; Photo 7, Appendix B)

Looking north along channel connecting north and south storm water drainage channels. (Point 91, Appendix A)

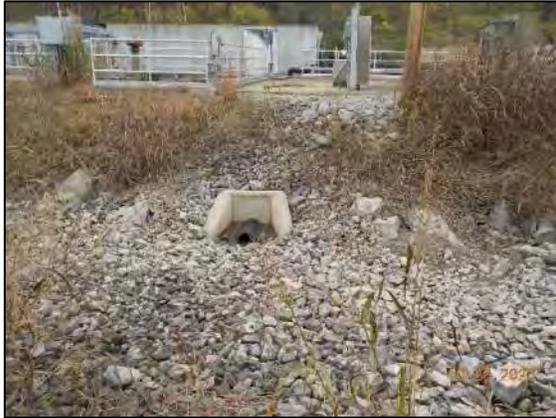
Photo 7

Invert of outlet pipe from truck wash rack is lower than invert of ditch. (Point 92, Appendix B)

- Improve drainage from the truck wash pipe outlet into the northern perimeter ditch to prevent sedimentation inside of the pipe.
- Remove chemical (caustic soda) labels from the plastic barrel housing the flow monitoring device and apply label stating actual purpose of barrel.

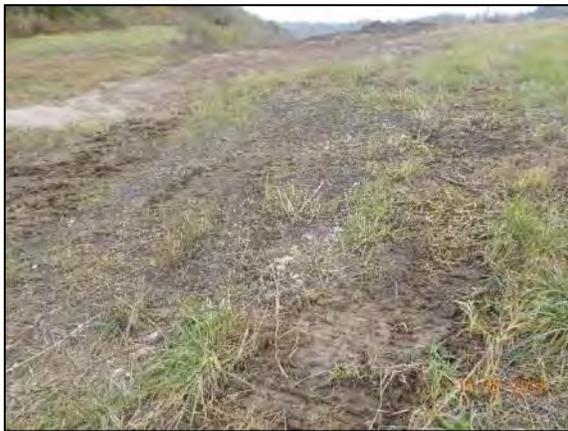
Photo 8

- Erosion rills and/or small animal burrows observed at the eastern toe of the landfill in 2019 have been repaired. (Point 100, Appendix A)
- Exposed CCR was observed on south side near top of landfill. (Point 95, Appendix A; Photo 8, Appendix B)

Exposed ash on south side of landfill near top looking west. (Point 95, Appendix A)

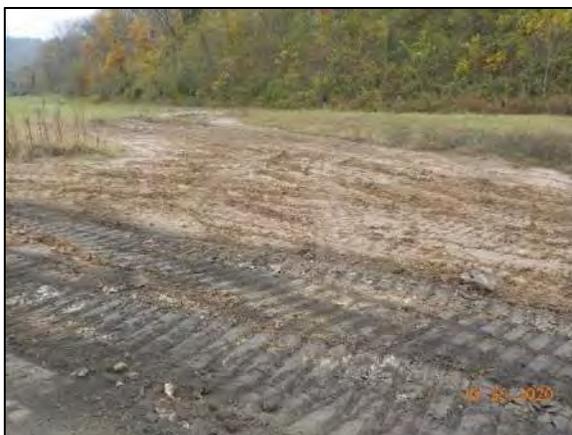
Photo 9

- A bare area was observed at edge of temporary vegetative cover. (Point 96, Appendix A; Photo 9, Appendix B)
- Active waste placement was ongoing in Cell 1C. Piles of bottom ash, used as chimney drains in the landfill, were visible. (Point 101, Appendix A; Photo 10, Appendix B)

Bare temporary cover on south side of landfill near top looking east. (Point 96, Appendix A)

- Maintain the vegetation along the exterior slopes and within the surface drainage channels to facilitate inspections. Remove taller weeds and woody vegetation or reestablish vegetation as needed. Temporary cover should be monitored and maintained.

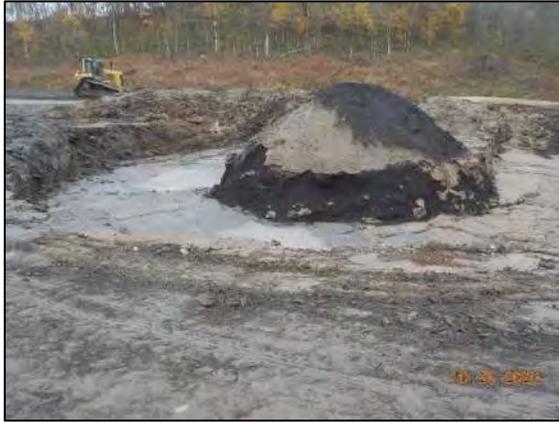
Photo 10  
Bottom ash chimney drain atop landfill.  
(Point 101, Appendix A)

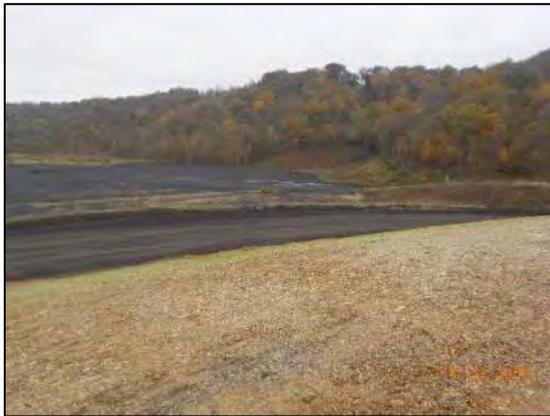
Photo 11  
Overview of west end of landfill showing  
boiler slag fill.

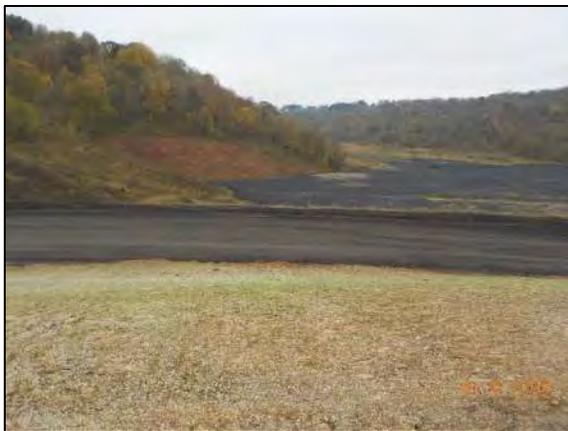
Photo 12  
Overview of west end of landfill showing  
boiler slag fill.

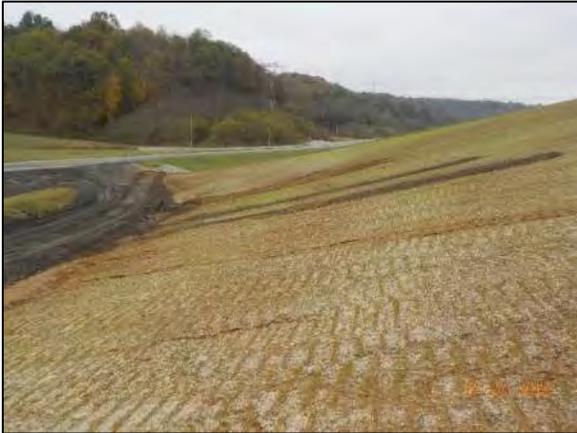
- The temporary cover outslopes of Subphase 1A/1B were consistent with the previous inspections and were generally flatter than and complying with the permitted final cover grades. (Points 102 through 105, Appendix A; Photos 13 and 14, Appendix B)

Photo 13  
Typical view of newly vegetated west face of landfill with repaired rills.

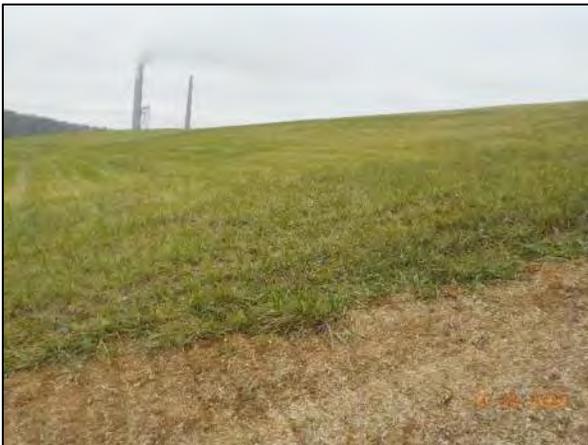
Photo 14  
Typical view of north face of landfill showing second year of maintained vegetative growth.

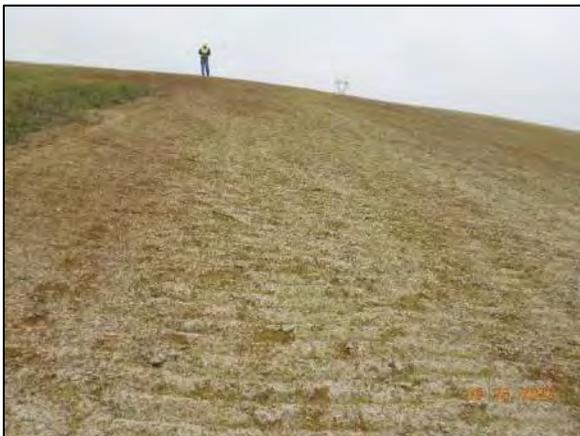
Photo 15  
Engineer at top of slope (Point 107, Appendix A) and east edge of newly established temporary vegetation.

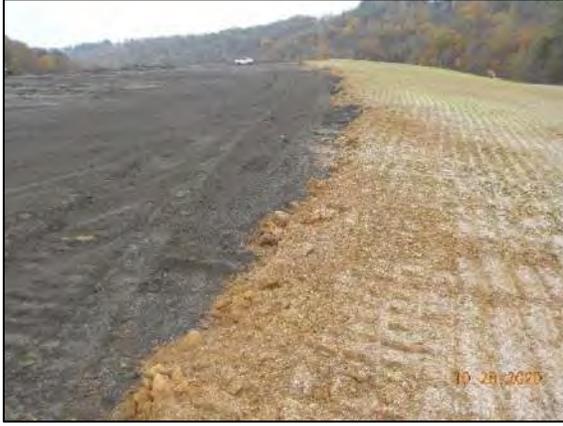
Photo 16  
View on top of slope (Point 107, Appendix A) looking west showing temporary cover/CCR boundary.

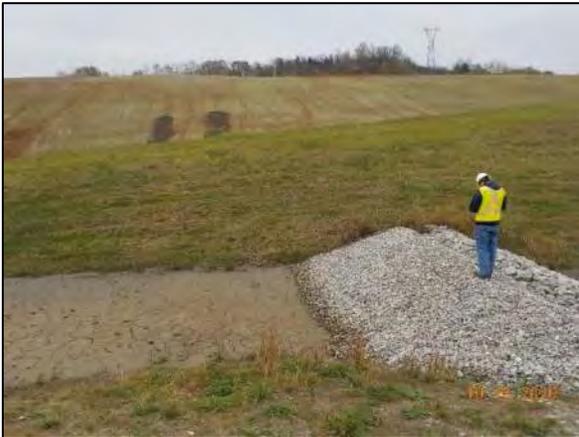
- Most rock check dams surrounding the landfill appear to be well maintained. Sediment was observed in a rock check dam on the north side of the landfill. (Point 109, Appendix A; Photo 17, Appendix B)

Photo 17  
Sediment in rock check dam on north side of landfill (Point 109, Appendix A)

- Continue to conduct weekly and monthly field inspections to schedule and maintain the necessary best management practices for the stormwater channels, sediment traps, and rock check dams serving the landfill. Consider cleaning out sediment traps/rock check dams.

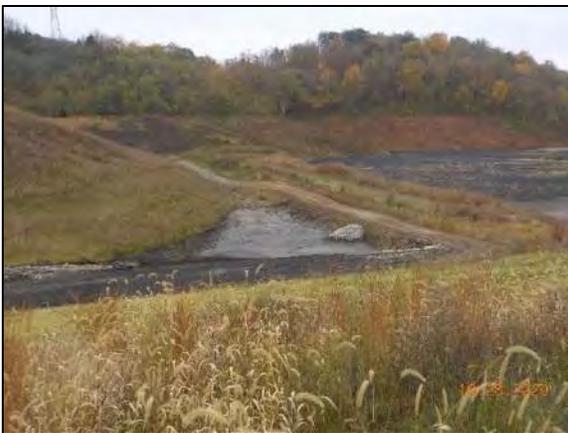
- A drainage channel between Phase 1 and Phase 2, southwest of the west temporary face of the landfill, has been lined with riprap (toe is Point 112, Appendix A; Photo 18, Appendix B)

Photo 18  
Toe of west end of landfill.

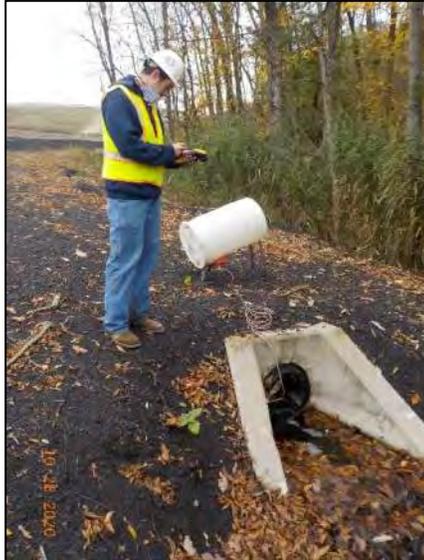
- The leachate pipe appeared unrestricted and actively flowing. The pipe terminated at a concrete headwall. A flow monitoring apparatus (housed in a plastic barrel) was set at the outlet. (Point 111, Appendix A; Photo 19, Appendix B).

Photo 19  
Leachate outfall (Point 111, Appendix A)

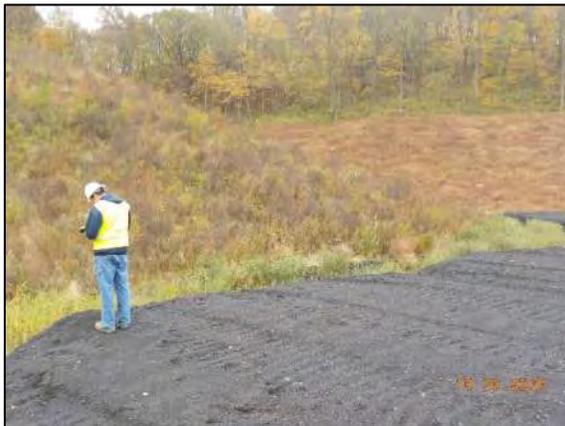
- Boiler slag has been placed to the western extent of the Phase 2 landfill. (Point 113, Appendix A; Photos 11, 12, and 20, Appendix B)

Photo 20  
West end of boiler slag fill (Point 113, Appendix A)
