**RE: Periodic Structural Stability Assessment
 Landfill Runoff Collection Pond
 EPA Coal Combustion Residuals (CCR) Rule
 Clifty Creek Station
 Madison, Jefferson County, Indiana**

**RE: Initial Structural Stability Assessment
Landfill Runoff Collection Pond
EPA Final Coal Combustion Residuals (CCR) Rule
Clifty Creek Station
Madison, Jefferson County, Indiana**

Initial Structural Stability Assessment

Clifty Creek Station
Landfill Runoff Collection Pond
Madison, Jefferson County, Indiana

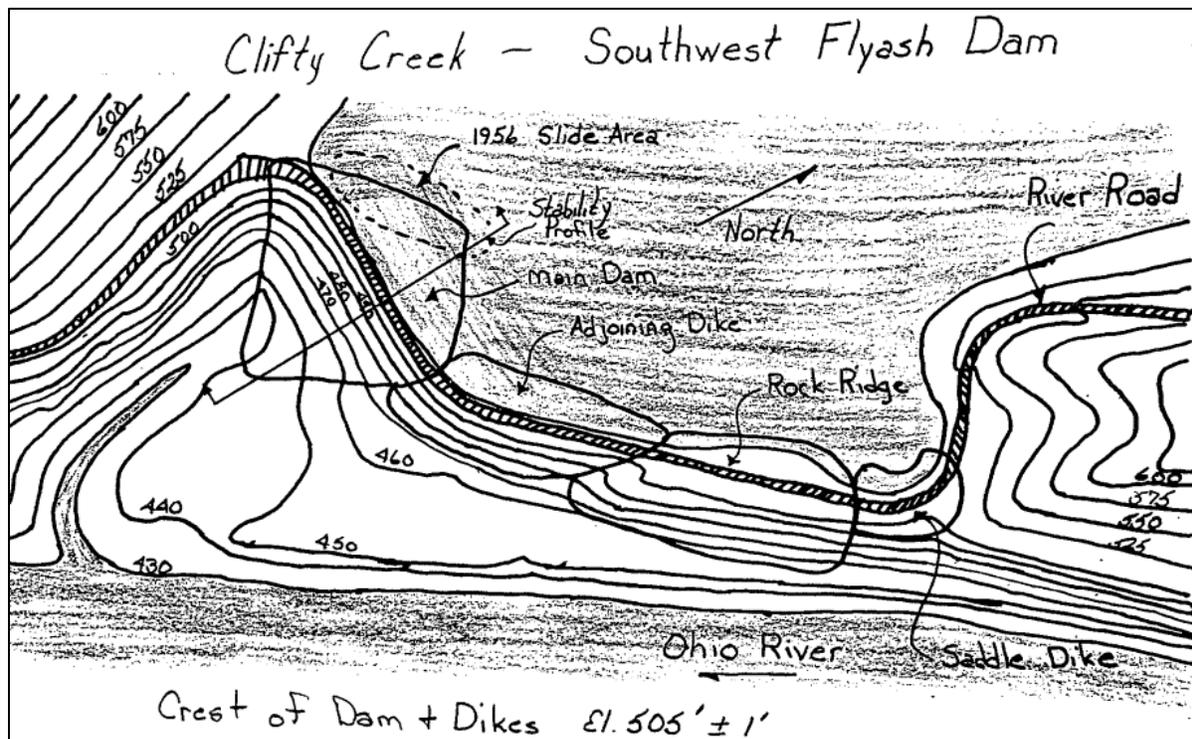
Figure 1 LRCP Dam Construction Detail (AEPSC, 1985)

The LRCP Dam consists of the main 70-foot high dam, a 25-foot high dike on top of an adjoining ridge, a natural rock ridge, and a 15-foot high saddle dike between the rock ridge and the east abutment (AEPSC, 1985). Figure 1 provides a sketch of the components of the LRCP Dam. The main dam has a constructed downstream slope of approximately 2.7H:1V above elevation 474 feet and 3.3H:1V below elevation 474 feet and an upstream slope of about 4.4H:1V. The saddle dike has a downstream slope of 2H:1V and a length of 250 feet (GZA, 2009).

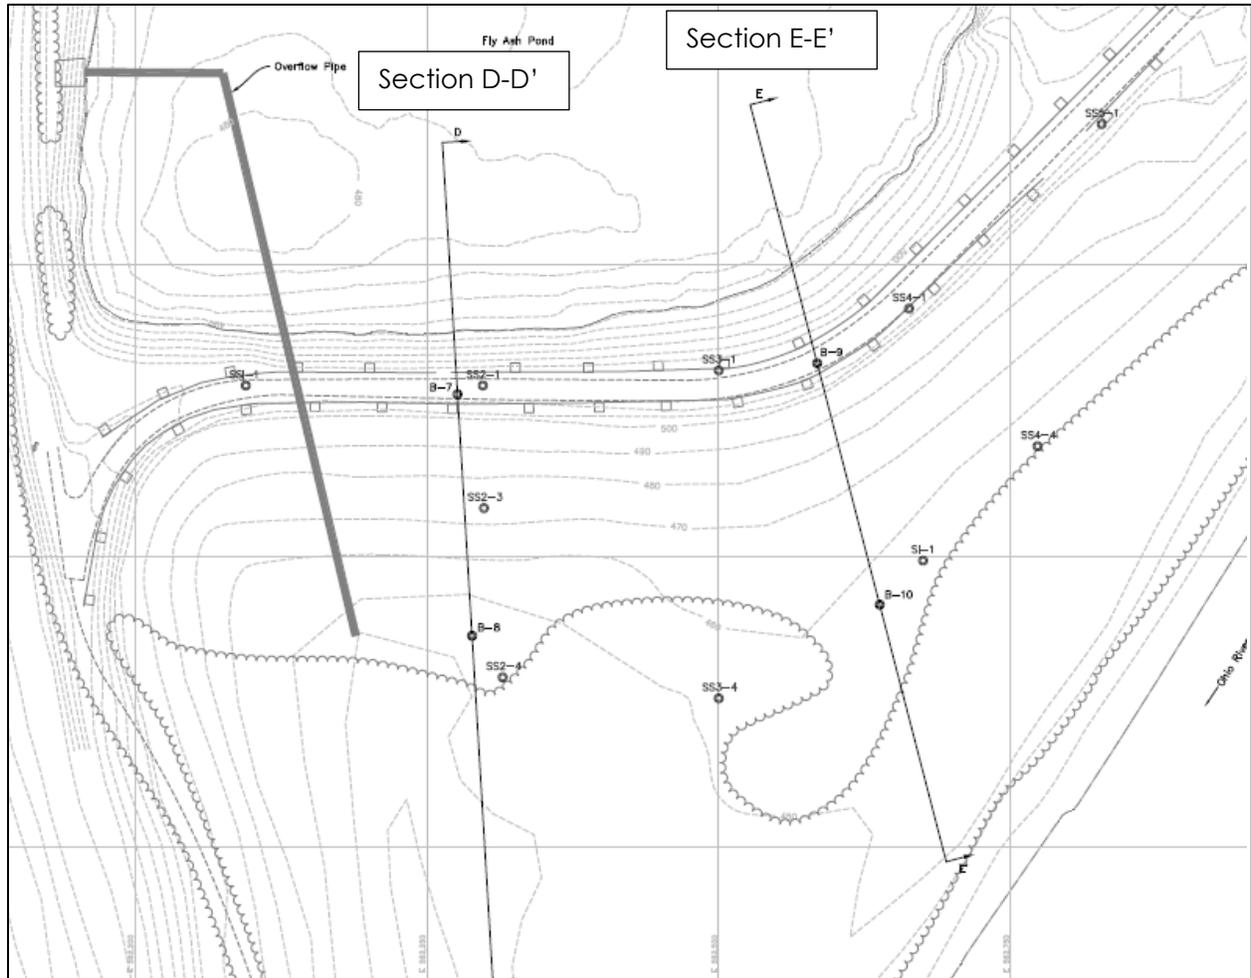
Figure 2 Clifty Creek LRCP Dam – Plan View of Cross Sections

surcharge pool. The two sections that were analyzed are labeled Sections D-D' and E-E' and are shown below in Figure 2.

The summary of the slope stability results from Stantec (2016a) is listed in Table 2. The pond levels were set at the 50% PMP elevation (501.4 feet for the Landfill Runoff Collection Pond). The tailwater was set near the elevation of the Ohio River.

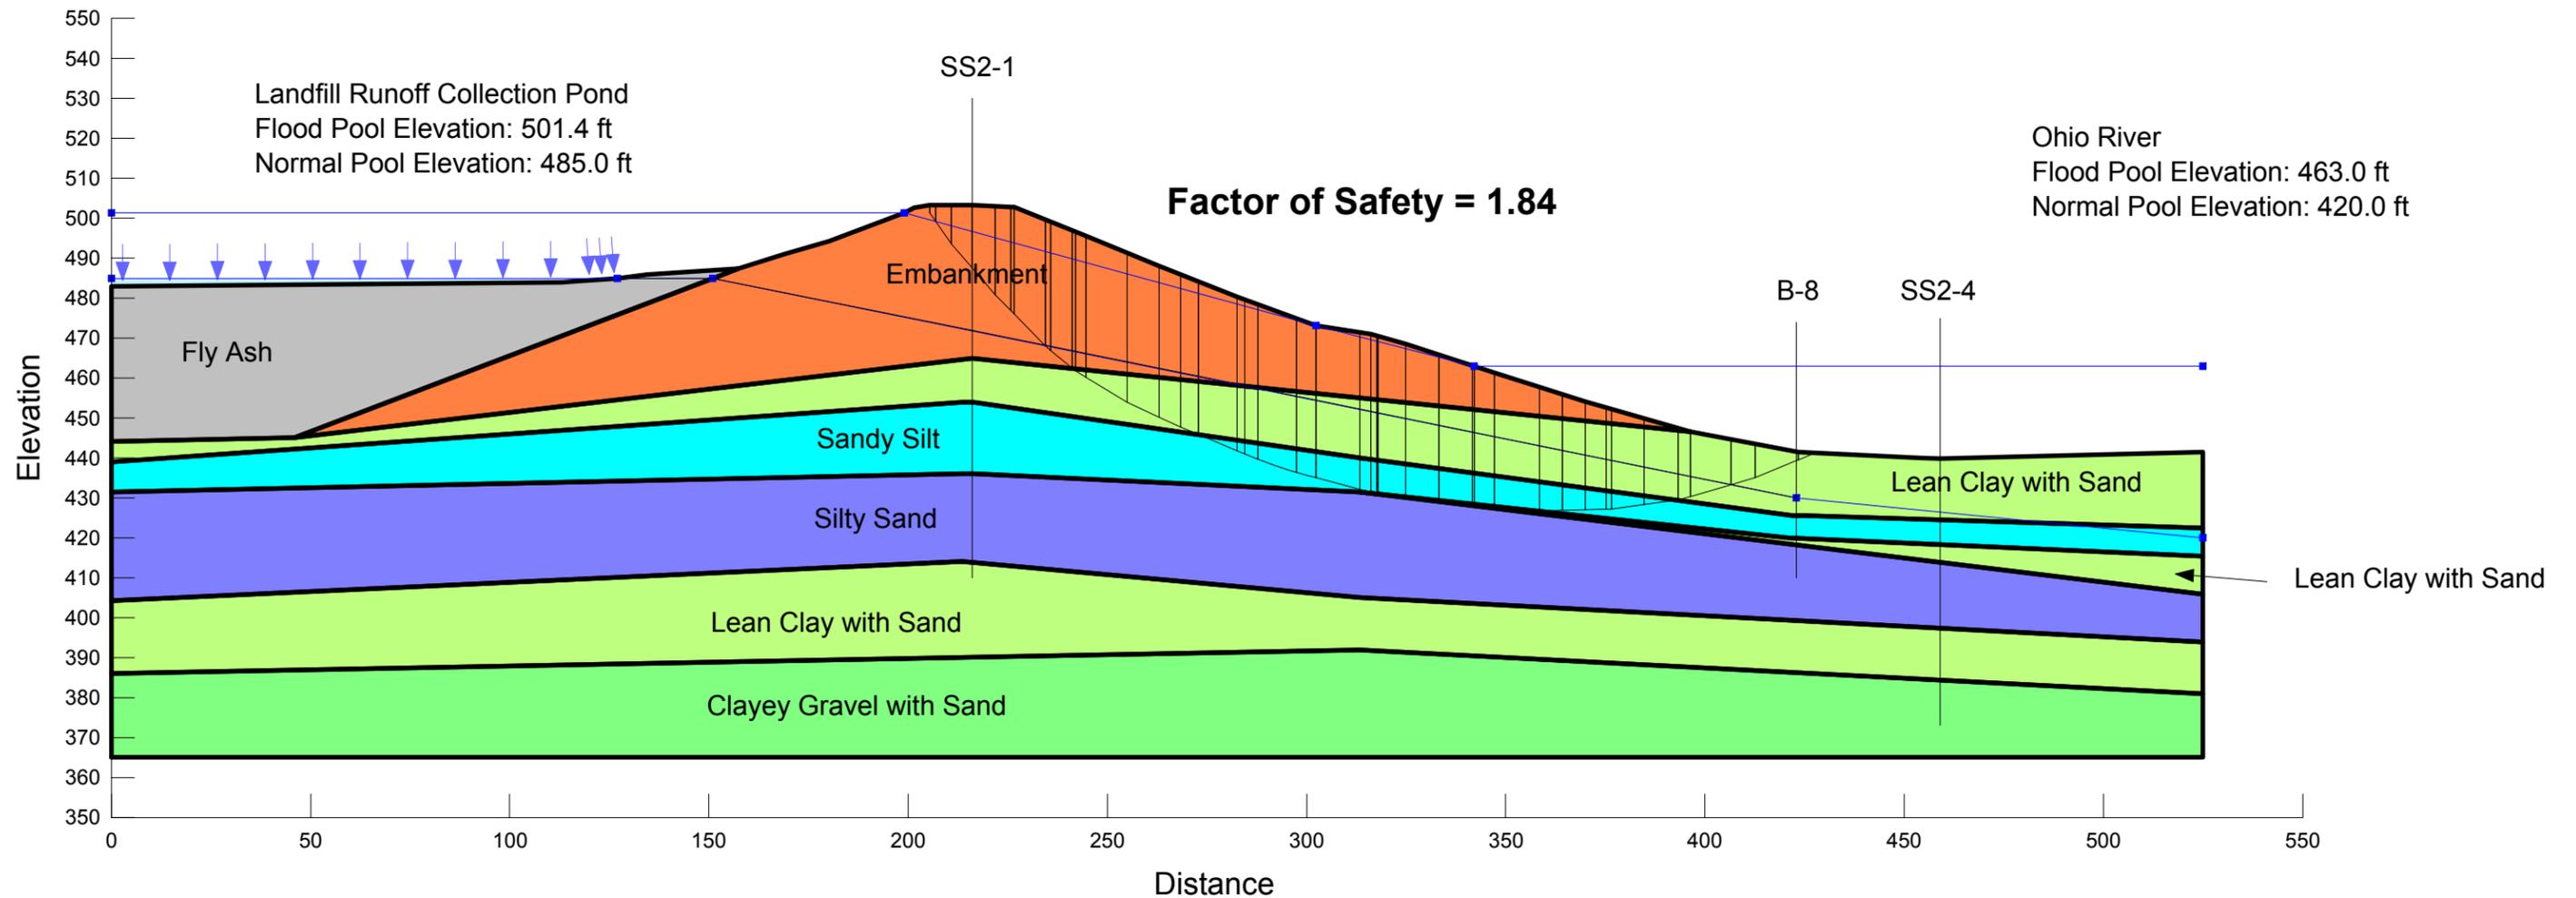
The slope stability assessment presented in this report is focused on the potential for slope failures of significant mass, which could directly impact potential release of water and CCR materials from the Landfill Runoff Collection Pond. The search for a critical slip surface in the slope stability assessment is thus restricted to consider only potential surfaces where the depth (measured at the base of at least one slice) is more than ten feet vertically below the ground surface. Table 4 summarizes the sudden drawdown safety factor evaluation results at the LRCP Dam Section D-D'. The results of the analysis are included in Appendix B.

Facility	Cross Section	EPA Final CCR Rule Criteria	Recommended Factor of Safety Criteria	Calculated Factor of Safety
Landfill Runoff Collection Pond	D-D'	Sudden Drawdown	1.1	1.8
