2016 ANNUAL DAM AND DIKE INSPECTION REPORT

**West Boiler Slag Pond
&
Landfill Runoff Collection Pond**

**CLIFTY CREEK PLANT
Indiana-Kentucky Electric Corporation
MADISON, INDIANA**

**Dam & Dike Inspection Report
West Boiler Slag Pond &
Landfill Runoff Collection Pond**

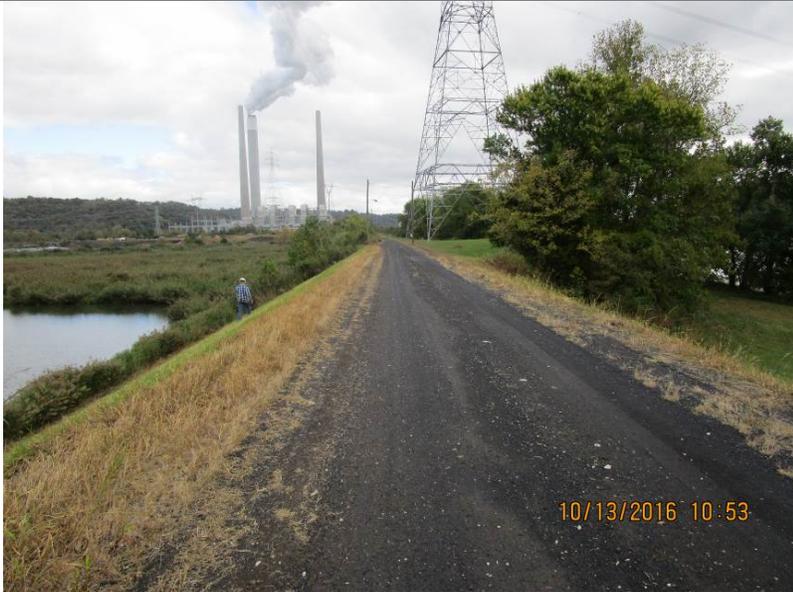
Photo No. 1

1. Photograph No. 1 illustrates a typical overview of the dike crest. The crest appears to be in good and stable condition. Signs of settlement, misalignment and cracking were not observed.

West Bottom Ash Pond Dike
From Crest Looking Northeast

Overview of Crest

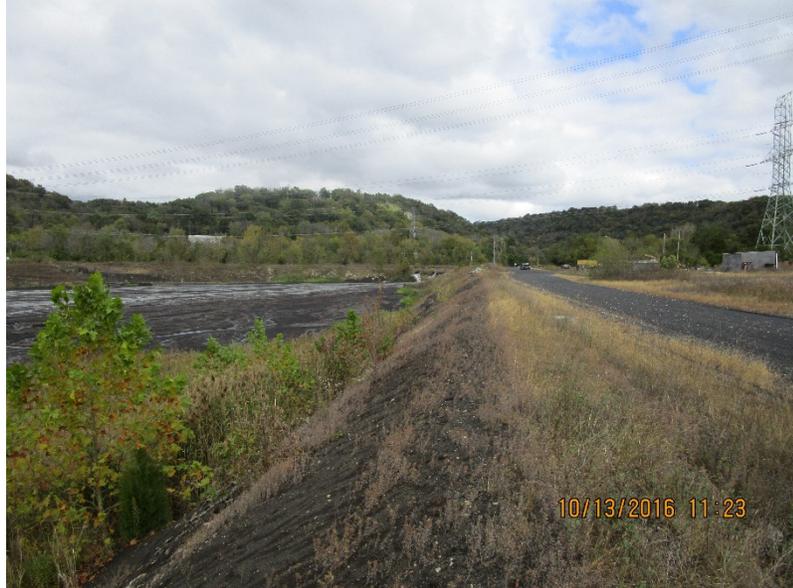
Photo No. 2

2. Photograph No. 2 and Photograph No. 3 illustrate the condition of the interior slopes at the settling end of the pond and the present extent of boiler slag buildup. The interior slope of the east dike at this end of the pond appeared to be in fair and stable condition. Photograph No. 3 shows an area of significant erosion on the interior slope.

West Bottom Ash Pond Dike –
Interior Slope at North End
Looking Toward Discharge Lines

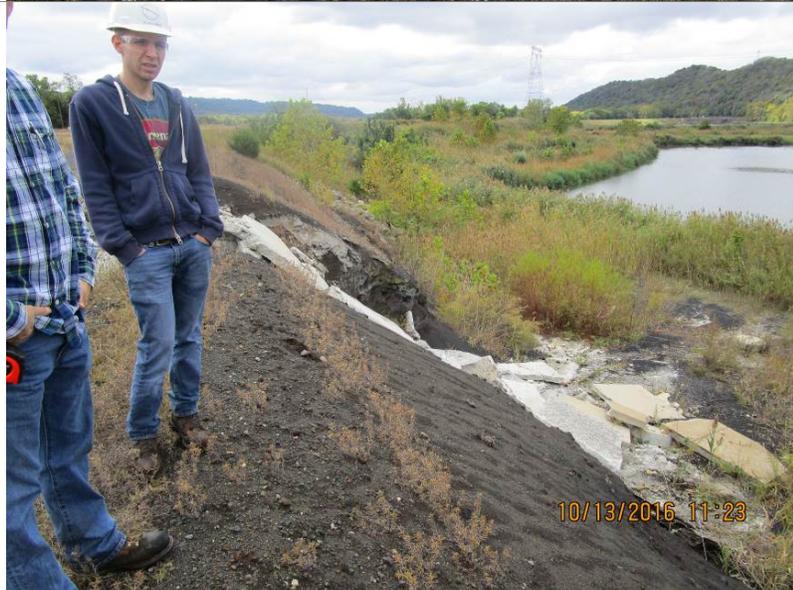
Photo No. 3

West Bottom Ash Pond Dike –
Interior Slope at North End
Looking South

Significant Erosion Caused By
Stormwater Runoff From
Roadway backfilled with concrete
debris

- As shown in photograph No. 3 shows an area of significant erosion on the interior slope. Even though the erosion is in an incised area of the pond and do not pose a stability issue to the pond, it is recommended that the should be filled in and regraded.

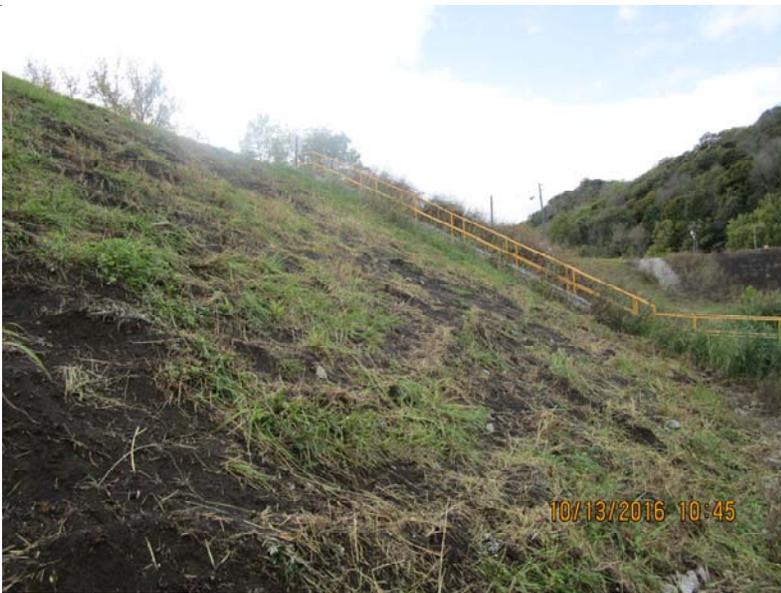
Photo No. 4

3. Photograph No. 4 shows a location where the use of the remotely controlled mower, appear to have caused disturbance to the inboard slopes at areas where the soil is more granular (bottom ash).

West Boiler Slag Pond – Near South End of Interior Slope

Area where some surface disturbance caused by the remotely controlled mower

- An evaluation of the use of the remotely controlled mower, purchased by the plant indicates that the anchors in the tracks are apparently disturbing the inboard slopes at areas (photo #4) where soil is more granular (bottom ash). Weed waking or other mowing techniques is recommended for these areas.

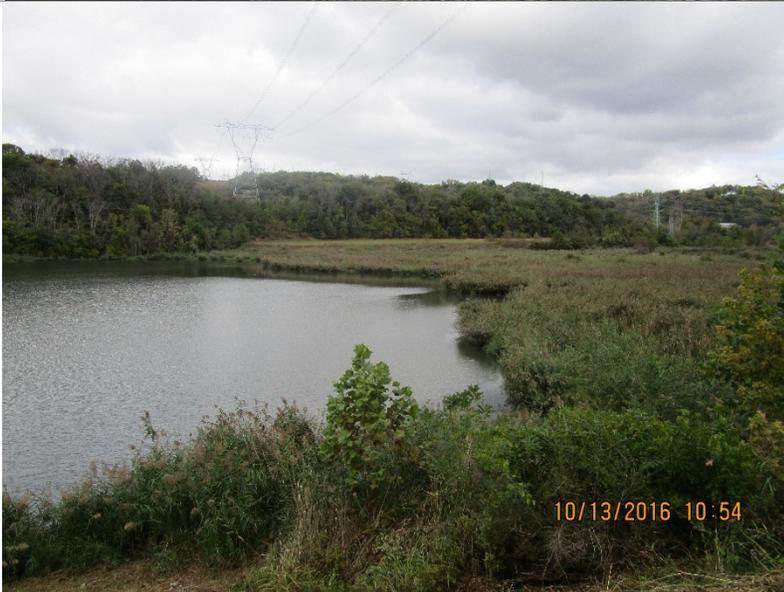
Photo No. 5

4. Photograph No. 5 provides an overview of the extent of the filtering vegetation within the clear water end of the pond. It was noted that the propagation of that filtering vegetation has not progressed to any significant extent since the last inspection.

West Boiler Slag Pond Interior Adjacent To Transmission Tower Looking North Across Pond

General Overview of Vegetation Propagation

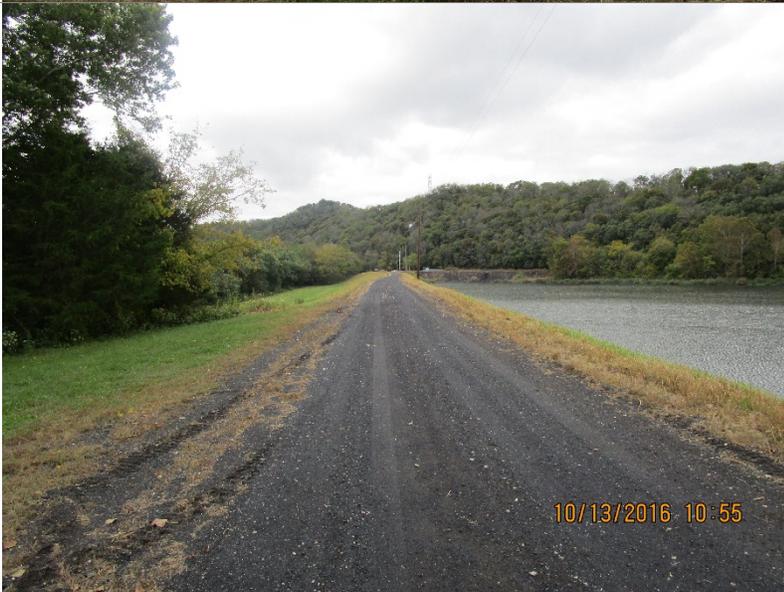
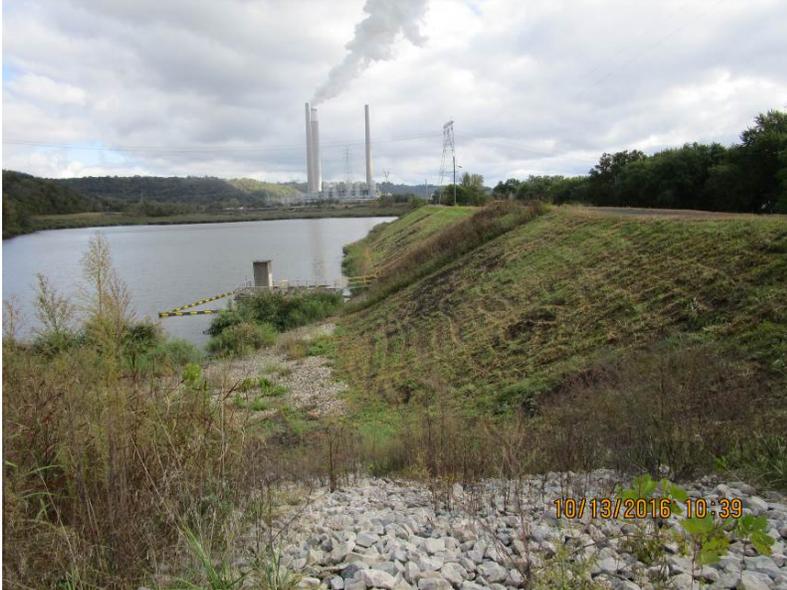
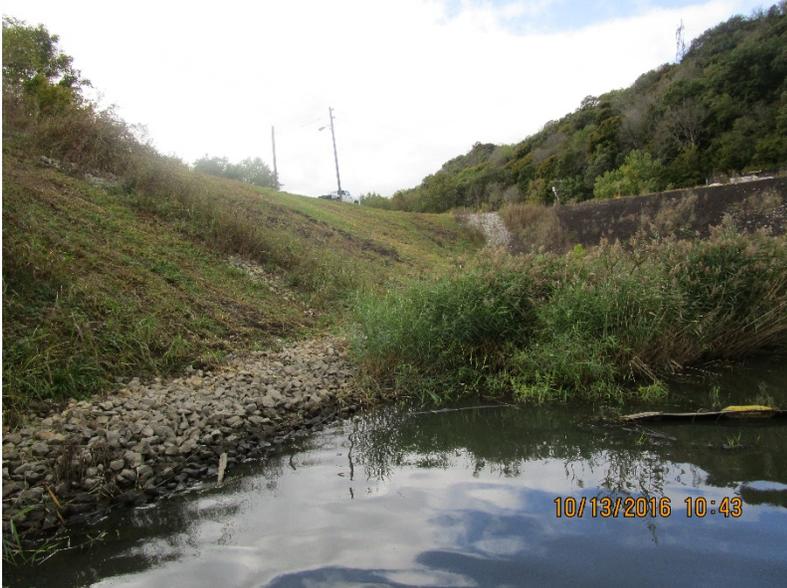
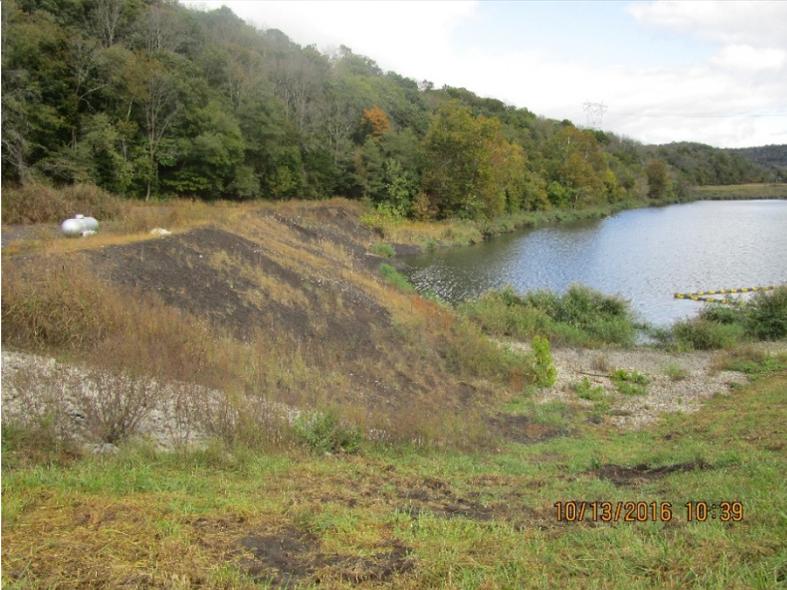
5. Photograph 6 through Photograph 9 show the general condition of the crest and the interior slope of the west end of the south dike.
6. Photograph No. 10 shows the overflow structure and the interior slopes of the dike. Localized areas of overgrown vegetation is present.

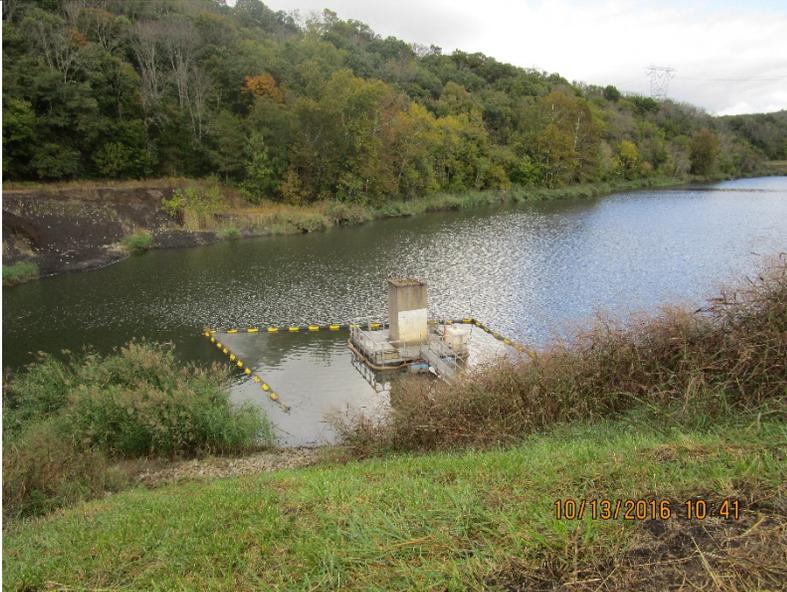
Photo No. 10

West Bottom Ash Pond Dike –
Interior Slope Looking Northwest
From Crest

Overview of General Condition
Local Vegetation growth

- Vegetation height was moderate at local areas on the inboard slopes of the WBSP (photo #10). These areas should be weed waked to prevent damage to the existing riprap in these areas.

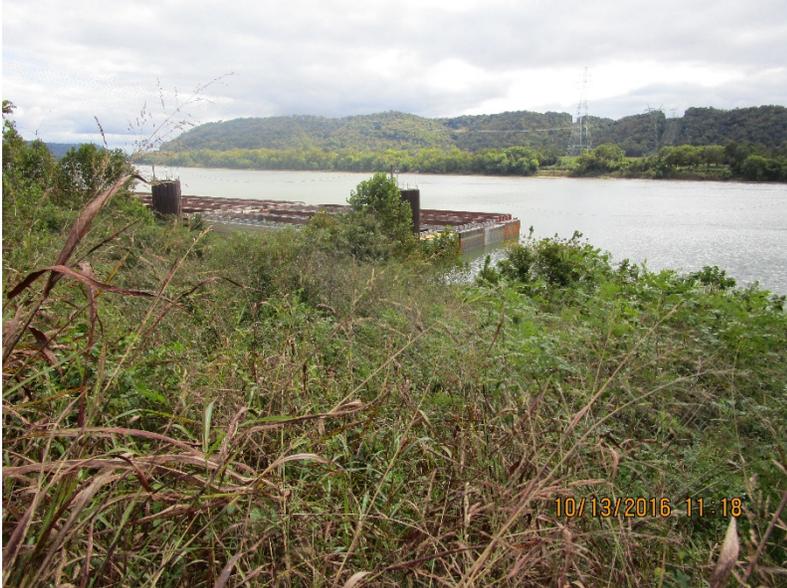
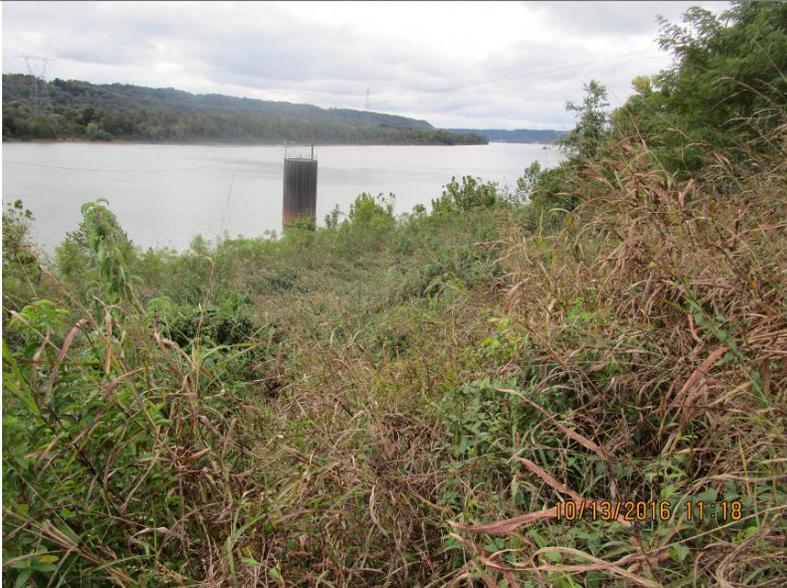
7. Photograph No. 11 and Photograph No. 12 show the excessive vegetation along the exterior slope at the northeast end of the dike.
8. Photograph No. 13, Photograph No. 14 and Photograph No. 15 show the general condition of the crest and the exterior slope of the west end of the south dike. No wet areas were noted during this inspection. The slope appeared in good and stable condition.

Overview of Excessive Vegetation

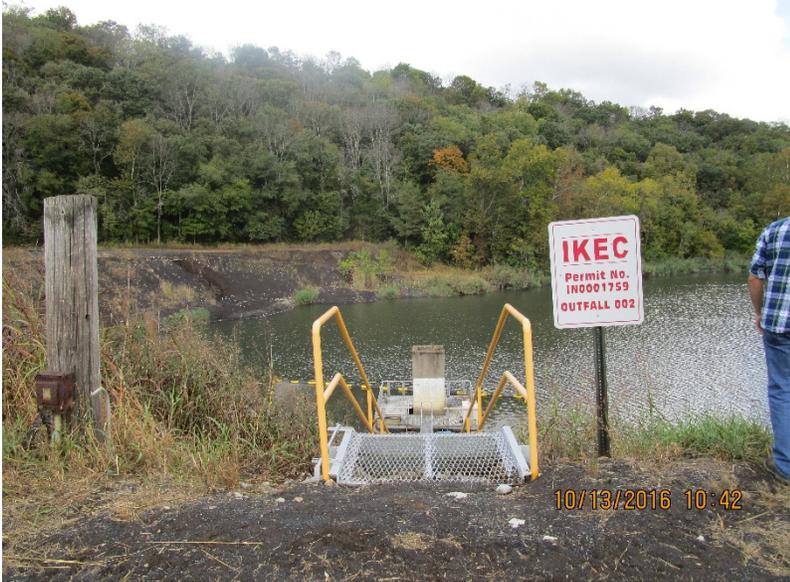
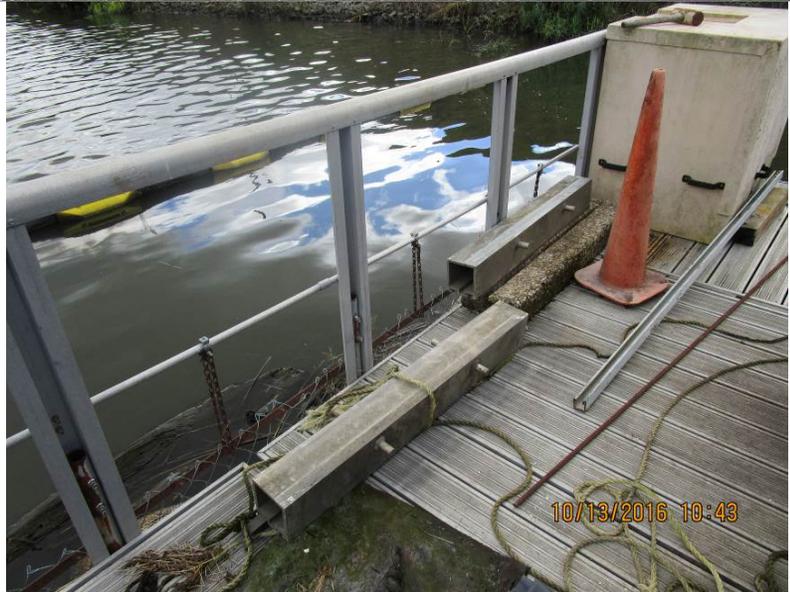
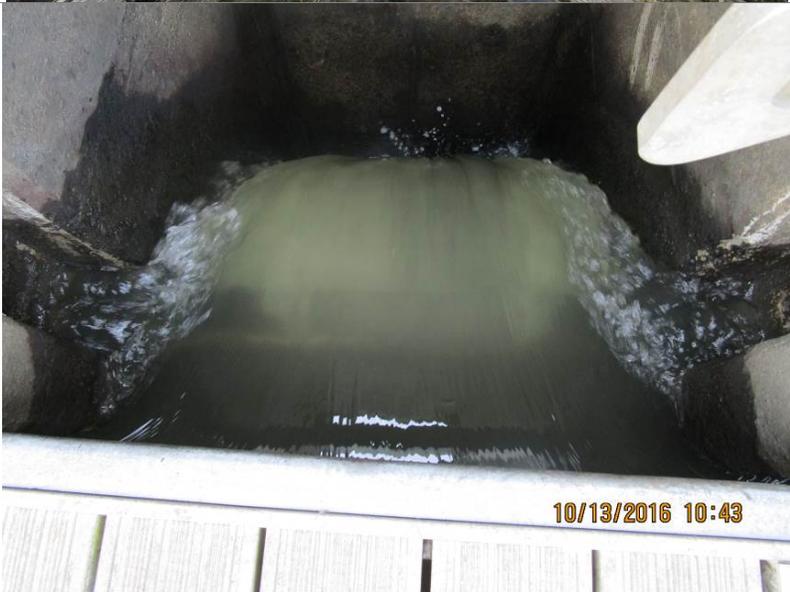
9. The overflow discharge structure walkway, railings, metal decking, and visible concrete were found to be in good, functional condition. Photographs No. 16, No. 17, and No.18 illustrate the access metal walkway, metal deck, spare stop logs and interior of the overflow discharge structure.

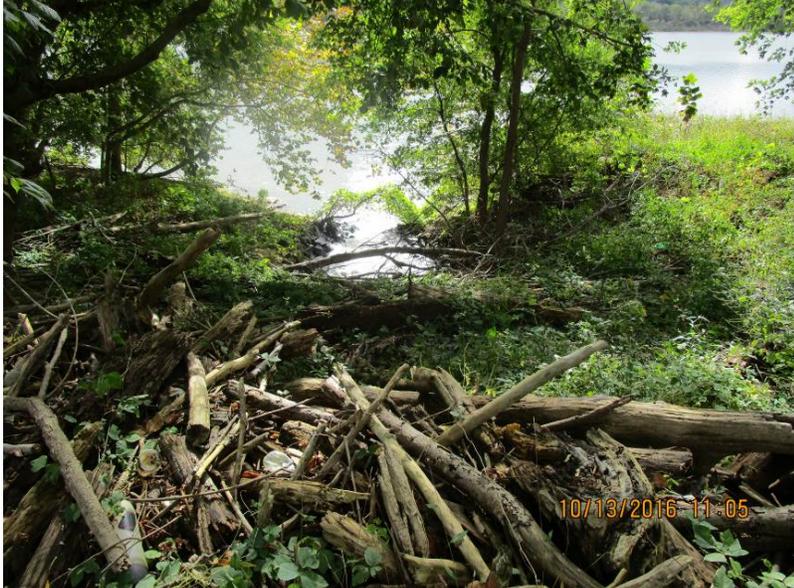
Photo No. 19

10. Photograph No. 19 shows the accumulation of significant wood debris carried by the river during flooding events above the discharge pipe.

West Bottom Ash Pond Principal Spillway Pipe Upstream of the Outlet Channel.

Significant wood debris carried by the river during flooding events

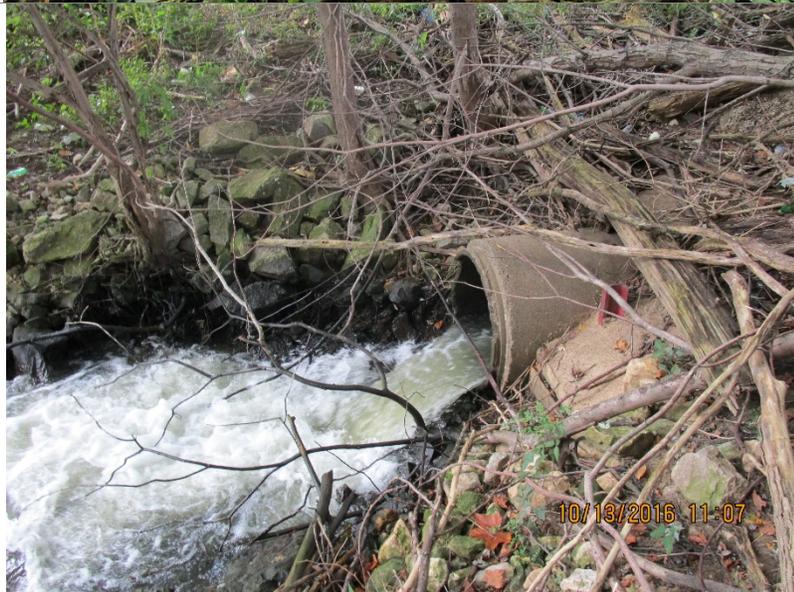
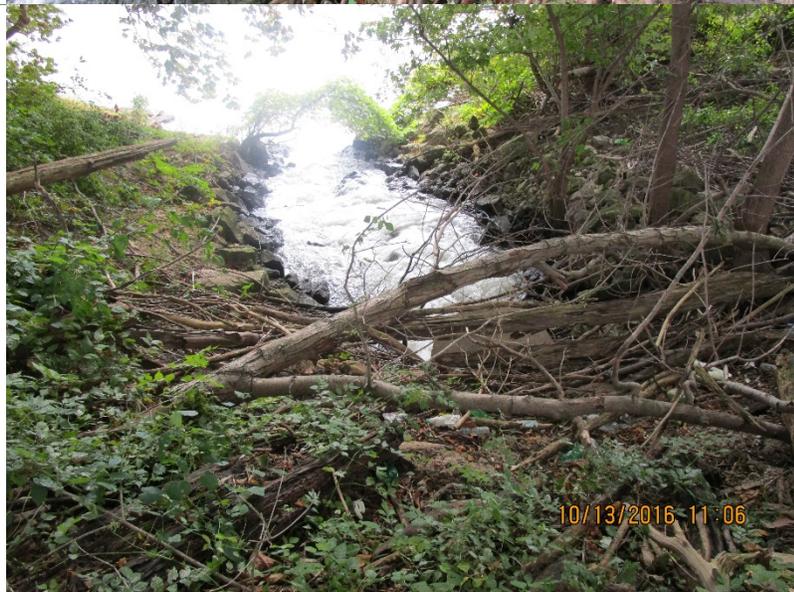
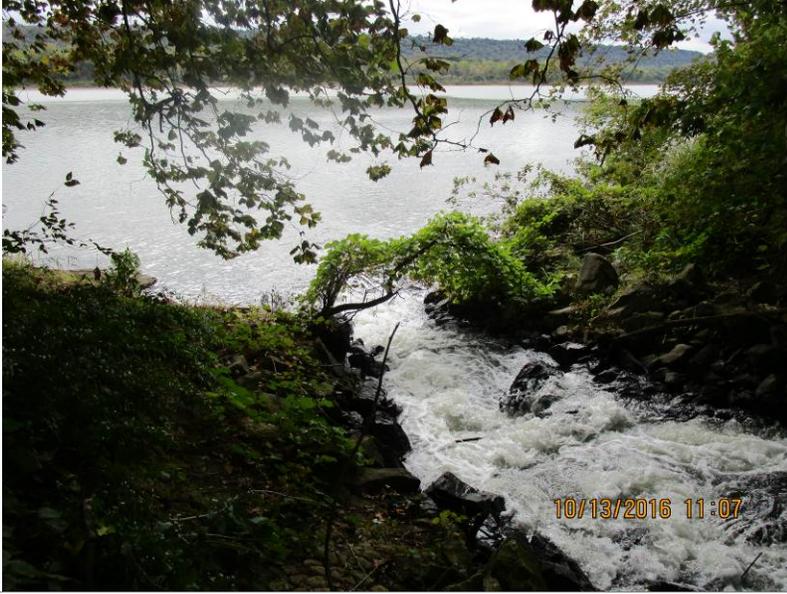
11. Photograph No. 20 Photograph No. 21 and Photograph No. 22 show the typical condition of the discharge pipe and outlet channel. Significant wood debris carried by the river during flooding events. Erosion at the confluence of the channel and the river was consistent with the conditions observed in the past years. The channel and outlet pipe were observed to be in good condition and were unobstructed and flowing steadily.

Significant wood debris carried by the river during flooding events

Current Condition of Non-
Vegetated Slopes – No Significant
Change Since Last Inspection

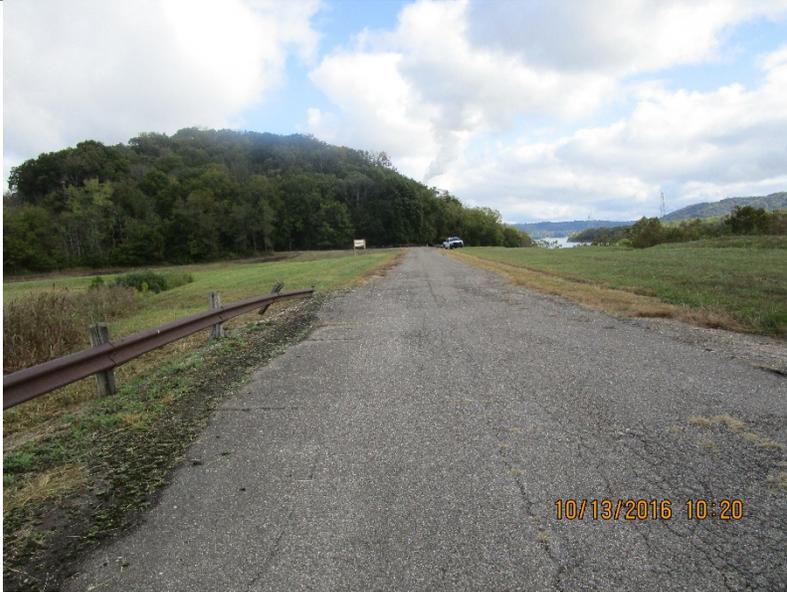
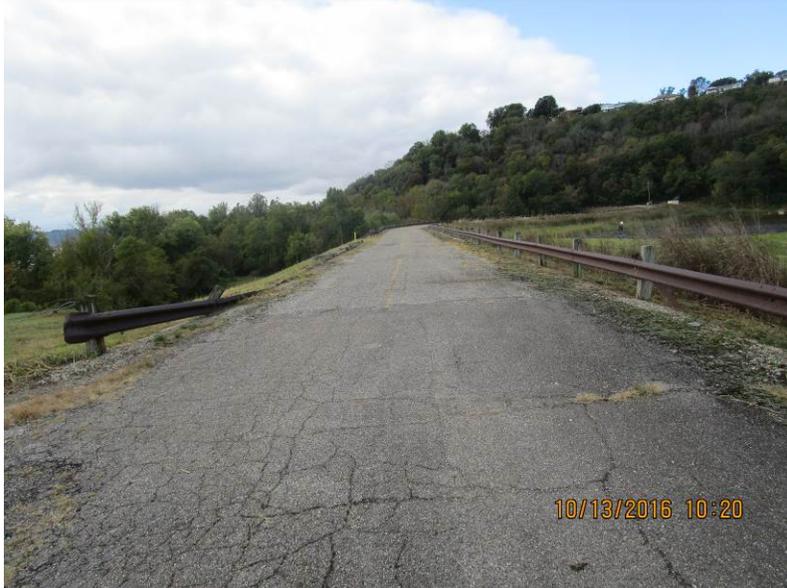
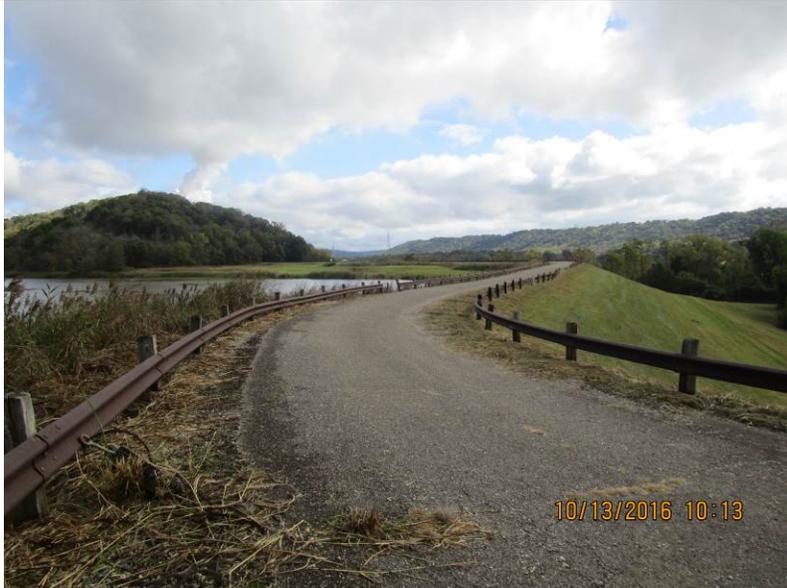
1. Photographs Nos. 1, 2 and 3 show the generally good condition of the crest of the dam. Signs of misalignment and settlement were not observed. Minor surface cracks in the pavement were observed. Those cracks are attributed to the age of the pavement and the effects from weathering.

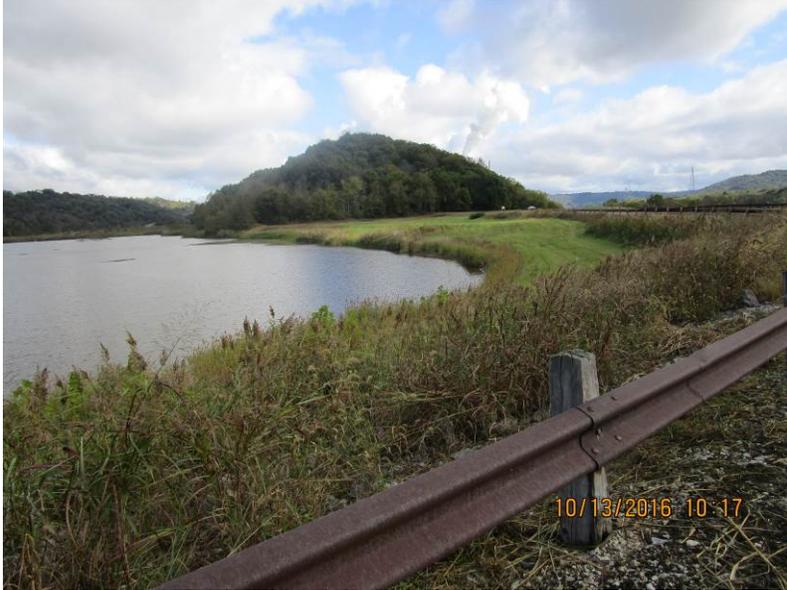
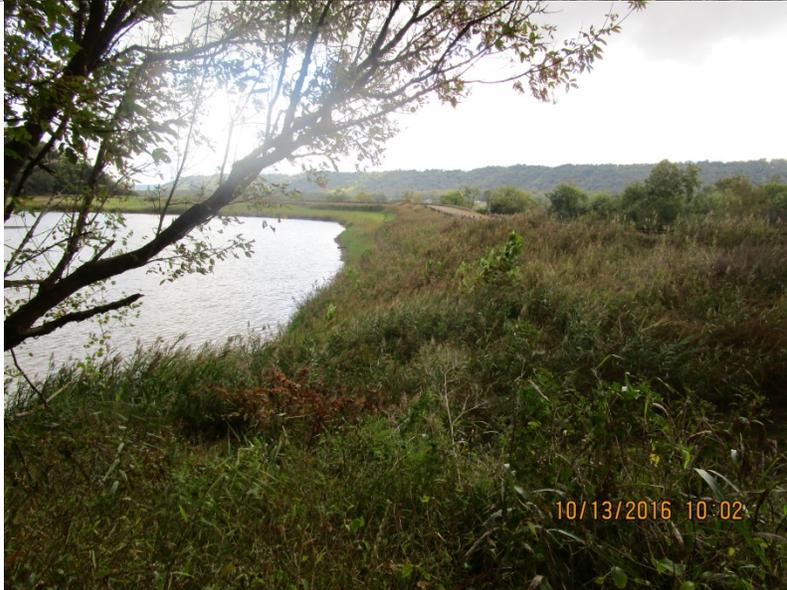
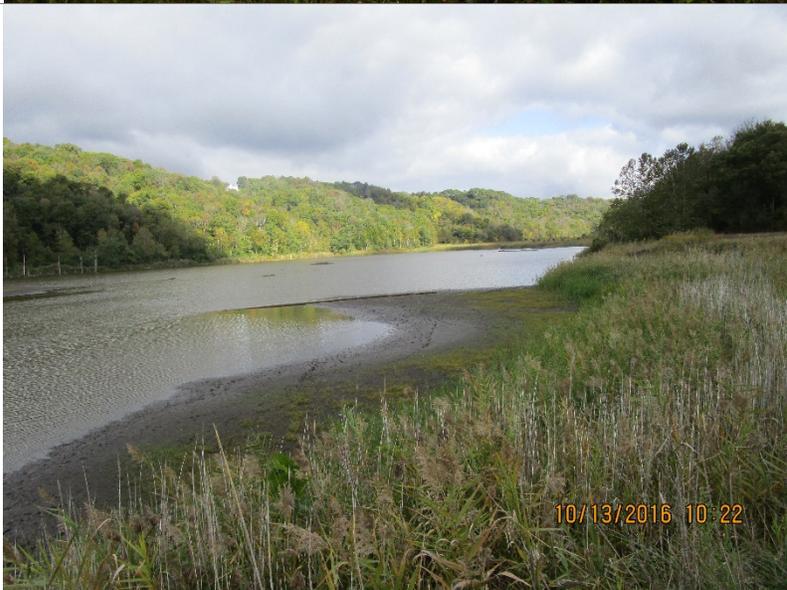
2. Photographs Nos. 4, 5 and 6 provide overviews of the interior slope of the dam above the operating pool. Vegetation control is lacking, however, erosion due to wave action was not observed. Overall the slope was found to be in good and stable condition.

Significant vegetation Growth
along the Upstream of Dam

- Vegetation height was moderate to high on the inboard slopes of the LRCP and should be mowed regularly.
- Fix design of the previously observed sloughing/slip near the left abutment should be implemented once the IDNR construction permit is granted.

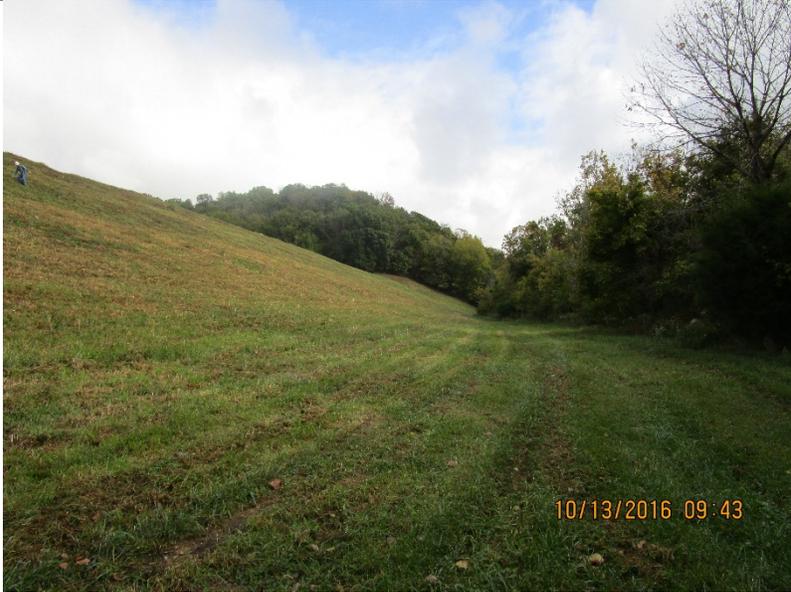
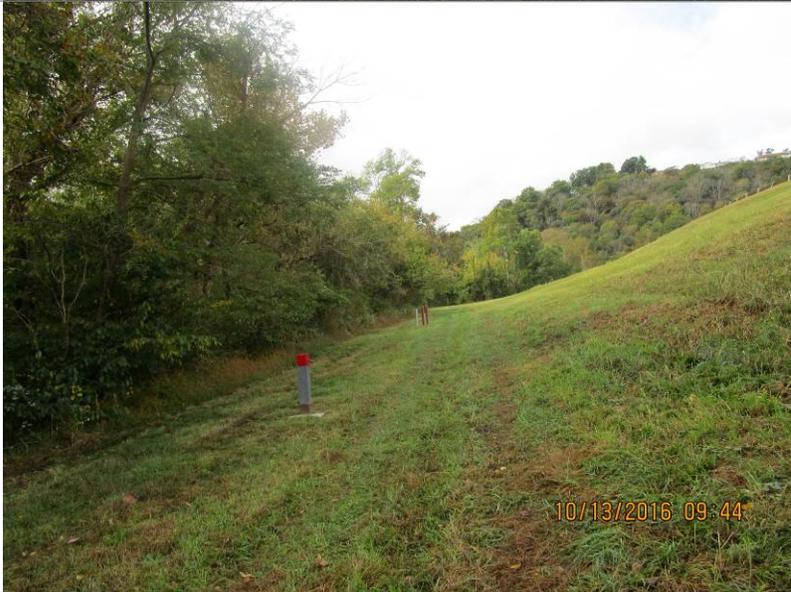
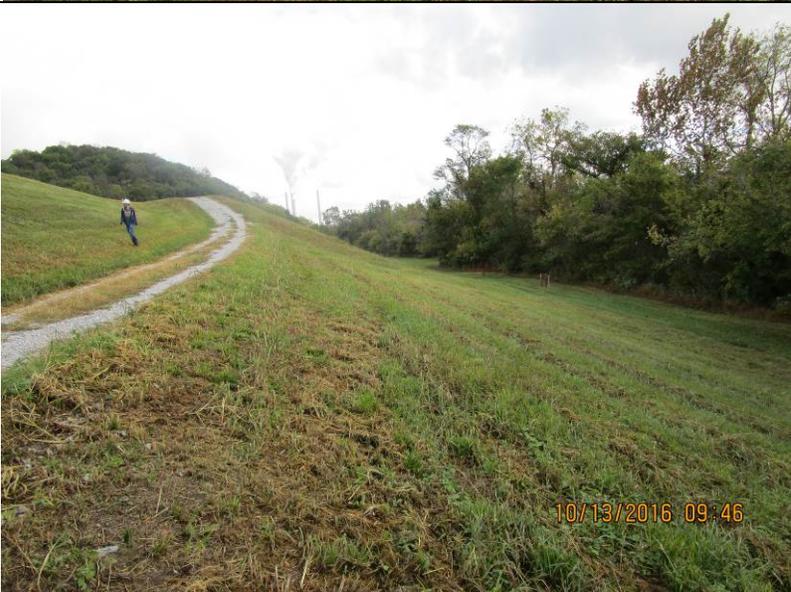
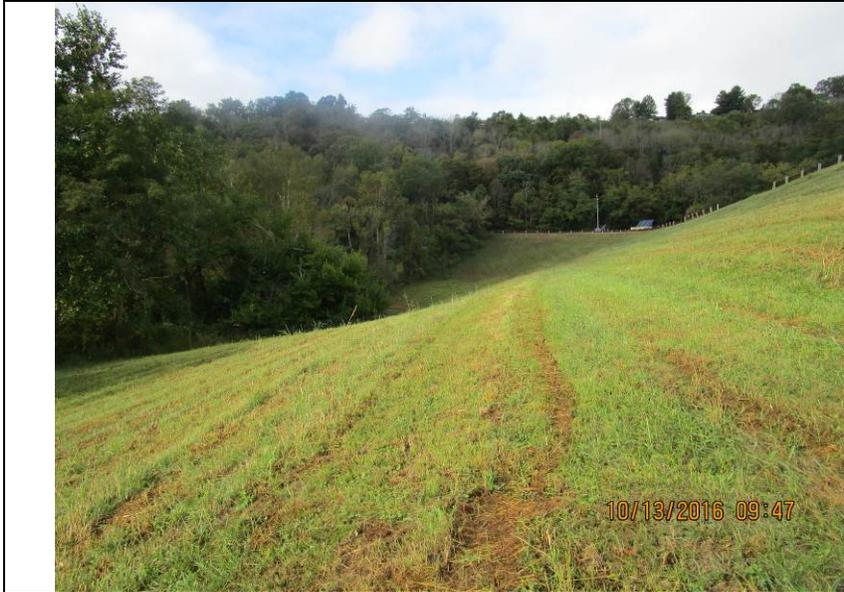
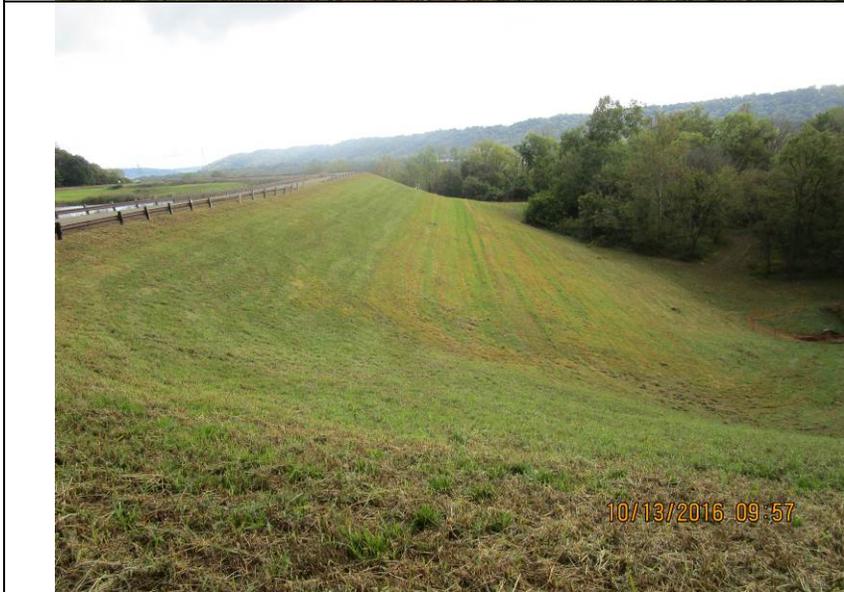
3. Photographs No's. 7 through 11 are all overviews of various areas of the exterior face of the dam as further described with each photograph. Throughout, vegetation control is acceptable. No visible change was observed from previous inspections. In general, the exterior slope appeared to be in good and stable condition.

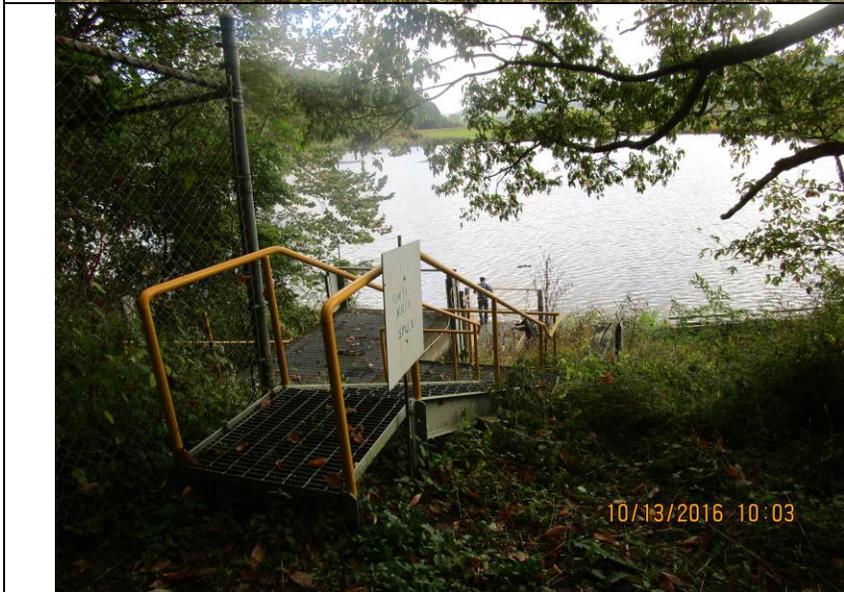
Photo No. 12

4. Photograph No.12 is an overview of the principal spillway decant structure. Vegetation control was observed to be good. The decant structure appeared to be functioning properly and was free of obstructions. Photograph No.13 Recently Added Pipe to allow for treatment of discharged water.

Fly Ash Pond Principal Spillway
Structure

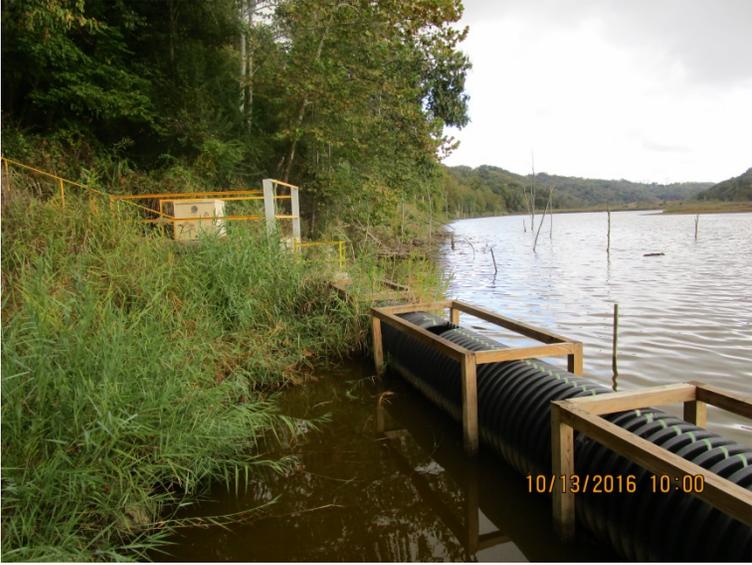
<p>Photo No. 13</p> <p>Fly Ash Pond Principal Spillway Structure</p> <p>Recently Added Pipe To allow for treatment of discharged water.</p>

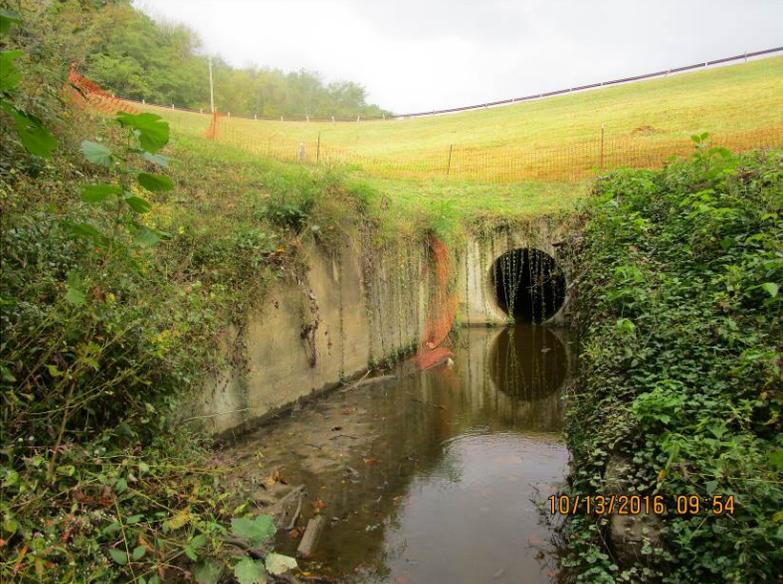
<p>Photo No. 14</p> <p>Fly Ash Pond Principal Spillway Outlet</p> <p>General Overview –Backwater has been minimized since last inspection.</p>

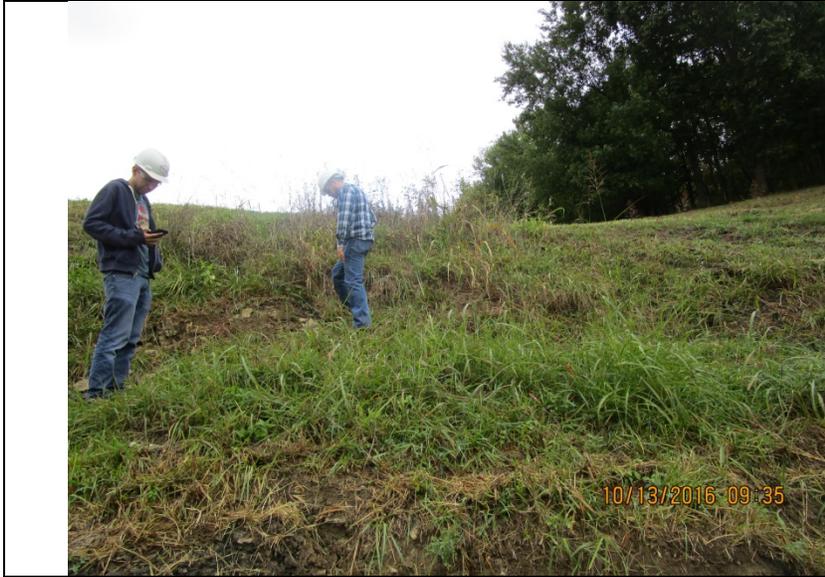
Photo No. 16

6. Photograph No.16 shows the previously observed sloughing/slip near the left abutment. Permit for fix was submitted to IDNR for Approval.

Fly Ash Pond Dam From
Bottom of Saddle Dam/Rock
Ridge Interface
