2017 ANNUAL DAM AND DIKE INSPECTION REPORT

**West Boiler Slag Pond
&
Landfill Runoff Collection Pond**

**CLIFTY CREEK PLANT
Indiana-Kentucky Electric Corporation
MADISON, INDIANA**

GERS-17-043

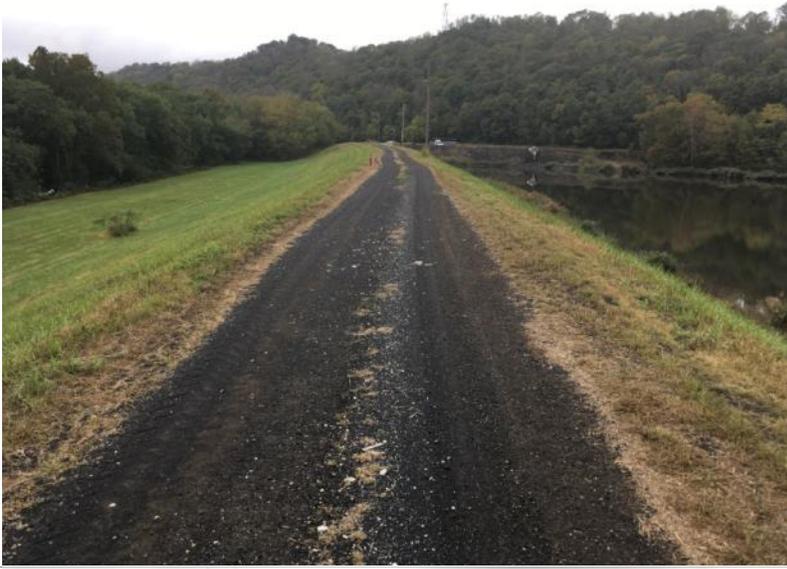
Photo No. 1

1. Photographs No. 1 and 2 illustrate a typical overview of the dike crest. The crest appears to be in good and stable condition. Signs of settlement, misalignment and cracking were not observed.

West Boiler Slag Pond Dike From Crest Looking West.

Overview of Crest

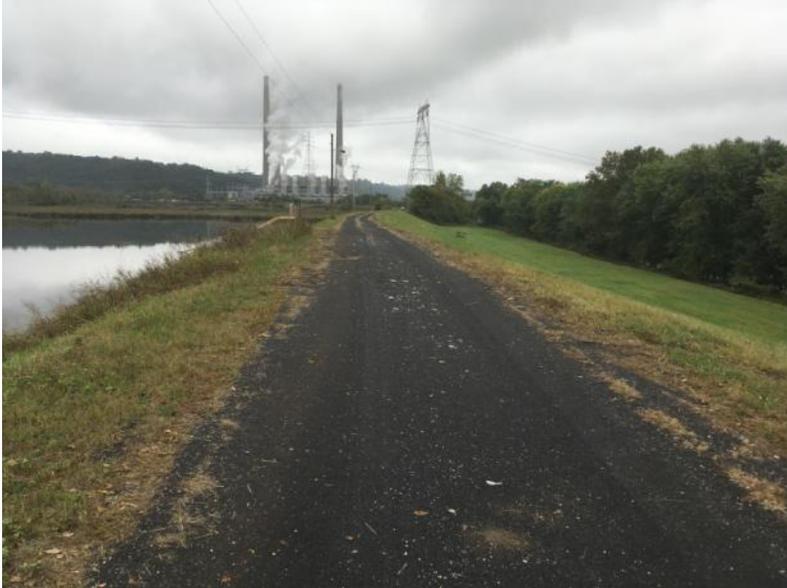
Photo No. 2

West Boiler Slag Pond Dike From Crest Looking East.

Overview of Crest

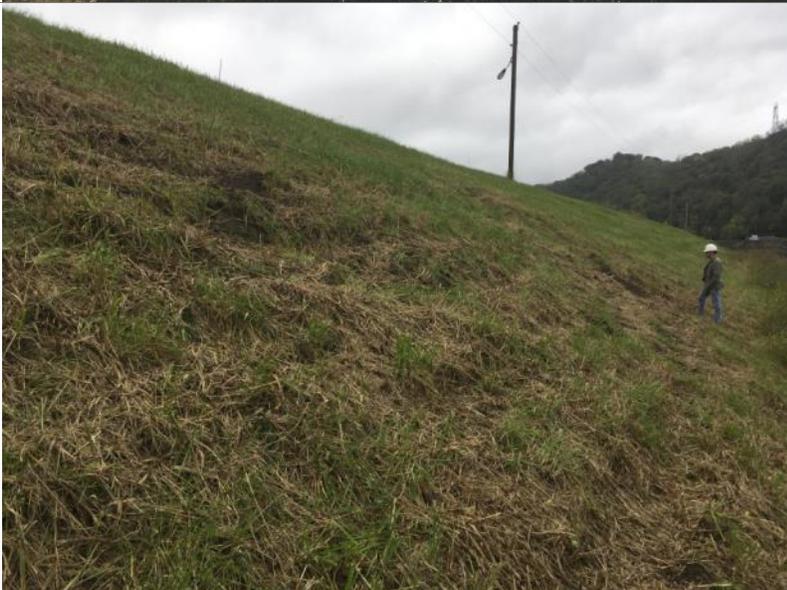
Photo No. 3

2. Photographs No. 3, 4 and 6 illustrate the condition of the interior slopes at the settling end of the pond and the present extent of boiler slag buildup. The interior slope of the east dike at this end of the pond appeared to be in satisfactory and stable condition.

West Boiler Slag Pond – Near West End of Interior Slope

Area where some surface disturbance caused by the remotely controlled mower

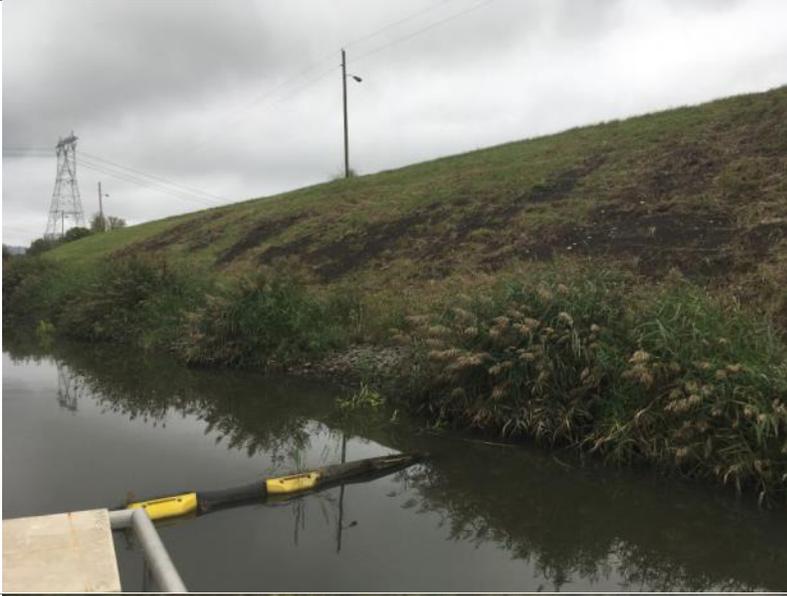
Photo No. 4

West Boiler Slag Pond Interior Slope Looking East Across Pond

General Overview of Disturbed Areas on Slope From Mowing Activities and excessive vegetation growth near the water line.

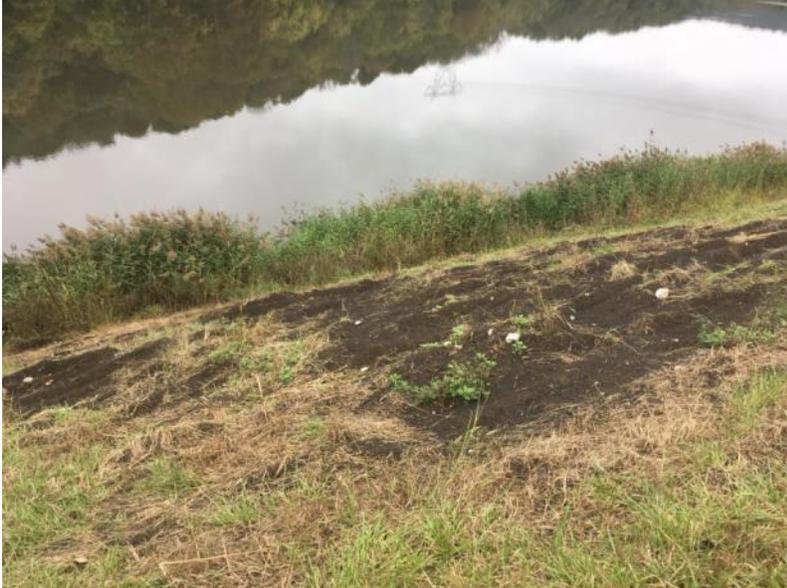
Photo No. 5

3. Photograph No. 5 shows a location where the use of the remotely controlled mower, appear to have caused disturbance to the inboard slopes at areas where the soil is more granular (bottom ash).

West Boiler Slag Pond Dike – Interior Slope From Mid Slope area.

Looking at disturbed Slope From Mowing Activities and excessive vegetation growth near water line.

- An evaluation of the use of the remotely controlled mower, purchased by the plant indicates that the anchors in the tracks are apparently disturbing the inboard slopes at areas (photo #5) where soil is more granular (bottom ash). Weed wacking or other mowing techniques is recommended for these areas.
- Vegetation height was moderate at local areas on the inboard slopes of the WBSP (photo #4). These areas should be weed wacked to prevent damage to the existing riprap in these areas.

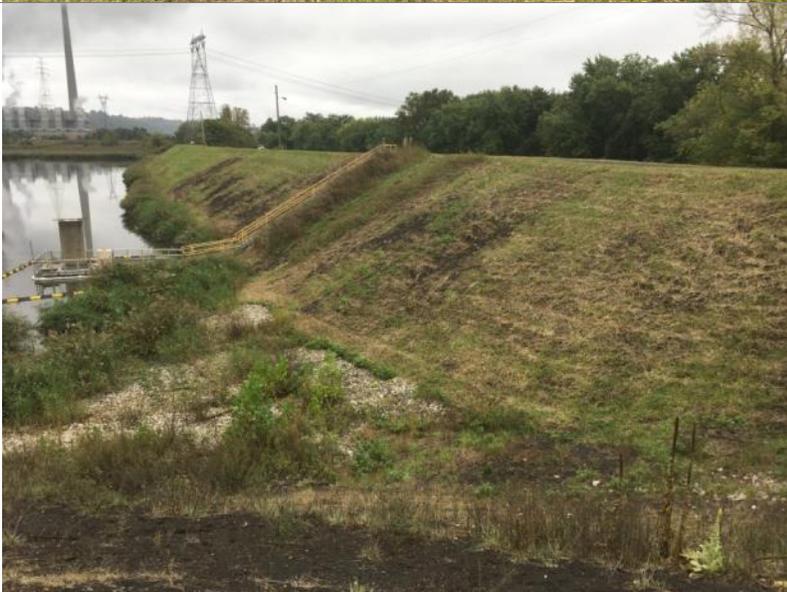
Photo No. 6

West Boiler Slag Pond Dike – Interior Slope Looking East From West End.

Overview of General Condition

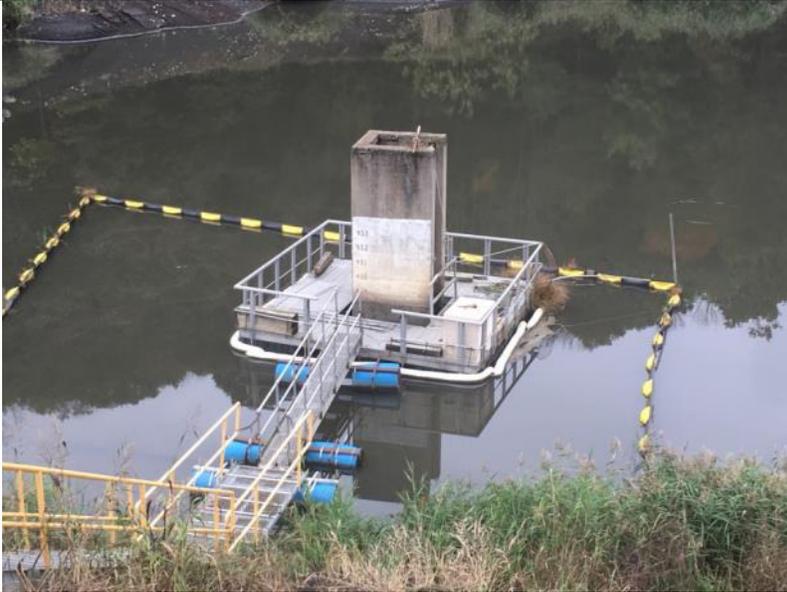
Photo No. 7

4. Photograph No. 7 shows the Principal Spillway and Decant Structure along with some localized overgrown vegetation near the access stairs and water line. The overflow structure appeared to be in satisfactory condition.

West Boiler Slag Pond – Principal Spillway and Decant Structure.

Overview of General Condition

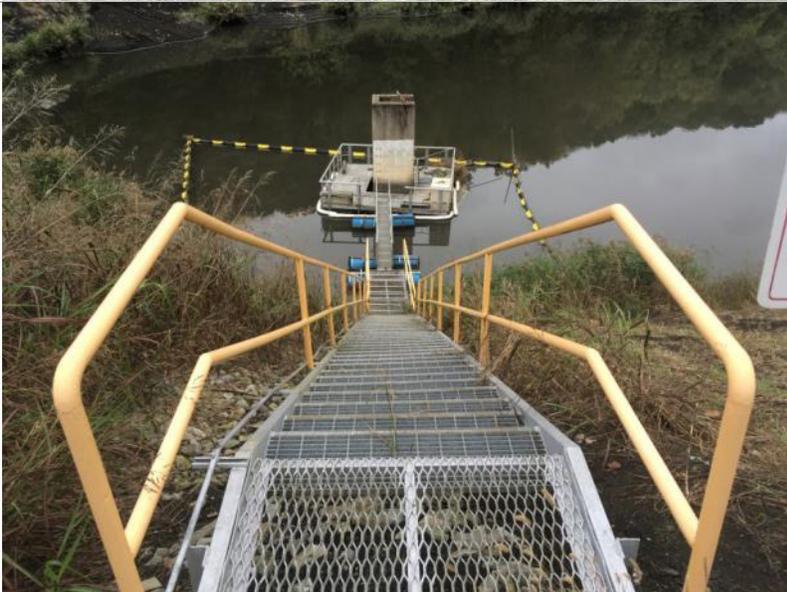
Photo No. 8

5. The overflow discharge structure walkway, railings, metal decking, and visible concrete were found to be in satisfactory, functional condition. Photographs No. 7, 8, and 9 illustrate the access metal walkway, metal deck, spare stop logs and interior of the overflow discharge structure.

West Boiler Slag Pond – Principal Spillway and Decant Structure Stairway Access.

Overview of General Condition

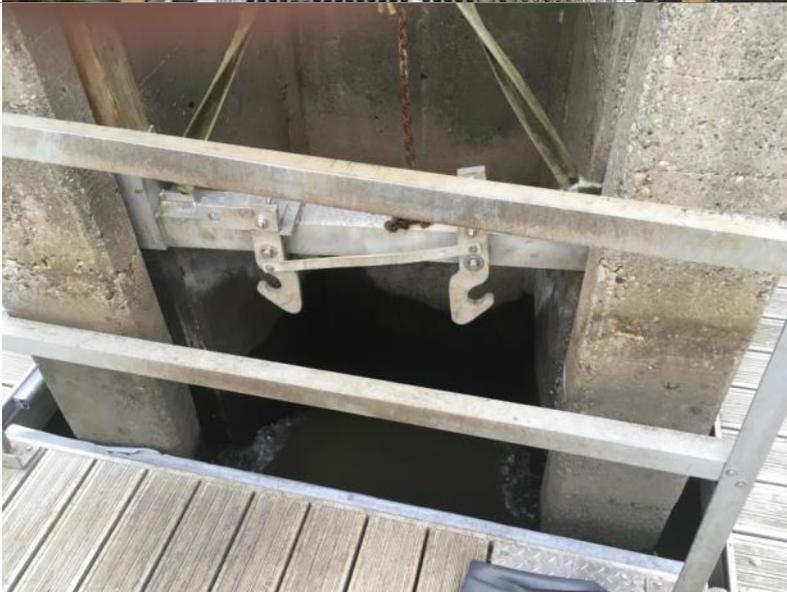
Photo No. 9

West Boiler Slag Pond – Principal Spillway and Decant Structure Floating Walkway Access.

Interior of the Overflow Discharge Structure.

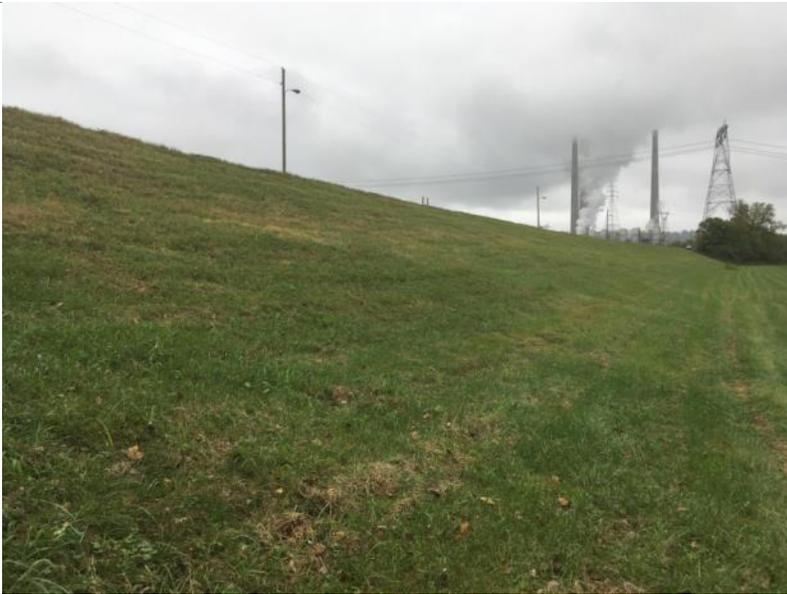
Photo No. 10

6. Photographs No. 10, 11 and 12 shows the general condition of the exterior slope of the south dike. The slope appeared in satisfactory and stable condition. There were no signs of settlement, misalignment, sloughing or erosion. No wet areas were noted during this inspection except along the toe area where it appears there was standing water in tire ruts caused from mowing activities.

West Boiler Slag Pond Dike –
Exterior Slope From Toe Area
Looking East

Overview of general conditions.

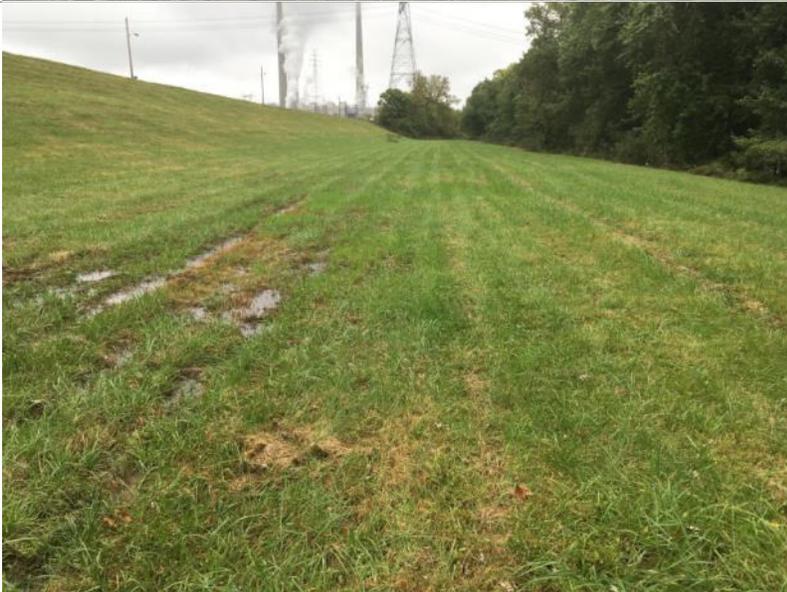
Photo No. 11

West Boiler Slag Pond Dike –
Exterior Slope From Toe Area
Looking East.

Overview of toe area showing
ponding of water in tire ruts from
mowing activities.

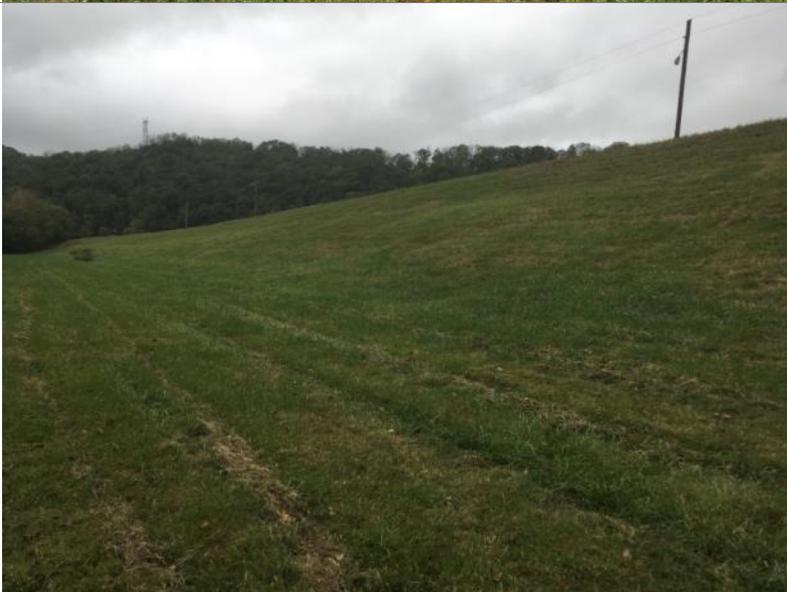
Photo No. 12

West Boiler Slag Pond Dike –
Exterior Slope form toes Area
Looking West.

General Condition.

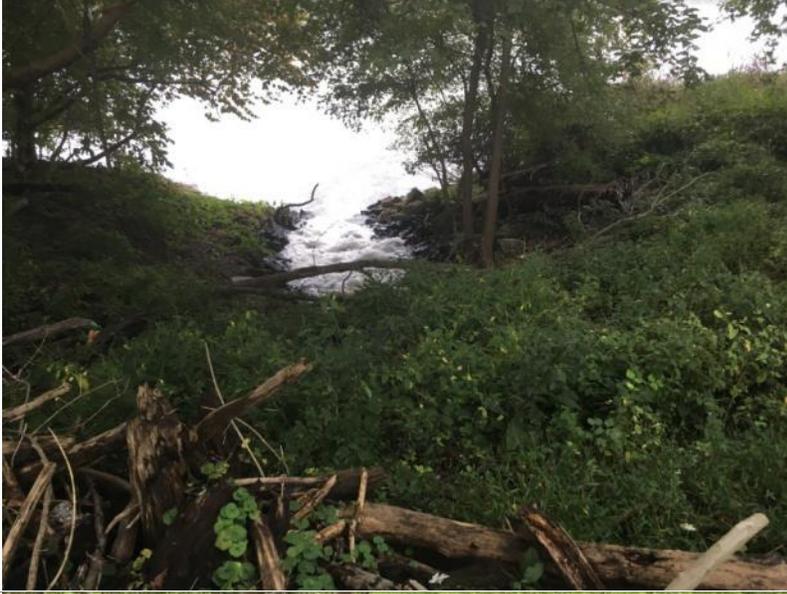
Photo No. 13

7. Photograph No. 13 and No. 14 show the typical condition of the discharge pipe and outlet channel. Erosion at the confluence of the channel and the river was consistent with the conditions observed in the past years. The channel and outlet pipe were observed to be in good condition and were unobstructed and flowing steadily.

West Boiler Slag Pond Dike – Principal Spillway Outlet Pipe Channel. Looking South Into Ohio River.

Overview of Vegetation and General Condition

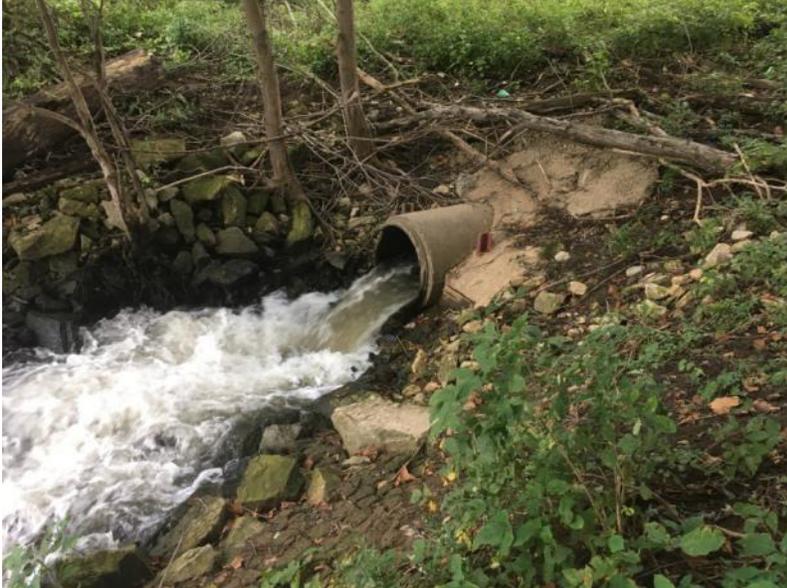
Photo No. 14

West Boiler Slag Pond Dike – Principal Spillway Outlet Pipe.

Overview of General Conditions.

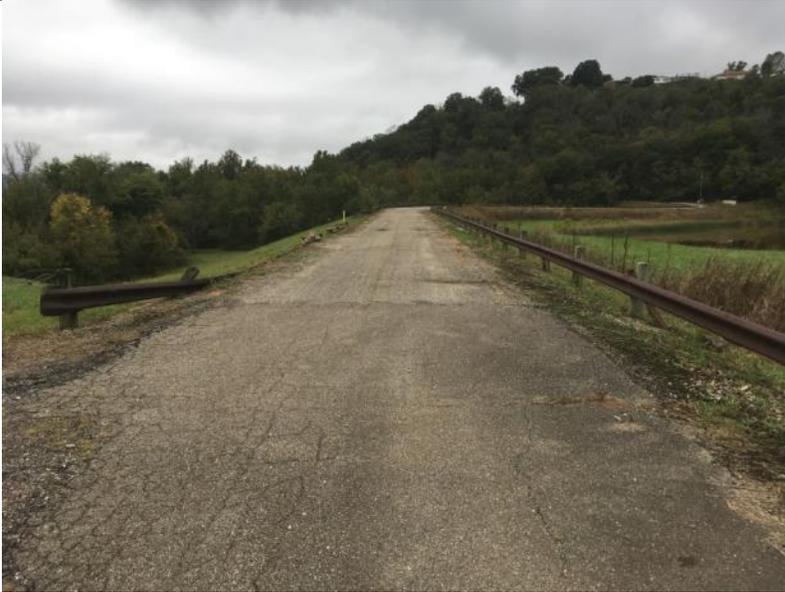
Photo No. 1

1. Photographs Nos. 1, 2 and 3 show the generally condition of the crest of the dam. Signs of misalignment and settlement were not observed. Minor surface cracks in the pavement were observed. Those cracks are attributed to the age of the pavement and the effects from weathering.

Landfill Runoff Collection Pond
Dam From Crest Looking
Southwest Across Saddle Dam.

General Overview.

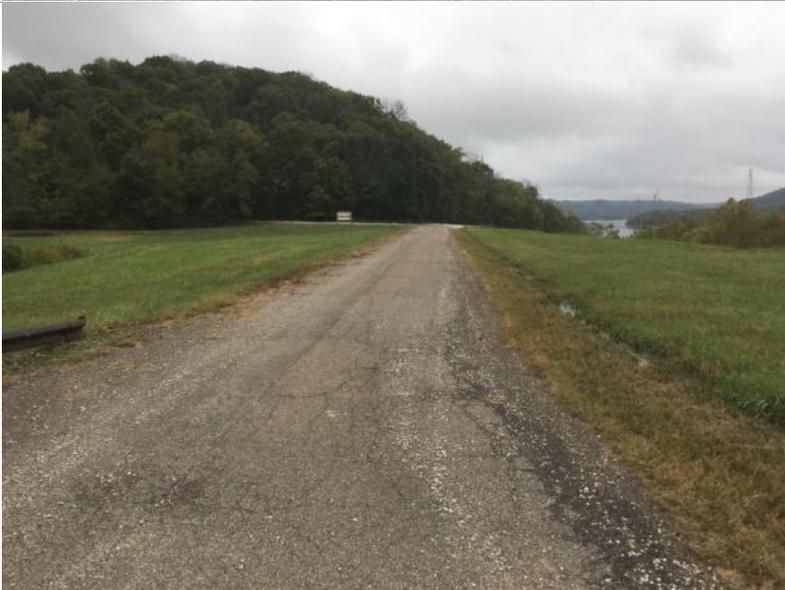
Photo No. 2

Landfill Runoff Collection Pond
Dam From Crest Looking
Northeast.

General Overview.

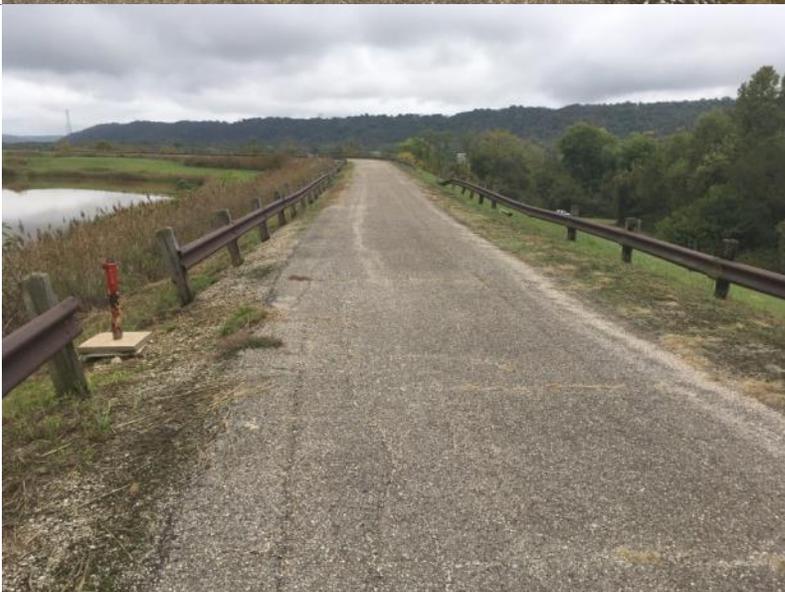
Photo No. 3

Landfill Runoff Collection Pond
Dam From Crest Looking East.

General Overview.

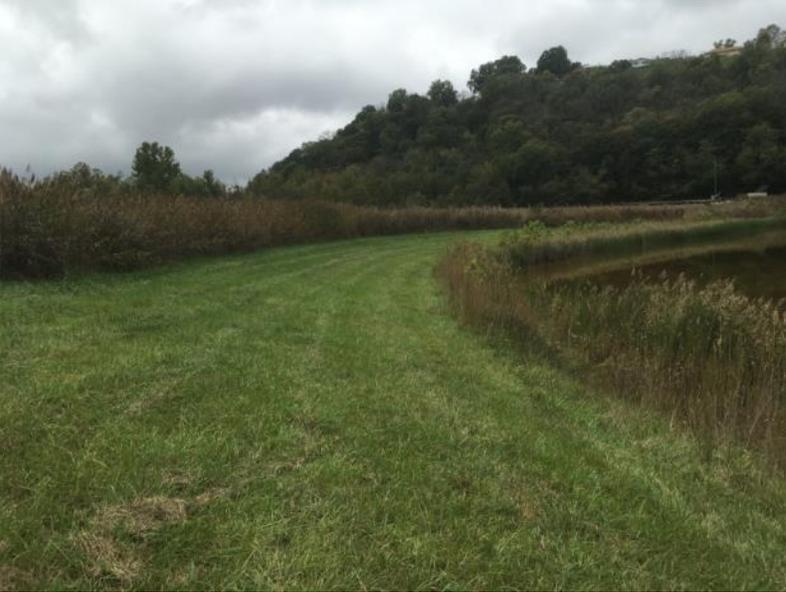
2. Photographs Nos. 4, 5, 6 and 7 provide overviews of the interior slope of the dam above the operating pool. Vegetation control near the water line and the upper slope areas is lacking, however, erosion due to wave action was not observed. Overall the slope was found to be in satisfactory and stable condition.

<p>Photo No. 4</p> <p>Landfill Runoff Collection Pond Dam From Up Stream Slope Overview of Current Operating Pool and Vegetation Conditions on Interior Slope.</p> <p>Significant vegetation Growth along the Upstream of Dam.</p>

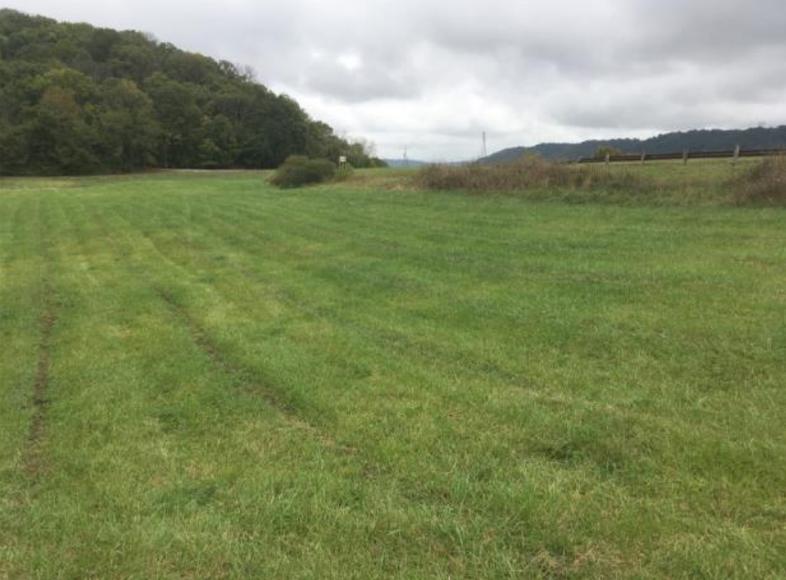
<p>Photo No. 5</p> <p>Landfill Runoff Collection Pond Dam From Up Stream Slope</p> <p>Overview of Current Operating Pool and Vegetation Conditions on Interior Slope Adjacent to Saddle Dam</p>

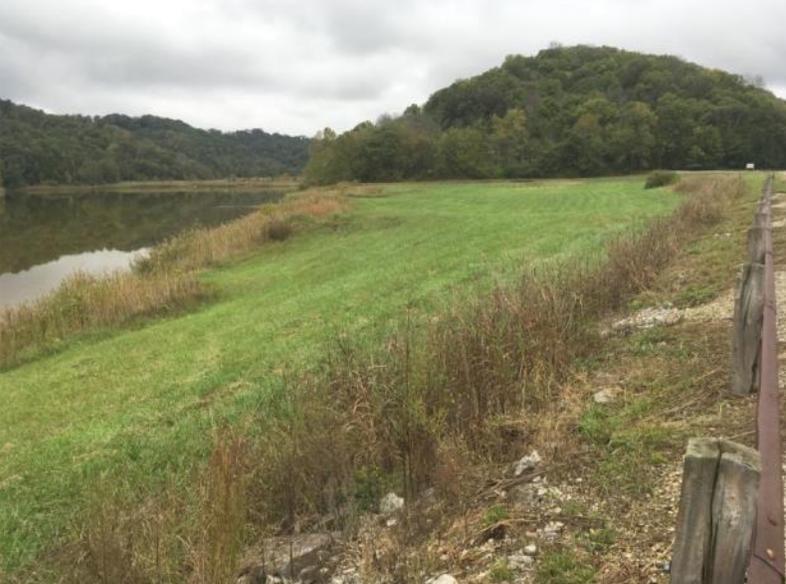
<p>Photo No. 6</p> <p>Landfill Runoff Collection Pond Dam From Up Stream Slope</p> <p>Overview of Vegetation and General Conditions.</p>

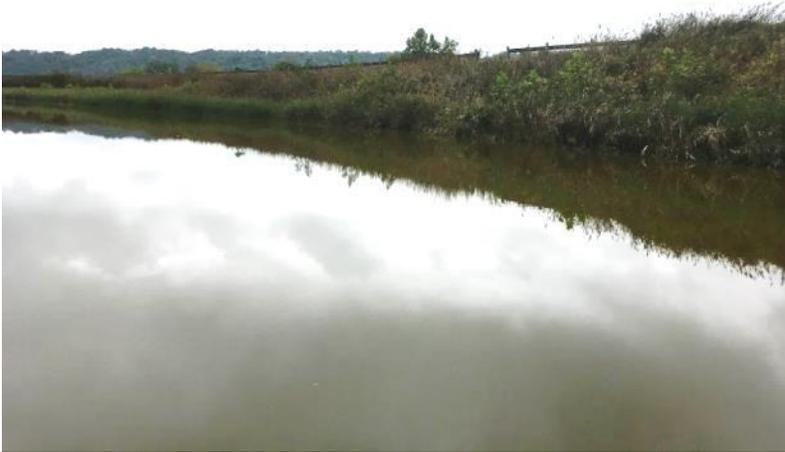
Photo No. 7

Landfill Runoff Collection Pond
Dam From Upstream slope
Looking South.

Overview of Pool Area and
Vegetation Management and
General Condition.

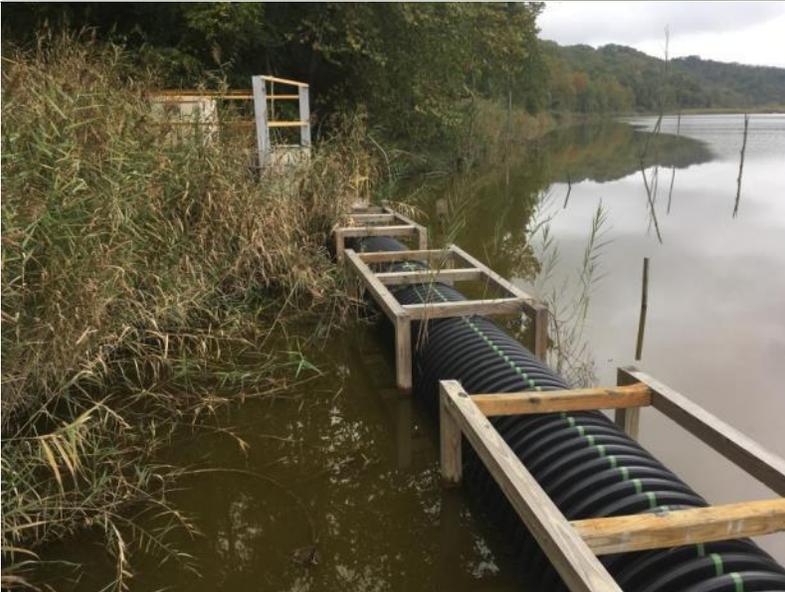
Photo No. 8

3. Photographs No. 8, 9 and 10 are an overview of the principal spillway decant structure. Vegetation control was observed to be satisfactory. The decant structure and the access stairway appeared to be functioning properly and was free of obstructions. Photograph No.8 shows the recently added pipe to allow for treatment of discharged water.

Landfill Runoff Collection Pond
Principal Spillway Structure.

Recently Added Pipe To allow
for treatment of discharged
water.

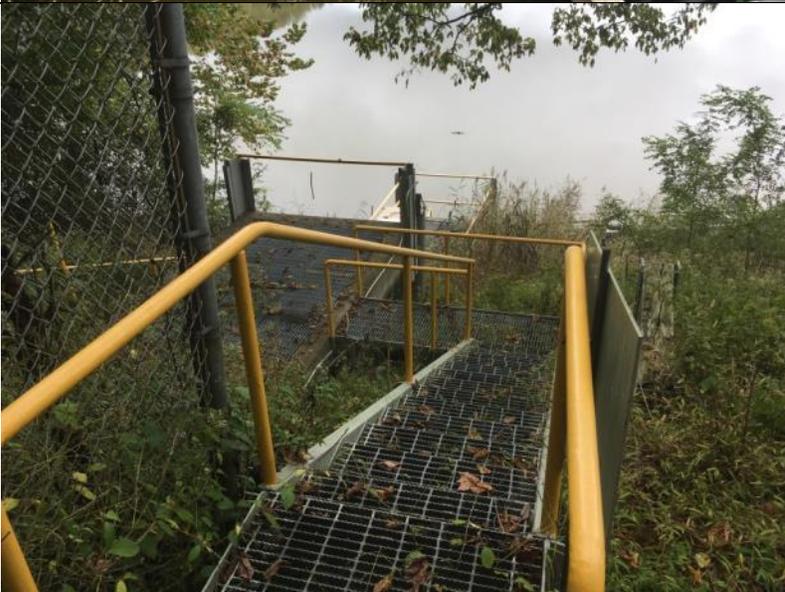
Photo No. 9

Landfill Runoff Collection Pond
Principal Spillway Structure.

Looking At Access Stairs
General Condition.

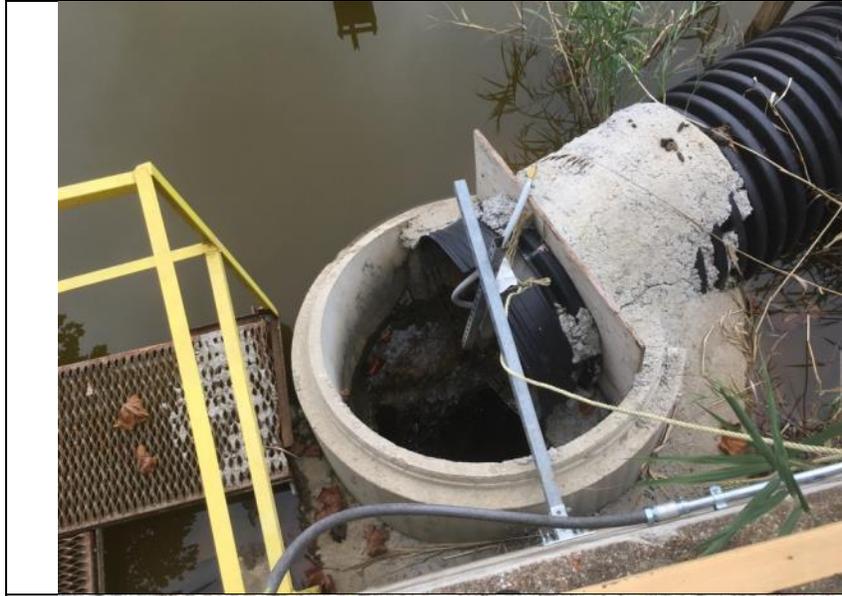
Photo No. 10

Landfill Runoff Collection Pond
Principal Spillway Structure.

Looking at Drop Inlet for
Treatment Pipe.

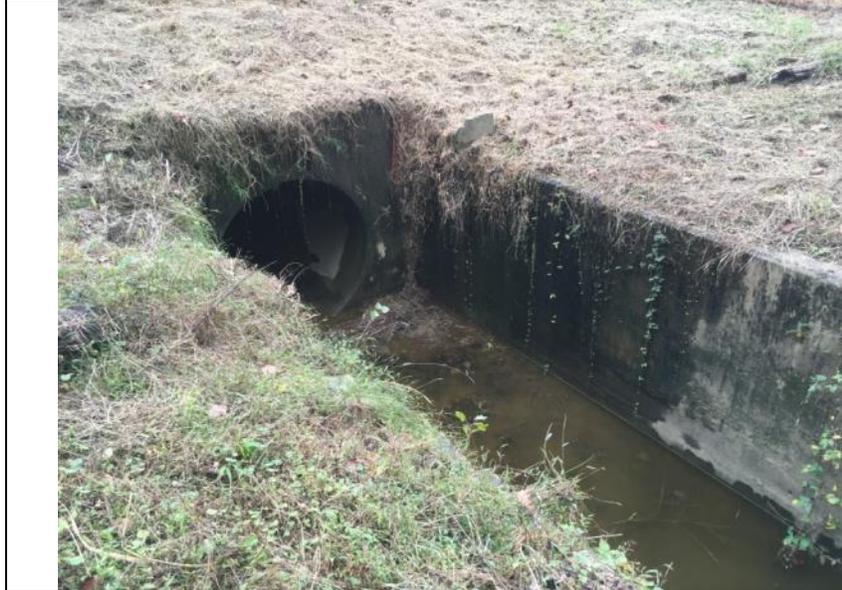
Photo No. 11

Landfill Runoff Collection Pond
Principal Spillway Outlet.

General Overview.

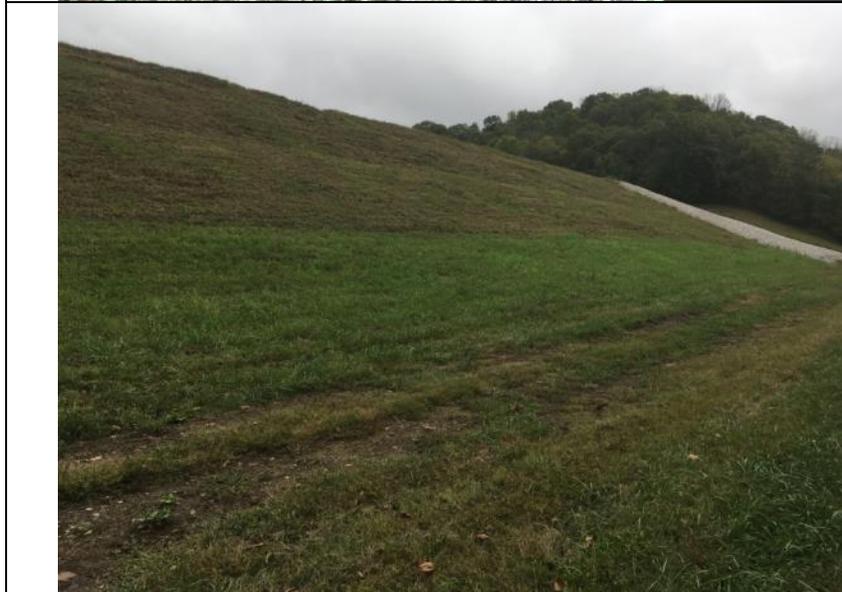
Photo No. 12

5. Photographs No's. 12 through 18 are all overviews of various areas of the exterior face of the dam as further described with each photograph. Throughout, vegetation control was adequate and there were no signs of sloughing, erosion or instability. No visible change was observed from previous inspections. In general, the exterior slope appeared to be in satisfactory and stable condition
6. Photograph No.13 and No. 14 shows the previously repaired slope area that experienced sloughing/slip near the left abutment. The repair also included installing a seepage collection pipe at the toe of rip rap placement. The pipe showed minimal flow at the time of inspection.

Landfill Runoff Collection Pond
Dam From Bottom of Saddle
Dam Looking Northeast.

General Overview.

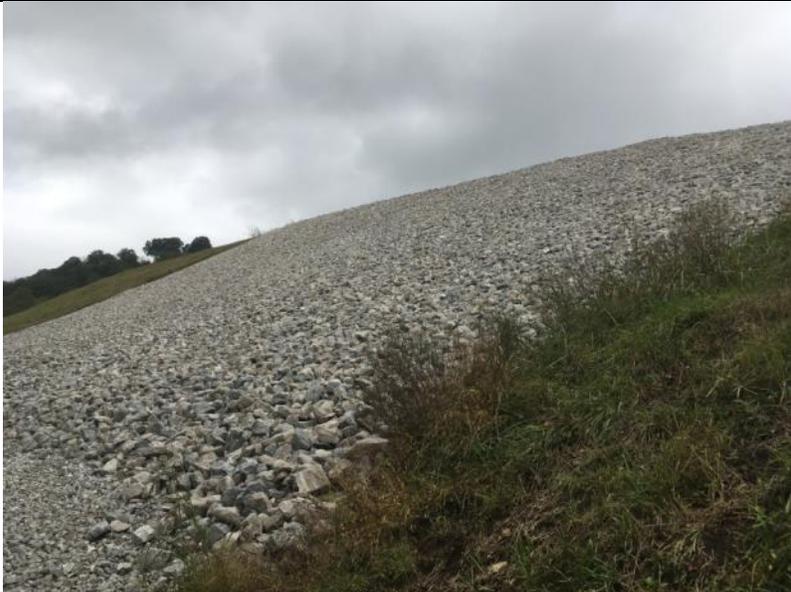
<p>Photo No. 13</p> <p>Landfill Runoff Collection Pond Dam From Bottom of Saddle Dam/Rip/Rap Interface.</p> <p>Localized Sloughing and Slips Were Repaired with a Rock Rip Rap Placement.</p>

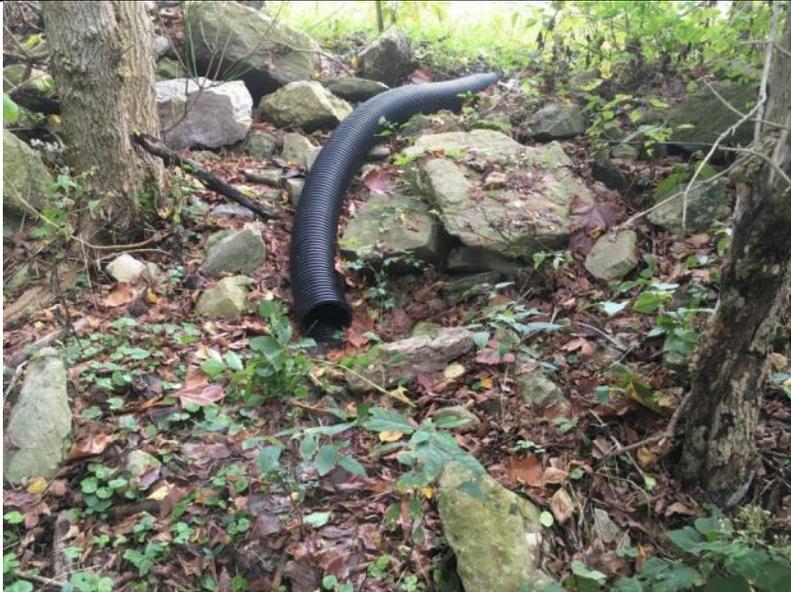
<p>Photo No. 14</p> <p>Landfill Runoff Collection Pond Dam Seepage Drain Pipe From Bottom of Rip/Rap Slope Area.</p> <p>General Conditions. Pipe Showed Minimal Flow.</p>

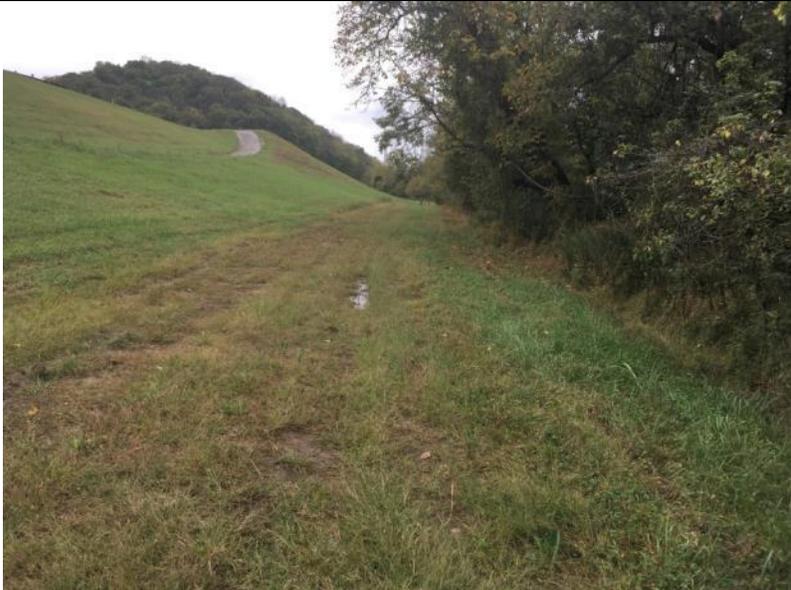
<p>Photo No. 15</p> <p>Landfill Runoff Collection Pond Dam From Roadway Leading to Crest Looking Northeast.</p> <p>General Overview.</p>

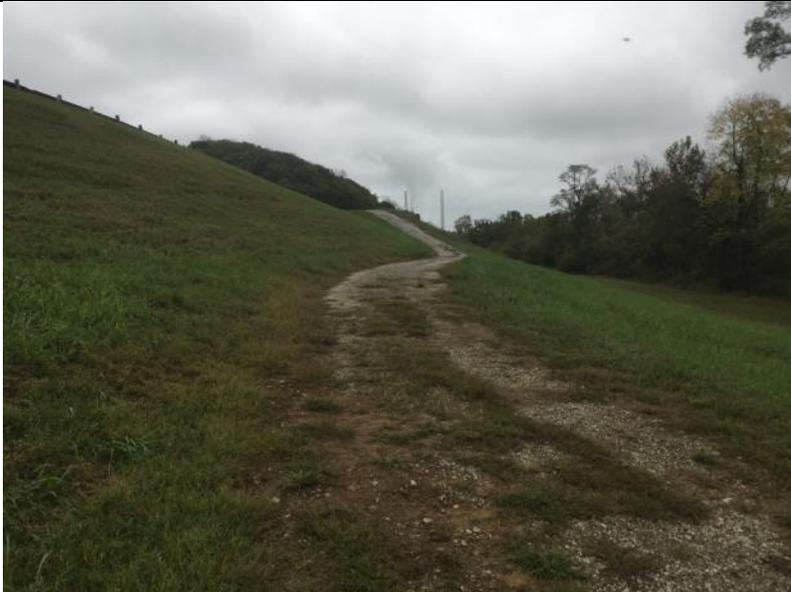
<p>Photo No. 16</p> <p>Landfill Runoff Collection Pond Dam Looking Up at Roadway Leading to Crest Area.</p> <p>General Overview</p>

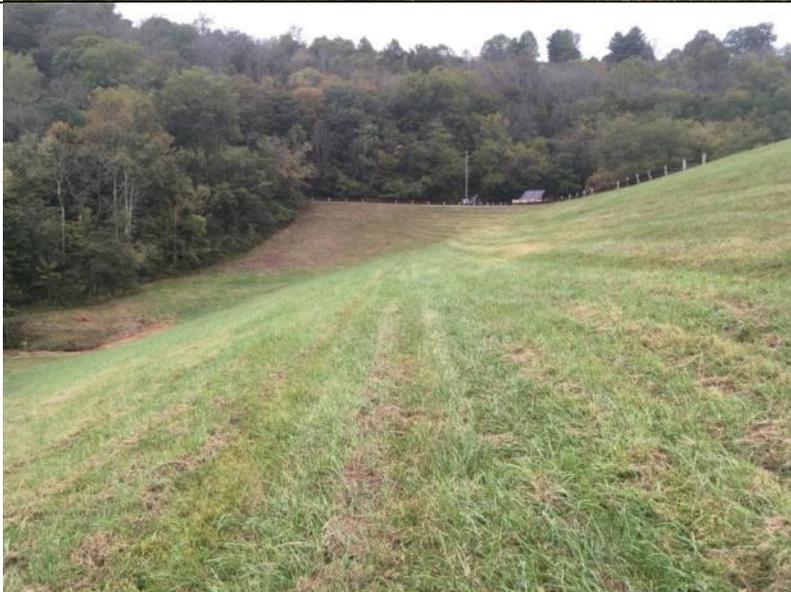
<p>Photo No. 17</p> <p>Landfill Runoff Collection Pond Dam Exterior Slope Looking Southwest.</p> <p>Overview of Vegetation and General Conditions.</p>

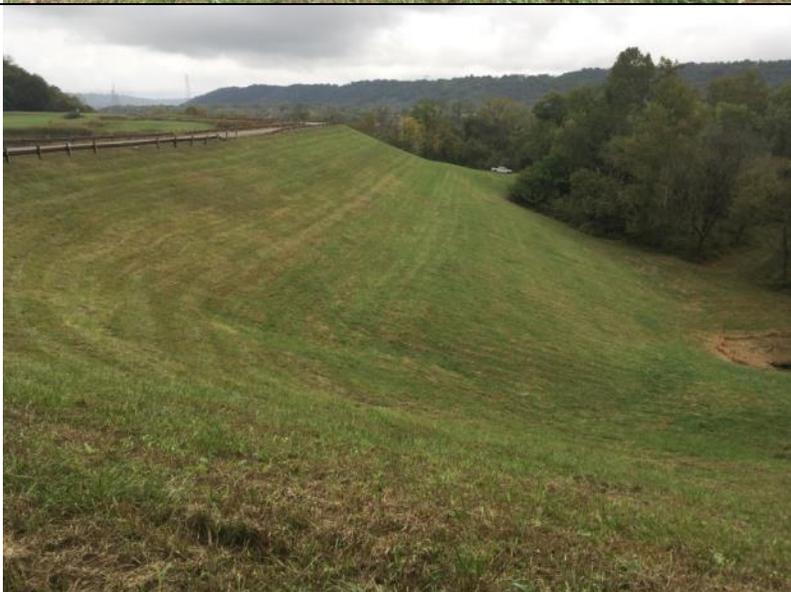
<p>Photo No. 18</p> <p>Landfill Runoff Collection Pond Dam Exterior Slope Looking From Top of Slope In Right Groin Looking East.</p> <p>Overview of Vegetation and General Conditions.</p>
