2018 ANNUAL DAM AND DIKE INSPECTION REPORT

**West Boiler Slag Pond
&
Landfill Runoff Collection Pond**

**CLIFTY CREEK PLANT
Indiana-Kentucky Electric Corporation
MADISON, INDIANA**

GERS-18-051

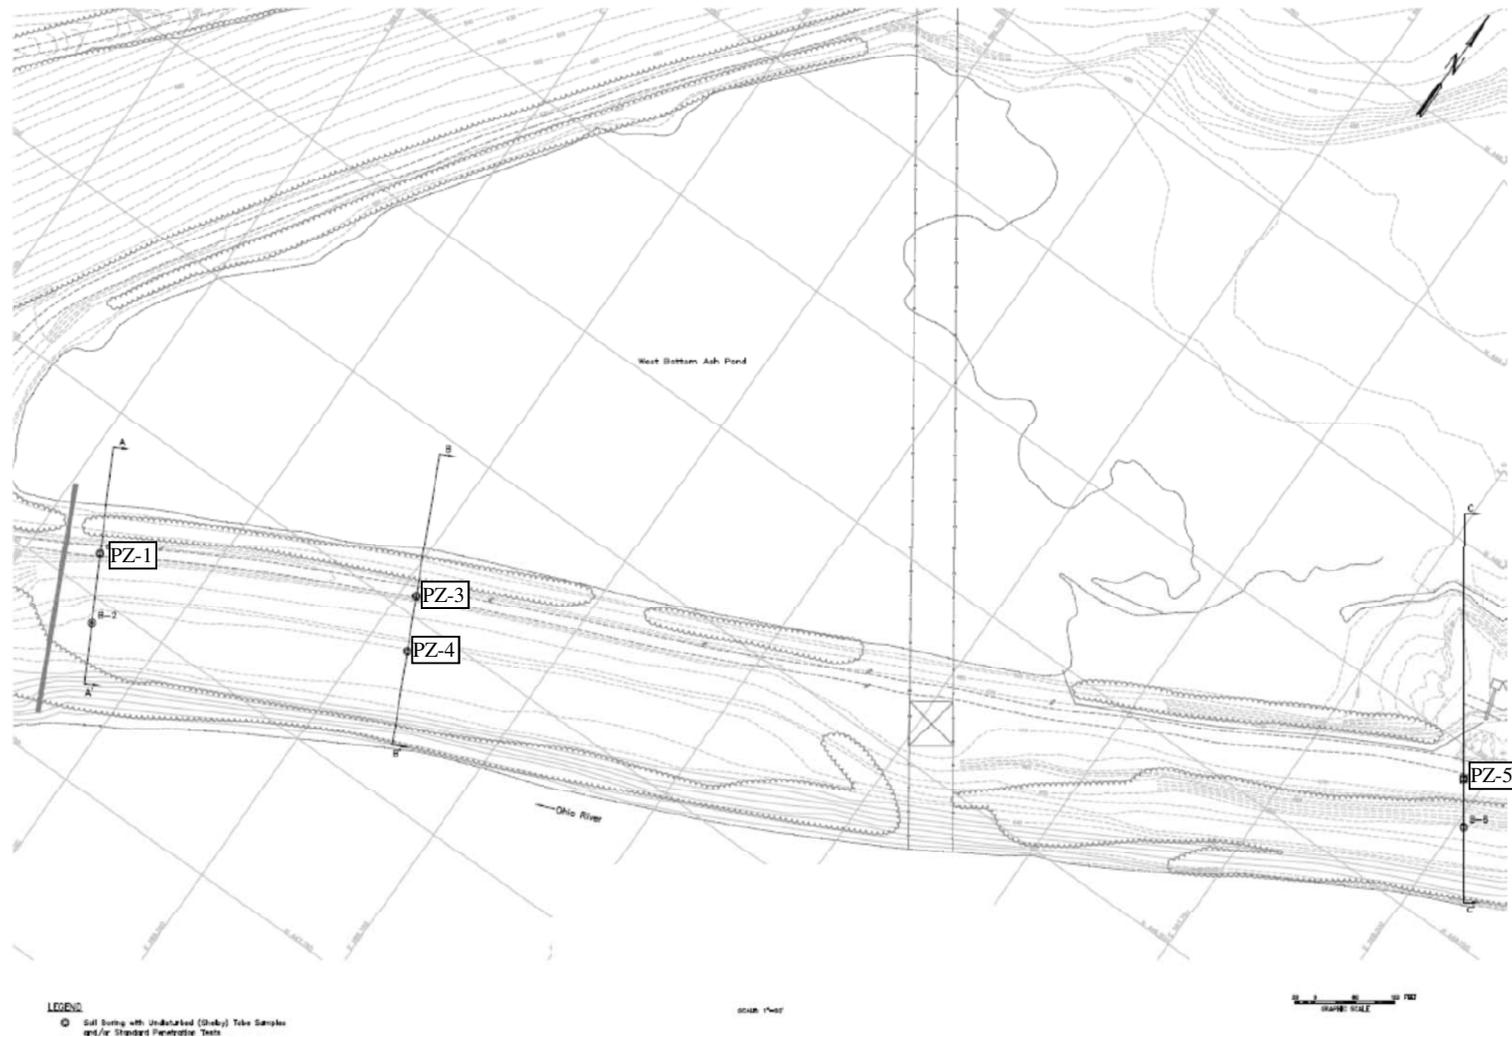
FIGURE 1. WEST BOILER SLAG POND INSTRUMENTS LOCATION PLAN

The location and type of instrumentation is shown on Figure 1. The results of the measurements of various piezometers since November 2015 are shown in Figure 2. The maximum recorded readings of each instrument since the previous annual inspection is shown in Table 1.

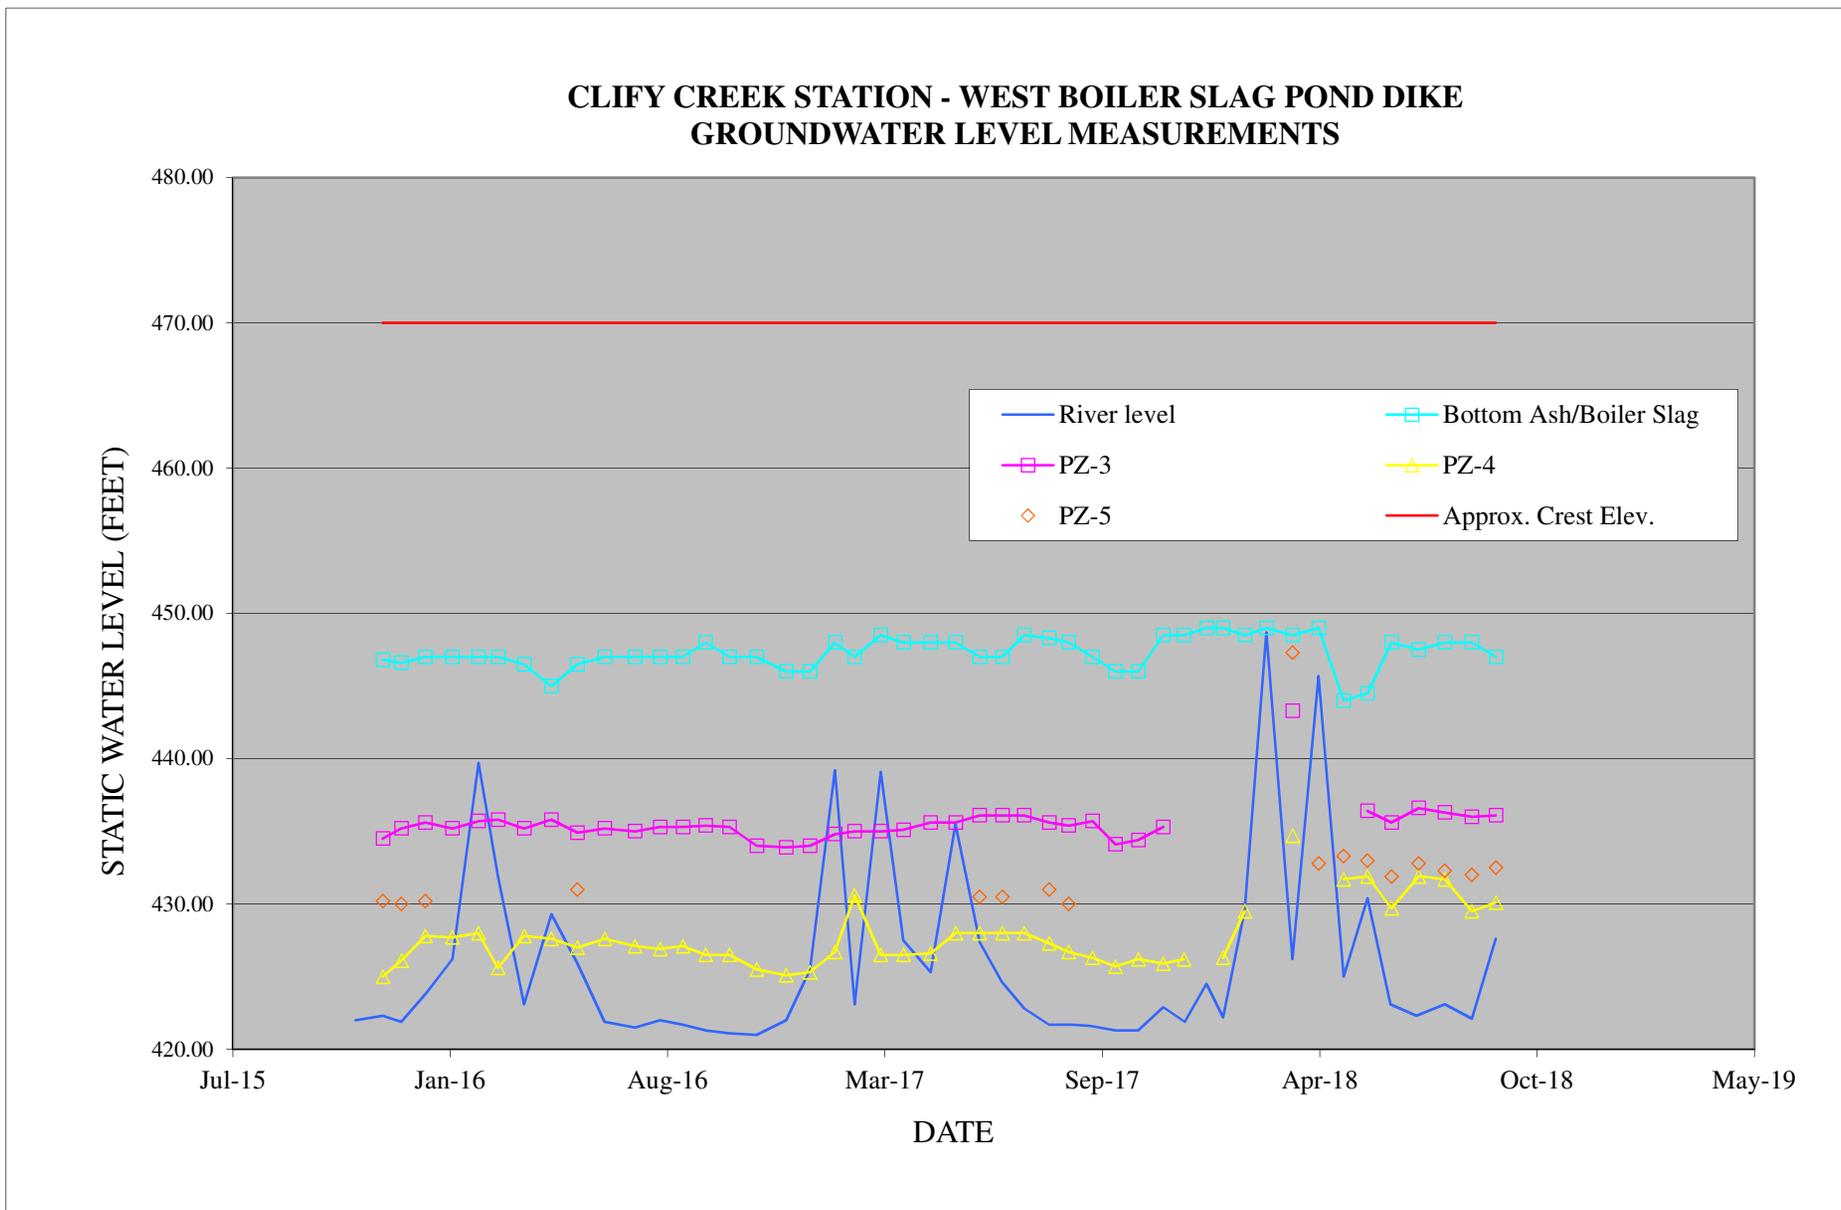
FIGURE 2. WEST BOILER SLAG POND GROUNDWATER LEVEL MEASUREMENTS

A review of the data contained on the WBSP static water elevation plot showed that all piezometers exhibit consistent water elevations. PZ-1 is a piezometer located at the crest of the constructed dike (shown as B-1 on location plan) which was dry for readings in 2018. PZ-2 is a piezometer located along a bench near the downstream toe of the constructed dike (shown as B-2 on location plan) which was damaged and abandoned. PZ-3 is a piezometer located at the crest of the constructed dike (shown as B-3 on location plan). PZ-4 is a piezometer located along a bench near the downstream toe of the constructed dike (shown as B-4 on location plan). PZ-5 is a piezometer located at the crest of the constructed dike (B-5 on location plan) and was dry for a few of the past 12 months readings, but there were several readings with water levels recorded. Review of the static water elevation plot

indicates that the static water levels for the piezometers and monitoring wells generally fluctuate as a result of the fluctuations in the pool and the river elevations.

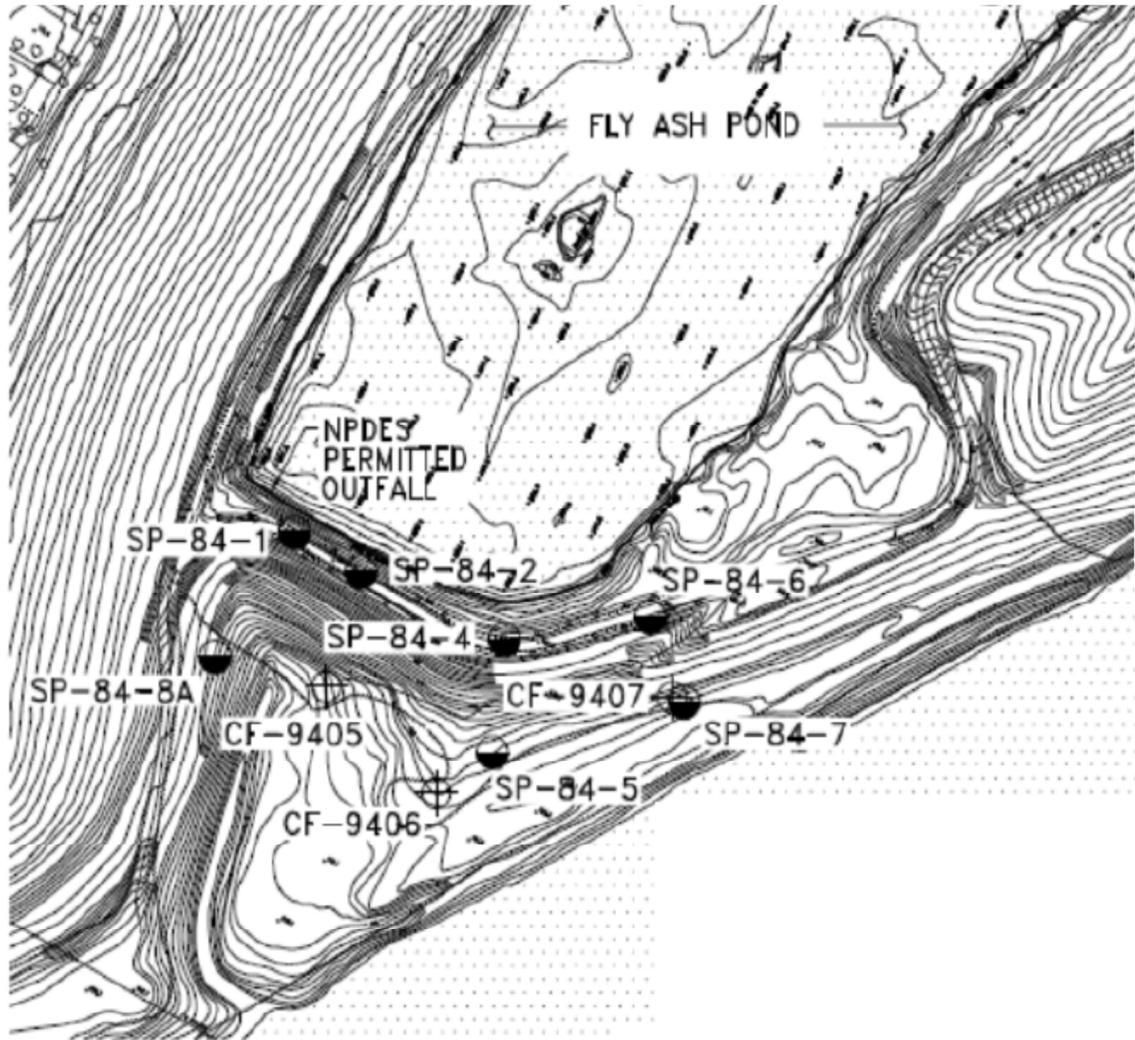
FIGURE 3. LANDFILL RUNOFF COLLECTION POND INSTRUMENTS LOCATION PLAN

The location and type of instrumentation is shown on Figure 3. The results of the measurements of various piezometers since November 2015 are shown in Figure 4. The maximum recorded readings of

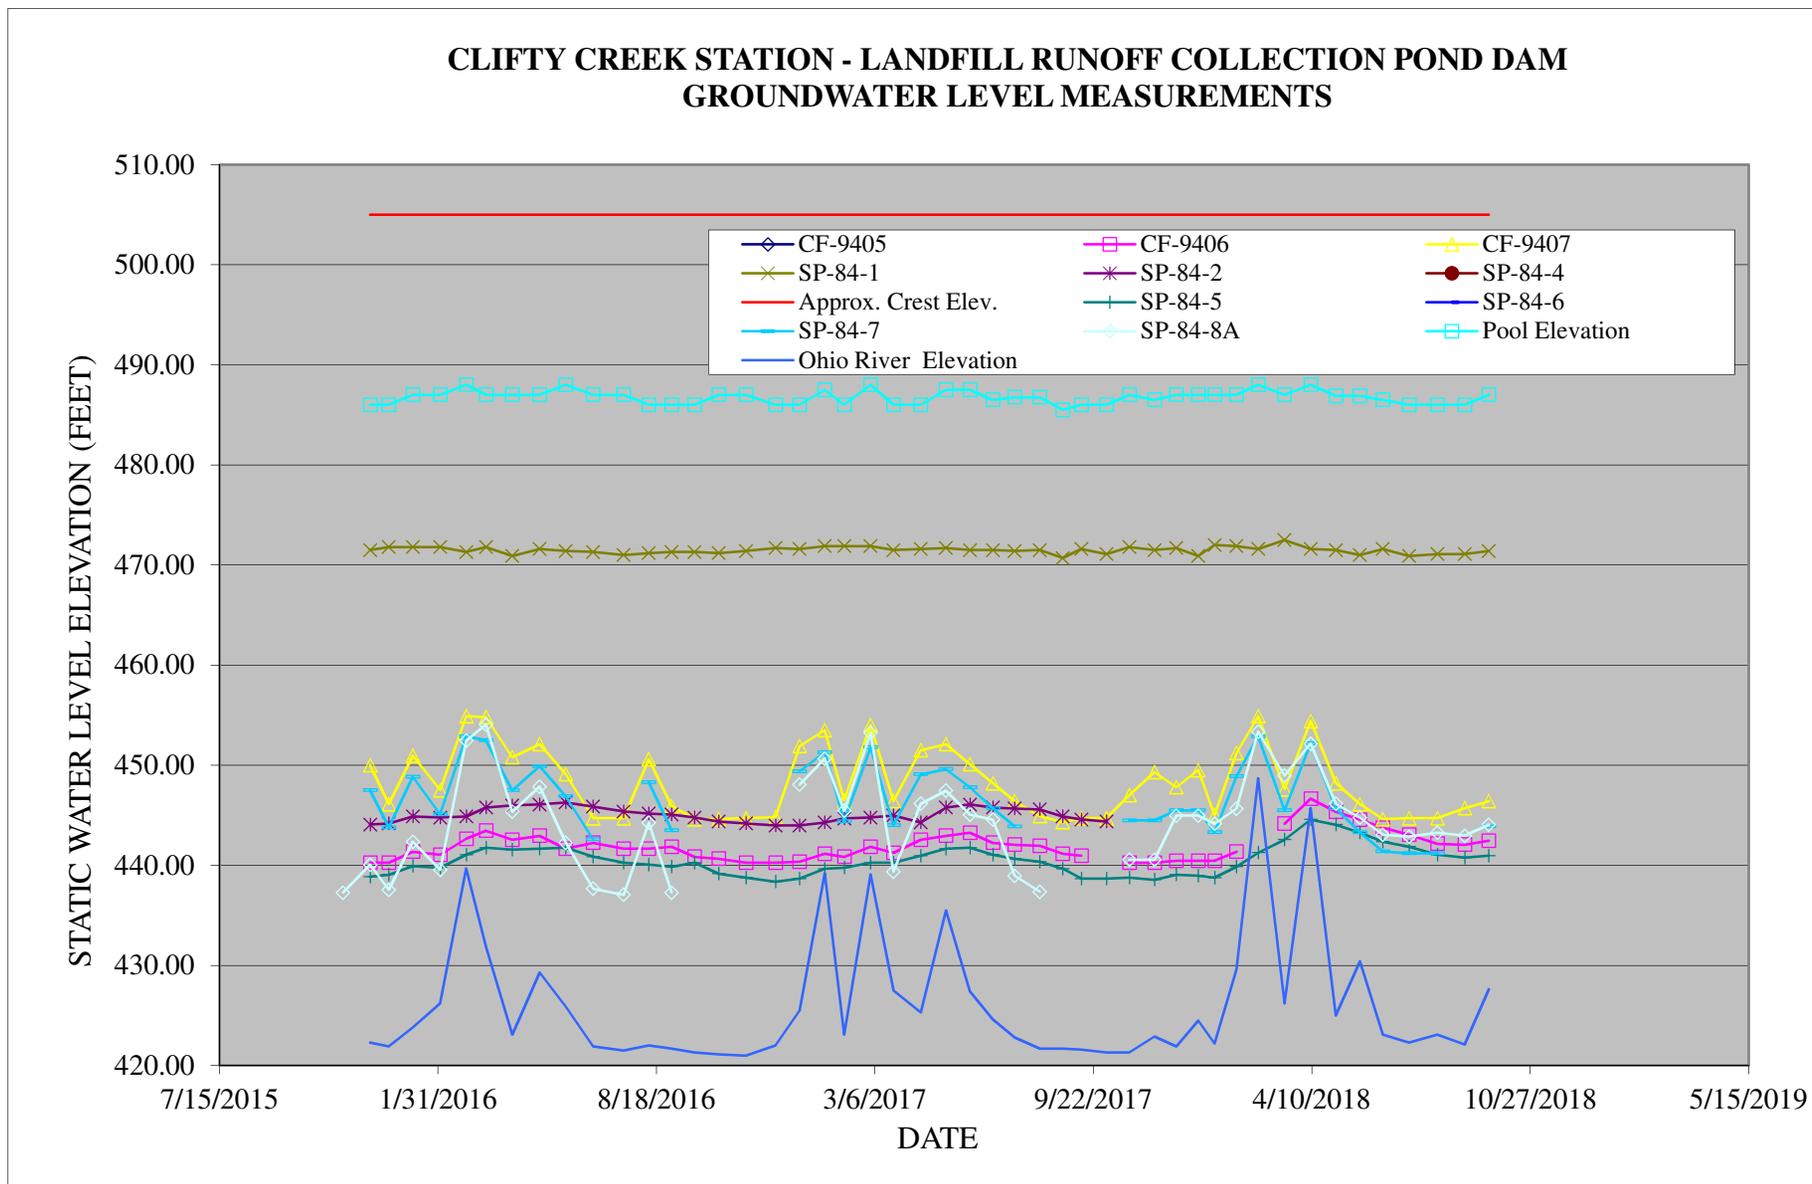
FIGURE 4. LANDFILL RUNOFF COLLECTION POND GROUNDWATER LEVEL MEASUREMENTS

A review of the LRCP static water elevation plot indicates that two of the piezometers (SP-84-1 and SP-84-6) located along the crest of the dam historically exhibit consistent water elevations. Review of the static water elevation plot indicates that the static water levels for the piezometers and monitoring wells generally fluctuate as a result of the fluctuations in the pool and the river elevations.

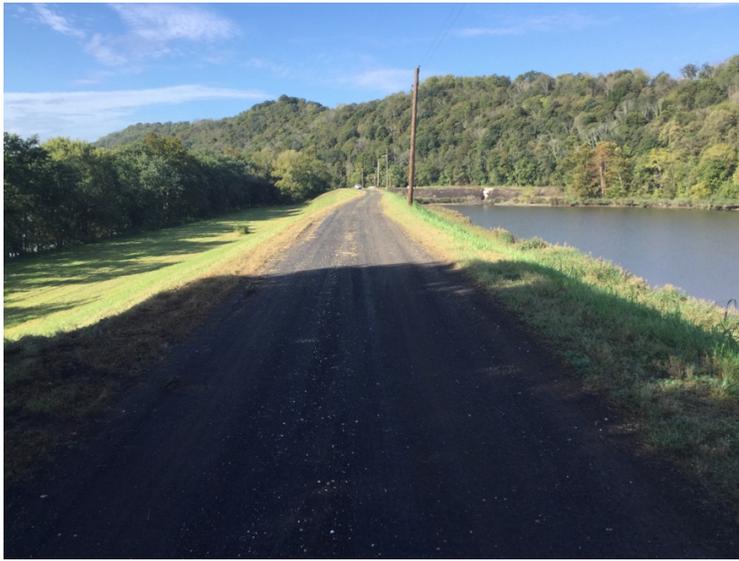
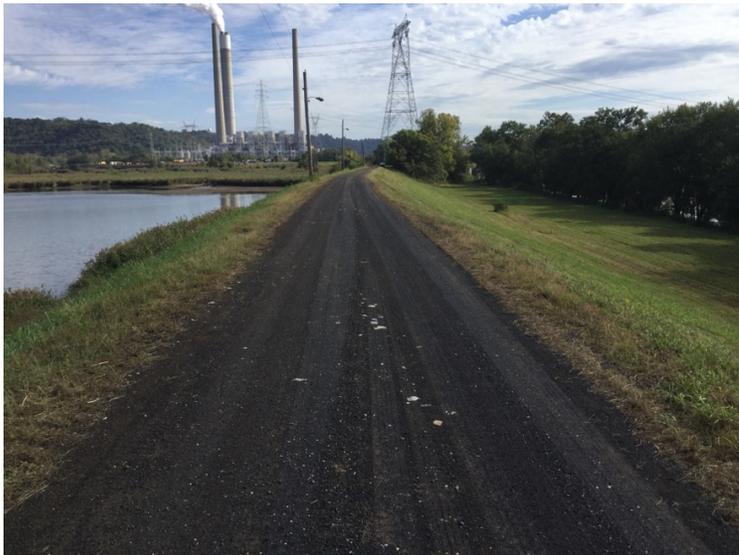
1. Photographs No. 1 and 2 illustrate a typical overview of the dike crest. The crest appears to be in good and stable condition. Signs of settlement, misalignment and cracking were not observed.

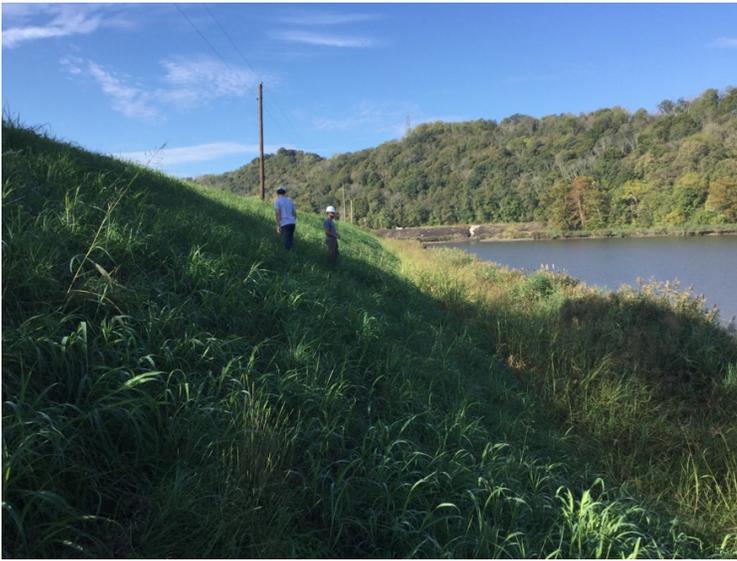
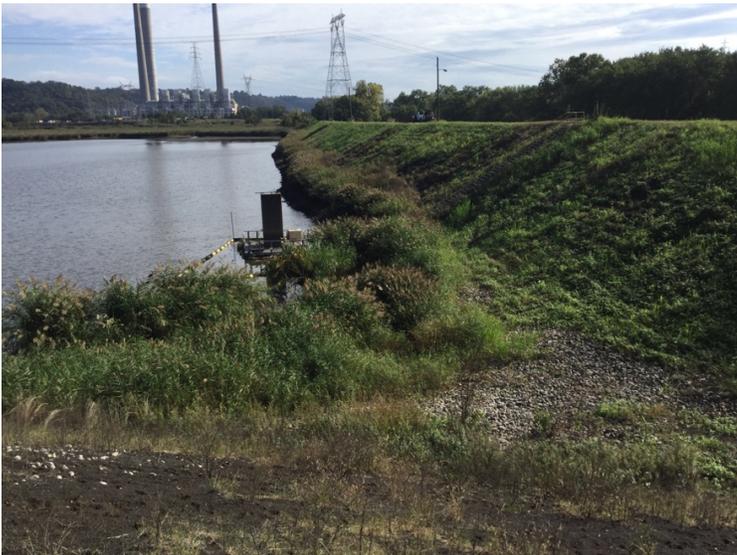
2. Photographs No. 3, and 4 illustrate the condition of the interior slopes at the settling end of the pond and the present extent of boiler slag buildup. The interior slope of the dike at this end of the pond appeared to be in satisfactory and stable condition.

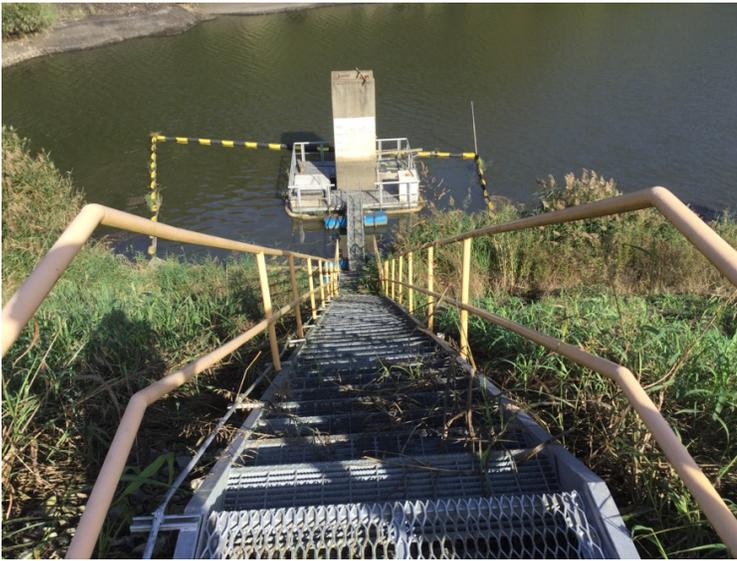
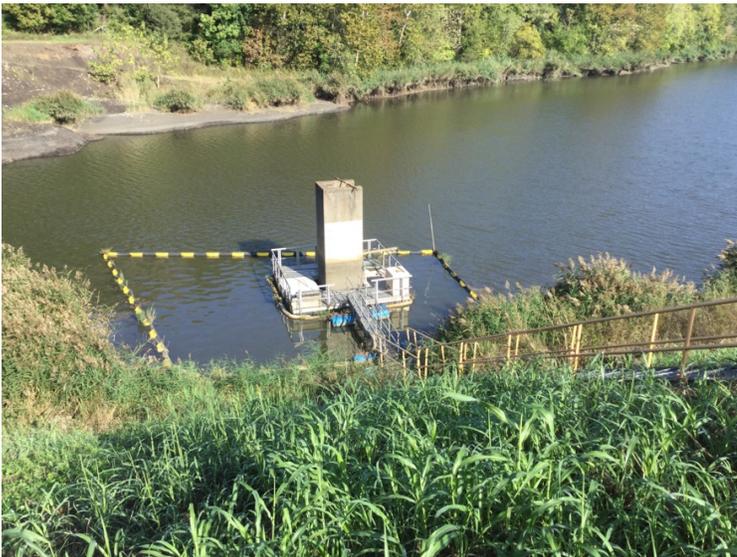
4. Photograph No. 5 shows the Principal Spillway and Decant Structure along with some localized overgrown vegetation near the access stairs and water line. The overflow structure appeared to be in satisfactory condition.

5. The overflow discharge structure walkway, railings, metal decking, and visible concrete were found to be in satisfactory, functional condition. However, there was some overgrown vegetation adjacent to the access stairs. Photographs No. 5 and 6 illustrate the access stairs, metal walkway, metal deck, and concrete structure of the overflow discharge structure.

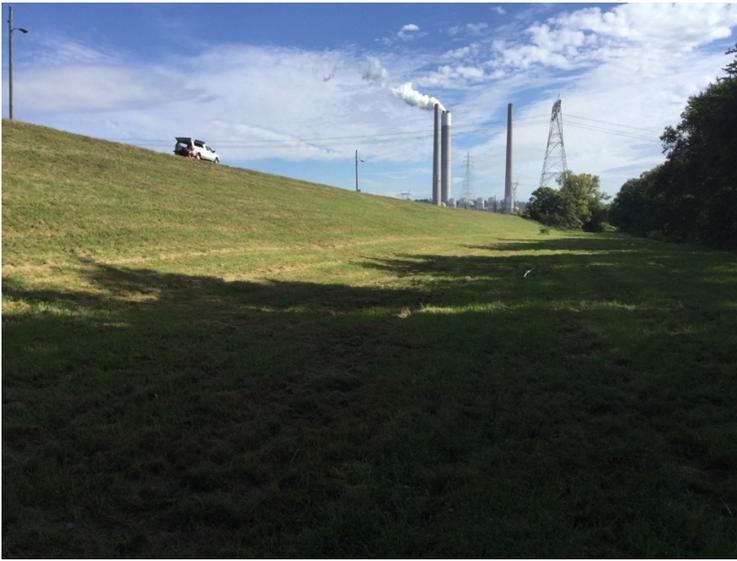
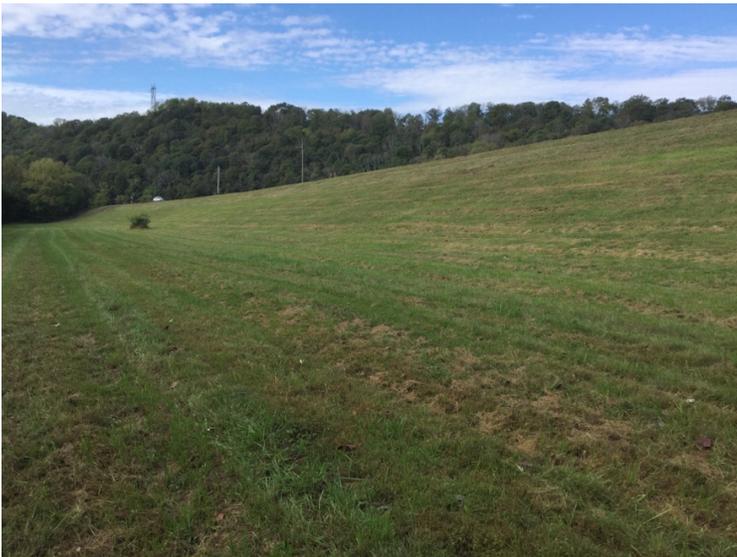
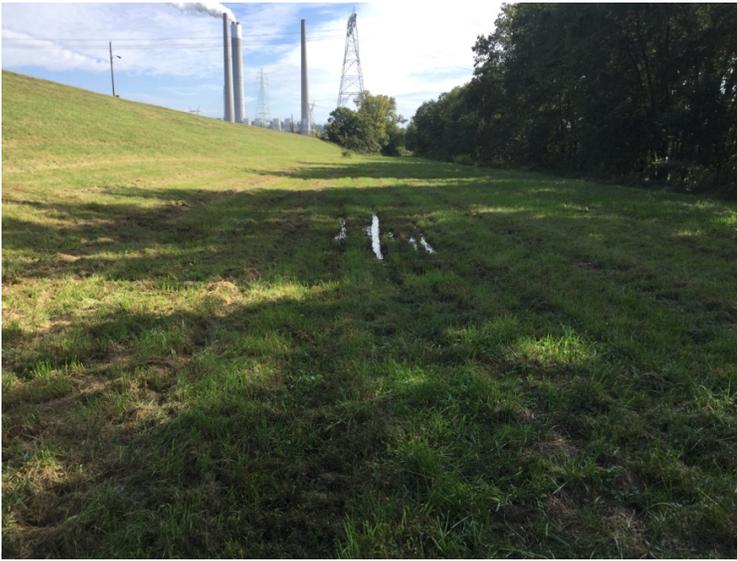
6. Photographs No. 7, 8 and 9 shows the general condition of the exterior slope and toe area of the south dike. The slope appeared in satisfactory and stable condition. There were no signs of settlement, misalignment, sloughing or erosion. No wet areas were noted during this inspection except along the toe area where it appears there was standing water in tire ruts caused from mowing activities.

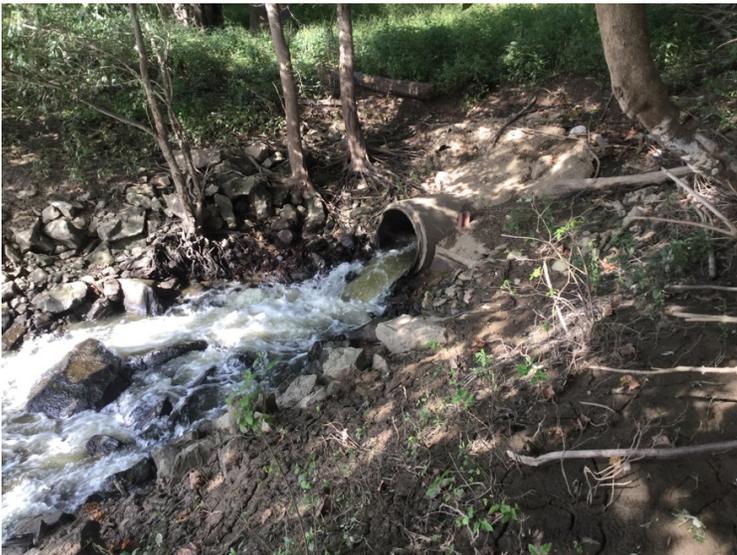
7. Photograph No. 10 shows the typical condition of the discharge pipe and outlet channel. Erosion at the confluence of the channel and the river was consistent with the conditions observed in the past years. The channel and outlet pipe were observed to be in good condition and were unobstructed and flowing steadily.

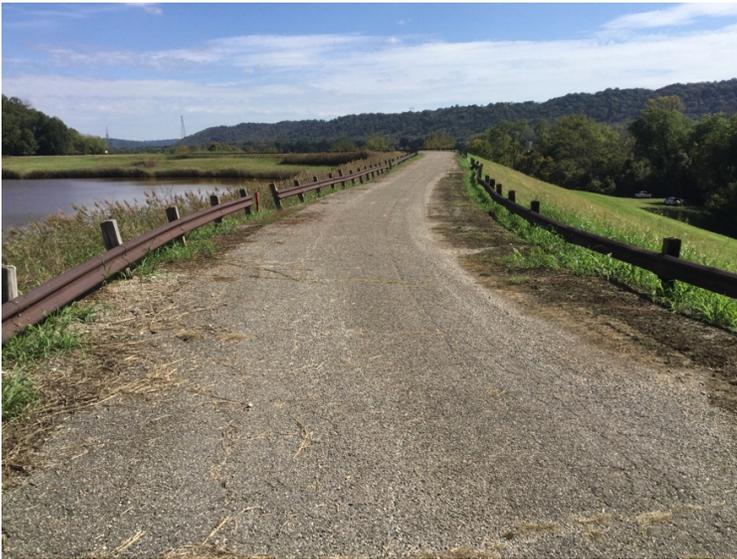
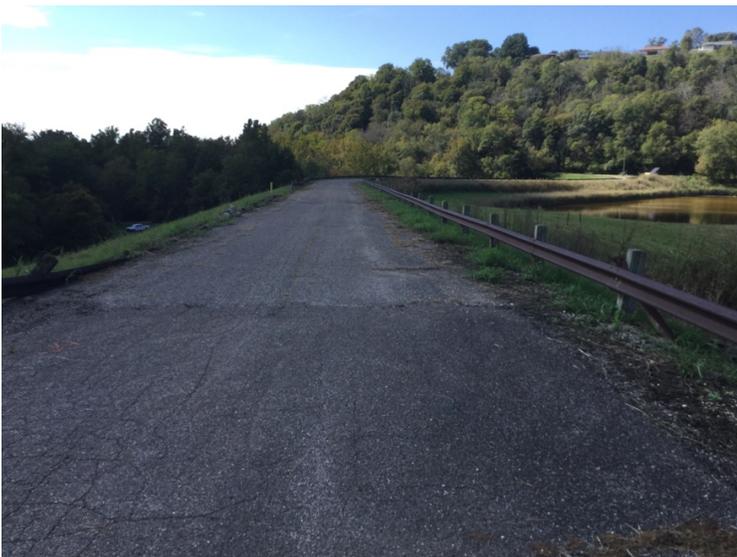
1. Photographs Nos. 1, and 2 show the generally condition of the crest of the dam. Signs of misalignment and settlement were not observed. Minor surface cracks in the pavement were observed. Those cracks are attributed to the age of the pavement and the effects from weathering.

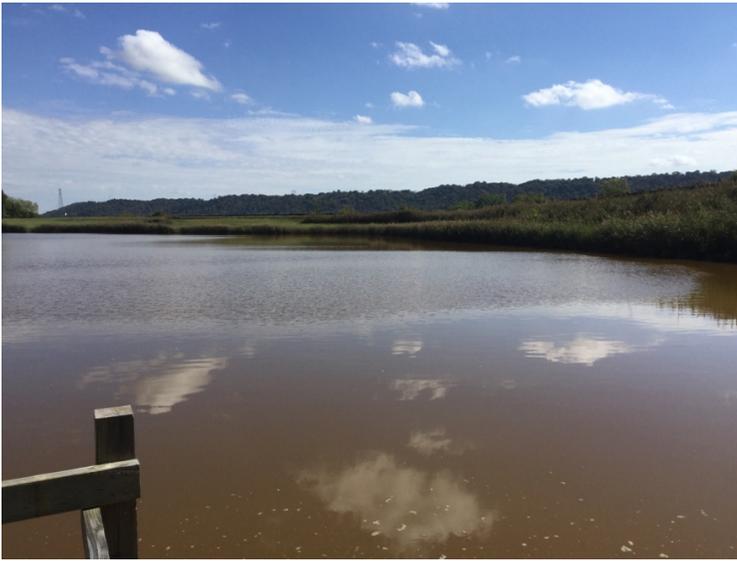
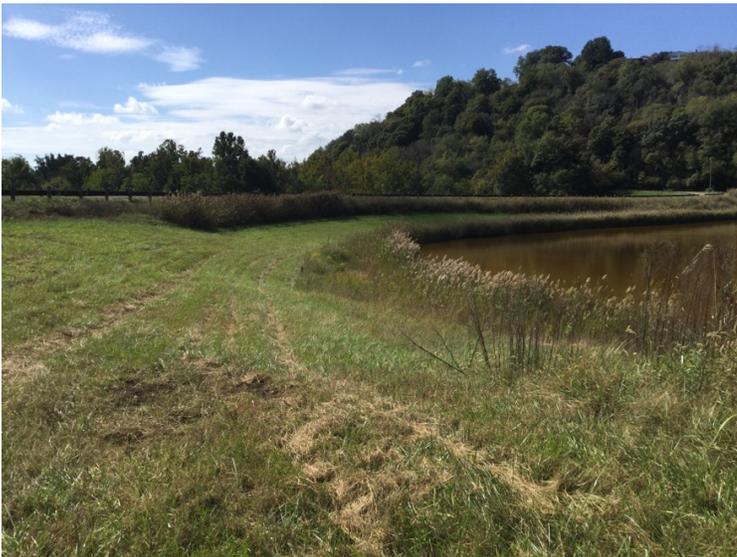
2. Photographs Nos. 3 and 4 provide overviews of the interior slope of the dam above the operating pool. Vegetation control near the water line and the upper slope areas is lacking, however, erosion due to wave action was not observed. Overall the slope was found to be in satisfactory and stable condition.

- Vegetation height was moderate to high on the inboard slopes of the LCRP near the top of the slope and at the water line. These areas should be maintained on a regular basis.
- The sloughing/slip area of the outside slope needs to be repaired and stabilized in order to prevent more significant damage to the slope area.

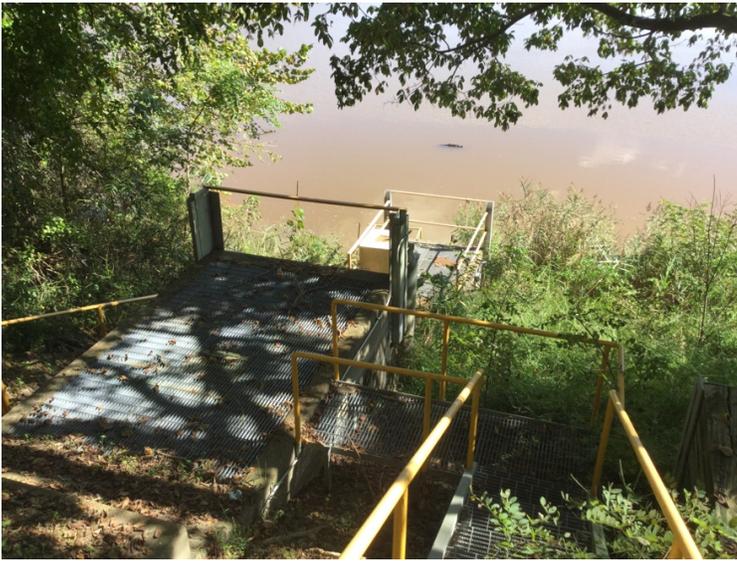
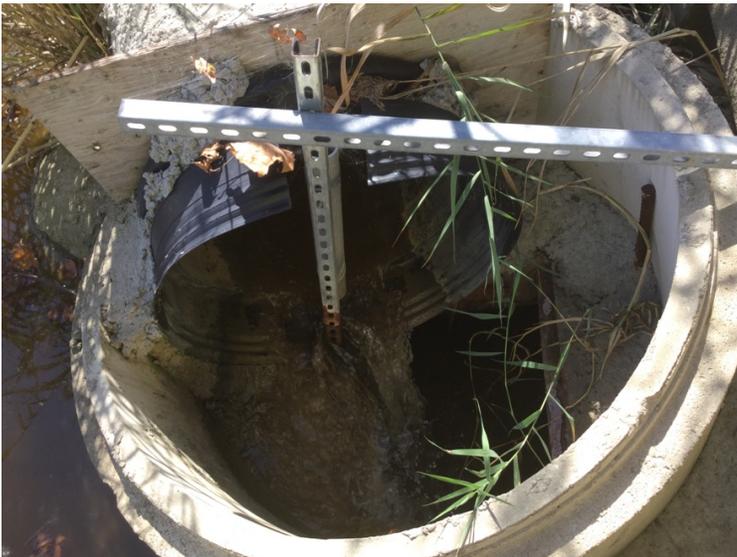
3. Photographs No. 5 and 6 are an overview of the principal spillway decant structure. Vegetation control was observed to be satisfactory. The decant structure and the access stairway appeared to be functioning properly and was free of obstructions. Photograph No.6 shows the recently added pipe to allow for treatment of discharged water.
