# 2019 ANNUAL DAM AND DIKE INSPECTION REPORT

**West Boiler Slag Pond  
& Landfill Runoff Collection Pond**

**CLIFTY CREEK PLANT  
Indiana-Kentucky Electric Corporation  
MADISON, INDIANA**

Document ID: GERS-22-003

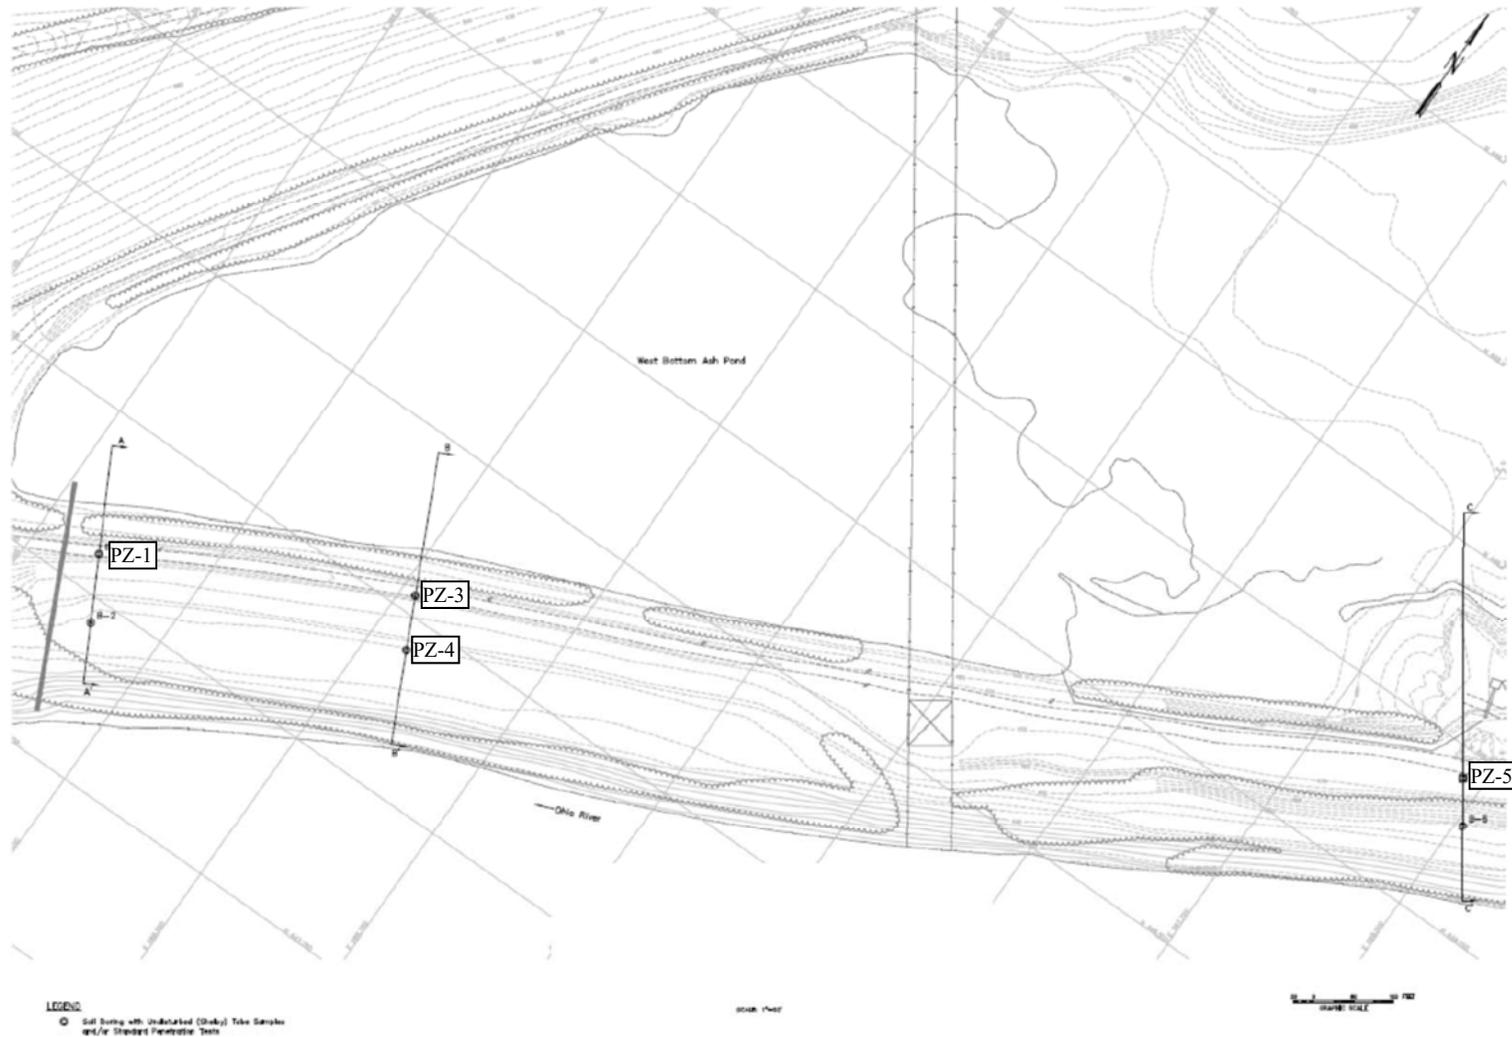
FIGURE 1. WEST BOILER SLAG POND PIEZOMETERS LOCATION PLAN

The location and type of instrumentation is shown on Figure 1. The results of the measurements of various piezometers since November 2015 are shown in Figure 2. The maximum recorded readings of each instrument since the previous annual inspection is shown in Table 1.

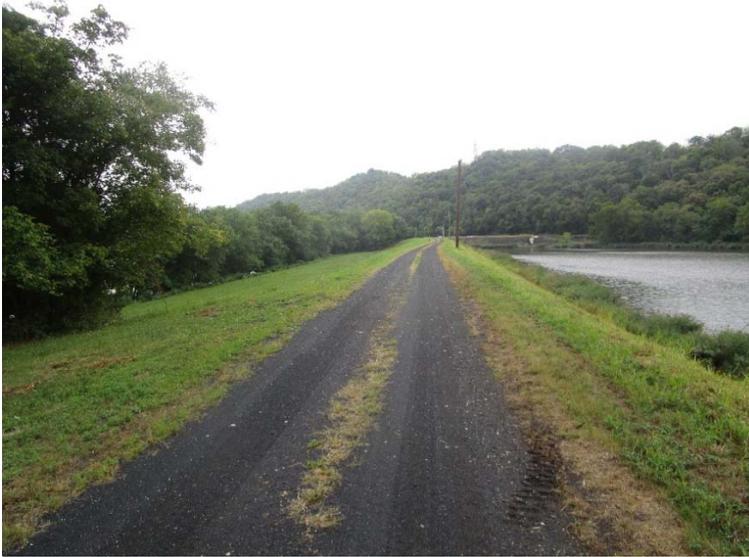
**Photo No. 1**

1. Photographs No. 1 and 2 illustrate a typical overview of the dike crest. The crest appears to be in good and stable condition. Signs of settlement, misalignment and cracking were not observed.

View of the erosion rills on the protective West Boiler Slag Pond Dike From Crest Looking Northeast

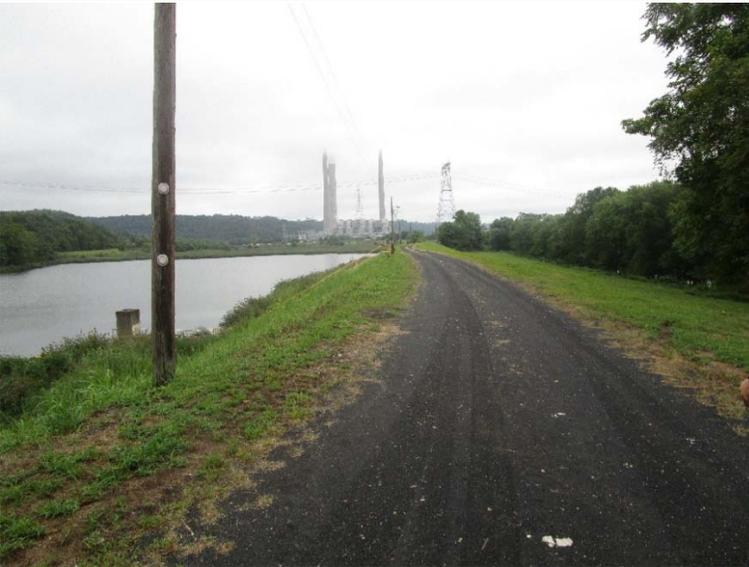
**Photo No. 2**

West Boiler Slag Pond Dike – Crest From Top Looking Northeast

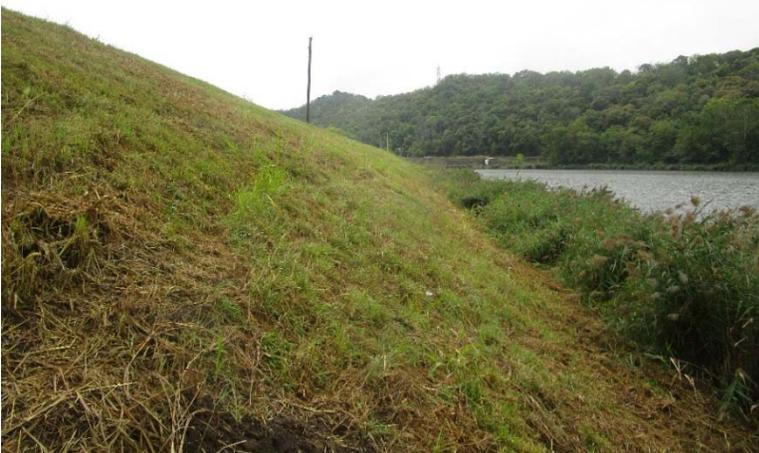
**Photo No. 3**

2. Photographs No. 3, and 4 illustrate the condition of the interior slopes at the settling end of the pond and the present extent of boiler slag buildup. The interior slope of the dike at this end of the pond appeared to be in satisfactory and stable condition.

3. There were a few locations where the use of the remotely controlled mower, appear to have caused disturbance to the inboard slope surfaces at areas where the soil is more granular.

West Boiler Slag Pond – Near South End of Interior Slope

Area where some surface disturbance caused by the remotely controlled mower

- An evaluation of the use of the remotely controlled mower, purchased by the plant indicates that the anchors in the tracks are apparently disturbing the inboard slopes at areas where soil is more granular. Weed wacking or other mowing techniques are suggested for these areas.
- Vegetation height was moderate at local areas on the inboard slopes of the WBSP (Photographs Nos. 4 and 6). These areas should be weed waked to prevent damage to the

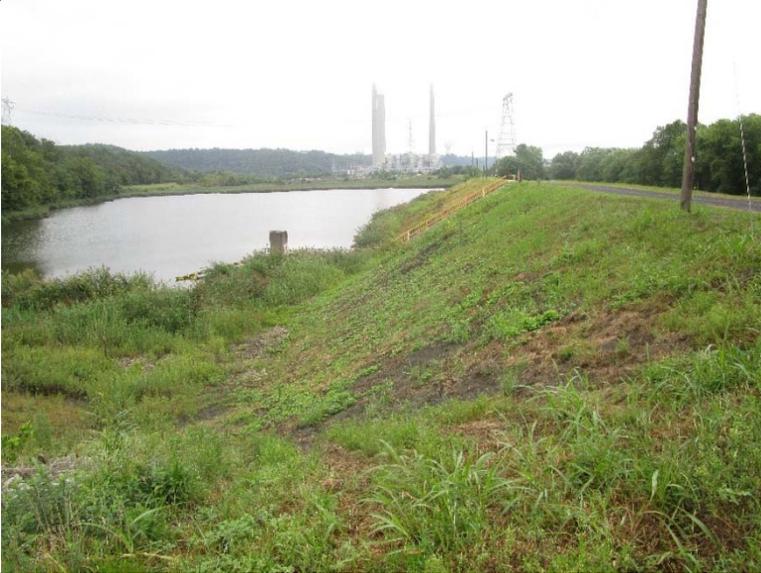
**Photo No. 4**

West Boiler Slag Pond Dike –  
Interior Slope Looking Northeast  
From Crest.

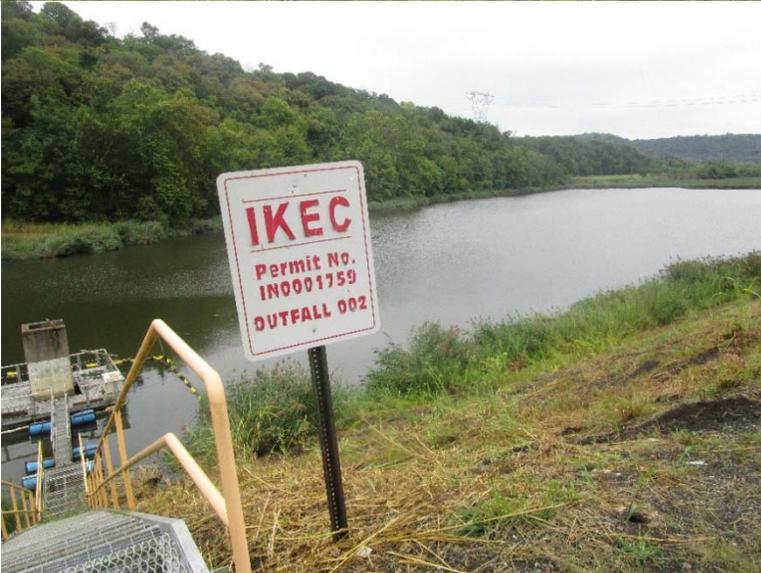
**Photo No. 5**

4. Photograph No. 5 shows the Principal Spillway and Decant Structure along with some localized overgrown vegetation near the access stairs and water line. The overflow structure appeared to be in satisfactory condition.

5. The overflow discharge structure walkway, railings, metal decking, and visible concrete were found to be in satisfactory, functional condition. However, there was some overgrown vegetation adjacent to the access stairs. Photographs No. 5 and 6 illustrate the access stairs, metal walkway, metal deck, and concrete structure of the overflow discharge structure.

West Boiler Slag Pond Principal  
Spillway Access Stairs and Decant  
Structure

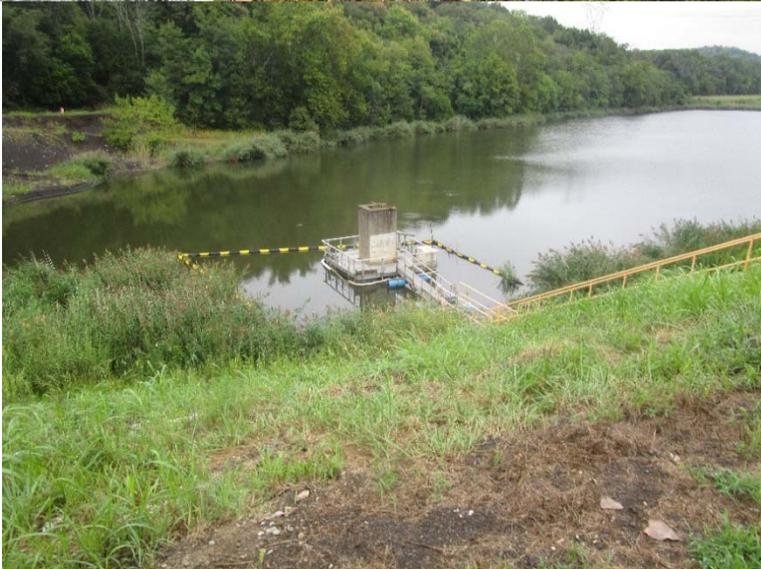
**Photo No. 6**

West Boiler Slag Pond Dike –  
Interior Slope Looking Northwest  
From Crest

Overview of General Condition  
Local Vegetation growth

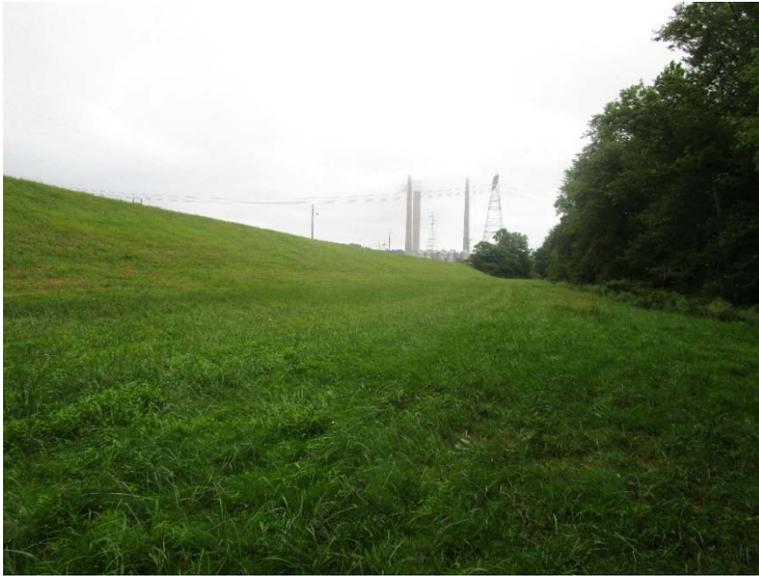
**Photo No. 7**

6. Photographs No. 7, 8 and 9 shows the general condition of the exterior slope and toe area of the south dike. The slope appeared in satisfactory and stable condition. There were no signs of settlement, misalignment, sloughing or erosion. No wet areas were noted during this inspection except along the toe area where it appears there was standing water in tire ruts caused from mowing activities.

West Boiler Slag Pond Dike –  
Exterior Slope From Toe Looking  
East

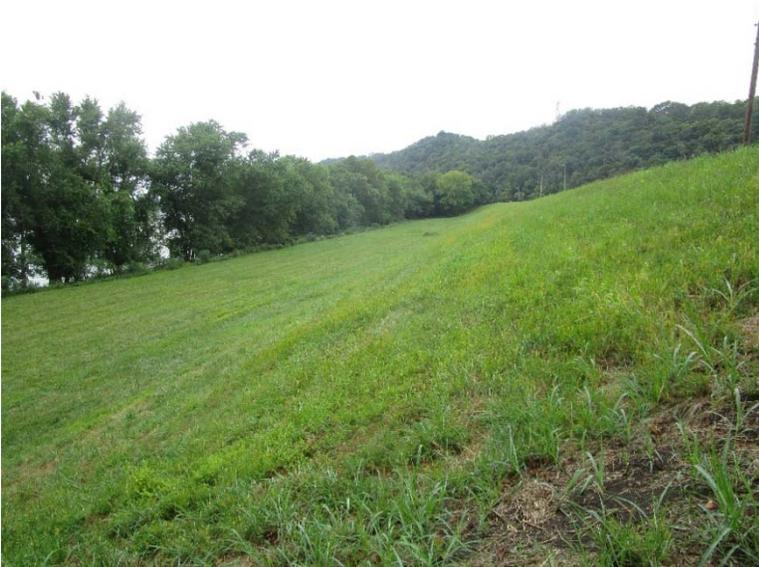
**Photo No. 8**

West Boiler Slag Pond Dike  
Exterior Slope From Toe Looking  
Southwest

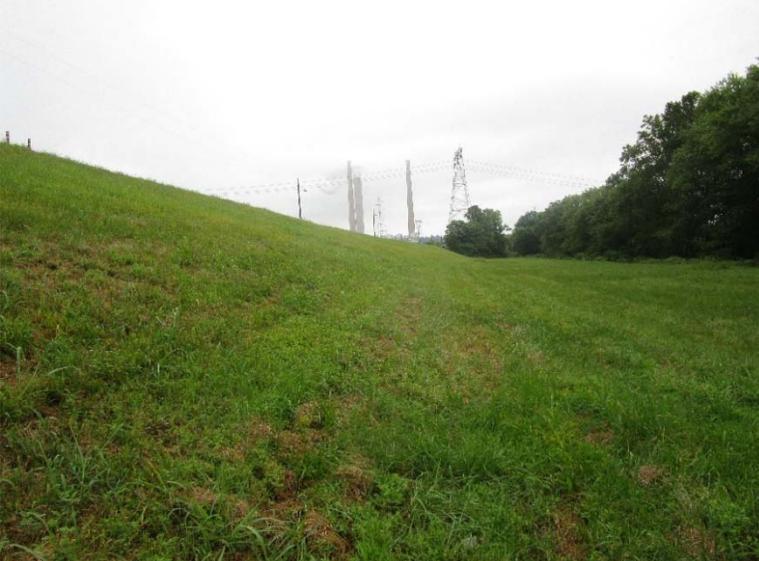
**Photo No. 9**

West Boiler Slag Pond Dike –  
Exterior Slope From Toe Looking  
East

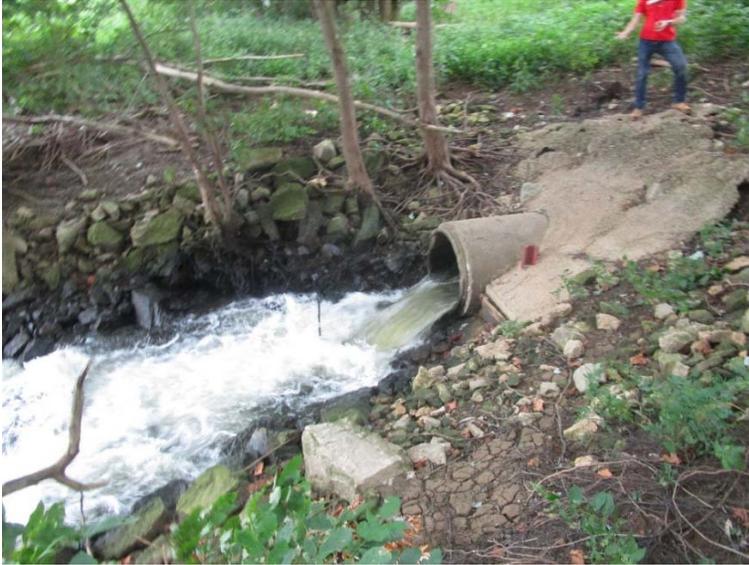
**Photo No. 10**

7. Photograph No. 10 shows the typical condition of the discharge pipe and outlet channel. Erosion at the confluence of the channel and the river was consistent with the conditions observed in past years. The channel and outlet pipe were observed to be in good condition and were unobstructed and flowing steadily.

West Boiler Slag Pond Principal Spillway Pipe Discharge

General Condition of End of Pipe and Outlet Channel

Some wood debris carried by the river during flooding events

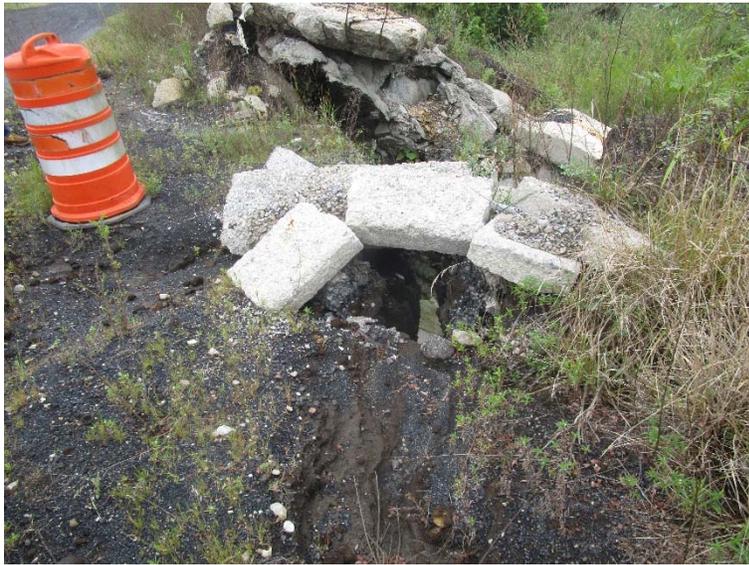
**Photo No. 11**

8. Significant Erosion along the Inboard slope few hundred feet from the inlet pipes. Erosion is taking place in an area with a very wide crest and does not constitute yet a detrimental condition to the integrity of the structure.

West Boiler Slag Inboard slope close to the Inlet Channel

Significant Erosion along the Inboard slope close to the Inlet Channel. Erosion is taking place in an area with a very wide crest and does not constitute detrimental conditions.

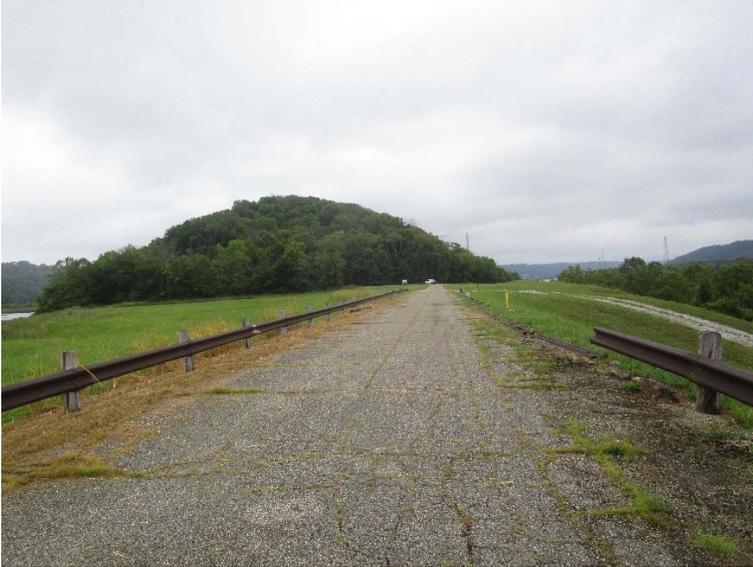
**Photo No. 1**

1. Photographs Nos. 1, and 2 show the generally condition of the crest of the dam. Signs of misalignment and settlement were not observed. Minor surface cracks in the pavement were observed. Those cracks are attributed to the age of the pavement and the results of weathering process.
2. Photographs Nos. 3 and 4 provide overviews of the interior slope of the dam above the operating pool. Vegetation control near the water line and the upper slope areas is lacking, however, erosion due to wave action was not observed. Overall the slope was found to be in satisfactory and stable condition.

Landfill Runoff Collection Pond Dam  
From Crest Looking Northeast Across  
Saddle Dam

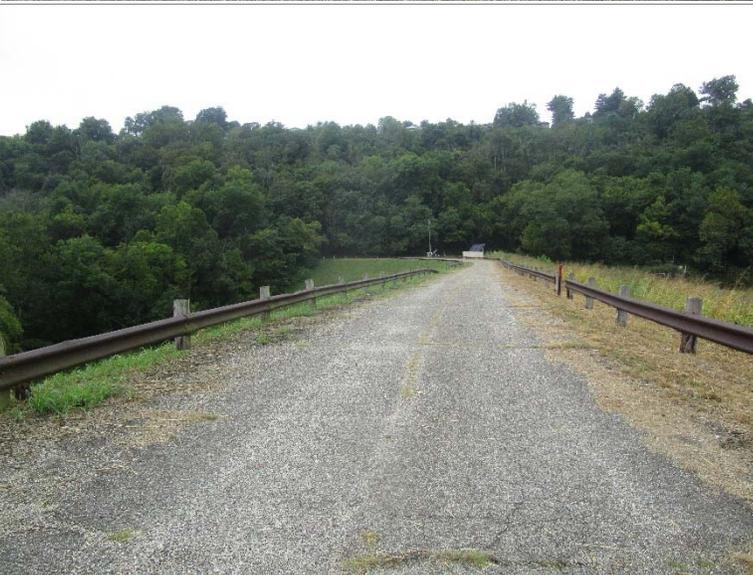
**Photo No. 2**

Landfill Runoff Collection Pond Dam  
From Crest Looking Southwest

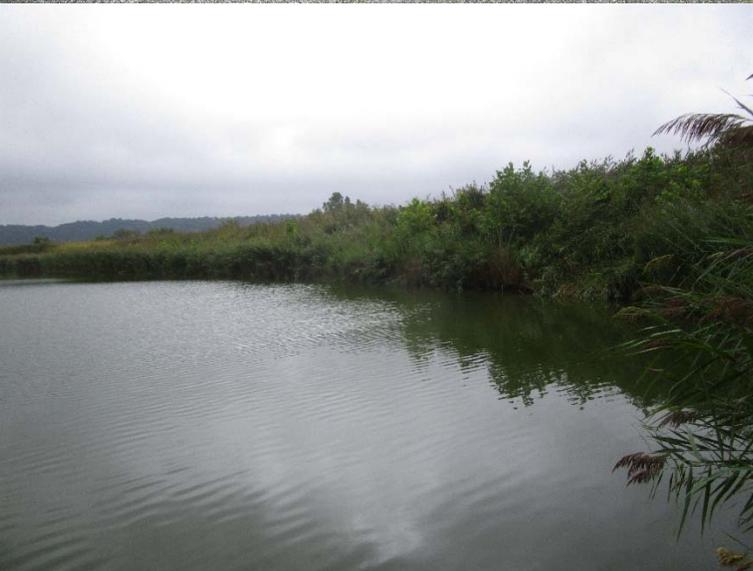
**Photo No. 3**

Overview of Current Operating Pool and  
Vegetation Conditions on Interior Slope.

Significant vegetation Growth along the  
Upstream of Dam

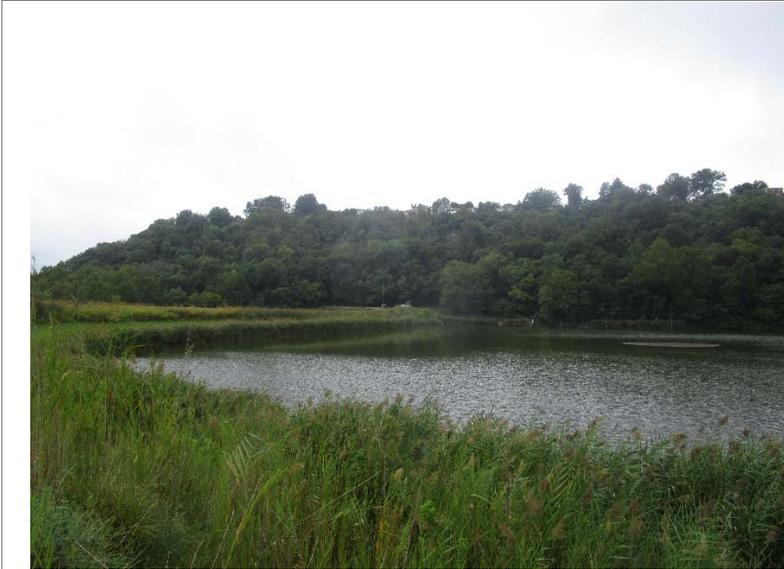
**Photo No. 4**

Landfill Runoff Collection Pond Dam  
From Up Stream Slope

Overview of Vegetation and General  
Conditions

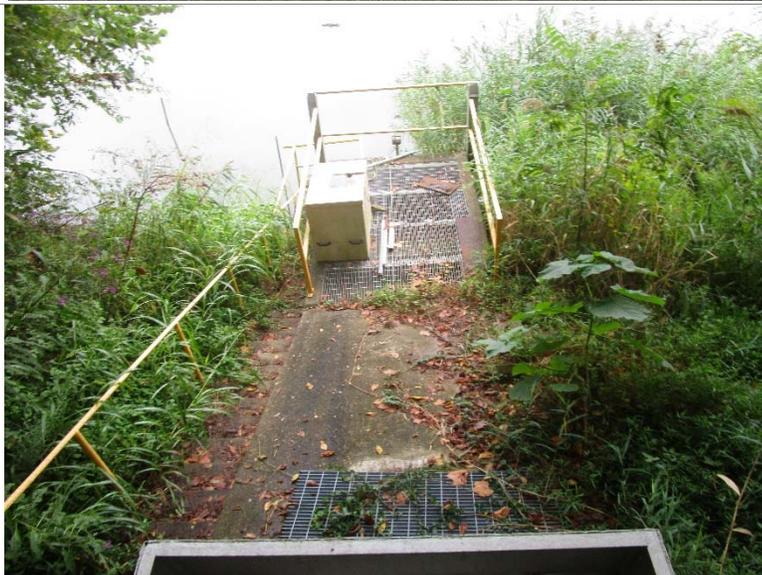
**Photo No. 5**

3. Photographs No. 5 and 6 are an overview of the principal spillway decant structure. Vegetation control was observed to be lacking. The decant structure and the access stairway appeared to be functioning properly and was free of obstructions. Photograph No.6 shows the recently added pipe to allow for treatment of discharged water.

Landfill Runoff Collection Pond Dam  
From Roadway Leading to Crest Looking  
Northeast

Overview of Vegetation Management and  
General Condition-overgrown vegetation.

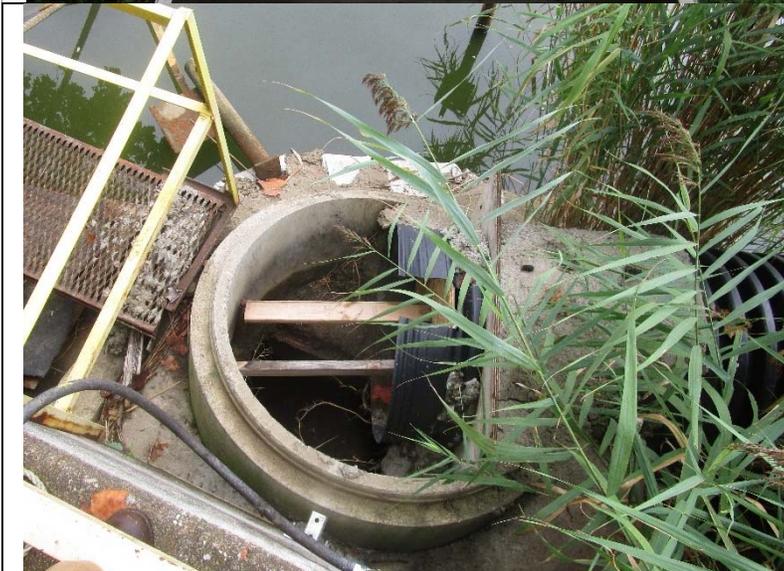
**Photo No. 6**

Landfill Runoff Collection Pond  
Principal Spillway Structure

Looking at drop inlet for  
treatment pipe.  
-overgrown vegetation

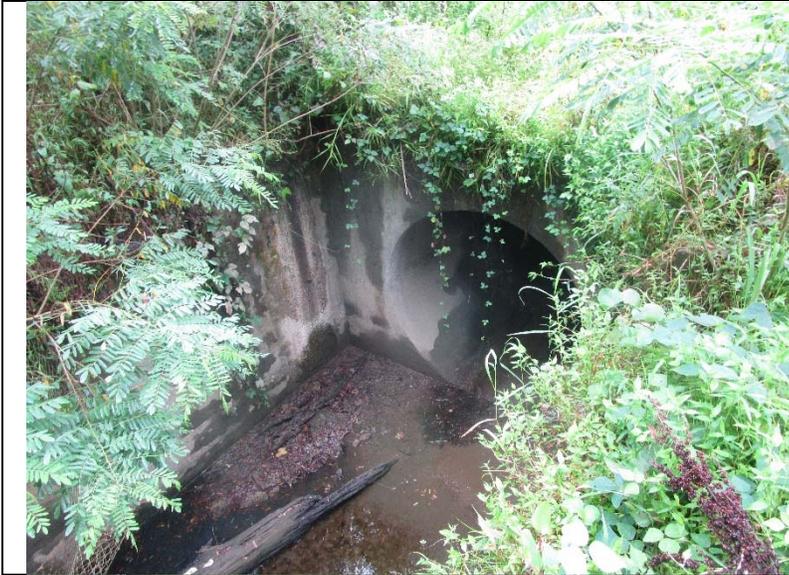
**Photo No. 7**

4. Photograph Nos. 7 and 8 is an overview of the principal spillway outlet channel. The channel is unobstructed with minimal flow at the time of the inspection. Vegetation control was observed to be lacking.

Landfill Runoff Collection Pond  
Principal Spillway Outlet

General Overview –Backwater has been minimized since last inspection.  
Overgrown vegetation

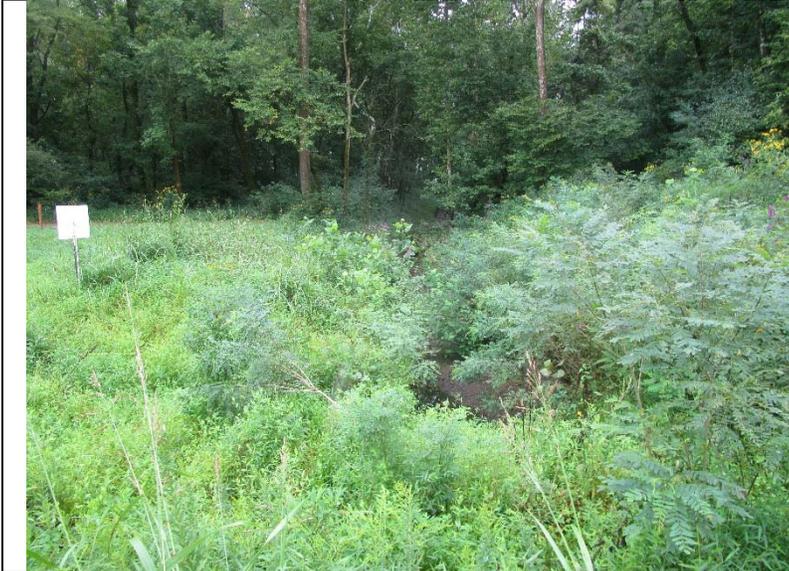
**Photo No. 8**

Landfill Runoff Collection Pond  
Principal Spillway Outlet Channel  
Looking Downstream

General Overview-overgrown vegetation

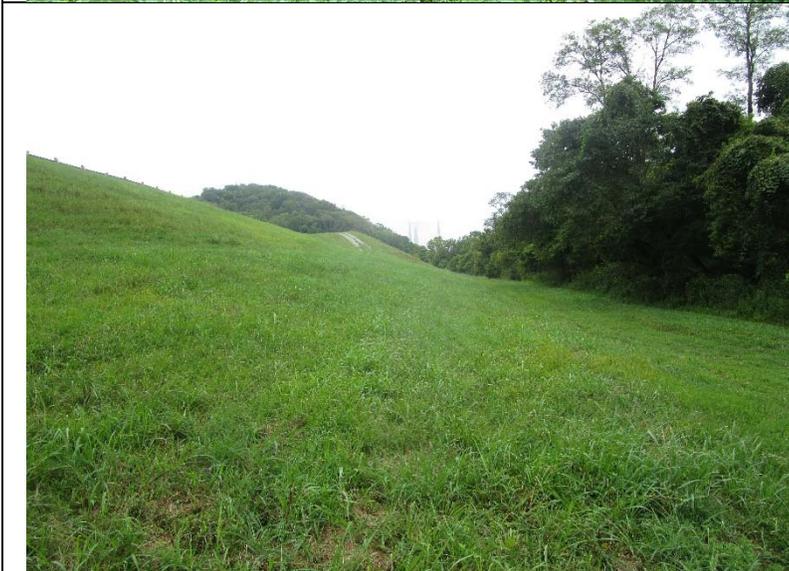
**Photo No. 9**

5. Photographs No's. 9 through 14 are all overviews of various areas of the exterior face of the dam as further described with each photograph. Throughout, vegetation control was adequate and there were no signs of sloughing, erosion or instability, except for the area adjacent to the previously repaired slope. No visible change was observed from previous inspections. In general, the exterior slope appeared to be in satisfactory and stable condition

Landfill Runoff Collection Pond Dam  
Adjacent To Toe of Slope Looking East

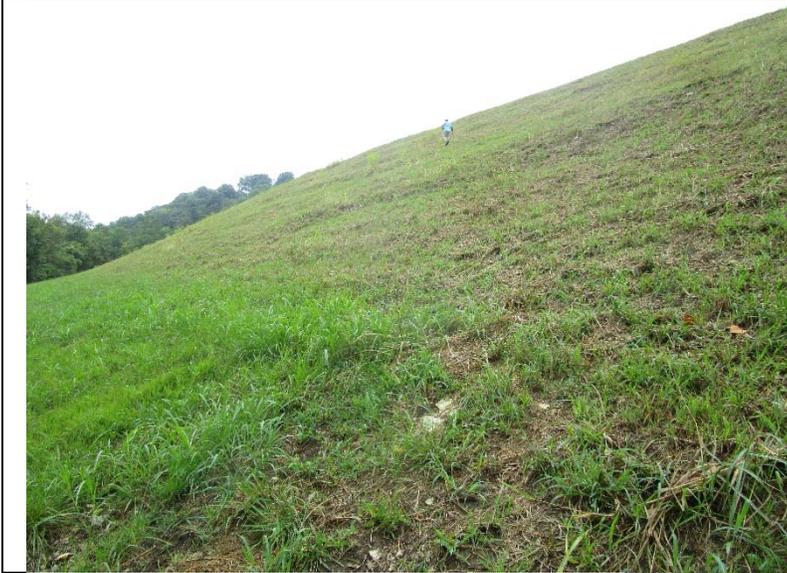
**Photo No. 10**

6. The one area of concern is the slope adjacent to the previously repaired area in 2017. This area apparently did not experience additional sloughing/slip activity. A repair detail has been submitted to the state for approval before implementation.

Overview of downstream slope adjacent  
to rip rap repair area.

- The soughing/slip area of the outboard slope needs to be repaired and stabilized in order to prevent additional damage to the slope area.

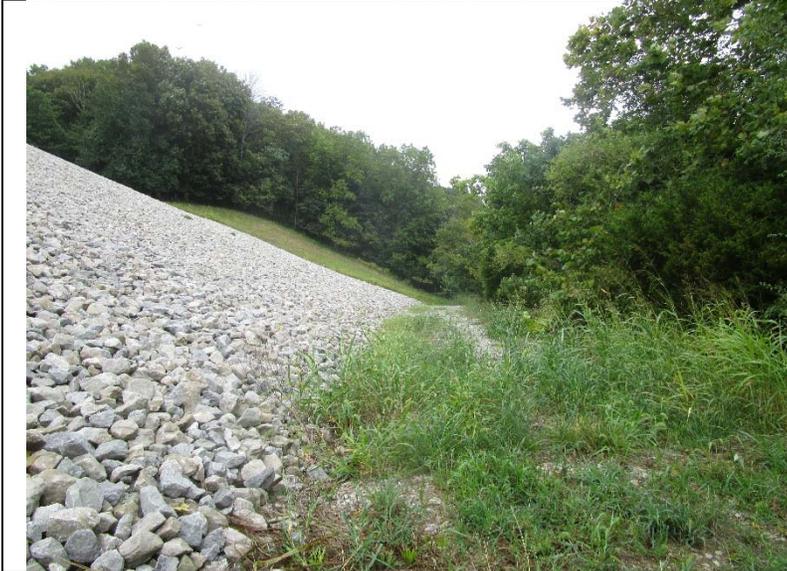
**Photo No. 11**

7. Photograph No.11 and No. 12 shows the previously repaired slope area that experienced sloughing/slip near the left abutment. The area appears to be in stable conditions. The repair also included installing a seepage collection pipe at the toe of rip rap placement. The pipe showed minimal flow at the time of inspection.

Landfill Runoff Collection Pond Dam  
Adjacent To Toe of Slope Looking  
Southwest

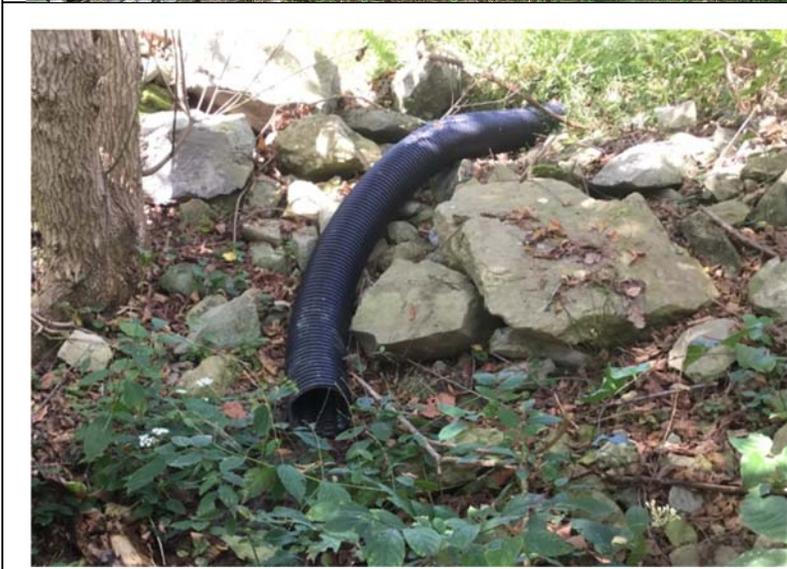
**Photo No. 12**

Overview of rip rap toe drain outlet pipe.  
There was minor flow at time of  
inspection. Looking west.

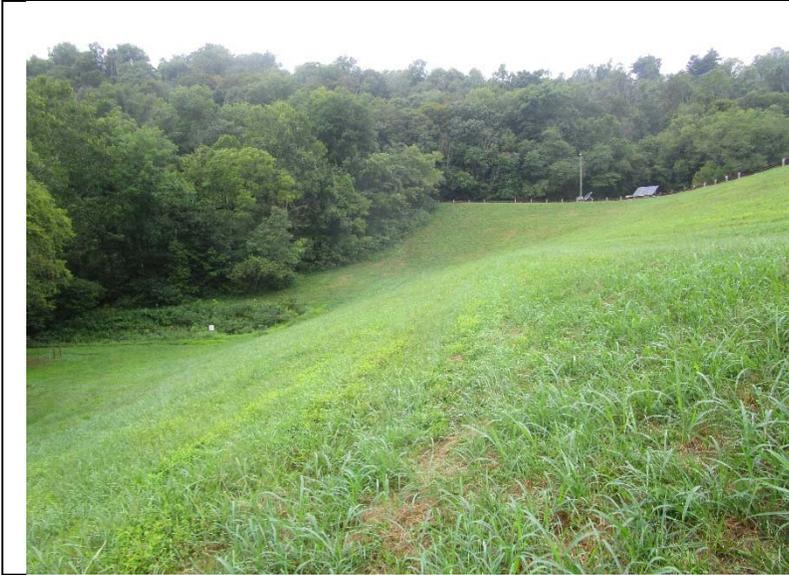
**Photo No. 13**

Overview of downstream slope area. Looking west.

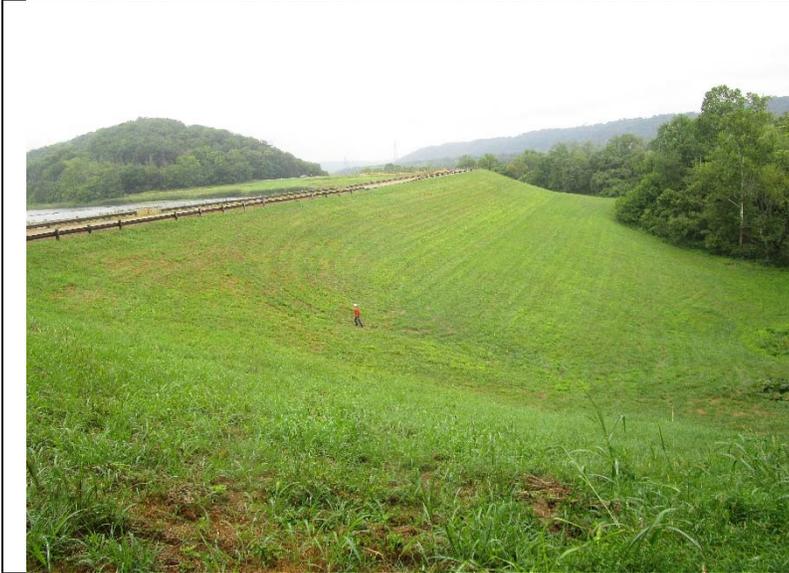
**Photo No. 14**

Landfill Runoff Collection Pond Dam From Top of Slope In Right Groin Looking East
