2017 Annual Dam and Dike Inspection Report

**Bottom Ash Pond Complex
South Fly Ash Pond**

**Kyger Creek Plant
Ohio Valley Electric Corporation (OVEC)
Gallia County, Ohio**

August 16, 2017

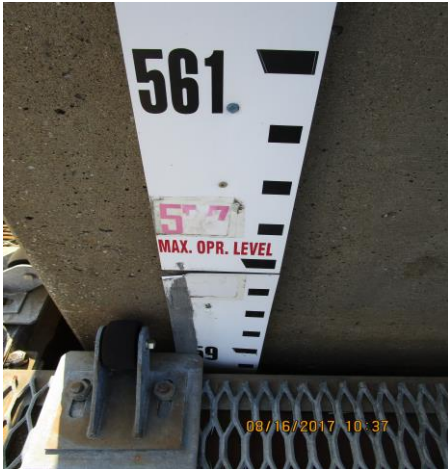
- 5) The maximum operating pool stage was indicated on the staff gages but would not be readily discernable from a distance. It is recommended that the max operating pool stage be stenciled (or otherwise denoted) on the concrete structure itself so that it is clearly visible from the crest of the embankment. (See Pictures 1 and 2)

Photo 1 Typical view of staff gage denoting Max Operating Pool.

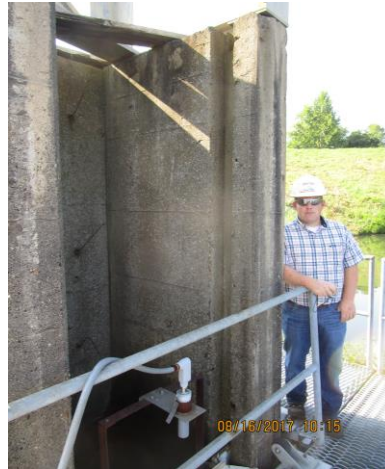
Photo 2 – Typical view of decant structure showing good conditions. Paul Hutchins is also depicted and participated in the inspection.

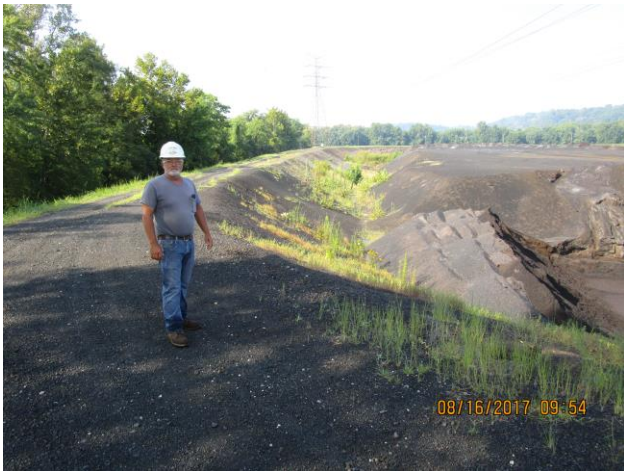
- 6) The plant is actively performing maintenance in mitigating erosion rills along the inboard slopes of the Boiler Slag Pond. The erosion that has occurred is located in the stockpiled boiler slag that is lining the inboard slope of the soil dike and is therefore not impacting the integrity of the dike. (See Picture 3)

Photo 3 – Typical view of crest and embankment showing good conditions. Ken Stapleton is also depicted and participated in the inspection.

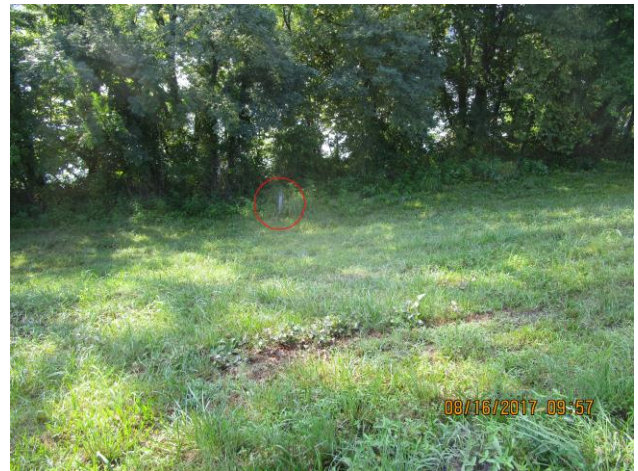
- 7) The plant is actively performing maintenance in controlling vegetation along the crest and the embankment slopes. Excessive vegetation was observed in the vicinity of the piezometers located along the toe of the embankments. Select piezometers should also be protected with the installation of bollards to prevent damage from mowing equipment. All piezometers should be labeled on the outside of the protective casing with the piezometer's number and a brass tag affixed with the piezometer number to the inside of the casing. (See Picture 4)

Photo 4 – Typical view of the downstream slope showing the location of the piezometer KC-1022 along the edge of mowed area.

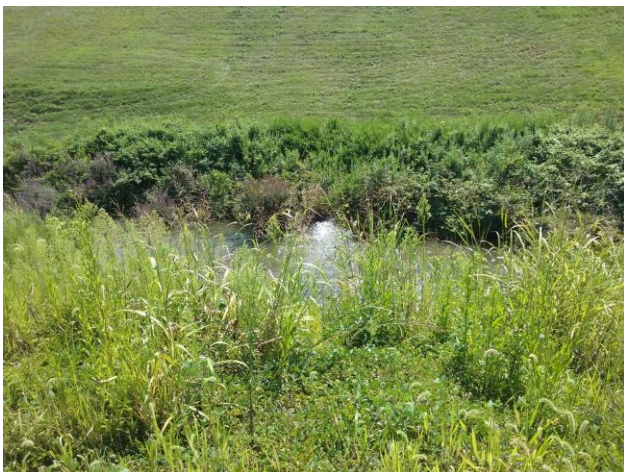
Photo 5 – Typical view of the downstream slope showing at the discharge pipe for the fly ash pond..

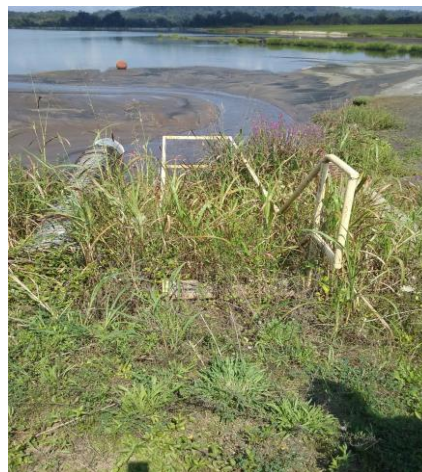
Photo 6 – A small area where excessive vegetation has grown along stairwell access.

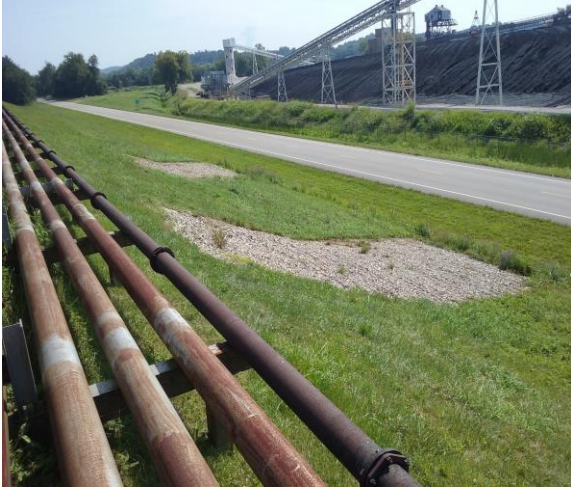
- 10) Isolated wet areas observed through the weekly inspections should continue to be monitored for flow rate and clarity of flow. The plant is actively mitigating such areas and repairing them using the same ODNR approved detail for controlling previous seepage areas along

embankment slope (See Pictures 7 and 8). If the flow rate increases or the water coming from the seep is not clear it should be brought to the immediate attention of AEP-Geotechnical Engineering.

Photo 7 – Typical view of the repairs to the seeps along the east embankment.

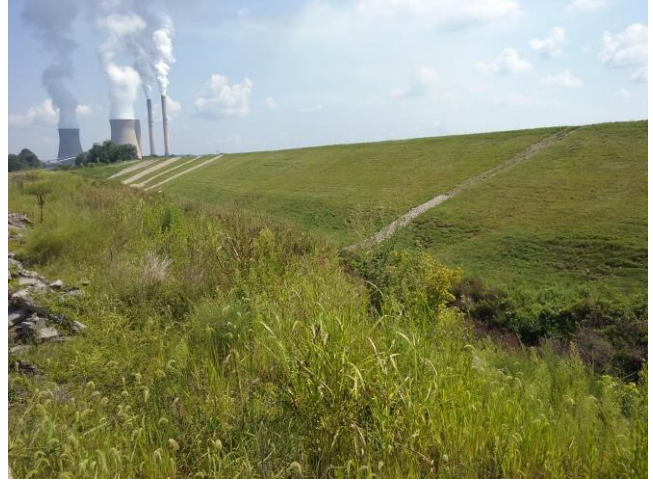
Photo 8– Typical view of the repairs to the seeps along the west embankment showing excellent conditions.

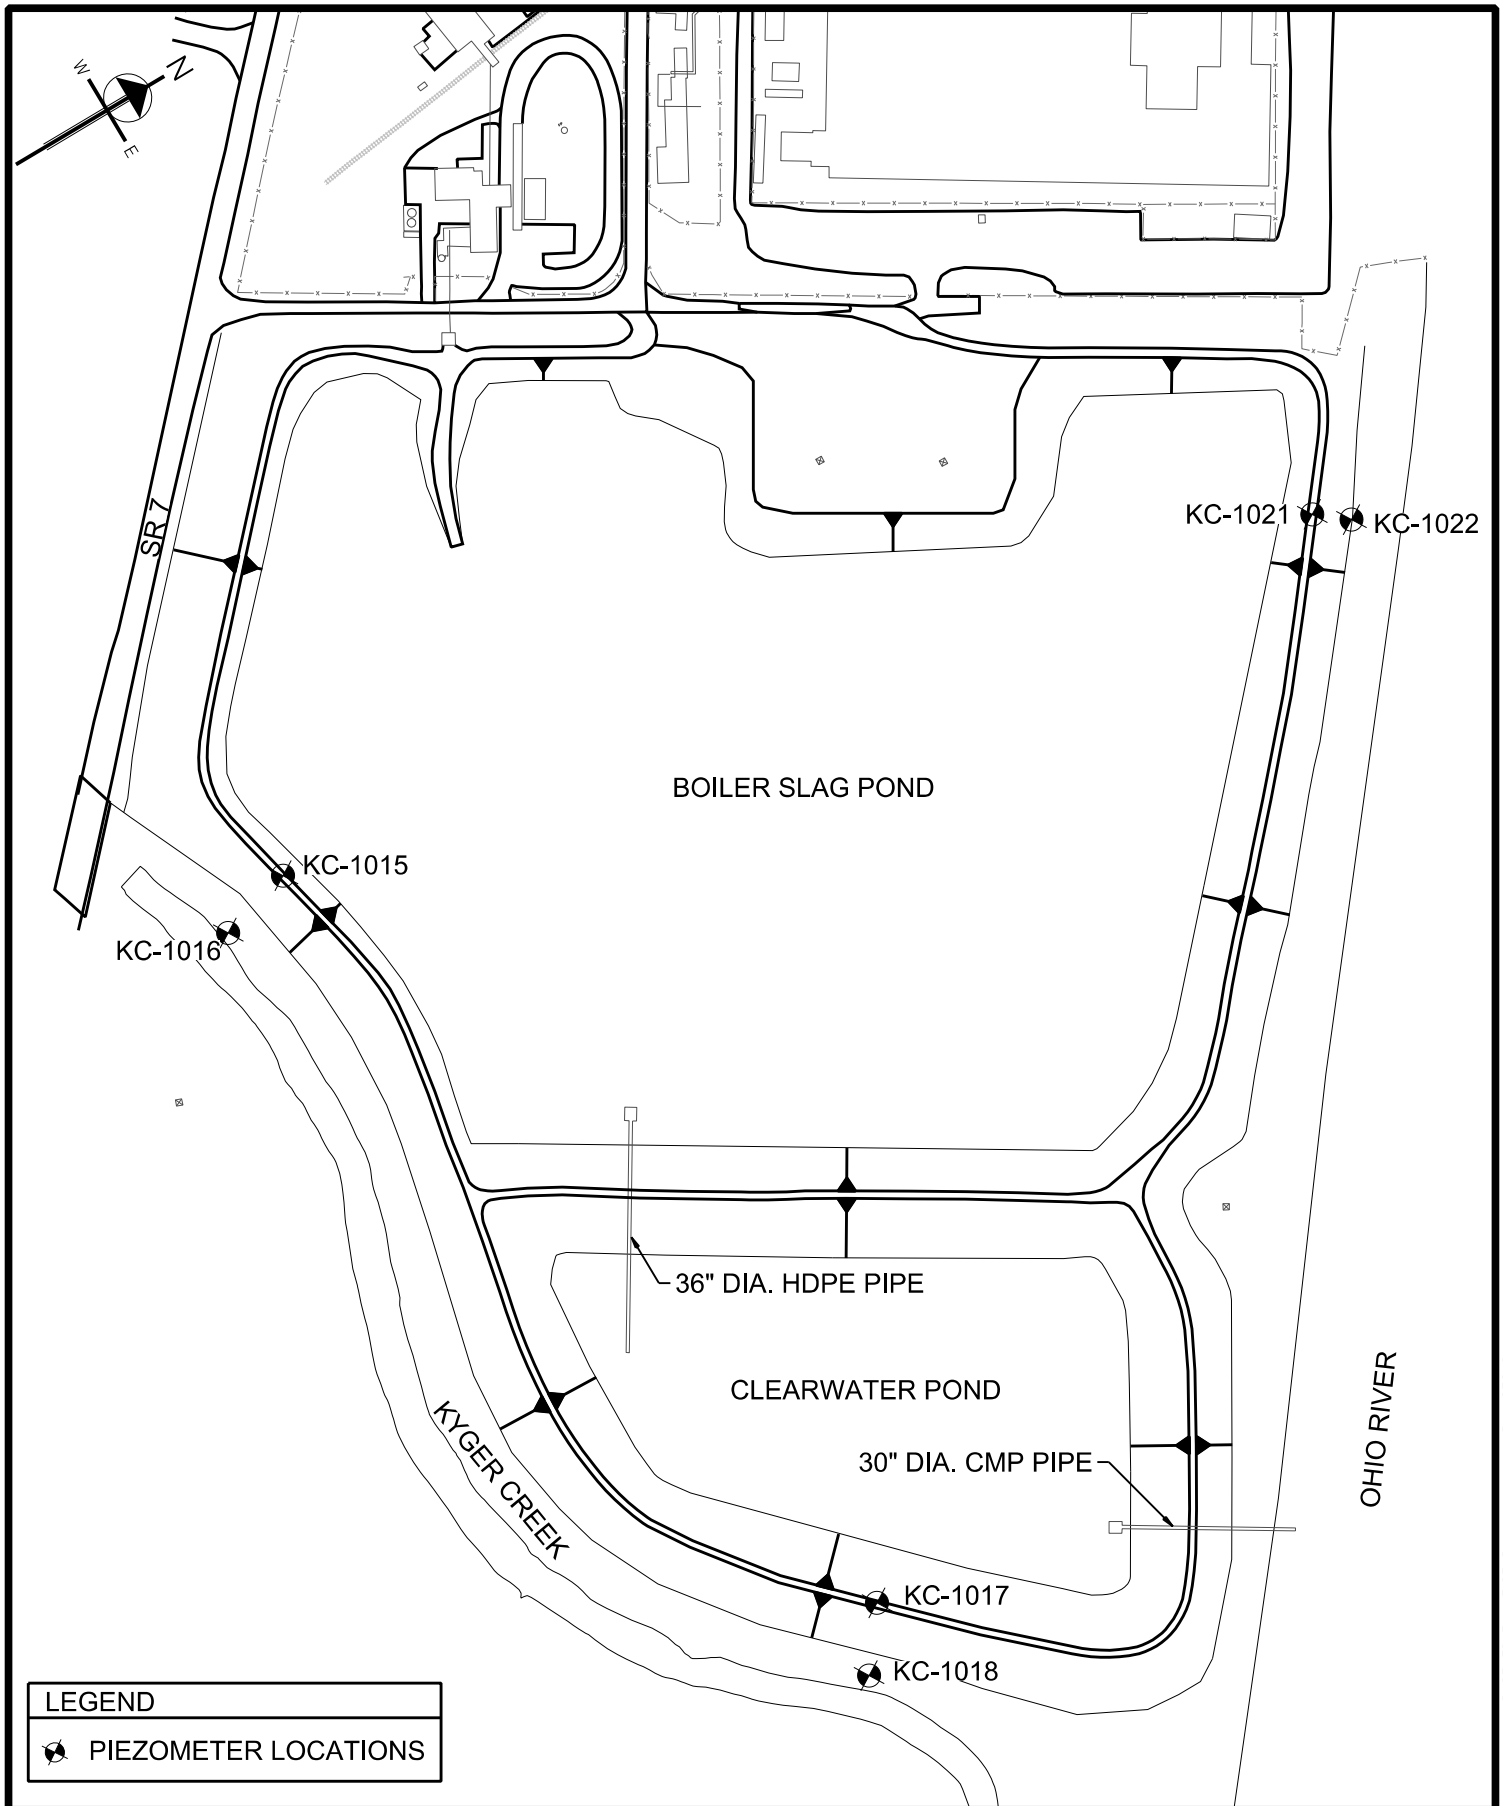
DRN BY:	KYGER CREEK POWER STATION	DWG NO: FIGURE 1
DATE:	SHEET 1 OF 1

The location and type of instrumentation is shown on Figure 2. The maximum recorded readings of each instrument since the previous annual inspection is shown in Table 1.

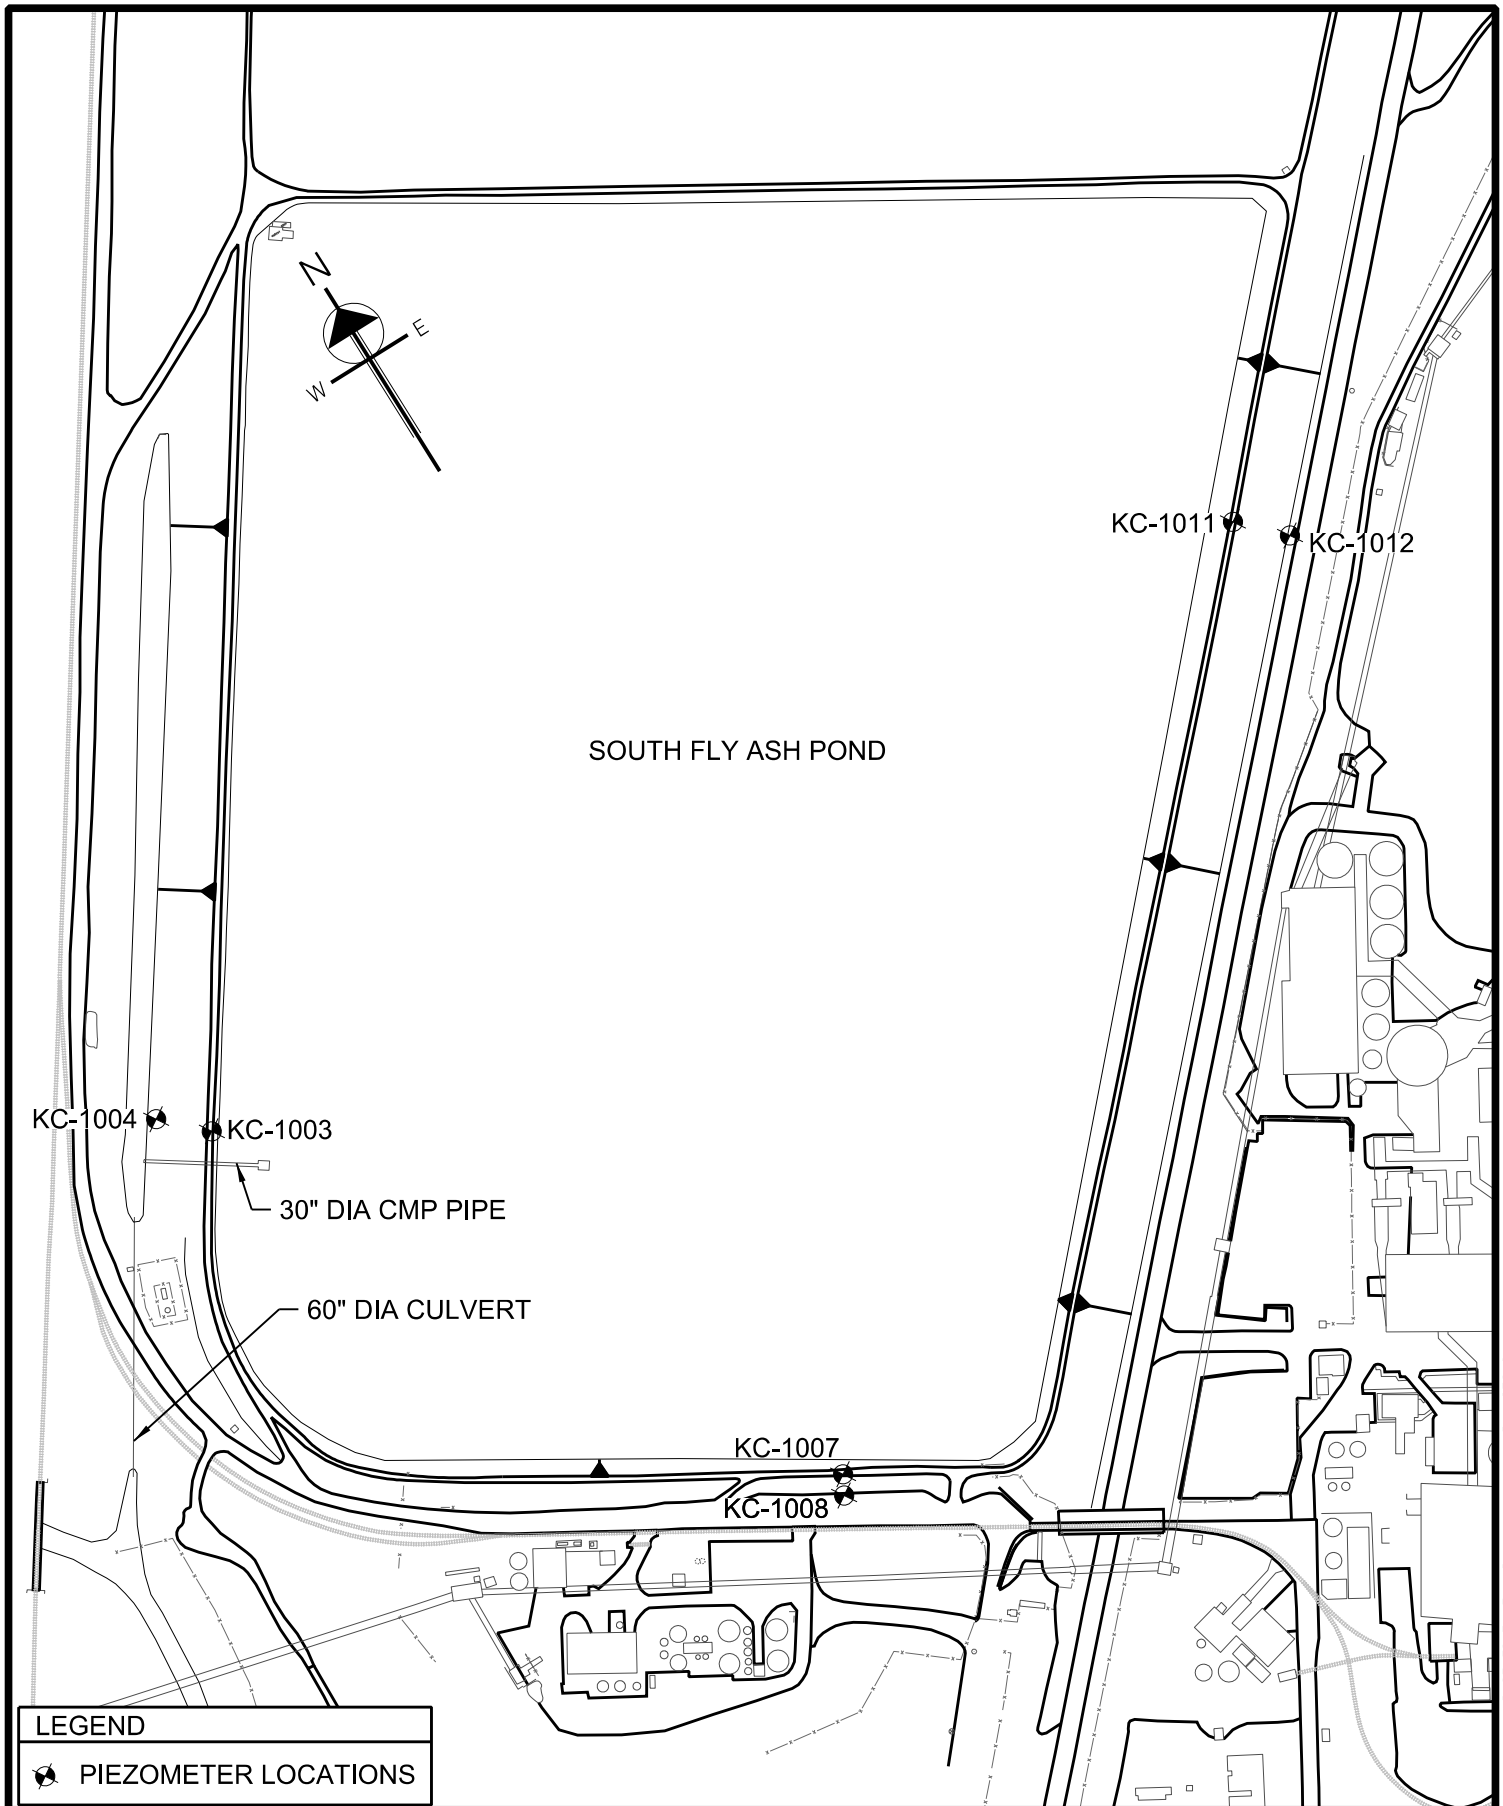
DWG NO: FIGURE 2

The location and type of instrumentation is shown on Figure 2. The maximum recorded readings of each instrument since the previous annual inspection is shown in Table 3.
