2018 Annual Dam and Dike Inspection Report

Kyger Creek Plant

Boiler Ash Pond Complex & South Fly Ash Pond

Document Number: GERS-18-045

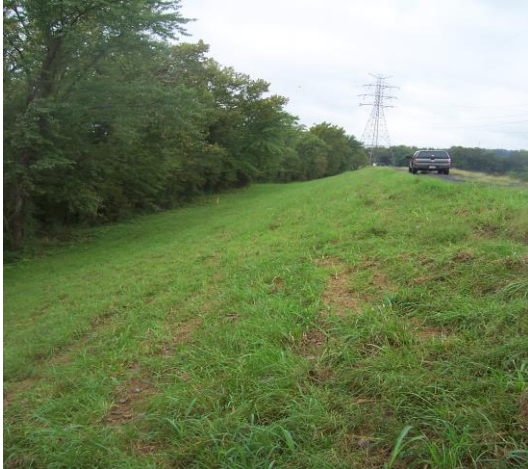
Vegetation is well established and is controlled through an active maintenance program (Photo 1).

Photo 1 Typical view showing good conditions of the boiler slag embankment.

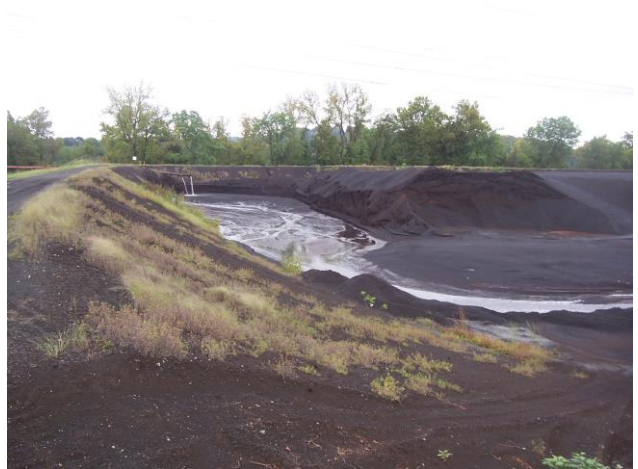
Discharge into the boiler slag pond is unobstructed and free draining (Photo 2).

Photo 2 Typical view showing good conditions of the boiler slag embankment and stockpile of material to be used for beneficial utilization.

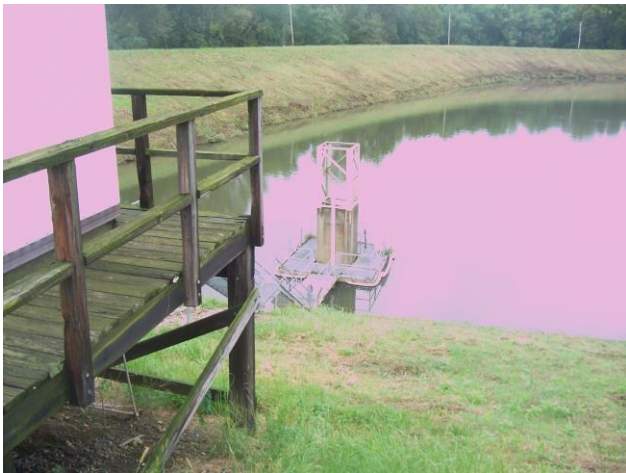
The decant structure for the clear water pond was observed to be in good condition and flow was unobstructed (Photo 3).

Photo 3 Typical view showing good conditions of the decant structure and interior embankment.

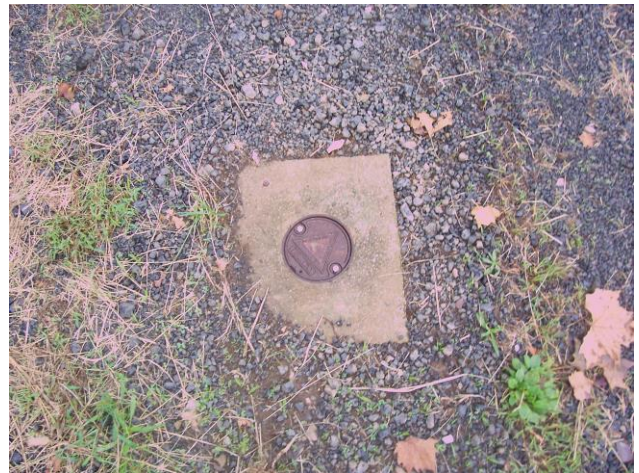
Surface seals and concrete pads for the dam's piezometers were observed to be free of defects (Photo 4).

Photo 4 Typical view showing good conditions of the flush mounted piezometer installation showing the well cap seal and concrete pad.

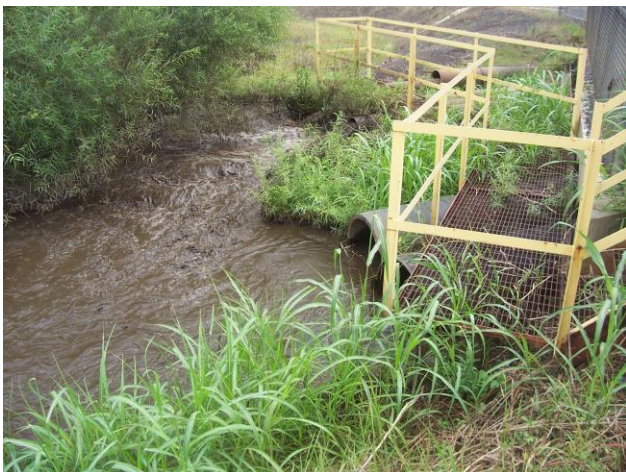
Discharge into the fly ash pond was observed to be free flowing and unobstructed (Photos 5 and 6).

Photo 5 Typical view showing good conditions of unobstructed discharge into the south fly ash pond.

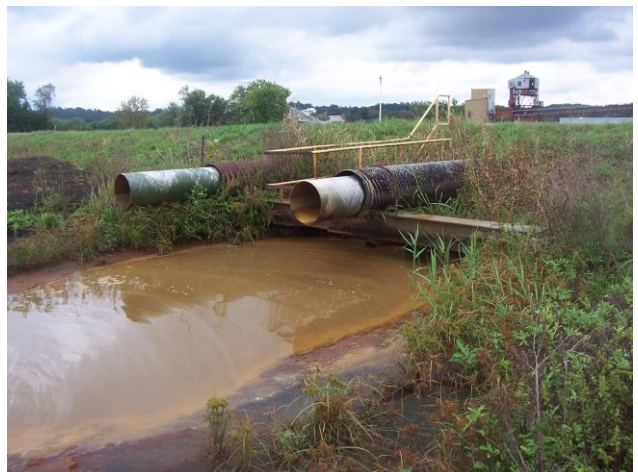
Photo 6 Typical view showing conditions of unobstructed discharge into the fly ash pond.

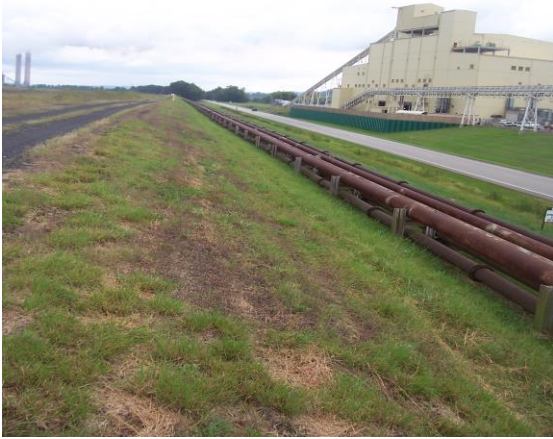
Embankment slopes and crest were observed to be in good condition (Photos 7, 8 and 9).

Photo 7 Typical view showing good conditions of the east embankment showing a uniform slope and a well maintained vegetative cover.

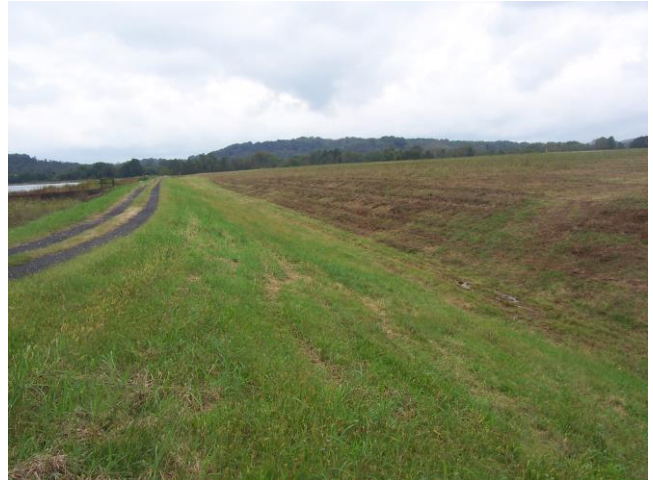
Photo 8 Typical view showing good conditions of the north embankment showing a uniform slope and a well maintained vegetative cover.

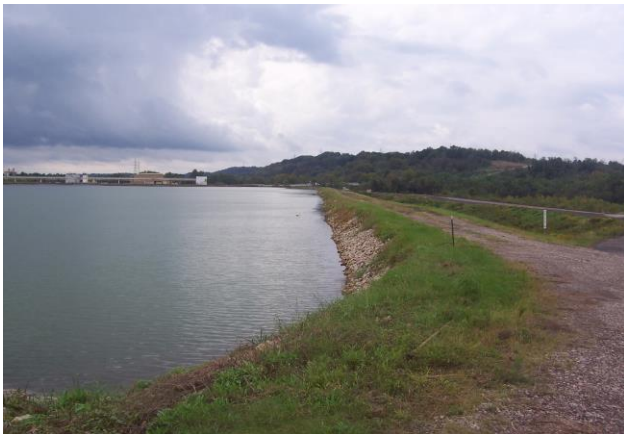
Photo 9 Typical view showing good conditions of the west embankment showing a uniform slope and crest. No erosion of the interior pond slopes was observed.

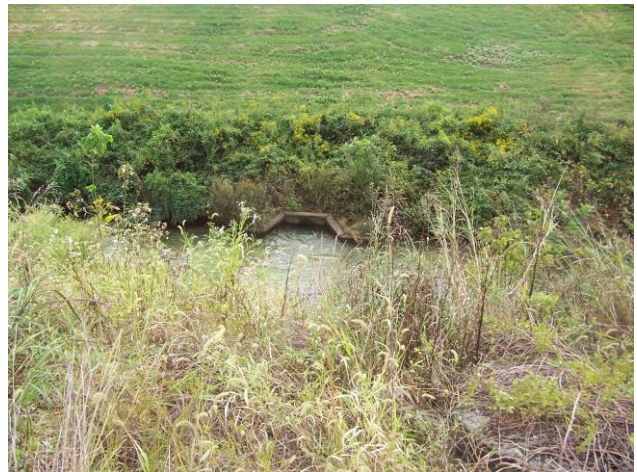
A minor seepage area (approximately 6 ft in diameter) was observed along the outboard slope of the pond's east embankments during the inspection and is intermittent based of the seven day inspection reports. (See Figure 3 for approximate location). A seep along the south dike was observed to be visually clear and flow is consistent with previous observations (Photo 10).

Photo 10 Typical view showing fair conditions of the south fly ash pond discharge structure. Additional mowing is scheduled to be performed within this area.

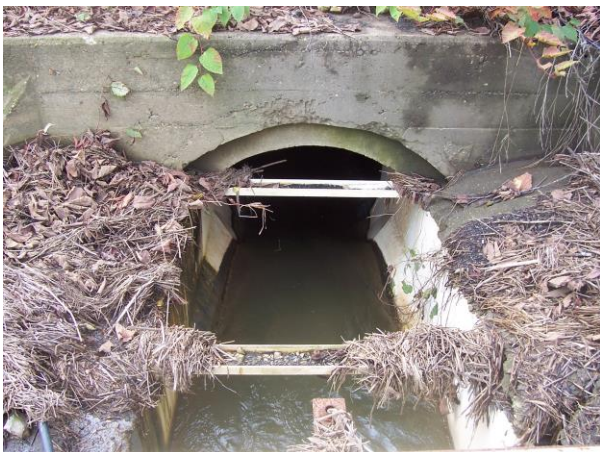
Discharge from the fly ash pond was observed to be free flowing and unobstructed (Photos 11 and 12).

Photo 11 Typical view showing unobstructed flow from the south fly ash pond.

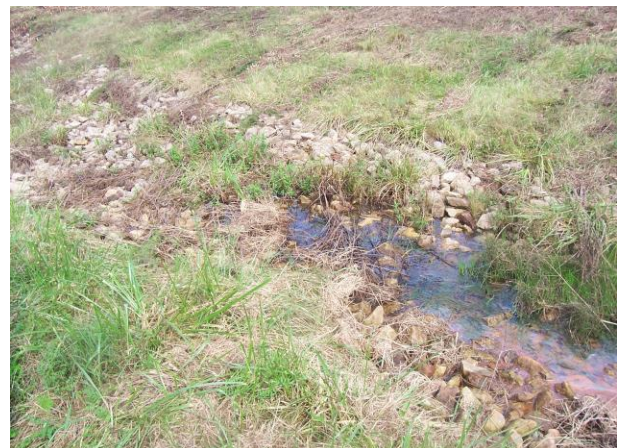
Photo 12 – Typical view of seep along the south dike showing a visually clear discharge.

- 8) Isolated wet areas observed through the weekly inspections should continue to be monitored for flow rate and clarity of flow. The plant is actively mitigating such areas and repairing them using the same ODNR approved detail for controlling previous seepage areas along embankment slope. If the flow rate increases or the water coming from the seep is not clear it should be brought to the immediate attention of AEP-Geotechnical Engineering.
- 9) The seepage located beyond the south toe was observed to be similar flow rate to previous inspections. Weekly inspections have noted that the flow rate is steady at 24 gpm. The flow was clear and there was no accumulation of solids around the seepage areas. The flow rate and clarity of this seep should continue to be monitored during the 7 day inspections.
