**Re: Ohio Valley Electric Corporation
Kyger Creek Station
Notification of CCR Rule Information Posting
Annual Certified CCR Dam and Dike (Surface Impoundment)
Inspection Report Posting**

**2023 CCR Rule – Surface Impoundments
Kyger Creek Dam/Dike Inspections**

Kyger Creek Generating Station
Cheshire, Ohio
Gallia County

January 19, 2024

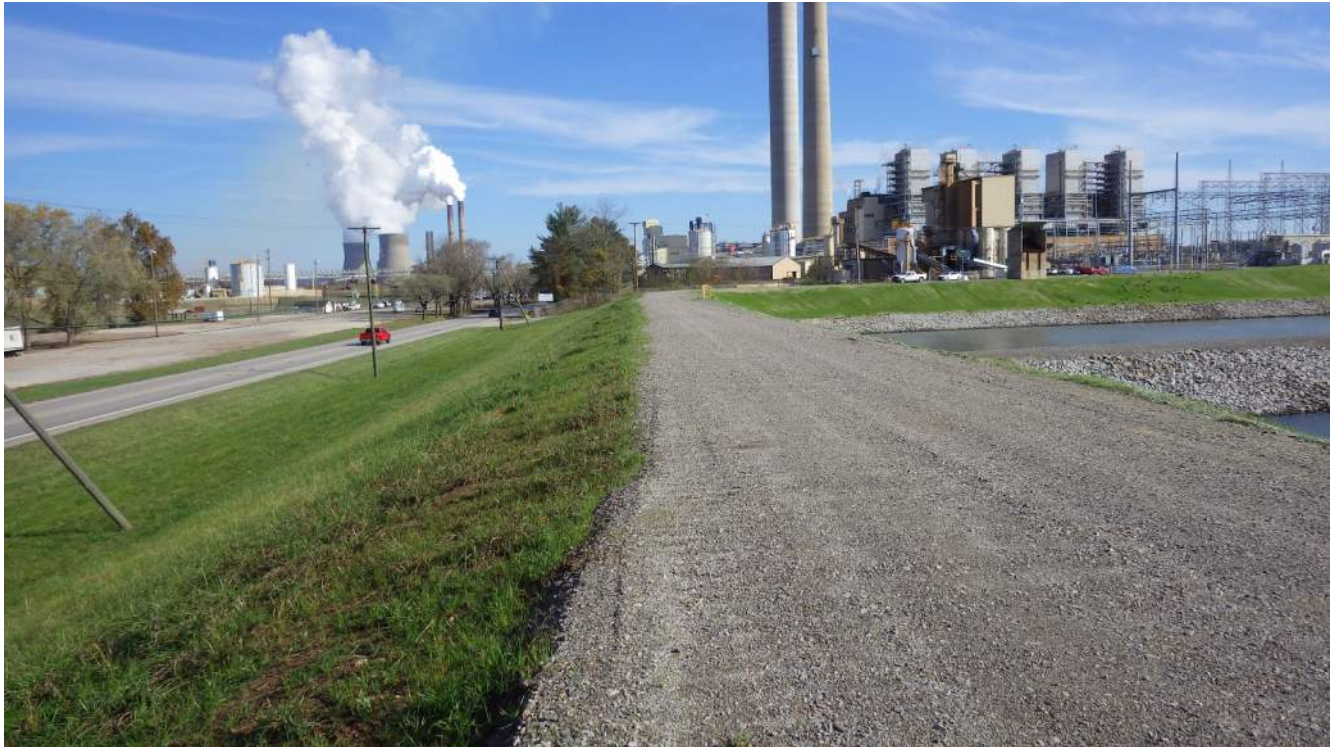
Photograph 5 – Erosion noted at change from access road to grassed slope.

Several areas of minor surface erosion, and bare spots were observed on the exterior slopes of the BSP, specifically in material changes between road surfacing and grass. These areas should be repaired and reseeded as needed. Remove potential CCRs and regrade as needed along the splitter dike and southeastern downstream slope.

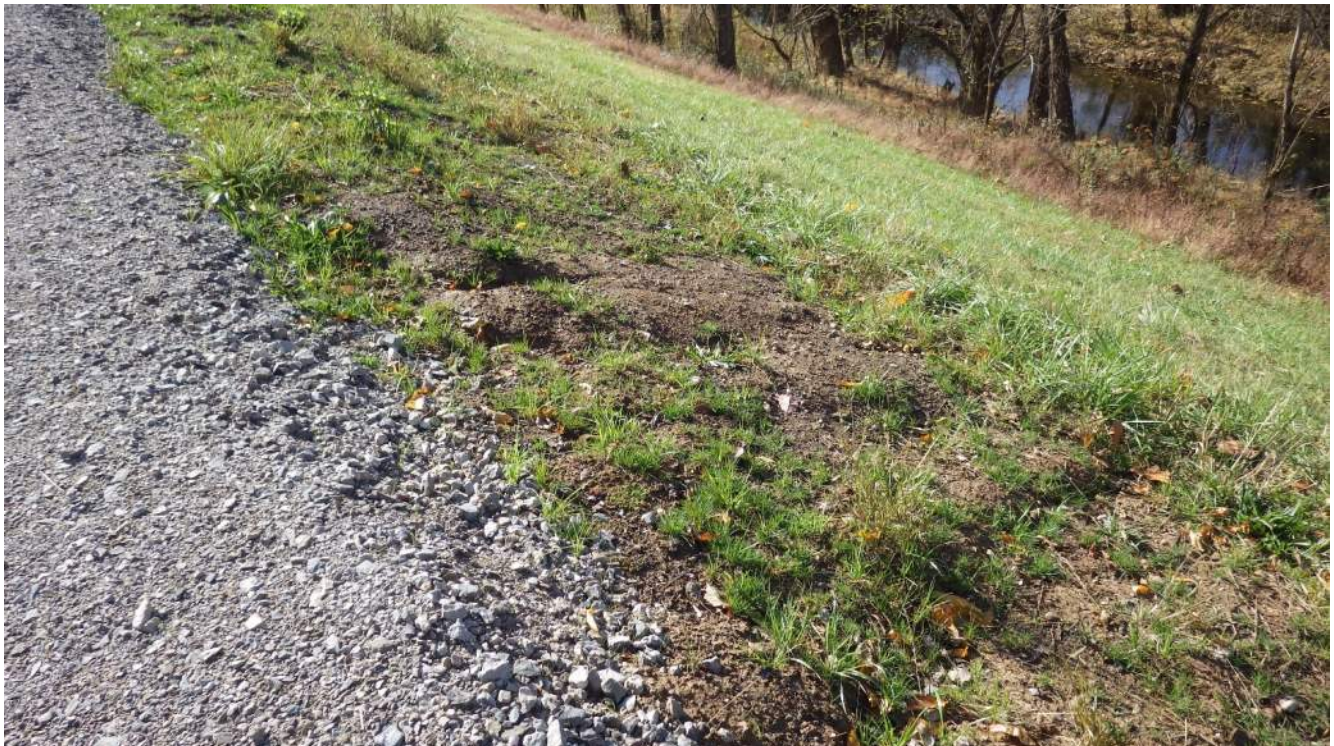
Photograph 6 – Bare spot located on slope between BSP and Kyger Creek.

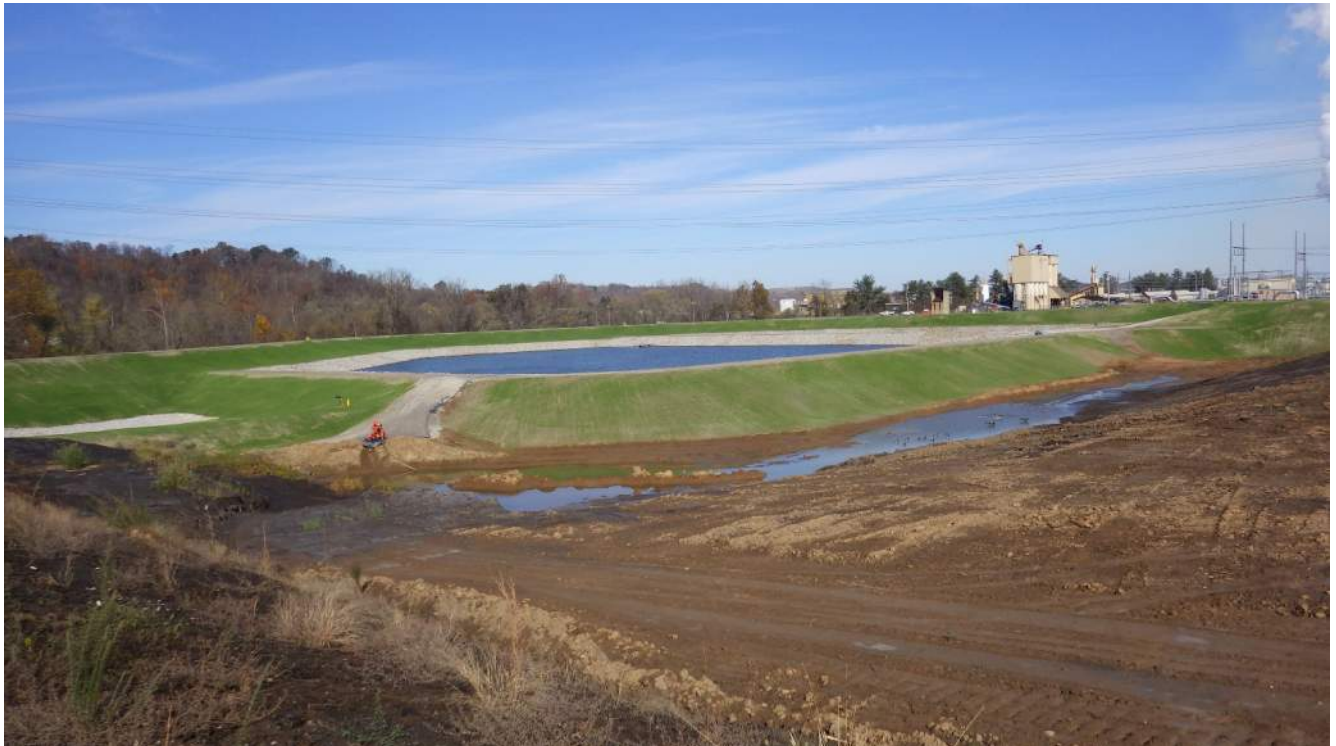
No flows were noted during the site visit into the boiler slag pond closure area. Piping for the LVWTS was noted. The outlet structure for the Clearwater Pond was observed (Photograph 11). Pounded water was limited to an area at the toe of the LVWTS within the boiler slag pond closure area (Photograph 10). A pump and hose were present at the southern end.

Photograph 10 – BSP water management and pumping adjacent to LVWTS.

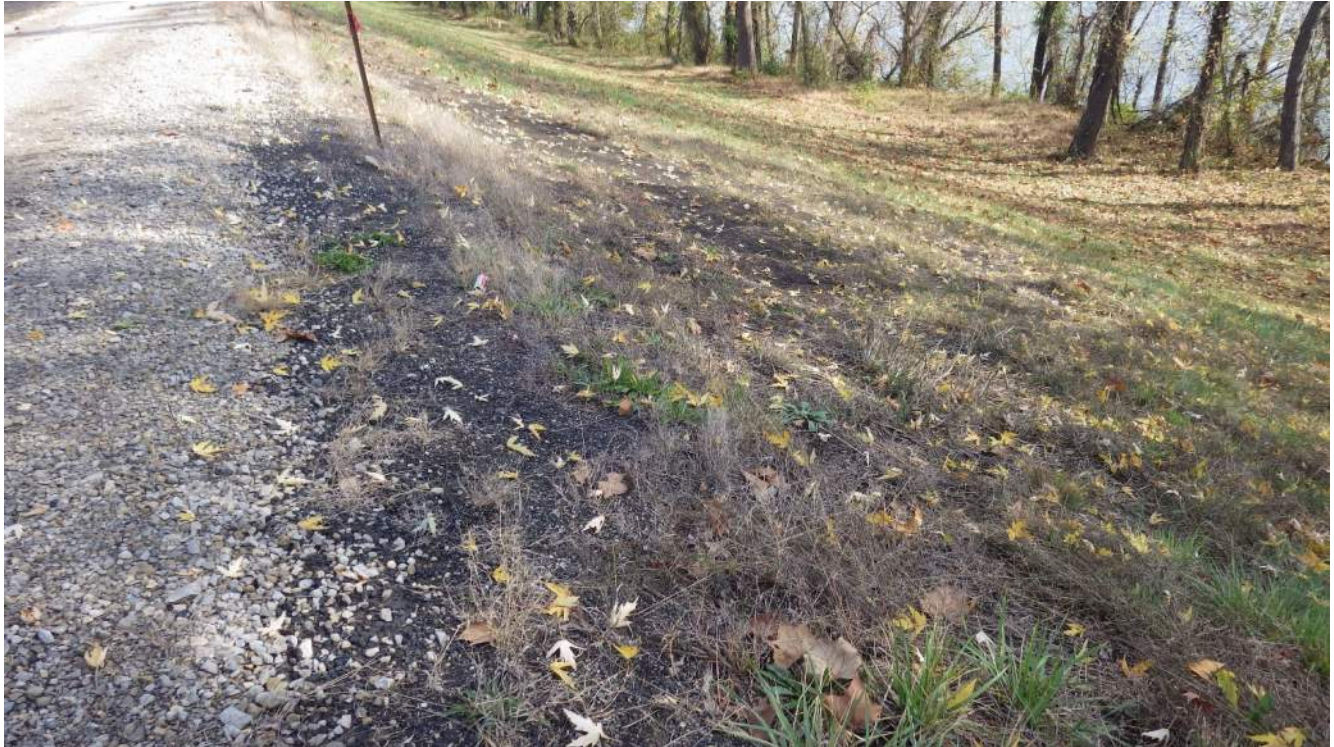
Photograph 15 – Minor erosion of surface material between BSP and Ohio River.

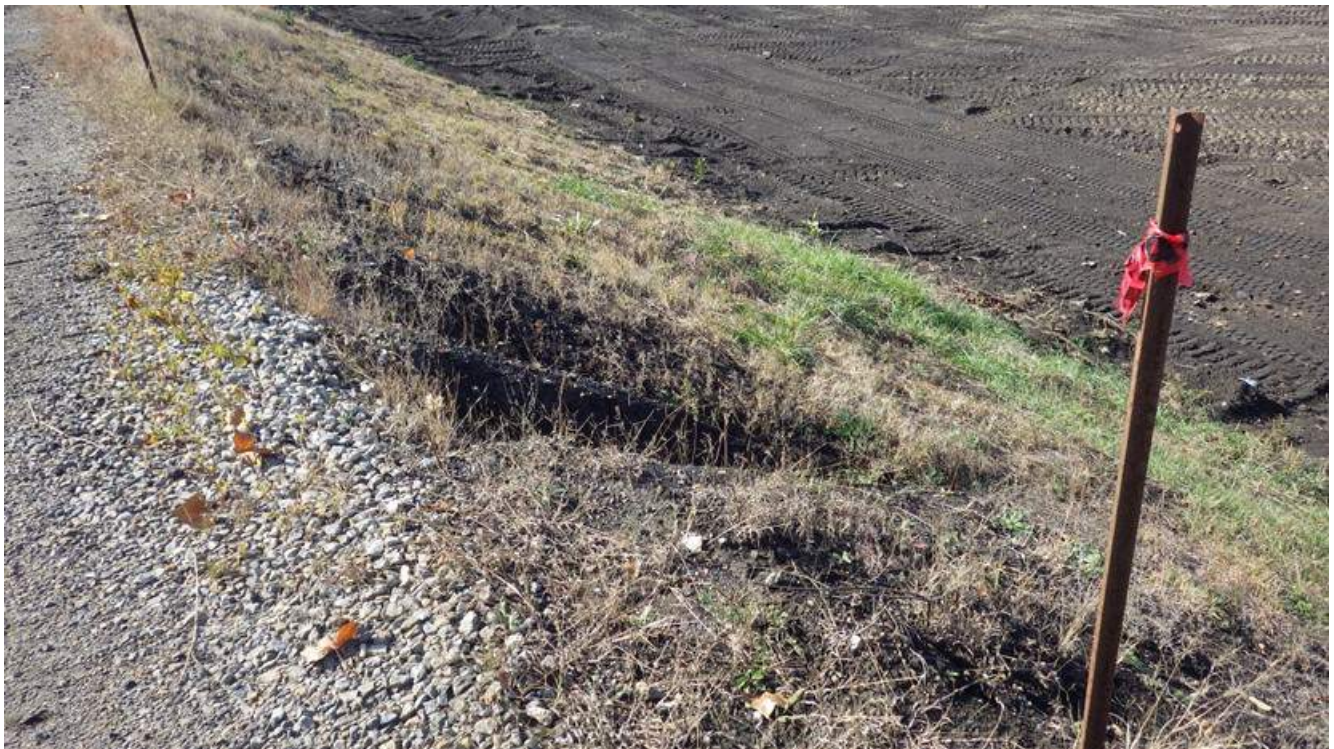
Photograph 16 – Erosion gulleys located on interior dam surface near northeastern corner of BSP.

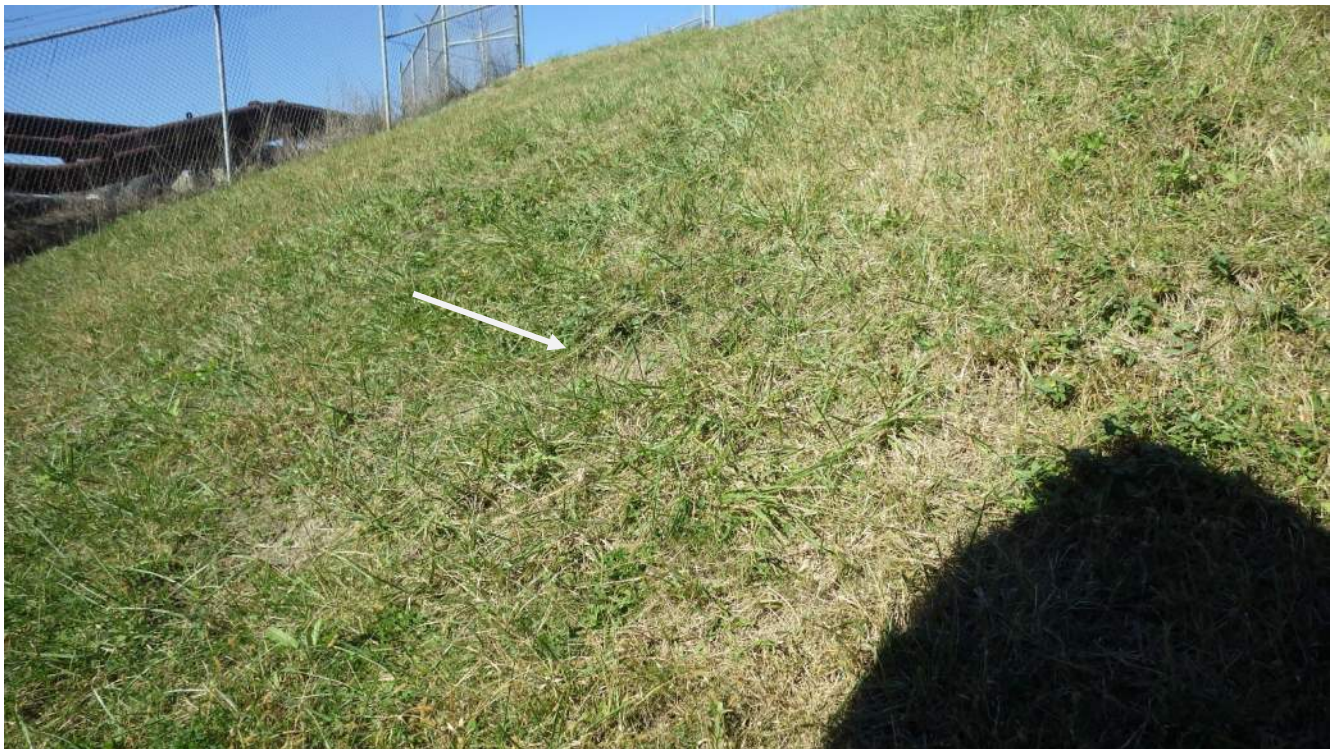
Photograph 4 – Minor surface sloughing of eastern slope of SFAP along State Route 7.

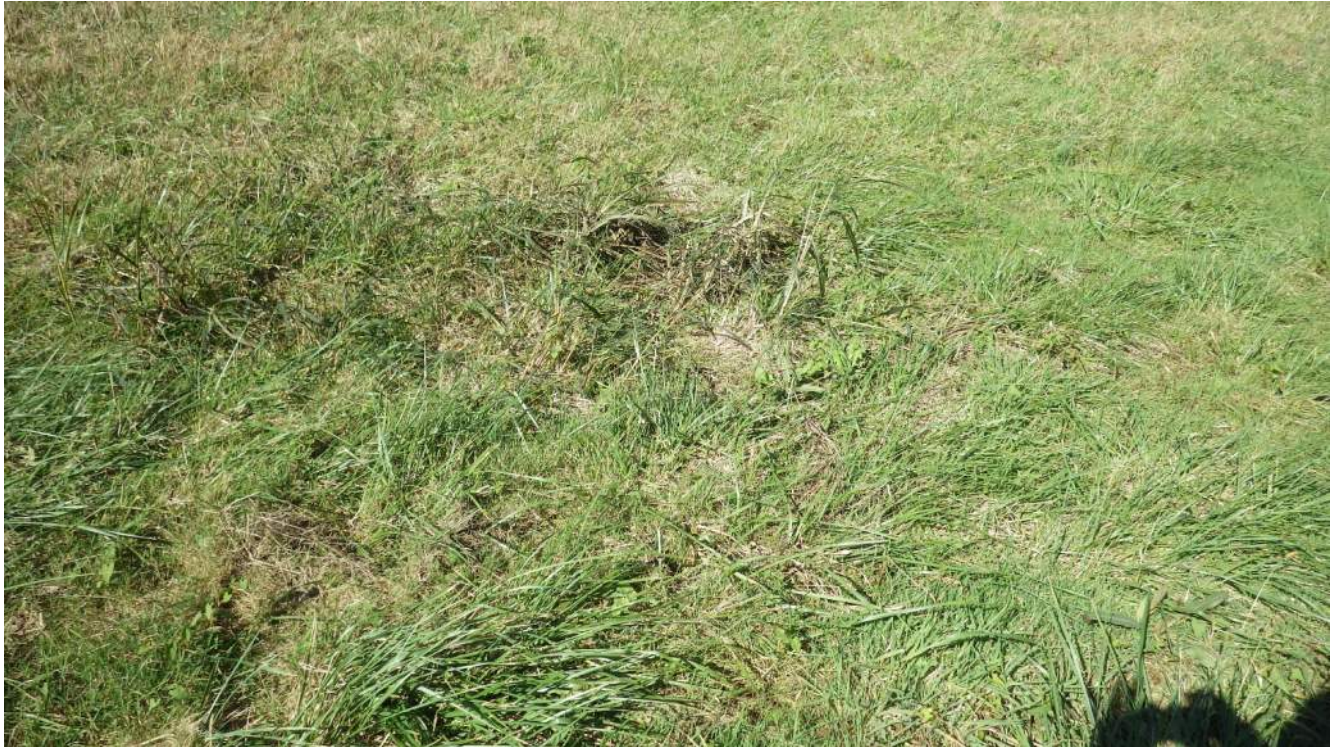
Photograph 7 – Erosion at toe of eastern embankment.

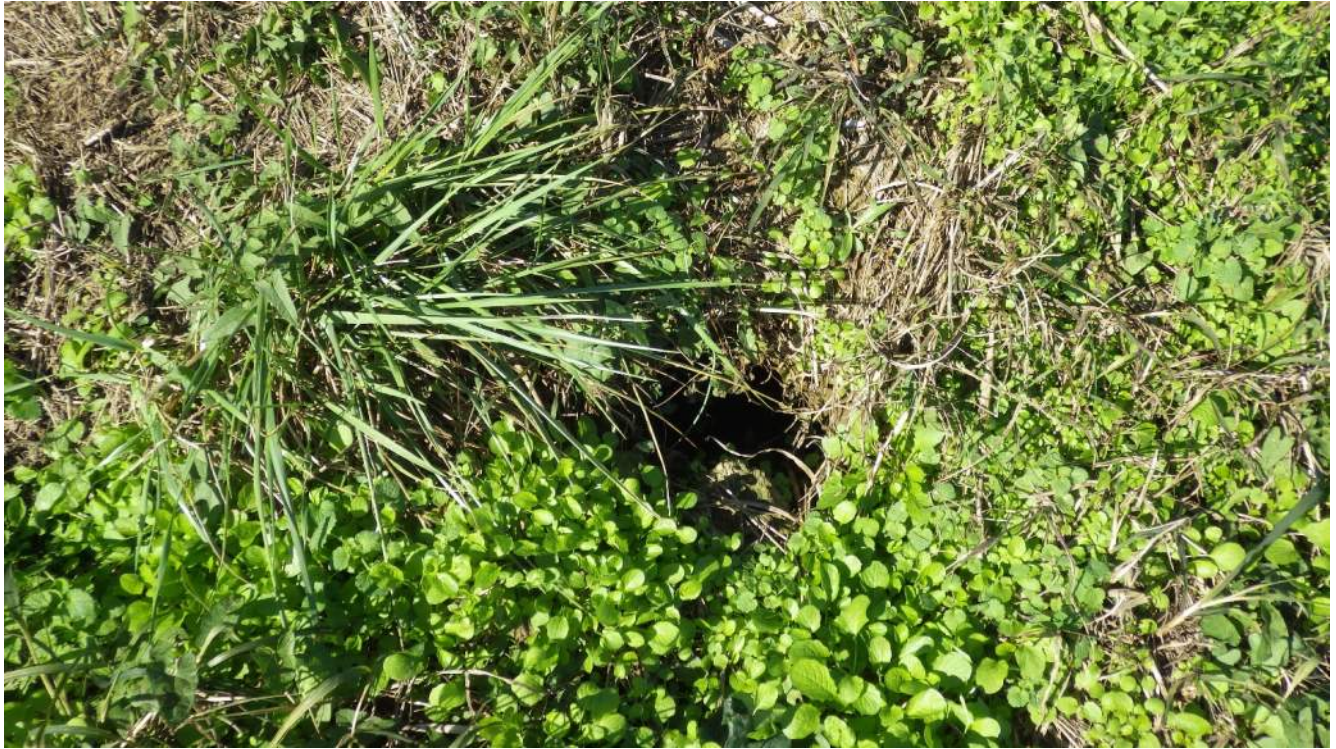
Photograph 9 – Small hole on eastern downstream slope of SFAP.

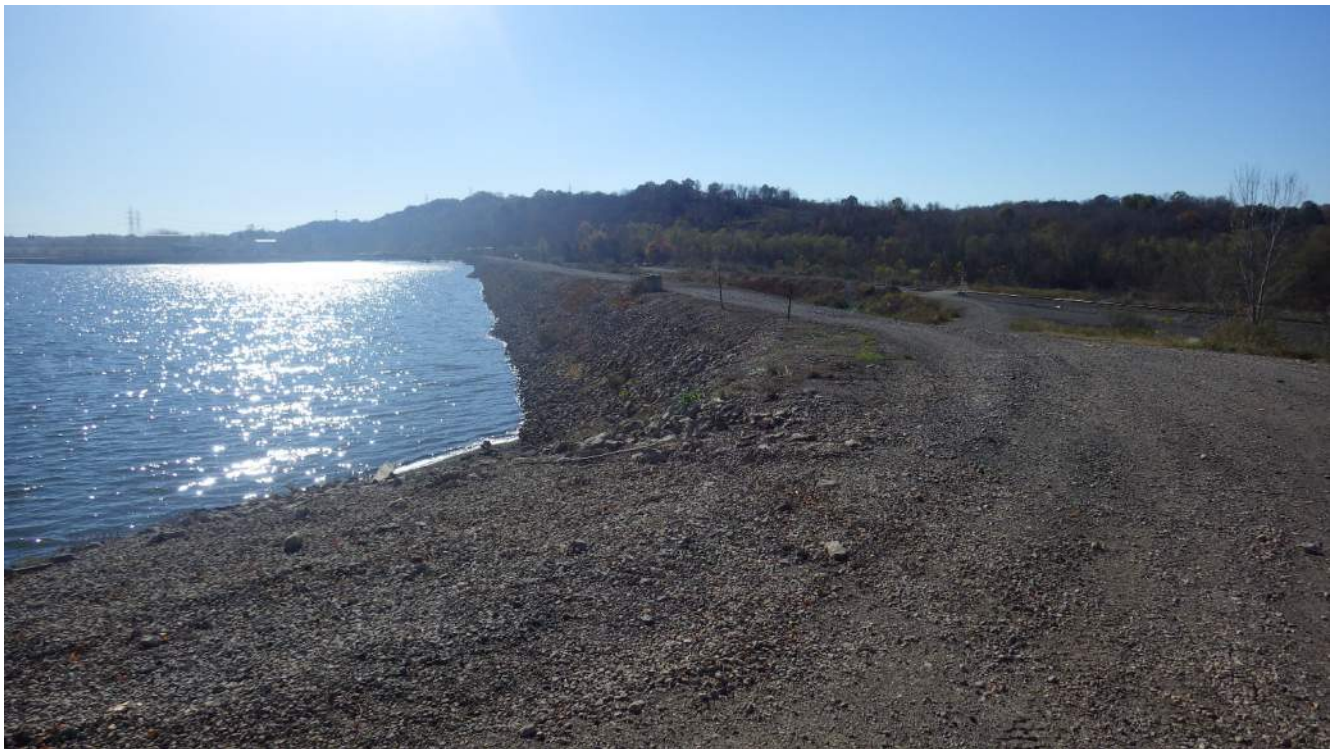
Photograph 12 – Western embankment showing upstream riprap protection.

Minor maintenance for the SFAP includes repairing sloughing of the surface (Photograph 12), determining the cause of holes and repairing them (Photograph 15), regrading the drive path for positive drainage (Photograph 17), and repairing bare spots (Photograph 20). Some additional riprap rock may be necessary along the base of the western slope of the SFAP is recommended to protect the soil slope (Photograph 19).
