**Reference: 2015 CCR Rule Inspection  
Initial Annual Landfill Inspection  
Kyger Creek Generating Station  
Cheshire, Ohio**

**2015 CCR Rule Inspection  
Kyger Creek Landfill**

Kyger Creek Generating Station  
Cheshire, Ohio  
Gallia County

January 15, 2016

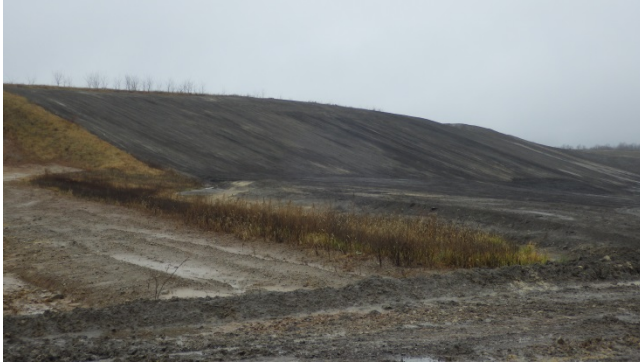
**Photo 1**

CCRs (3H:1V slopes) on interior of the landfill on eastern active face of Area 1, Part 1.

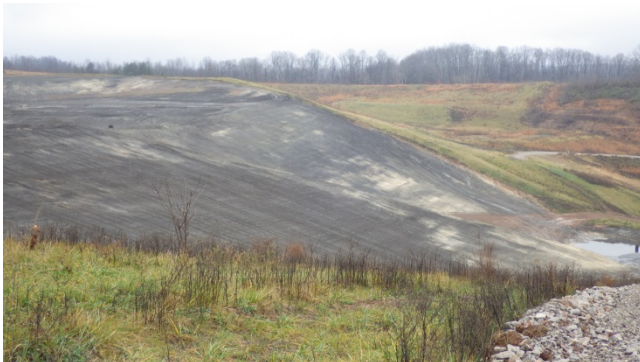
**Photo 2**

CCRs (3H:1V slopes) on interior of the landfill on eastern active face of Area 1, Part 3.

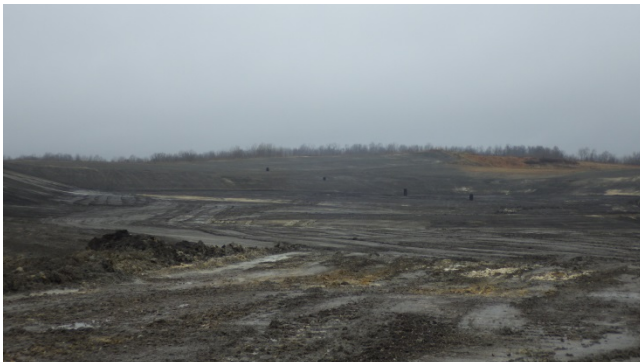
**Photo 3**

Series of chimney drains within the active area of Phase 1.

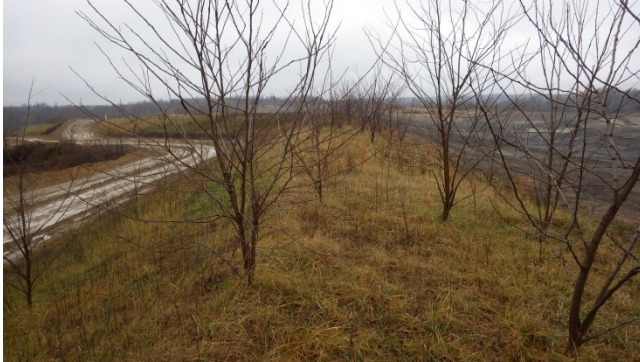
**Photo 4**

- Approximately 3-inch or less diameter trees were observed on the temporary exterior slopes along the anchor trench on the south side (Photo No. 4; Point 1, Appendix A) and on the exterior temporary north slope (Photo No. 5; Point 9, Appendix A) of Phase 1, Parts 1 and 2.

Approximately 3-inch or less diameter trees on temporary exterior slopes along the anchor trench on the south side.

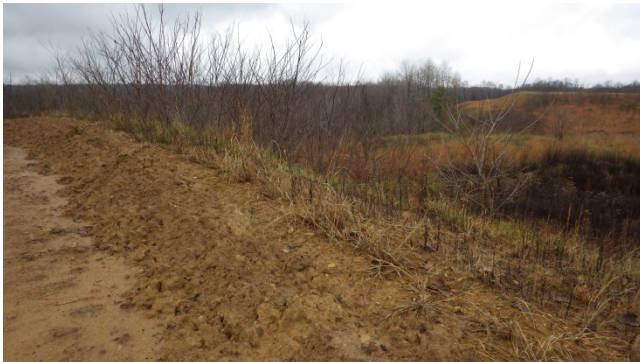
**Photo 5**

Tree growth on the exterior temporary north slope.

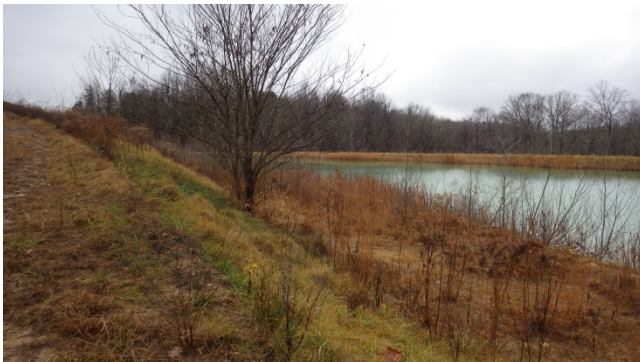
**Photo 6**

- Approximately 6-inch or less diameter trees were observed on the temporary slope on the west side of the landfill, between Phase 1 and the West Sedimentation Pond (Photo No. 6).

Trees six-inches in diameter or less on the temporary slope on east side of the landfill.

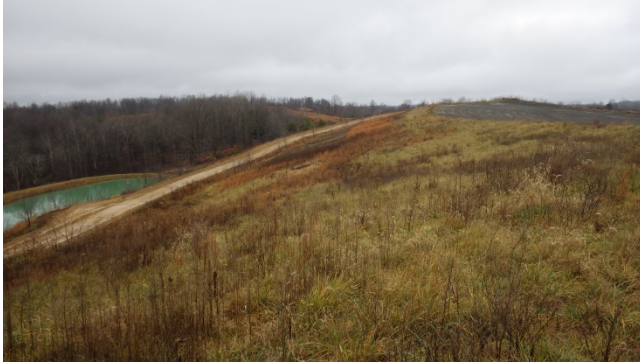
**Photo 7**

- The temporary exterior slope on the west side of Phase 1 is at an approximate 2.5H:1V slope (Photo No. 7) and is vegetated with heights between 12 and 30 inches.

Temporary exterior slope on the west side of Phase 1 is approximately 2.5:1V with dense vegetation.

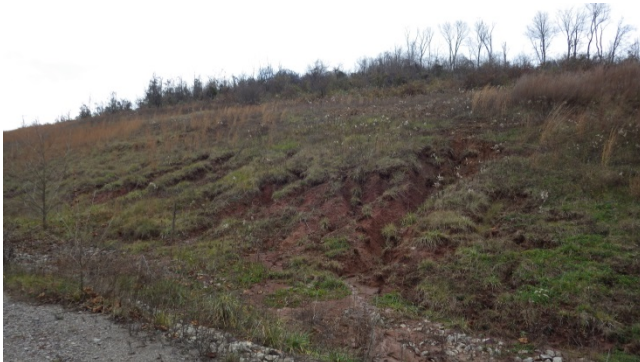
**Photo 8**

Erosion gullies on the west exterior slope of Phase 1.

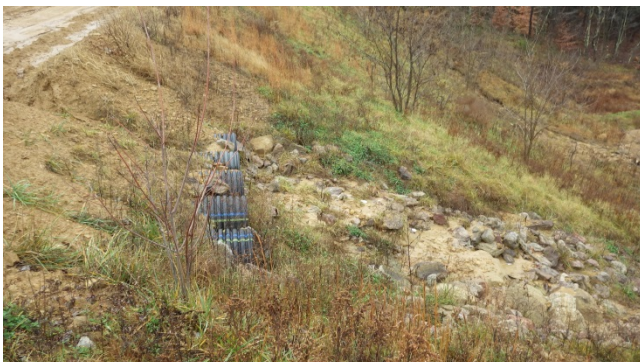
**Photo 9**

- Five 24-inch high-density polyethylene (HDPE) pipes were observed on the west side of Phase 1, underlying the access road on the exterior slope (Photo No. 9). The pipes outlet into a riprap-lined channel that leads to the West Sedimentation Pond.

Five 24-inch HDPE pipes west of Phase 1, flowing towards the West Sedimentation Pond.

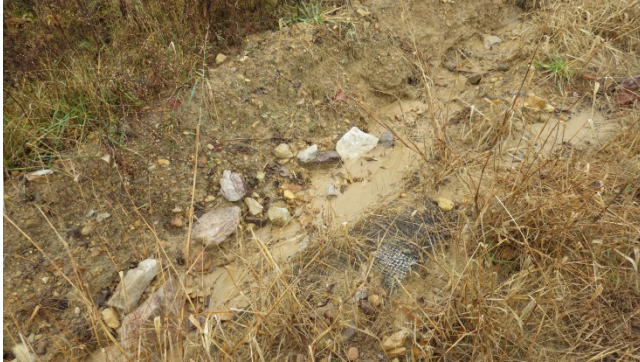
**Photo 10**

- Plastic mesh was observed within the drainage channel along the perimeter road on the western side of the landfill between Phase 1 and the West Sedimentation Pond (Photo No. 10).

Plastic mesh visible in drainage channel along access road to West Sedimentation Pond.

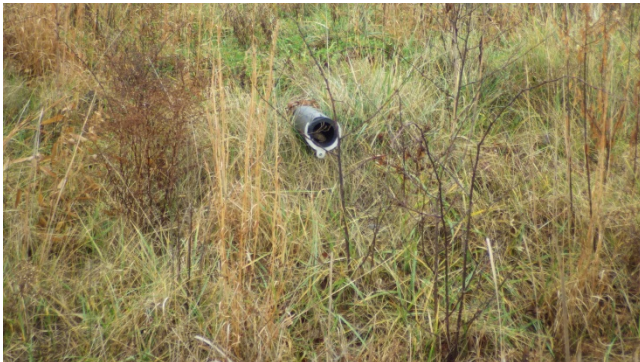
**Photo 11**

- A 4-inch outside diameter plastic pipe was observed on the exterior temporary west slope. The cap for the pipe was missing (Photo No. 11; Point 2, Appendix A).

Uncapped four-inch diameter plastic pipe along western exterior slope of Phase 1.

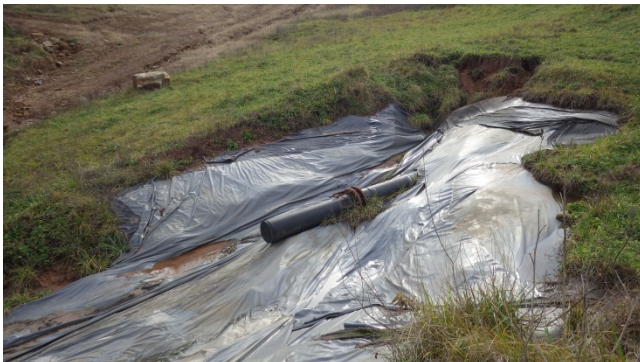
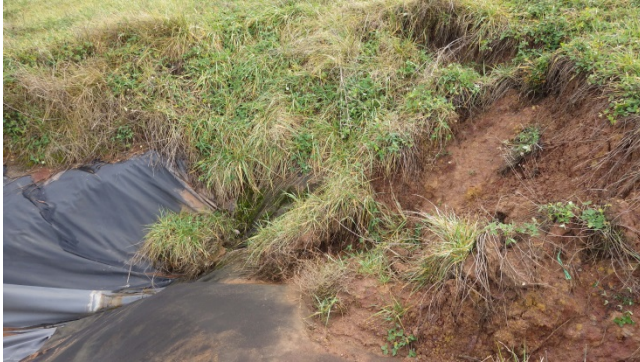
- Sloughing and erosion around the outlet of the leachate collection pipe at the east end of the landfill was observed (Photo Nos. 12 and 13; Points 6, 7, and 8, Appendix A).

Sloughing and erosion around the outlet of the booted underdrain pipe at east end of Phase 1.

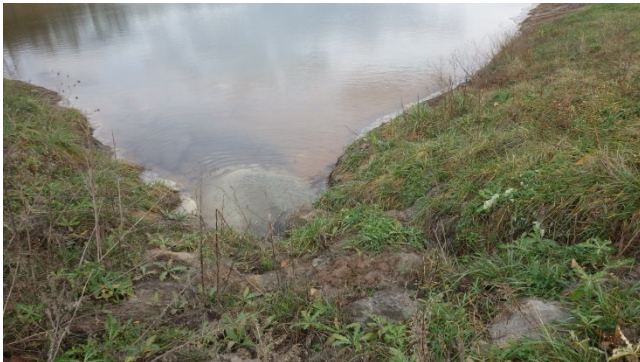
**Photo 14**

CCRs observed on the surface of the Interim Leachate Collection Pond.

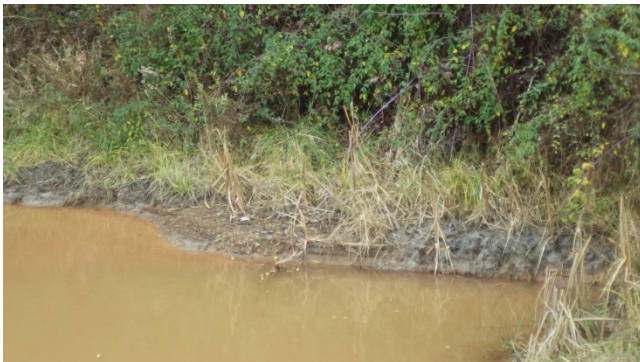
**Photo 15**

CCRs observed on the surface of Sediment Trap No. 21.

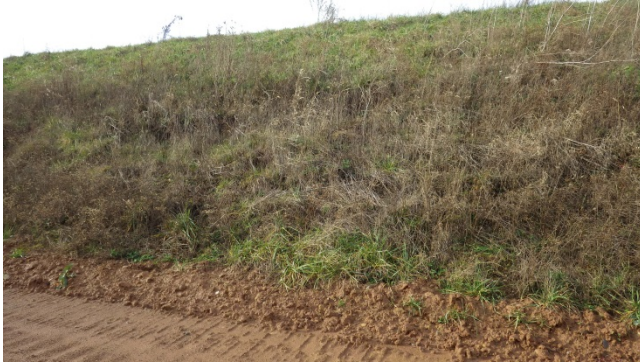
**Photo 16**

A slough was noted along the southern exterior slope of the Interim Leachate Collection Pond.

- Maintain the vegetation along the exterior slope of the Interim Leachate Collection Pond. Characterize the slough identified during the field visit, and address stability concerns of the existing slopes, if needed.
- Characterize and address the erosion occurring near the underdrain pipe at the east side of Phase 1. Take measures to control the flow, minimize sediment transport, and review the design to verify that it is performing as designed. Continue to monitor the toe of the active waste slope.

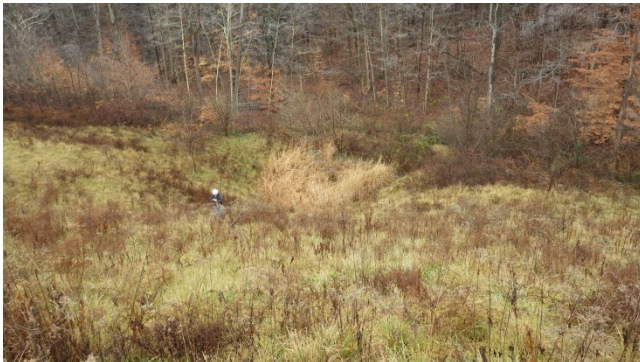
**Photo 17**

The exterior slope of the West Sedimentation Pond, overlooking Sediment Trap No. 13.

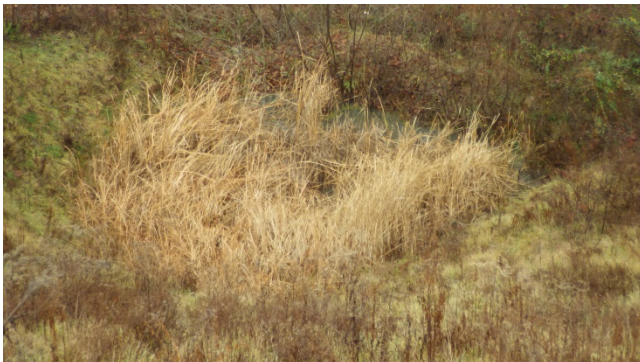
**Photo 18**

Dead vegetation within Sediment Trap No. 13 at the exterior toe of the West Sedimentation Pond.

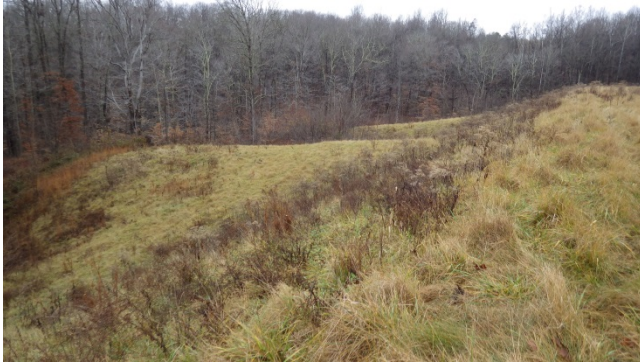
**Photo 19**

Vegetation growth to a height of 18 to 36 inches was observed on the western exterior slope of the West Sedimentation Pond.

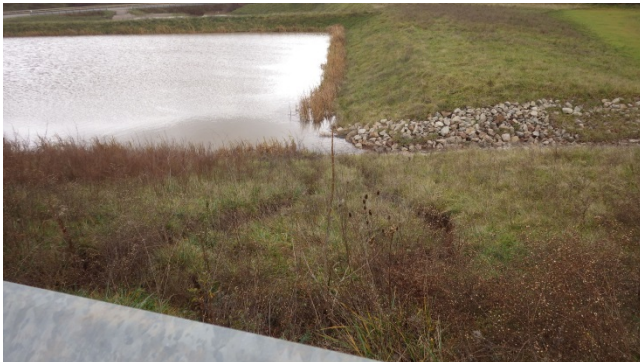
**Photo 20**

- Several erosion gullies are located along the northwest slope of the pond connecting the East Sedimentation Pond to the paved haul road (Photo No. 20).

Erosion gullies from the paved haul road into the northwest corner of the East Sedimentation Pond.

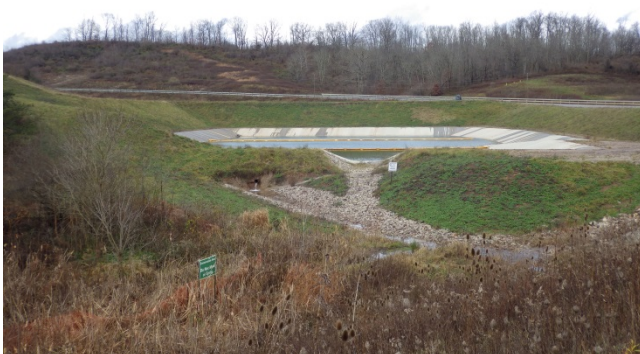
**Photo 21**

Leachate Collection Pond, looking northwest. Note the 12-inch outer-diameter CPP at the left edge of the riprap-lined channel.

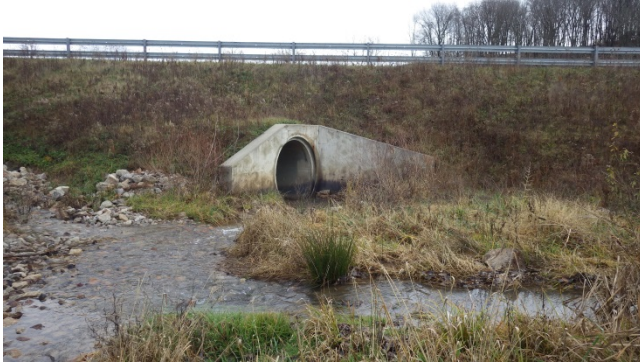
**Photo 22**

The 84-inch diameter concrete culvert connecting Sediment Trap No. 6 under the paved haul road to Sediment Trap No. 7 at the northeastern corner of the landfill site.

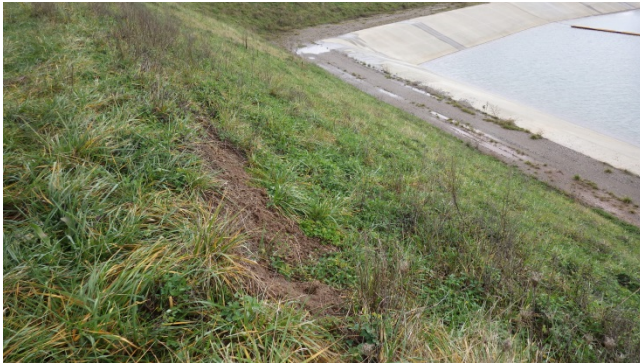
**Photo 23**

Sloughing was observed on the northwest interior slope of the Leachate Collection Pond.

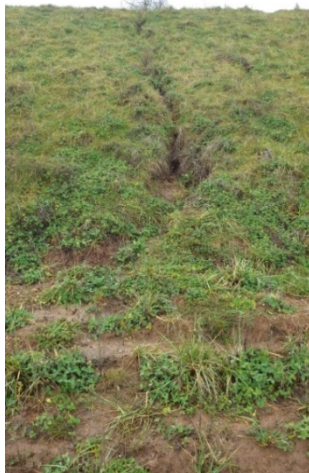
**Photo 24**

- Erosion gullies were observed on eastern interior grass-covered slopes of the pond (Photo No. 24).
- The vegetated interior slopes of the pond were approximately 2.5H:1V.

Erosion rills were observed on the northwest interior slope of the Leachate Collection Pond.

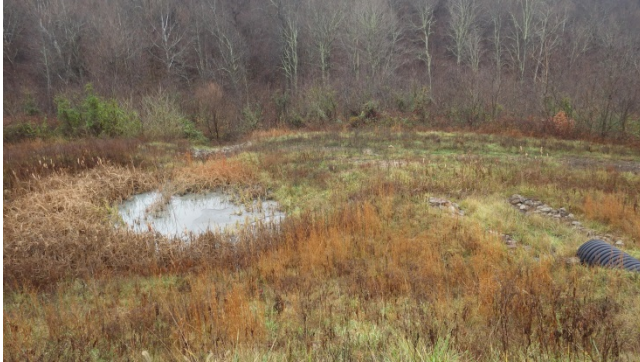
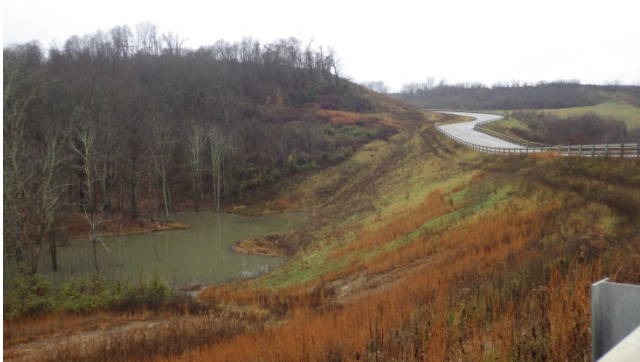
- A number of the sedimentation traps were clogged with sedimentation or not able to be observed due to high water potentially as a result of recent rainfall events (Photo Nos. 25 and 26).

Sediment traps were obscured by high waters due to recent rainfall events.

Sediment traps were obscured by high waters due to recent rainfall events (Sediment Trap Nos. 19 and 20).

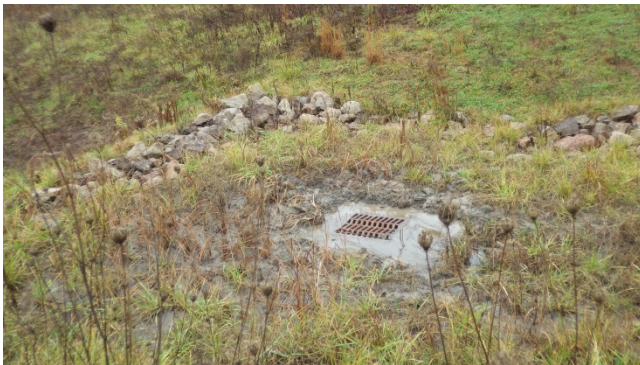
**Photo 27**

Potential CCRs observed at the inlet grate east of Sediment Trap No. 20.

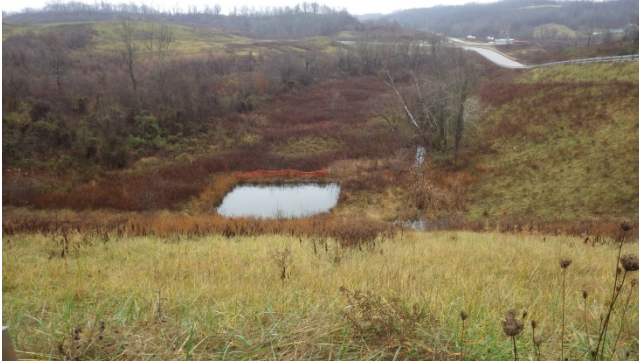
**Photo 28**  
Sediment Pond No. 2.

- Sediment Pond No. 2 has been partially filled in with soil (Photo No. 28).
- Washout of the riprap-lined surface water channel on the east side of the perimeter road was observed east of Sediment Trap No. 26, potentially due to recent rainfall events (Photo No. 29).

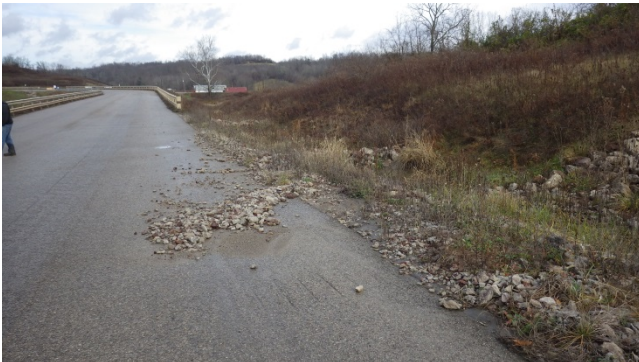
**Photo 29**  
Washout of riprap-lined surface water channel on east side of the perimeter road east of Sediment Trap No. 26.

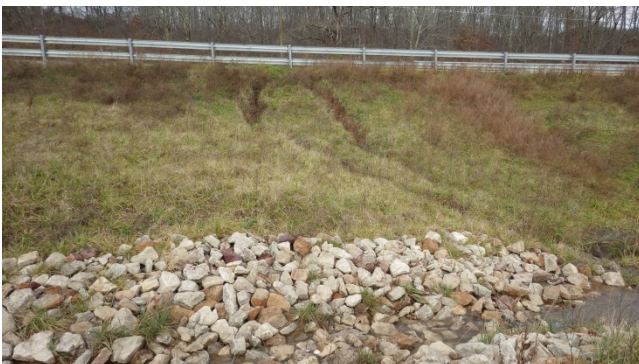
- Erosion gullies, approximately 24 inches deep, were observed on the south side of the perimeter road, near the northeast corner of the East Sedimentation Pond (Photo No. 30).

**Photo 30**  
Erosion gullies approximately 24 inches deep were observed on the south side of the perimeter road near the northeast corner of the East Sedimentation Pond.

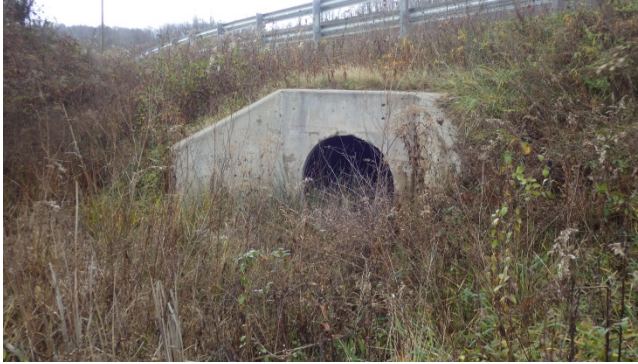
**Photo 31**

- Small tree growth, approximately 2 to 3 inches in diameter, was observed at the inlet of a 36-inch CPP, west of the East Sedimentation Pond on the perimeter road (Photo No. 31).

Small tree growth, 2- to 3-inches in diameter, were observed at inlet for the 36-inch CPP west of the East Sedimentation Pond.
