**Re: Ohio Valley Electric Corporation  
Kyger Creek Station's 2017 Annual Landfill Inspection**

**Reference: 2017 CCR Rule Inspection  
Annual Landfill Inspection  
Kyger Creek Generating Station  
Cheshire, Ohio**

**2017 CCR Rule Inspection  
Kyger Creek Landfill**

Kyger Creek Generating Station  
Cheshire, Ohio  
Gallia County

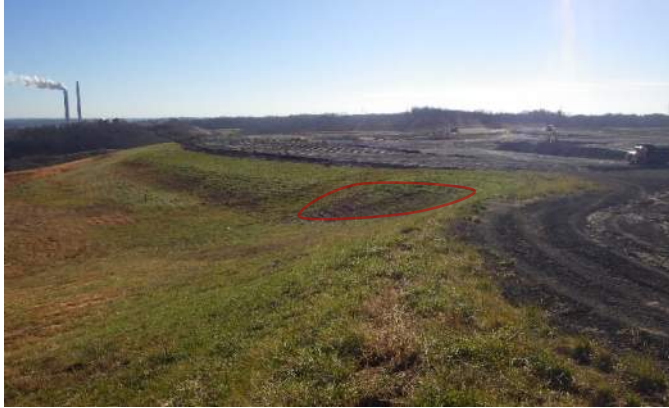
**Photo 1**

- The exterior temporary north slope of Phase 1 is mowed with vegetation less than 6 inches (Photo 1).
- A triangular zone of minimal vegetation was observed on the temporary slope between Phase 1 and 2. The maximum dimensions are 45 feet by 85 feet (Photo 1; Points 1 and 2, Appendix A).

Exterior temporary north slope of Phase 1, looking southeast. Note the triangular zone of minimal vegetation.

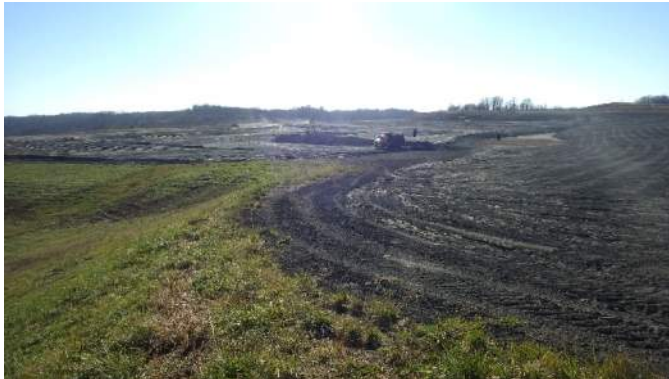
**Photo 2**

- The Phase 1/Phase 2 separation/transition berm is visible in only a few areas. As waste placement comes up in Phase 1, it is tying into the separation/transition berm in several locations. CCRs were not noted downhill of the berm in the Phase 2 area adjacent to the active cell (Photos 2 and 3; Points 3 and 4, Appendix A).

Phase 1/Phase 2 separation/transition berm at northern Phase 1 boundary, looking southeast.

- Relocate the Phase 1/Phase 2 separation/transition berm. Maintain the toe of the active waste limit as shown in the construction drawings to allow contact stormwater management within the facility. CCRs outside of the berm were not observed during this field visit.

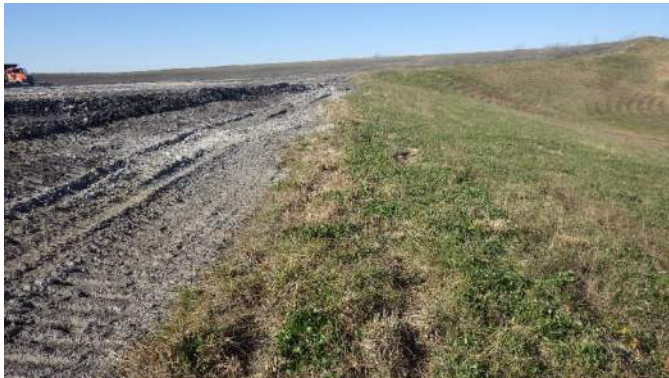
**Photo 3**

Phase 1/Phase 2 separation/transition berm at northern Phase 1 boundary, looking northwest.

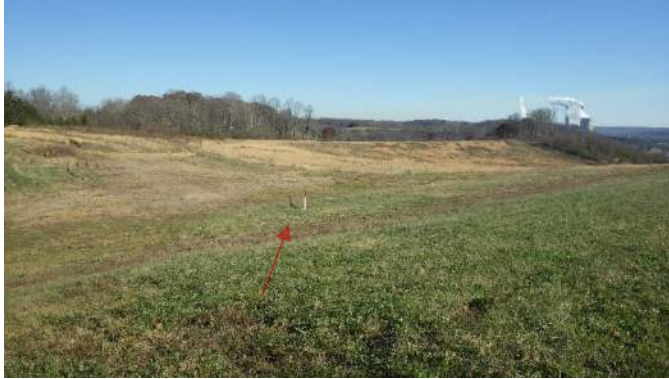
**Photo 4**

- A CCR monitoring well was noted along the northern Phase 1 boundary. It was capped and locked with two bollards protecting the northern side of the well (Photo 4).

A CCR monitoring well located along the northern Phase 1 boundary, looking east.

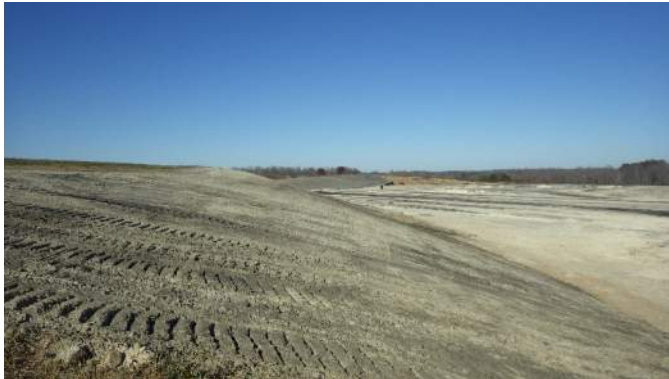
**Photo 5**

- Temporary CCR slopes within the landfill are being placed at a slope of approximately 3.3H:1V (horizontal to vertical) on the interior slopes and the eastern temporary slope of Phase 1 (Photos 5 and 6). Signs of instability such as sloughs or slides were not noted.

Temporary CCR slopes within the Phase 1 landfill, looking north.

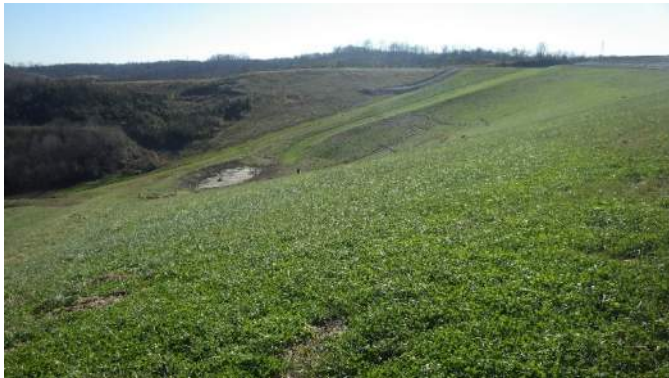
**Photo 6**

The eastern temporary slope of Phase 1, looking south.

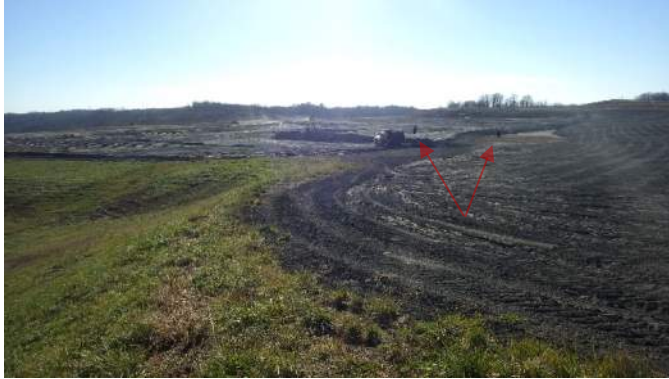
**Photo 7**

- A series of chimney drains was visible at regular intervals within the phase from west to east (Photos 7 and 8).

Chimney drains in the Phase 1 footprint, looking southeast.

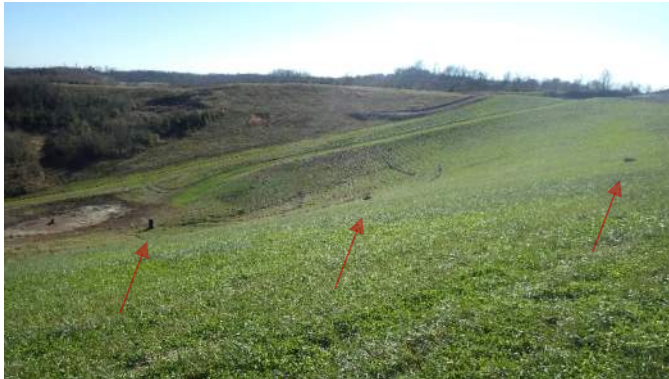
**Photo 8**

Chimney drains in the Phase 1 footprint, looking south.

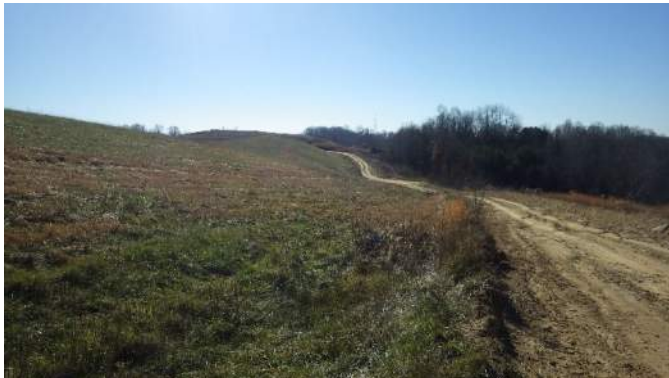
**Photo 9**

- The exterior slopes along the anchor trench on the south side and the west side have temporary cover that is mowed with vegetation less than 6 inches (Photos 9 and 10).

The western Phase 1 slope has temporary cover that is mowed with vegetation less than 6 inches. Photo is looking south.

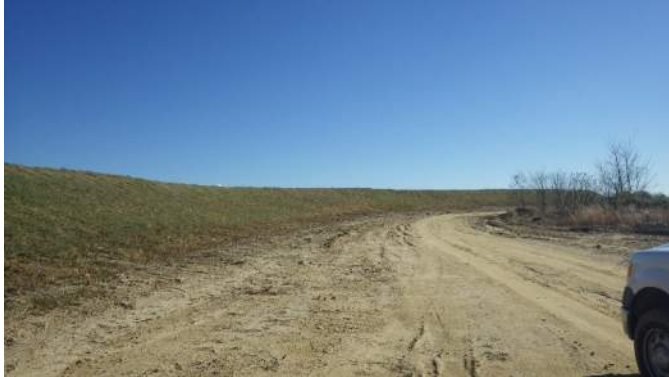
**Photo 10**

The southern Phase 1 slope has temporary cover that is mowed with vegetation less than 6 inches. Photo is looking southeast.

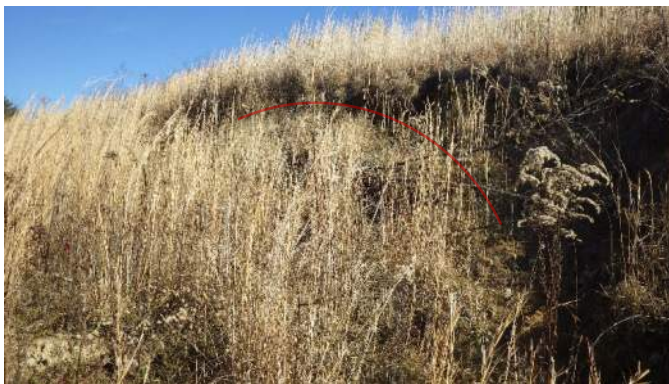
**Photo 11**

- Small diameter trees and taller vegetation (12 to 48 inches) remain on the western slope of Phase 1 above the West Sedimentation Pond. Field observations suggest multiple sloughs in this area, including a progressive slough with a total of 3-foot head scarp and a width of 38 feet located approximately 10 feet from the road elevation and a second smaller scarp located north of it. Heavy vegetation obscures clearer measurement of the conditions. This region is identified in red on the figure (Photo 11; Red region, Appendix A).

Slough on the western edge of Phase 1 above the West Sedimentation Pond, looking east. Observation is obscured by heavy vegetation.

- Mow the vegetation along the western edge of Phase 1 above the West Sedimentation Pond to understand potential stability concerns in this area. Characterize and remediate the sloughs as needed. The scarp on the northwestern exterior slope of the West Sedimentation Pond has been regraded and vegetated since the 2016 inspection.

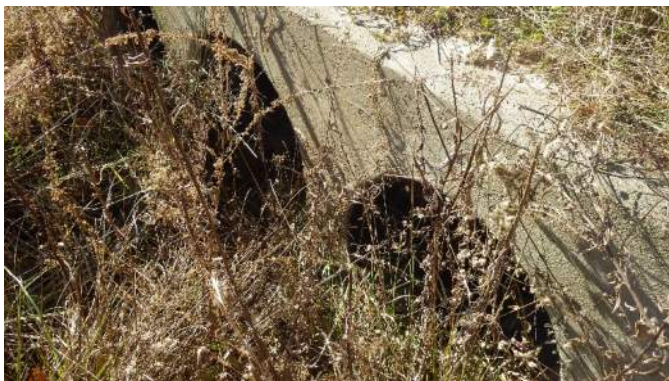
**Photo 12**

- Five 24-inch high-density polyethylene (HDPE) pipes underlie the access road west of Phase 1. The pipes outlet into a riprap-lined channel that flows to the West Sedimentation Pond. The pipe inlets are partially blocked due to soil erosion of the road and Phase 1 temporary cover. The roadway above the pipe outlets is heavily eroded (Photos 12 and 13; Points 7 and 8, Appendix A).

The five stormwater pipes on the western edge of Phase 1 are partially blocked with sediment and obscured by vegetation. Photo is looking west.

- Remove the vegetation and sediment restricting flow through the five HDPE pipes flowing from the Phase 1 western slope to the West Sedimentation Pond. Repair and maintain the stormwater best management practice (BMPs) for the channels flowing to the pipes. Remediate the eroded area at the pipe outlets to protect the access road for Phase 1.

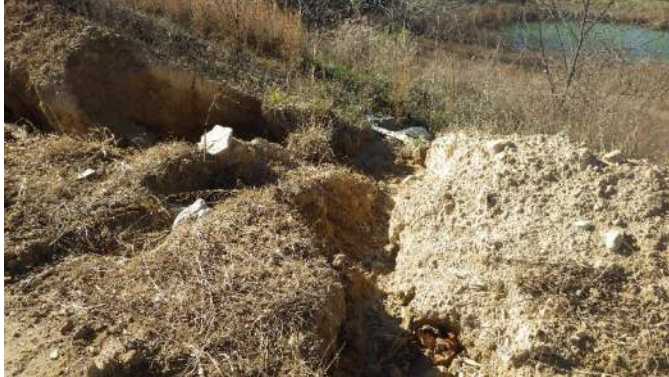
**Photo 13**

Erosion of the access road above the stormwater discharge on the western edge of Phase 1, looking west.

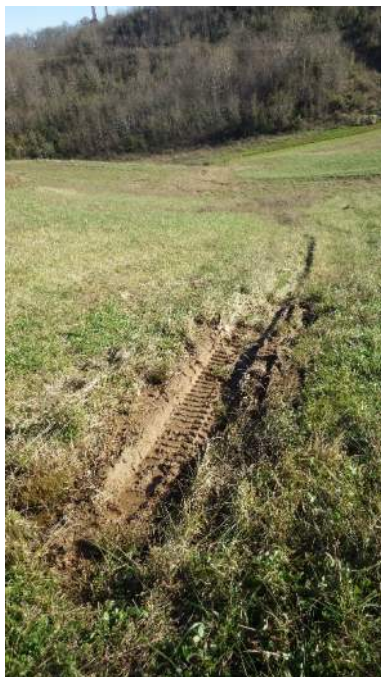
**Photo 14**

- Standing water was observed in an equipment rut just outside of Phase 1 (Photo 14; Point 9, Appendix A).
- The eastern temporary slope of Phase 1 shows erosion rills near the toe. Rows of 6-inch-diameter erosion control sock have been placed down the slope to slow surface water runoff. The zone is vegetated and mowed. This is a maintenance issue for observation (Photos 15 and 16; Point 10, Appendix A).

Standing water in an equipment rut just outside of the northeast corner of Phase 1, looking southeast.

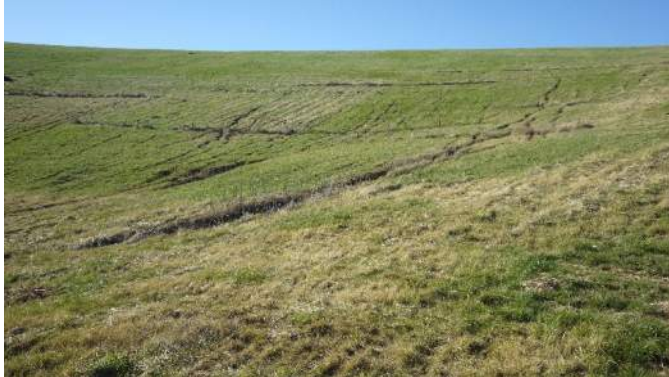
**Photo 15**

Erosion rills in the temporary cover of the eastern edge of Phase 1, looking northwest.

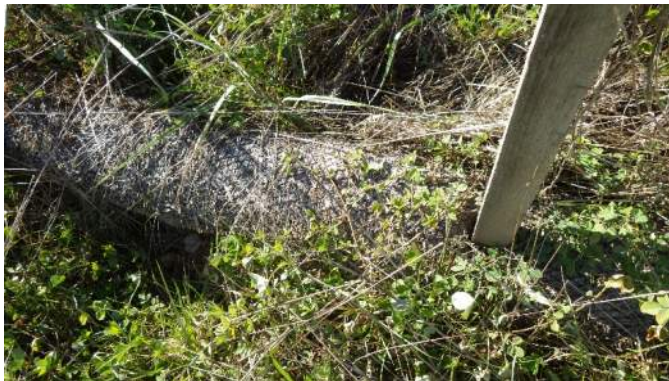
**Photo 16**

Erosion control socks are installed at regular intervals along the eastern edge of Phase 1.

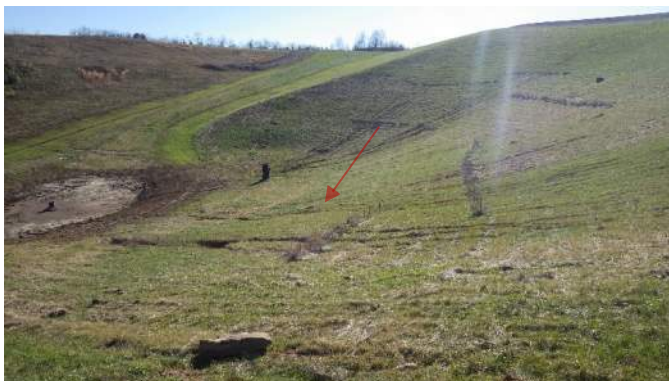
**Photo 17**

- A change of slope was noted on the northern section of the eastern Phase 1 face. No additional indicators of slope instability were observed. However, the region was noted for continued monitoring (Photo 17; Point 11, Appendix A).

A change in slope on the northeastern portion of the Phase 1 temporary slope. Photo is looking south.

- Monitor the slope change at toe of slope of the northeast Phase 1 face during the weekly and monthly inspections for changes to the current conditions.

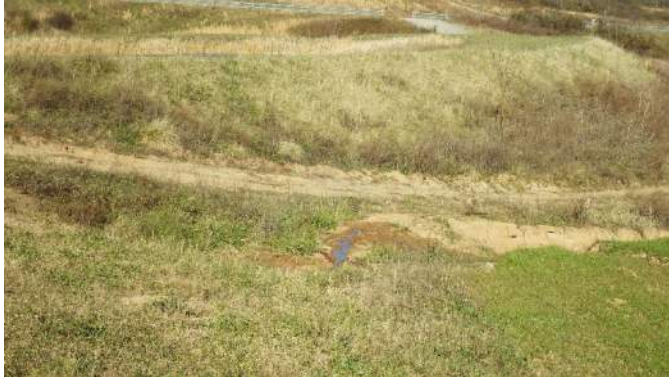
**Photo 18**

- The area beyond the eastern edge of the active Phase 1 cell remains spongy with clear seepage flowing eastward (Photos 18 and 19; Point 12, Appendix A).

Active clear water seep east of the Phase 1 toe of slope, looking north.

- Monitor the termination of the Phase 1 underdrain system during site inspections. Characterize and address the seepage as part of operations. This area is contained within the waste footprint with surface water controls in place downstream.

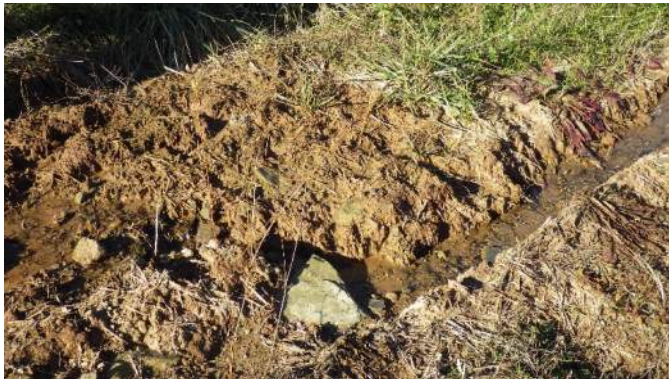
**Photo 19**

Active clear water seep east of the Phase 1 toe of slope, looking west.

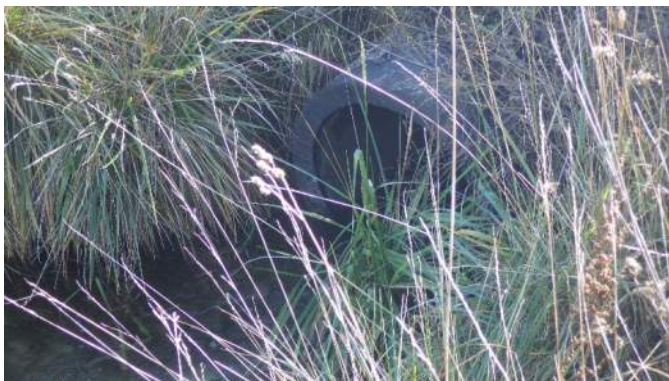
**Photo 20**

- The leachate pipe outlet from Phase 1 was observed within the Interim Leachate Collection Pond. It appeared to be freely flowing though obscured by vegetation (Photo 20).

The leachate pipe outlet into from Interim Leachate Pond from the eastern edge of Phase 1, looking southeast.

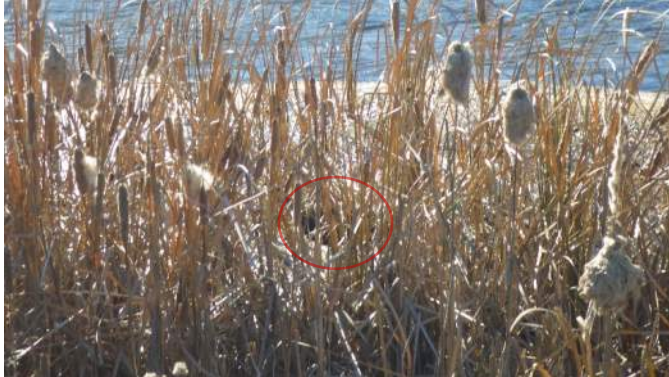
**Photo 21**

The overflow outlet for the Interim Collection Pond, looking south.

- Continue to repair erosion gullies, reestablish grass vegetation, and monitor in future inspections.
- A cover grate is recommended for the overflow pipe at the Interim Leachate Collection Pond to minimize debris carried into the pipe.

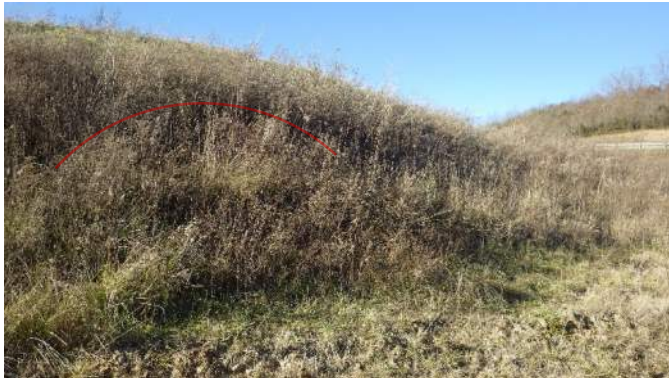
**Photo 22**

- The slough previously observed on the south side of the Interim Leachate Collection Pond appears unchanged. Visual observation continues to be obscured by vegetation (Photo 22).

Slough on the southeastern exterior slope of the Interim Leachate Collection Pond, looking north.

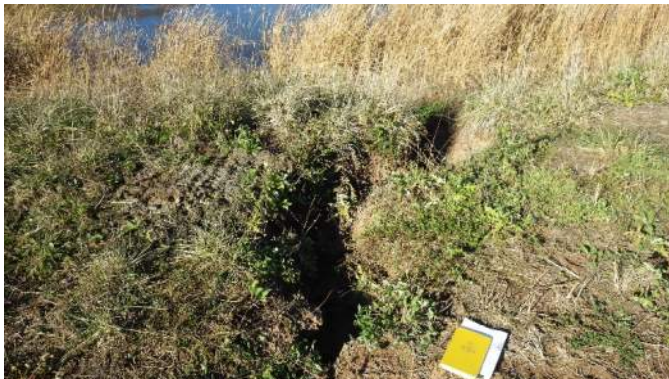
**Photo 23**

- Deep erosion gullies were noted on the western and southern interior slopes of the Interim Leachate Collection Pond. Gullies measured 1 to 2 feet with depths up to 2.5 feet (Photo 23; Points 13 and 14, Appendix A).

Erosion gullies were observed on the western interior slope of the Interim Leachate Collection Pond. Photo is looking east.

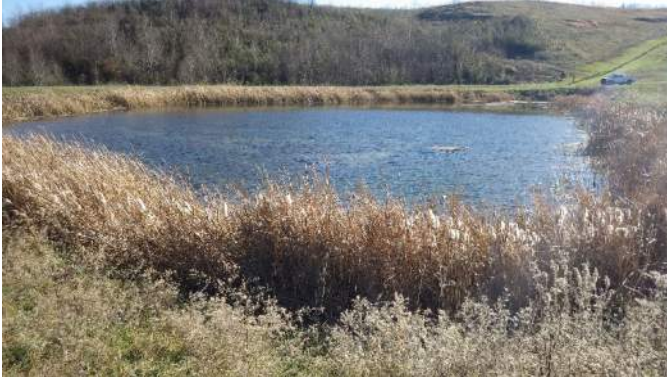
**Photo 24**

The bottom of the Interim Leachate Collection Pond was visible with algae and heavy reeds around the perimeter. Photo is looking southeast.

- Sediment buildup within the Interim Leachate Collection Pond may need to be addressed to maintain the required design capacity.
- Characterize and address the cause of the erosion scour hole west of the Leachate Collection Pond's overflow spillway.

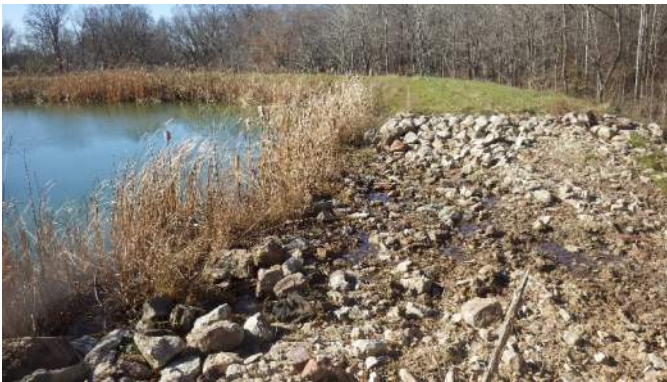
**Photo 25**

- The small trees previously noted in the pond spillway during the 2016 inspection have been removed (Photo 25).
- The scarp observed on the outside slope of the pond adjacent to the Stormwater Outfall 034 channel during the 2016 inspection has been regraded and vegetated. Silt fence is present at the toe of the reworked area. A small scarp was noted at the southwestern end of the reworked zone north of Sediment Trap No. 13 (Photos 26; Point 6, Appendix A).
- Vegetation growth to a height of 12 to 48 inches was observed on the western exterior slope of the West Sedimentation Pond, obscuring visual observation (Photo 27).

The West Sedimentation Pond spillway is clear of woody vegetation. Photo is looking west.

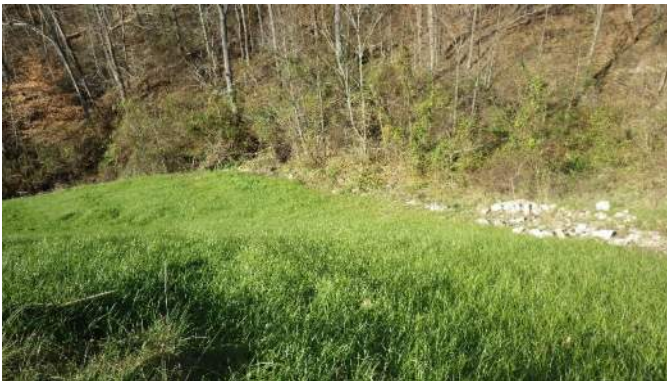
**Photo 26**

The scarp observed on the north exterior slope of the West Sedimentation Pond has been regraded and vegetated. Photo is looking northwest.

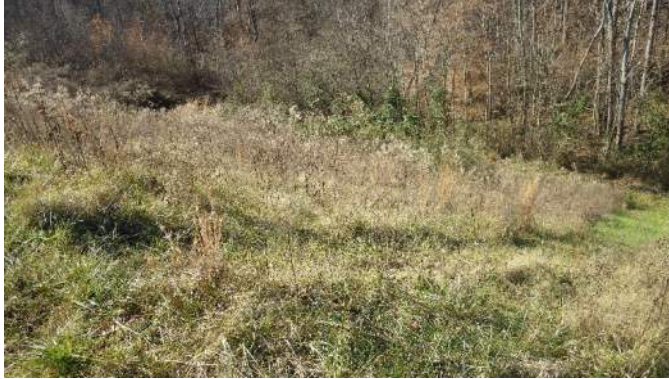
**Photo 27**

The western exterior slope of the West Sedimentation Pond is obscured by vegetation. Photo is looking west.

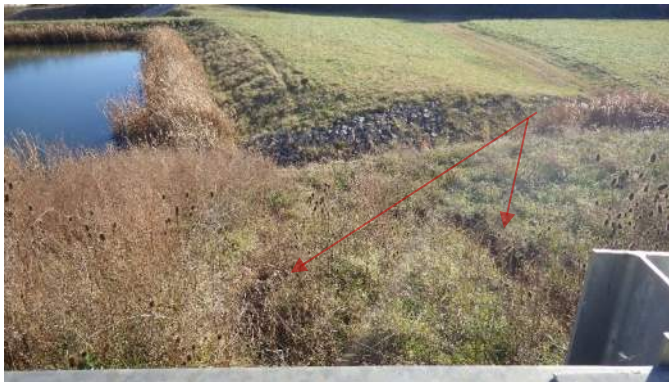
**Photo 28**

Erosion gullies observed from the paved haul road to the East Sedimentation Pond, looking southeast.

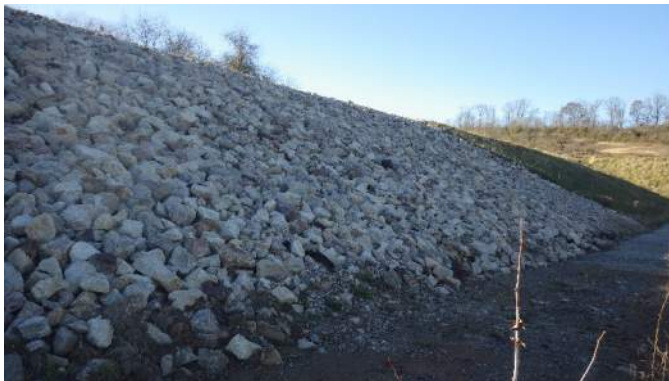
**Photo 29**

The riprap repair on the western earthen slope above the Leachate Collection Pond, looking northwest.

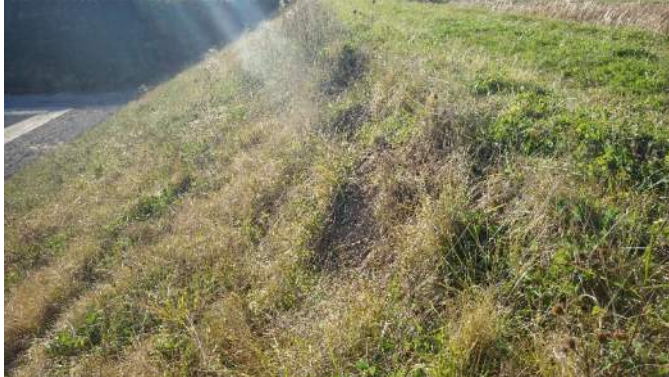
**Photo 30**

- A seepage zone was observed along the southwestern edge of the pond. Flow through concrete joints within the pond was noted, and a wet region of the earthen embankment was noted (Points 17 and 18).
- Just north of the seepage zone, a riprap repair was performed on the western slope of the Leachate Collection Pond in the earthen zone above the concrete liner. This appears to address erosion gullies observed in the 2016 inspection (Photo 29; Points 19 and 20, Appendix A).
- A slough approximately 4-feet high and 20-feet wide was noted on the northwest interior slope above the concrete slope. This appears unchanged from the 2016 inspection report (Photo 30; Point 21, Appendix A).

A slough in the earthen embankment between the Leachate Collection Pond and the East Sedimentation Pond, looking west.

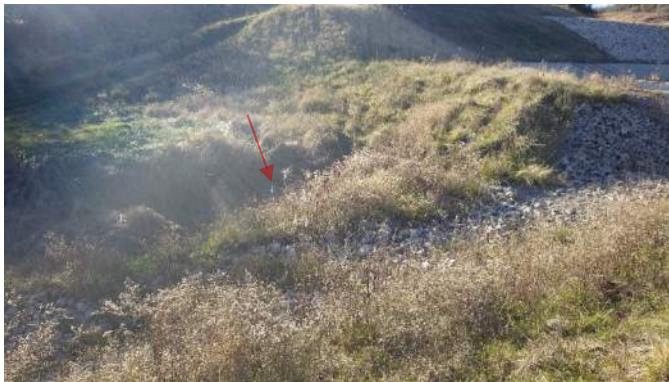
**Photo 31**

- An erosion scour hole is present southwest of the existing emergency overflow structure for the pond. It appears lower in elevation than the spillway (Photo 31; Point 22, Appendix A).
- The outlet of a 12-inch outside diameter CPP was observed on the southeast side of the pond. The pipe empties into a riprap-lined channel that passes beneath the perimeter road via an 84-inch diameter concrete culvert. The pipes were unobstructed and flowing.

An erosion scour hole is present west of the overflow spillway for the Leachate Collection Pond. Photo is looking west.

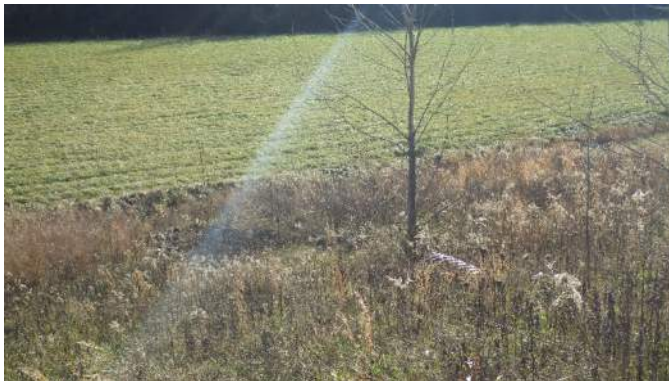
**Photo 32**

- The sedimentation traps along the perimeter haul road were observed during the December site visit. When accessible, pipe inlets and outlets were observed. The sedimentation traps appeared to be working as intended with minimal sedimentation buildup and freely flowing pipes.
- Along the gravel road to Phase 2, trees (2 to 3 inches in diameter) were observed at the stormwater drop inlets, channels, and pipe outlets. Flow did not appear to be restricted (Photo 32; Point 15, Appendix A).

Trees (2 to 3 inches in diameter) were observed at the stormwater drop inlets, channels, and pipe outlets. Photo is looking south.
