**Re: Ohio Valley Electric Corporation
Kyger Creek Station's 2018 Annual Landfill Inspection**

**Reference: 2018 CCR Rule Inspection
Annual Landfill Inspection
Kyger Creek Generating Station
Cheshire, Ohio**

**2018 CCR Rule Inspection
Kyger Creek Landfill**

Kyger Creek Generating Station
Cheshire, Ohio
Gallia County

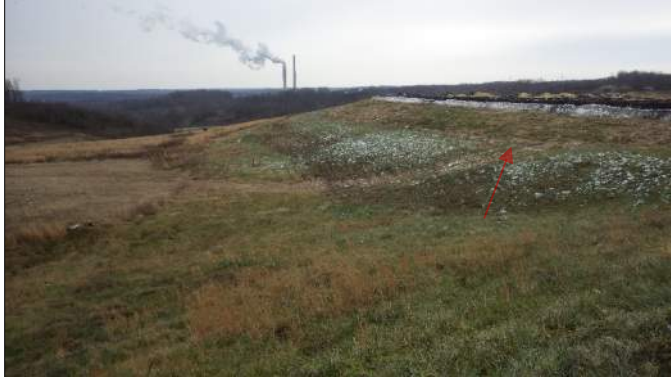
**Photo 4**

- The vegetation between Phases 1 and 2 is thin with bare earthen areas near the phase boundary. (Photo 4, Appendix B). The plant appears to be revegetating the area with zones of new vegetation noted (Photo 5, Appendix A; Point 1, Appendix B).

The phase boundary between Phases 1 and 2, looking east. Note the thin vegetation and bare spots.

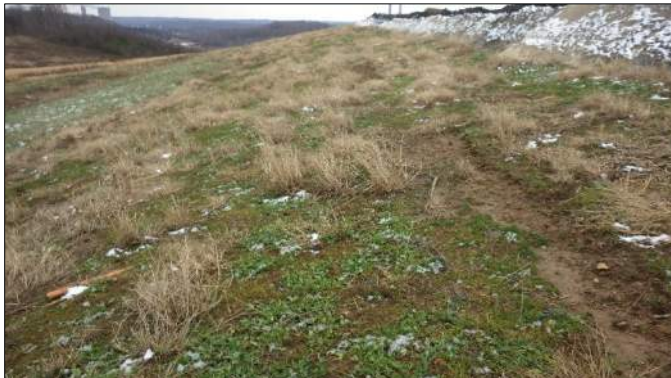
**Photo 5**

New vegetation between Phases 1 and 2, looking east. See Point 11 in Appendix A.

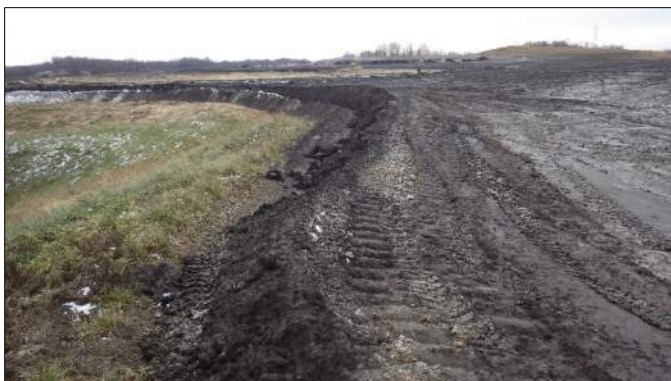
**Photo 6**

- The Phase 1/Phase 2 separation/transition berm is visible in only a few areas. As waste placement comes up in Phase 1, it is tying into the separation/transition berm in several locations. The CCRs were not noted downhill of the berm in the Phase 2 area adjacent to the active cell (Photo 6, Appendix A; Point 2, Appendix B).

The Phase 1/Phase 2 separation/transition berm, looking southeast. See Point 2 in Appendix A.

- Relocate the Phase 1/Phase 2 separation/transition berm. Maintain the toe of the active waste limit as shown in the construction drawings to allow contact stormwater management within the facility. CCRs outside of the berm were not observed during this field visit.

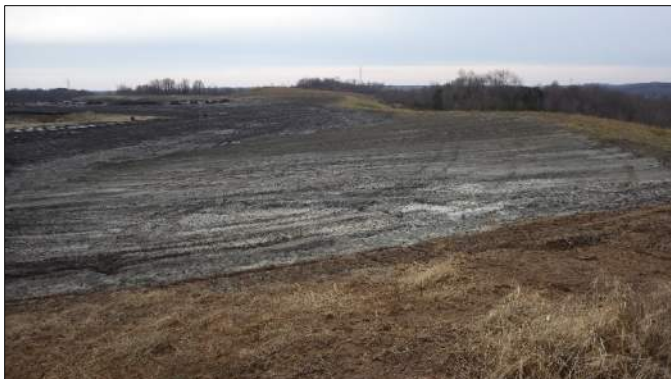
Photo 9

- Temporary CCR within the landfill are being placed at a slope of approximately 2.7H:1V (horizontal to vertical) on the interior slopes at the southwestern edge of Phase 1 (Point 3, Appendix A), flattening to 7.1H:1V at the northwestern edge of Phase 1 (near Point 2, Appendix A; Photo 9, Appendix B). Signs of instability such as sloughs or slides were not noted.

The temporary CCR slopes along the western edge of Phase 1, looking southwest.

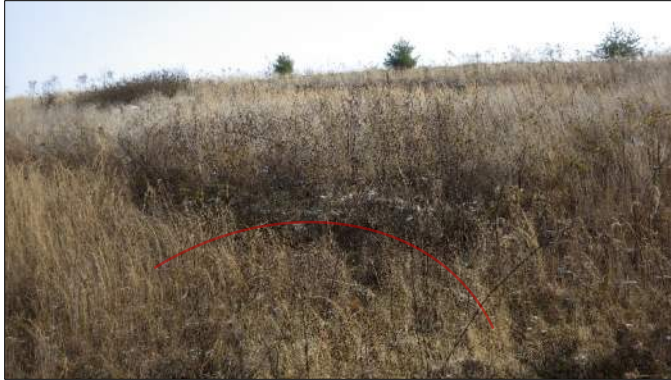
**Photo 10**

- Small diameter trees and taller vegetation (12 to 48 inches) remain on the western slope of Phase 1 above the West Sedimentation Pond. Heavy vegetation obscures clearer measurement of the conditions. This region is identified in red on the figure (red region, Appendix A; Photo 10, Appendix B). In 2017, field observations suggest multiple sloughs in this area, including a progressive slough with a 3-foot head scarp and a width of 38 feet located approximately 10 feet from the road elevation and a second smaller scarp located north of it.

Slough on the western edge of Phase 1 above the West Sedimentation Pond, looking east. Observation is obscured by heavy vegetation.

- Mow the vegetation along the western edge of Phase 1 above the West Sedimentation Pond to understand potential stability concerns in this area. Characterize and remediate the sloughs as needed. A progressive scarp was observed on the northwestern exterior slope of the West Sedimentation Pond.

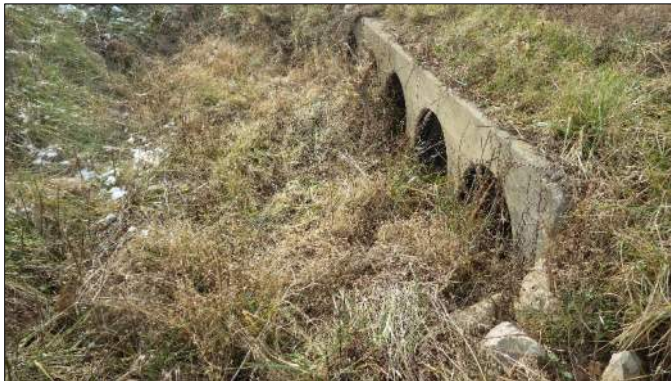
**Photo 11**

The five stormwater pipes on the western edge of Phase 1 are partially blocked with sediment and obscured by vegetation. Photo is looking southwest.

- Remove the sediment restricting flow through the five HDPE pipes flowing from the Phase 1 western slope to the West Sedimentation Pond. Repair and maintain the stormwater best management practices (BMPs) for the channels flowing to the pipes. Remediate the eroded area at the pipe outlets to protect the access road for Phase 1.
- Maintain the vegetation along the exterior slopes and within the surface drainage channels to facilitate inspections by removing taller weeds and trees as needed.
- Continue to repair erosion gullies, reestablish grass vegetation, and monitor in future inspections.
- A cover grate is recommended for the overflow pipe at the Interim Leachate Collection Pond to minimize debris carried into the pipe.

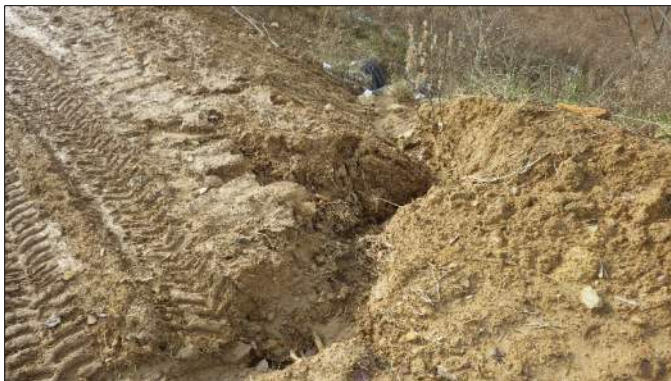
**Photo 12**

Erosion of the access road above the stormwater discharge on the western edge of Phase 1, looking west.

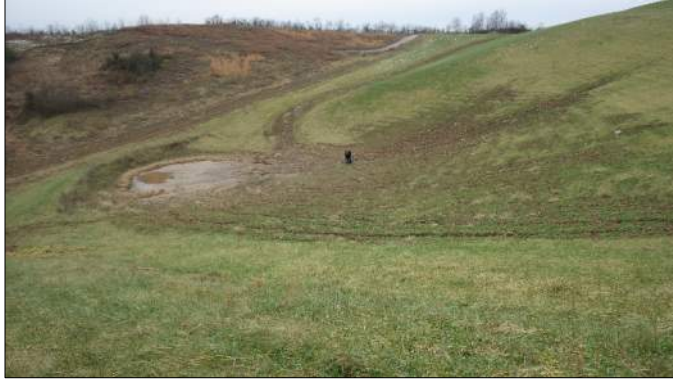
**Photo 13**

- The change of slope noted in the 2017 report on the northern section of the eastern Phase 1 face was not observed. The erosion control socks have been removed, and the vegetation looks uniform and maintained. No additional indicators of slope instability were observed (Photos 8 and 13, Appendix B).

Erosion rills near the toe of the eastern temporary slope of Phase 1, looking south. Note the chimney drain in the center of the photo.

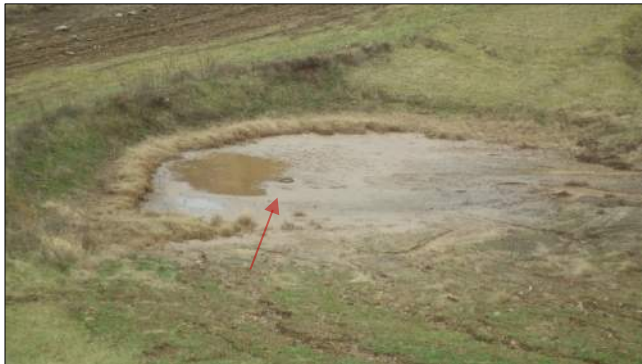
**Photo 14**

The sedimentation pond at the toe of the temporary eastern slope for Phase 1. The overflow structure is unrestricted but near capacity, looking southeast.

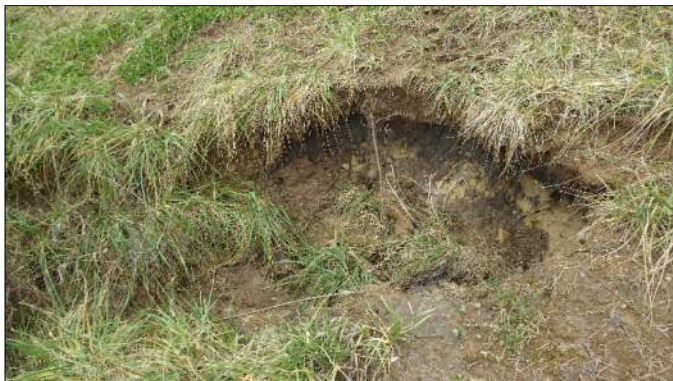
**Photo 15**

- At the northern edge of the eastern Phase 1 face, an erosion hole and gully have formed near the transition from Phase 1 to Phase 2. The erosion hole is approximately four feet by two feet. Two points are noted for the top and toe of the gully (Points 8 and 9, Appendix A; Photos 15 and 16, Appendix B).

Erosion hole in the temporary cover of the eastern edge of Phase 1 near the Phase 1/Phase 2 boundary, looking west.

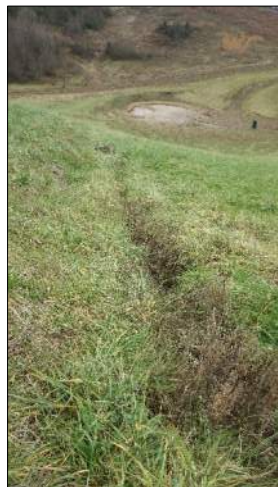
**Photo 16**

The erosion gully along the Phase 1/Phase 2 boundary of the eastern temporary cover, looking southeast.

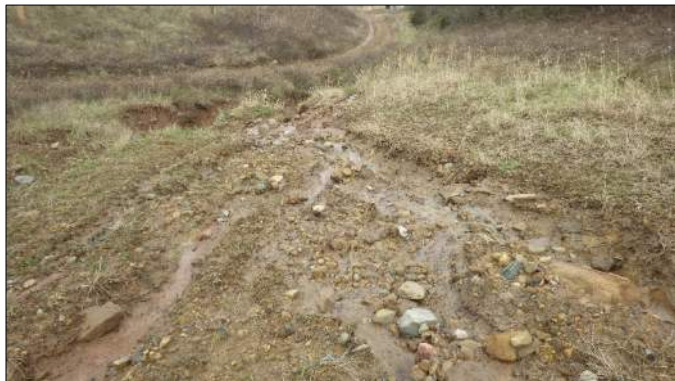
**Photo 17**

The seepage zone downstream of the toe of the temporary eastern slope of Phase 1, looking south.

- Several wet or standing water zones were identified during this field visit following a dry period for the site. Seepage conditions appeared to be a known issue for the design, but should be monitored during operations for future planning purposes.

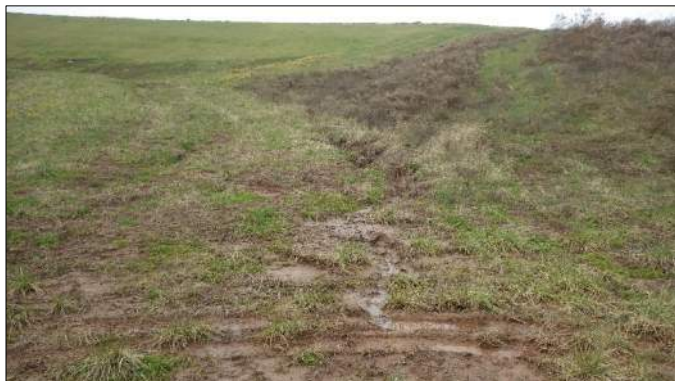
**Photo 18**

Active clear water seep east of the Phase 1 toe of slope, looking northwest.

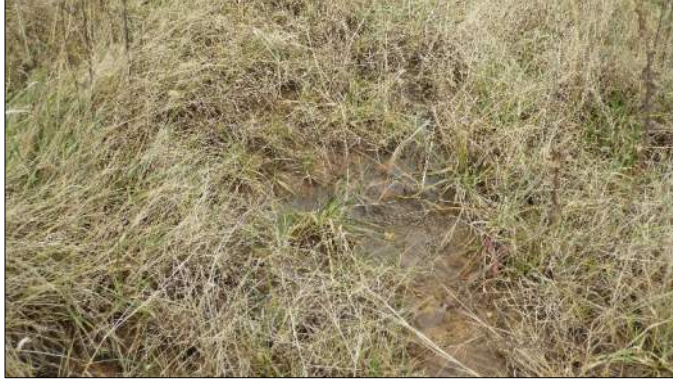
**Photo 19**

Active clear water seep east of the Phase 1 toe of slope, looking west.

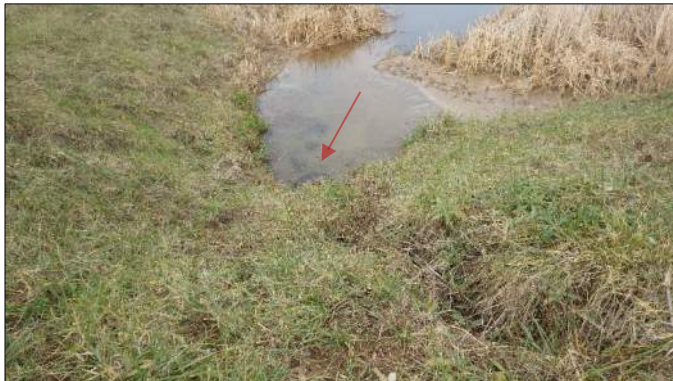
**Photo 20**

- The leachate pipe outlet from Phase 1 was observed within the Interim Leachate Collection Pond and appeared to be freely flowing (Photo 20, Appendix B).

The leachate pipe outlet into Interim Leachate Pond from the eastern edge of Phase 1, looking north.

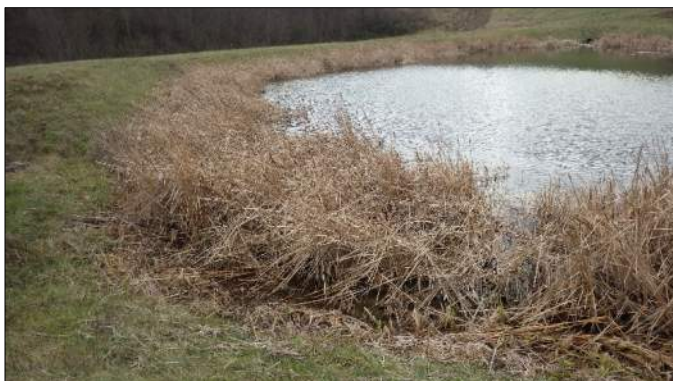
**Photo 21**

The area containing the overflow outlet for the Interim Collection Pond, looking northwest. The pipe could not be visually located.

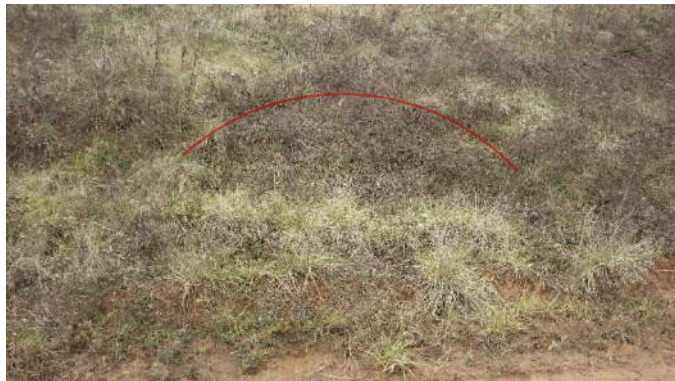
**Photo 22**

- The slough previously observed on the south side of the Interim Leachate Collection Pond appears unchanged. Visual observation continues to be obscured by vegetation (Photo 22, Appendix B).

Slough on the southeastern exterior slope of the Interim Leachate Collection Pond, looking north.

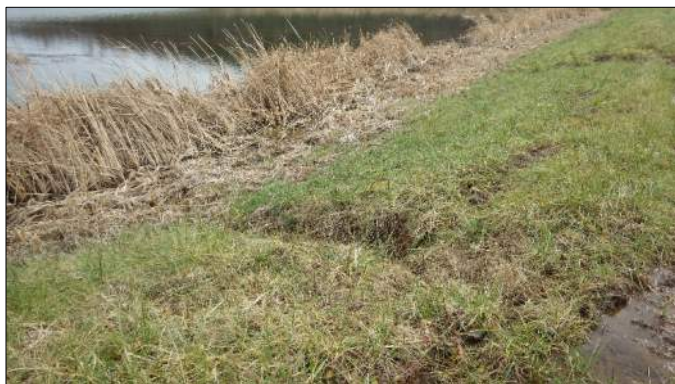
**Photo 23**

- Deep erosion gullies were noted on the western and southern interior slopes of the Interim Leachate Collection Pond. Gullies measured one to three feet wide with depths up to 2.5 feet (Points 12 through 15 (area denoted by the navy line), Appendix A; Photos 23 and 24, Appendix B). Taller vegetation obscures visual observation along the crest of the dike.

Erosion gullies were observed on the western interior slope of the Interim Leachate Collection Pond. Photo is looking northwest.

- Maintain the vegetation near the Interim Leachate Collection Pond and address the erosion gullies along the western and southern interior embankment.

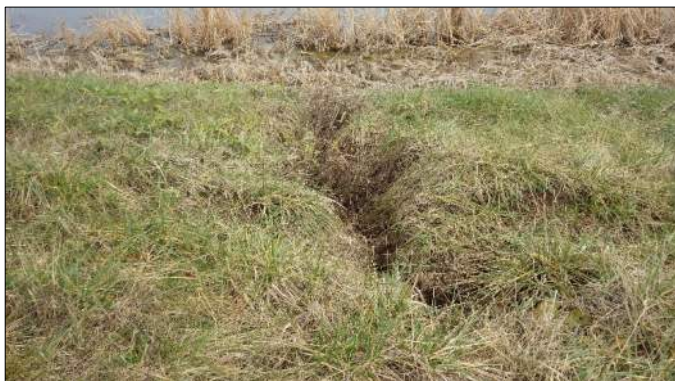
**Photo 24**

Erosion gullies were observed on the western interior slope of the Interim Leachate Collection Pond. Photo is looking east.

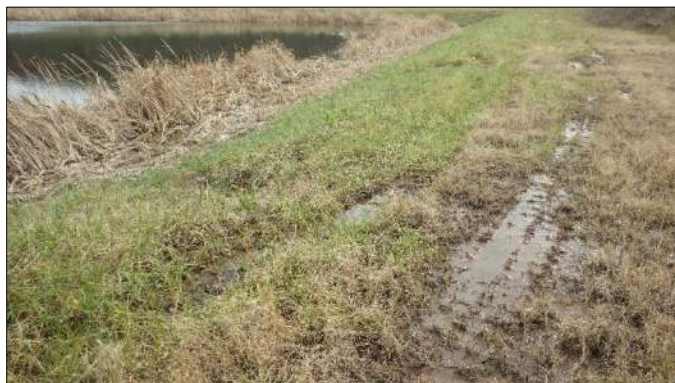
**Photo 25**

The wet zone along the western crest of the Interim Leachate Collection Pond, looking north.

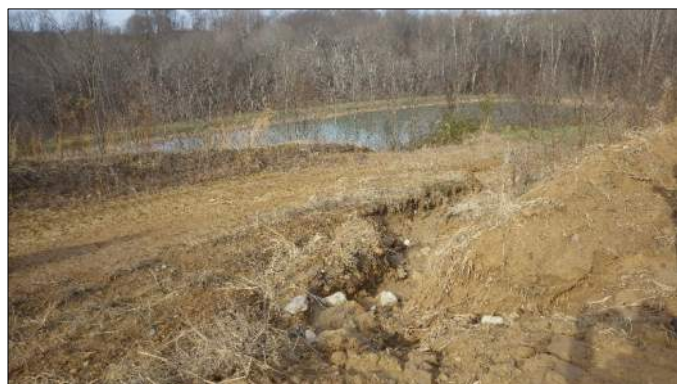
**Photo 26**

The erosion gully at the top of the access road to the West Sedimentation Pond. Photo is looking northwest.

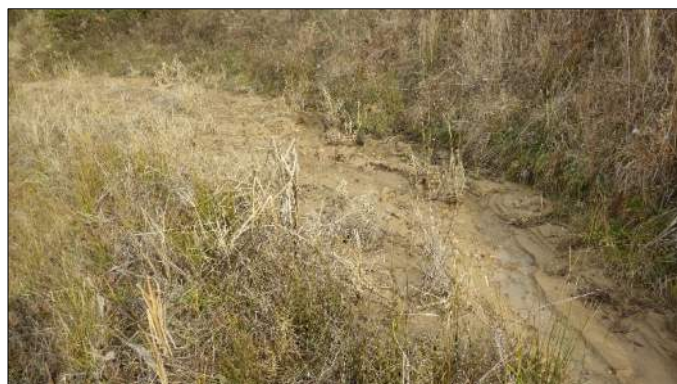
**Photo 27**

Sediment in the stormwater channel at the toe of the access road to the West Sedimentation Pond. Photo is looking north.

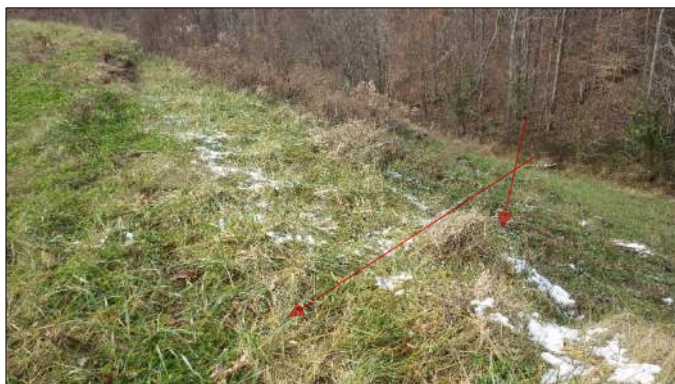
**Photo 29**

A progressive scarp has formed on the northwestern exterior slope of the West Sedimentation Pond. Arrows point to the heads of two scarps. Photo looking southwest.

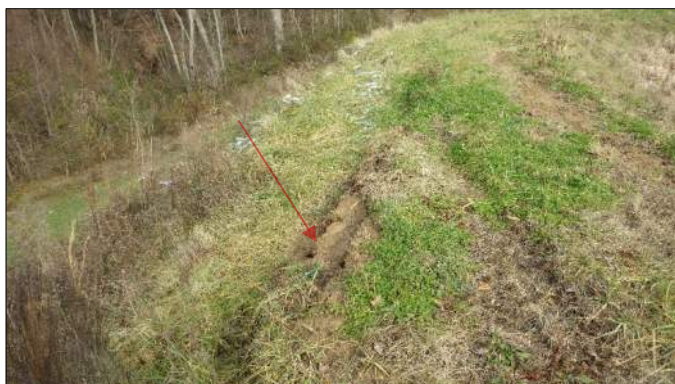
**Photo 30**

A progressive scarp has formed on the northwestern exterior slope of the West Sedimentation Pond. Arrow points to the heads of two scarps. Photo looking north.

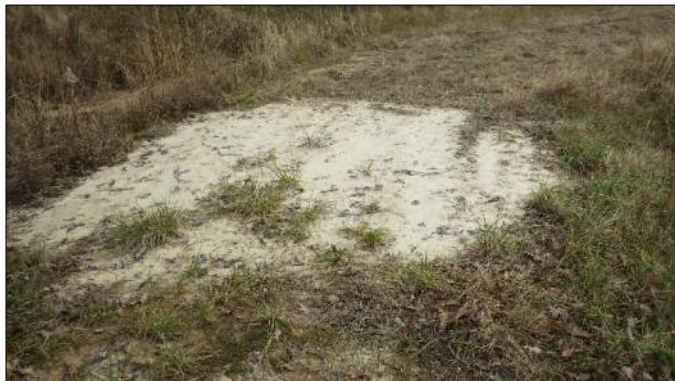
**Photo 31**

- Small scarps (6 to 24 inches in depth) were noted uphill of Sediment Trap No. 13 (Point 21, Appendix A).
- Two light sediment piles, approximately 14 feet in diameter, were observed. One was at the south end of the pond. The other was at the northern end (Points 22 and 23, Appendix A; Photo 31, Appendix B).

A light sediment pile, approximately 14 feet in diameter at the north end of the West Sedimentation Pond, looking north.

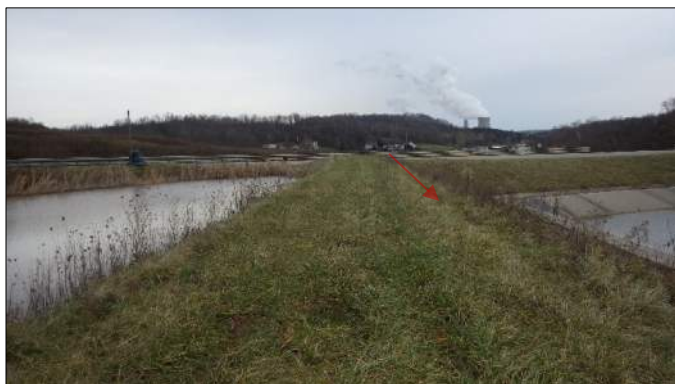
**Photo 32**

- A slough approximately 4-feet high and 20-feet wide was noted on the northwest interior slope above the concrete slope. This is the shared dike with the East Sedimentation Pond. This appears unchanged from the 2017 inspection report (Point 26, Appendix A; Photos 32 and 33, Appendix B).

The southeastern crest of the East Sedimentation Pond. The arrow marks the estimated location of the slough above the Leachate Collection Pond. Photo is looking northeast.

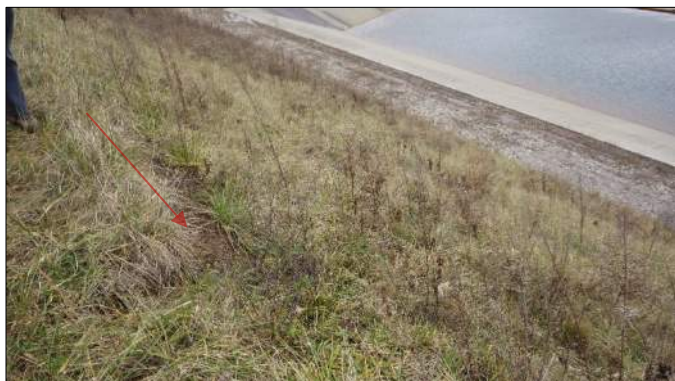
**Photo 33**

The slough observed on the shared dike between the East Sedimentation Pond and the Leachate Collection Pond. Photo is looking southeast.

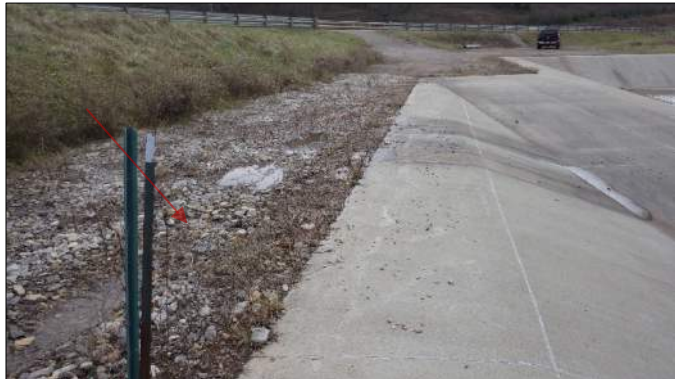
**Photo 34**

- Wet zone at northeast corner on the pond's concrete liner (Photo 34, Appendix B).
- A seepage zone was observed along the southwestern edge of the Leachate Collection Pond. Flow through concrete joints within the pond was noted, and a wet region of the earthen embankment was noted (Points 27 and 28, Appendix A; Photos 34 and 35, Appendix B).

Standing water along the northeastern side of the Leachate Collection Pond. Photo is looking southeast.

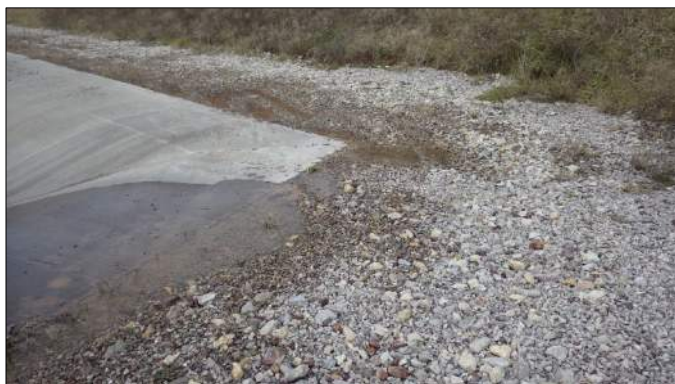
**Photo 35**

The seepage zone along the southwestern side of the Leachate Collection Pond, looking southwest.

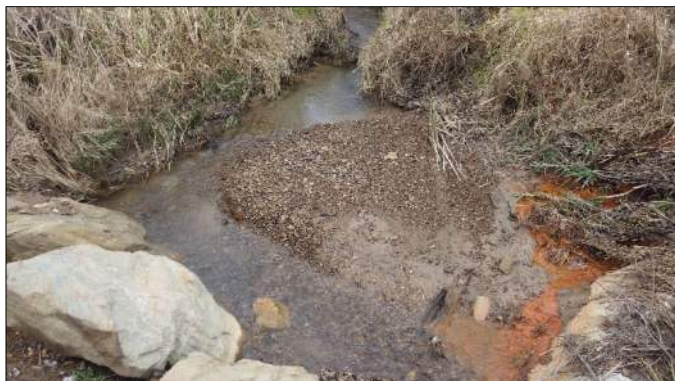
**Photo 36**

A discolored sheen was observed at the northwestern side of Sediment Trap No. 6, looking south.
