**2023 CCR Rule - Landfill  
Kyger Creek Landfill Inspection**

Kyger Creek Generating Station  
Cheshire, Ohio  
Gallia County

January 19, 2024

Stantec Consulting Services Inc.  
Cincinnati, Ohio

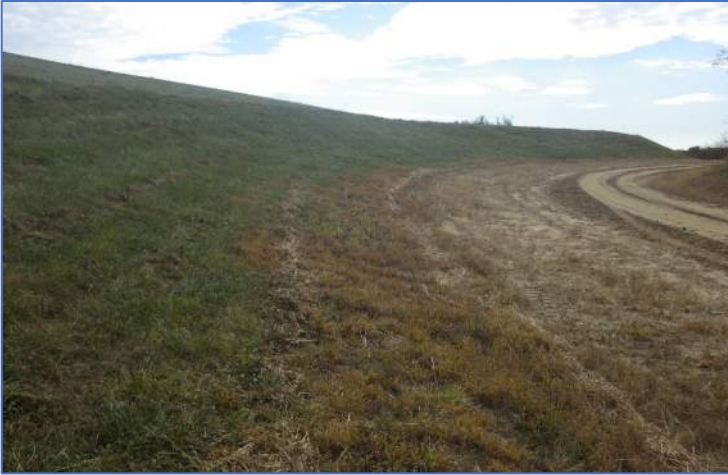
**Photo 1**  
Outer slope of the southwestern side of Phase 1. Mowed, uniform vegetation.

- The southwestern outer temporary slope is mowed, vegetated, and uniform. Slopes in this area are estimated at 4 horizontal (H) to 1 vertical (V). (Point 2, Appendix A. Photos 1 and 2, Appendix B) Recent hydroseeding is noted on the benched temporary slopes within the Phase 1 cell.

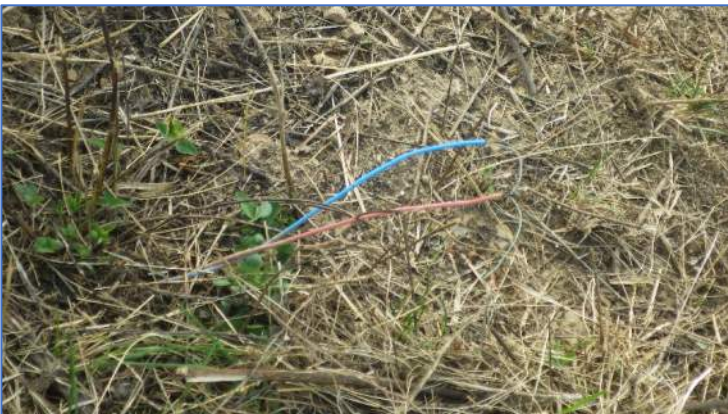
**Photo 3, Point 3**  
Exposed wires at a point on the outer slope southwest of Phase 1.

- Exposed wires were noted on the outer slopes near the Phase 5 and Phase 1 boundary (Photo 3, Appendix B).
- Points 4 and 5 locate the edge of the working CCR area within the southwestern corner of Phase 1 (Appendix A). The points are within the Phase 1 waste limits (Appendices A and C).

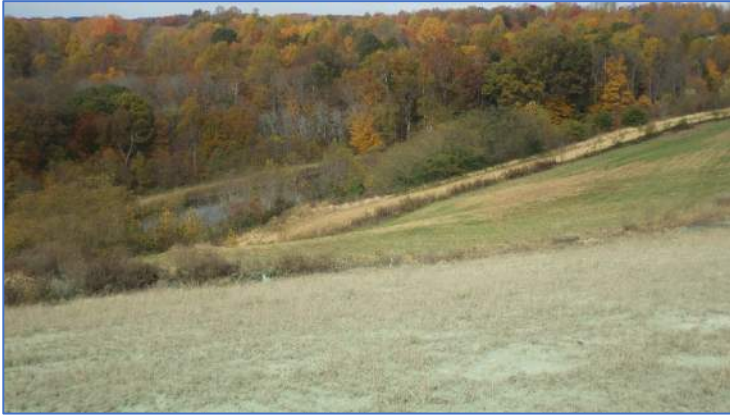
**Photo 7**

- Slopes from the bench to the top of hydroseeding at the southwest outer slope (Point 6, Appendix A) is estimated as 3.7 H to 1 V.
- Dormant vegetation noted at the middle of the ridge towards the western outer slope of Phase 1 (Point 7, Appendix A; Photo 7, Appendix B).

Western slope of Phase 1 facing West Sedimentation Pond. Access road separates phase from pond area.

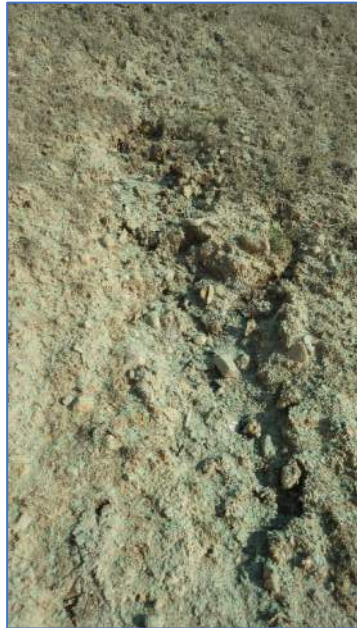
**Photo 8, Point 10**

- Two erosion features are present at the toe of the landfill at Points 8 and 9. The erosion feature at Point 8 is about 8 inches deep and about 2 feet by 4 feet in size. The erosion feature at Point 9 is 6 inches deep and about of 1.5 feet by 6 feet in size. (Appendix A; Photo 8, Appendix B)

Erosion feature at the toe west of Phase 1.

- Backfill and protect the stormwater culvert outlets near the West Sedimentation Pond to protect the access road for Phase 1. Clear vegetation near the culvert headwall to maintain flow into the culverts.
- Regrade and repair erosion gullies as noted.
- Identify and address the exposed wires as needed.
- Remove CCRs identified in Phase 2 and address grading to maintain stormwater within the Phase 1 footprint.

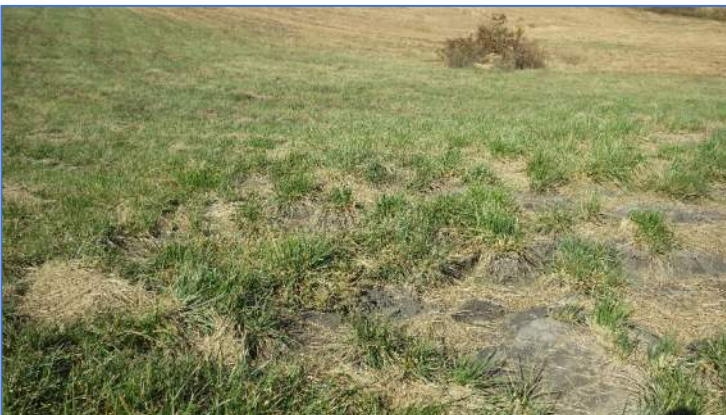
**Photo 21, Points 19, 20, 21**

- CCRs present at toe of Phase 1 slope within Phase 2 (Points 19-21, Appendix A; Photo 21 Appendix B).
- A graded and hydroseeded stockpile is noted on the northern edge of the Phase 2 footprint (Photos 19 and 20, Appendix B).

Area of visible CCR at Phase 2 and close to Phase 1 toe.

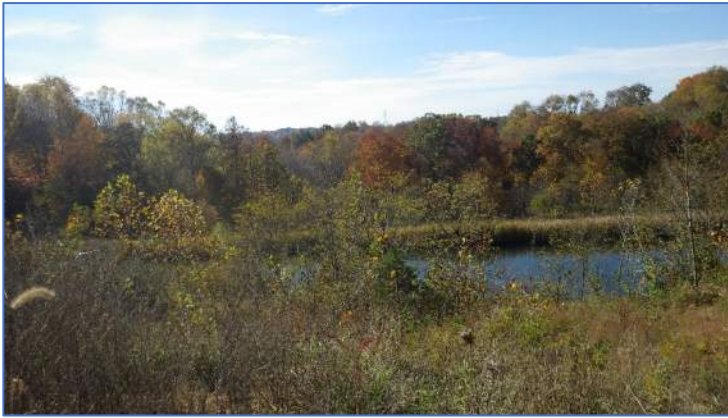
**Photo 25**  
West Sedimentation Pond. As viewed from a point close to the northern access road, looking west.

- Tall, dense vegetation limits inspection of the slopes of the West Sedimentation Pond (Photos 25 and 26, Appendix B).
- Two potential scarps were identified on the west and northwest outer slopes of the pond embankment (Points 27 and 28, Appendix A. Photos 27 and 28, Appendix B). Dense vegetation limits observation of scarps.
- Dense vegetation blocks the headwall to the stormwater culverts between Phase 1 and the West Sedimentation Pond (Photo 24, Appendix B).
- Erosion of the dirt access road has exposed the culvert outlets and created erosion gullies. Erosion gully is estimated as 2 to 3 feet wide (Point 29, Appendix A; Photos 29 and 30, Appendix B).

- Keep the vegetation around the West Sedimentation Pond mowed to understand the ongoing stability concerns in this area. This affects the western access road around Phase 1 of the landfill and the northwestern exterior slope of the West Sedimentation Pond. Characterize and remediate the scarps as needed.

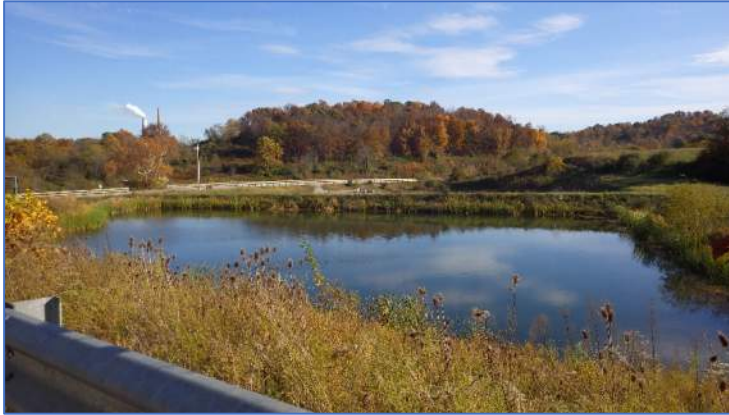
**Photo 31**  
East Sedimentation Pond as viewed from the paved road on the eastern edge of the pond.

- Dense, woody vegetation obscures the inner slope along the eastern side of the pond, bordering the paved haul road (Photos 31 and 32, Appendix B).
- Erosion noted in the northeastern corner of the pond close a new riprap zone (Photo 32, Appendix B).

- Maintain the vegetation along the interior and exterior slopes of the Interim Leachate Collection Pond and the East Sedimentation Pond. Address the interior and exterior erosion as needed to maintain integrity of the ponds.
- Continue to conduct field surveys to measure current topography and compare to design geometry. Regrade surface to conform to design if needed. Areas near final completion grade are recommended to be capped, closed, and vegetated. Further engineering evaluation of slope stability may be warranted, if deformations, steepened slopes, or sloughing indicate potential for significant instabilities.

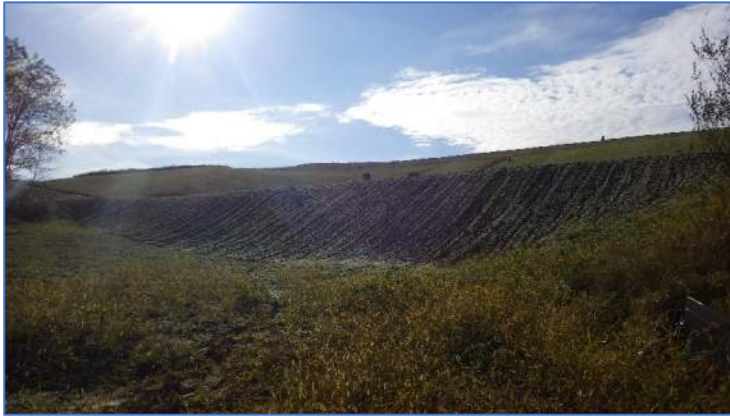
**Photo 34, Point 30**  
Eastern toe of Phase 1 near the  
Interim Leachate Collection Pond.

- The Phase 1 eastern toe is located near the southern edge of the Interim Leachate Collection Pond. It is uniform and hydroseeded. The estimated slope is 2.5 H to 1 V (Points 30-33, Appendix A; Photo 34, Appendix B).

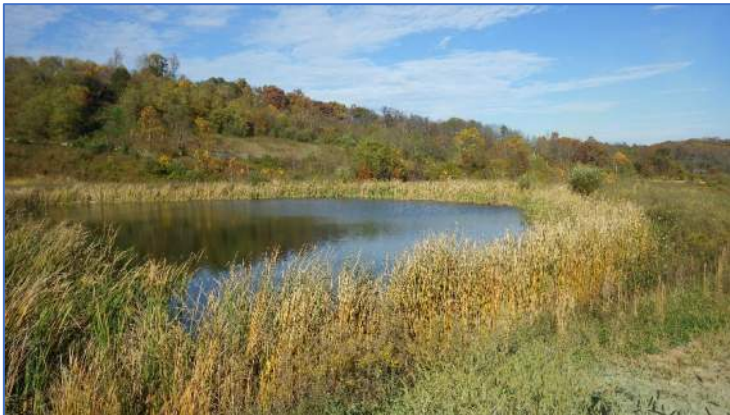
**Photo 35, Point 30**  
The Interim Leachate Collection Pond  
as viewed from the southwest corner.

- Dense vegetation limits observation of the crest and embankment slopes for the pond (Photos 35-37, Appendix B)
- Overflow structure was heard by not observed from the crest of the embankment due to dense vegetation (Photo 36, Appendix B).

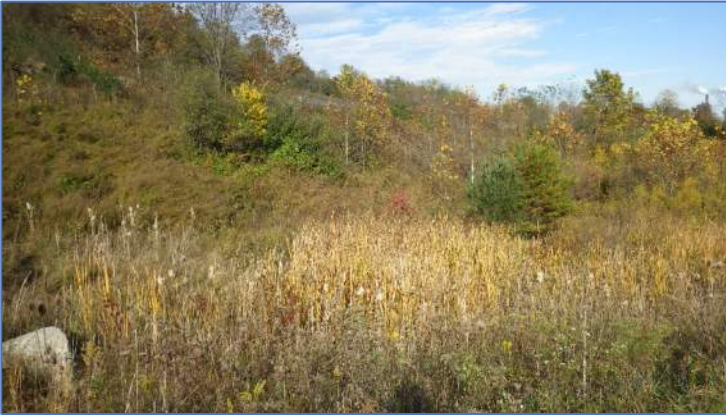
**Photo 37, Point 32**

High and dense vegetation near the Interim Leachate Collection Pond.

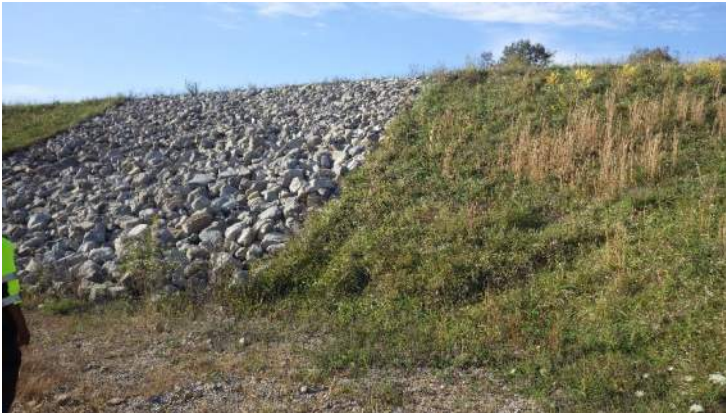
**Photo 38, Point 34**

- The earthen slopes above the concrete appear well vegetated and uniform near the Leachate Collection Pond.
- The riprap seepage blanket on the western grass slope appears in good condition (Photo 38, Appendix B).
- Slopes for the embankment northwest of the Leachate Collection Pond were estimated between 1.8 H to 1 V and 2 H to 1 V (Points 34-36, Appendix A).

Riprap seepage blanket on western slope of Leachate Collection Pond.
