2015 DAM & DIKE INSPECTION REPORT

GERS-15-020

**BOTTOM ASH COMPLEX
SOUTH FLY ASH POND**

**KYGER CREEK STATION
GALLIPOLIS, OHIO**

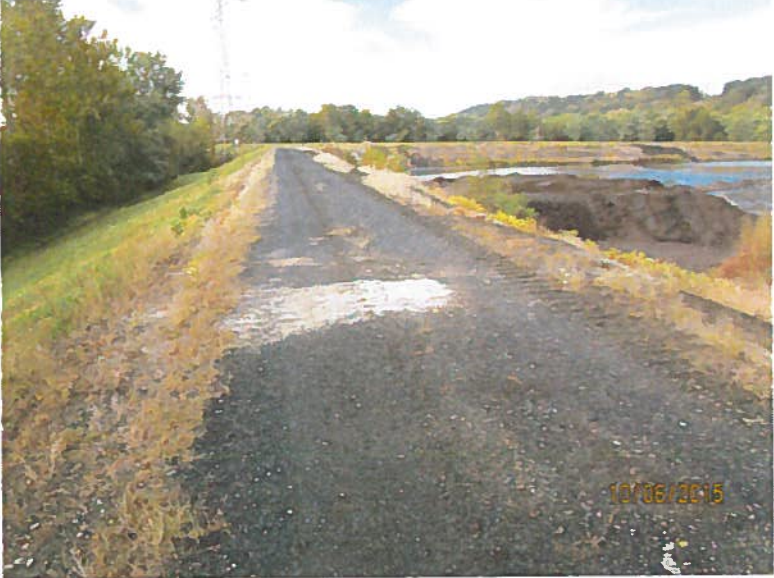
<p>Photo # BAP- 01</p>

1. The crest of the bottom ash pond which is used for vehicular traffic for operations and maintenance activities appeared in good and stable condition with no significant settlement, misalignment, potholes, or noticeable sign of distress. There were newly drilled monitoring wells located in the crest in several locations. The wells were covered with a flushed mounted cap supported by concrete. In general the crest is in good condition. (See Photos BAP-01 to BAP-03)

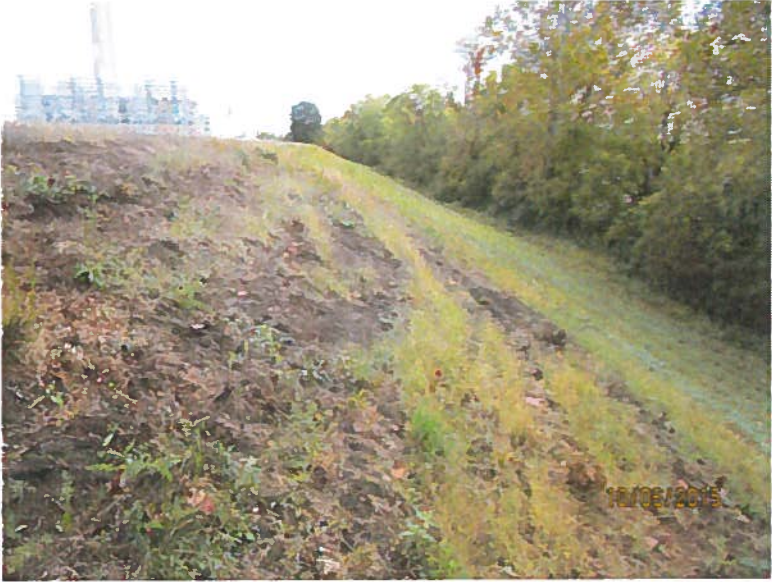
<p>Photo # BAP- 04</p>

2. The outboard slope of the east dike adjacent to the Ohio River is generally in good condition. It is well vegetated and was recently mowed within the past 4 weeks. There were no signs of bulging or settlement. There were no seepage or wet areas observed. No animal activity was observed. There is an area on the south end of the dike that appeared to have rutting possibly from the recent drilling activities or mowing. (See Photos BAP-04 to BAP-05)

<p>A photograph showing a dirt embankment with several deep, parallel ruts running down its length. The ground is uneven and appears to have been driven on. In the background, there are trees and a utility structure. A date stamp '10/06/2015' is visible in the bottom right corner of the photo.</p>
<p>Rutting along East dike.</p>

2. The minor rutting observed on the east dike should be regraded and reseeded.
3. The area around the new stairway installed at the east dike should be seeded to prevent erosion.

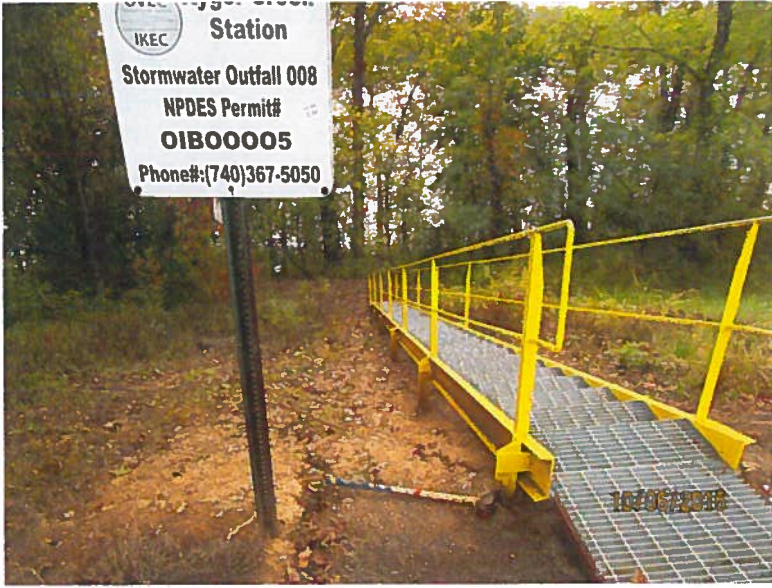
<p>Newly constructed stairs at north end of east dike</p>	<p>Station Stormwater Outfall 008 NPDES Permit# 01B00005 Phone#:(740)367-5050</p>

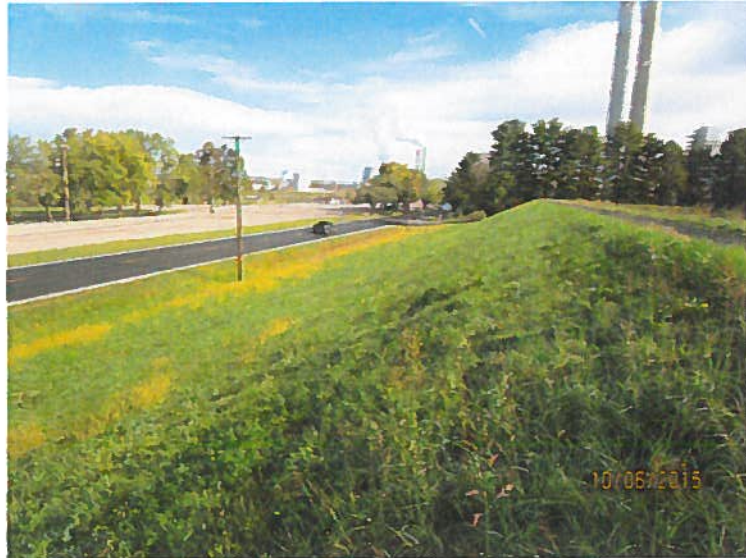
Photo # BAP- 07

4. The outboard slope of the west dike adjacent to Route 7 is well vegetated and was recently mowed within the past 4 weeks. There were no signs of bulging or settlement. There were no seepage or wet areas observed. No animal activity was observed. The highway drainage channel near the toe is in good condition and there was no standing water or erosion. The general condition of the slope is good. (See Photo BAP-07)

Typical view of west dike along SR 7.

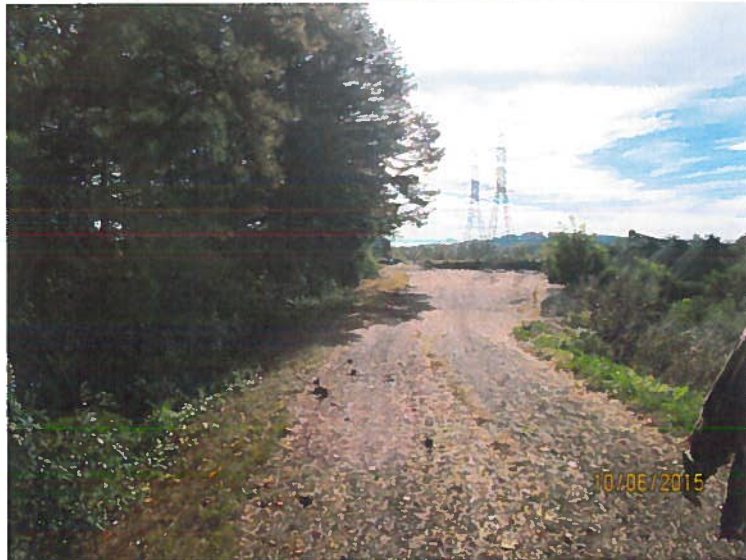
Photo # BAP- 08

5. The outboard slope of the north dike adjacent to the access road (west section) is in good condition. Full grown trees and brush are present on this section of the slope which makes this portion of dike difficult to inspect. The slope appears in stable condition. The ditch appeared to have positive drainage. (See Photo BAP-08)

View of the north dike. Trees and brush are located on the outboard slope.

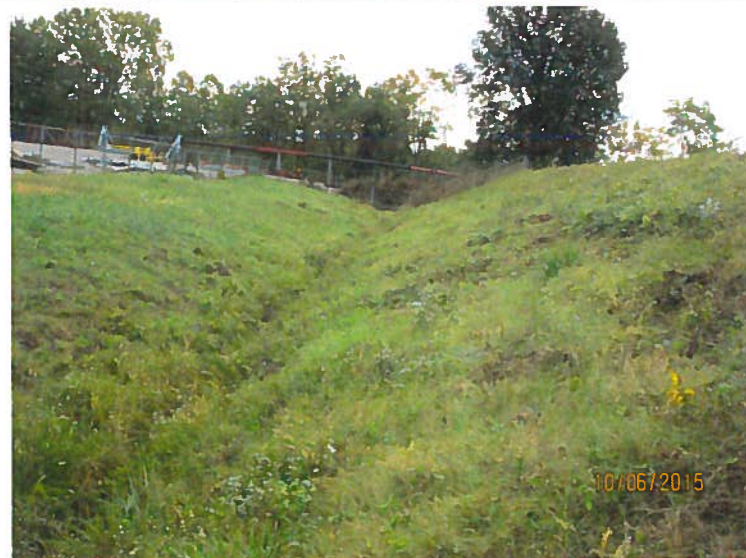
Photo # BAP- 09

Typical view of the north dike

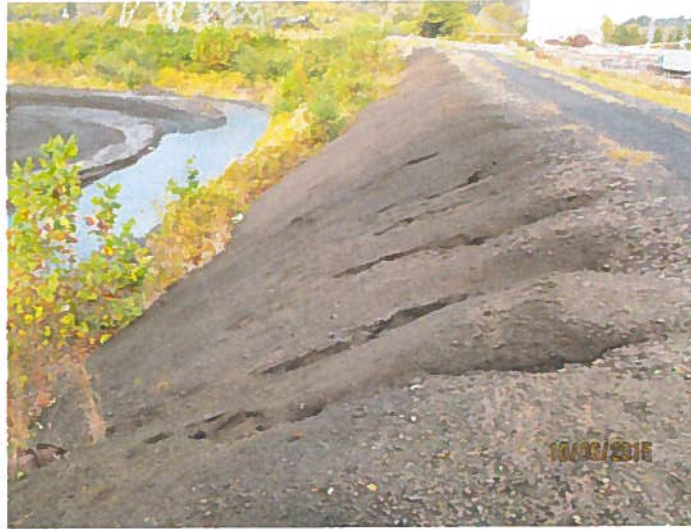
Photo # BAP- 10

7. The inboard slope along most of the bottom ash pond is in fair condition. There are areas of high vegetation and woody plants where it may be difficult to get

Typical view of the inboard slope of the Bottom Ash Pond

1. The inboard slopes appeared to be in good and stable condition, but in general had overgrown brush and vegetation. There are also areas of erosion of the bottom ash material that lines the inboard slopes. It is recommended that the vegetation be cut and the inboard slopes be regraded to repair the erosion.

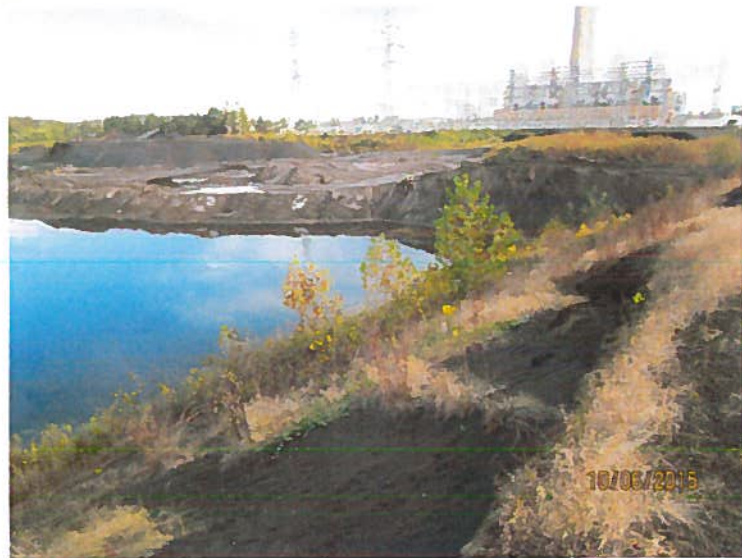
Photo # BAP- 11

Typical view of the inboard slope of the Bottom Ash Pond

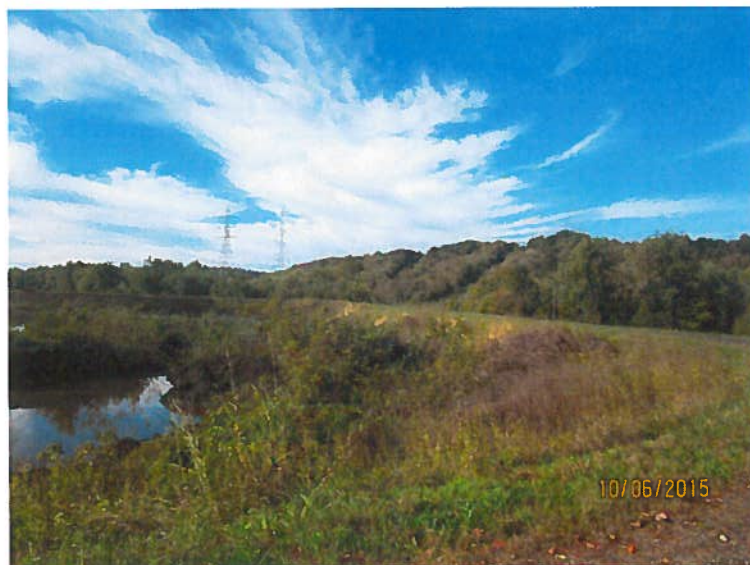
Photo # BAP- 12

Typical view of the inboard slope of the Bottom Ash Pond

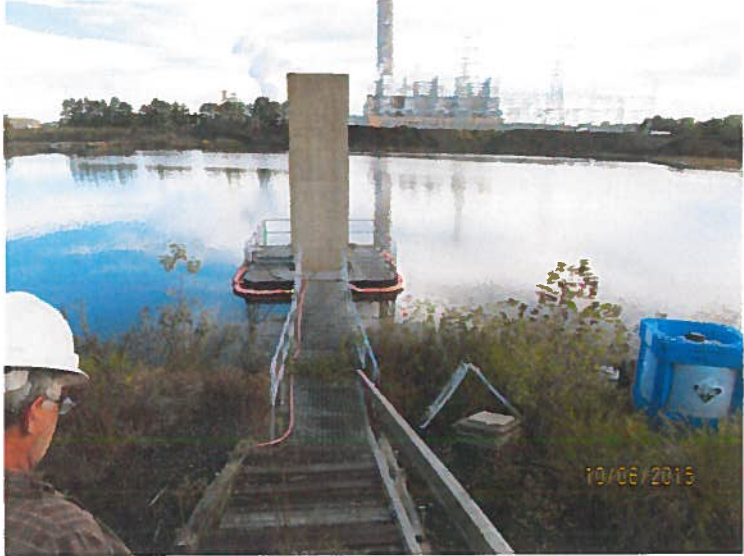
<p>Photo # BAP- 13</p>

8. In general the overflow discharge structure located at the north slope of the splitter dike that conveys water from the Bottom Ash Pond to the Clearwater is in good condition. Water flowed unobstructed into the structure. There was no spalling or deterioration of the concrete structure observed. Additionally there are spare stop logs stored on the deck platform of the structure. The access-way consisting of wooden ties and handrail installed over the slope followed by metal walkway is generally in good condition. (See photograph BAP-13)

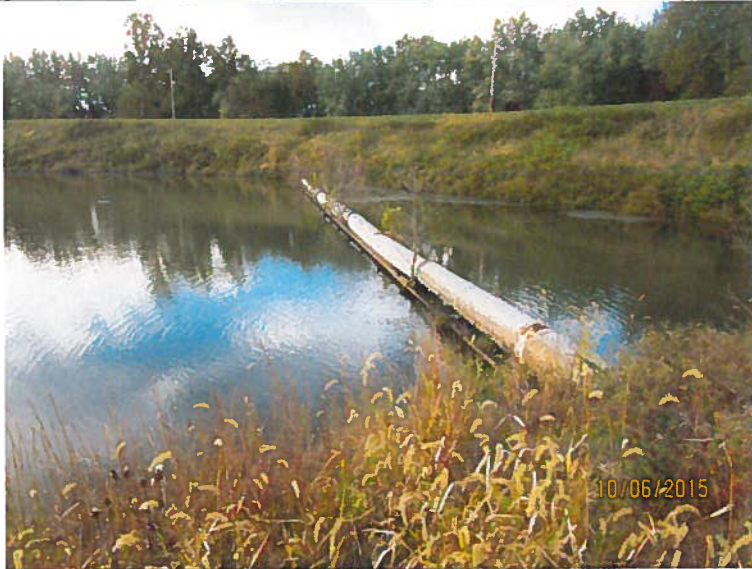
6. The discharge pipe entering the Clearwater Pond from the Bottom Ash Pond is in poor condition. The pipe which runs on cribbing above the water is deteriorated and has failed along the bottom near the splitter dike. The pipe's ability to dissipate water across the pond for water quality purposes is greatly diminished. (See Photo BAP-21)
7. The splitter dike that separates the Clearwater Pond from the Bottom Ash Pond is generally in good condition. The material that makes up the surface is generally made of bottom ash and will not support much vegetation. The vegetation is sparse and where it exists it has not been recently mowed. There were no signs of instability or erosion present along the splitter dike. Where the discharge pipe runs through the splitter there is no signs of settlement or instability. (See Photo BAP-22)

<p>Outlet pipe from the Bottom Ash Pond into the Clearwater Pond. The pipe is misaligned in places and the bottom of the pipe is deteriorated and failed.</p>

4. The outlet pipe that conveys water from Bottom Ash Pond to the Clearwater Pond should be repaired where it is deteriorated. The portion of pipe running through the splitter dike should be camera inspected to determine its condition and repaired if necessary.

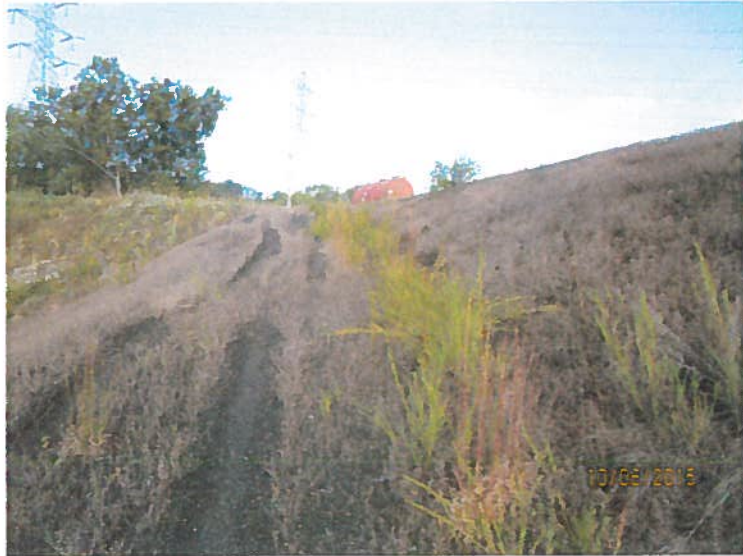
Photo # BAP- 22

Typical view of the
splitter dike slope

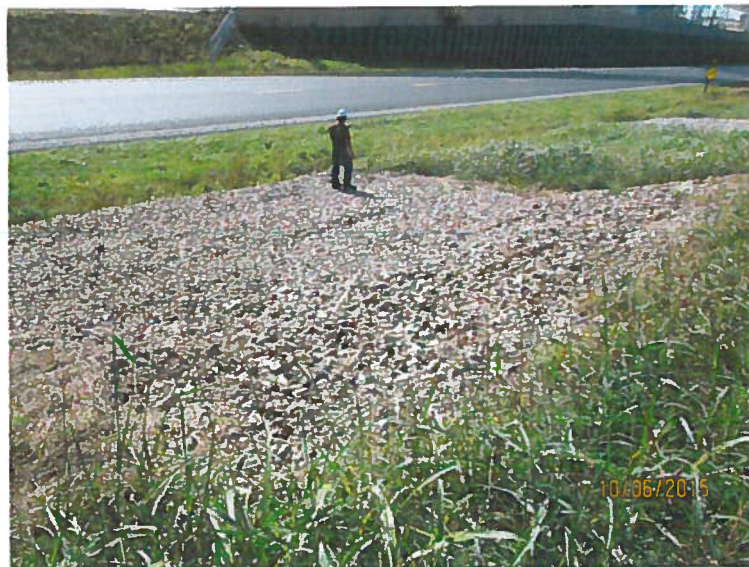
Photo # FAP- 08

4. The crest, inboard, and outboard slopes of the east dike along SR 7 are generally in good condition. There are no signs of settlement, deformations, or cracks observed. A seepage area was repaired since the 2014 annual inspection by placing a sand and gravel blanket along the face of the dike similar to the previous two repairs made along the same embankment. The other two previous seep repairs were in good condition and appear to be functioning as designed. The most southern repair area appeared to have a minor slough of the cover aggregate or it was pushed downslope by mowing equipment. (See Photos FAP-07 to FAP-09)

Typical view of seepage repair along east dike

3. The three locations along the east dike where seepage control repair was installed appear stable and functioning as designed. One of the repair areas appeared to have a minor slough. This could have occurred from the mowing equipment. This area should be monitored to ensure the slough does not worsen.

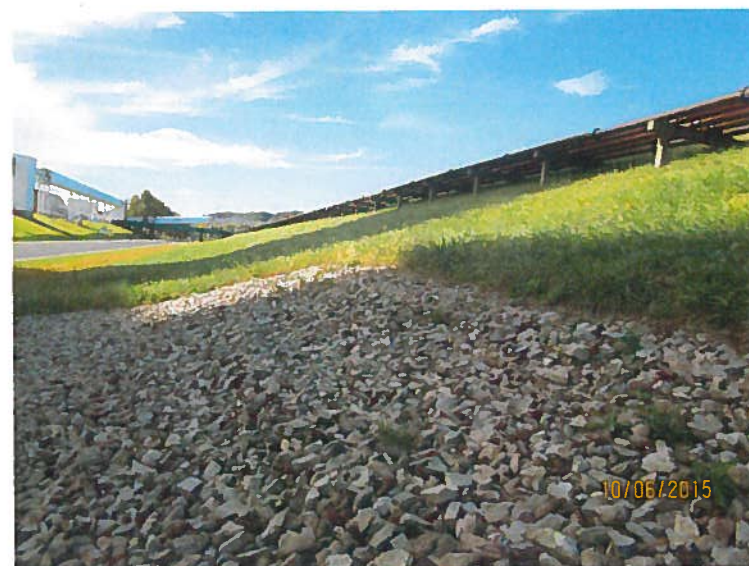
Photo # FAP- 09

Minor slough of aggregate at seepage repair

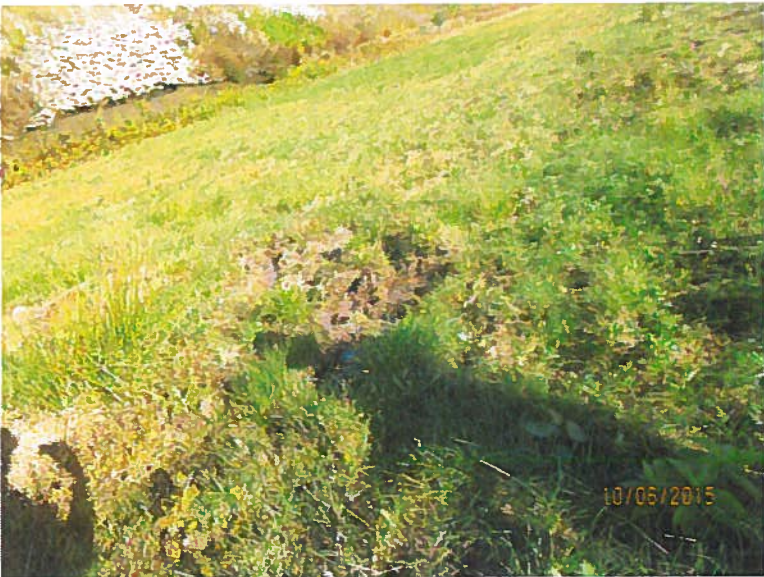
<p>Photo # FAP- 13</p>

8. There is an area of seepage on the south side of the west dike. This seepage area has been noted on 2014 annual inspection reports and does not appear to be increasing in flow from previous years. (See Photo FAP-13)

<p>Seepage located on the south end of the west dike</p>	
<p>Photo # FAP- 14</p>

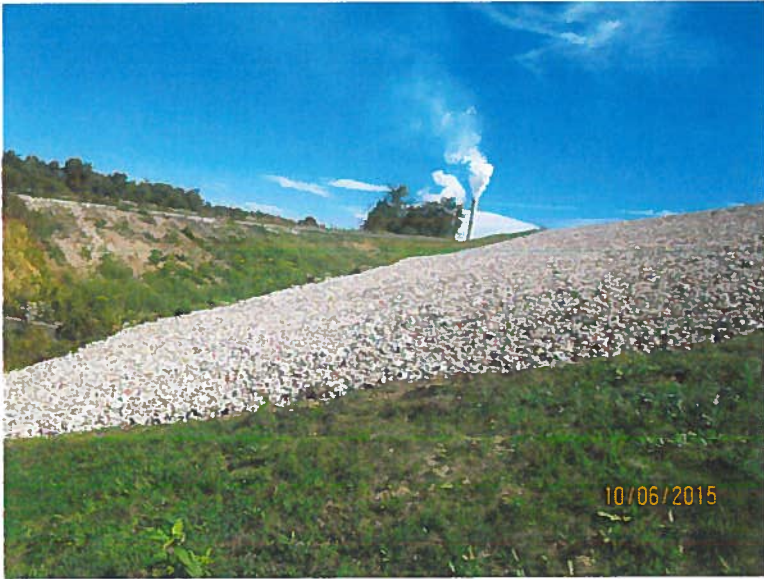
9. The seepage area on the north side of the west dike that was noted in the 2014 annual inspection report has recently been repaired. The repair consisted of a sand and gravel drainage blanket to prevent piping and erosion of the seep. The drainage blanket is in good condition. (See Photo FAP-14)

<p>Seepage repair area at the north end of the west dike</p>	
<p>Photo # FAP- 15</p>

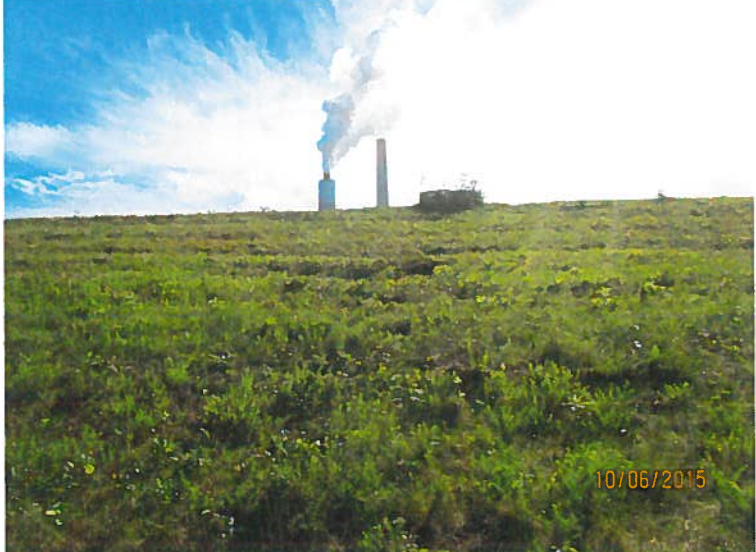
10. While inspecting the area on the outboard slope directly above the outlet pipe of the principle spillway, a slight depression was noticed. This did not appear to be a major issue and may be attributed to the normal minor undulations in the ground surface. Positive flow was observed from the pipe into the ditch, but some unusual slug flow and burping was noticed at the outlet end of the pipe. The slug flow and burping has been present for the past several years. (See Photo FAP-15)

<p>A slight depression in the west dike directly over the outlet pipe</p>

4. A minor depression was observed directly over the outlet pipe on the outboard slope of the west dike. This depression could be due to a minor slough or ruts from the mowing equipment, however it should be monitored to ensure it does not worsen.

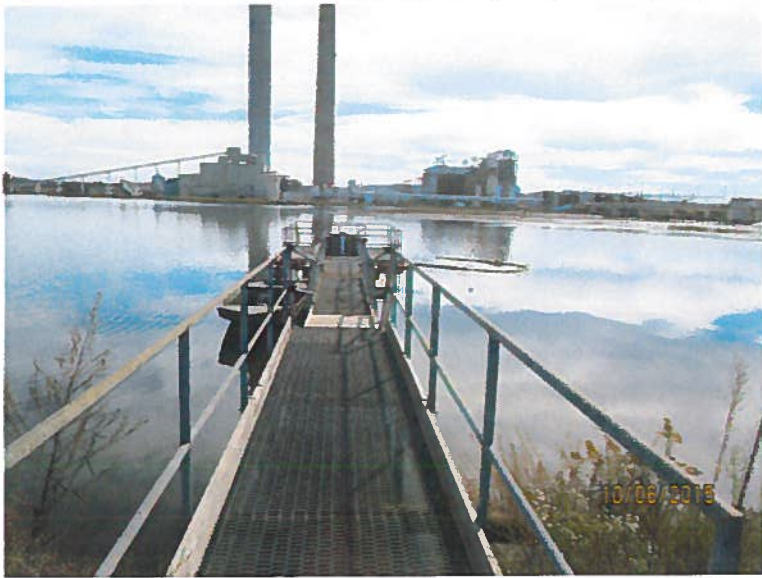
Photo # FAP- 16

11. The overflow discharge structure was generally in good condition. The platform and walkway leading to an around the discharge structure did not show signs of deterioration. The concrete structure had no spalling or cracks. Water was entering the structure unobstructed. The extra stop log that was present at the discharge structure deck is in good condition. (See Photo FAP-16 to FAP-17)

Platform to overflow discharge structure

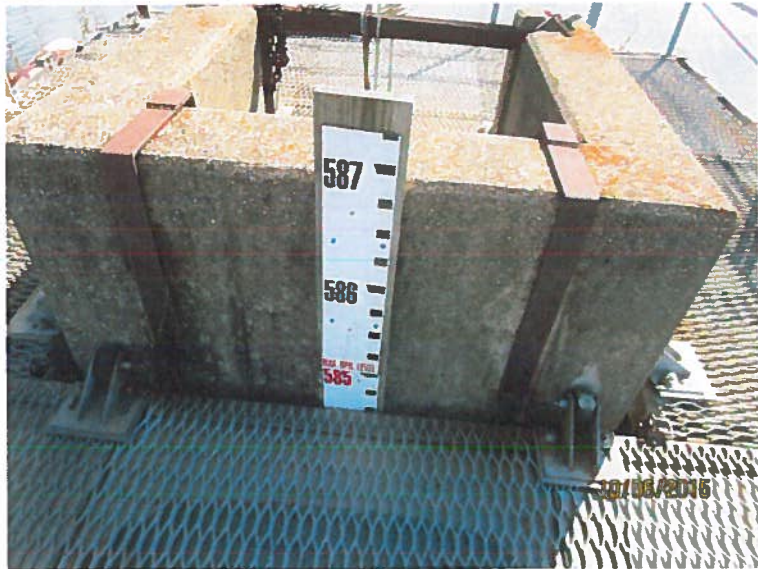
Photo # FAP- 17

View of the overflow discharge structure

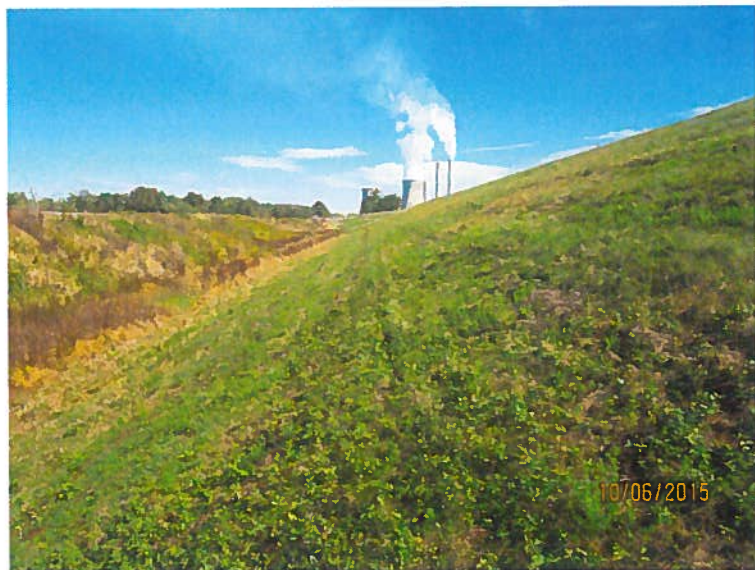
Photo # FAP- 18

12. The channel just below the toe of the west dike appeared to be in good condition. This area is not normally mowed and vegetation was high. There did not appear to be any standing water in this channel. (See Photo FAP-18)

Outboard slope of the west dike and channel at toe

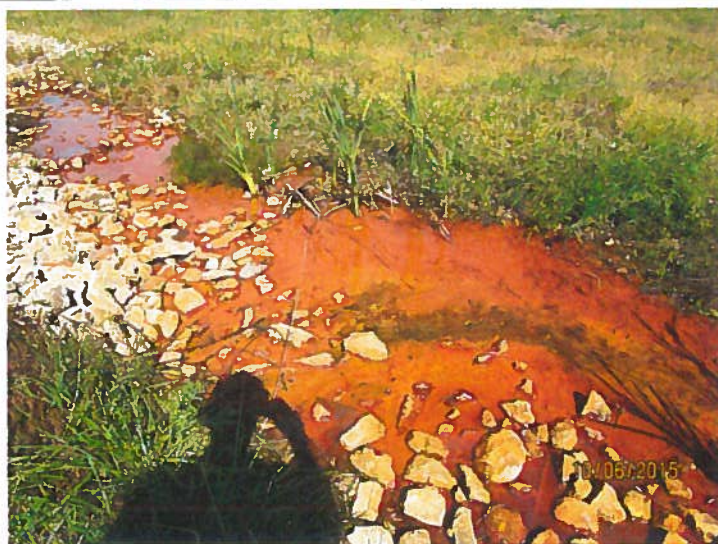
Photo # FAP- 21

14. The area located beyond the toe at the southwest portion of the complex was observed to be seeping water as noted in previous annual inspections. The flow rate of this water was somewhere around 10-20 gpm estimated from visual observation which is consistent with previous years. This area was lined several years ago with rip rap to accommodate this flow. The flow rate can be measured by pumping out a depression at the outlet of a culvert and measuring the amount the free flowing water into the depression. (See Photo FAP-21)

Seepage located beyond
the toe of the southeast
corner of the pond

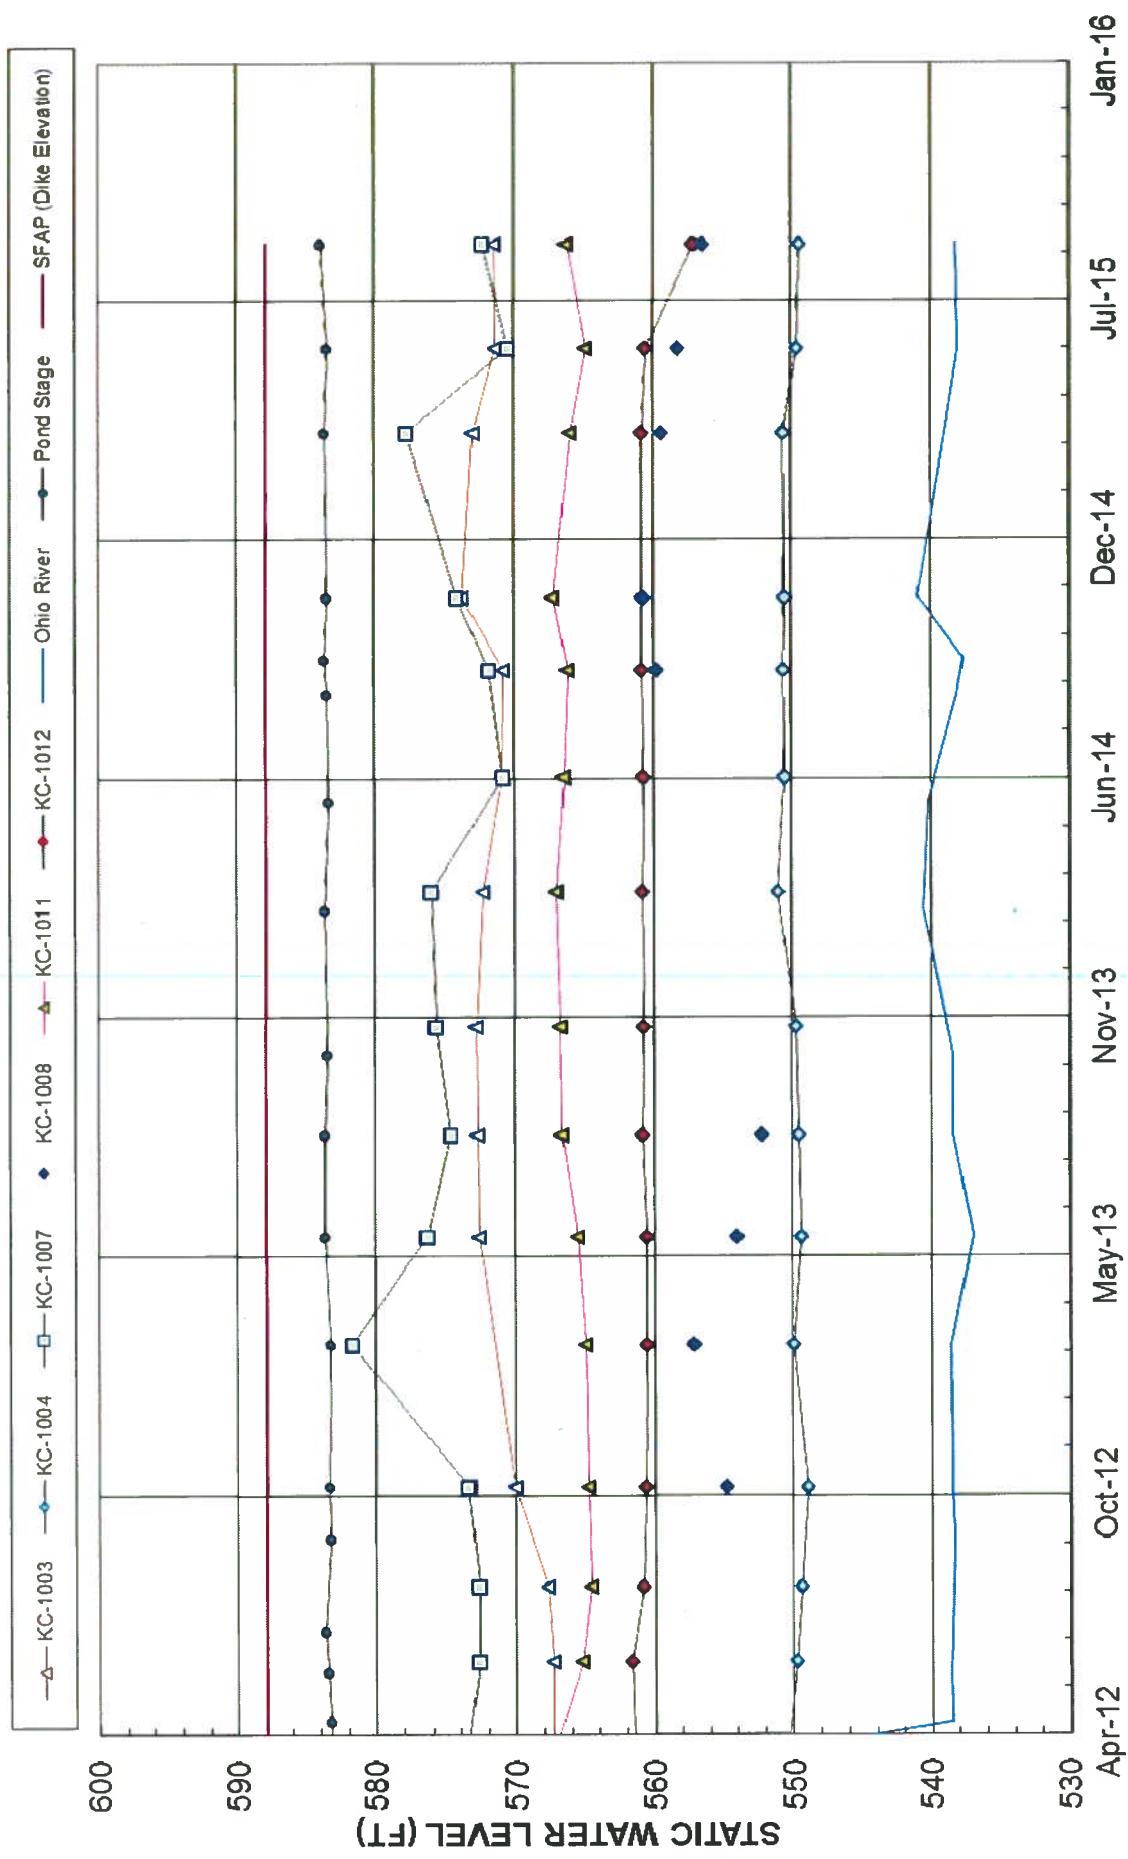
Figure 13 – South Fly Ash Pond Static Water Elevations

Figure 13 includes the piezometers water elevation along with the ponds elevations and the embankment elevations for the SFAP. Figure 13 shows that the freeboard is less than 5 ft (4.1 ft). It was noticed that readings taken from piezometer KC-1004 have fluctuated a considerable amount compared to other piezometers at the SFAP. The elevations of the pond pool level and Ohio River have remained constant and do not appear to be the cause for these fluctuations. AEP – Geotechnical Engineering Services will request more frequent readings taken over the next 90 days and further evaluate the readings of these wells.
