2022 Annual Dam and Dike Inspection Report

**Bottom Ash Pond Complex
South Fly Ash Pond**

**Kyger Creek Plant
Ohio Valley Electric Corporation (OVEC)
Gallia County, Ohio**

Document Number: GERS-22-030

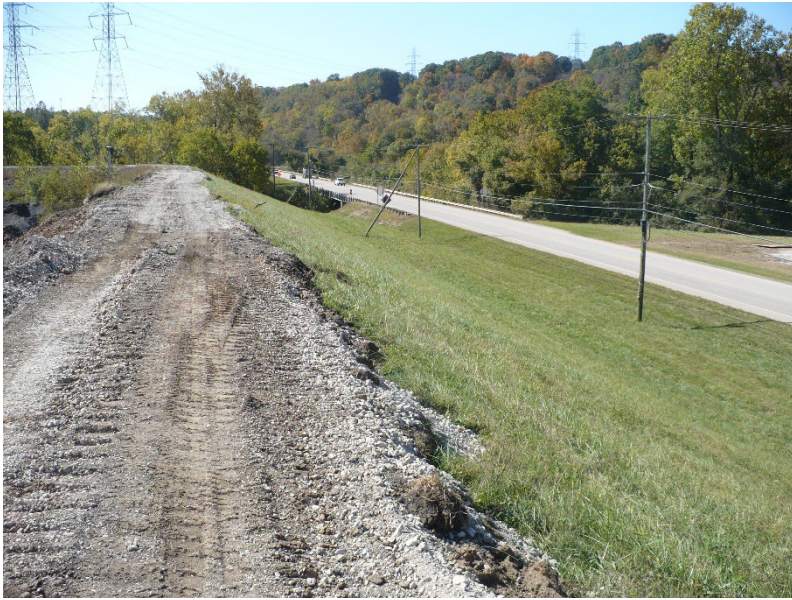
- The exterior slopes of the remaining diking system have been recently mowed and are in good condition (photos 1-6). There were no signs of instability of the dike. No seepage or soft areas were observed during the inspection. No rutting was observed along the crest of the dikes.

BAP #1 – exterior slope west dike– looking south

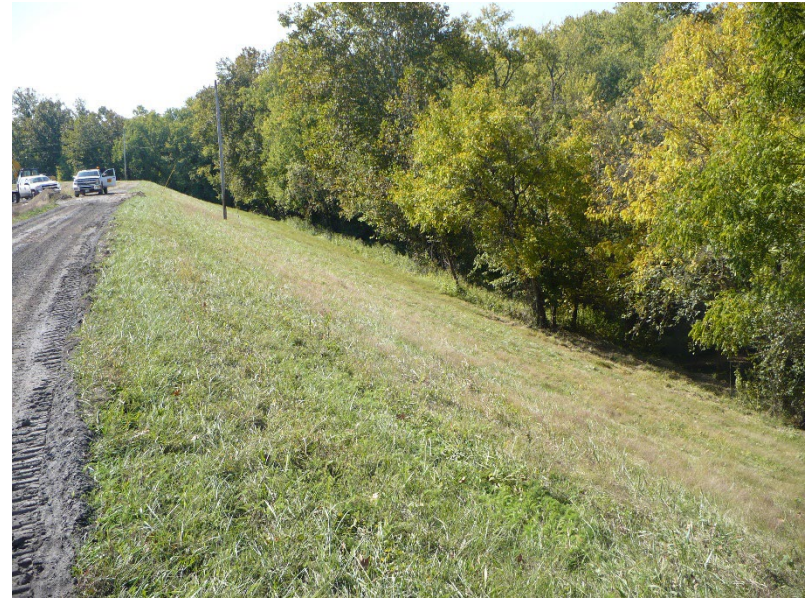
BAP #2 – exterior slope of south dike-looking southeast

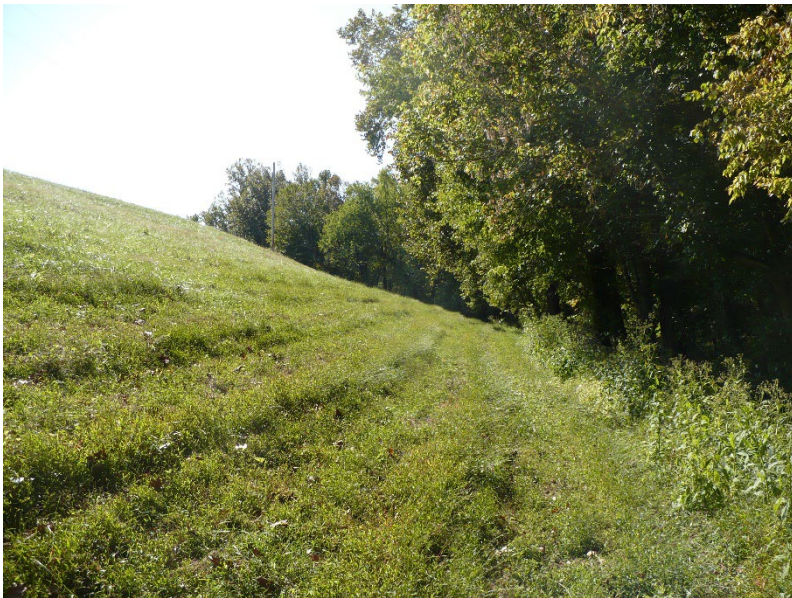
BAP #3 –exterior slope of south dike-looking east

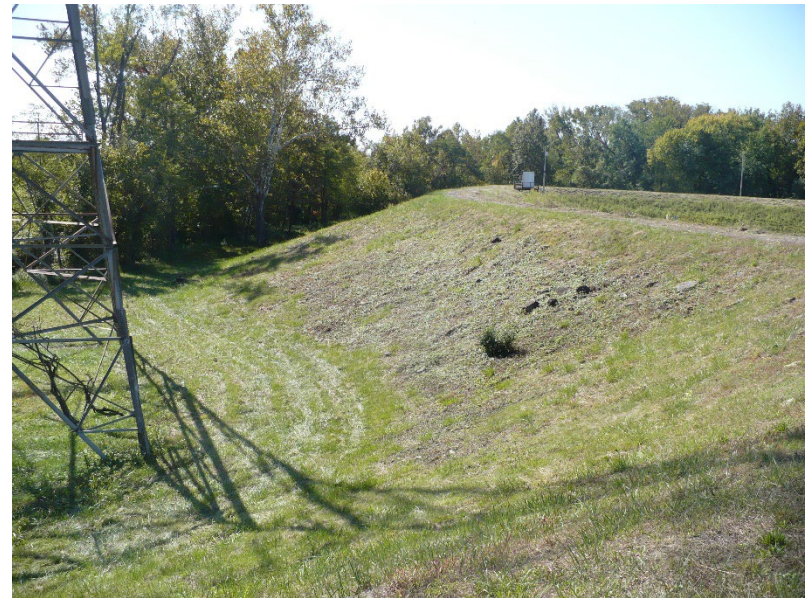
BAP #4 – exterior slope of east-looking south

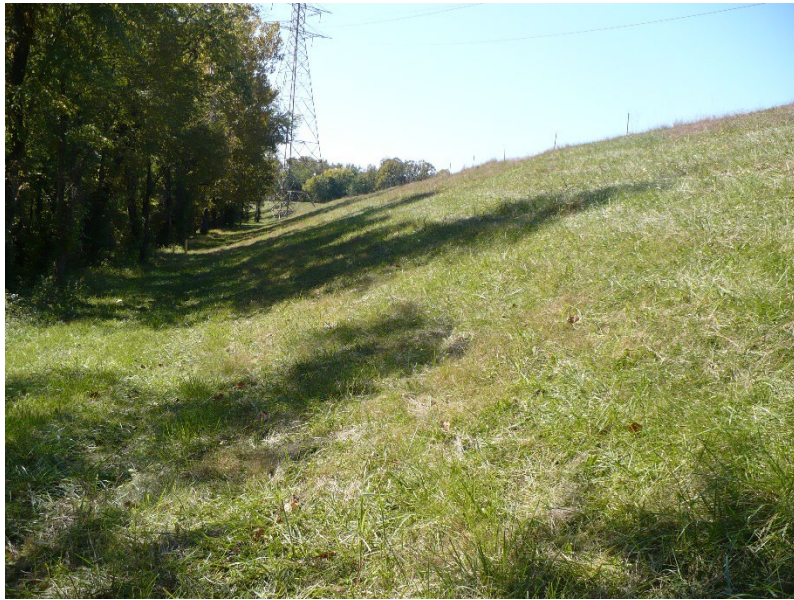
BAP #5 – exterior slope of east dike-looking south

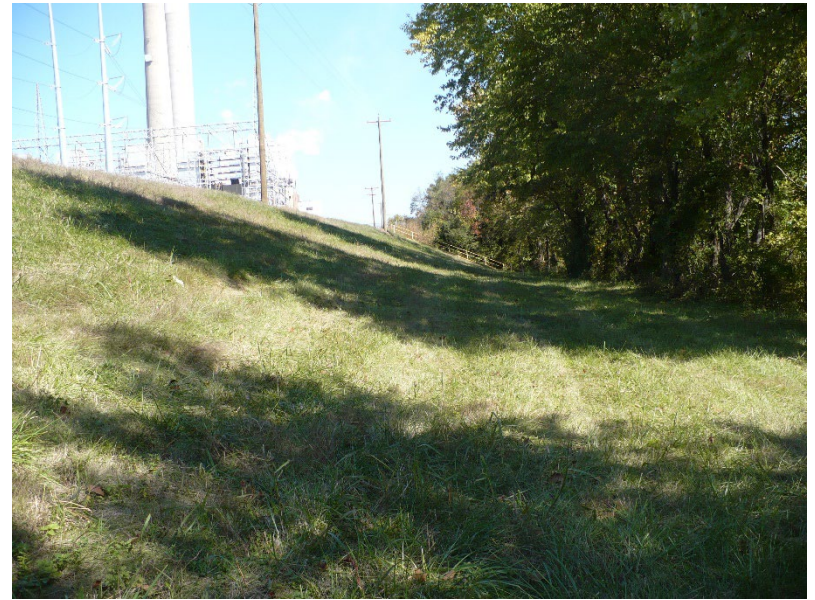
BAP #6 – exterior slope of east dike-looking north

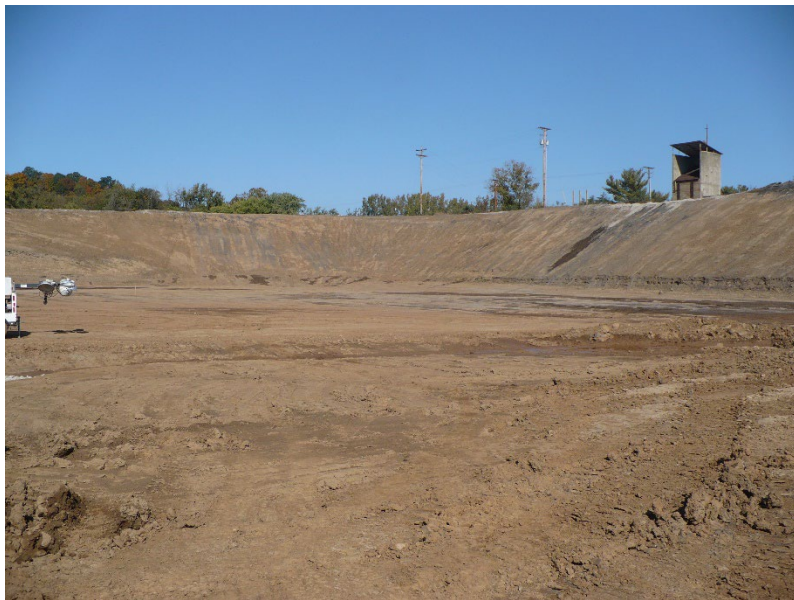
- The CCR material in the western portion of the BSP has been removed. The interior slopes appear stable and minor erosion rills have developed but these will be regraded as construction within this area continues (photo 7).

BAP #7 – interior of west portion of BSP

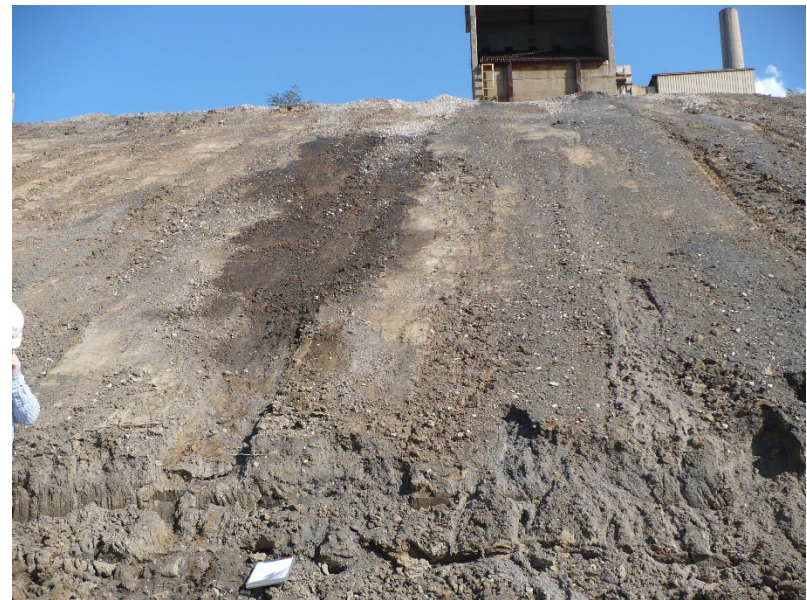
- A seepage area on the interior slope of the north dike was observed (photo 8). Some evidence of erosion due to the seepage was observed at the toe but not significant. The source of the seepage is unknown at this time since the zone is above the surrounding grade and no source of pond water exists. This is in the area where the influent pipes previously discharged into the pond.

BAP #8 – seepage-interior slope of north dike

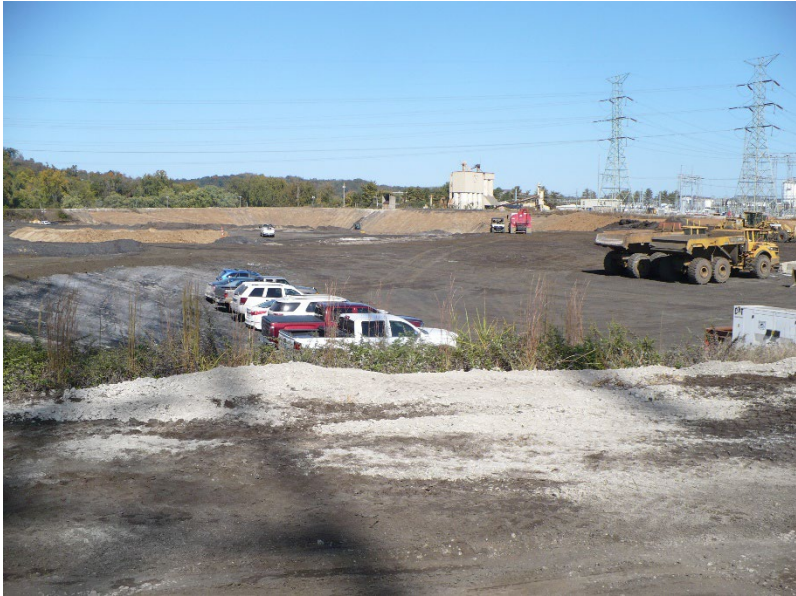
- The eastern portion of the BSP is still receiving sluiced bottom ash while CCR removal operations are continuing (photo 9). There is very little ponded water in the BSP due to the construction activities.

BAP #9 – interior-eastern portion of BSP

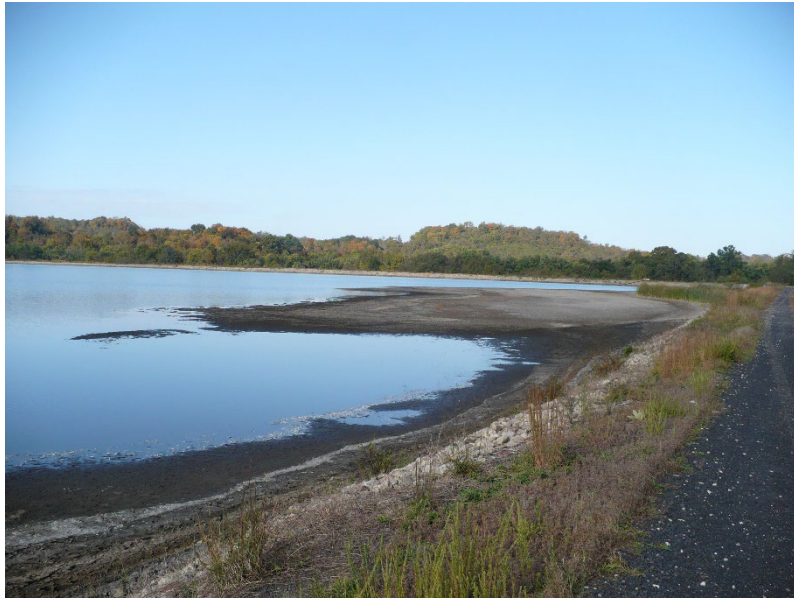
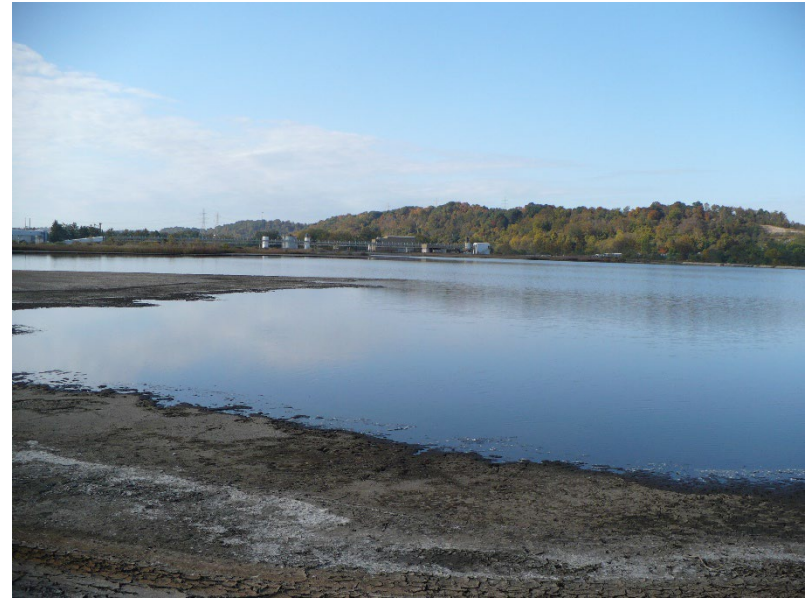
- The water level in the FAP has been slowly dropping due to the reduced influent to the pond. Photos 1-2 show the exposed ash delta and pool area.
- The crest and slopes of the north dike between the north and south ponds showed no signs of any significant settlement, deformation, or cracks.

SFAP #1 – interior view of pond

SFAP #2 – interior view of pond

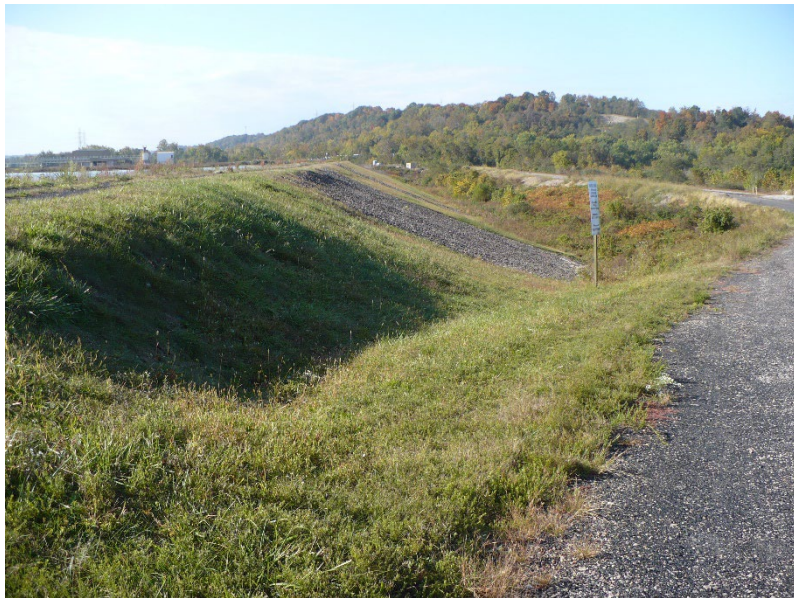
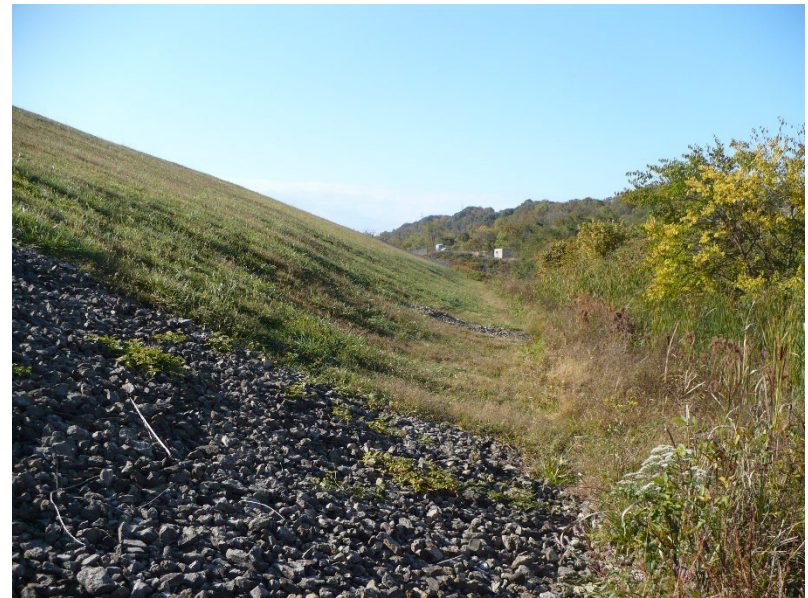
- The overall condition of the west dike exterior slope consists of several sections with the inverted filter blanket with stone cover to control previous seepage areas. There were no new signs/evidence of additional seepage. The slope appeared in good and stable condition. The vegetative cover on the slope was recently mowed and in good condition (photos 3-4).

SFAP #3 – exterior slope of west dike-looking south

SFAP #4 – exterior slope of west dike-looking south

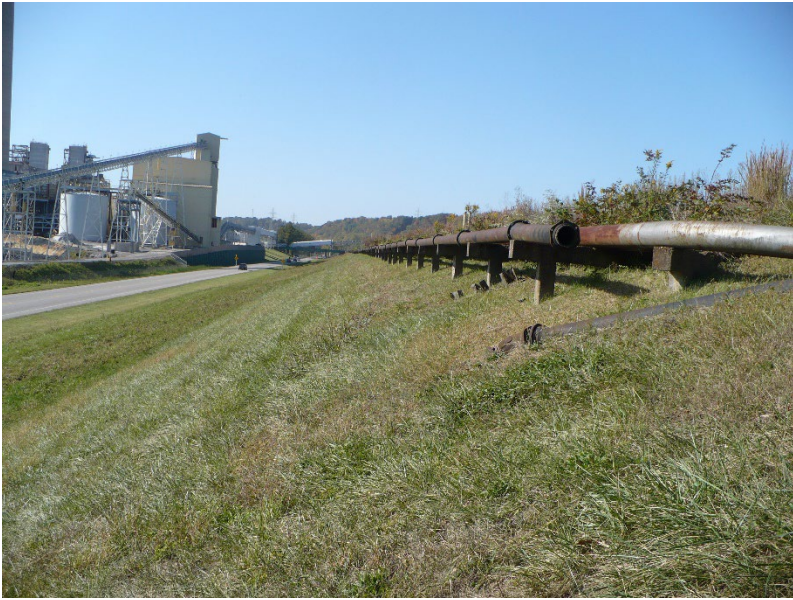
- The exterior slope of the east dike appeared in good condition. The rock blankets (repair areas) along the slope appeared stable and well maintained (photo 5).

SFAP #5 – exterior slope of east dike-looking south

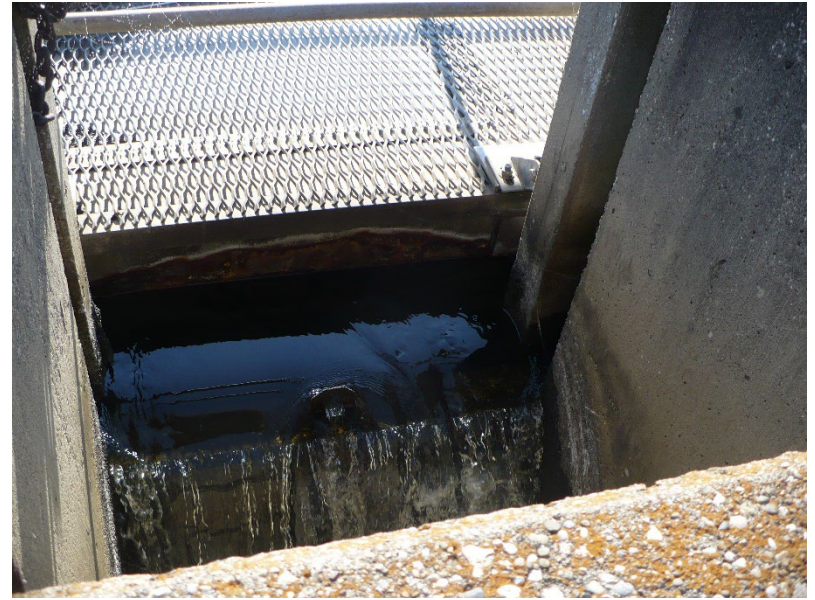
- The access structure platform, deck, and handrail to the outlet structure appeared in fair and stable condition. The visible concrete, railings, metal deck, stop logs, and accessories appeared in functional condition. Flow over the stoplog was smooth and unobstructed (photo 6).

SFAP #6 – outlet structure- smooth flow over stoplog
