**2023 CCR Rule – Surface Impoundments  
Kyger Creek Dam/Dike Inspections**

Kyger Creek Generating Station  
Cheshire, Ohio  
Gallia County

January 19, 2024

Stantec Consulting Services Inc.  
Cincinnati, Ohio

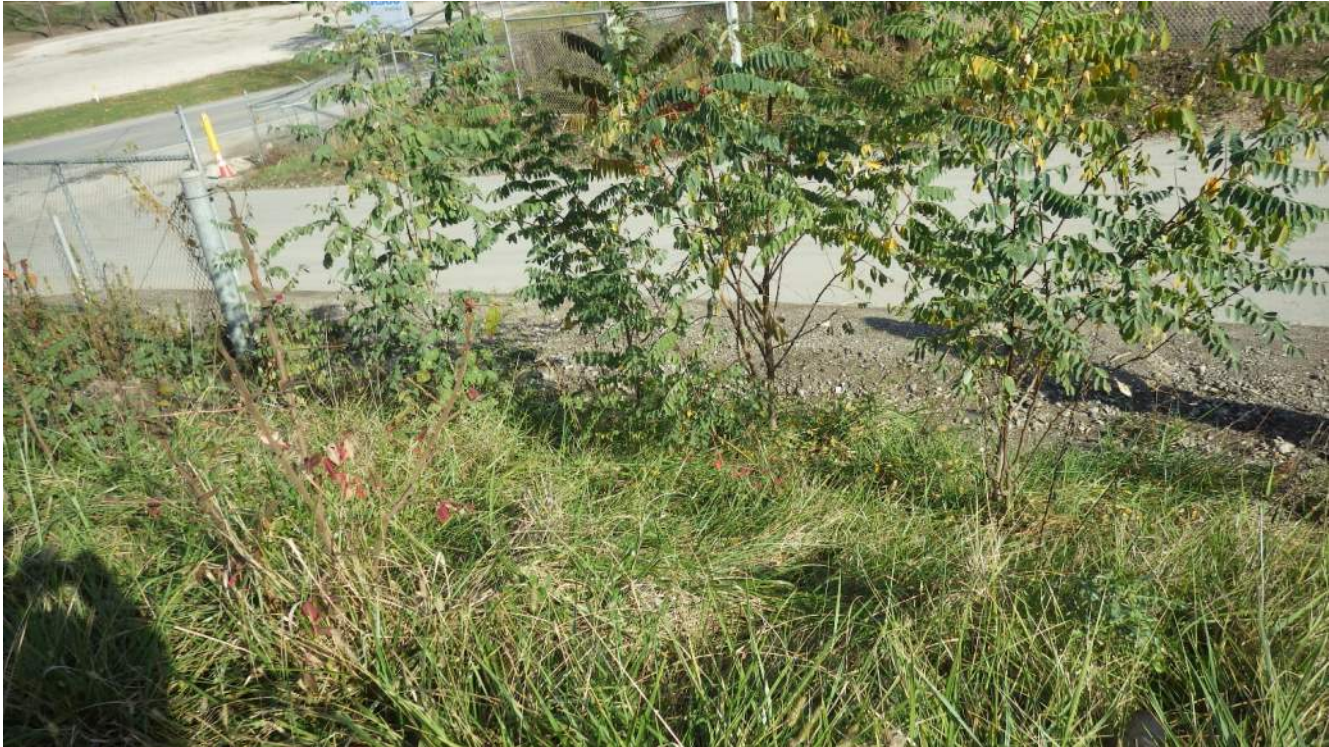
The visual inspection began with observations of the perimeter embankment and splitter dike. In general, the upstream and downstream embankment slopes appear to be in good condition. The northwest corner has woody vegetation and stumps on the exterior slope (Photograph 1, Points 1 through 3). The interior slopes around the LVWTS are newly vegetated with grass visible. Erosion rills are noted, particularly where the material changes from the road surfacing to the grassy slopes (Photographs 5 and 6, Points 5 through 7; Photographs 15 and 16). Vegetation is thin in a few areas. A potentially wet spot (Point 9) was noted

Photograph 1 – Vegetation at northwest corner of BSP.

The northwestern corner of the BSP was obscured by small trees, stumps, and heavy brush (Photograph 1 in Appendix D). Stantec recommends that this area be stripped of foliage, grubbed, and seeded with grass to protect it from erosion.

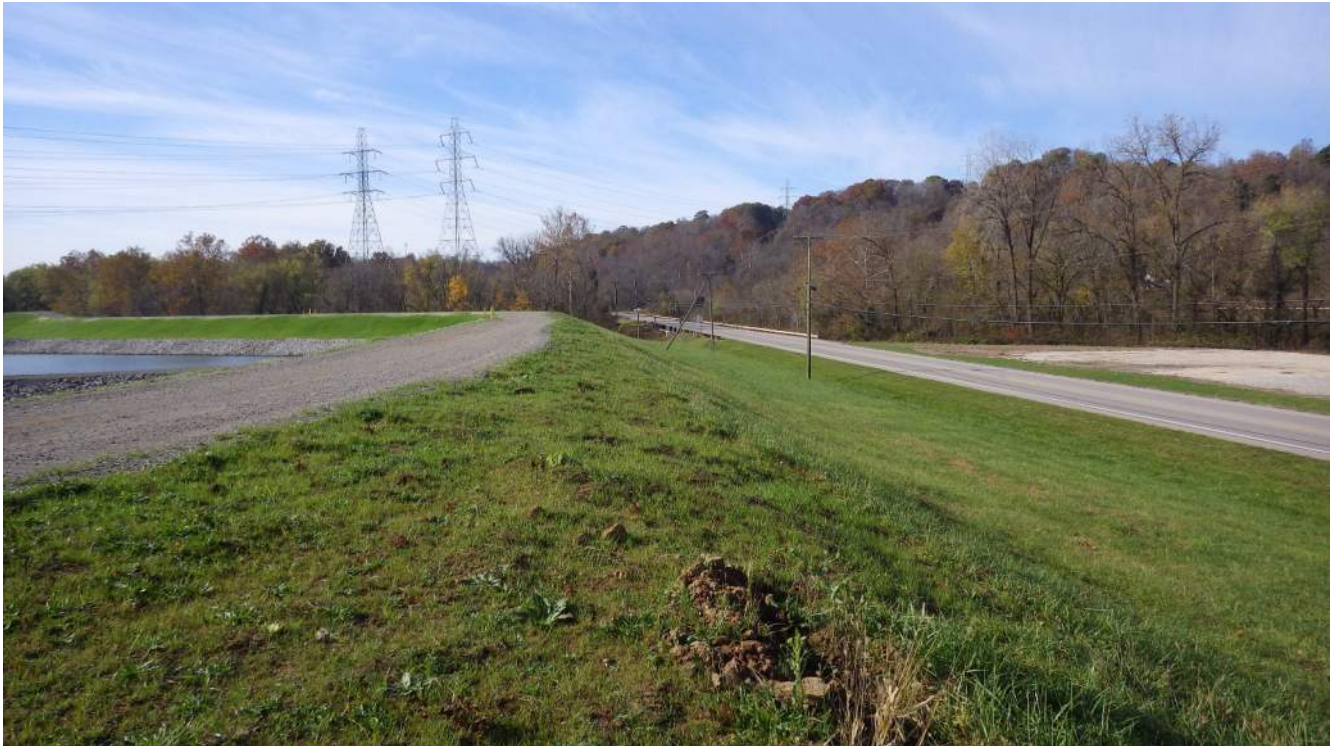
Photograph 2 – Western embankment of BSP.

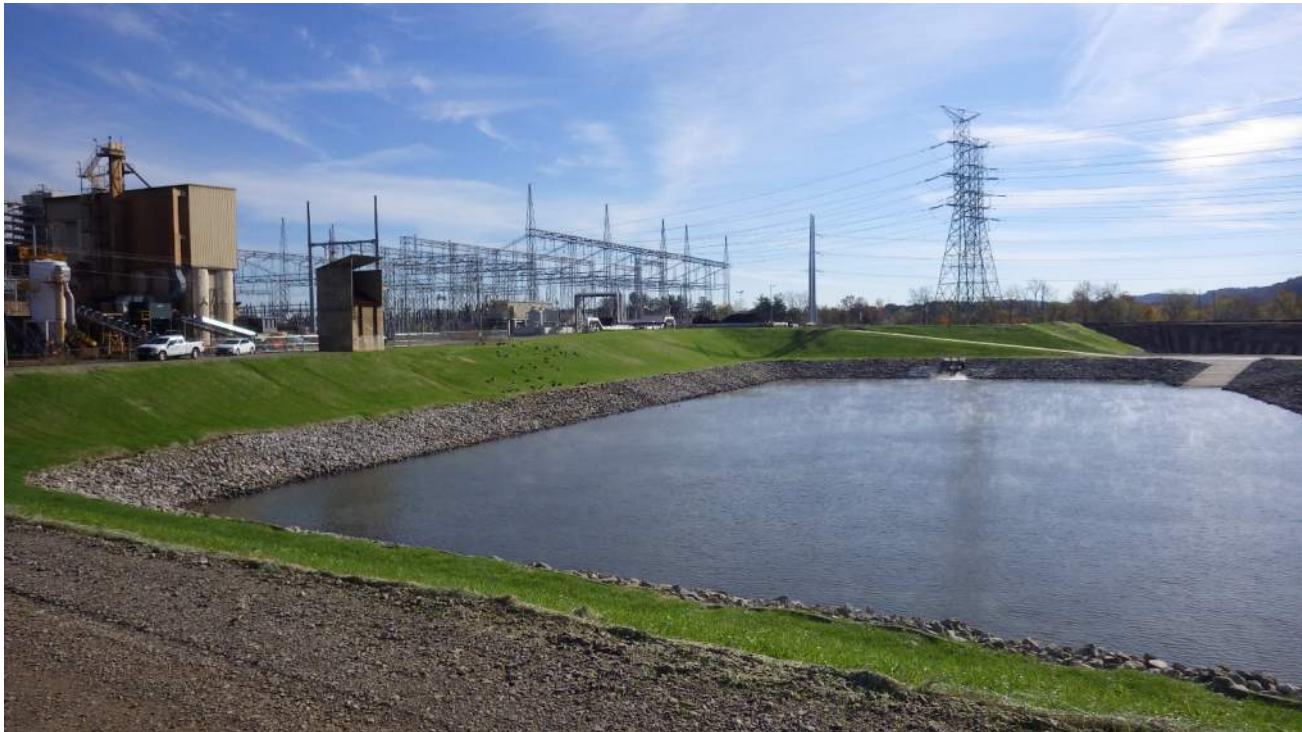
A LVWTS has been installed in the northwest corner of the BSP (Photographs 3 and 4, Appendix D). During LVWTS construction, the crest elevation of the adjacent embankment was lowered to elevation 575 feet. CCR was excavated to the original basin design grades. The interior slopes of the embankment were flattened to 2.5:1 (horizontal:vertical) or flatter prior to construction of the two lined basins (Burns & McDonnell 2023). Reference drawings are provided in Appendix B. Modifications to the BSP geometry was complete in June 2023. The perimeter geometry of the surface impoundment has remained essentially unchanged beyond the recent construction.

**Photograph 3 – New vegetation at northern side of LVWTS, primary basin.**

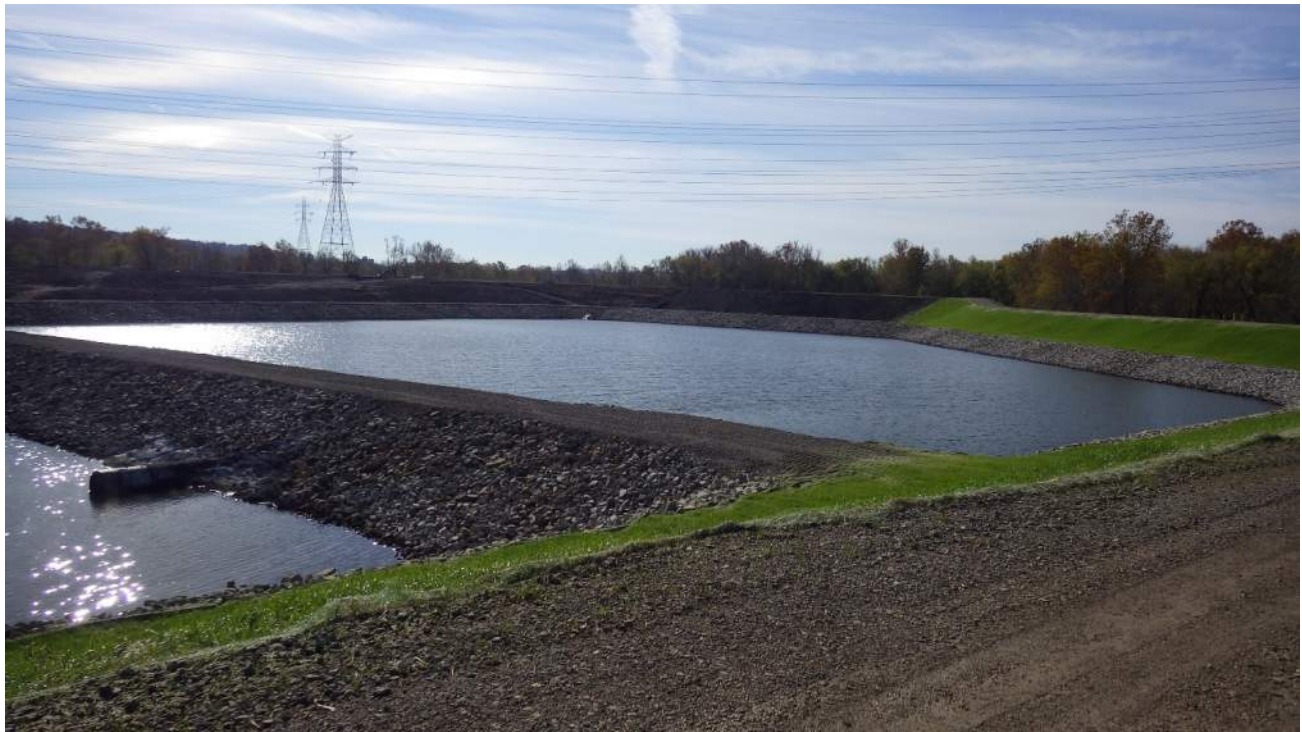
**Photograph 4 – New vegetation along western and southern side of LVWTS, secondary basin.**

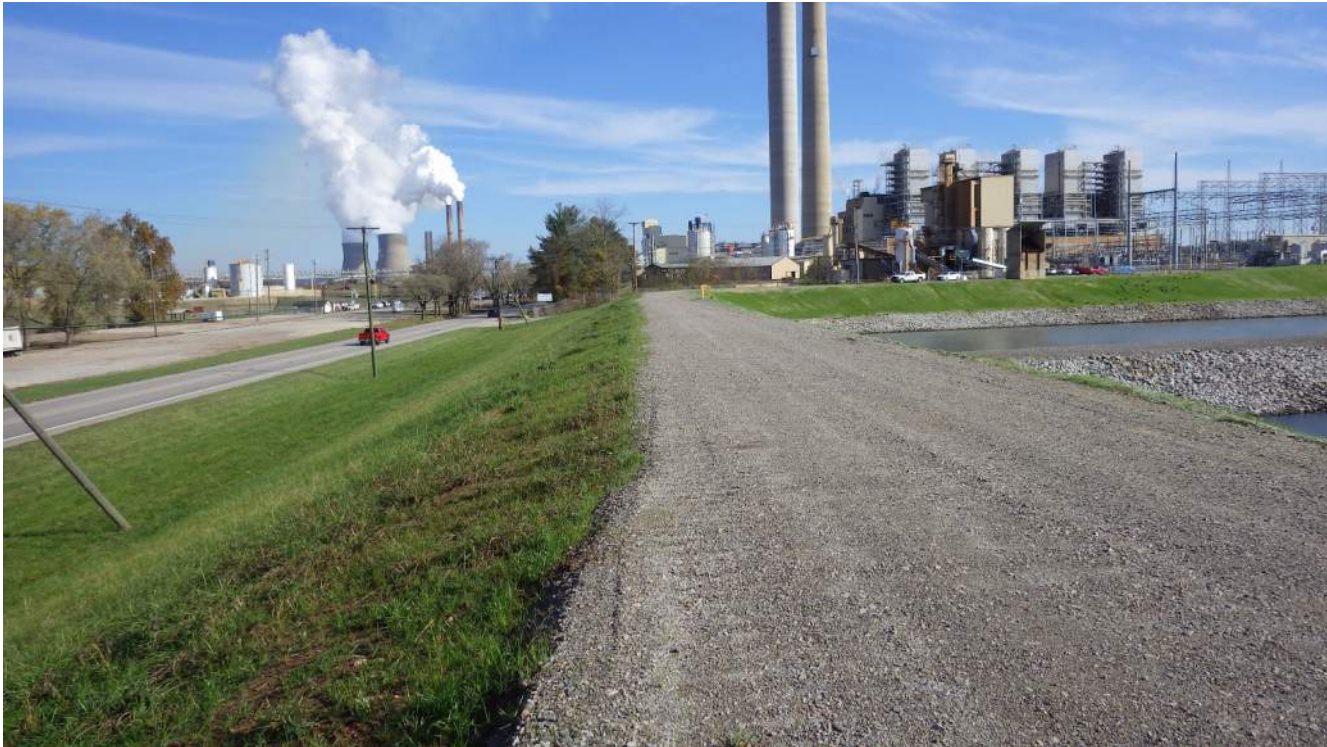
Photograph 5 – Erosion noted at change from access road to grassed slope.

Several areas of minor surface erosion, and bare spots were observed on the exterior slopes of the BSP, specifically in material changes between road surfacing and grass. These areas should be repaired and reseeded as needed. Remove potential CCRs and regrade as needed along the splitter dike and southeastern downstream slope.

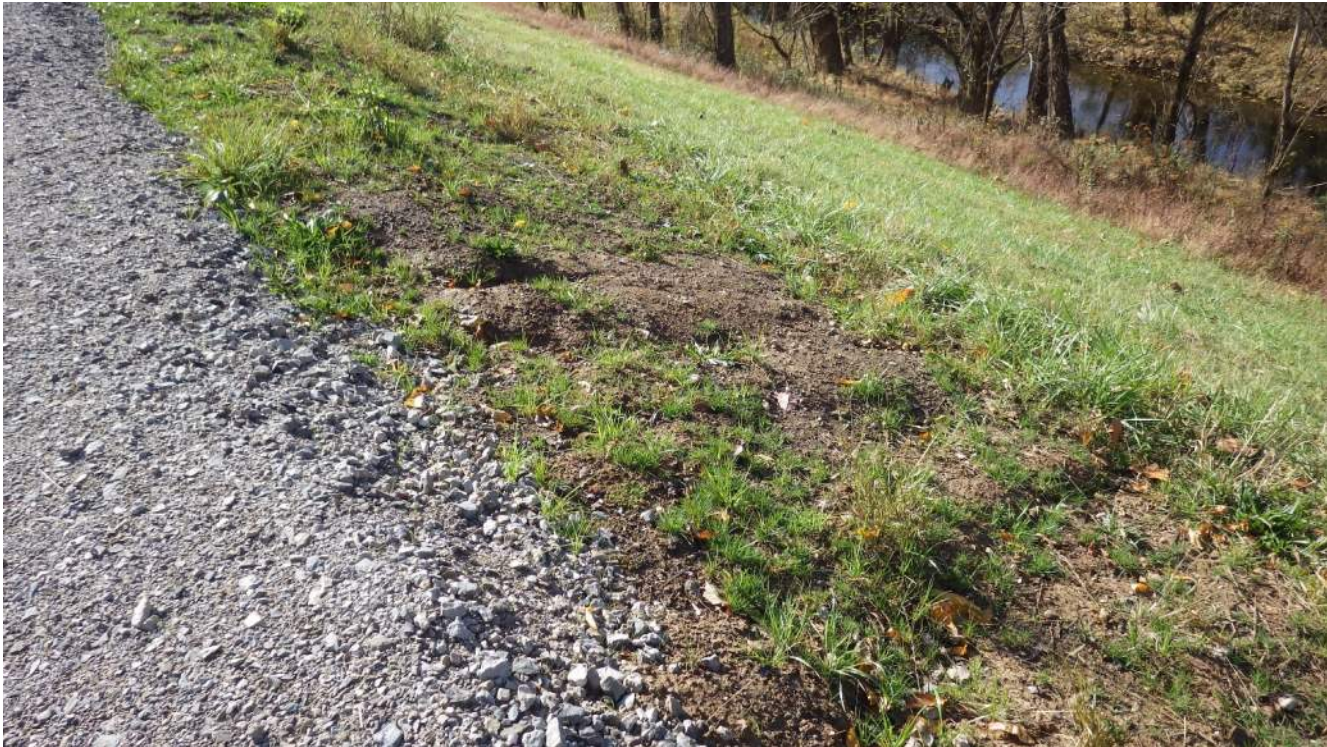
Photograph 6 – Bare spot located on slope between BSP and Kyger Creek.

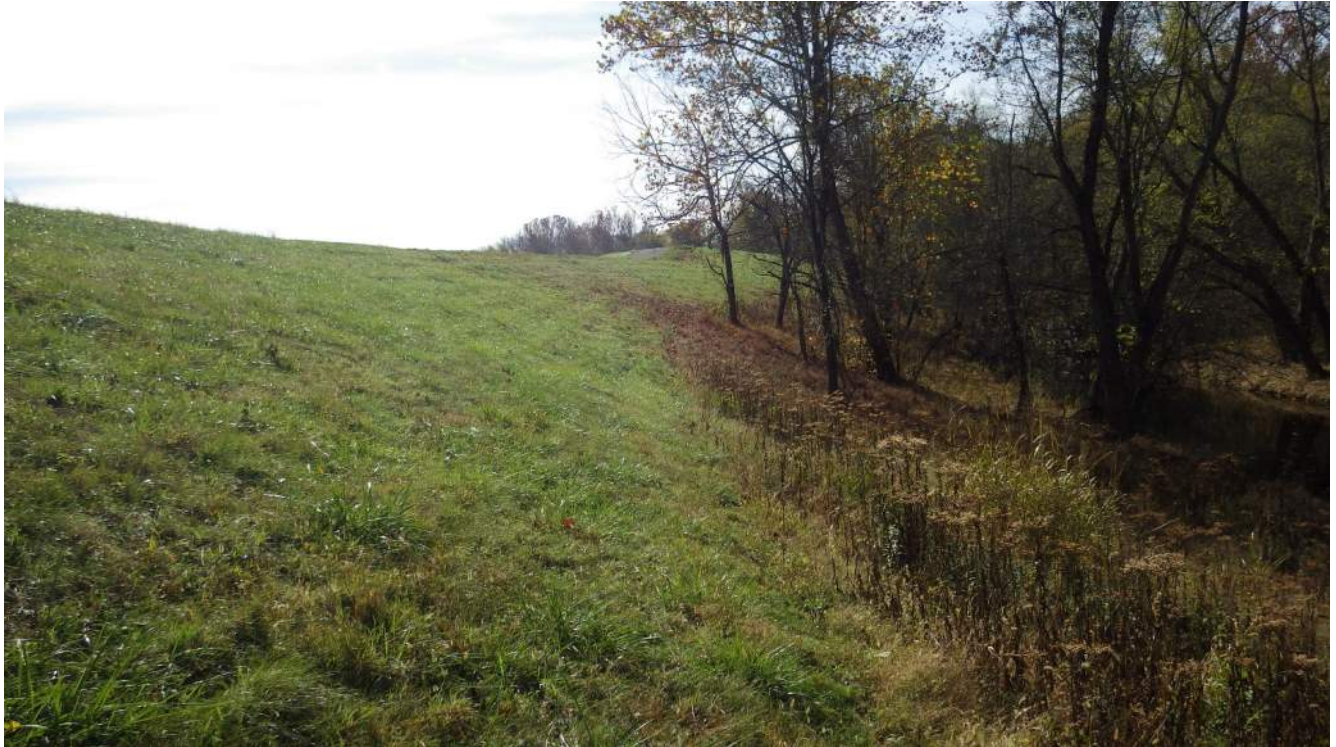
**Photograph 7 – Downstream southwestern slope near Kyger Creek.**

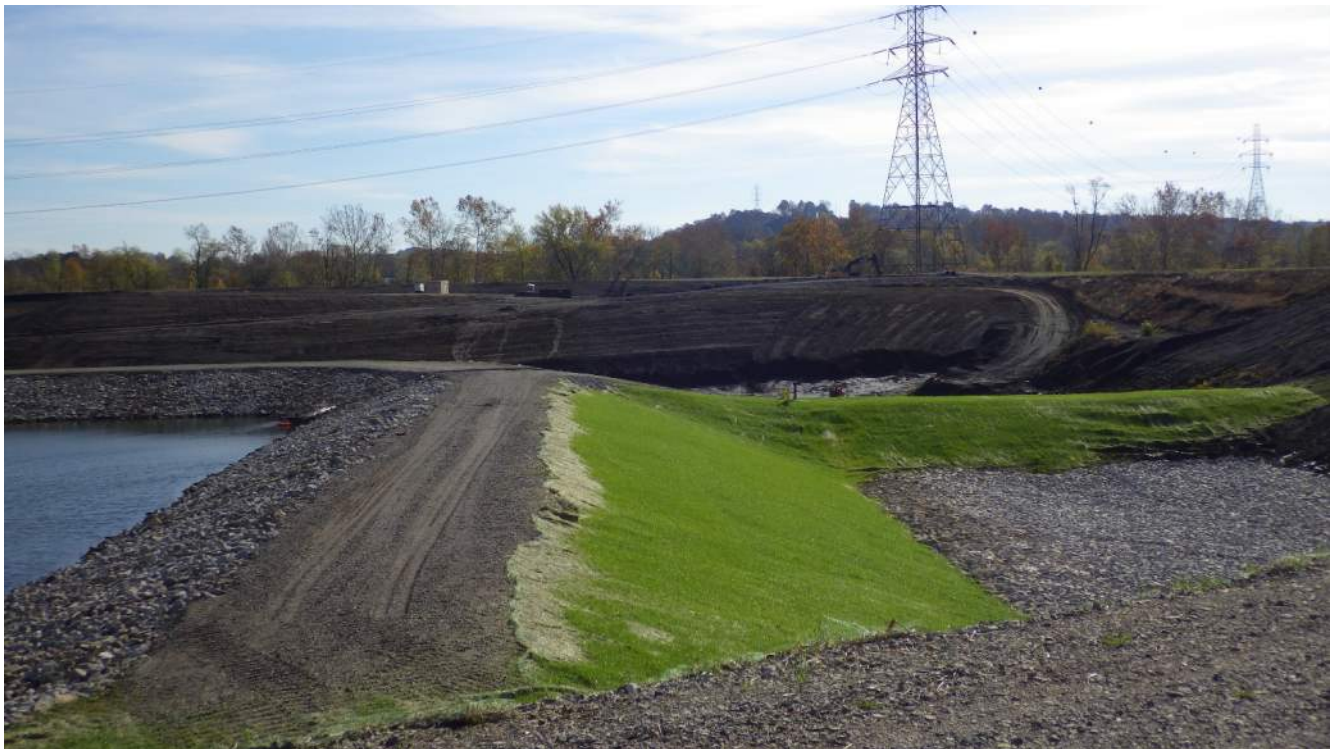
**Photograph 8 – New vegetation on southern LVWTS dike, secondary basin.**

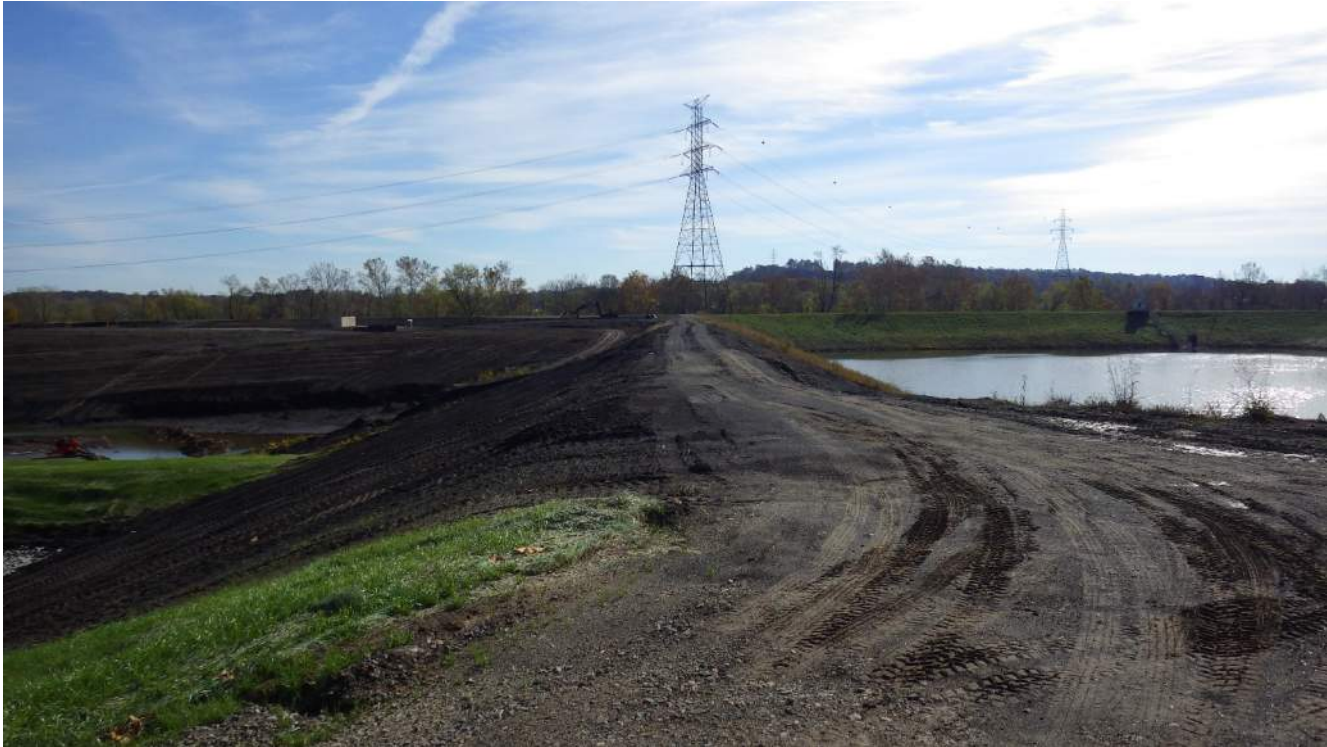
Photograph 9 – Splitter dike between BSP and Clearwater Pond.

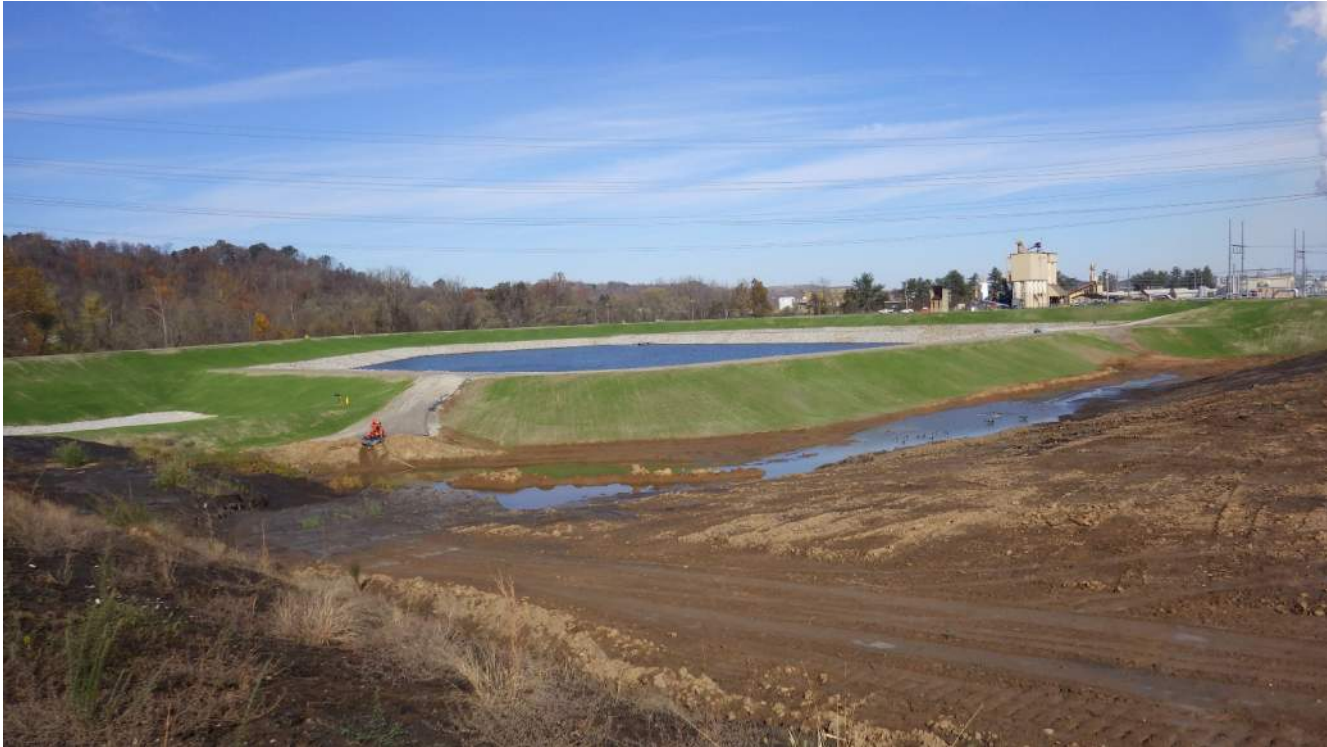
No flows were noted during the site visit into the boiler slag pond closure area. Piping for the LVWTS was noted. The outlet structure for the Clearwater Pond was observed (Photograph 11). Pounded water was limited to an area at the toe of the LVWTS within the boiler slag pond closure area (Photograph 10). A pump and hose were present at the southern end.

Photograph 10 – BSP water management and pumping adjacent to LVWTS.

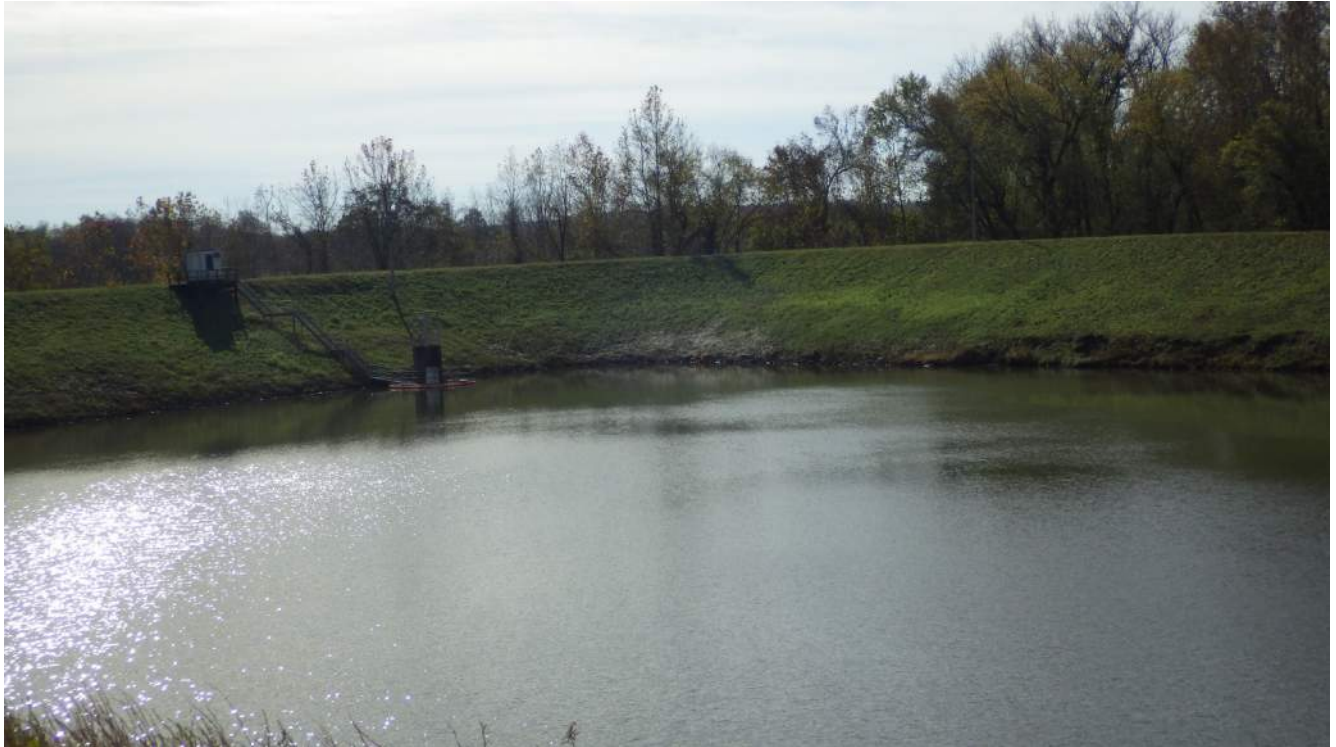
**Photograph 11 – Outlet structure from Clearwater Pond to the Ohio River.**

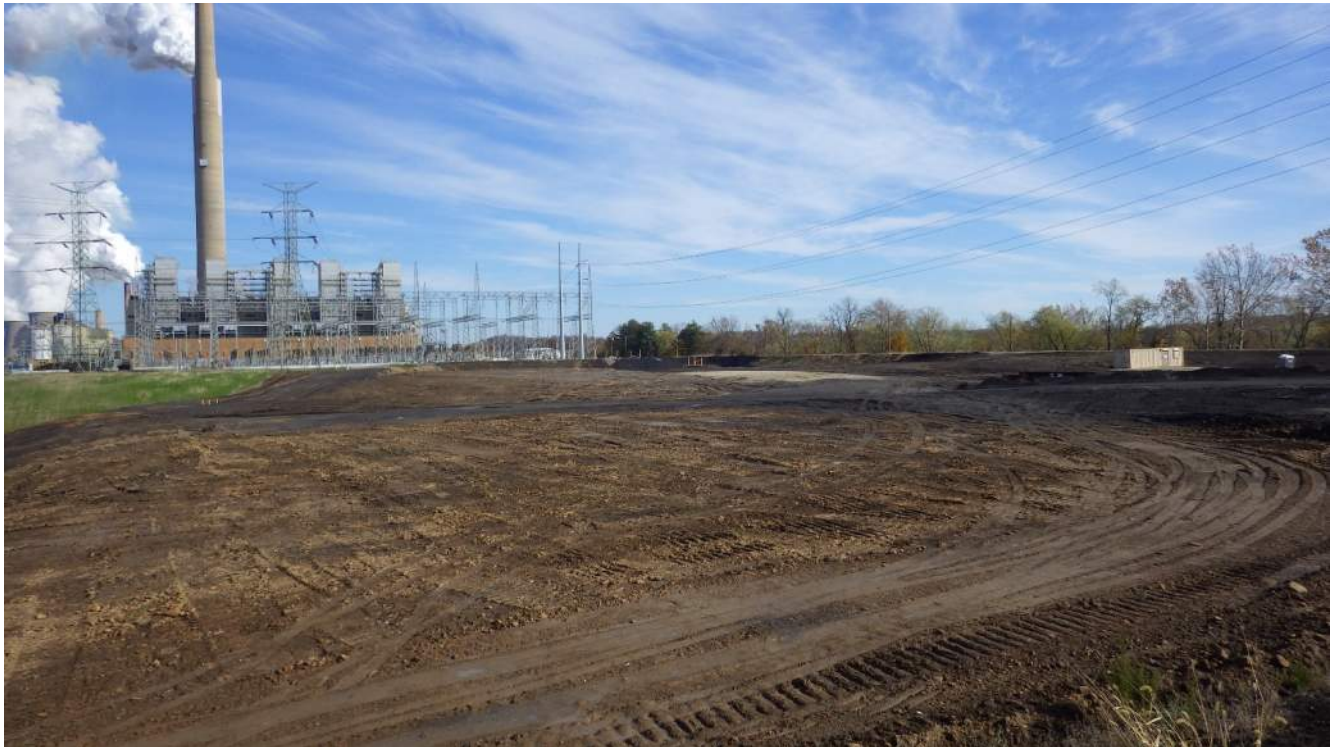
**Photograph 12 – Boiler slag pond closure area east of LVWTS.**

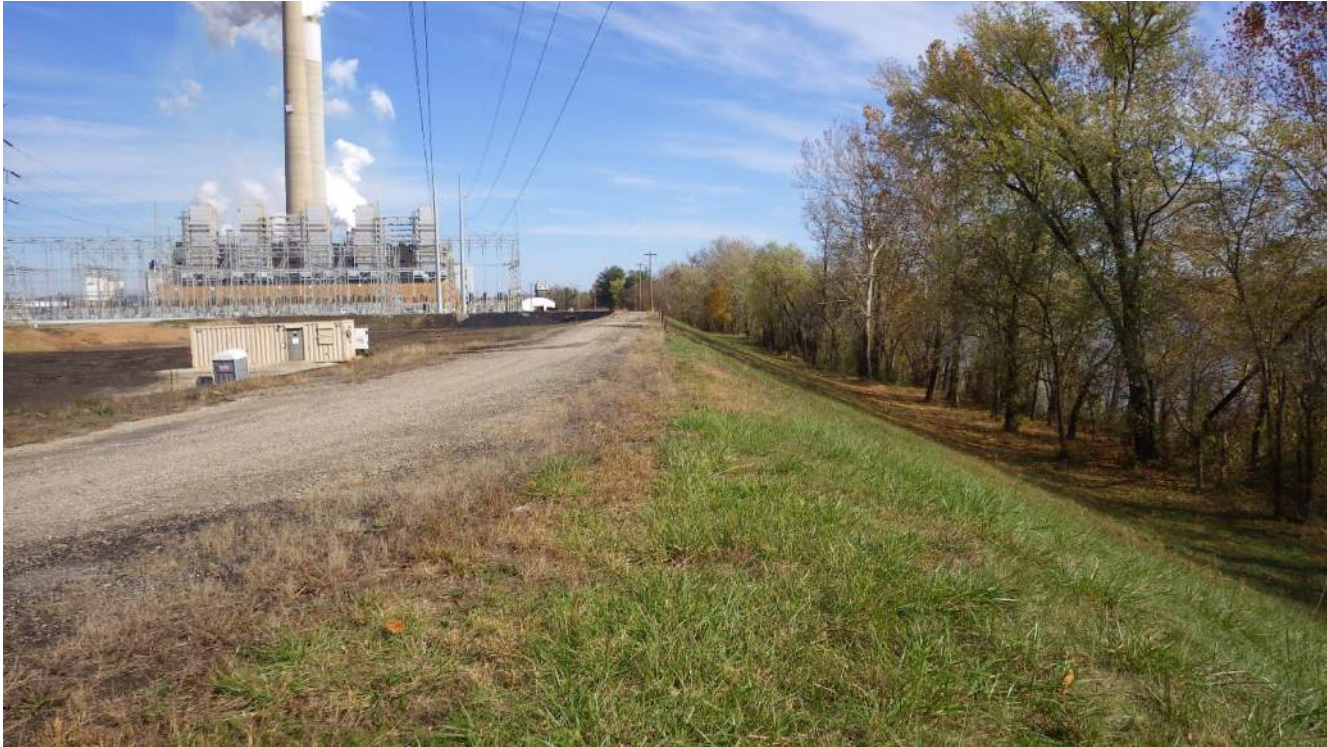
**Photograph 13 – Downstream eastern embankment of BSP.**

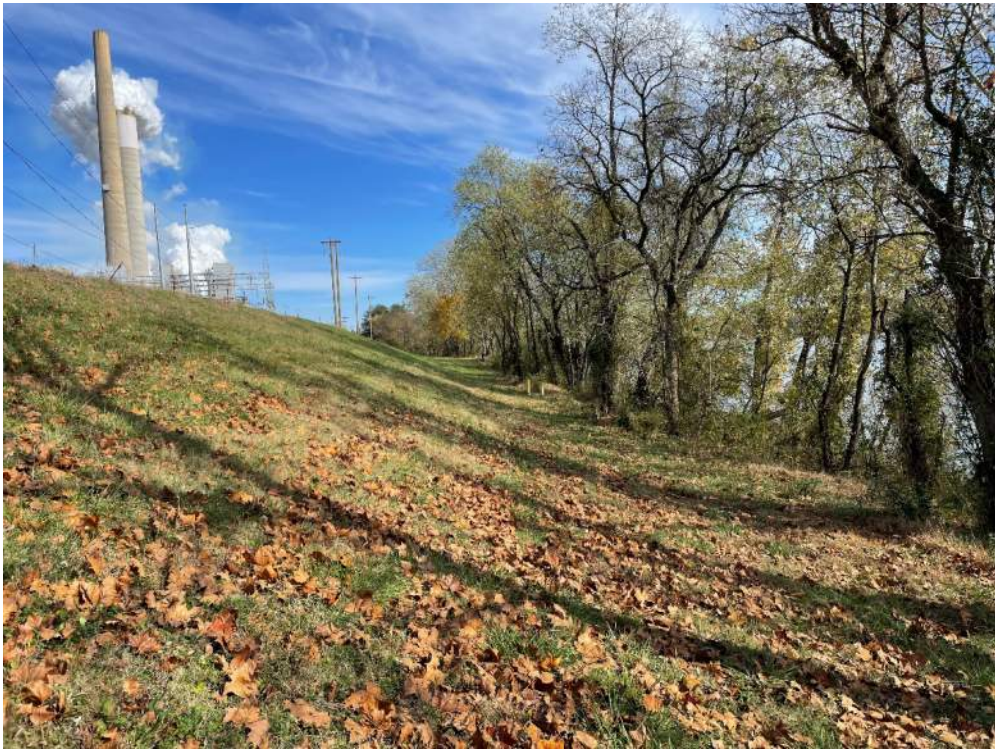
**Photograph 14 – Downstream eastern embankment of the BSP.**

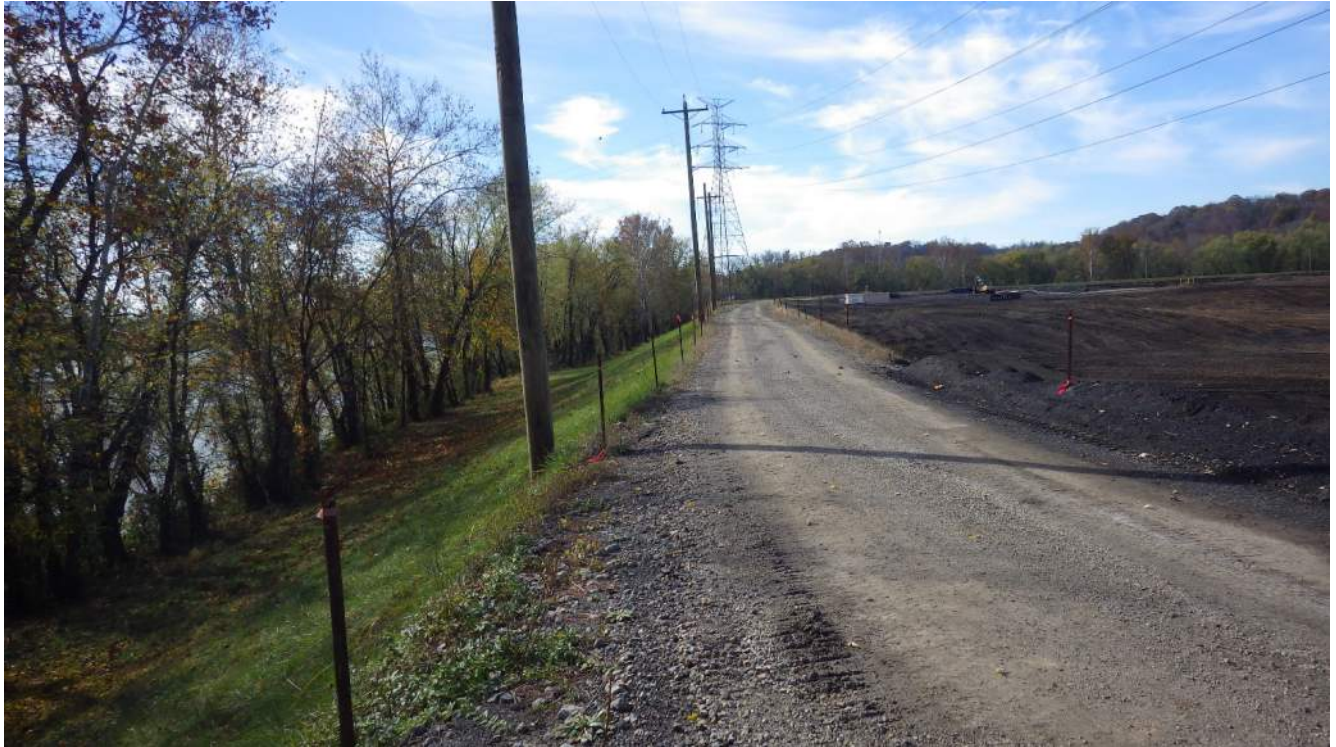
**Photograph 17 – Eastern embankment with boiler slag closure area on the right.**

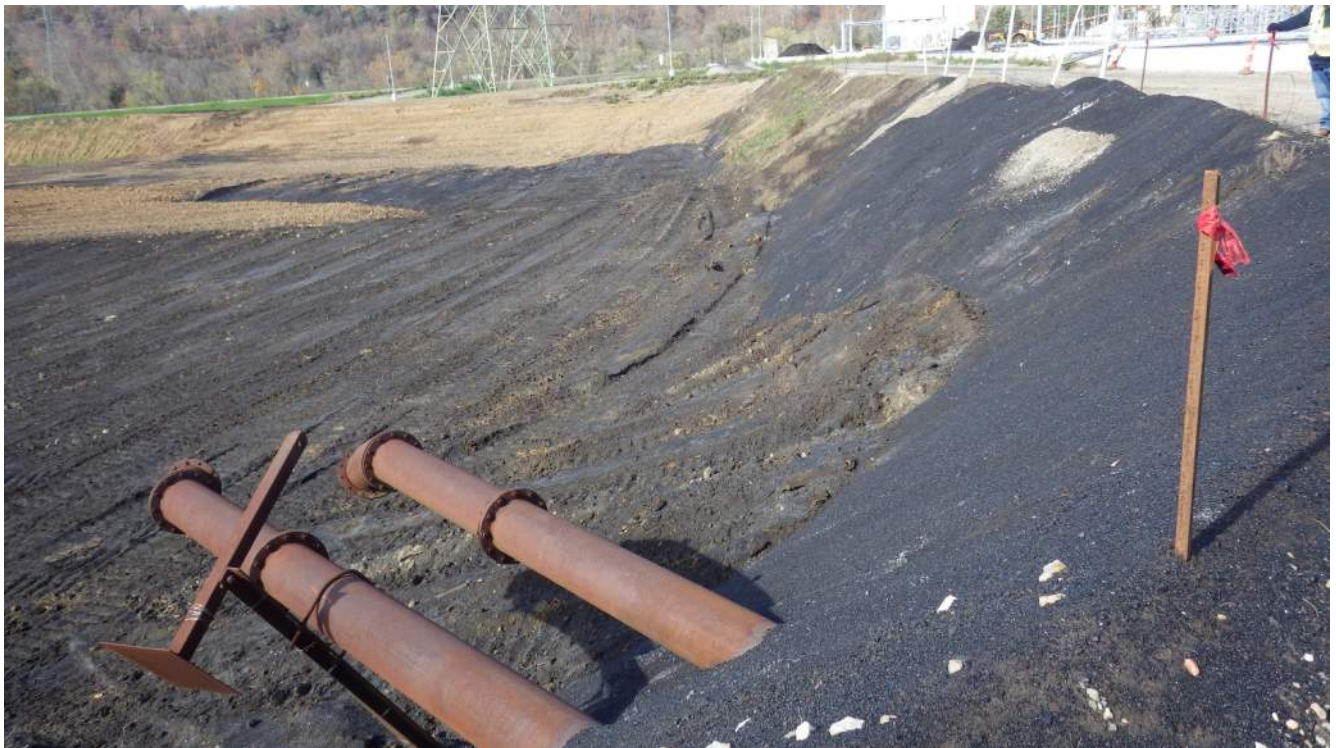
on the slope near Kyger Creek. CCR and a bare area noted on the southern slope near the roadway (Points 10 and 11). The toe of the interior slope was excavated in the northeast corner near the historic sluice lines (Photograph 18, Points 13 and 14).

**Photograph 18 – Excavation in northeastern corner of boiler slag closure area.**

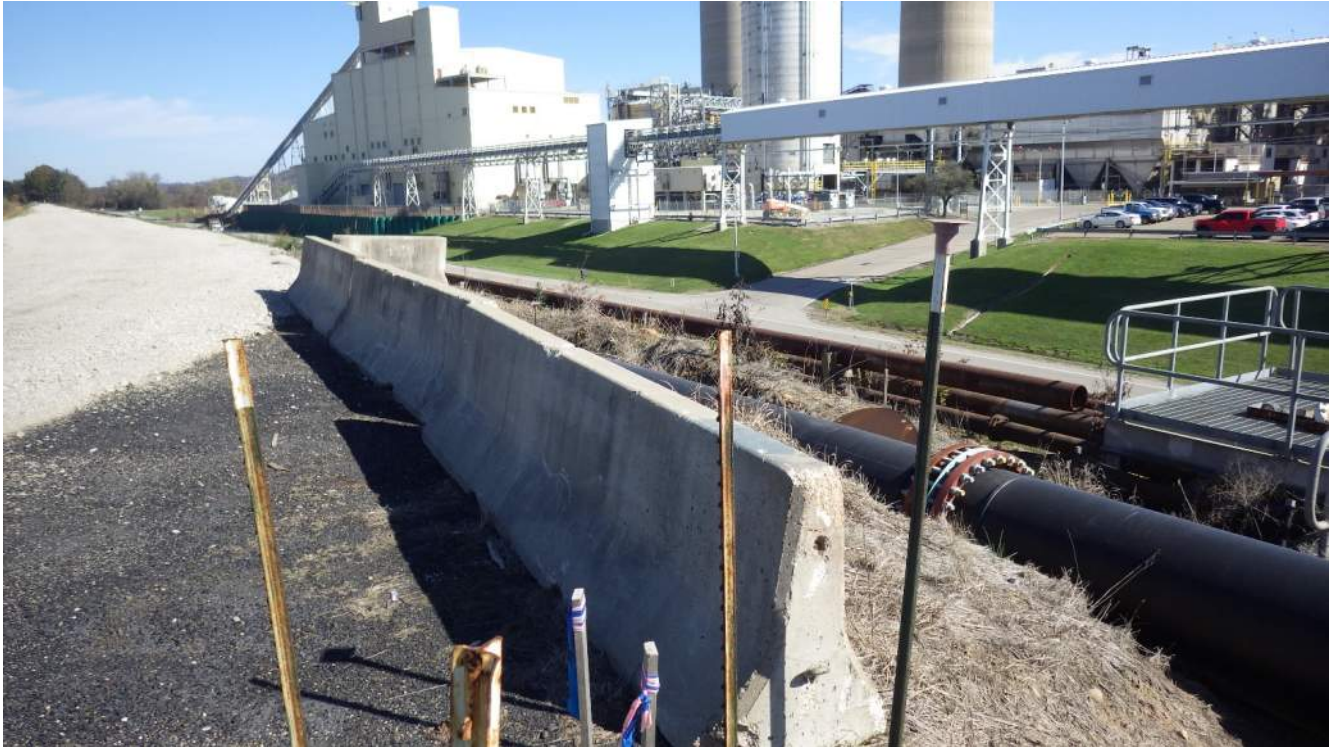
Photograph 1 – LVWTS piping entering southeast corner of the SFAP embankment.

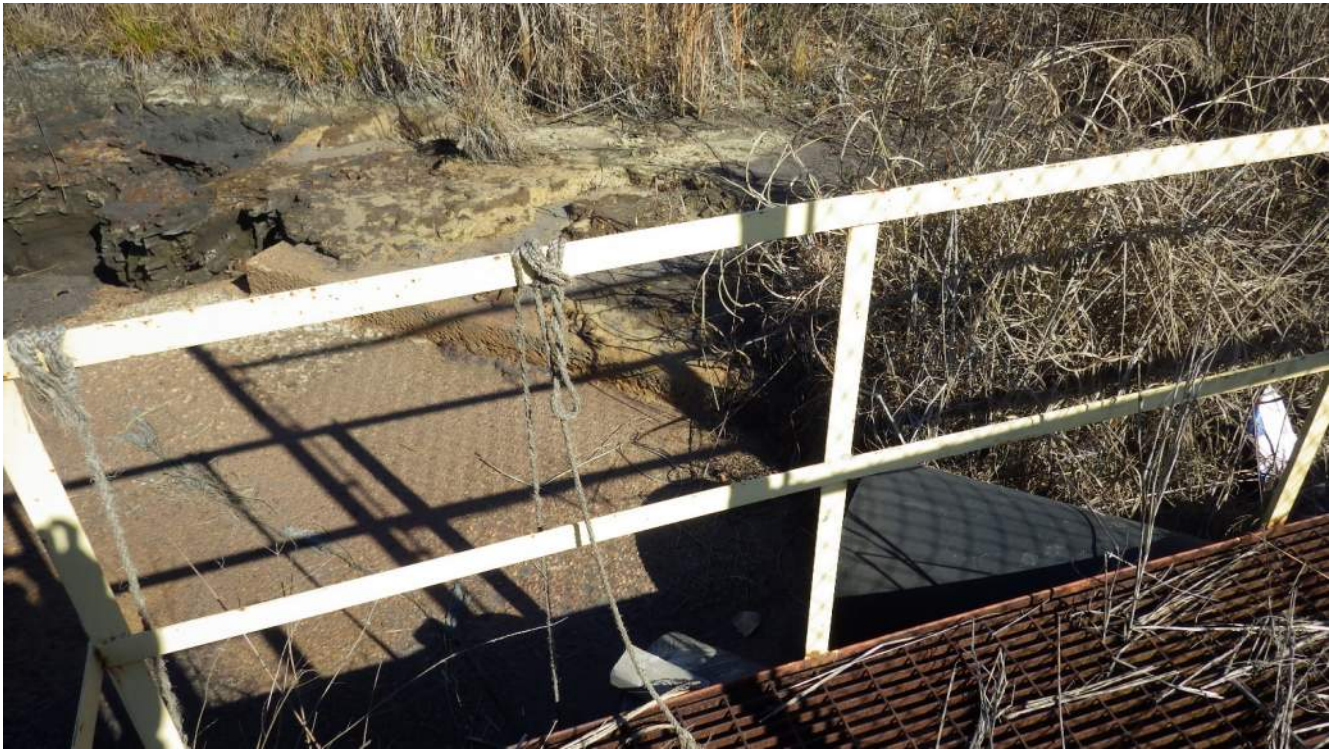
No flow was noted at the inlet to the SFAP at the southeastern corner (Photograph 2). The interior of the pond is relatively flat and dry in the eastern half with woody vegetation and tall grass, limiting observation (Photograph 3). An excavation or test pit was present in the tall grass along the southeastern corner and discussed with the personnel present.

Photograph 2 – Southeast inlet into SFAP.

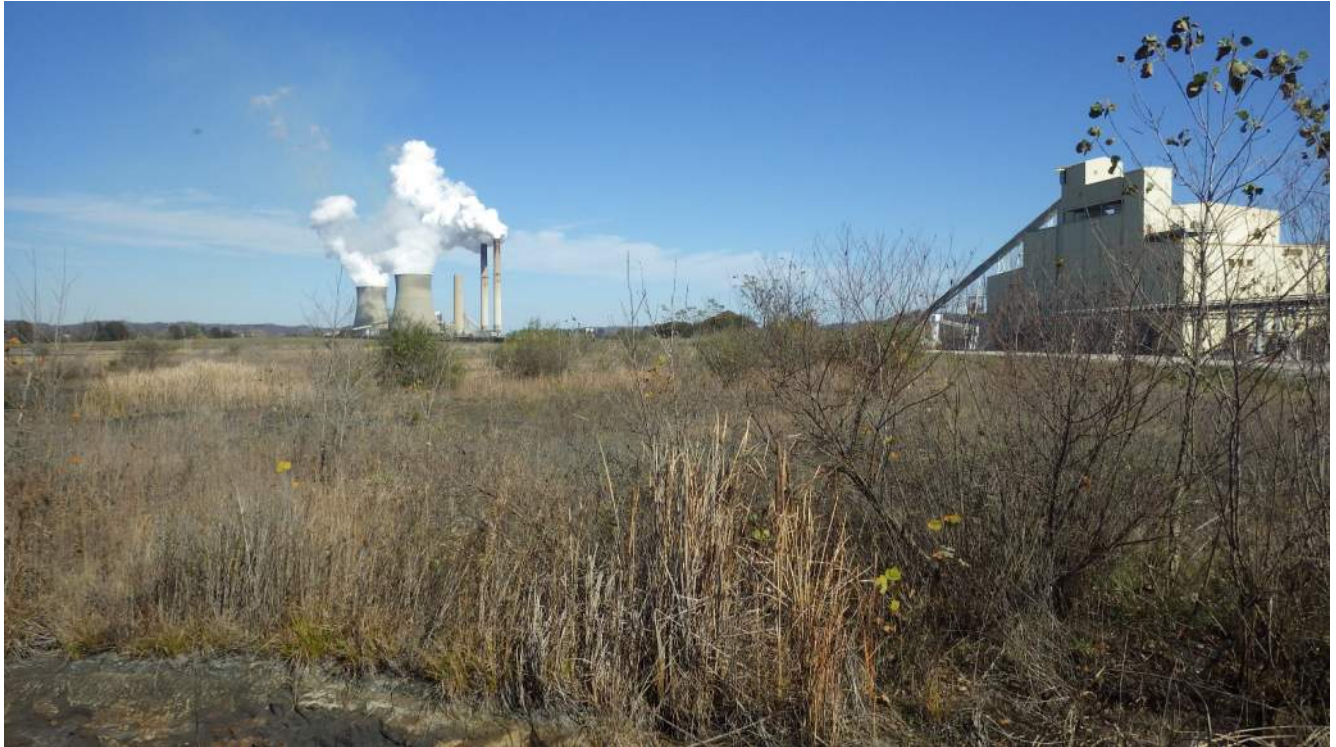
**Photograph 3 – Southeast corner of the SFAP.**

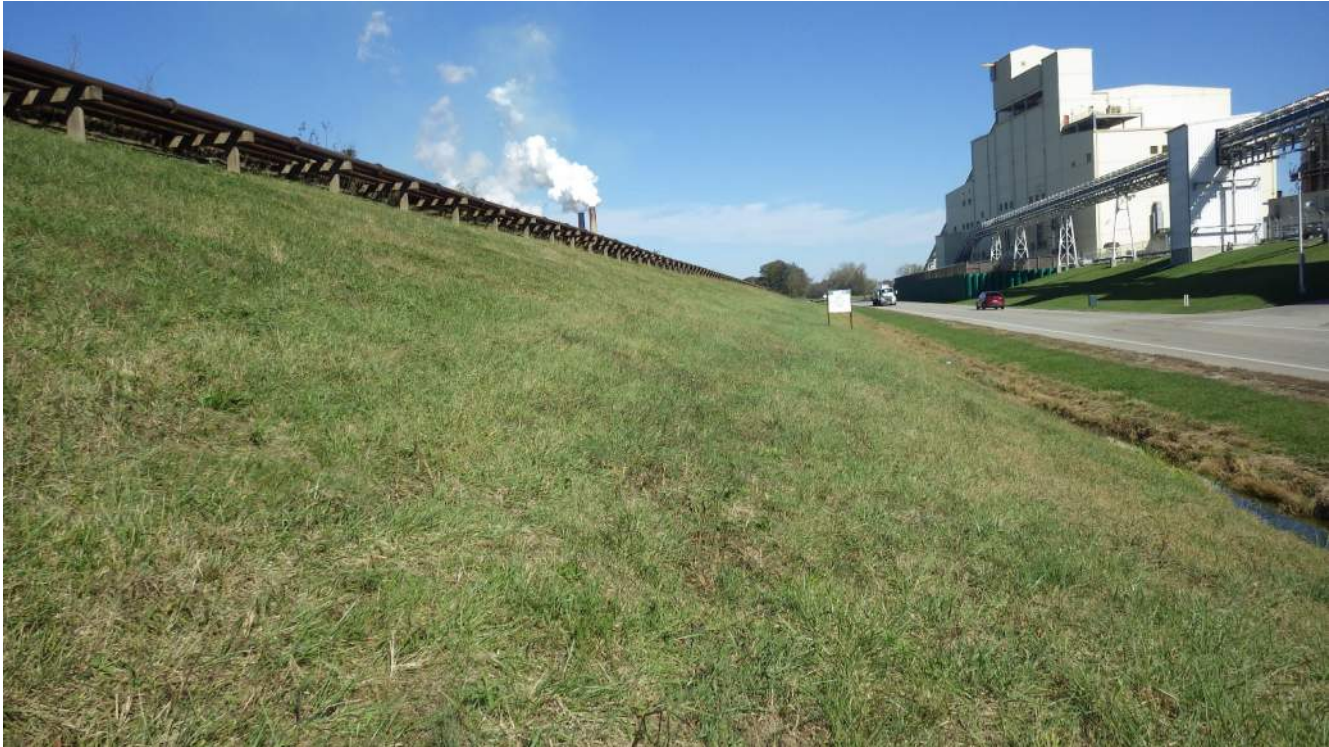
Soft spots, holes, and erosion were noted on the downstream slope along State Route 7. Most appeared minor and were noted as maintenance items. Standing water was observed in the channel at the toe of slope (Photographs 5 and 6). Continued monitoring of this slope and the existing seepage blankets is recommended.

**Photograph 5 – Downstream side of eastern perimeter embankment.**

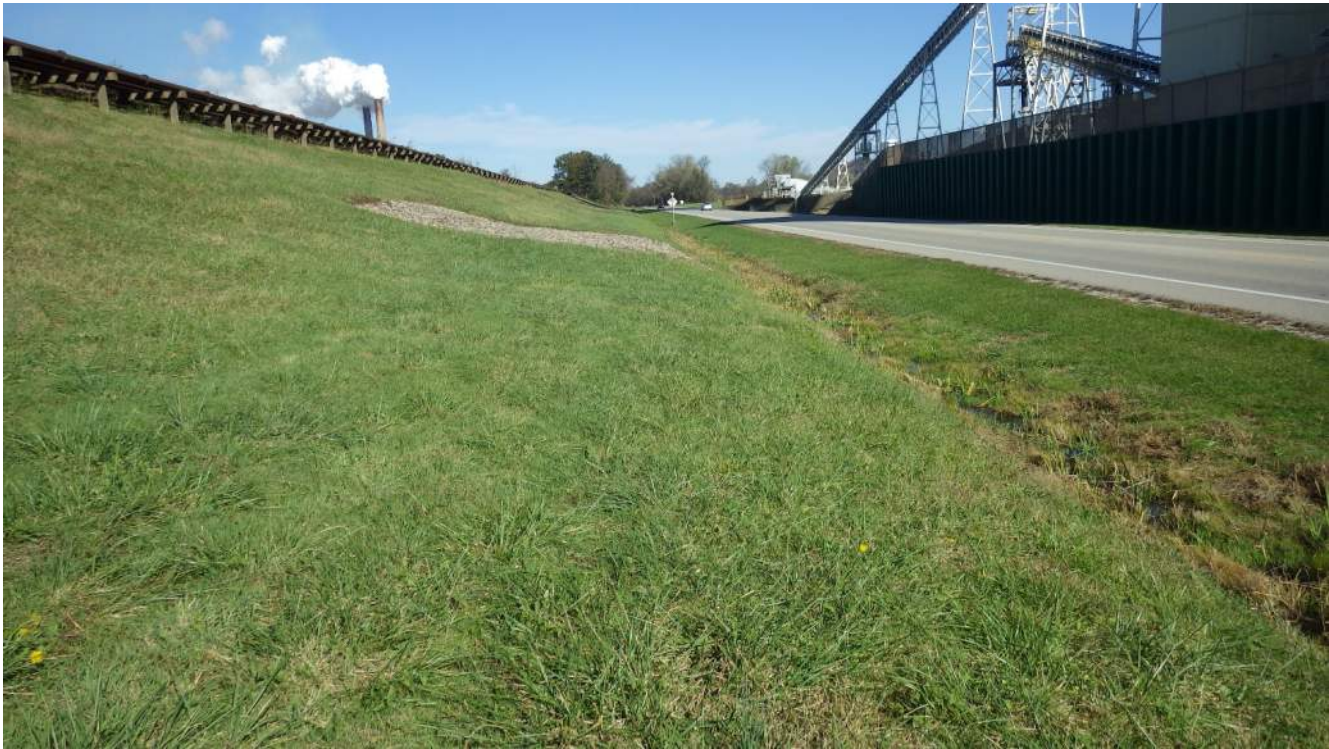
**Photograph 6 – Seepage blanket on downstream side of eastern perimeter embankment.**

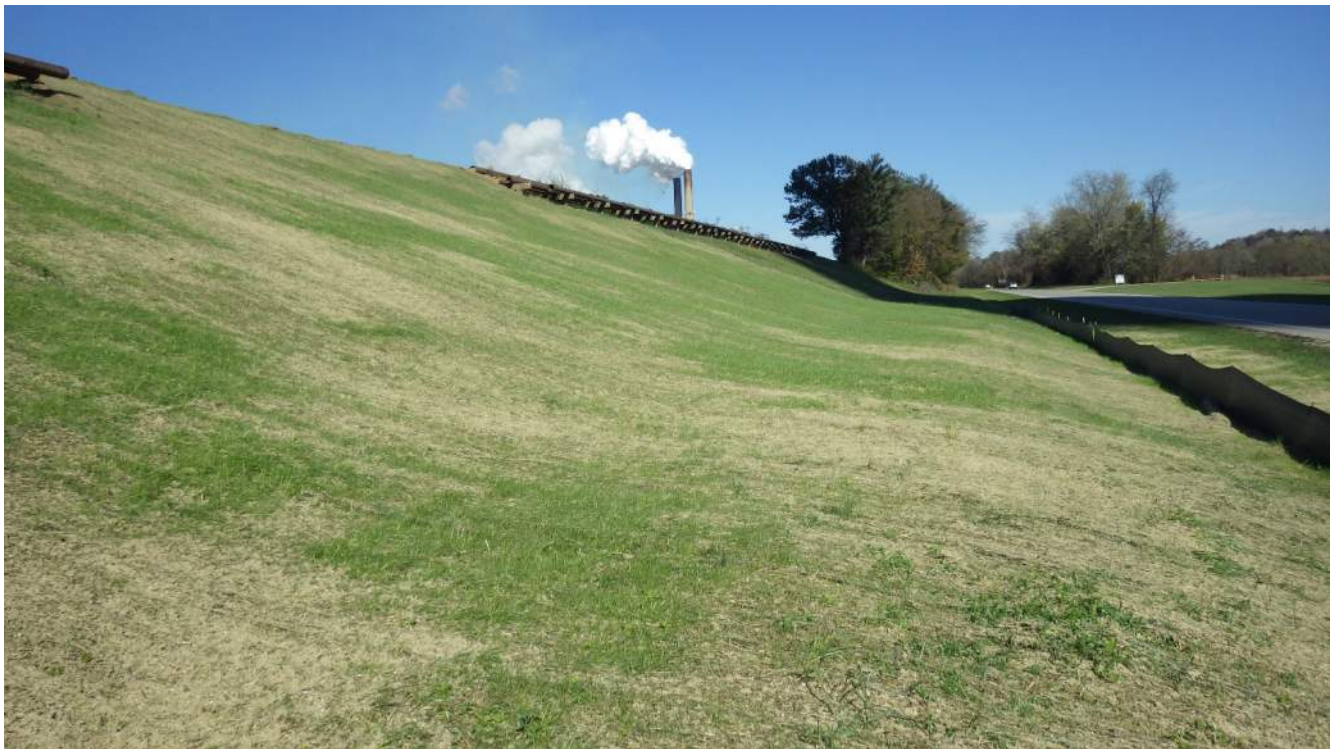
**Photograph 8 – New vegetation at possible LVWTS piping crossing on downstream side eastern embankment.**
