**2023 CCR Rule – Surface Impoundments  
Kyger Creek Dam/Dike Inspections**

Kyger Creek Generating Station  
Cheshire, Ohio  
Gallia County

January 19, 2024

Stantec Consulting Services Inc.  
Cincinnati, Ohio

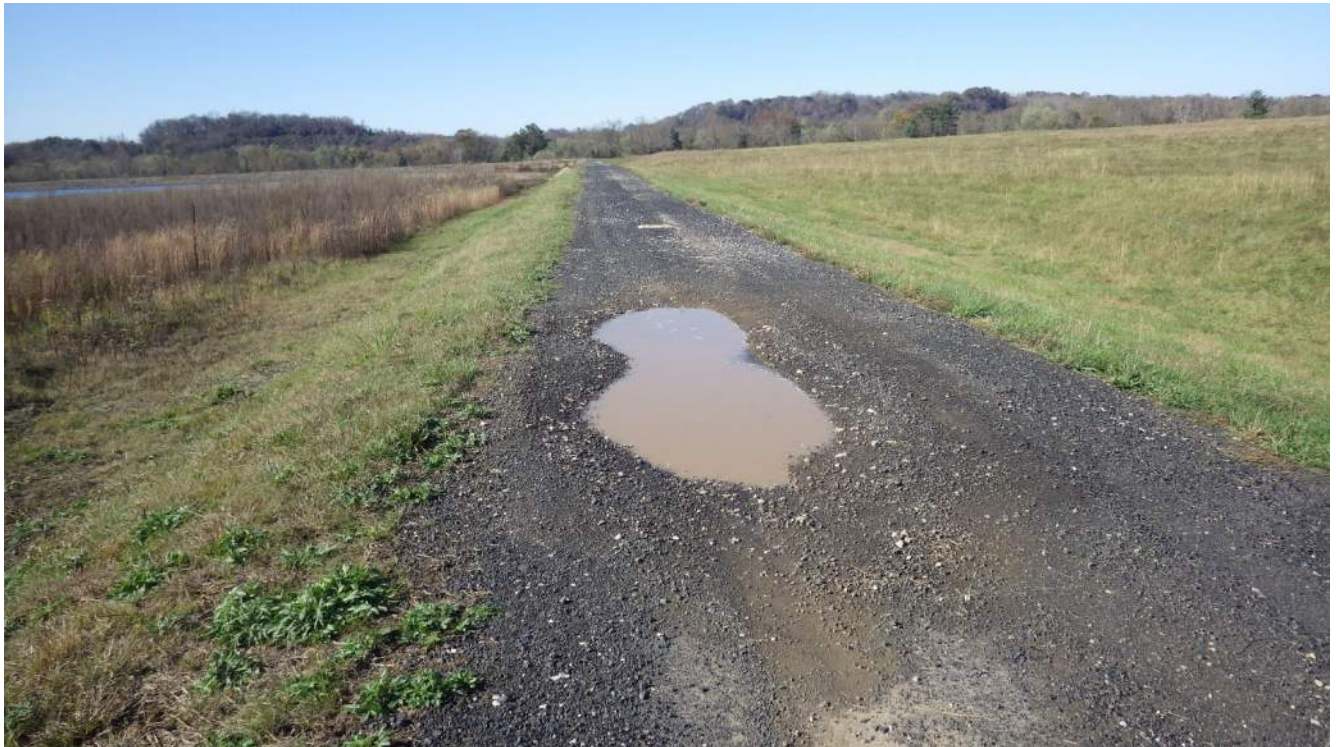
The northern dike has an established operational road with a boiler slag surface. Monitoring wells were noted during the site visit. Low spots with standing water on the road were noted (Photograph 10; Point 22). In areas with open water, the upstream slope of the northern dike included a riprap surface (Photograph 11).

**Photograph 10 – Standing water on northern dike.**

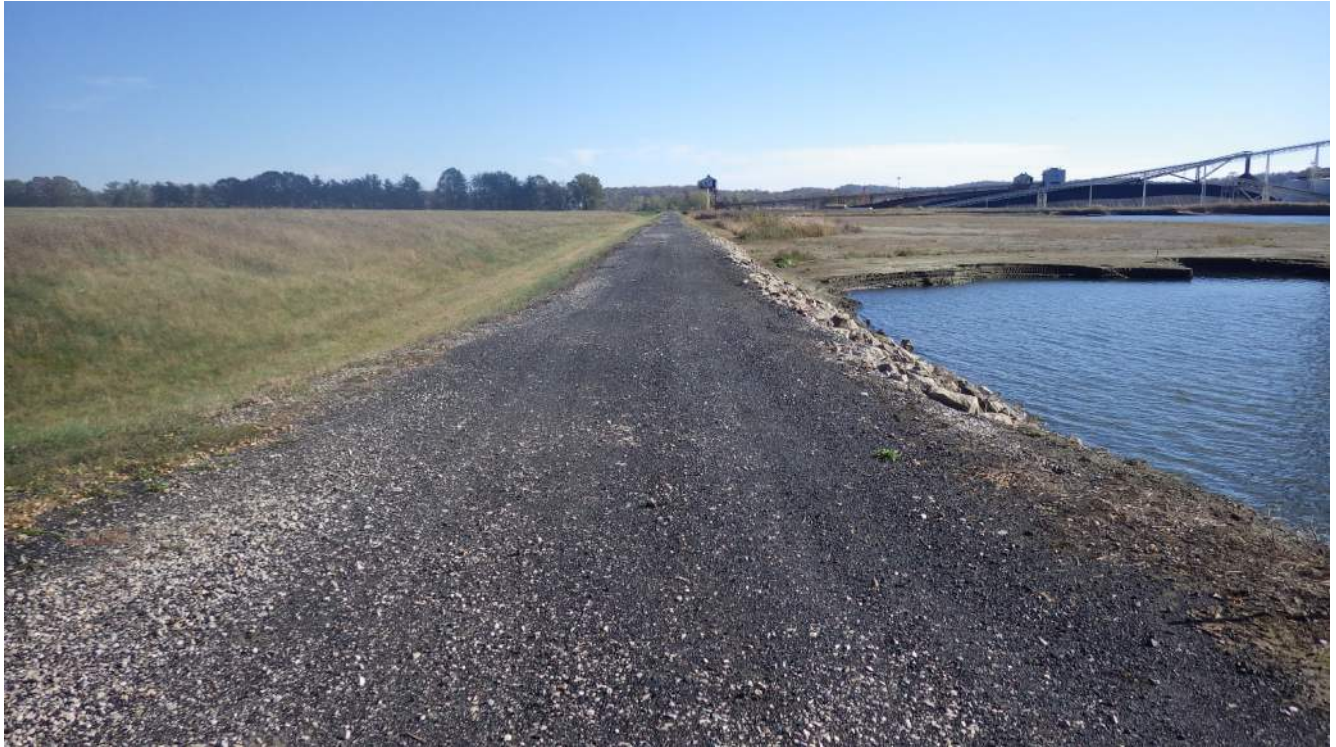
**Photograph 11 – Northern dike showing upstream riprap protection.**

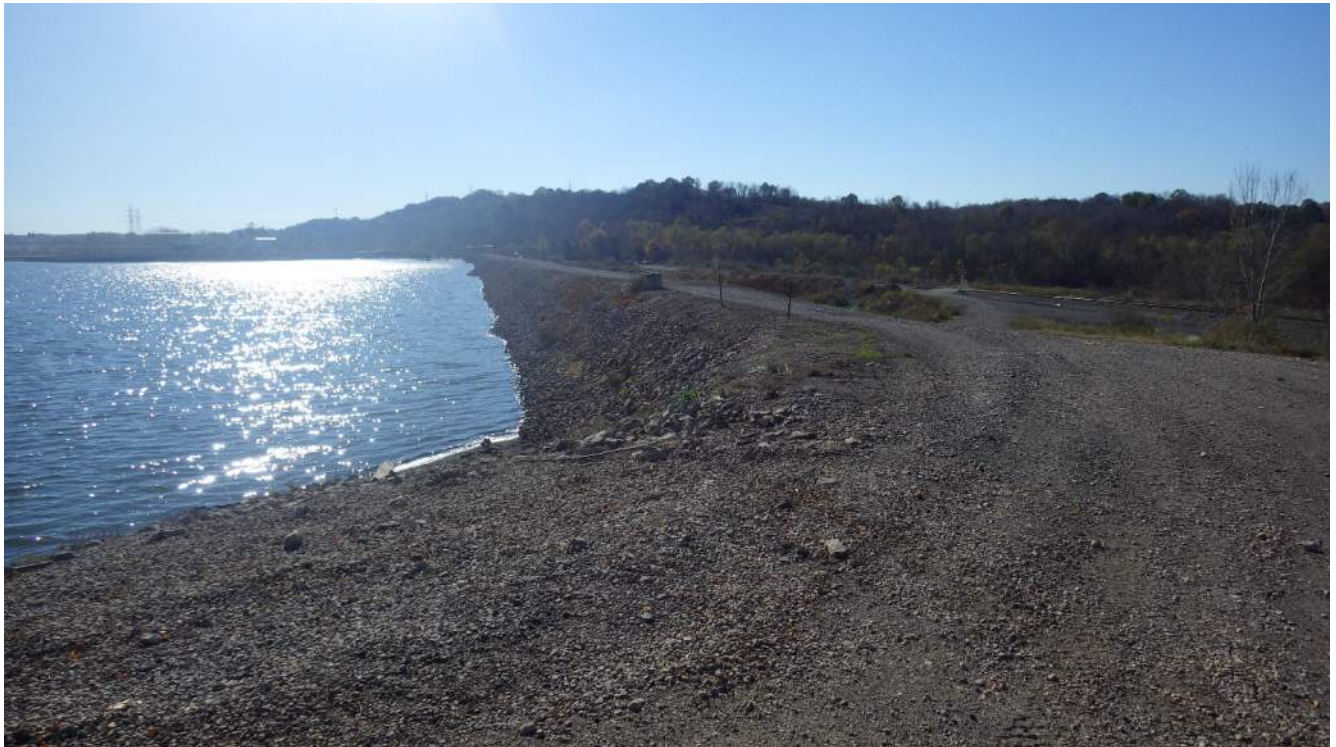
**Photograph 12 – Western embankment showing upstream riprap protection.**

Minor maintenance for the SFAP includes repairing sloughing of the surface (Photograph 12), determining the cause of holes and repairing them (Photograph 15), regrading the drive path for positive drainage (Photograph 17), and repairing bare spots (Photograph 20). Some additional riprap rock may be necessary along the base of the western slope of the SFAP is recommended to protect the soil slope (Photograph 19).

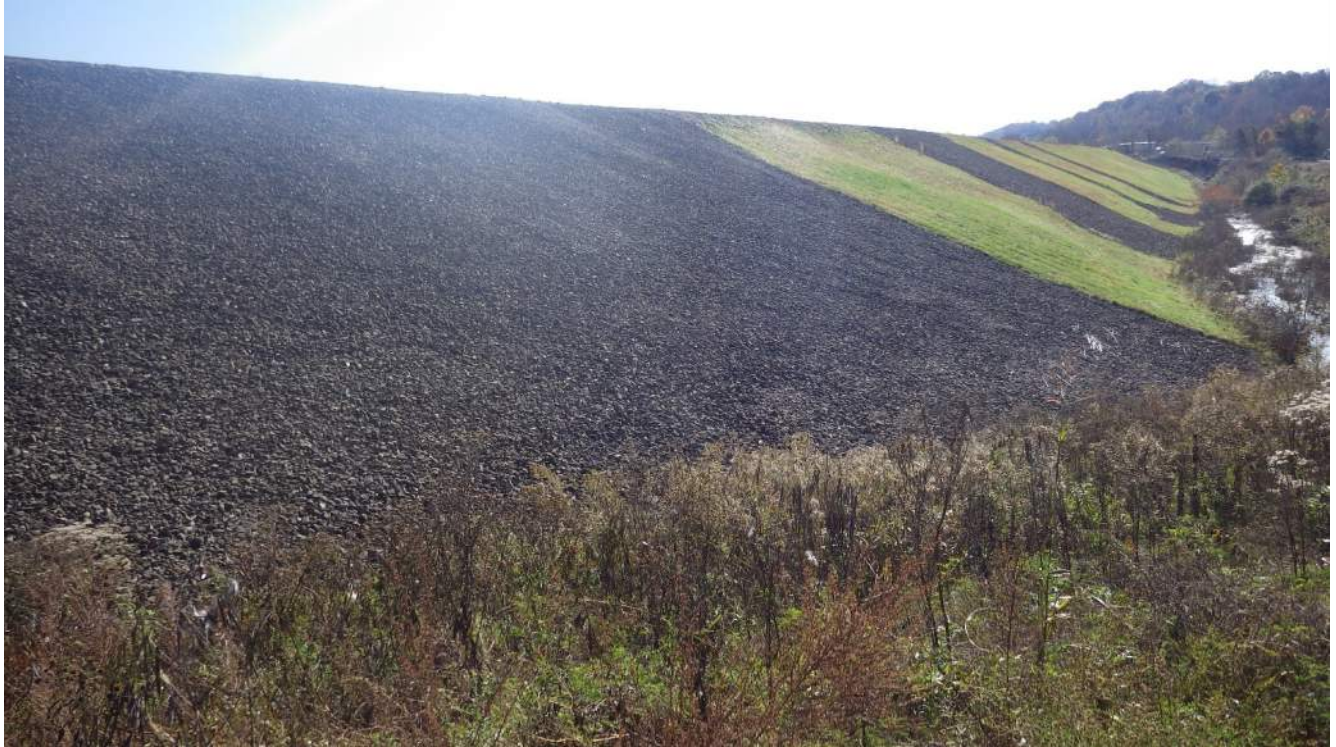
The downstream side of the western slope was mowed with several seepage blankets (Photograph 13). A channel with standing water was located at the toe of slope. Signs of slope instability or new areas of seepage were not identified during the site walk. Monitoring of this slope should continue. The outfall to Kyger Creek was located at the southern end of the channel (Photograph 14). The concrete outfall for the SFAP was observed at the southwestern corner of the pond (Photograph 15). The upstream slope had a riprap surface above the water line.

Photograph 13 – Aggregate seepage blankets on western slope.

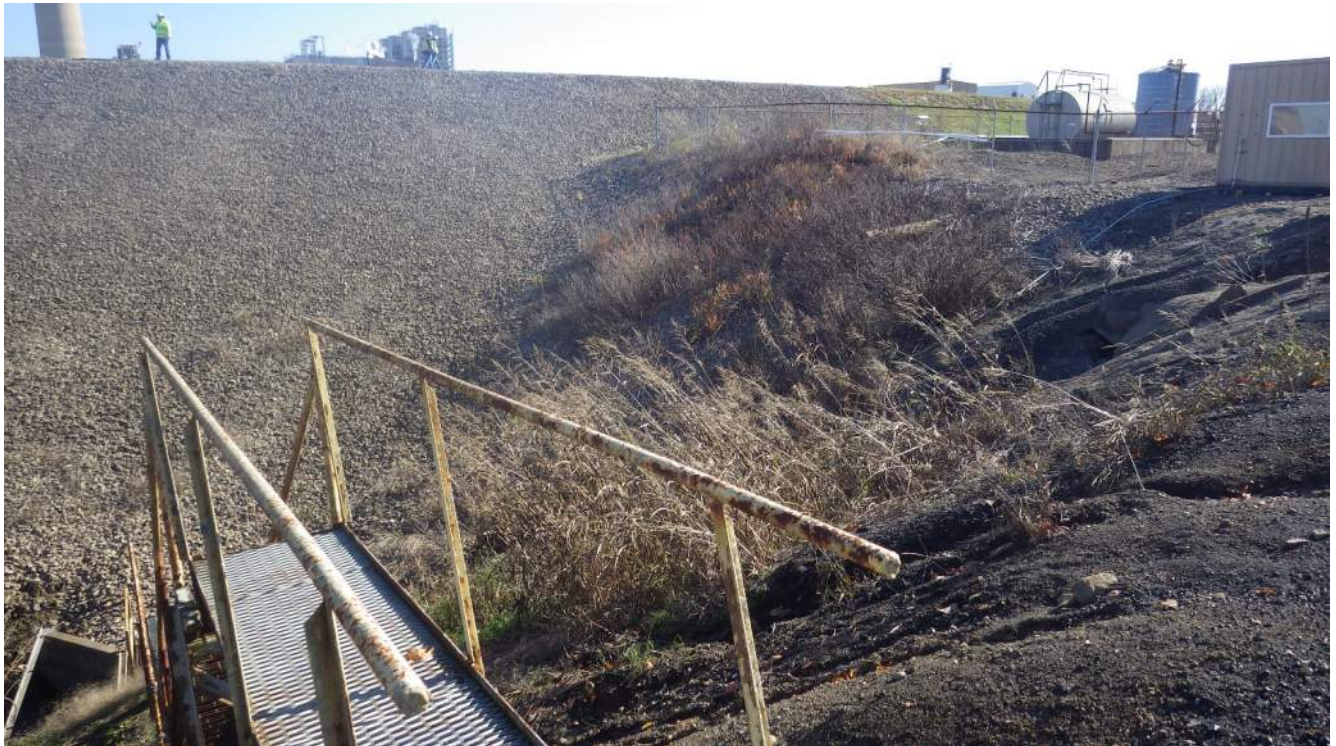
Photograph 14 – Outfall to Kyger Creek west of SFAP.

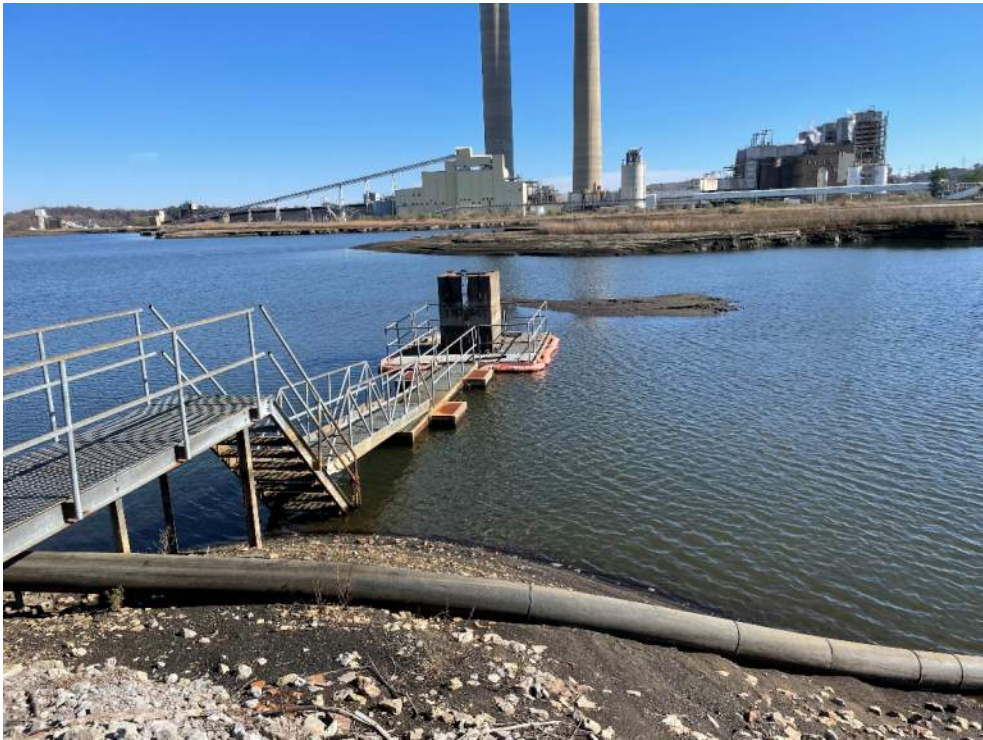
Photograph 15 – Outlet structure in southwestern corner of SFAP.

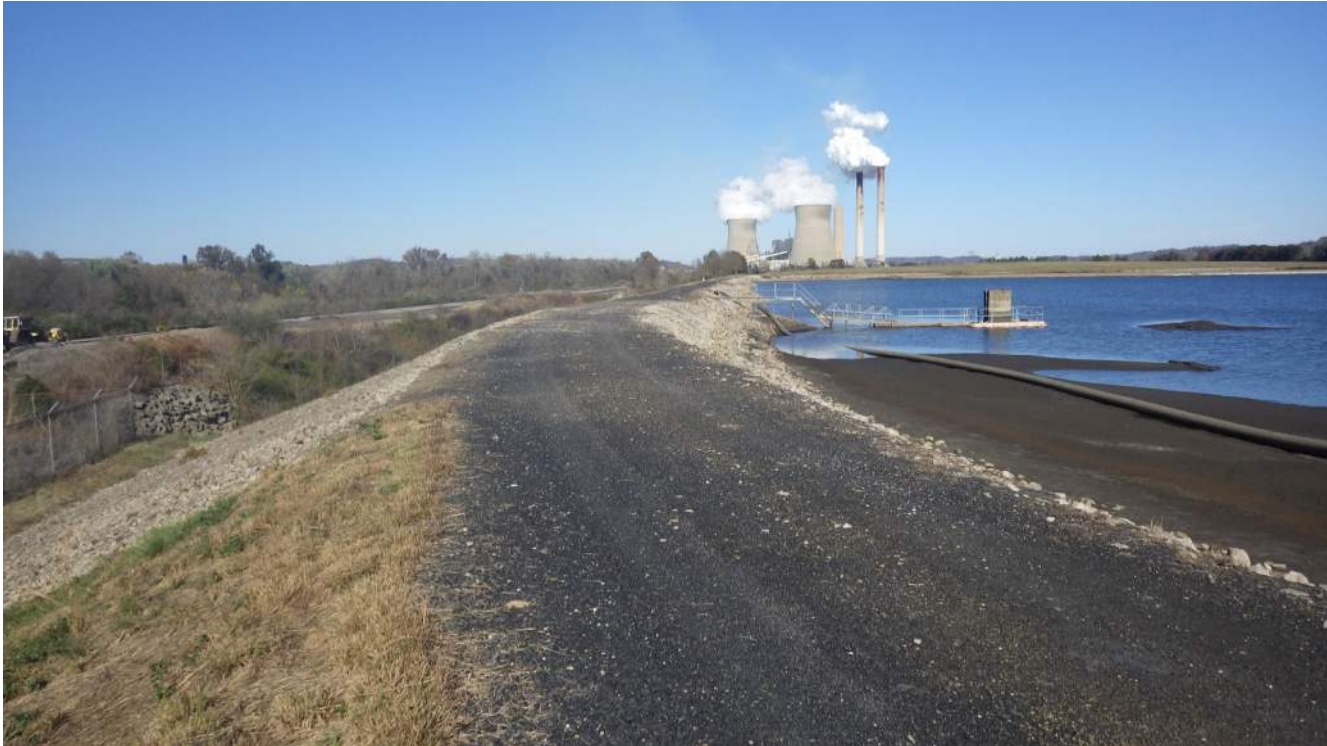
Photograph 16 – Southwestern corner of SFAP.

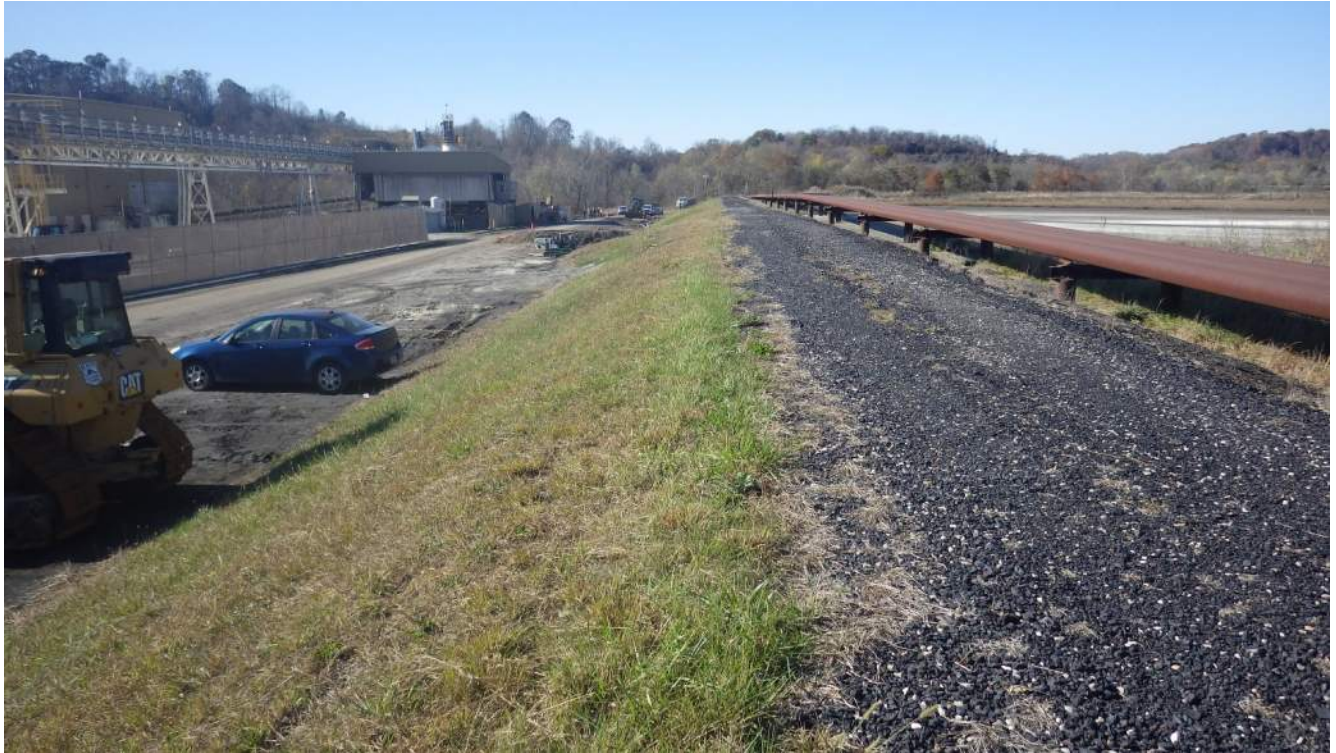
**Photograph 17 – Downstream side of southern embankment. Construction near area toe was excavated.**
