**Re: Indiana-Kentucky Electric Corporation  
Clifty Creek Station's 2025 Annual CCR Landfill  
Inspection Posting Notification**

**2025 CCR Rule – Landfill  
Clifty Creek Landfill Inspection**

Clifty Creek Generating Station  
Madison, Indiana  
Jefferson County

January 19, 2026

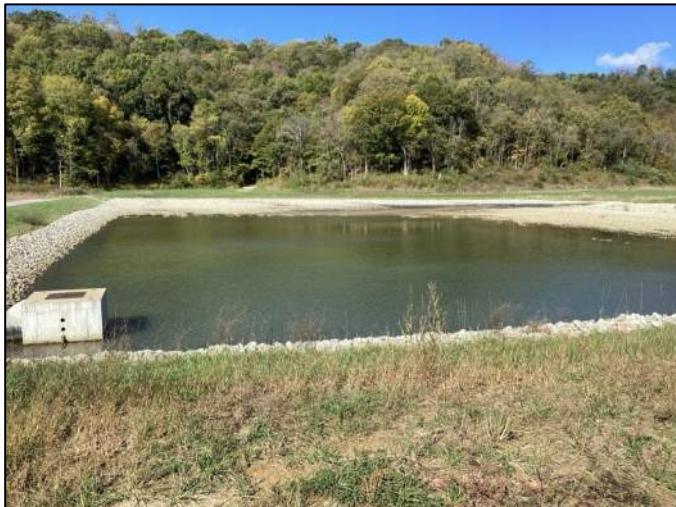
**Photo 1, Point 1**

Looking northwest at Southwest Sediment Basin.

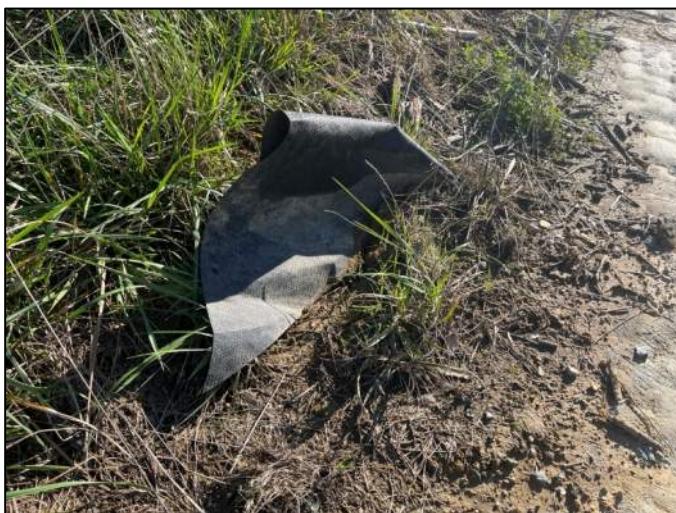
**Photo 3, Point 3**

Exposed geotextile fabric liner on edge of lined stormwater channel adjacent to Southwest Sediment Basin.

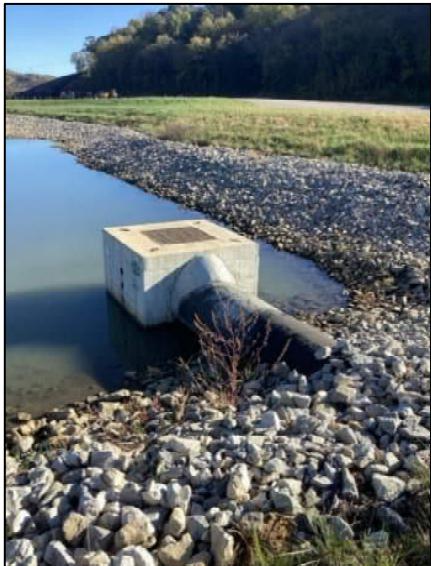
**Photo 4, Point 4**

Southwest Sediment Basin – Riser/inlet structure.

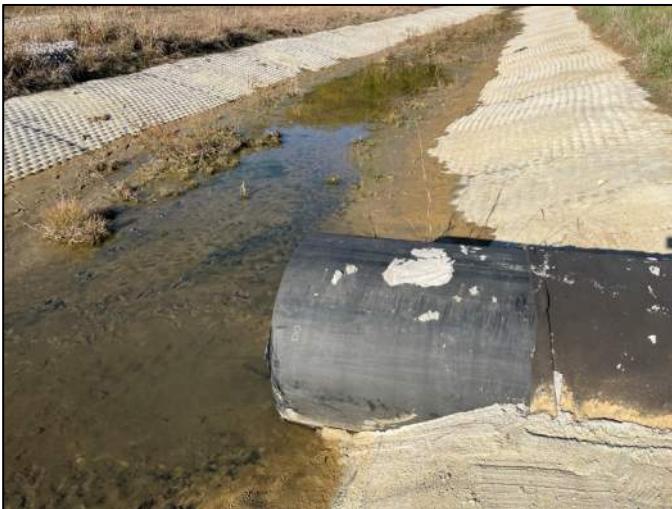
**Photo 5, Point 5**

- The lined stormwater channel on the west and south sides of the Southwest Sediment Basin and on the south side of the Southwest Leachate Pond has sediment build up and vegetation. There was riprap observed in lined stormwater channel on the west side. No obstructions or other hindrances to flow were observed (Points 5 and 14, Appendix A; Photos 5 and 14, Appendix B).

Pipe outlet to the lined stormwater channel. Observed sediment build up and vegetation.

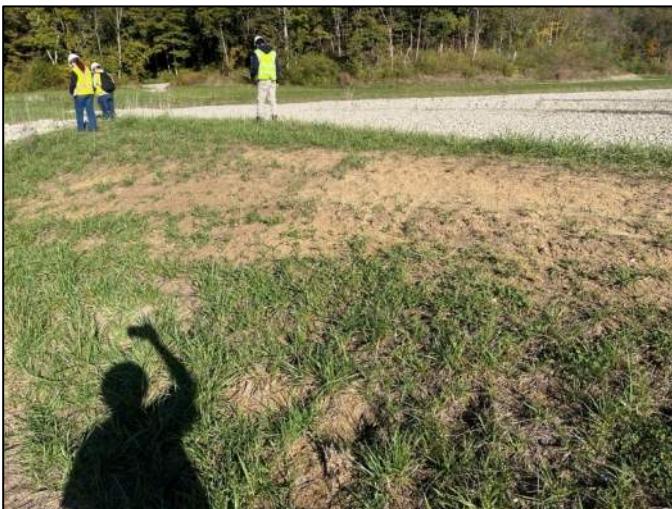
**Photo 6, Point 6**

Southwest Sediment Basin – Bare spot on slope.

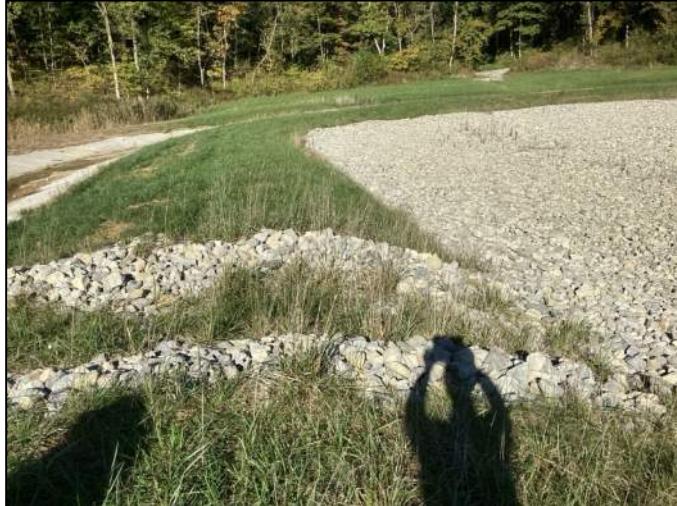
- The emergency spillway on the south side of the Southwest Sediment Basin has vegetation. No obstructions or other hindrances to flow were observed (Point 7, Appendix A; Photo 7, Appendix B).

**Photo 7, Point 7**  
Southwest Sediment Basin – Emergency spillway to lined stormwater channel.

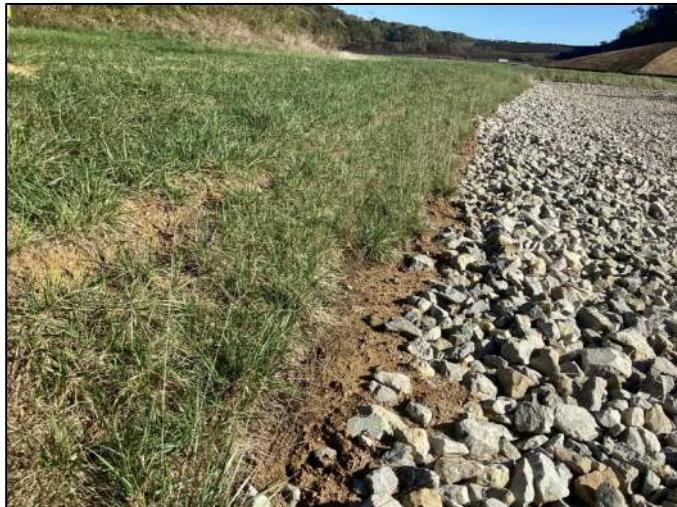
**Photo 8, Point 8**  
Southwest Sediment Basin – Sloughing on inside slope.

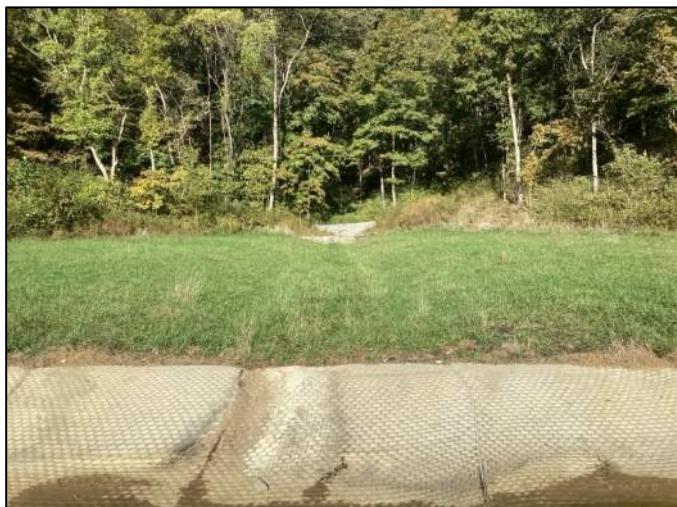
- A drainage channel leading to the fabric-formed ditch was observed to the southwest of Southwest Sediment Basin. No obstructions or other hinderances to flow were observed (Point 9, Appendix A; Photo 9, Appendix B).

**Photo 9, Point 9**  
Drainage channel outlet southwest of Southwest Sediment Basin.

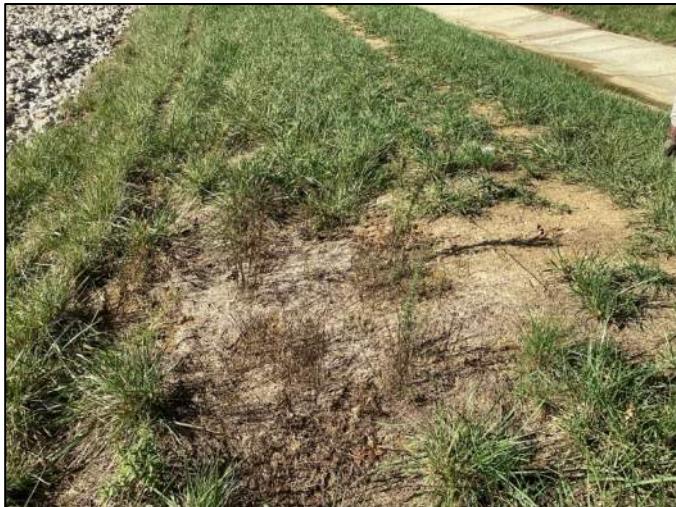
**Photo 10, Point 10**  
Southwest Sediment Basin – Bare spot with mulch on slope.

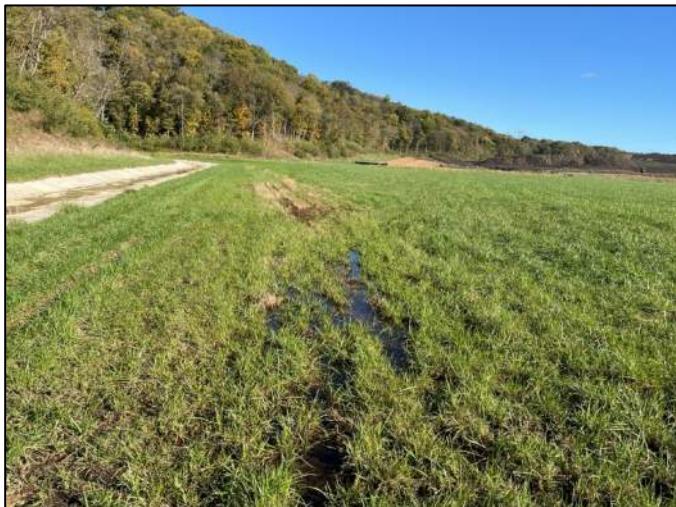
**Photo 11, Point 11**  
Phase 3 – Standing water near perimeter.

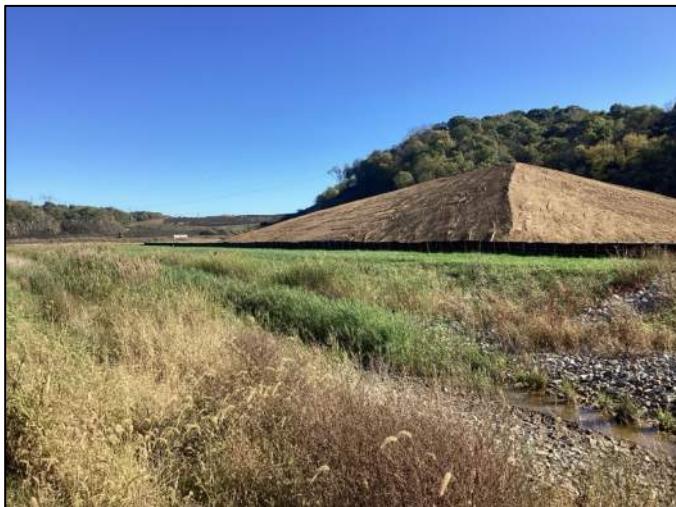
- The ditch located in the central area of future Phase 3 footprint was observed to have heavy vegetation present (Point 12, Appendix A; Photo 12, Appendix B).

**Photo 12, Point 12**  
Phase 3 – Vegetation in central ditch.

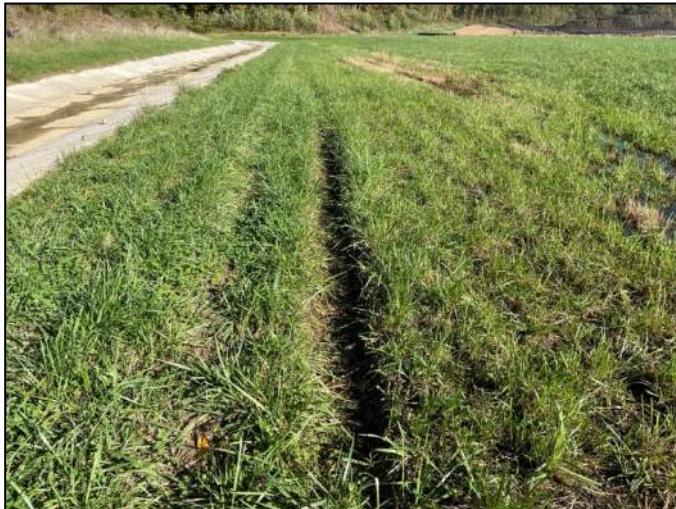
**Photo 13, Point 13**  
Phase 3 – Tire rutting near perimeter.

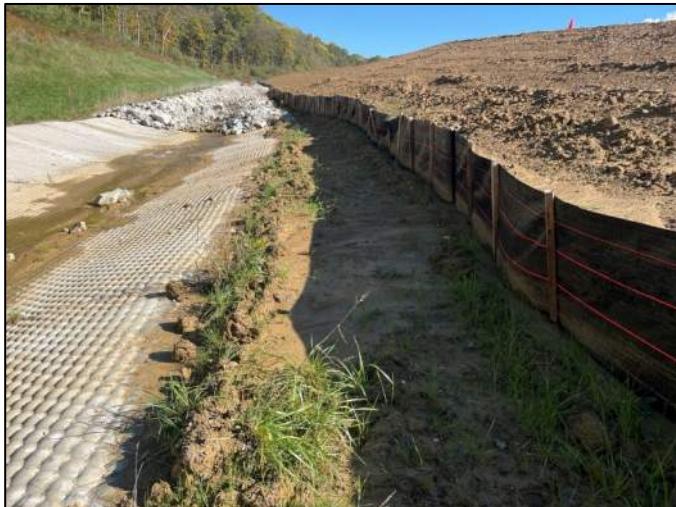
**Photo 14, Point 14**  
Bare spot on slope and riprap in lined stormwater channel.

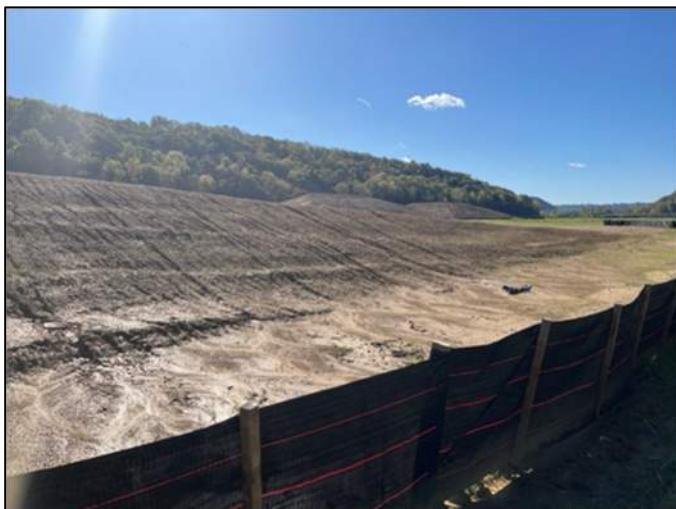
**Photo 15, Point 15**  
Bare soil in Phase 2 active construction.

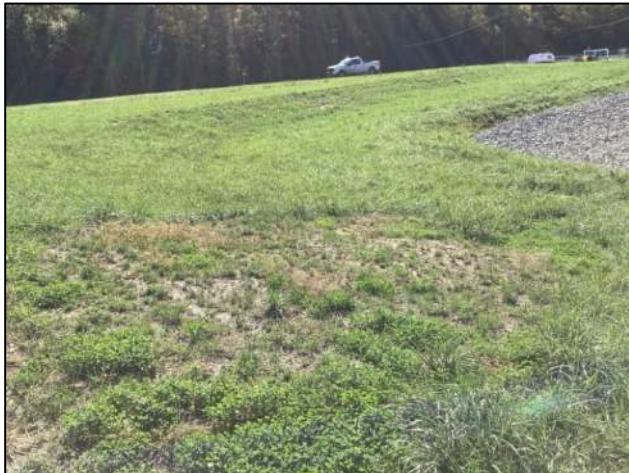
**Photo 17, Point 17**  
Southwest Sediment Basin – Bare spot.

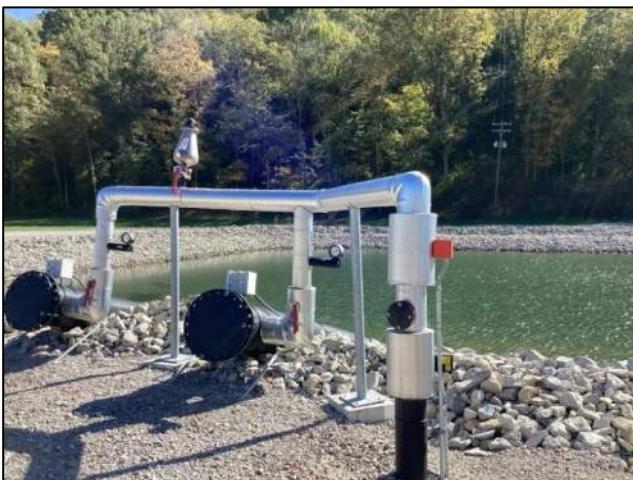
- The pump piping for the Southwest Leachate Pond appears to be in good condition, and the area is clear of obstruction (Point 21, Appendix A; Photo 21, Appendix B).

**Photo 21, Point 21**  
Southwest Leachate Pond – Pump piping.

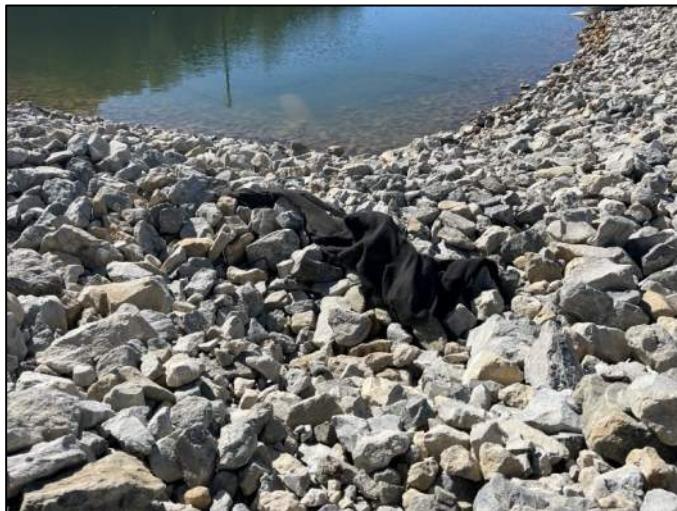
- Exposed geotextile fabric is present at the northwest corner of the Southwest Leachate Pond (Point 22, Appendix A; Photo 22, Appendix B).
- The lined stormwater channel temporary crossing adjacent to the Southwest Leachate Pond was observed to be functioning properly. No obstructions or hinderances to flow were observed (Point 23, Appendix A; Photo 23, Appendix B).

**Photo 22, Point 22**  
Southwest Leachate Pond – Geotextile fabric exposed in riprap protection on northwest corner.

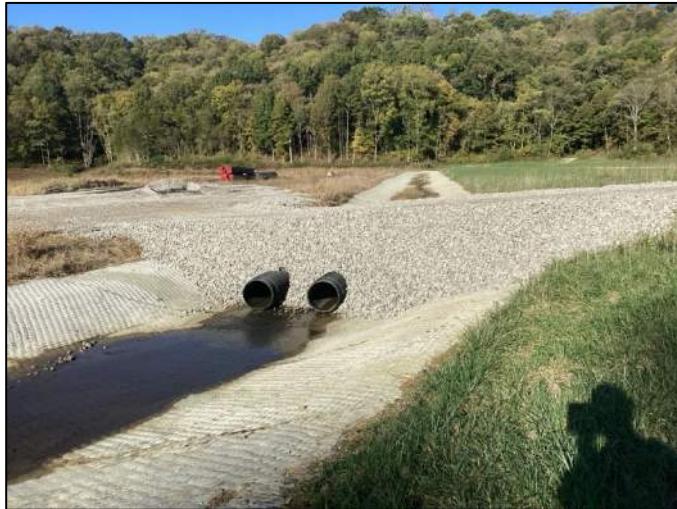
**Photo 23, Point 23**  
Lined stormwater channel crossing outlet adjacent to Southwest Leachate Pond.

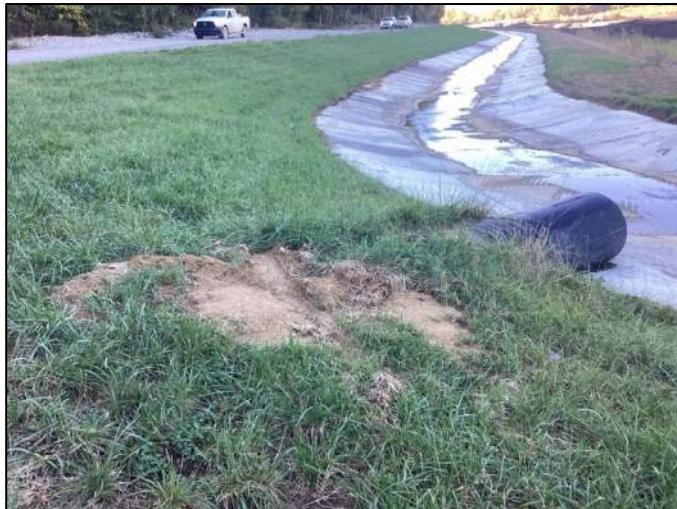
**Photo 24, Point 24**  
Bare spot above pipe outlet to lined stormwater channel.

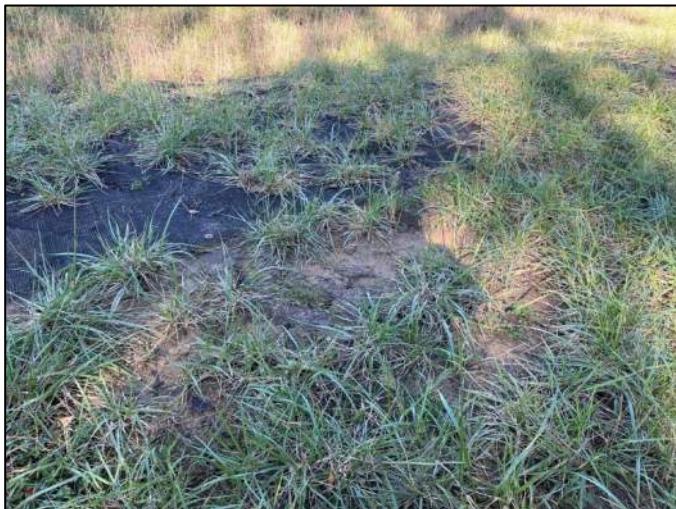
**Photo 28, Point 28**  
Bare spot with exposed TRM near stormwater channel.

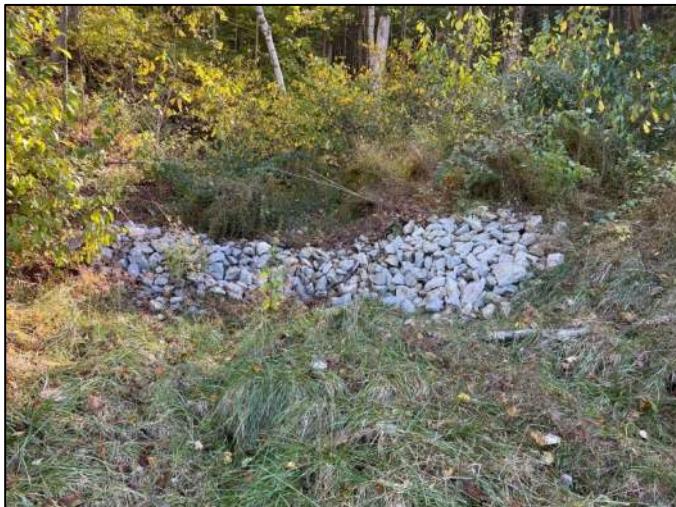
- A check dam on the north side of the stormwater channel located east of the Southwest Leachate Pond was observed to be washed out (Point 29, Appendix A; Photo 29, Appendix B).

**Photo 29, Point 29**  
Check dam of stormwater channel is washed out.

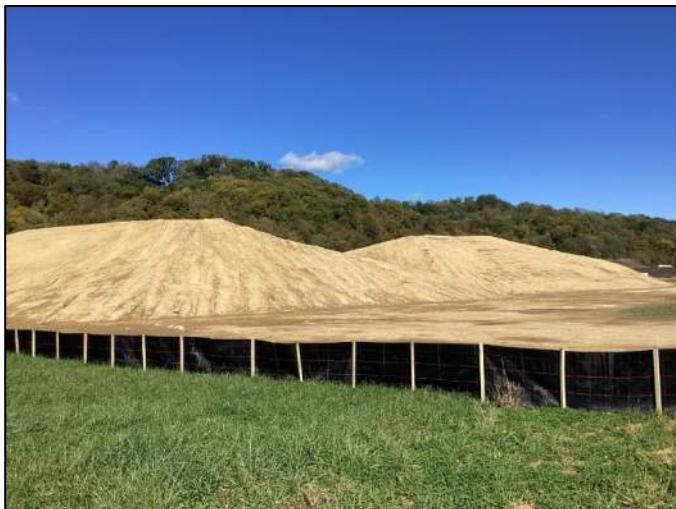
- Stockpiles of soil materials were observed within the future Phase 3 footprint. The material is being utilized for current construction projects. (Point 30, Appendix A; Photo 30, Appendix B).

**Photo 30, Point 30**  
Stockpiles on footprint of Phase 3.

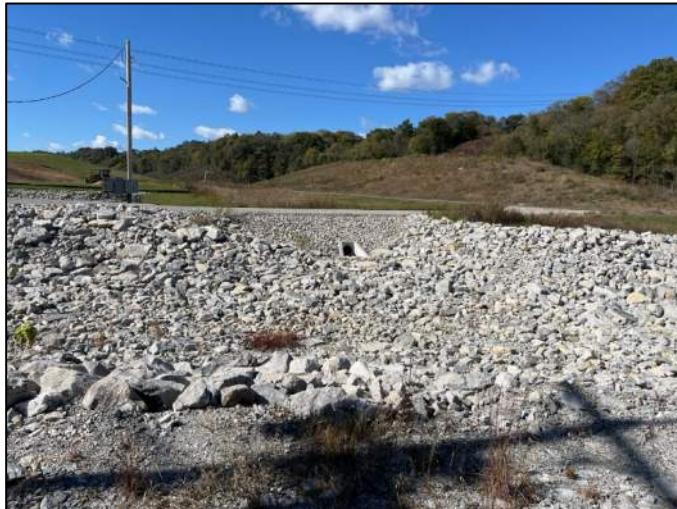
- The stormwater channel inlet north of the Northeast Leachate Pond flows to the outfall lined with riprap east of the Northeast Leachate Pond. No obstructions or other hinderances to flow were observed (Points 31 and 35, Appendix A; Photos 31 and 35, Appendix B).

**Photo 31, Point 31**  
Stormwater channel outlet into riprap-lined ditch east of Northeast Leachate Pond.

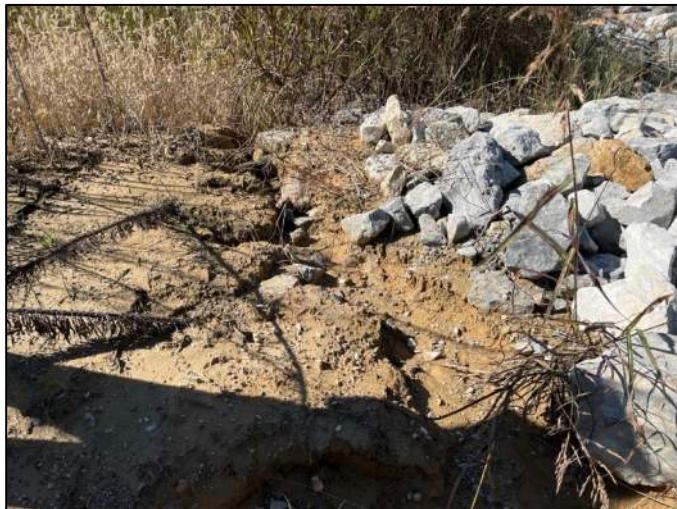
**Photo 32, Point 32**  
Erosion channel (18 in. deep max.) outside of riprap-lined area.

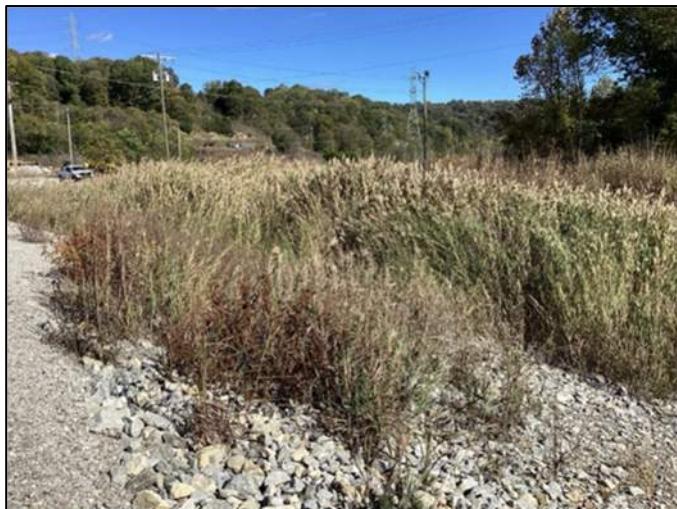
- The ditches located east of the Northeast Leachate Pond and west of the Northeast Sediment Basin were observed to have heavy vegetation present (Points 33 and 40, Appendix A; Photos 33 and 40, Appendix B).

**Photo 33, Point 33**  
Heavy vegetation in ditch near Northeast Leachate Pond.

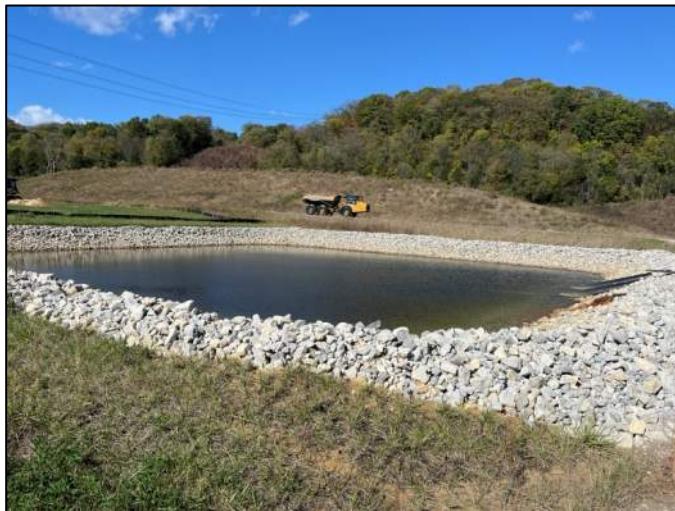
**Photo 34, Point 34**

Looking northwest at Northeast Leachate Pond. Vegetated stockpile in background.

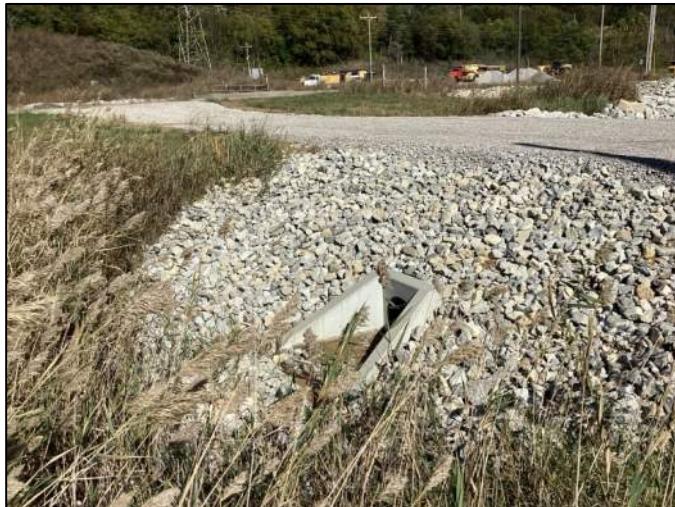
**Photo 35, Point 35**

Stormwater channel inlet headwall north of Northeast Leachate Pond.

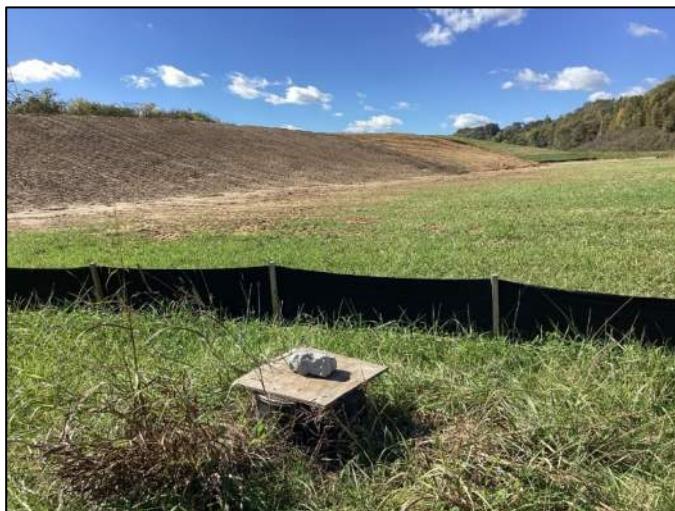
**Photo 36, Point 36**

- An estimated 24-inch diameter plastic standpipe was observed west of the Northeast Leachate Pond (Point 36, Appendix A; Photo 36, Appendix B).
- Bare earth and erosion rills are present on the northeast and north slopes of the Northeast Sedimentation Basin (Points 37 and 43, Appendix A; Photos 37 and 43, Appendix B).

An estimated 24-inch diameter standpipe located west of Northeast Leachate Pond and stockpile in the background.

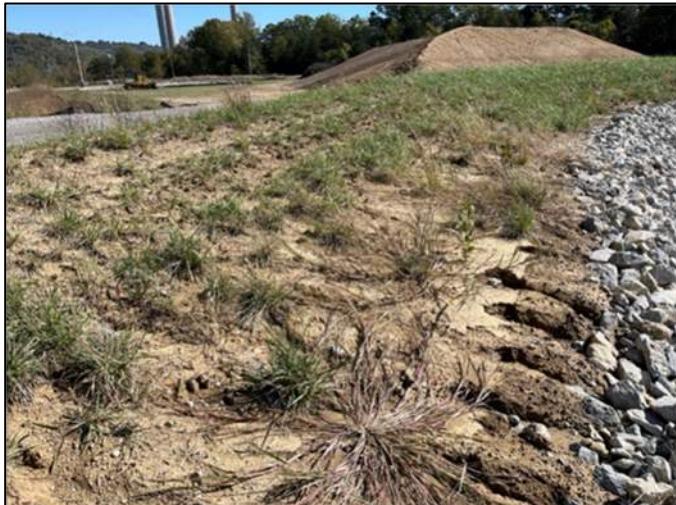
**Photo 37, Point 37**  
Northeast Sedimentation Basin – Bare spot and erosion rill on inner slope.

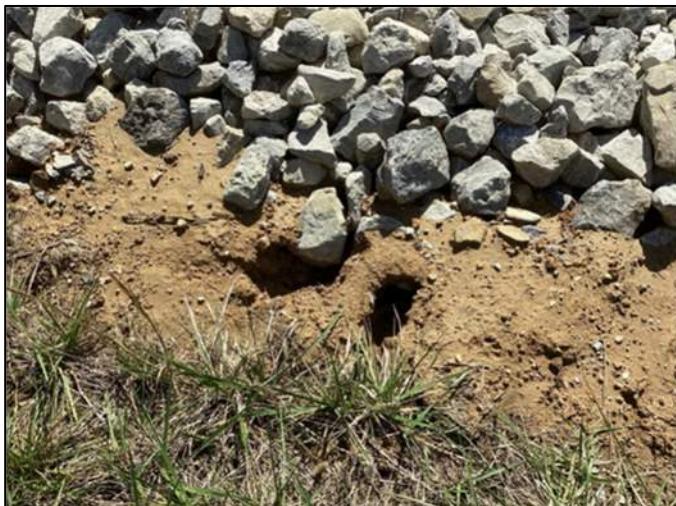
**Photo 38, Point 38**  
Northeast Sedimentation Basin – Small holes on inner slope.

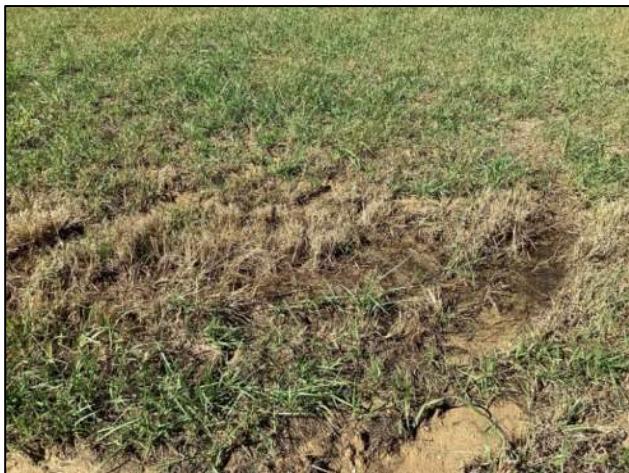
**Photo 41, Point 41**

- Areas of standing water, bare earth, and exposed CCR materials were observed west of the Northeast Sedimentation Basin (Points 41 and 42, Appendix A; Photos 41 and 42, Appendix B).

Area of standing water in area northwest  
of Northeast Sedimentation Basin.

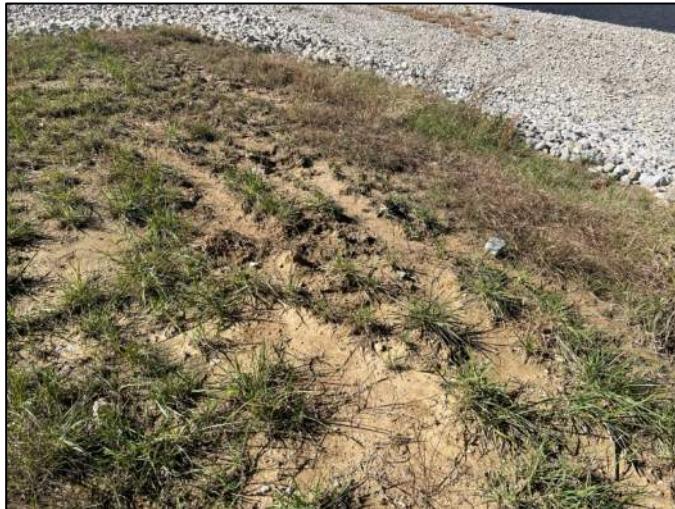
**Photo 43, Point 43**  
Northeast Sedimentation Basin – Bare spot and erosion rill on slope.

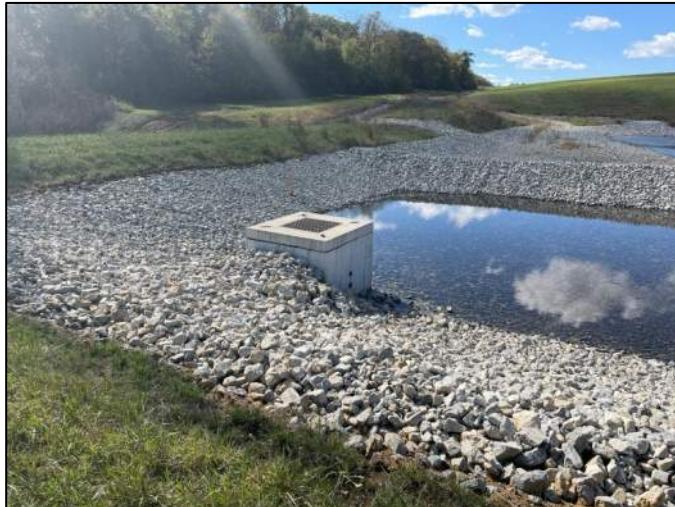
**Photo 44, Point 44**  
Northeast Sedimentation Basin – Riser/inlet structure.

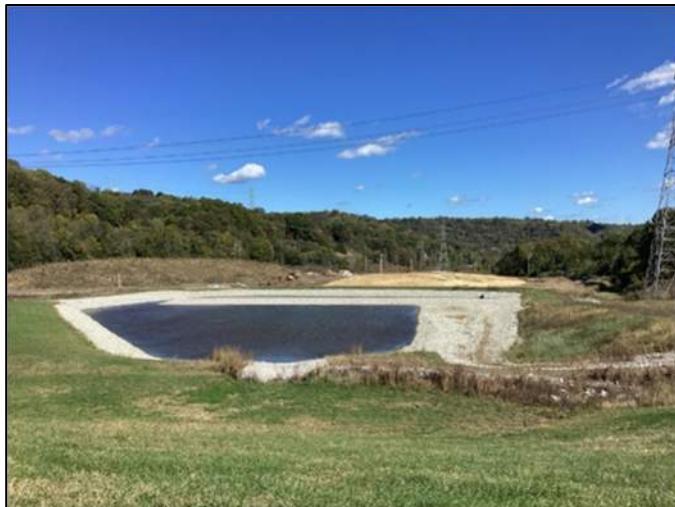
**Photo 45, Point 45**  
Looking east at Northeast Sedimentation Basin and drainage ditches.

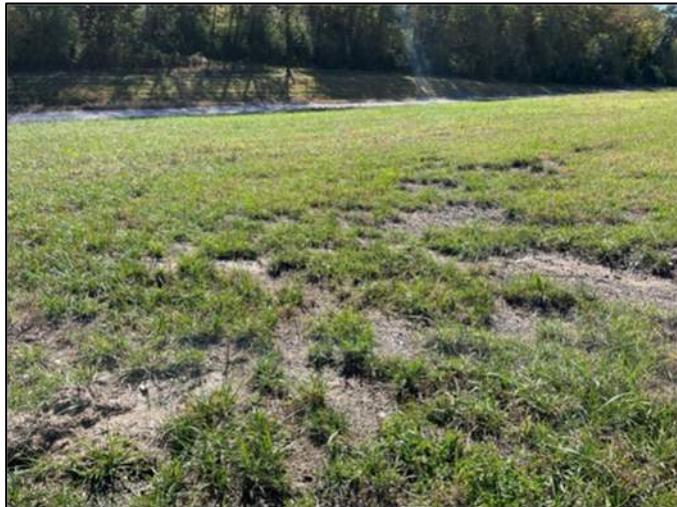
**Photo 46, Point 46**  
Phase 1 – Bare spot on southeast slope temporary cover.

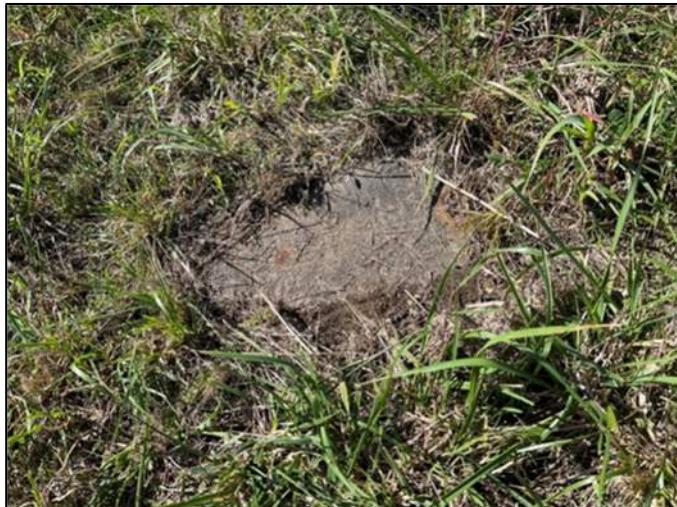
- Concrete debris was found on the southeast slope of the temporary cover of Phase 1 (Point 47, Appendix A; Photo 47 Appendix B).
- Holes were identified at several locations in the temporary cover of Phase 1 (Points 49, 56, and 61, Appendix A; Photos 49, 56, and 61, Appendix B).

**Photo 47, Point 47**  
Phase 1 – Concrete found on southeast slope.

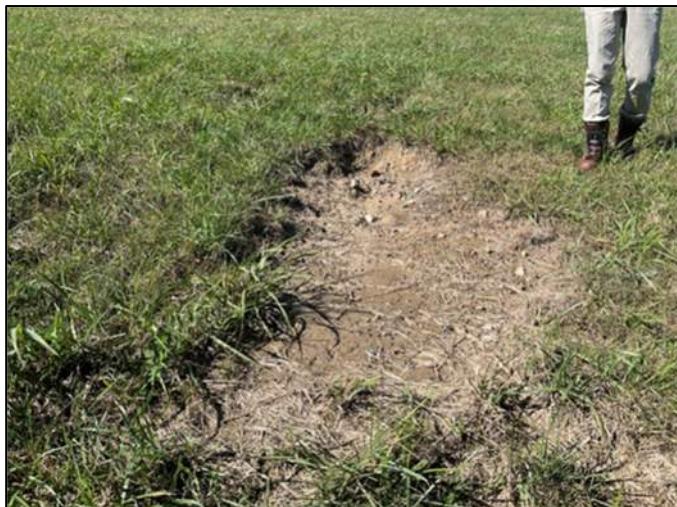
**Photo 48, Point 48**  
Phase 1 – Bare spot with exposed CCR on southeast slope temporary cover.

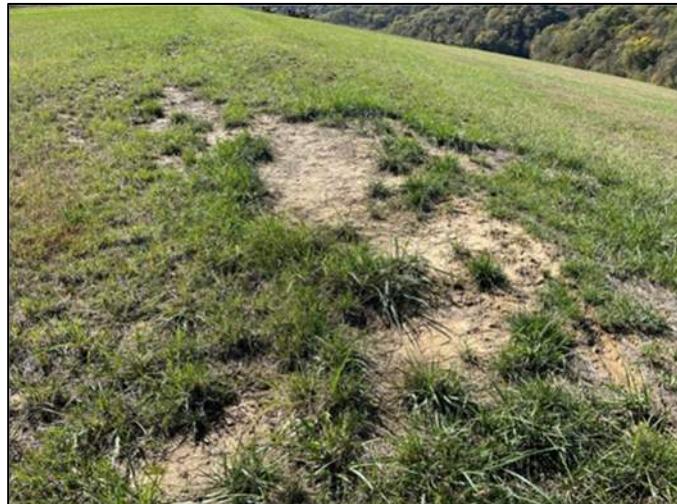
**Photo 50, Point 50**  
Phase 1 – Bare spot on crest temporary cover.

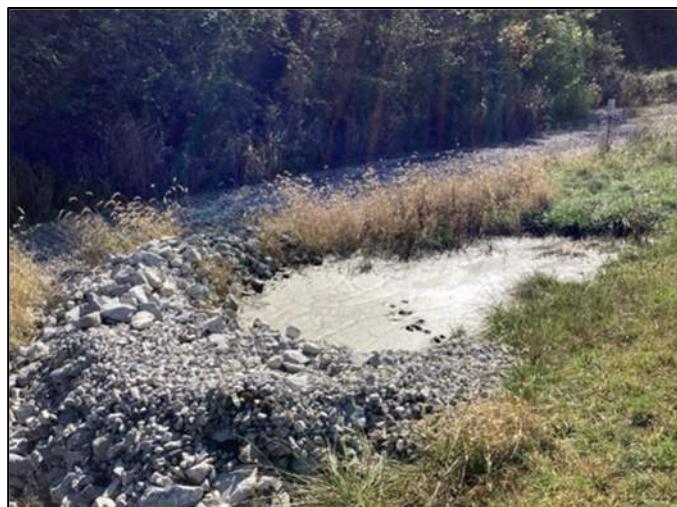
- The check dam to ditch adjacent to south slope of Phase 1 Landfill was observed to have significant sediment buildup (Point 51, Appendix A; Photo 51 Appendix B).

**Photo 51, Point 51**  
Phase 1 – Check dam with sediment buildup in ditch adjacent to south slope.

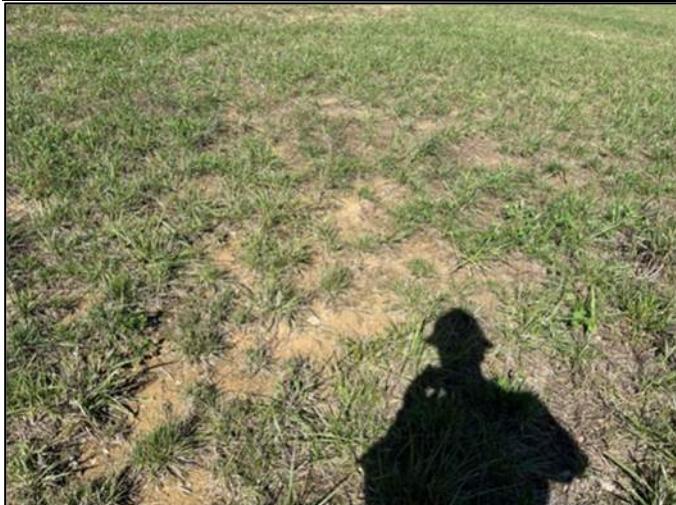
**Photo 52, Point 52**  
Phase 1 – Bare spot on southwest slope temporary cover.

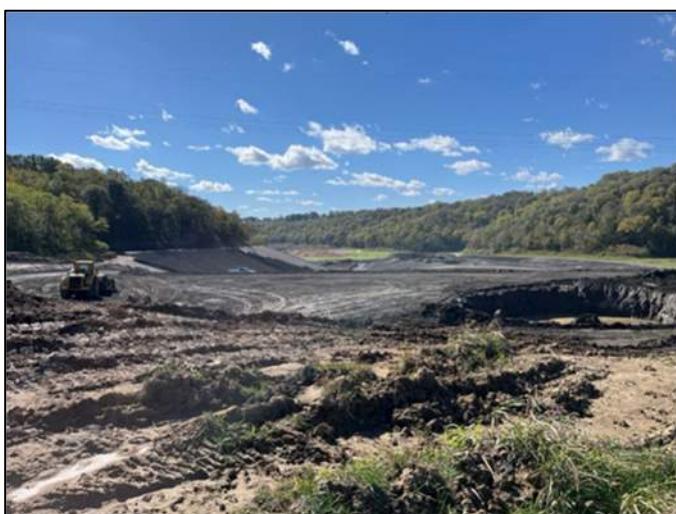
- Active CCR placement was observed on the southwest side of Phase 1 landfill (Point 54, Appendix A; Photo 54 Appendix B).
- Surficial erosion rills, rutting, and depressions were noted in the temporary cover of Phase 1 (Points 57 through 59, Appendix A; Photos 57 through 59, Appendix B).

**Photo 54, Point 54**  
Phase 1 – Active CCR placement on southwest side.

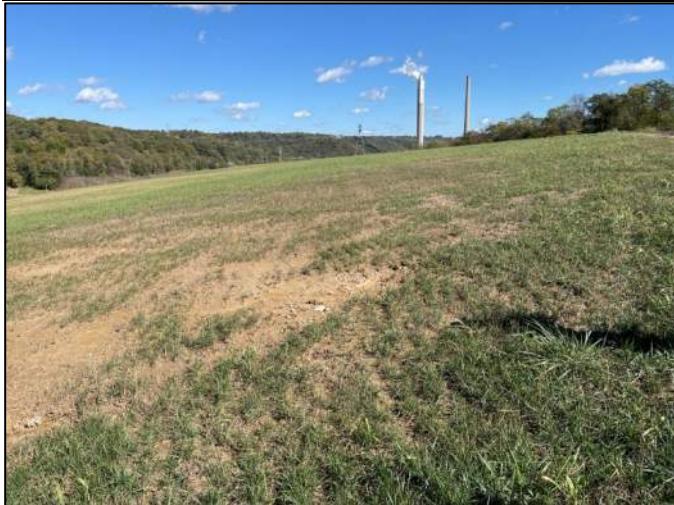
**Photo 55, Point 55**  
Phase 1 – Bare spot from construction vehicle on northwest slope temporary cover.

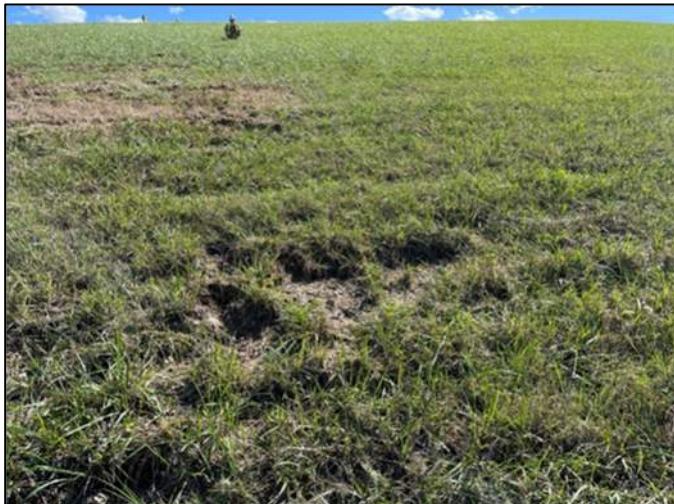
**Photo 56, Point 56**  
Phase 1 – Holes on northwest slope temporary cover.

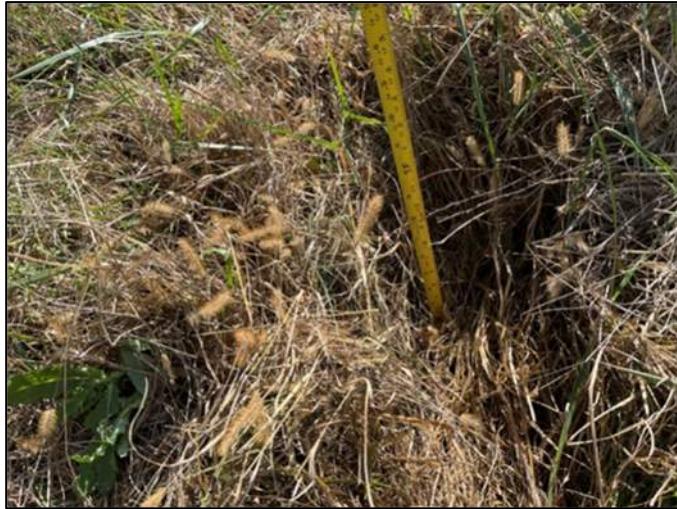
**Photo 58, Point 58**

Phase 1 – Depression (16 in. deep max.) on northwest slope temporary cover.

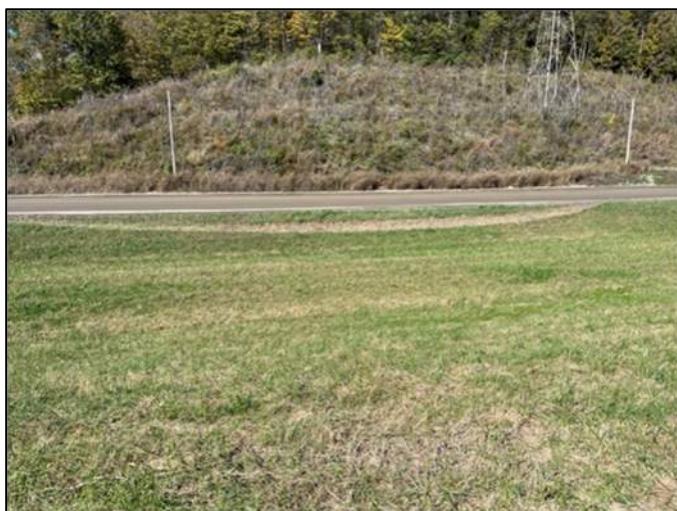
**Photo 60, Point 60**

Phase 1 – Dead vegetation from large tire track on north slope temporary cover.

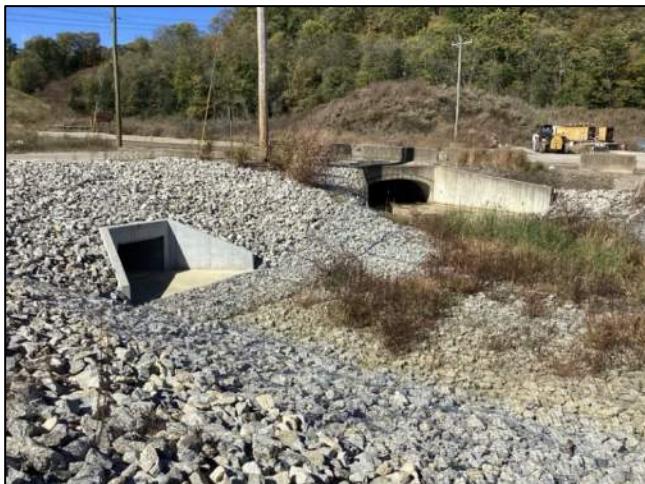
- The culvert outlets to the northern ditch were observed to be clear of obstructions and other hinderances to flow (Point 62, Appendix A; Photo 62, Appendix B).

**Photo 62, Point 62**  
Headwall and outlet to northern ditch.

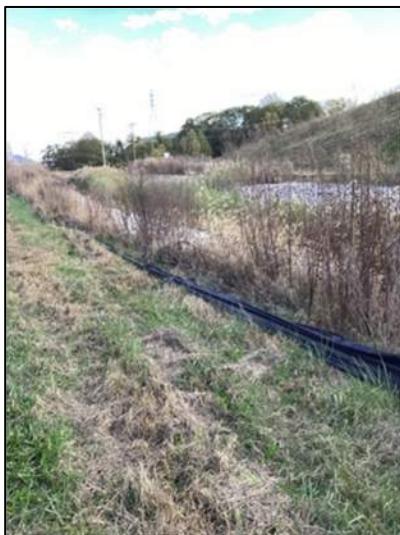
- Standing water and rutting were observed to the north of the northern ditch (Point 64, Appendix A; Photo 64, Appendix B).
- A failed siltfence was identified along the northern ditch (Point 65, Appendix A; Photo 65, Appendix B).

**Photo 65, Point 65**  
Failed silt fence on slope of northern ditch.

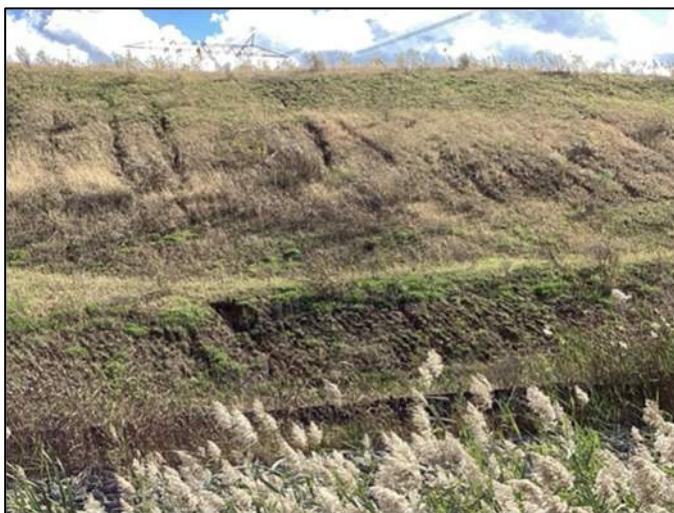
- Erosion rills and scarping were observed on the vegetated stockpile north of Northeast Sedimentation Basin (Points 66 and 67, Appendix A; Photos 66 and 67, Appendix B).
- A drainage channel leading to the northern ditch was observed to have heavy vegetation present. No obstructions or other hindrances to flow were observed (Point 69, Appendix A; Photo 69, Appendix B).
- Fallen trees were identified on a slope north of the northern ditch (Point 71, Appendix A; Photo 71, Appendix B).
- The northern ditch was observed to have heavy vegetation present (Point 72, Appendix A; Photo 72, Appendix B).
- Stockpiles of soil and geosynthetic materials were observed adjacent to the northern ditch. (Point 73, Appendix A; Photo 73, Appendix B).

**Photo 66, Point 66**  
Erosion rills on stockpile located north of  
Northeast Sedimentation Basin.

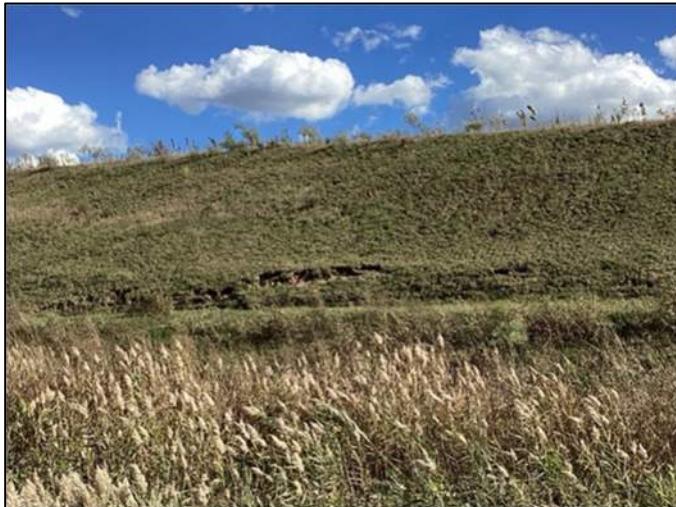
**Photo 67, Point 67**  
Scarp on stockpile located north of  
Northeast Sedimentation Basin.

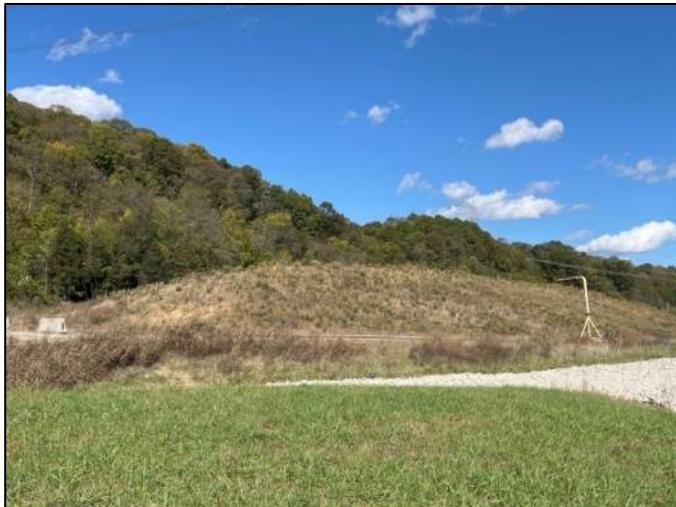
**Photo 68, Point 68**  
Vegetated borrow soil stockpile located  
north of Northeast Sedimentation Basin.

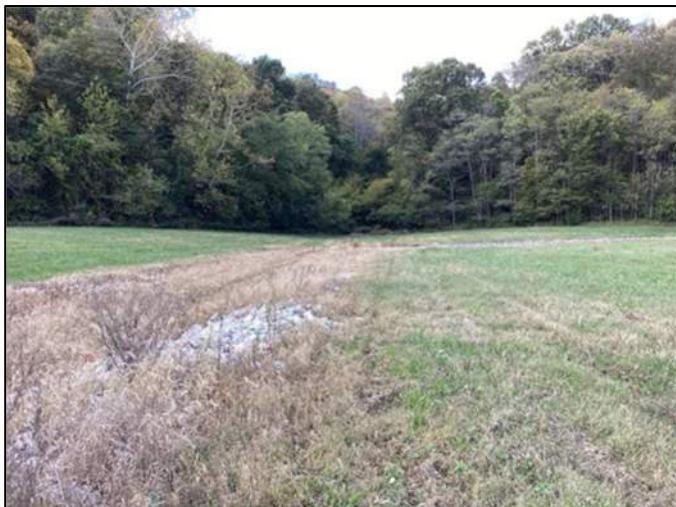
**Photo 69, Point 69**  
Drainage channel outlet from northern  
ditch.

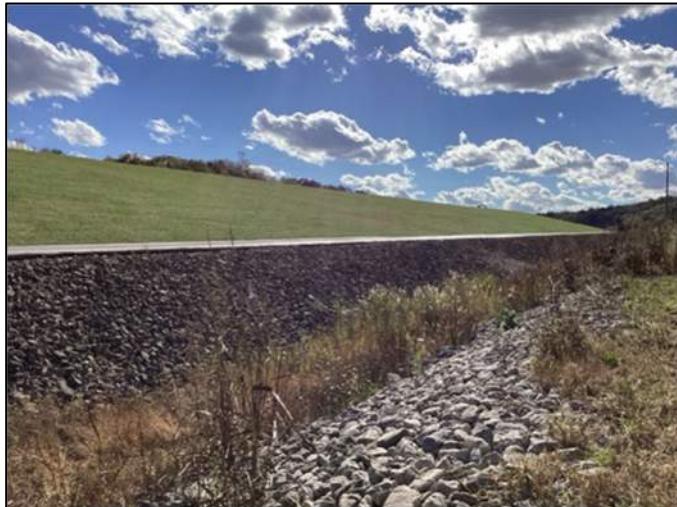
**Photo 70, Point 70**  
Looking south at Phase 1 landfill.

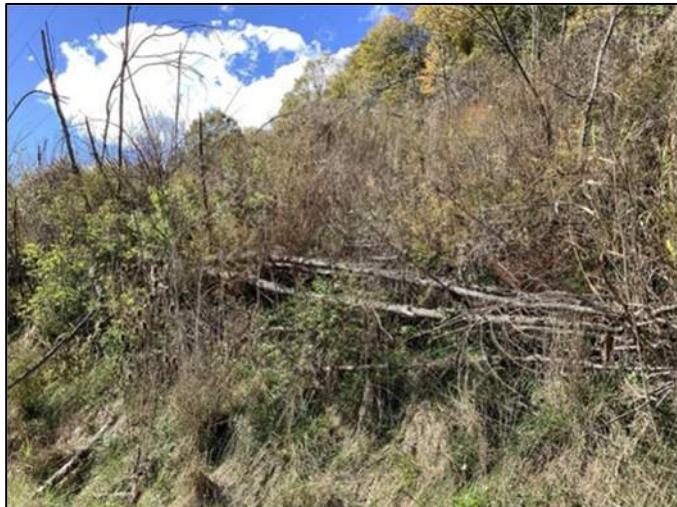
**Photo 71, Point 71**  
Fallen trees on northern slope adjacent to northern ditch.

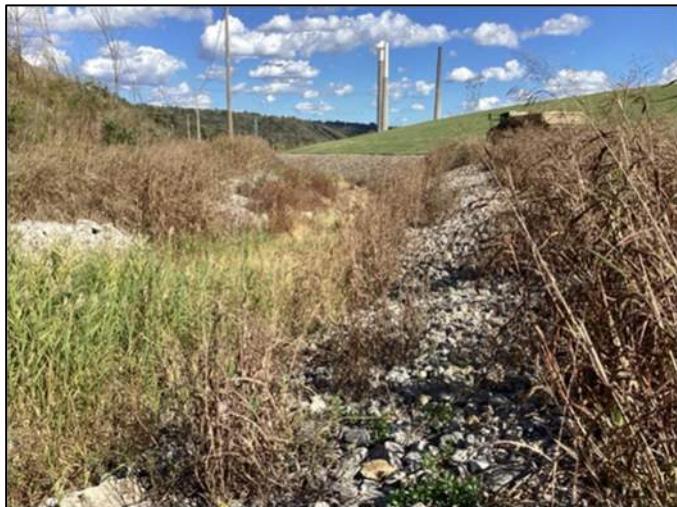
**Photo 72, Point 72**  
Vegetation in northern ditch.

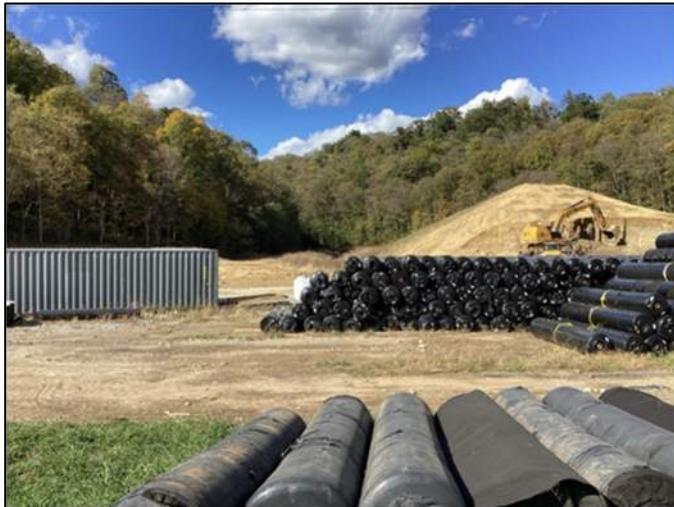
**Photo 73, Point 73**

Looking north at stockpile area next to northern ditch.

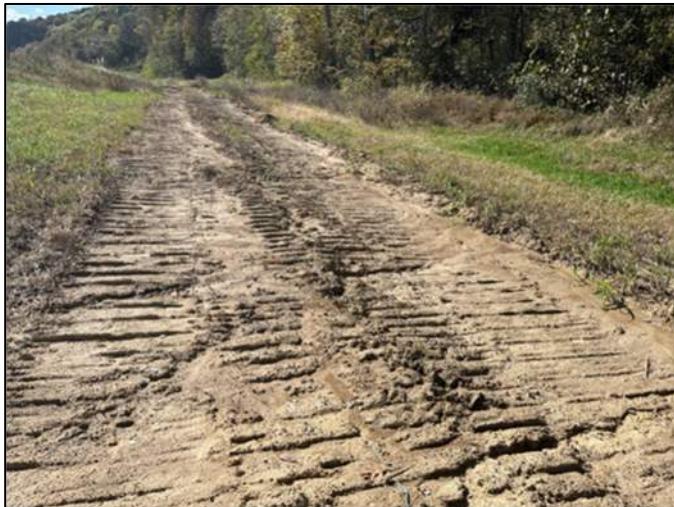
**Photo 74, Point 74**

Equipment tracks and bare spot west of stockpile area.

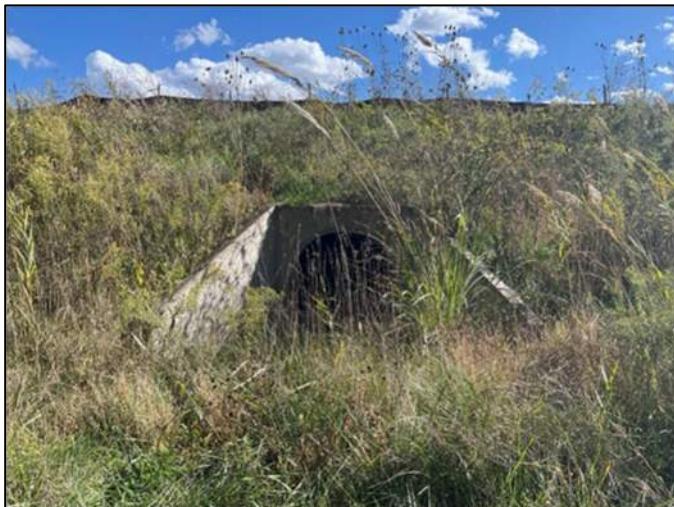
**Photo 75, Point 75**

Vegetation around culvert to diversion ditch.

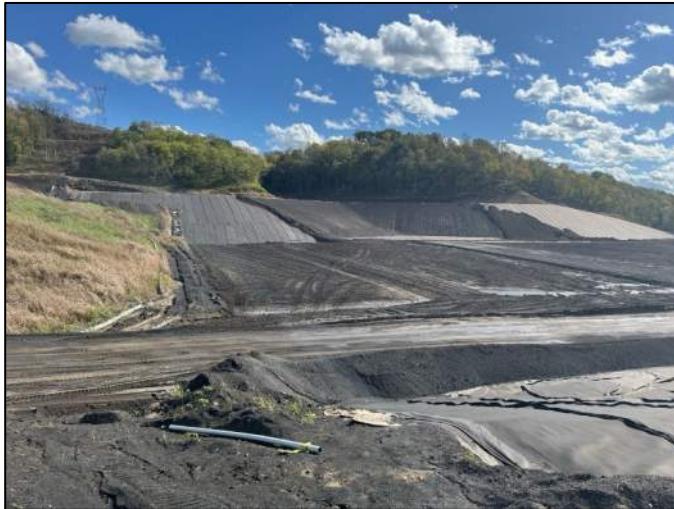
- Active construction activities were observed in Phase 2 landfill (Point 76 Appendix A; Photo 76, Appendix B).
- A drainage channel leading to the diversion ditch was observed to have heavy vegetation present (Point 77, Appendix A; Photo 7, Appendix B).

**Photo 76, Point 76**  
Phase 2 – Active construction in Phase 2.

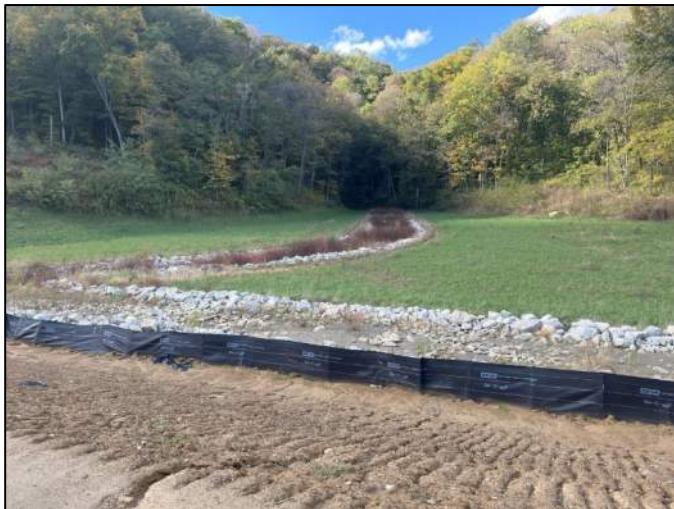
**Photo 77, Point 77**  
Drainage channel outlet from diversion  
ditch.
