**Re: Indiana-Kentucky Electric Corporation
Clifty Creek Station
Notification of CCR Rule Information Posting
Annual Certified CCR Dam and Dike (Surface Impoundment)
Inspection Report Posting**

**2025 CCR Rule – Surface Impoundments
Clifty Creek Dam/Dike Inspections**

Clifty Creek Generating Station
Madison, Indiana
Jefferson County

January 19, 2026

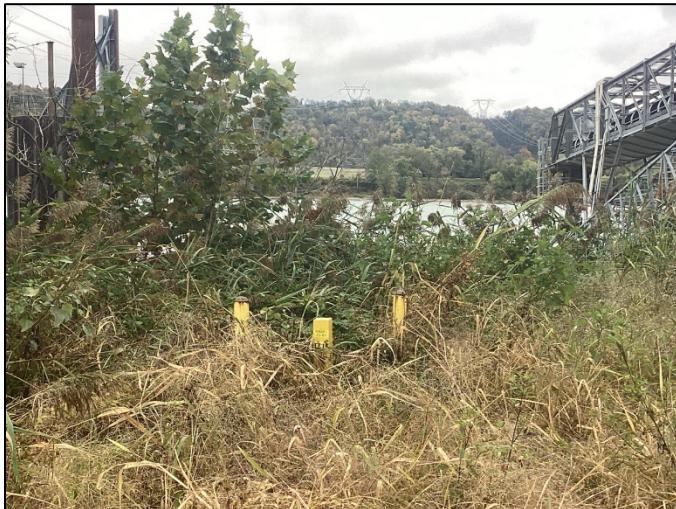
Photo 1, Point 1
Heavy Vegetation looking south near
Gypsum Loadout area.

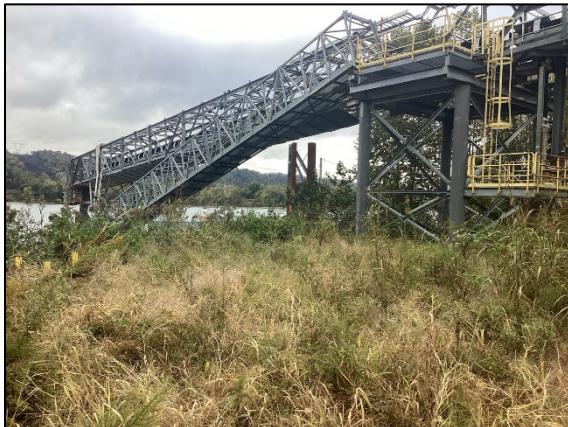
Photo 2, Point 1
Heavy Vegetation looking east near
Gypsum Loadout area.

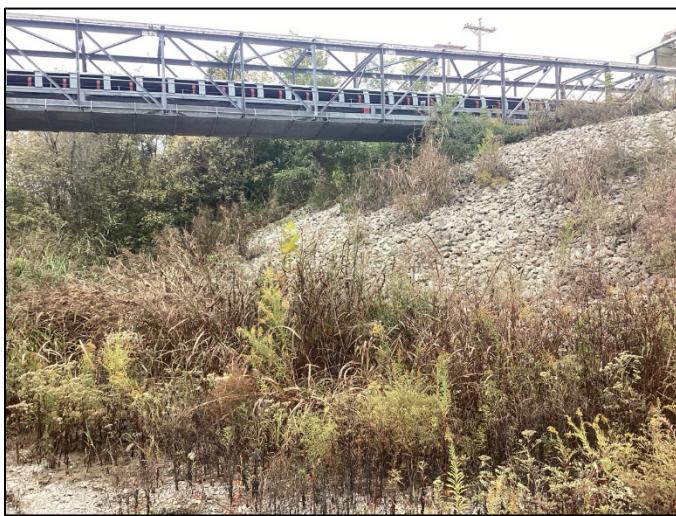
Photo 3, Point 1
Vegetated slope looking north near
Gypsum Loadout area.

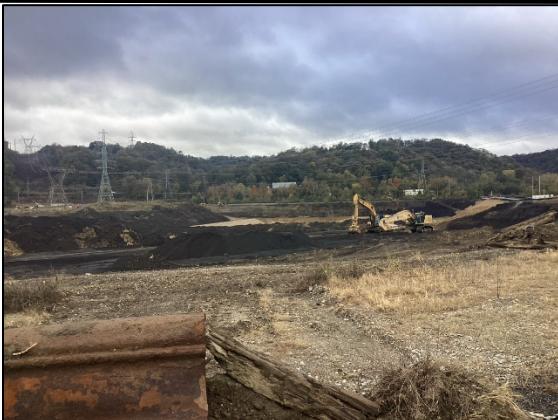
Photo 4, Point 2

Temporary Lined Containment construction.

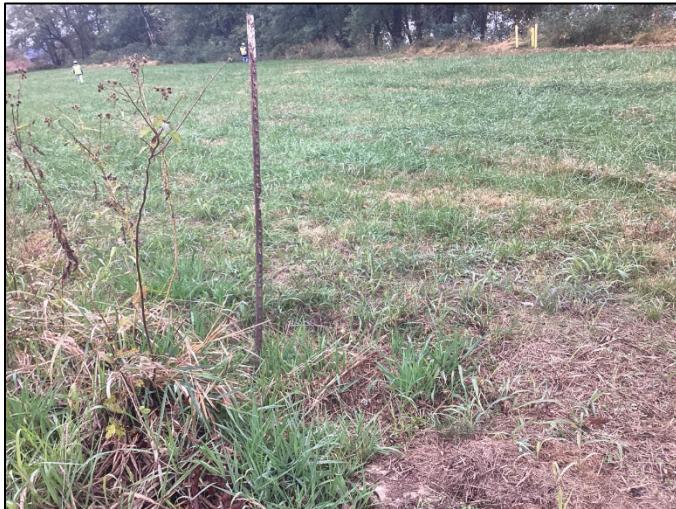
Photo 13, Point 11

Metal post with small vegetation overgrowth.

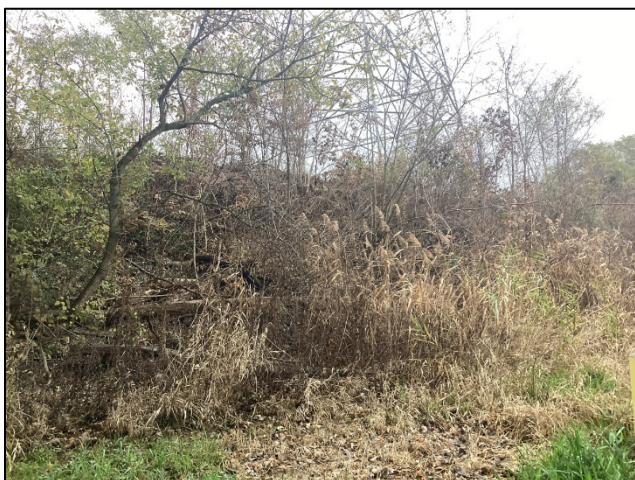
Photo 17, Point 14
High vegetation overgrowth on Dam face
and at electric tower slope.

The upstream and downstream dike slopes and crest areas, east of the LVWTS, are overgrown with small to large trees and heavy brush (Photographs 16, 17, and 18 in Appendix D). These conditions make it virtually impossible to inspect the slopes. The trees and larger brush can also provide seepage pathways as the larger foliage dies off. Trees that topple in windstorms can leave large holes exposed in the face of the dam. Stantec recommends that the overgrown crest and downstream side of the dam be stripped of foliage, graded for ease of maintenance, and seeded with grass to protect it from erosion. This will allow for future inspections to be conducted on this portion of the dam.

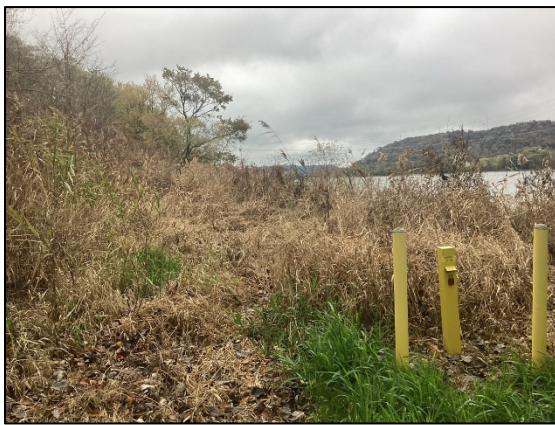
Photo 18, Point 14
High vegetation overgrowth on Dam face
and at electric tower slope.

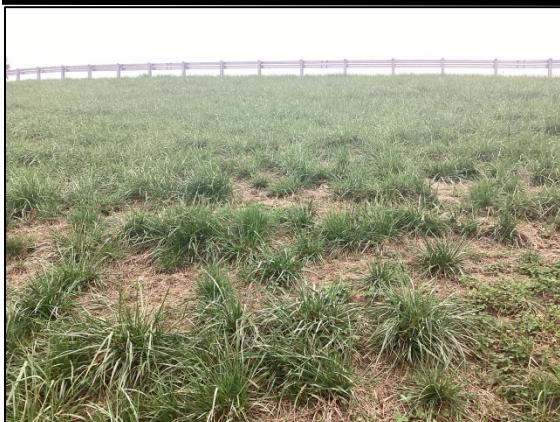
Photo 7, Point 5
Bare areas on dam face.

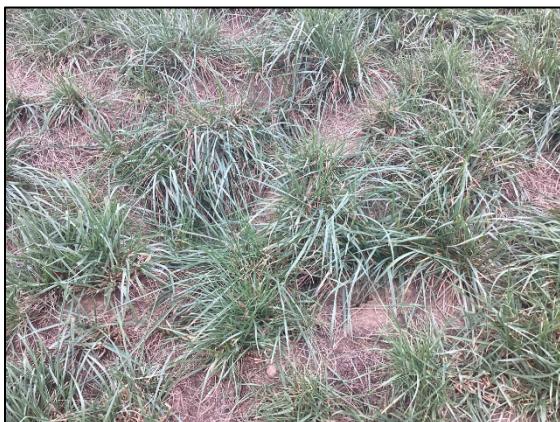
Photo 8, Point 6
Animal burrowing.

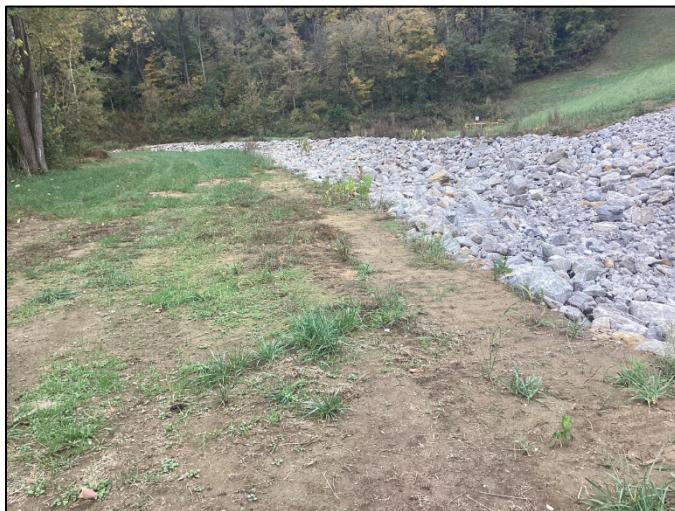
Photo 24, Point 18
Bare area along diversion channel.

Minor maintenance for the LRCP includes repairing the erosion rills above and below the downstream channel, and monitoring the surface-sloughed area beneath the access road to the toe will likely require attention as well (Photographs 19, 21, 22, 24, and 30).
