**2024 CCR Rule – Surface Impoundments
Clifty Creek Dam/Dike Inspections**

Clifty Creek Generating Station
Madison, Indiana
Jefferson County

January 19, 2025

Stantec Consulting Services Inc.
Cincinnati, Ohio

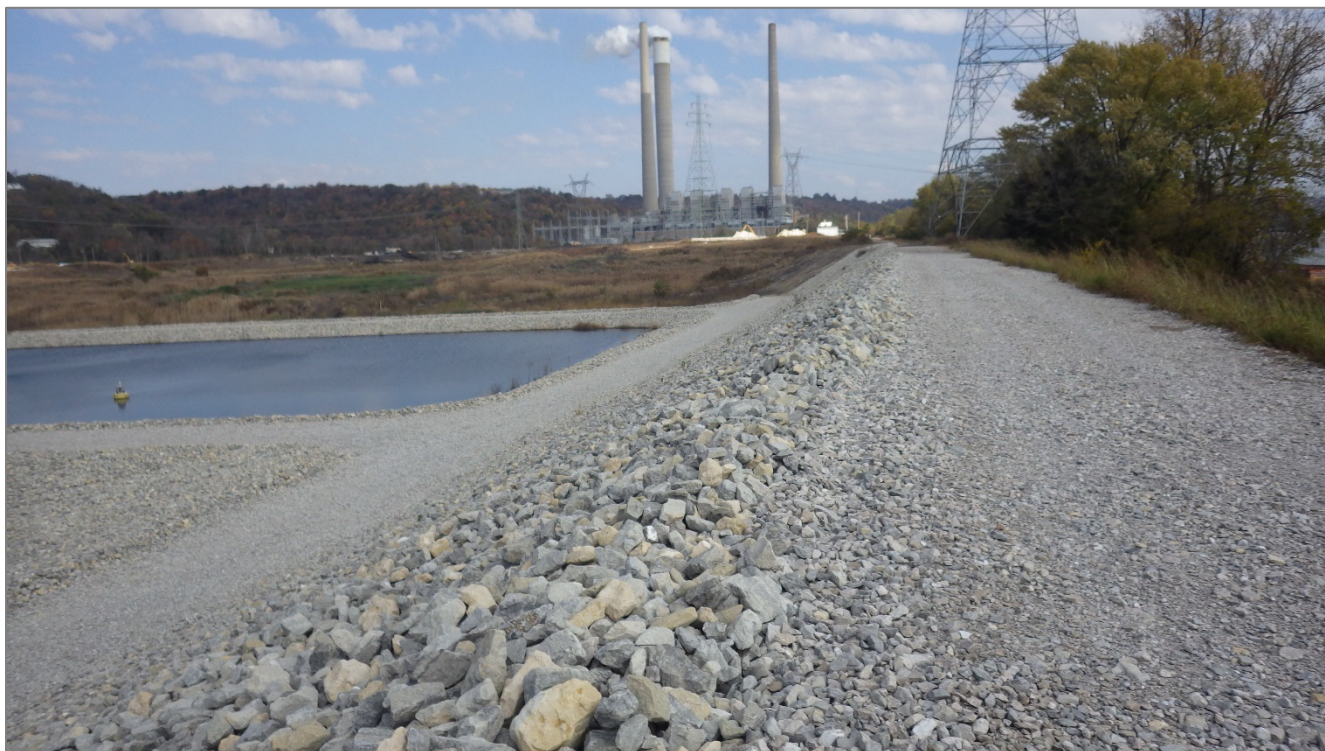
Photograph 1 – South dike embankment, upstream side looking east. LVWTS on left.

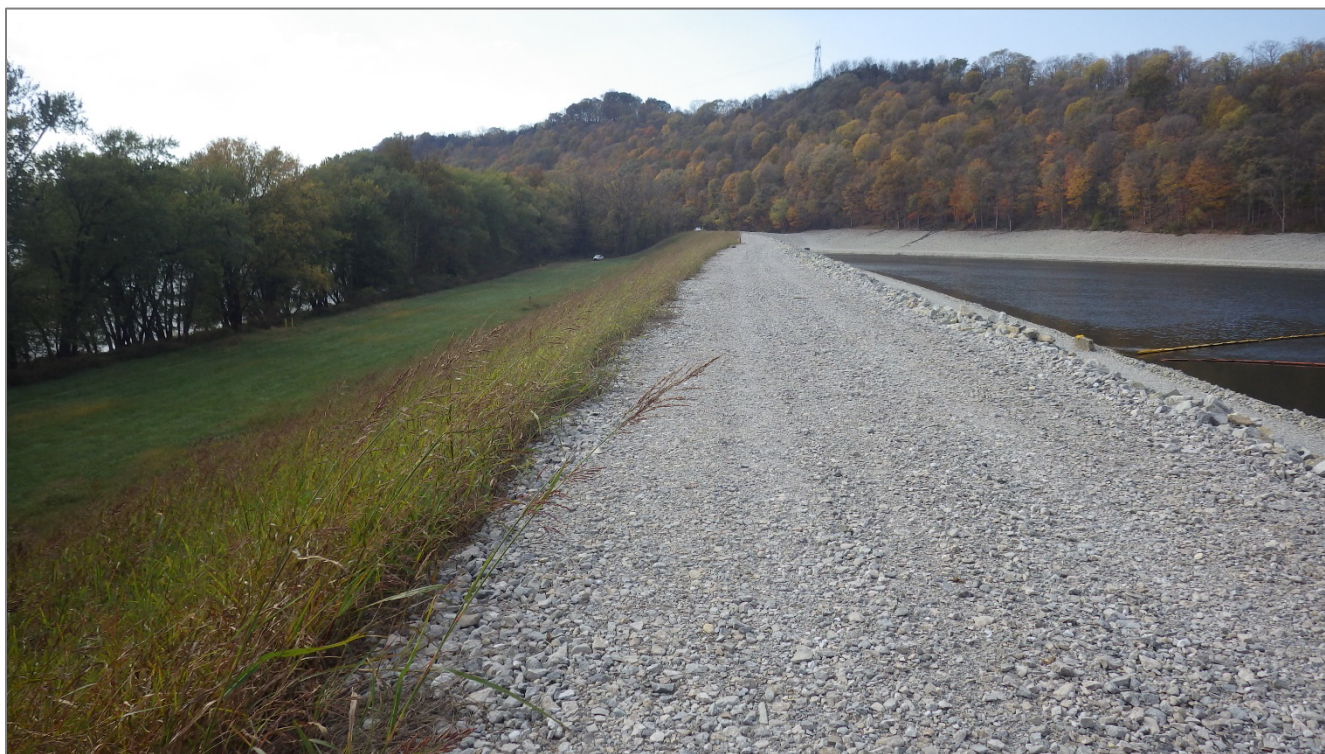
Photograph 2 – Exterior southwest dike embankment crest, looking west.

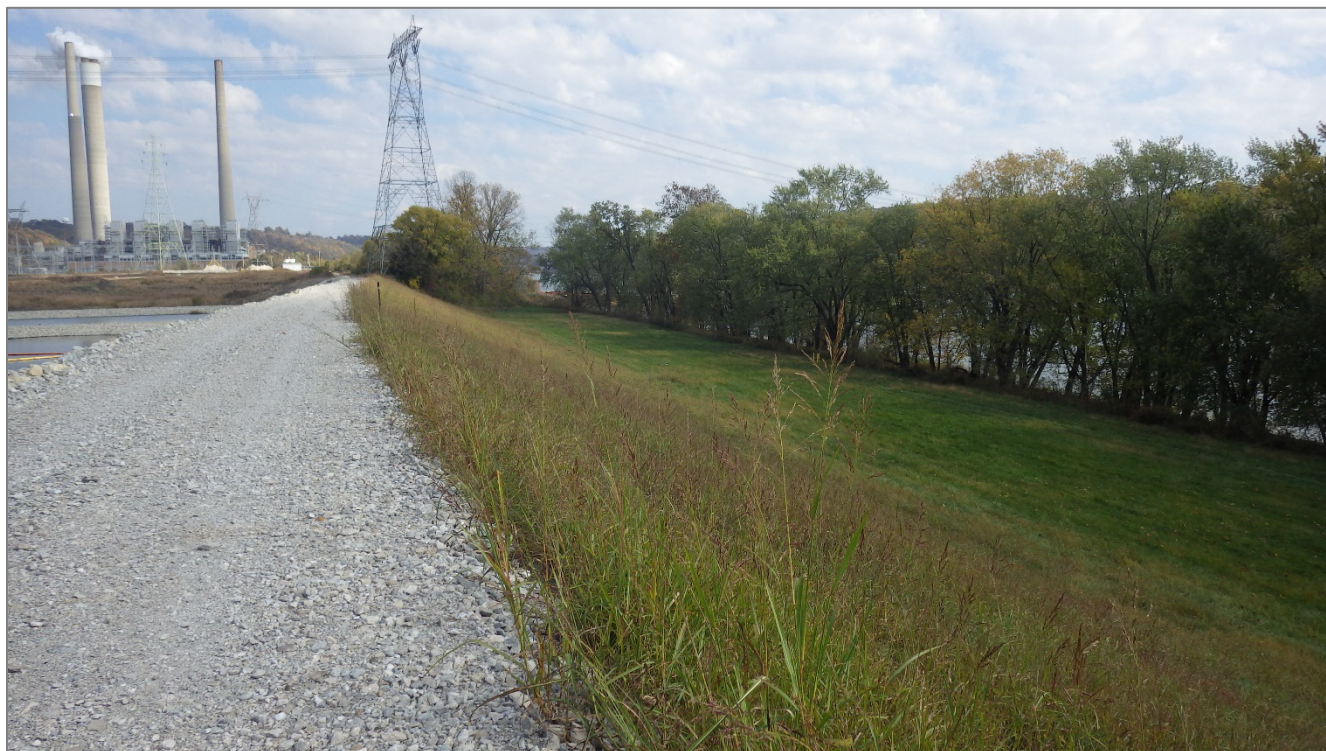
Photograph 3 – Exterior southwest dike embankment, looking east.

The upstream and downstream dike slopes and crest areas, east of the LVWTS, are overgrown with small to large trees and heavy brush (Photographs 3, 4, and 6 in Appendix D). These conditions make it virtually impossible to inspect the slopes. The trees and larger brush can also provide seepage pathways as the larger foliage dies off. Trees that topple in windstorms can leave large holes exposed in the face of the dam. Stantec recommends that the overgrown crest and downstream side of the dam be stripped of foliage, graded for ease of maintenance, and seeded with grass to protect it from erosion. This will allow for future inspections to be conducted on this portion of the dam.

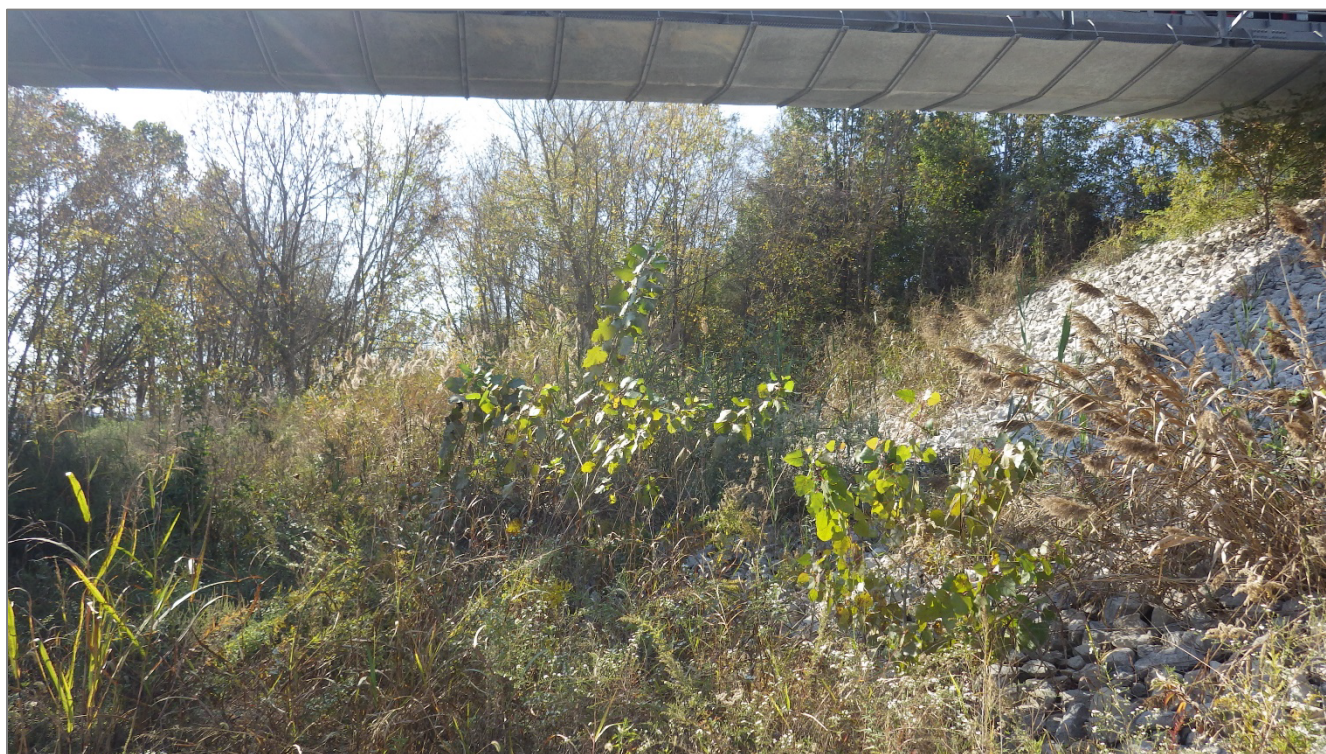
Photograph 4 – Exterior southeastern dike embankment e looking west beneath the gypsum conveyor.

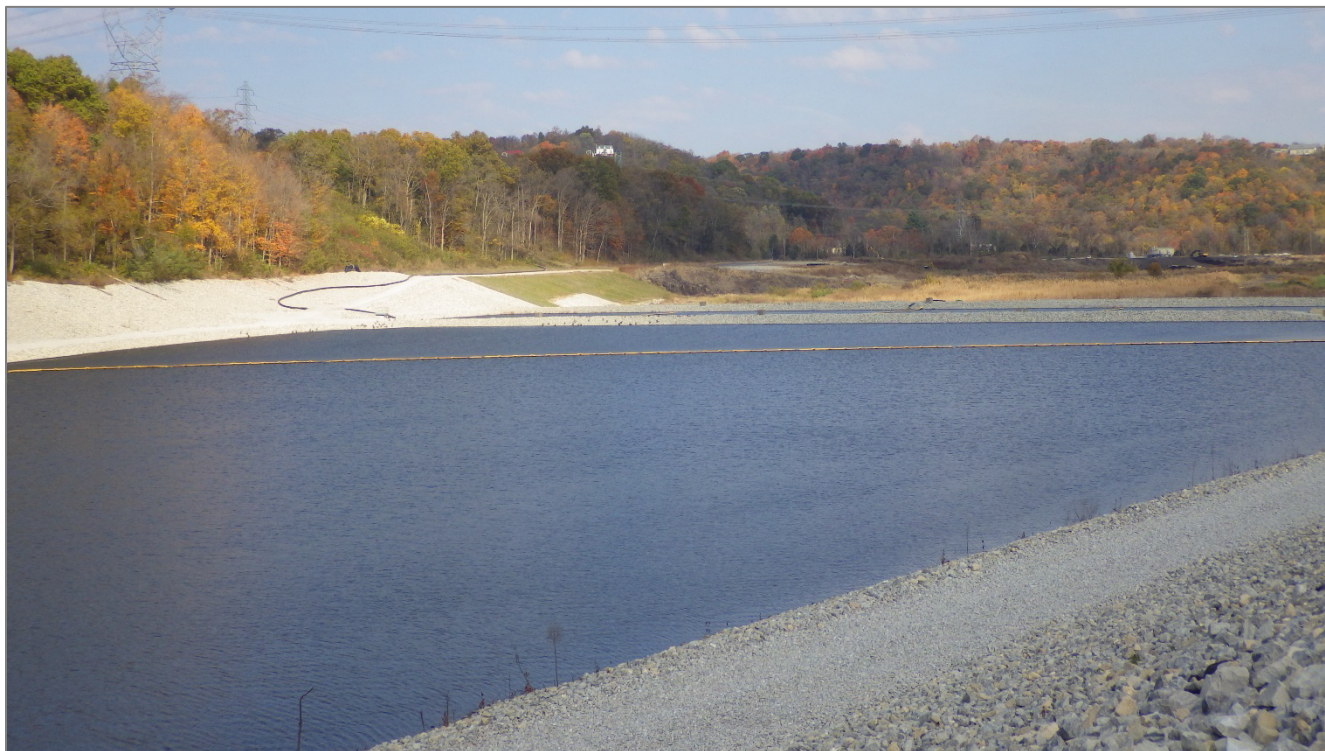
Photograph 7 – Looking north and west across LVWTS from the southern dike embankment.

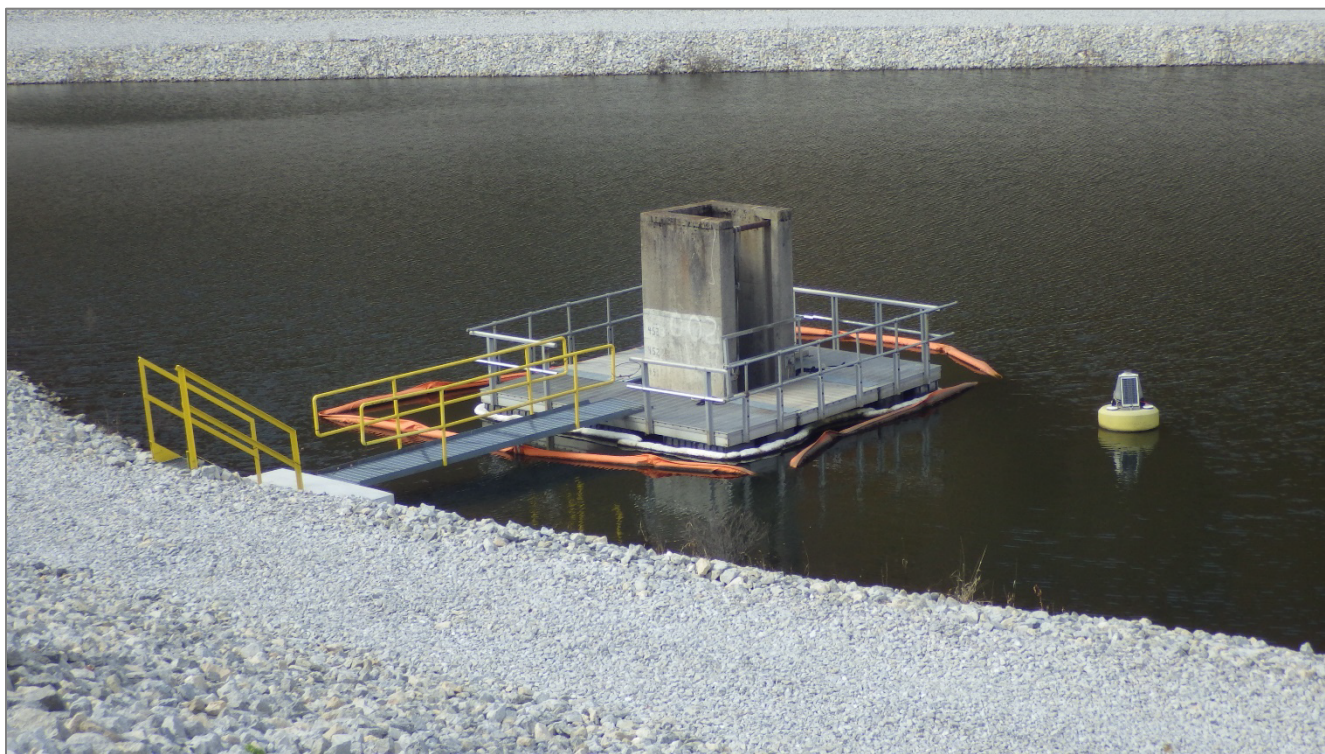
Both the upstream and the downstream side of the outfall structure from the LVWTS to the Ohio River appear to be in satisfactory condition. No other water inlet or outlet structures were observed for the WBSP other than the pipe carrying process water to the LVWTS. A culvert controls flow between the two LVWTS lined basins.

Photograph 8 – Outfall structure at southwestern corner of the LVWTS.

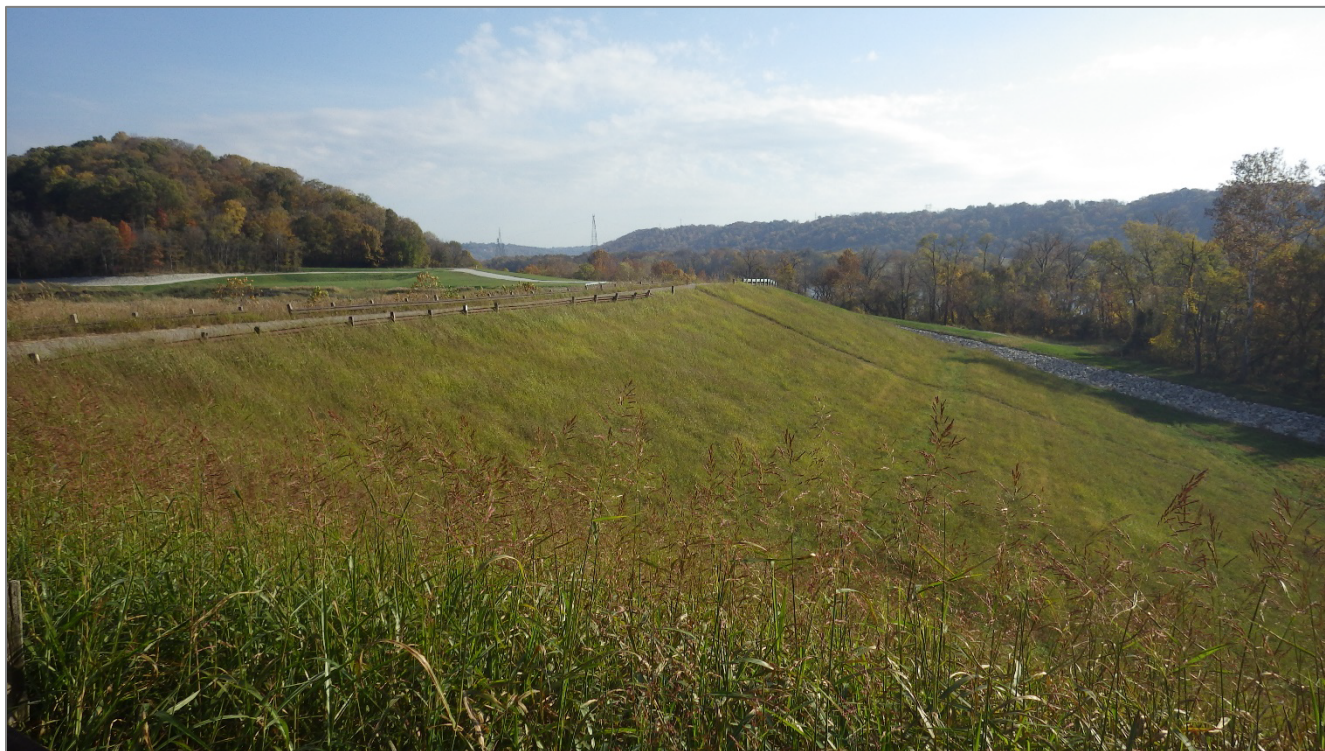
Photograph 1 – West downstream side of LRCP looking east.

Minor maintenance for the LRCP includes mowing of the dam slopes to observe potential issues or concerns, repairing the erosion rills above the downstream channel, and monitoring the surface-sloughed area beneath the access road to the toe will likely require attention as well (Photographs 1, 2, 3, 6, and 9).

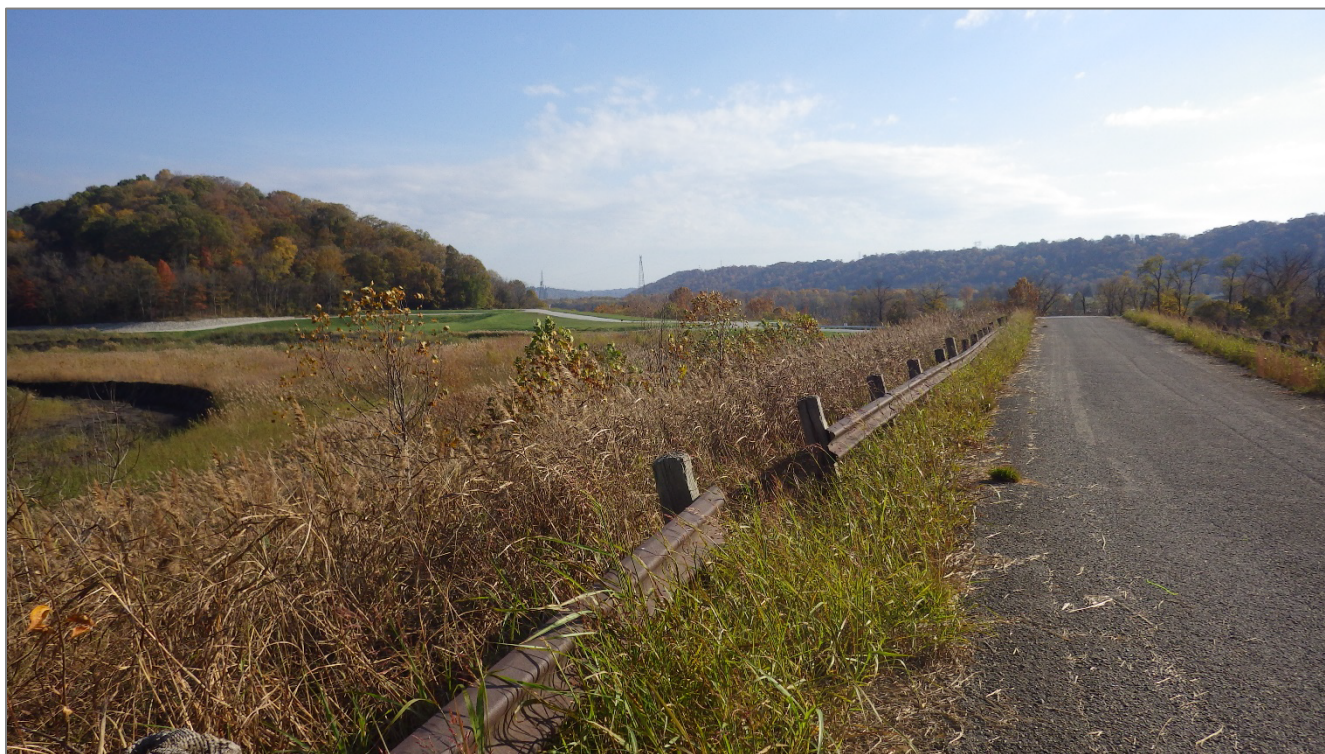
Photograph 2 – West upstream side of LRCP looking east.

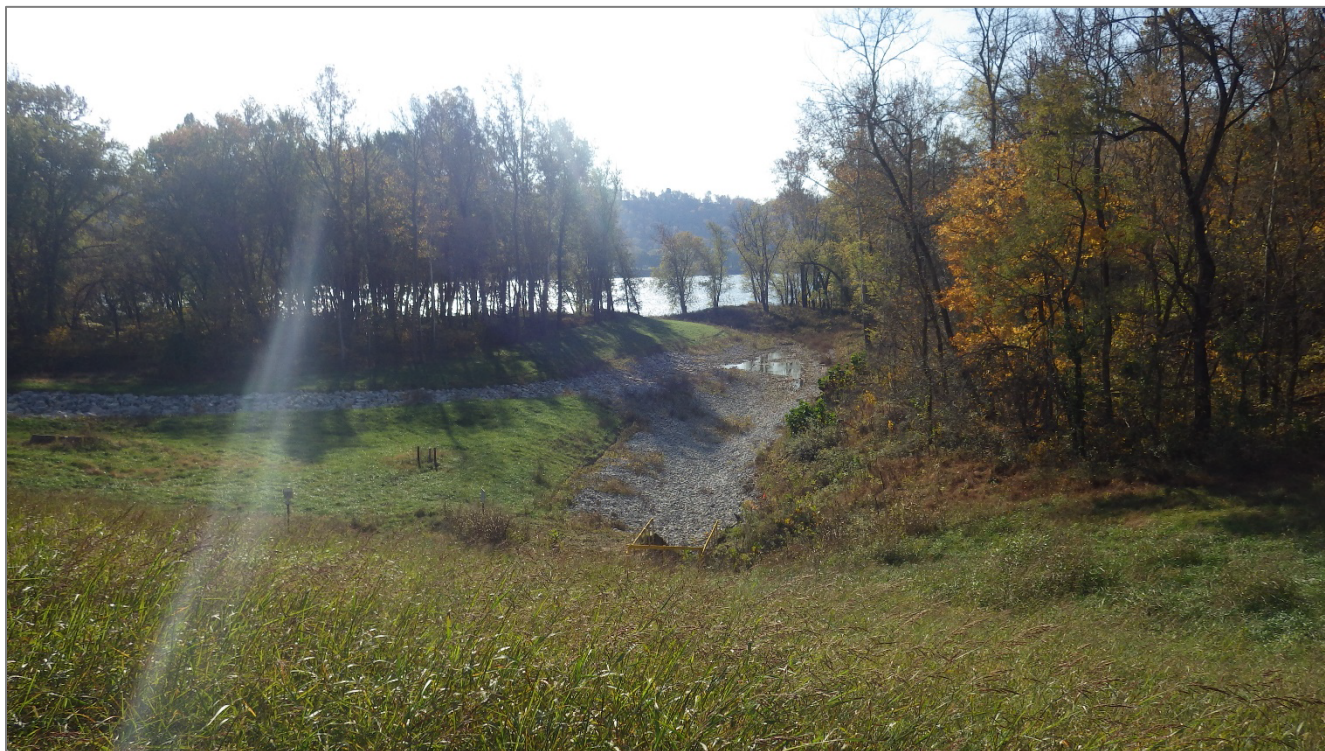
Photograph 3 – Downstream side of dam, outfall channel to the Ohio River.

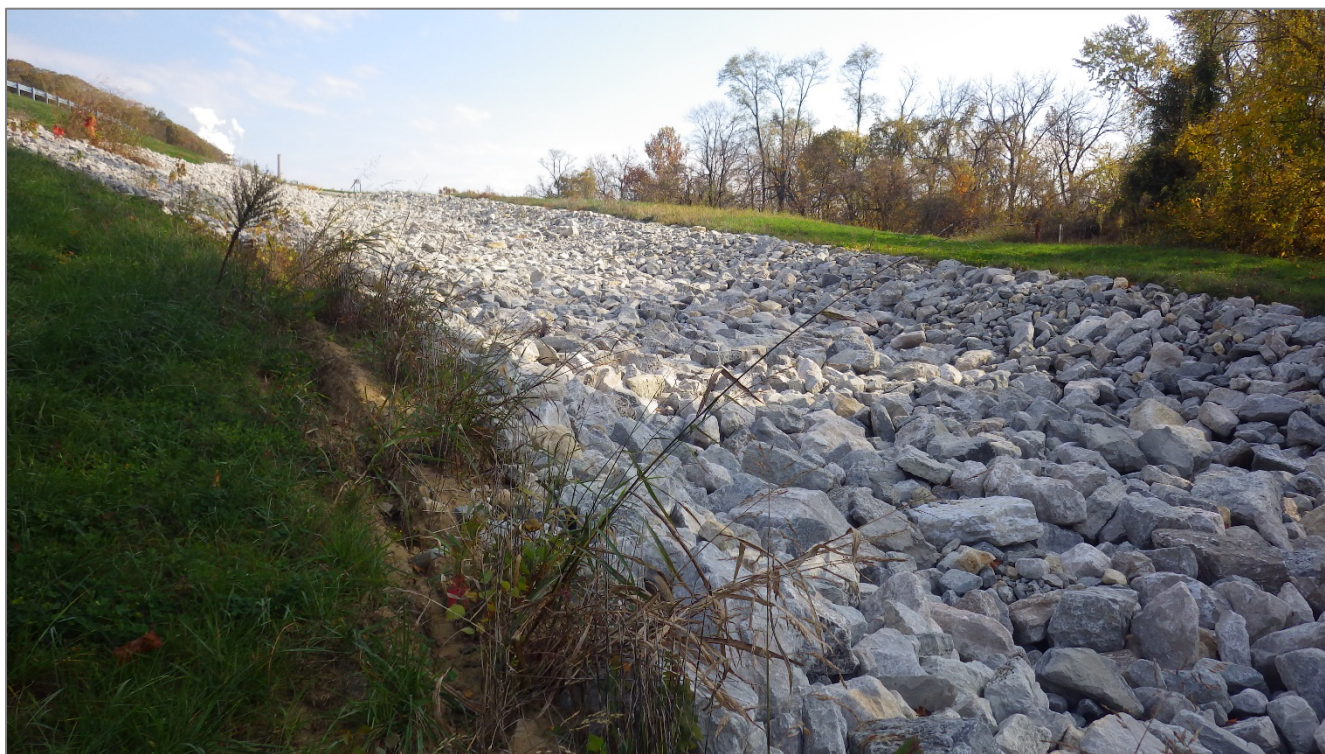
Photograph 4 – Western downstream channel showing erosion due to material change and silt fence removal.

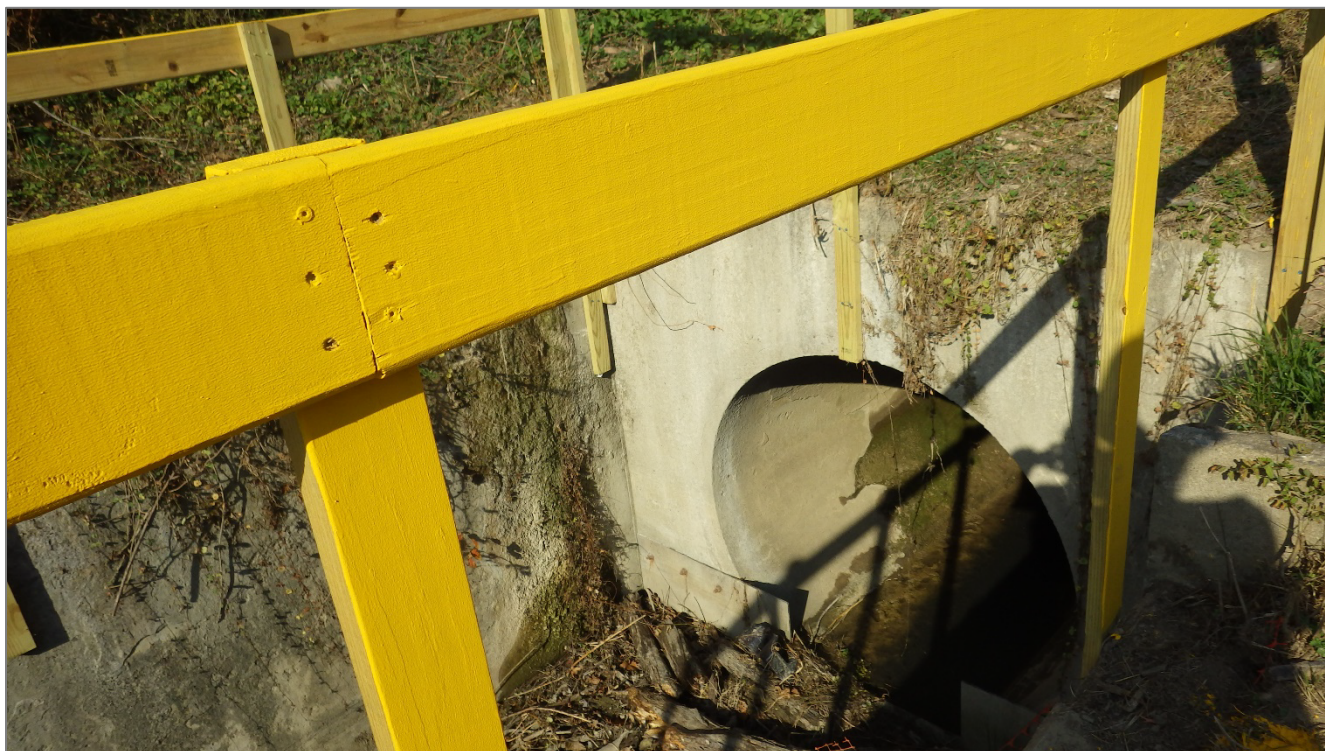
Photograph 5 – Outfall 001 outlet structure at toe of dam.

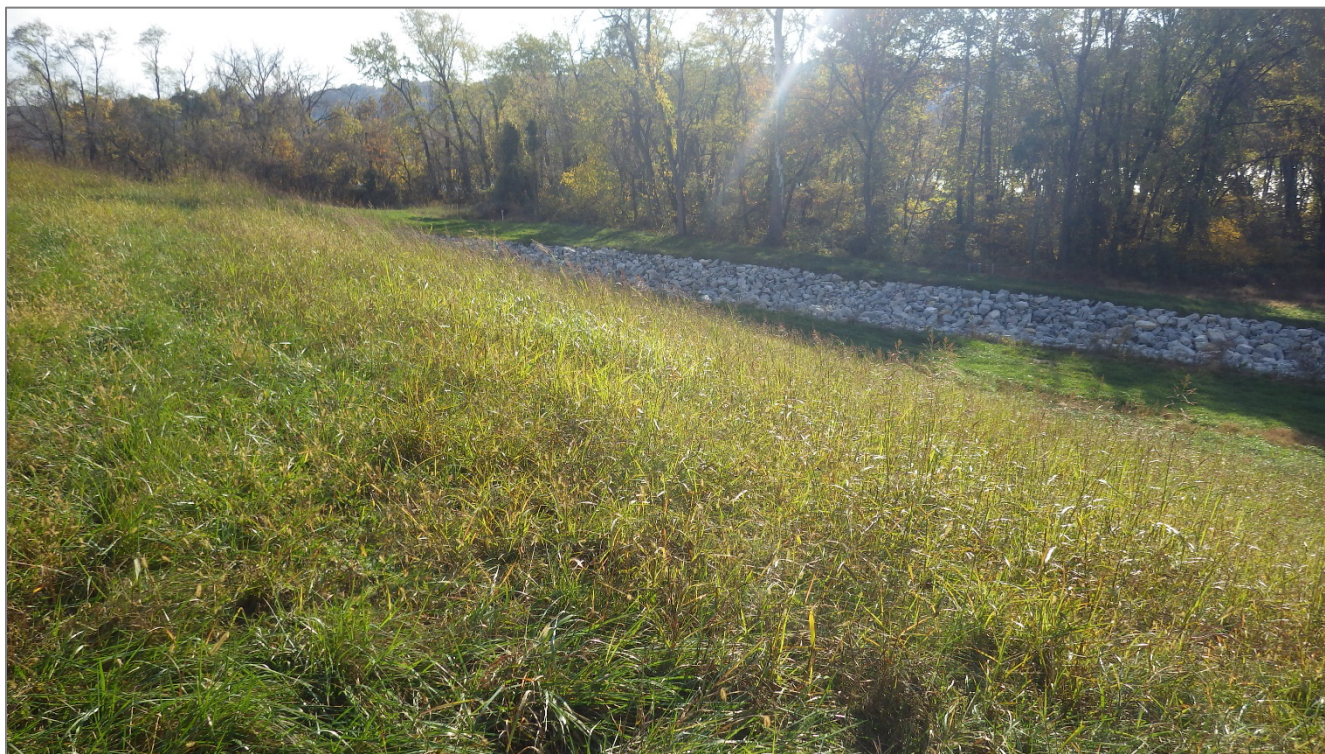
Photograph 6 – Western downstream side where the channel extends along the face and toe of the embankment. Note tall grass along slope.

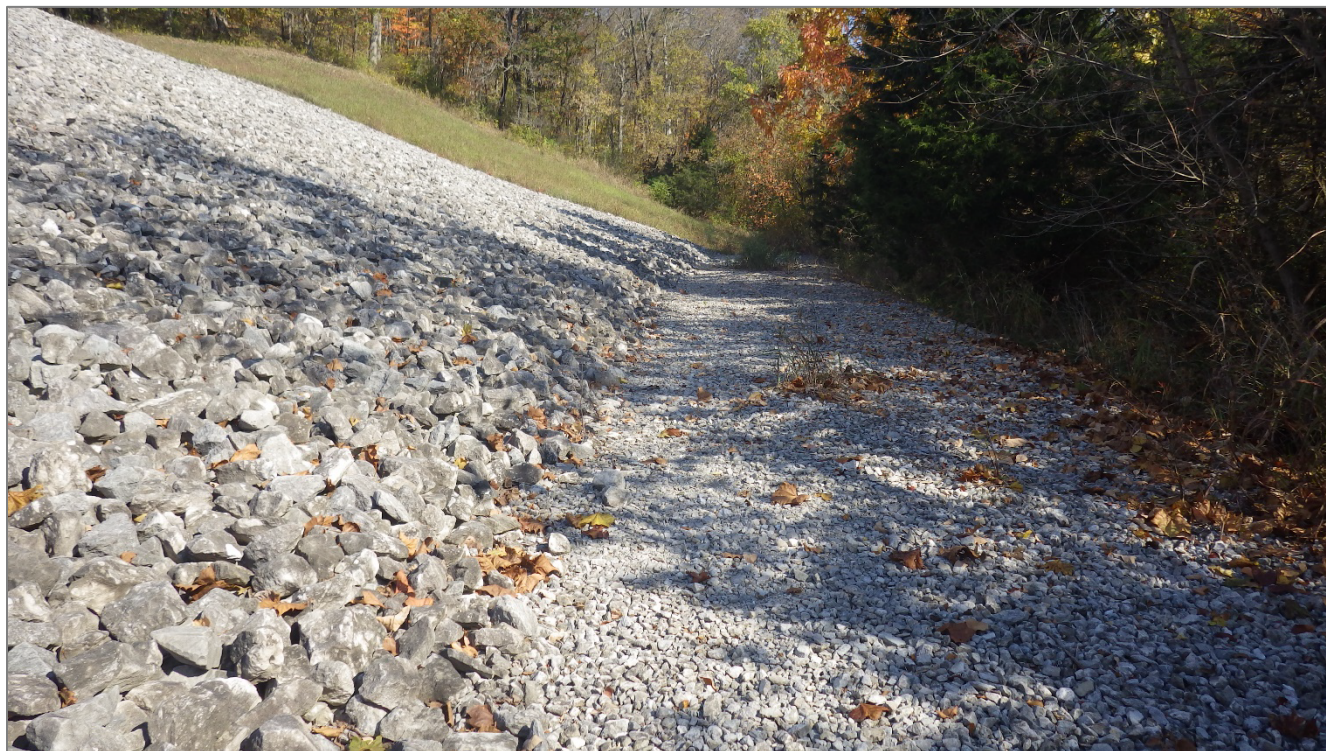
Photograph 7 – Downstream side of dam. Eastern side, looking east.

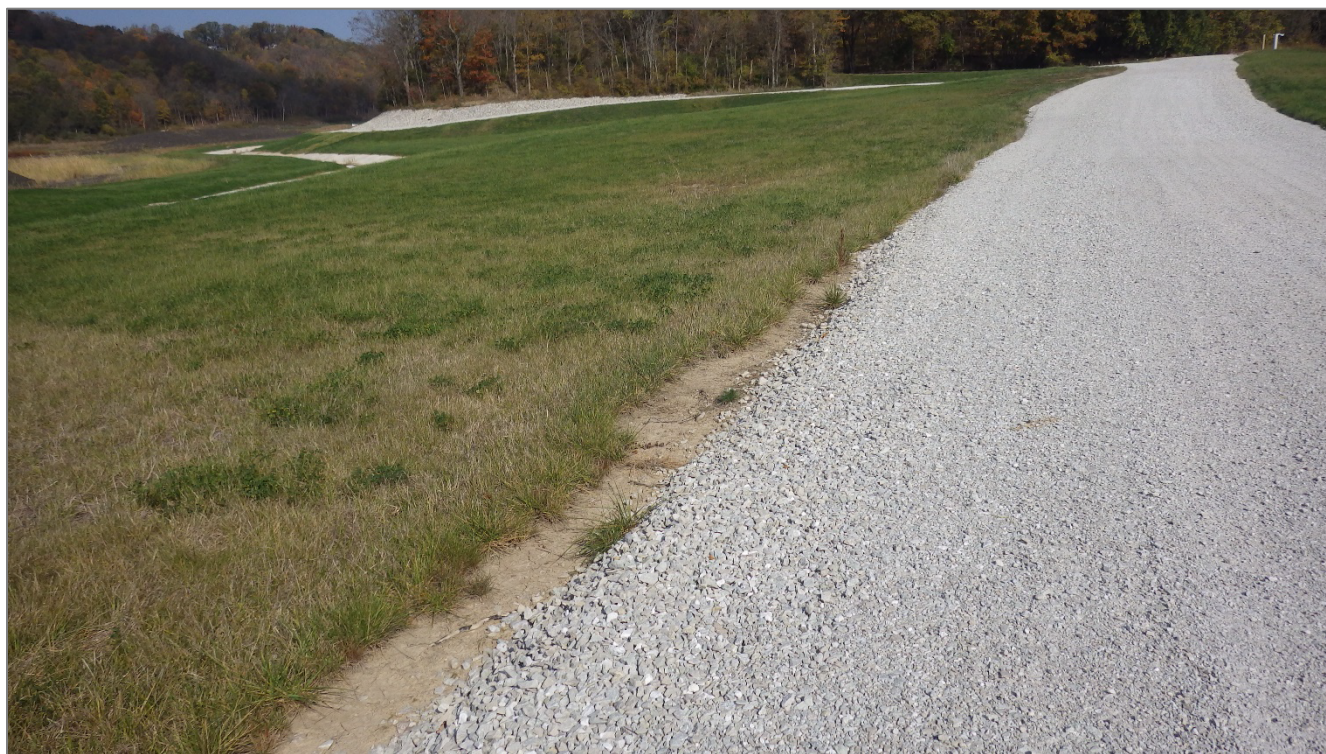
Photograph 8 – Crest of dam at the east end, looking north at access road and Phase 1 closure area.

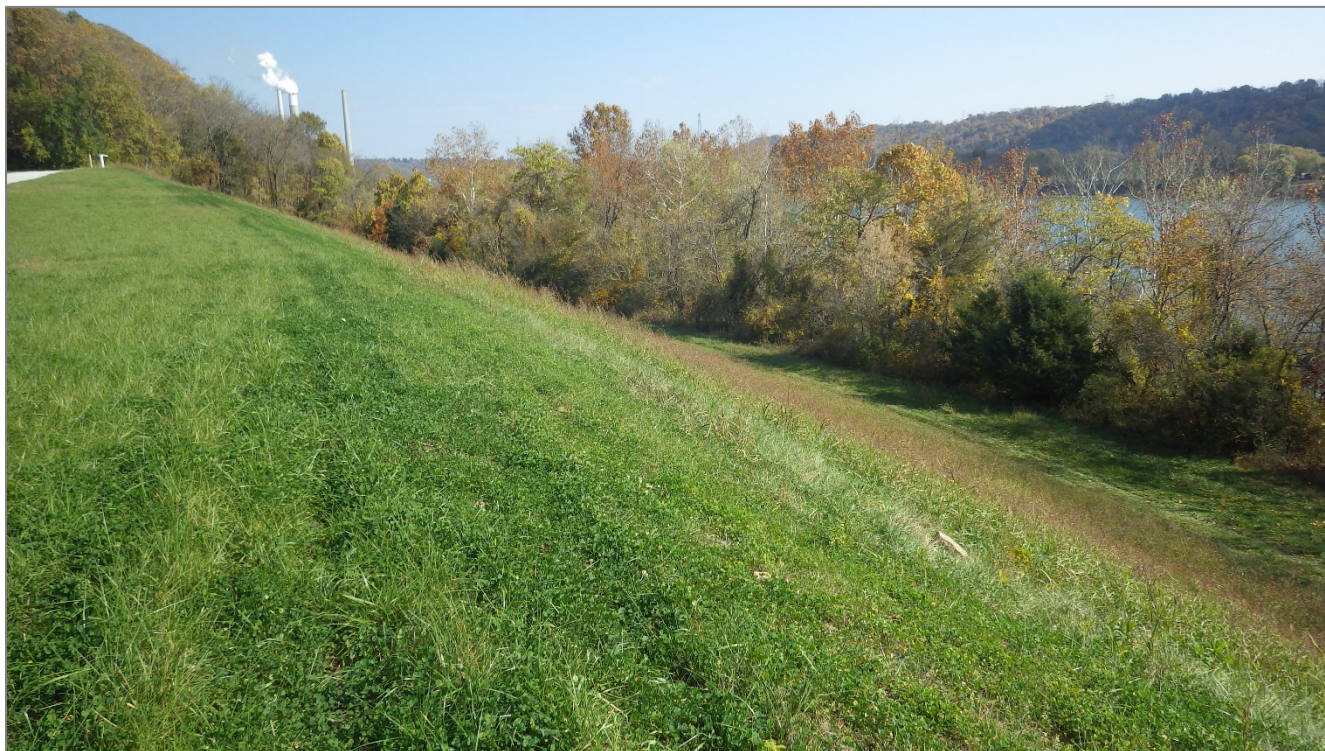
Photograph 9 – Crest of dam near center, looking east. Note tall grass on downstream slope.

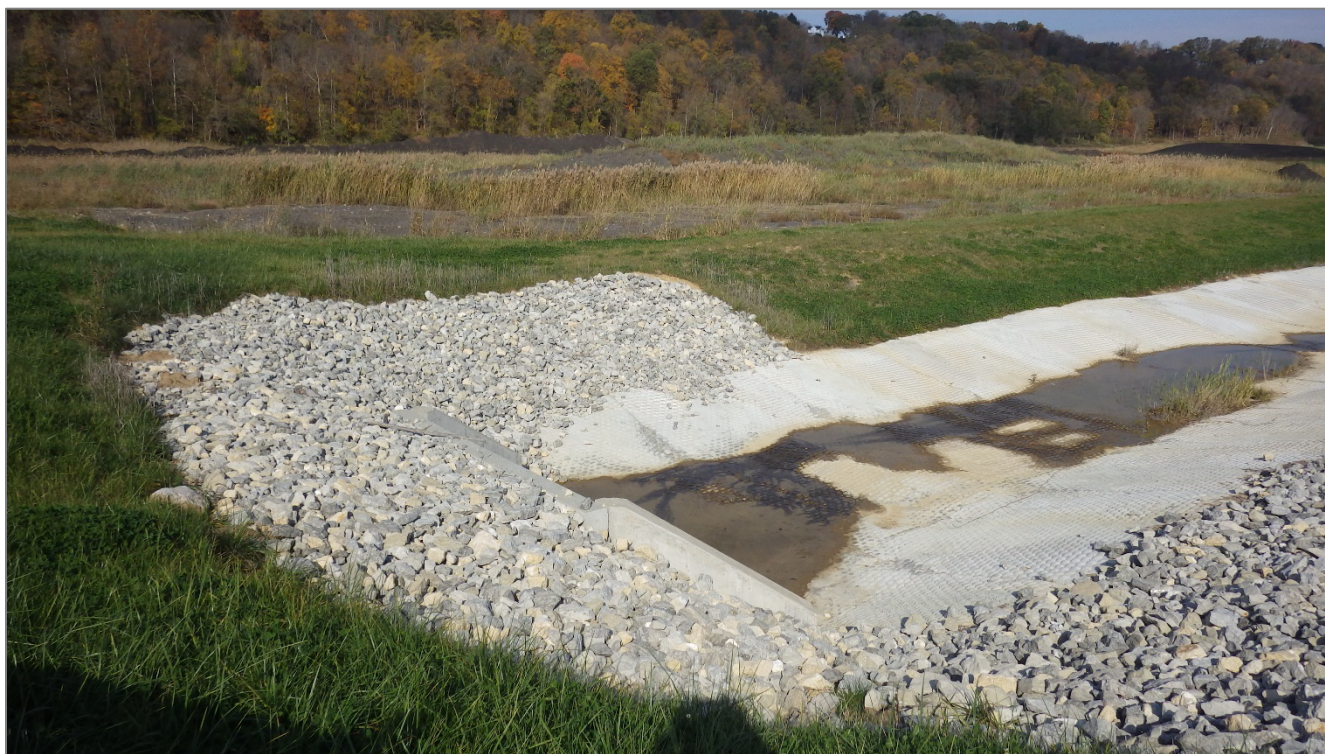
Photograph 10 – Upstream side of dam at 12 ft. x 4 ft. culvert.

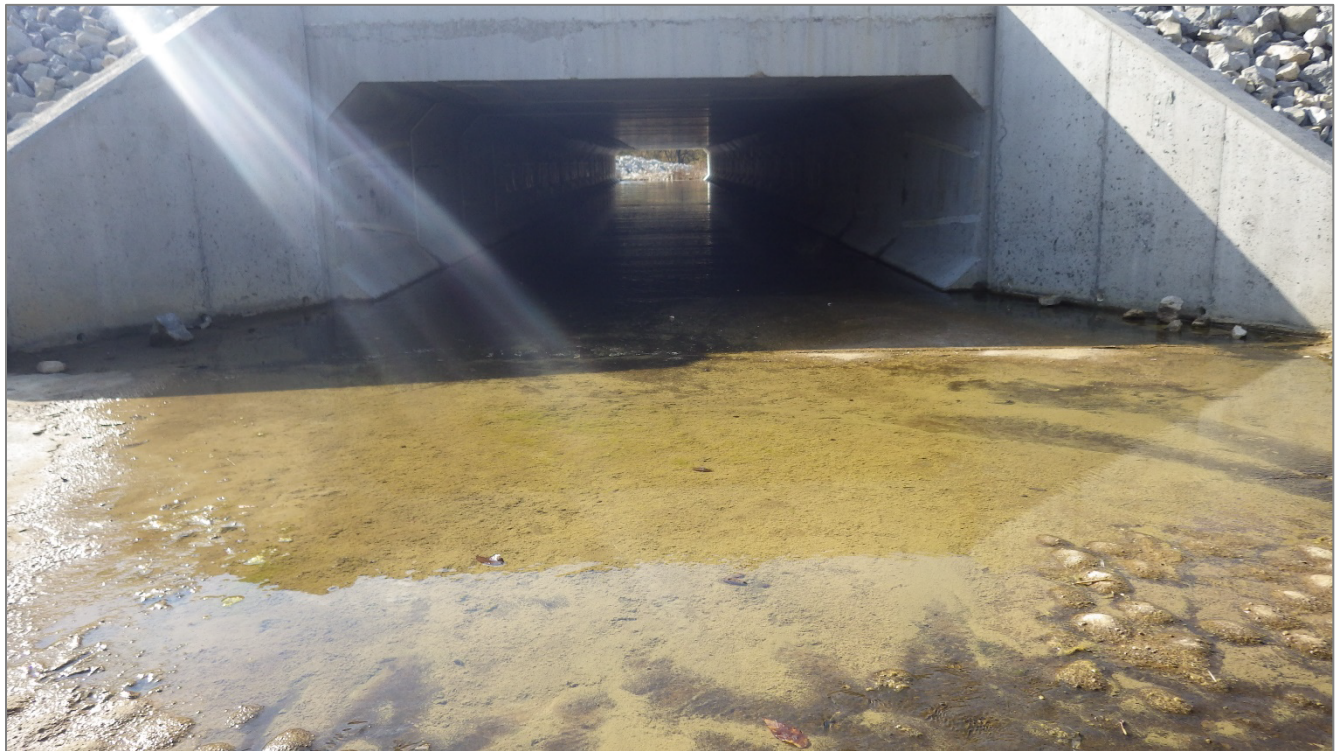
Photograph 11 – Upstream side of dam at 12 ft. x 4 ft. culvert, looking southwest through the culvert.

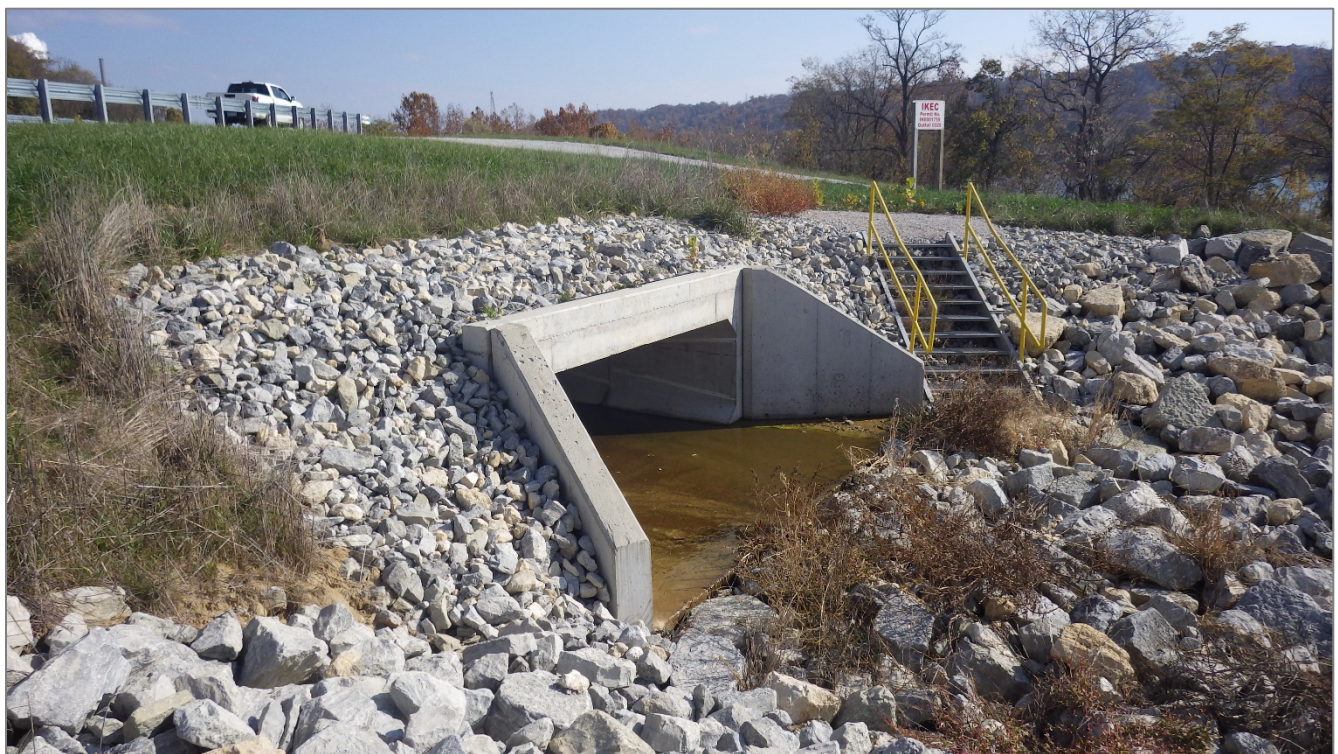
Photograph 12 – Downstream side of dam at 12 ft. x 4 ft. culvert.
