**2025 CCR Rule – Surface Impoundments  
Clifty Creek Dam/Dike Inspections**

Clifty Creek Generating Station  
Madison, Indiana  
Jefferson County

January 19, 2026

Stantec Consulting Services Inc.  
Cincinnati, Ohio

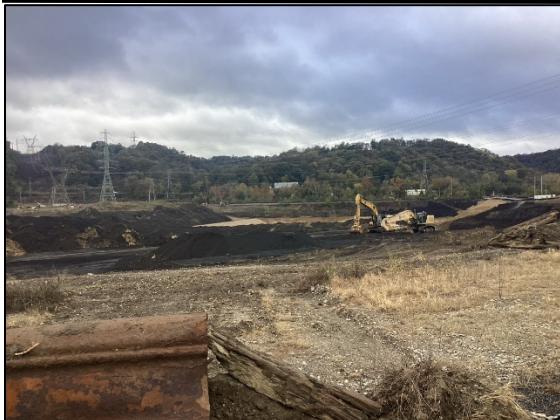
**Photo 4, Point 2**

Temporary Lined Containment construction.

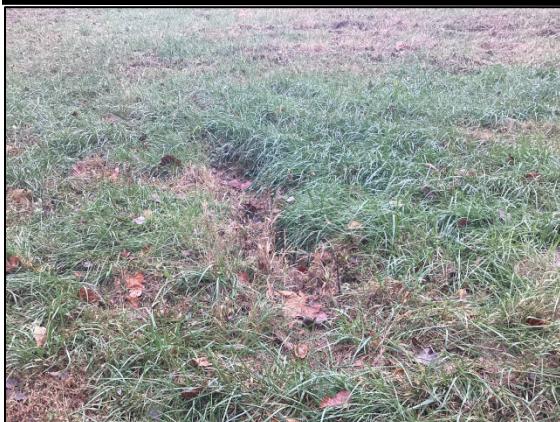
**Photo 7, Point 5**

Rutting on lower, flat area.

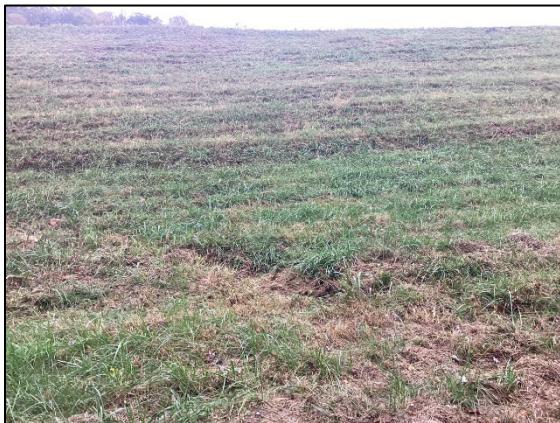
**Photo 8, Point 6**

Rutting from equipment tracks.

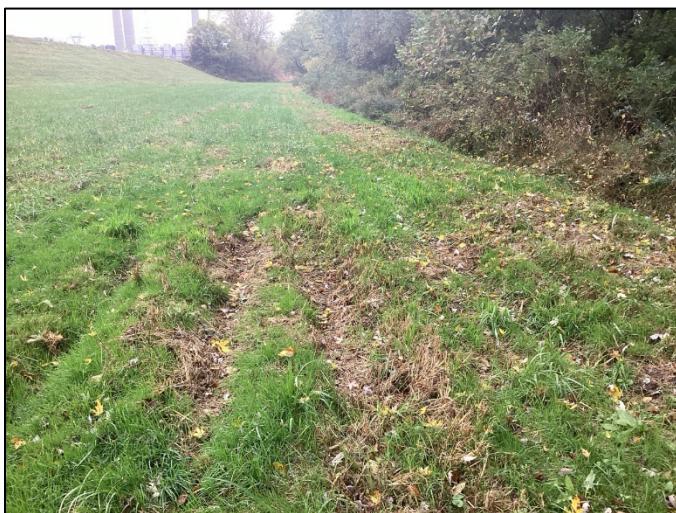
**Photo 9, Point 7**

Rutting from equipment tracks.

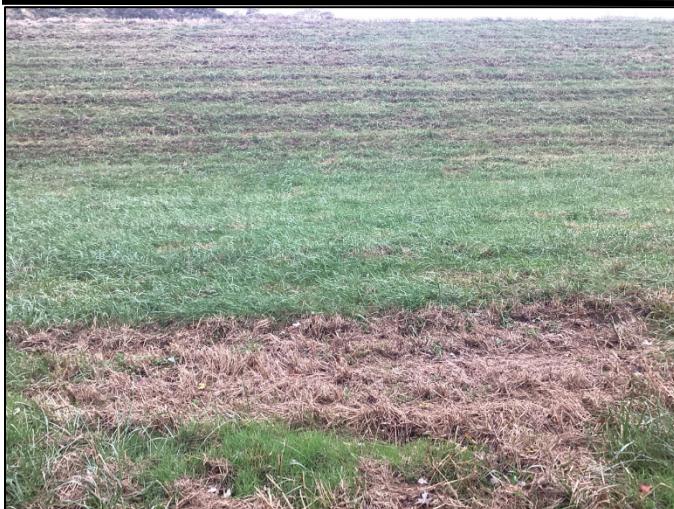
**Photo 10, Point 8**  
Dead grass, bare area.

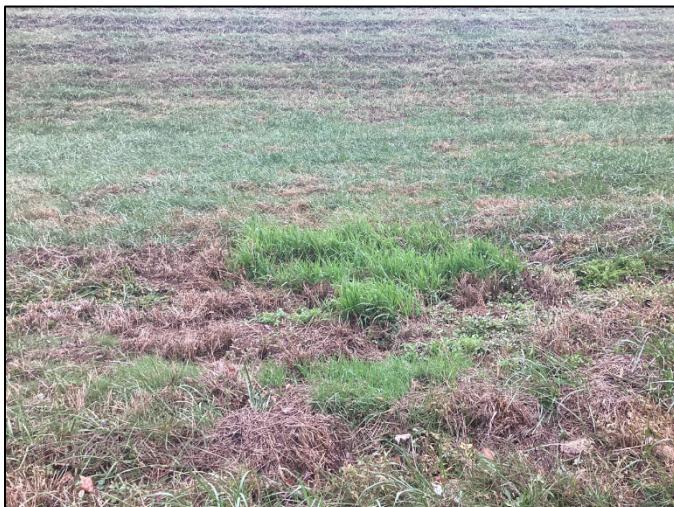
**Photo 11, Point 9**  
Dead grass, bare area.

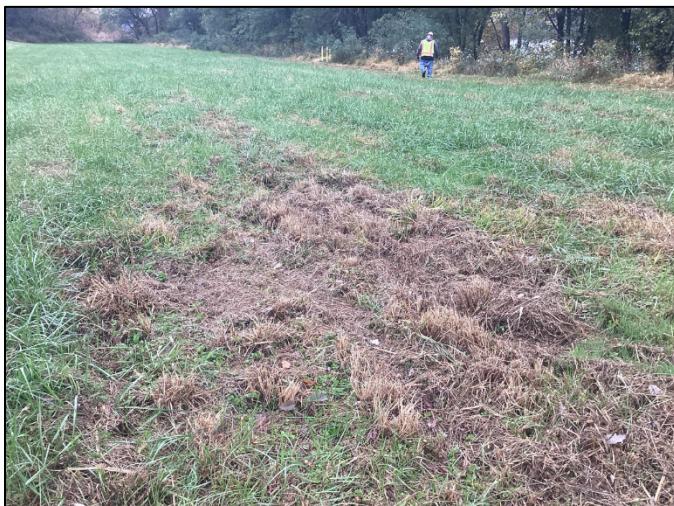
**Photo 12, Point 10**  
Rutting, dead grass, and bare area.

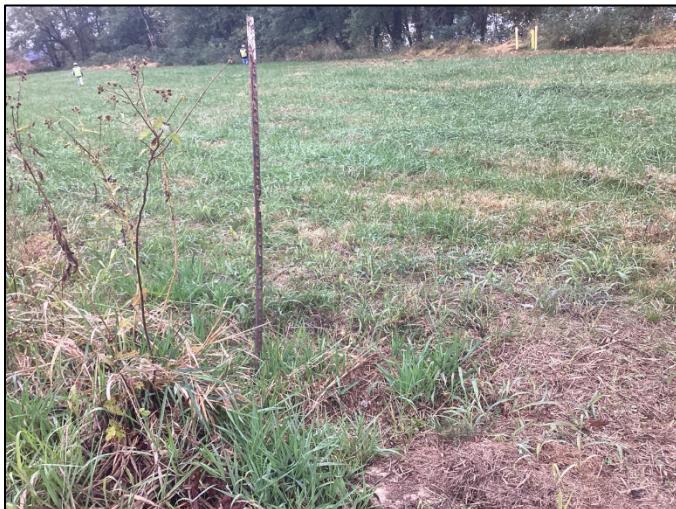
**Photo 13, Point 11**

Metal post with small vegetation overgrowth.

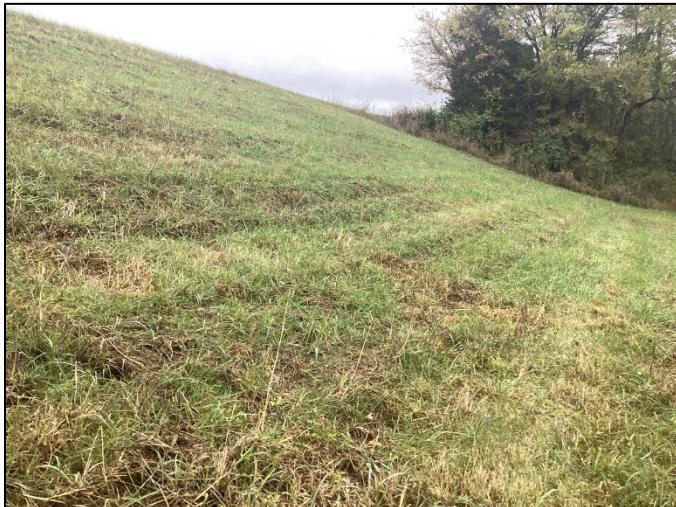
**Photo 14, Point 12**

Small dam face depression.

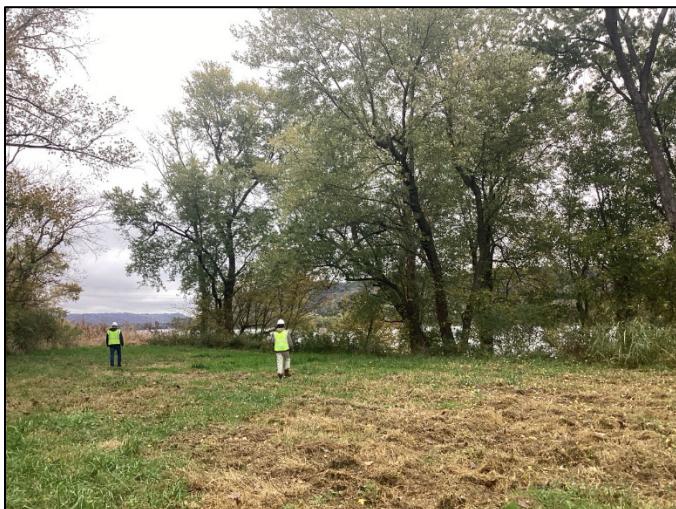
**Photo 15, Point 13**

Low vegetation overgrowth on Dam flat area.

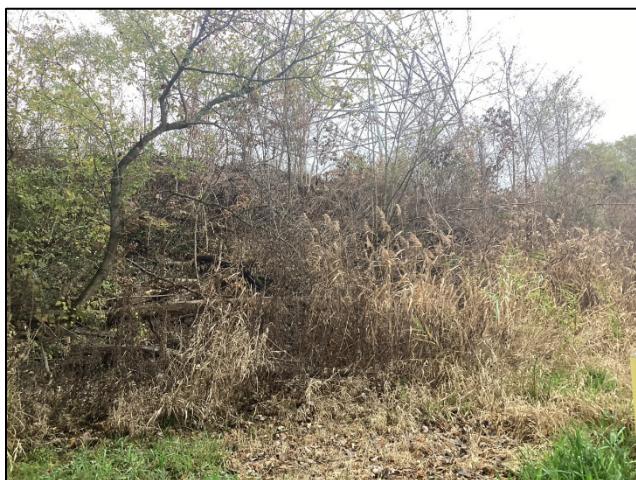
**Photo 17, Point 14**

The upstream and downstream dike slopes and crest areas, east of the LVWTS, are overgrown with small to large trees and heavy brush (Photographs 16, 17, and 18 in Appendix D). These conditions make it virtually impossible to inspect the slopes. The trees and larger brush can also provide seepage pathways as the larger foliage dies off. Trees that topple in windstorms can leave large holes exposed in the face of the dam. Stantec recommends that the overgrown crest and downstream side of the dam be stripped of foliage, graded for ease of maintenance, and seeded with grass to protect it from erosion. This will allow for future inspections to be conducted on this portion of the dam.

High vegetation overgrowth on Dam face and at electric tower slope.

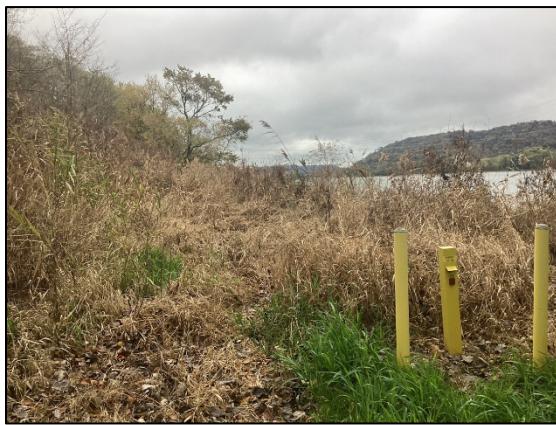
**Photo 18, Point 14**

High vegetation overgrowth on Dam face and at electric tower slope.

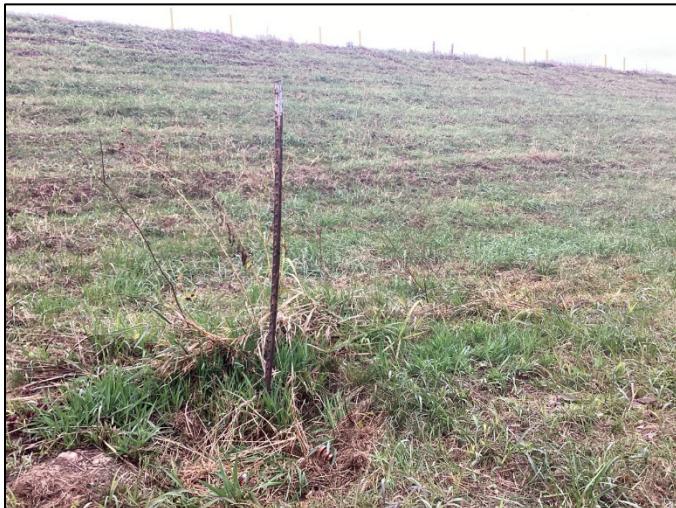
**Photo 23, Point 19**  
Metal post overgrowth area.

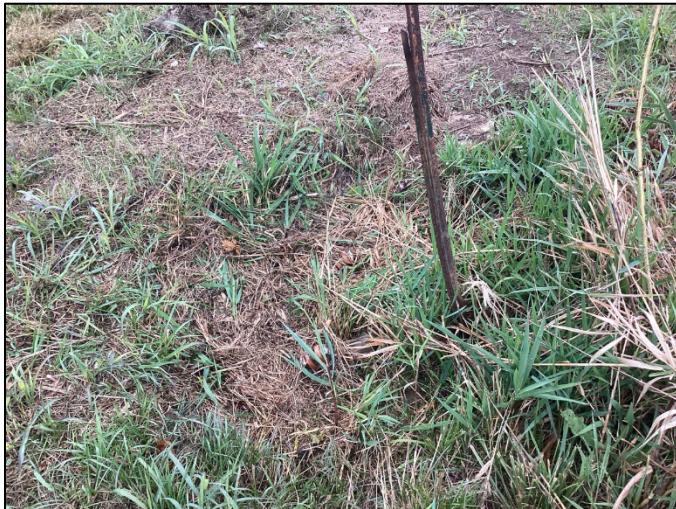
**Photo 24, Point 19**  
Bare spot around pipe area.

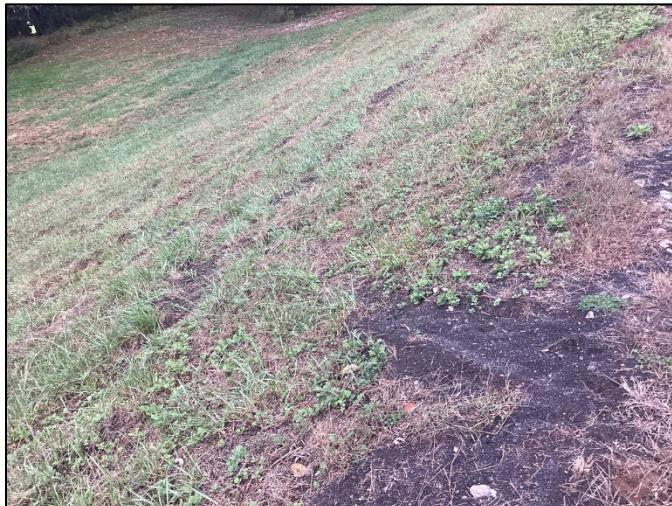
**Photo 29, Point 23**  
Bare spots with exposed ash.

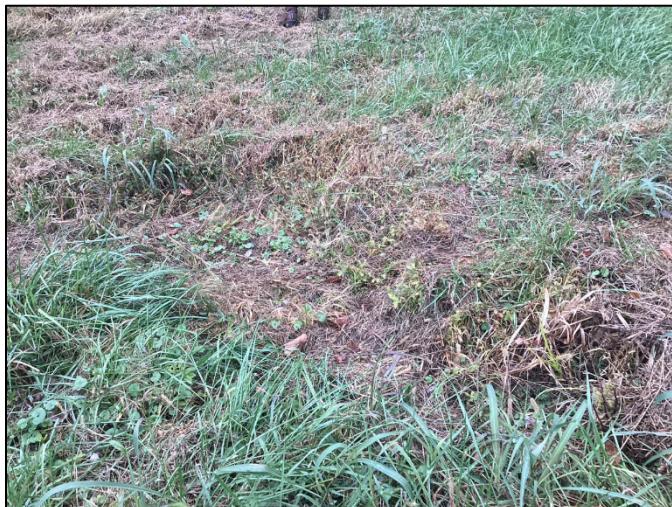
**Photo 30, Point 24**  
Rutted area from equipment tracks.

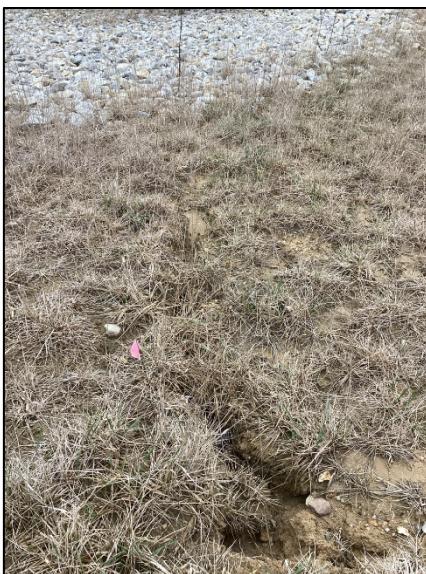
**Photo 39, Point 28**  
Erosion pin flagged on WBSP-Devil's Backbone Road slope.

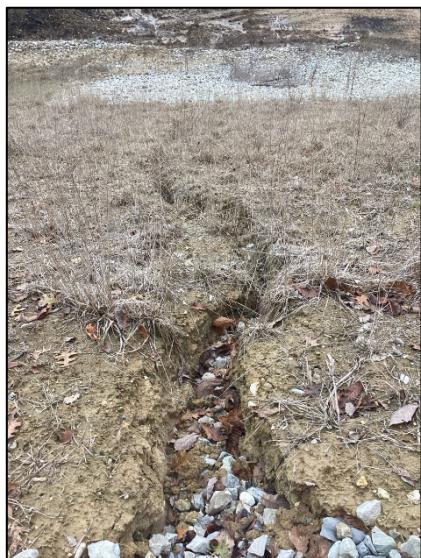
**Photo 42, Point 29**

Erosion and riprap blanket on WBSP-Devil's Backbone Road slope.

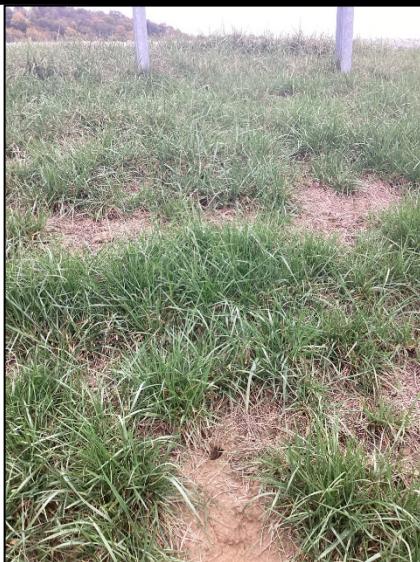
**Photo 4, Point 3**  
Animal burrowing and bare areas.

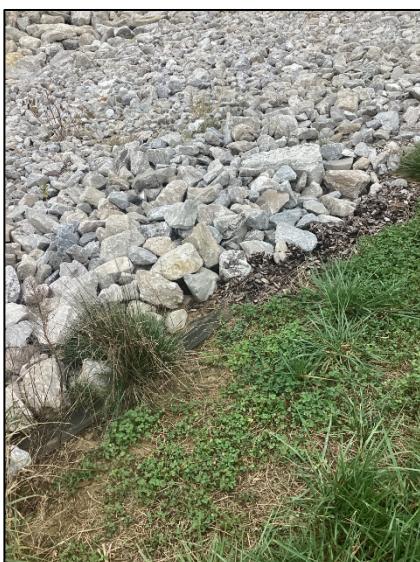
**Photo 5, Point 4**  
Exposed liner from erosion.

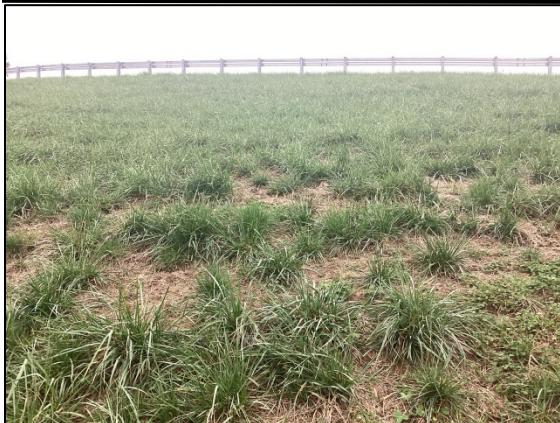
**Photo 7, Point 5**  
Bare areas on dam face.

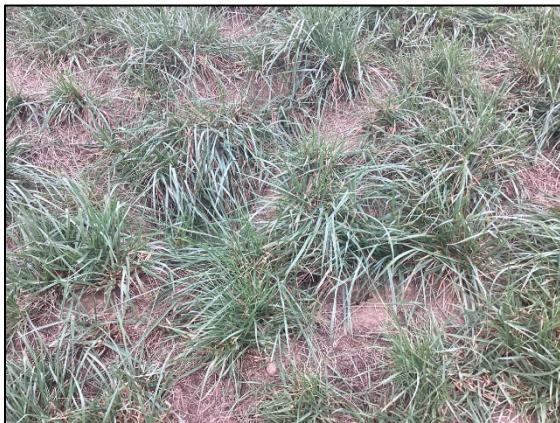
**Photo 8, Point 6**  
Animal burrowing.

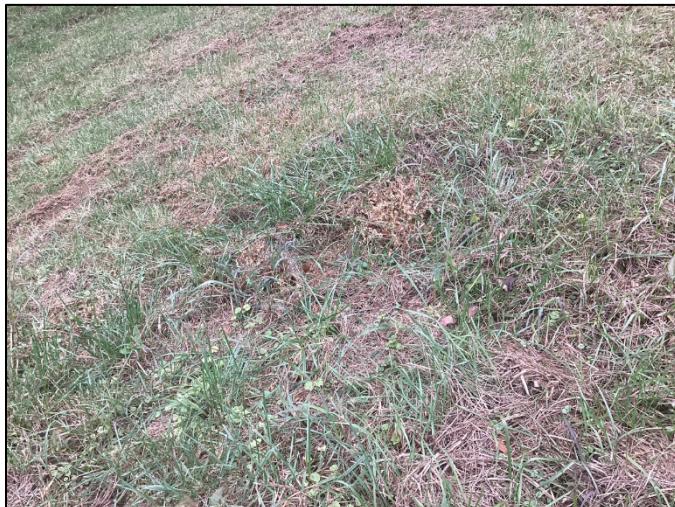
**Photo 12, Point 9**  
Soft area on dam face.

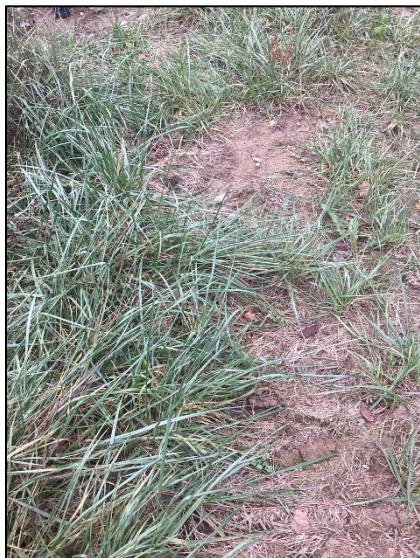
**Photo 18, Point 15**  
Bare areas.

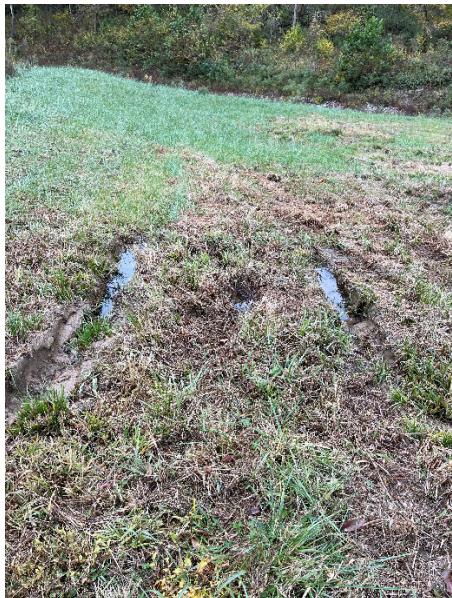
During visual inspection, two areas of concern appeared to the inspection team. One area of concern was the soft, wet ground around instruments CF-15-07, CF-9405, and CF-9405A between the toe of the LRCP dam and the outlet channels. The area was softer than the surrounding areas and had ponding water in deep equipment ruts. The second area observed was the mouth of the outlet channel to the Ohio River. The area had received large amounts of silt buildup that could create blockage in the outlet channel. Close observation and proactive maintenance to clear the silted material is recommended.

Further investigation of the wet/saturated area near the wells at the toe of the slope should be considered. As part of the weekly/monthly monitoring, this area should be checked and evaluated for changing conditions. If this area does not dry out, even during the summer months, then it may be indicative of a potential seep or potential artesian activity associated with one of the nearby wells.

**Photo 19, Point 15**  
Bare, soft areas near monitoring well area.

Minor maintenance for the LRCP includes repairing the erosion rills above and below the downstream channel, and monitoring the surface-sloughed area beneath the access road to the toe will likely require attention as well (Photographs 19, 21, 22, 24, and 30).

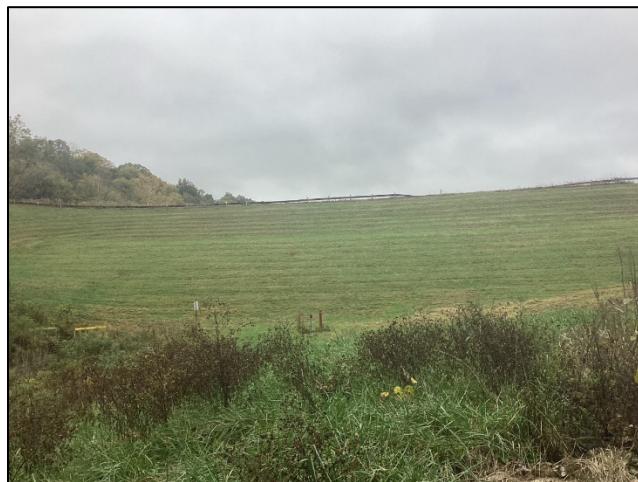
**Photo 21, Point 16**  
LRCP Dam face looking north.

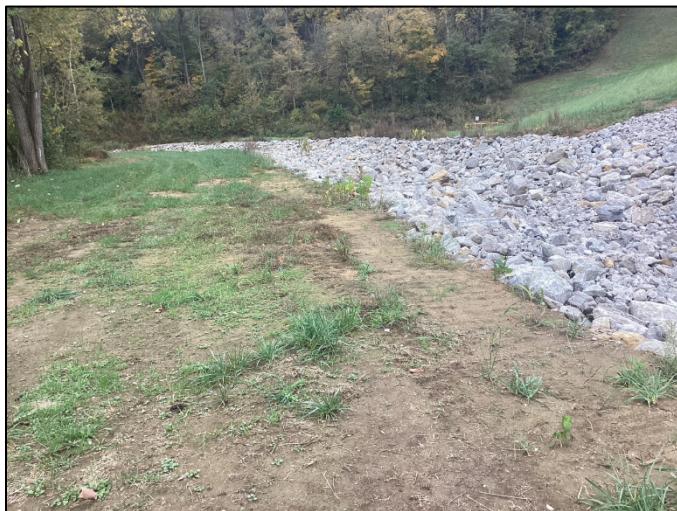
**Photo 24, Point 18**  
Bare area along diversion channel.

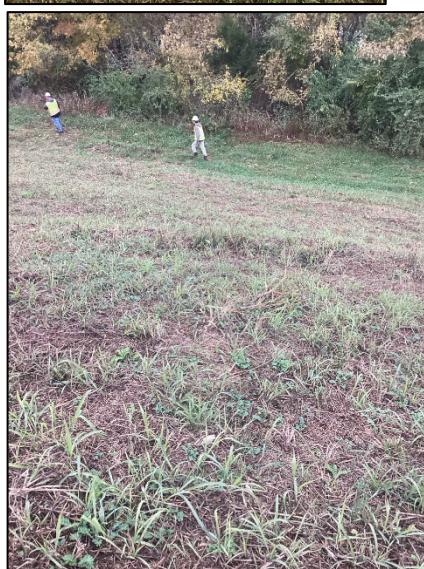
**Photo 30, Point 21**

Depression and bulging near middle of the dam face and riprap blanket.
