**Re: Indiana-Kentucky Electric Corporation**  
**Clifty Creek Station's 2019 Annual Landfill Inspection**

**Reference: 2019 CCR Rule Inspection  
Annual Landfill Inspection  
Clifty Creek Generating Station  
Madison, Indiana**

**2019 CCR Rule Inspection  
Clifty Creek Landfill**

Clifty Creek Generating Station  
Madison, Indiana  
Jefferson County

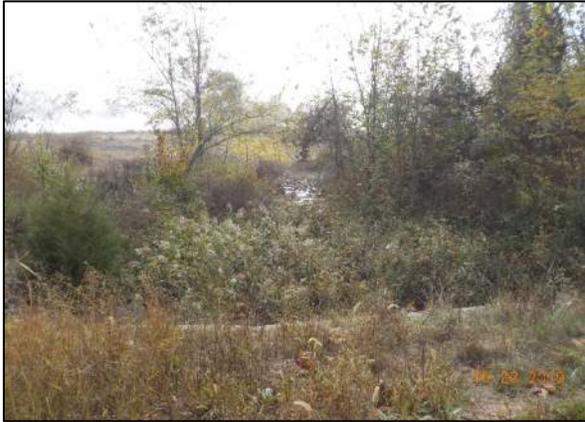
**Photo 1**

Dense vegetation growing in stormwater drainage ditch that flows to West Boiler Slag Pond. Photo taken at access road Conspan and looking east from downstream headwall. (Point 39, Appendix A)

- Remove excess vegetation from drainage channels, pipe inlets, and outlets. Flow was visible at the pipes observed by Stantec during the October site visit.

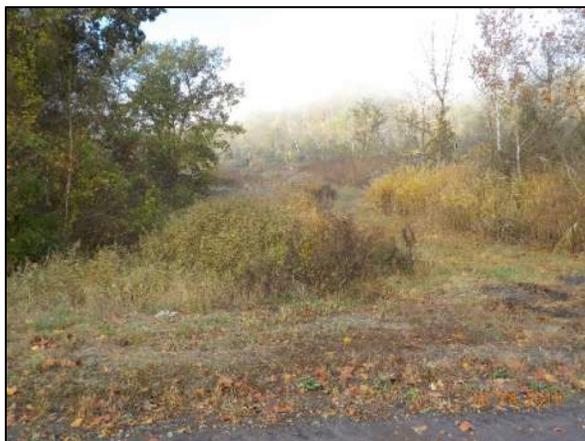
**Photo 2**

Dense vegetation growing in stormwater drainage ditch from landfill to West Boiler Slag Pond. Photo taken atop access road Conspan and looking west (upstream) toward landfill. Ditch is in center of photograph. (Point 40, Appendix A)

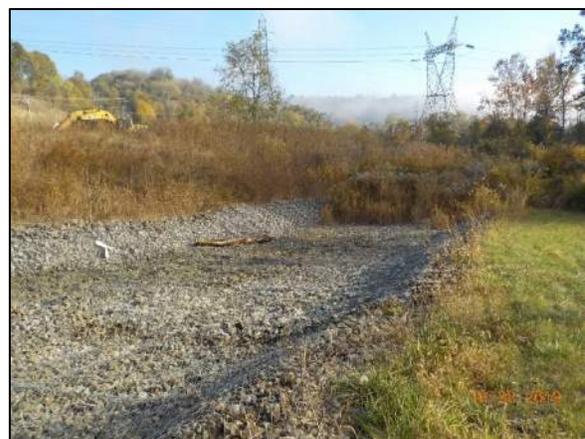
**Photo 3**

Looking east (downstream) between access road and landfill at dense vegetation growing in stormwater drainage ditch from landfill to West Boiler Slag Pond. Log and other debris are also present. (Point 42, Appendix A)

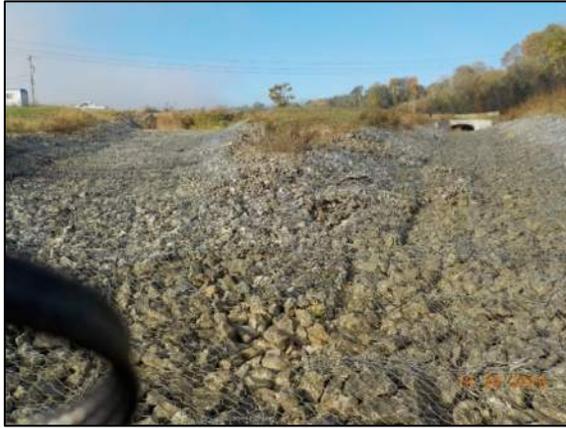
**Photo 4**

Looking west at stormwater drainage ditch confluence between access road and landfill. Gabion fill rock has shifted within baskets creating uneven channel lining. (Point 43, Appendix A)

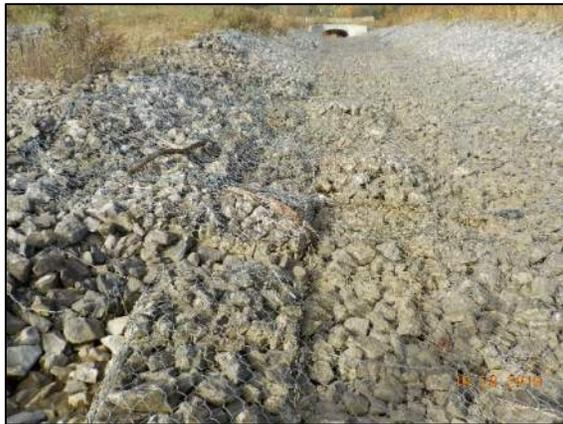
**Photo 5**

Looking west at uneven gabion fill rock in north stormwater drainage ditch. (Point 43, Appendix A)

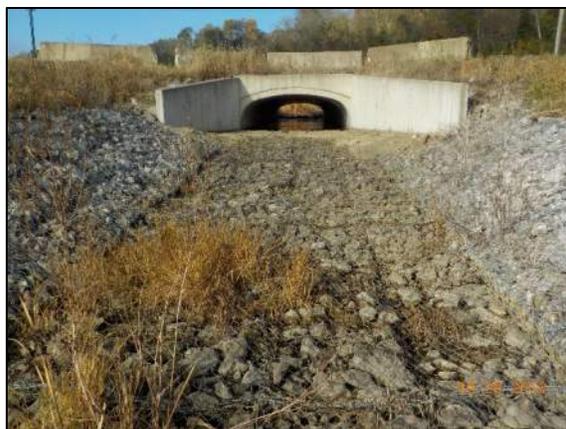
**Photo 6**

Looking west at clear channel at headwall of north storm water drainage channel upstream of confluence. Note a small amount of vegetation downstream of headwall. (Point 44, Appendix A)

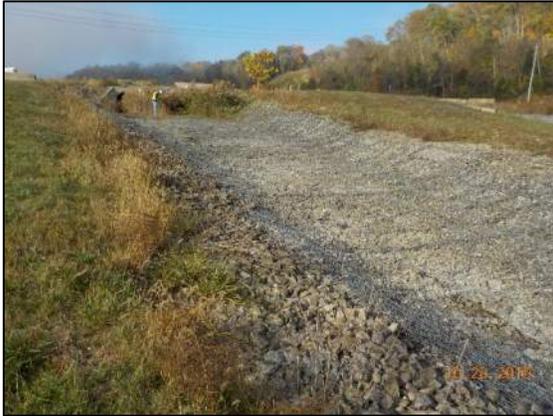
**Photo 7**

Looking west at clear channel of south storm water drainage channel upstream of confluence.

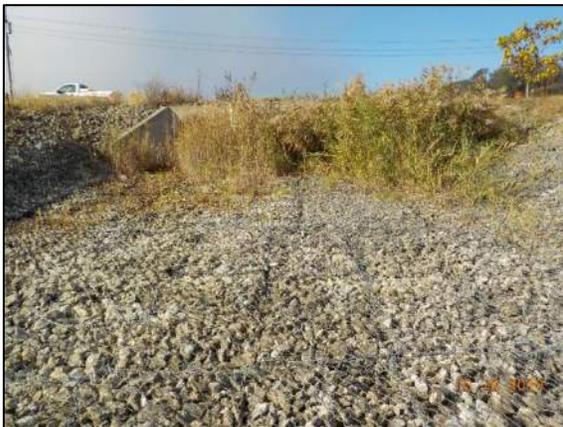
**Photo 8**

Dense vegetation at headwall of south storm water drainage channel above confluence. (Point 41, Appendix A)

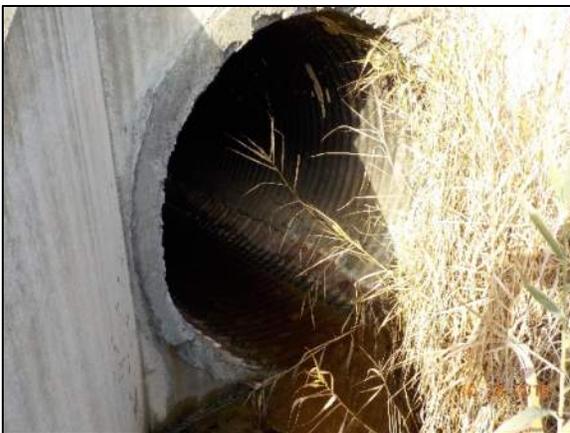
**Photo 9**

Photo of culvert outlet at headwall of south storm water drainage channel showing deterioration of culvert pipe lining. (Point 41, Appendix A)

- Continue to repair erosion features, reestablish vegetation, and monitor in future inspections.
- Continue to monitor the surface water channel headwalls and culverts east of the landfill. Repair as needed.

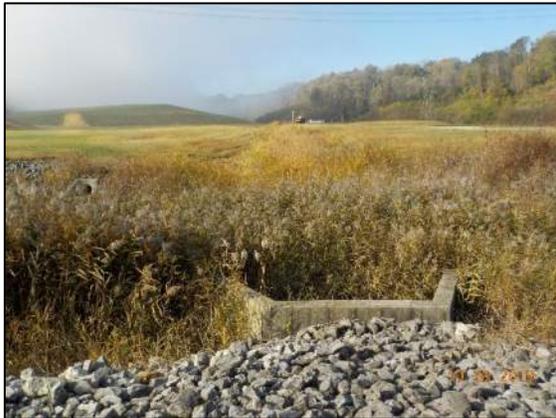
**Photo 10**

View looking west of dense vegetation in drainage channel on north side of inactive landfill Subphases 1A and 1B. Headwall of culvert beneath access road in foreground. (Point 45, Appendix A)

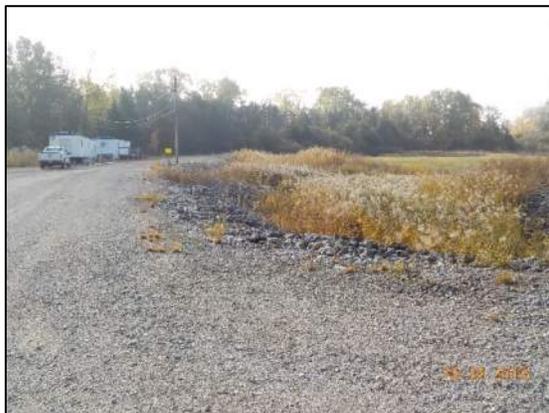
**Photo 11**

Overview of access road at east end of inactive landfill Subphases 1A and 1B looking south showing dense vegetation in drainage area. (Point 45, Appendix A)

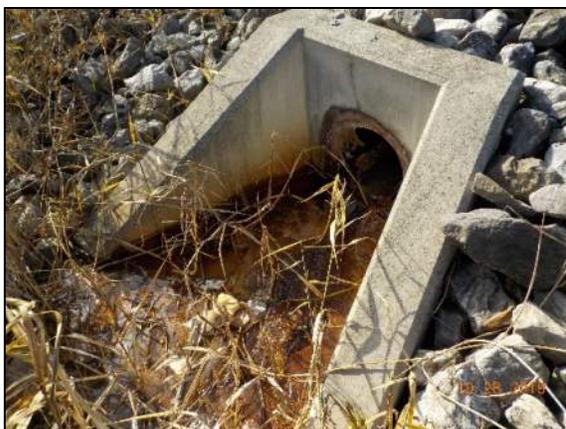
**Photo 12**

Headwall of north leachate collection line of inactive landfill Subphases 1A and 1B with orange-colored leachate. (Point 46, Appendix A)

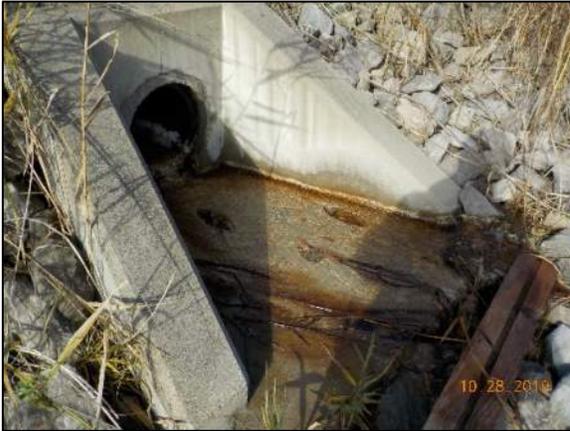
**Photo 13**

Headwall of south leachate collection line of inactive landfill Subphases 1A and 1B, unobstructed but filling with sediment. (Point 46, Appendix A)

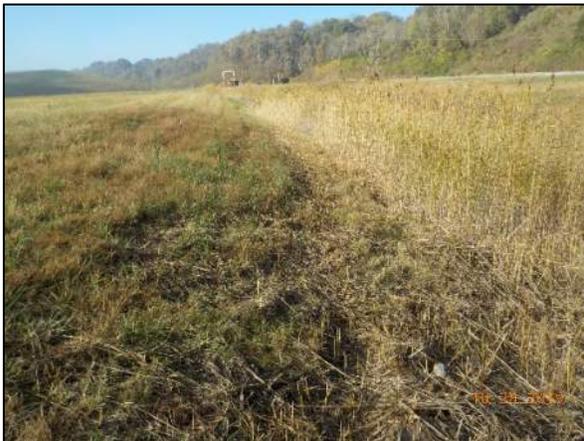
**Photo 14**

Dense vegetation in east end of drainage channel on north side of inactive landfill Subphases 1A and 1B.

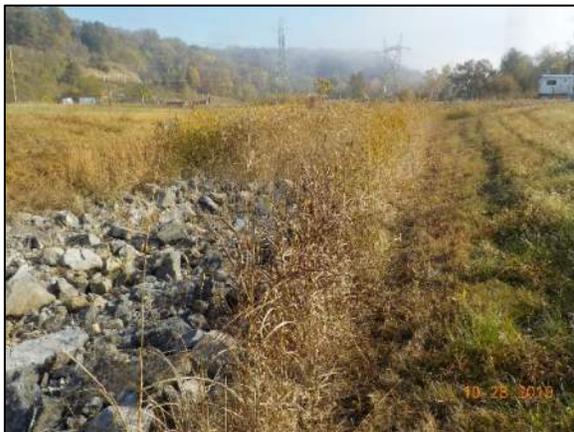
**Photo 15**

West end of dense vegetation in drainage channel on north side of inactive landfill Subphases 1A and 1B. (Point 47, Appendix A)

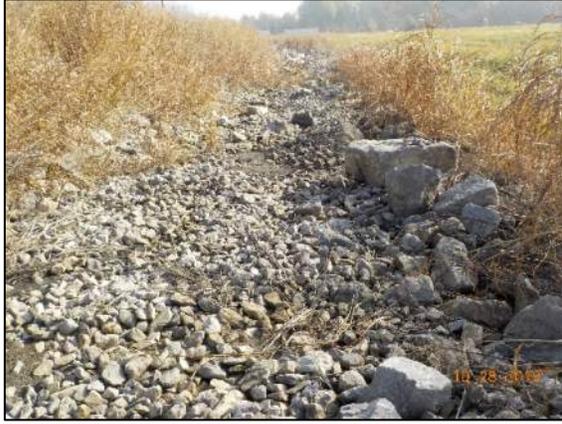
**Photo 16**

Ash (center of photo) in invert of drainage channel on north side of inactive landfill Subphases 1A and 1B just downstream of truck wash outlet. (Point 49, Appendix A)

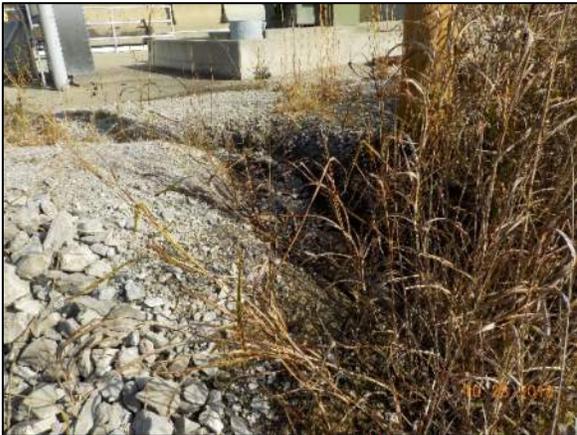
**Photo 17**

Erosion and vegetation at truck wash outlet to drainage channel on north side of inactive landfill Subphases 1A and 1B. (Point 50, Appendix A)

- Repair erosion feature near the truck wash surface water drainage pipe outlet/headwall area.

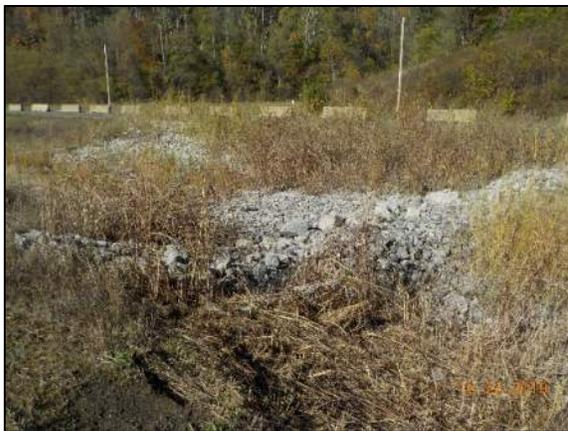
**Photo 18**

Rock check dam in drainage channel on north side of inactive landfill Subphases 1A and 1B just west of truck wash outlet. (Point 53, Appendix A)

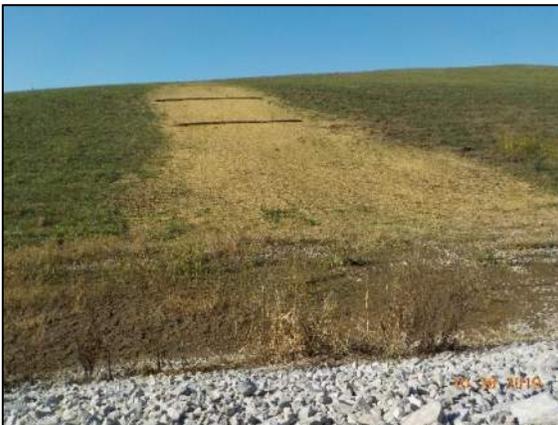
**Photo 20**

Repaired slope on east side of landfill.  
(Point 56, Appendix A)

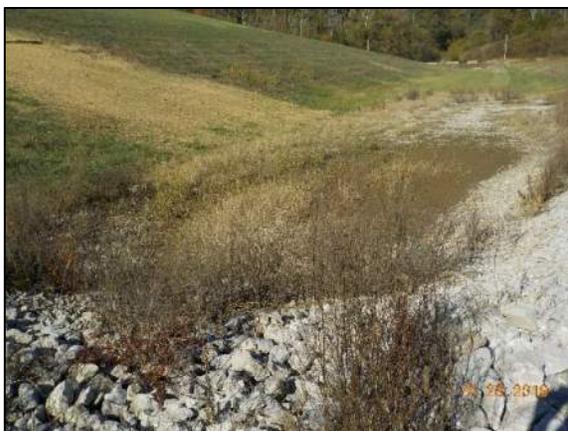
**Photo 21**

Toe of repaired slope on east side of landfill. Collected sediment at bottom of slope. (Point 57, Appendix A)

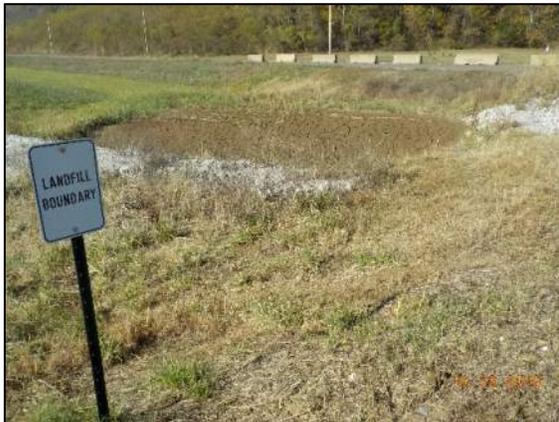
**Photo 23**

- A rock check dam was observed to be near capacity on the northeast corner of the landfill. (Point 54, Appendix A; Photo 23, Appendix B)
- A rock check dam was observed to be near capacity on the north side of the landfill. There is an erosion feature on one side of the dam. (Points 73, 74, Appendix A; Photos 34, 35, Appendix B)

Sediment basin at northeast corner of landfill. (Point 54, Appendix A)

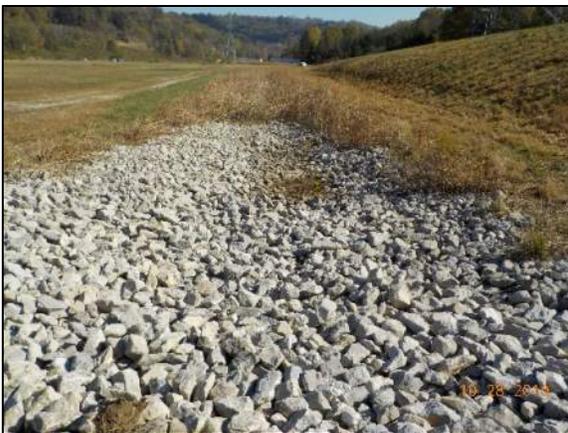
**Photo 24**

West end of drainage channel on south side of inactive landfill Subphases 1A and 1B showing channel lining and dense vegetation in channel beyond.

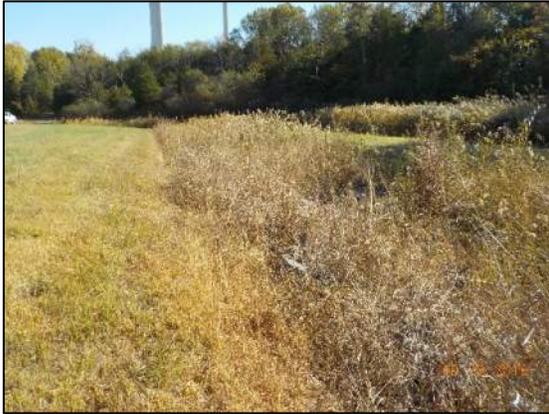
**Photo 25**

East end of drainage channel on south side of inactive landfill Subphases 1A and 1B showing dense vegetation in channel. (Point 58, Appendix A)

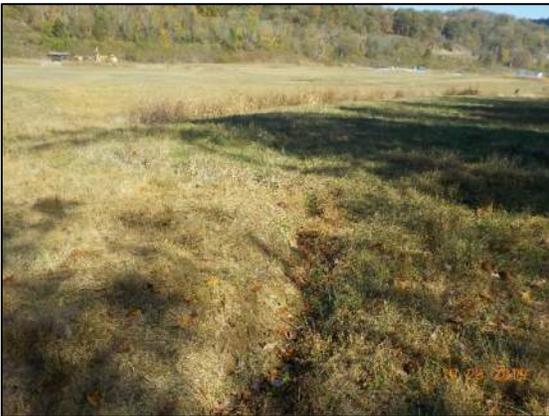
**Photo 26**

- Erosion rills (3'w x 3'd to 2'w x 1'd) were observed at the southwest corner of the inactive landfill. (Points 59 & 60, Appendix A; Photo 26)
- As observed in 2018, Subphases 1A1 and 1B1 were observed to be nearly built to permitted final CCR grades. The subphases have been temporarily covered with approximately six inches of soil, and vegetation has generally been established.

Erosion rills (3'w x 3'd to 2'w x 1'd) at southwest corner of inactive landfill Subphases 1A and 1B. (Points 59 & 60, Appendix A)

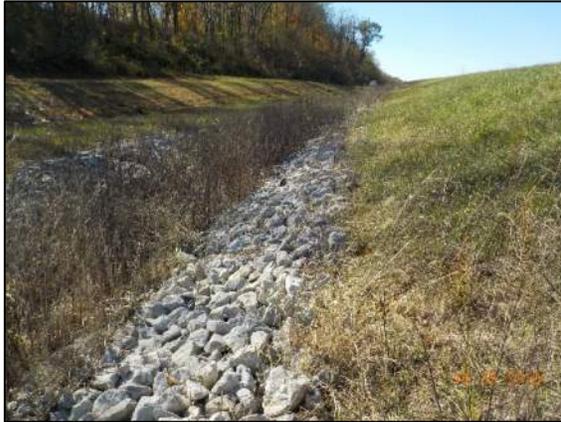
**Photo 28**

Dense vegetation along invert of drainage ditch along south side of landfill.

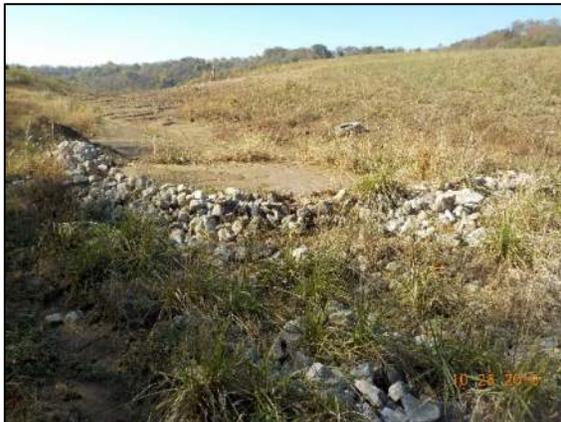
**Photo 29**

- A rock check dam was observed to be near capacity on the south side of the landfill. (Point 64, Appendix A; Photo 29, Appendix B)
- Erosion rills and/or small animal burrows were observed at the eastern toe of the landfill. (Point 55, Appendix A; Photo 33, Appendix B)

Rock check dam at capacity on south side of landfill near top of active area. (Point 64, Appendix A)

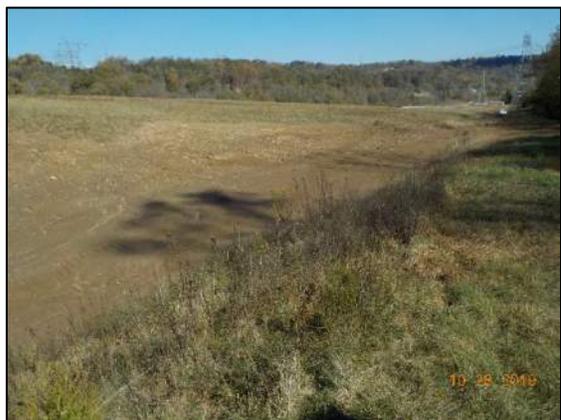
**Photo 30**

Unseeded/bare area above full rock check dam at southeastern edge of active ash area on south side of landfill. (Point 65, Appendix A)

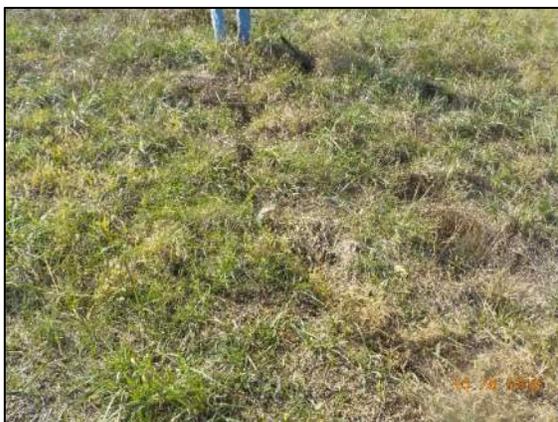
**Photo 33**

Erosion rills and/or small animal  
burrowing at eastern toe of landfill.  
(Point 55, Appendix A)

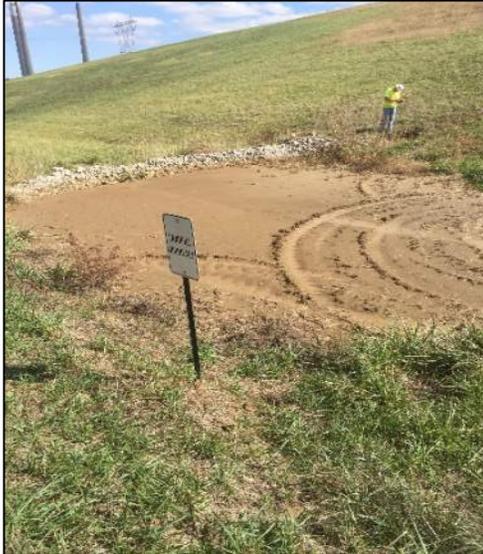
**Photo 34**

Rock check dam at capacity on northeast corner of active landfill. (Point 73, Appendix A)

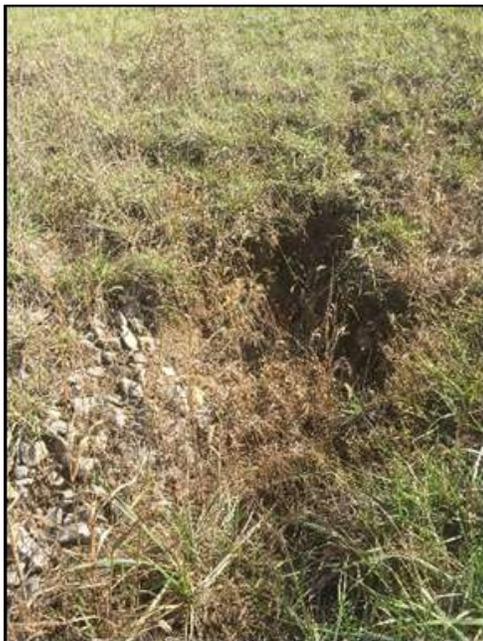
**Photo 35**

Erosion feature at south edge of check dam on northeast corner of active landfill (Point 74, Appendix A)

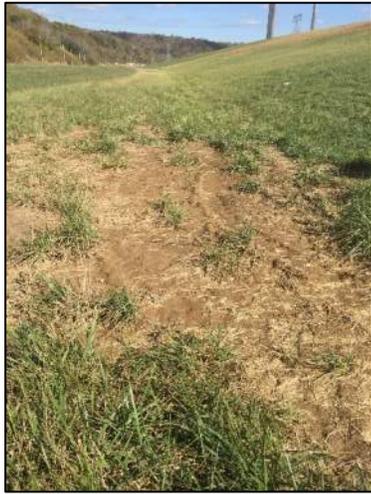
**Photo 36**  
Unseeded area on north side of active landfill. Sediment apparently from regrading/revegetation of slope above. (Point 79, Appendix A)

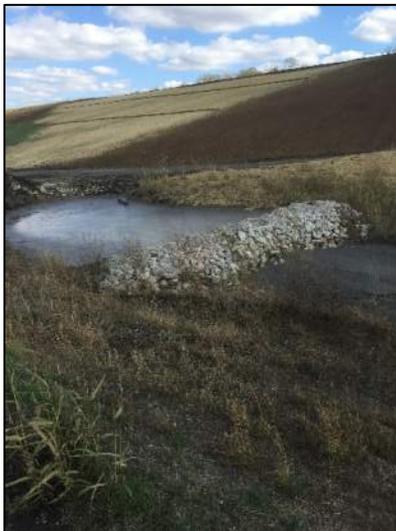
- Another rock check dam, at the northwest corner of the active area, was observed to be near capacity. (Point 87, Appendix A; Photo 37, Appendix B)
- Several bare or rocky areas were observed on the temporary cover slopes of Subphases 1A2/1B2. Several erosion rills were observed in the grassed areas downslope from the rocky/bare areas.

**Photo 37**  
Full rock check dam on north side of active landfill. (Point 87, Appendix A)
