**Re: Indiana-Kentucky Electric Corporation
Clifty Creek Station's 2021 Annual Landfill Inspection**

**2021 CCR Rule Inspection
Clifty Creek Landfill**

Clifty Creek Generating Station
Madison, Indiana
Jefferson County

February 2, 2022

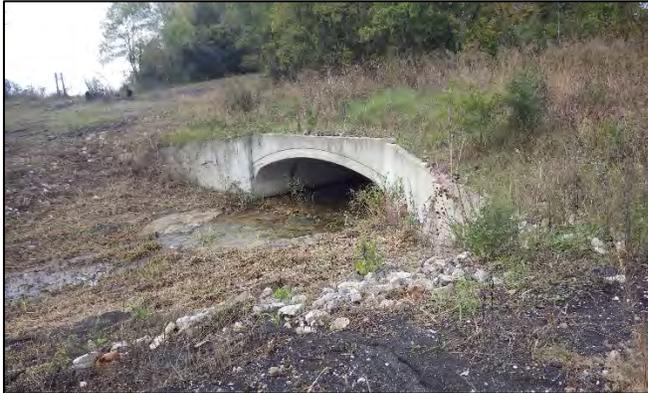
Photo 1

Outlet of Conspan upstream of Boiler Slag Pond showing clear channel.

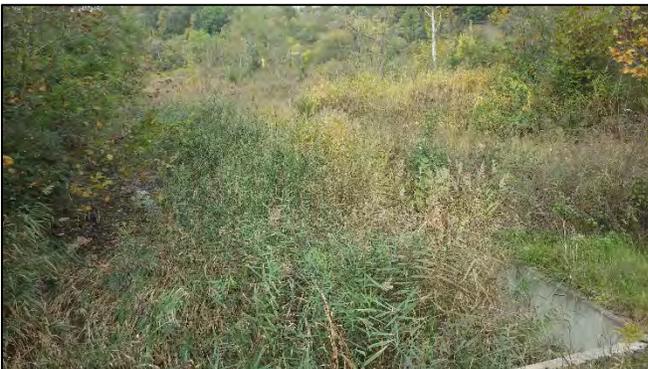
Photo 2

Dense vegetation growing in front of west face of Conspan in stormwater drainage ditch from landfill to West Boiler Slag Pond. Photo taken atop access road. Ditch is in center of photograph. (Point 1, Appendix A)

- Remove excess vegetation from drainage channels, pipe inlets, and outlets. Flow was visible at the pipes observed by Stantec during the October 2021 site visit.

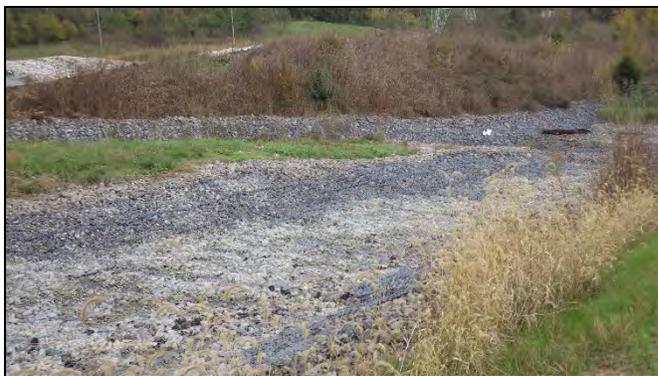
Photo 3

Looking east (downstream) between access road and landfill at controlled vegetation in stormwater drainage ditch from landfill to West Boiler Slag Pond. Log and other debris are also present. (Point 2, Appendix A, beyond)

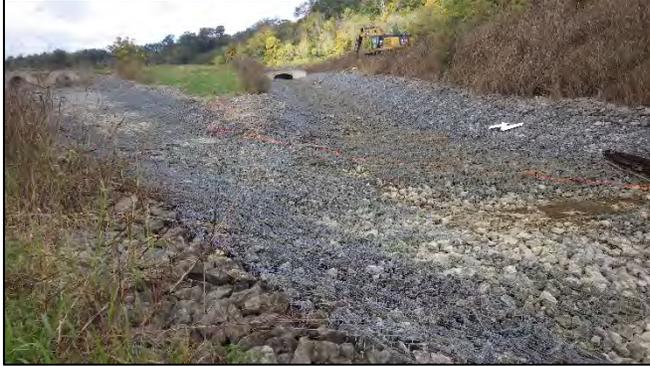
Photo 4

Looking west at stormwater drainage ditch confluence between access road and landfill. Gabion fill rock has shifted within baskets creating uneven channel lining. Condition is unchanged from previous year. (Point 2, Appendix A)

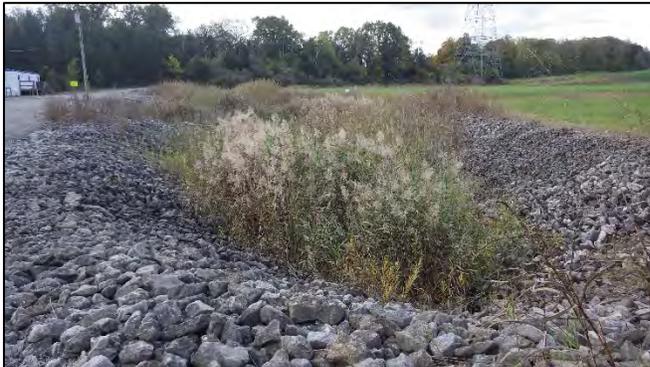
Photo 5

Looking south along channel connecting north and south storm water drainage channels. (Point 5, Appendix A)

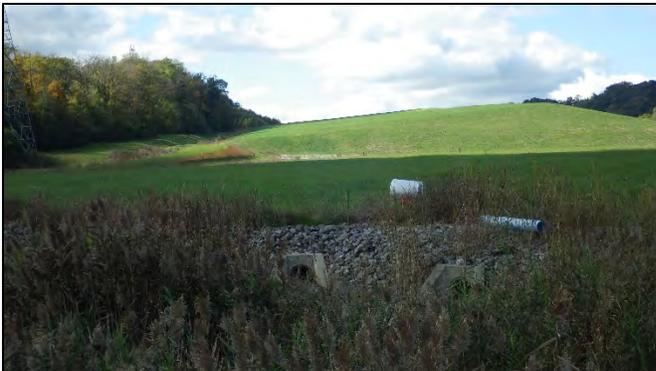
Photo 6

Leachate line headwalls at east end of closed Type III landfill. (Point 5, Appendix A)

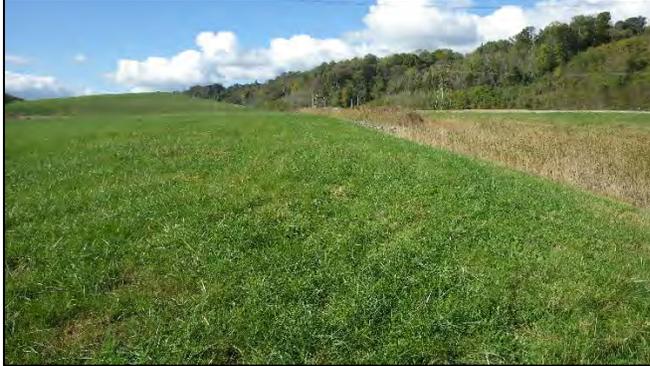
Photo 7

Vegetation cover of closed Type III landfill. (Point 15, Appendix B)

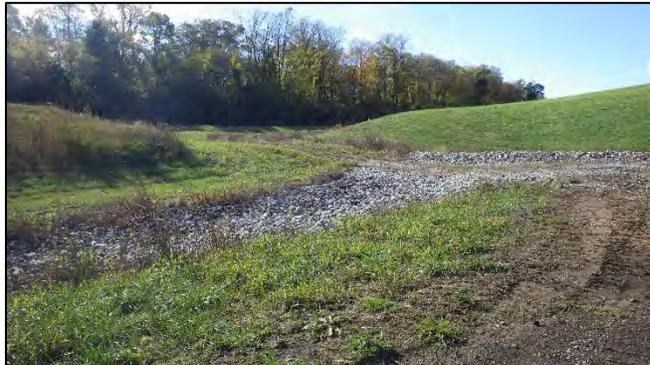
Photo 8

Temporary access road on south edge of closed Type III landfill crossing riprap ditch near toe of Phase 1 landfill. (Point 10, Appendix A)

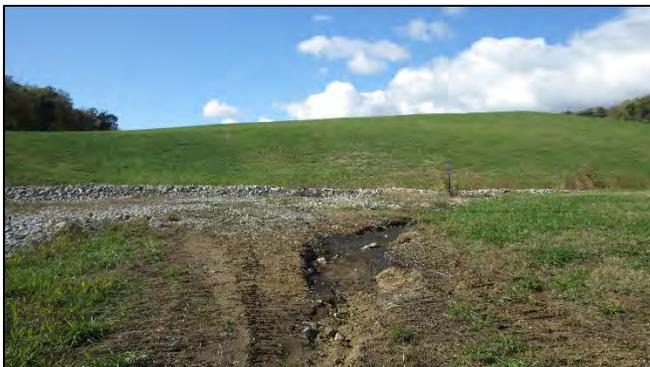
Photo 9

Temporary access road on south edge of closed Type III landfill crossing riprap ditch near toe of Phase 1 landfill. Continued from Photo 8. (Point 10, Appendix A)

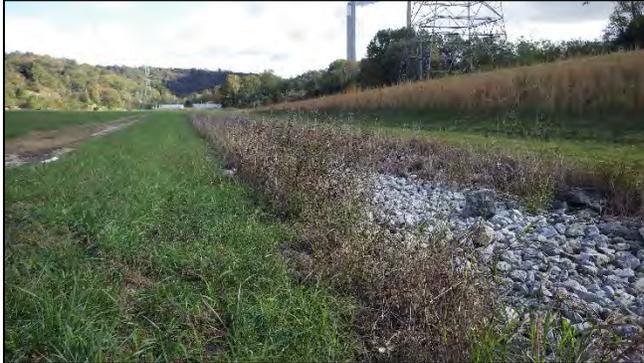
Photo 10

Riprap ditch along south edge of closed Type III landfill looking downstream or east. (Point 36, Appendix A)

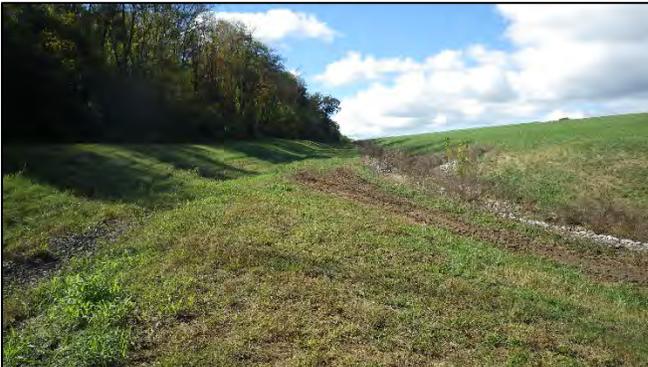
Photo 11

View along south side of Phase 1 landfill looking west.

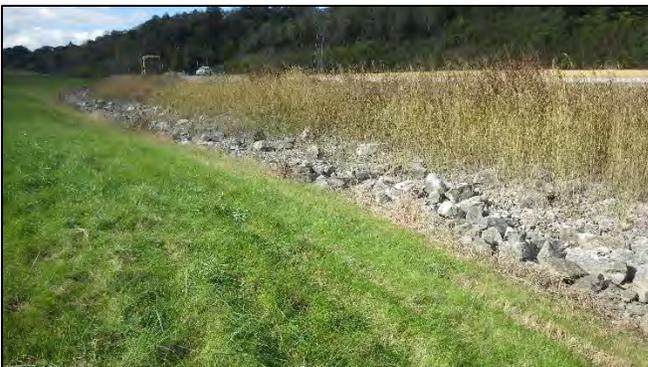
Photo 12

Riprap ditch along north edge of closed Type III landfill looking upstream or west.

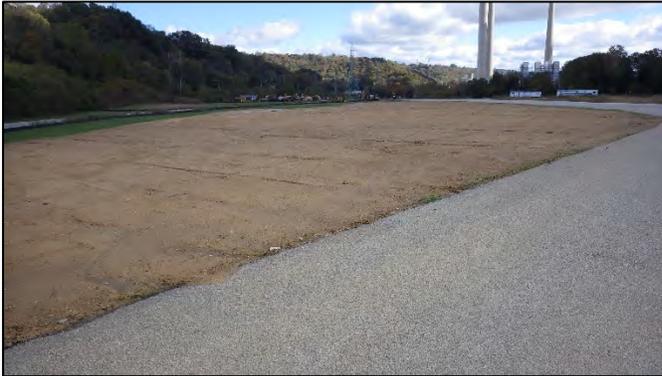
Photo 13

Surface of closed Type III landfill north of road.

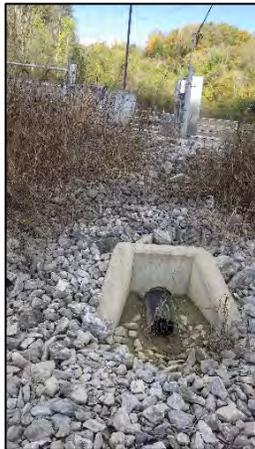
Photo 14

- The northern, southern, and eastern channels appear to be fairly clear of vegetation and maintained. Vegetation is dense at some isolated locations, as described in the GPS Points table in Appendix A.
- The closed Type III landfill cap appears uniform, mowed, and maintained.
- An inlet of a small pipe culvert beneath an access road on the south side of the closed Type III landfill is nearly buried in channel lining, as reported in previous years. (Point 6, Appendix A)
- An outlet pipe from the truck wash that was lower than the invert of the ditch has now been properly adjusted. (Point 20, Appendix A, Photo 14, Appendix B)

Truck wash outlet into ditch. (Point 20, Appendix A)

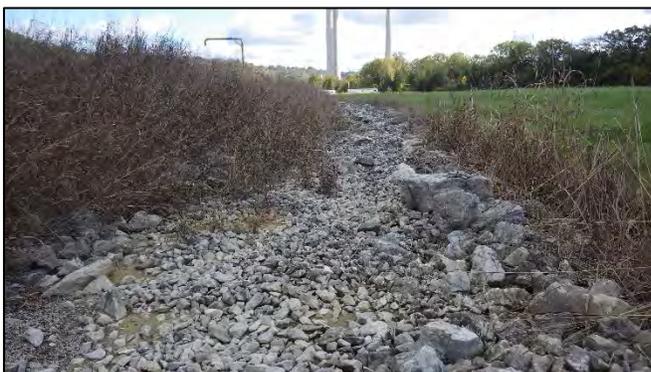
Photo 15

Riprap ditch along north edge of closed Type III landfill near truck wash outlet looking downstream or east. (Point 21, Appendix A)

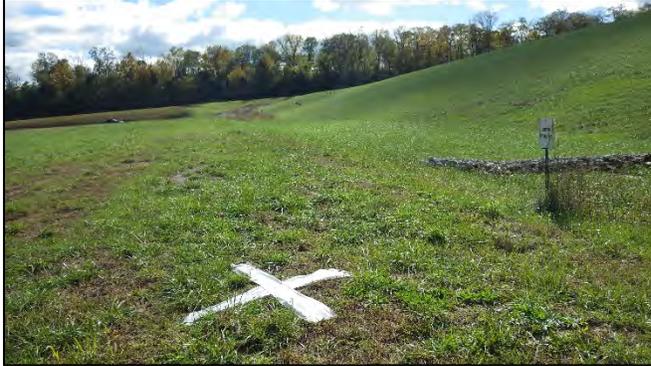
**Photo 16**

Vegetative cover and surveying panel point on north side of closed Type III landfill looking south along toe of Phase 1 landfill. (Point 22, Appendix A)

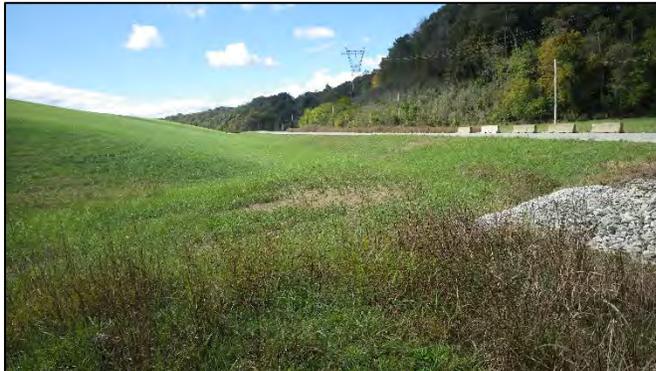
**Photo 17**

Vegetative cover on north side and in ditch of Phase 1 landfill looking west. (Point 22, Appendix A)

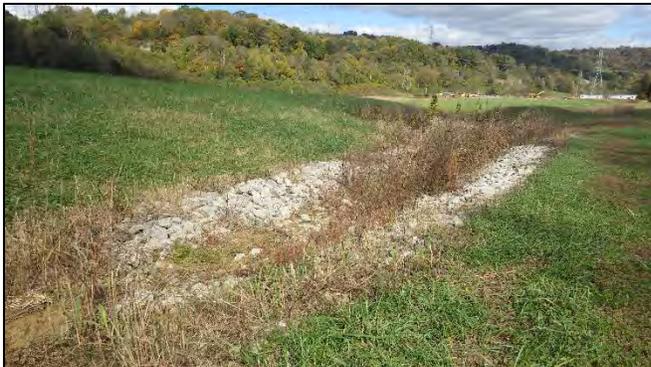
**Photo 18**

Temporary access road and riprap ditch on south side of Phase 1 landfill looking east. (Point 25, Appendix A)

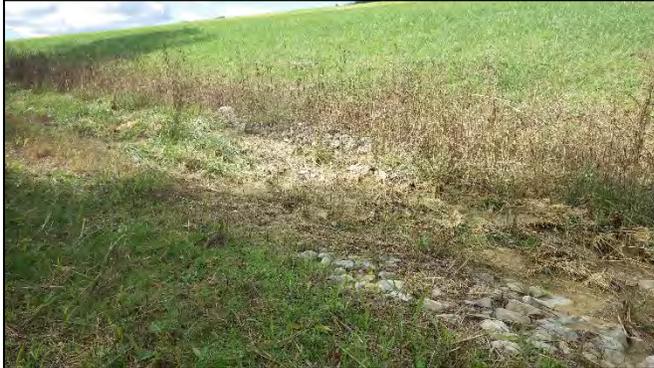
Photo 19

Temporary access road and riprap ditch on south side of Phase 1 landfill looking west. (Point 26, Appendix A)

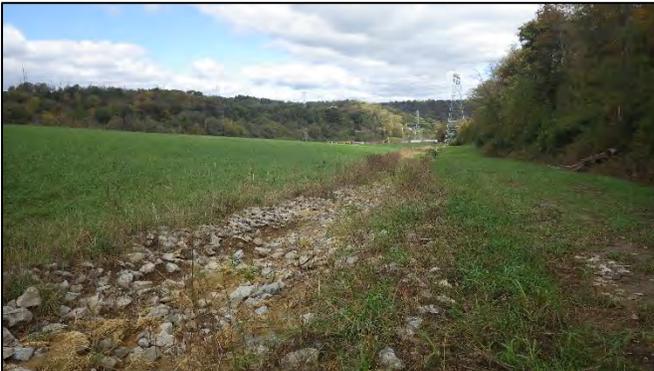
Photo 20

Temporary access road and riprap ditch on south side of Phase 2 landfill looking downstream or east. (Point 27, Appendix A)

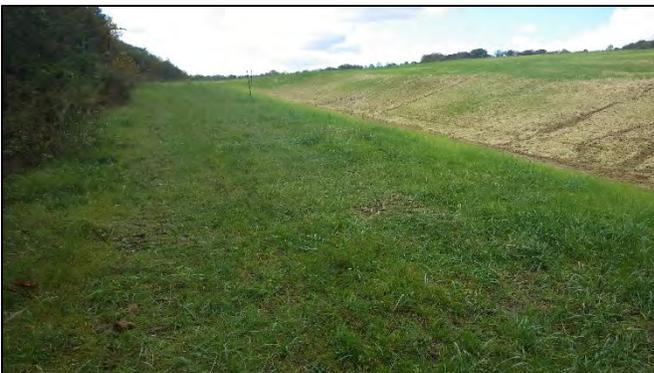
Photo 21

Temporary access road and riprap ditch on south side of Phase 2 landfill looking upstream or west. (Point 27, Appendix A)

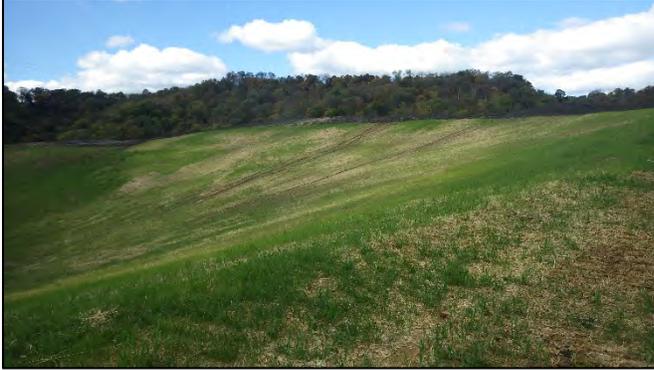
Photo 22

Vegetated cover of Phase 1 landfill western slope looking north showing recently seeded areas and rills.

- Continue to repair erosion features, reestablish vegetation, and monitor in future inspections.
- Continue to monitor the surface water channel headwalls and culverts east of the landfill. Repair as needed.

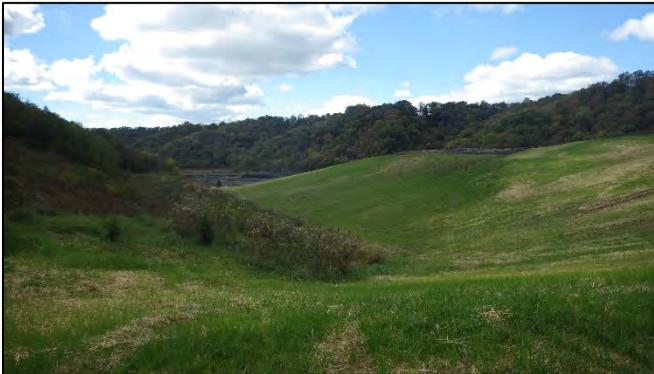
Photo 23

Vegetated cover of Phase 1 landfill slope looking west showing recently seeded areas and rills.
(Point 28, Appendix A)

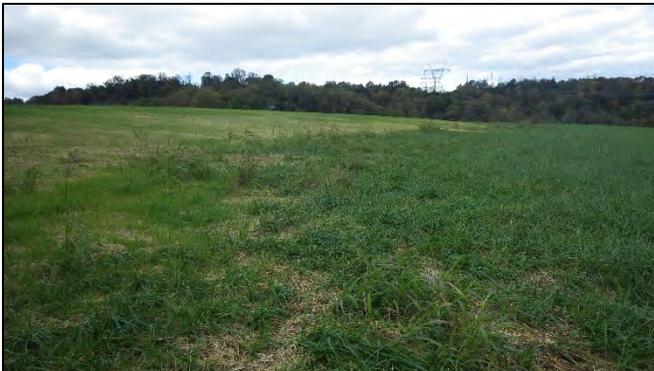
Photo 24

Typical view of vegetated cover of Phase 2 landfill top looking north.
(Point 30, Appendix A)

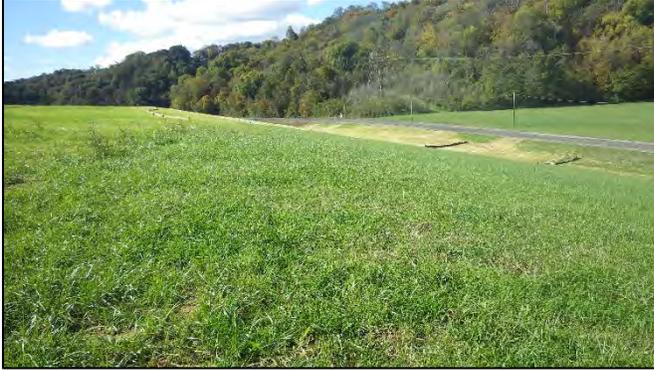
Photo 25

Vegetated cover of Phase 1 landfill top looking west. (Point 34, Appendix A)

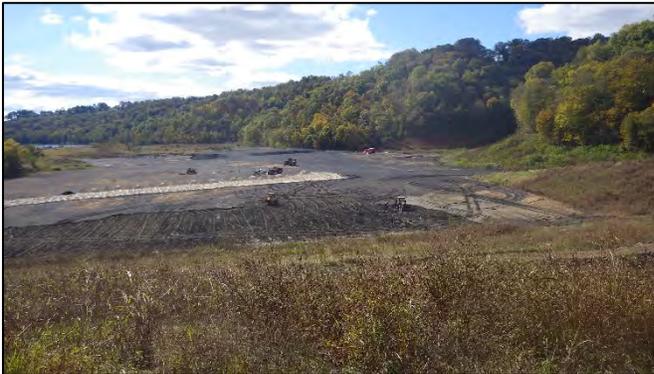
Photo 26

Underdrain layer and structural fill placement in Cell 2A looking west.

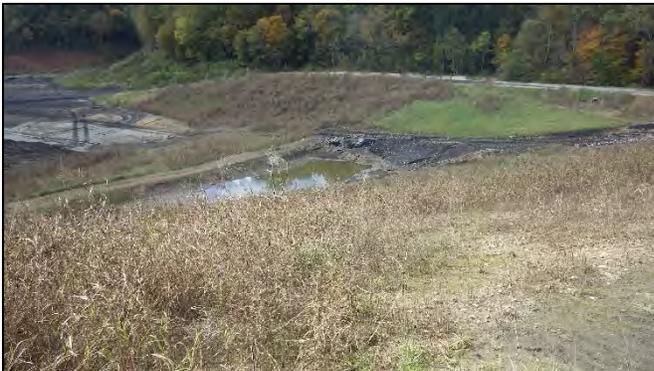
Photo 27

Temporary silt trap in Cell 1C looking northwest.

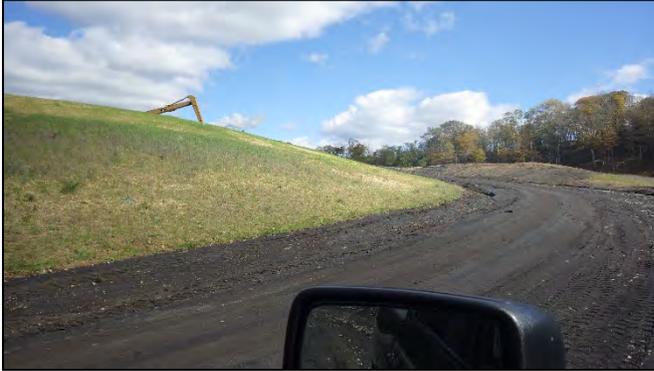
Photo 28

Western face of Phase 1 landfill at west toe looking east.

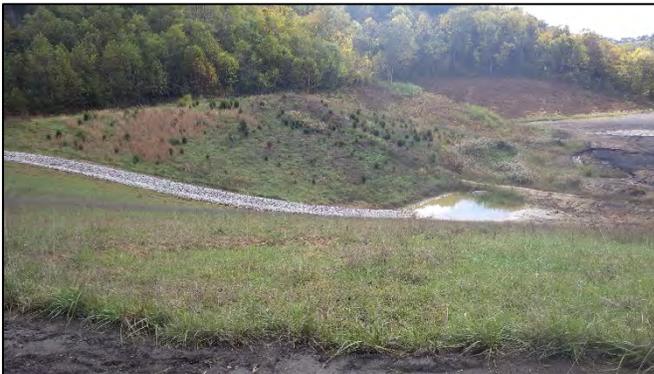
Photo 29

Temporary silt pond at end of Cell 1C.

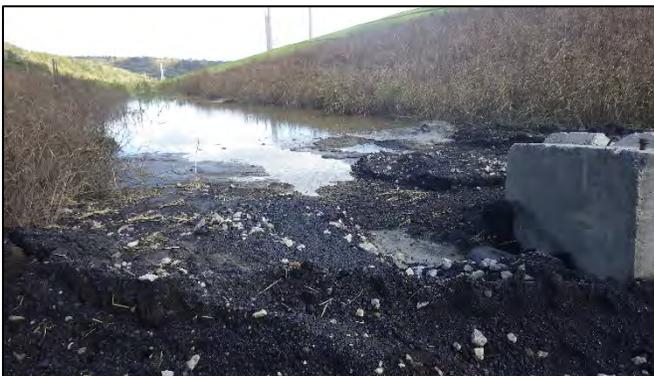
Photo 30

North side of Phase 1 landfill showing drainage at toe. (Point 38, Appendix A.)
