**Re: Indiana-Kentucky Electric Corporation  
Clifty Creek Station's 2023 Annual Landfill  
Inspection Posting Notification**

**2023 CCR Rule – Landfill  
Clifty Creek Landfill Inspection**

Clifty Creek Generating Station  
Madison, Indiana  
Jefferson County

January 19, 2024

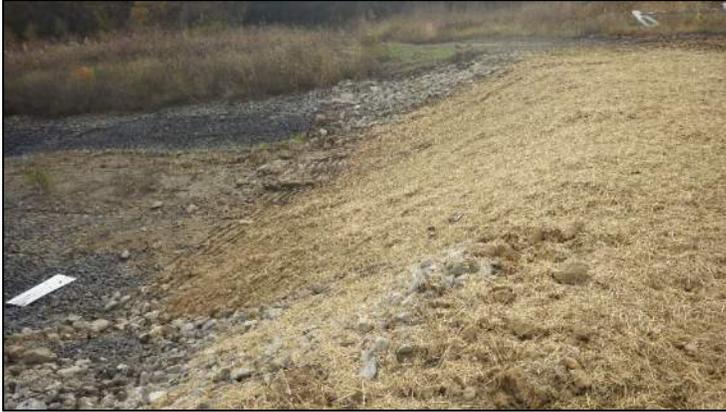
**Photo 1**

- The stormwater drainage channel from the landfill to the WBSP appears abandoned with its flows redirected to the northern stormwater ditch and the new northeast sediment basin and leachate collection pond. The culverts from the east end of the Type III landfill have been removed and backfilled. The slopes have been mulched and seeded. Some dense vegetation obscures the channel east towards the WBSP. No flow was observed in this channel. (Point 1, Appendix A; Photos 1 and 2, Appendix B)

Mulched and seeded area adjacent to the stormwater channel from the landfill to WBSP. Culverts were removed. The photo was taken from the end of channel, looking south. (Approx. 80 feet to the southeast of Point 1, Appendix A)

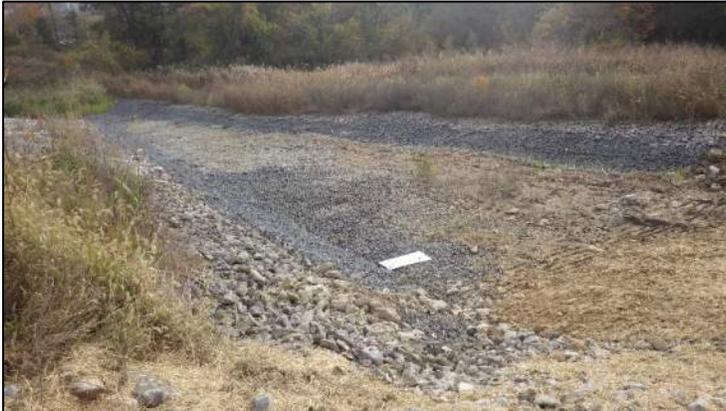
**Photo 2**

Stormwater drainage channel from the landfill to WBSP. Dense vegetation to the east (far left) within channel. The photo was taken on the channel edge looking east down the channel. (Approx. 80 feet to the southeast of Point 1, Appendix A)

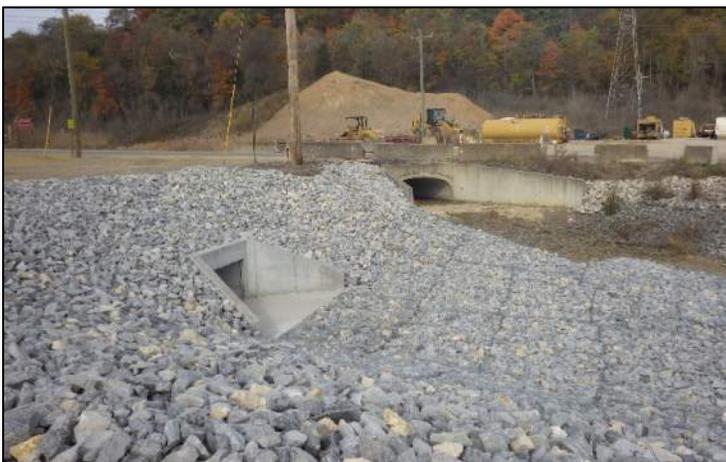
**Photo 3**

Looking north at stormwater drainage ditch confluence crossing haul road and the eastern access road from the landfill. New stormwater drainage ditch constructed for southern stormwater flows. (Point 1, Appendix A)

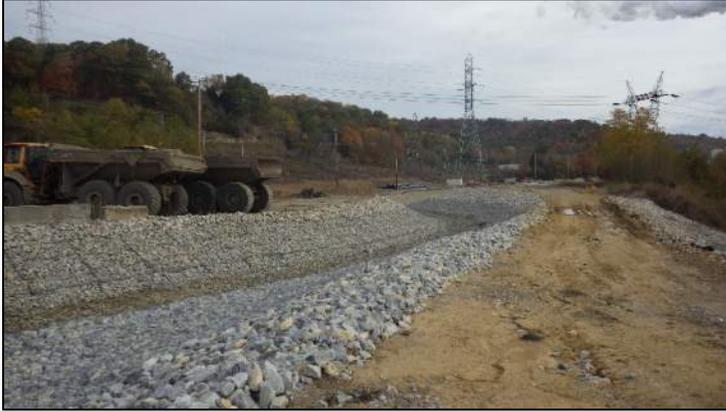
**Photo 4**

Looking east at new northern stormwater ditch, flowing north of the WBSP. New gabion fill rock has been placed in channel. (Point 1, Appendix A)

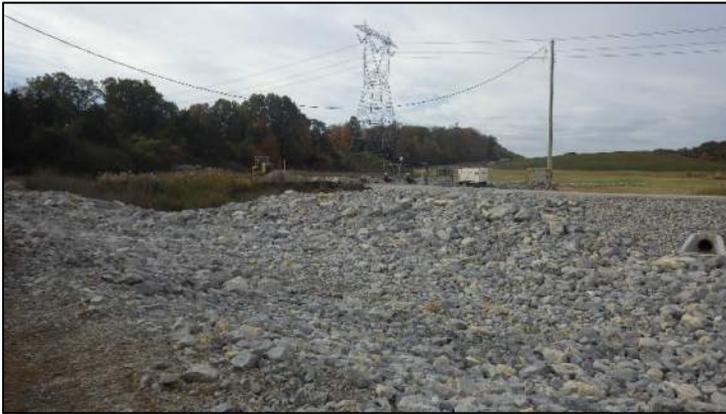
**Photo 5**

Looking southwest towards the landfill at the new stormwater basin. Riprap lines the new the basin. Type III landfill footprint in the background. (Approx. 65 feet to the west of Point 1, Appendix A)

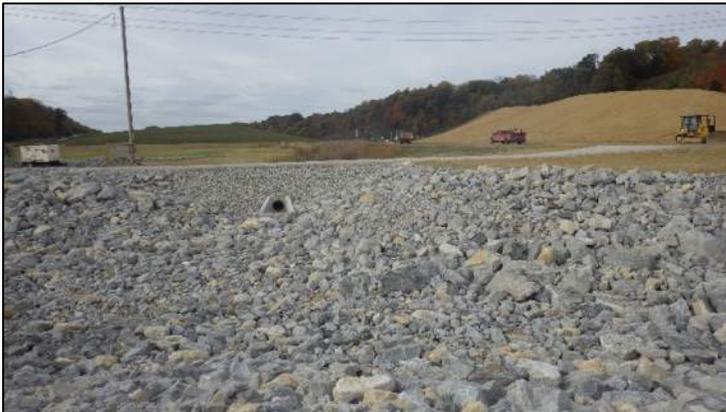
**Photo 6**

Looking west towards the landfill at the new stormwater basin. Riprap lines the new the basin. Type III landfill footprint in the background. (Approx. 65 feet to the west of Point 1, Appendix A)

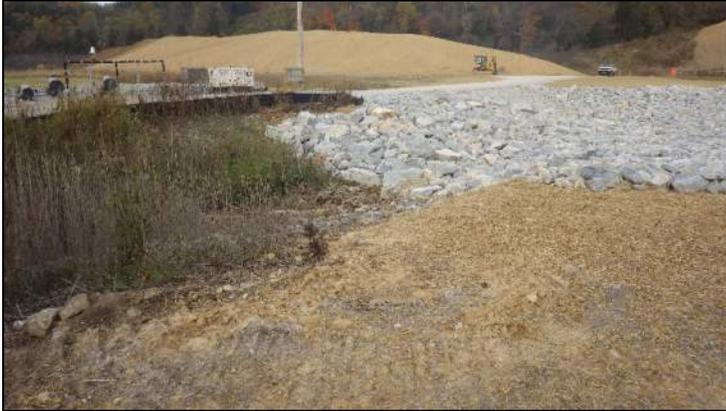
**Photo 7**

New stormwater basin where the new riprap meets the existing southern final cover stormwater channel (Devils Backbone side). (Point 2, Appendix A)

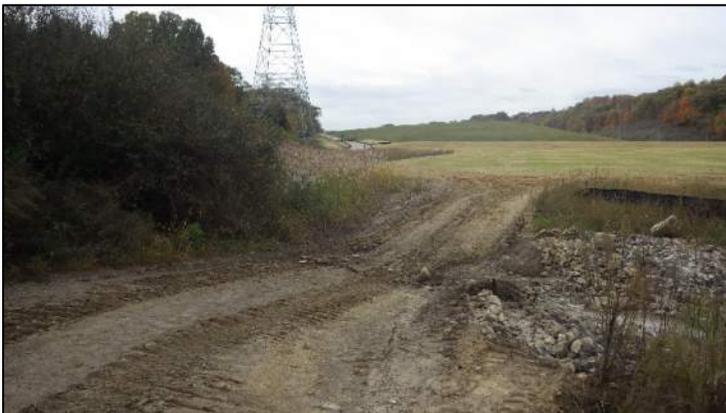
**Photo 8**

- Heavy vegetation was noted within the southern final cover stormwater channel. (Point 2, Appendix A; Photos 7 and 8, Appendix B)
- A dip in the access road allowed access to the Type III landfill. Erosion and accumulated sediment were observed. (Point 3, Appendix A; Photos 8-9, Appendix B)

A crossing for the final cover stormwater channel for access to the eastern side of Type III landfill. Accumulated sediment and limited stormwater management. (Point 3, Appendix A)

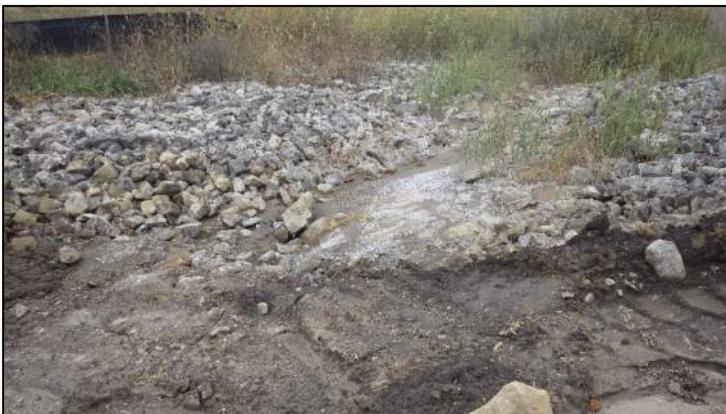
**Photo 9**

Erosion and accumulated sediment at the crossing to the Type III landfill. (Point 3, Appendix A)

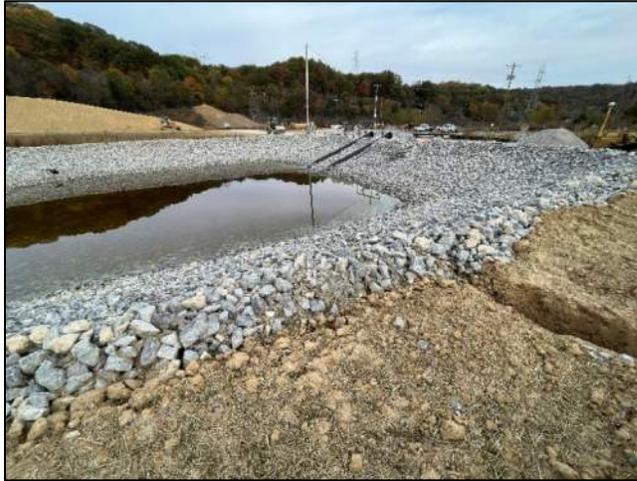
**Photo 10**

- The northeast sediment basin and northeast leachate pond have been constructed within the Type III landfill area east of the active landfill. Riprap lines both basins. Erosion or an excavation trench was observed on the south side of the northeast leachate pond. (Points 4 (leachate pond), 10 and 11 (sediment basin), Appendix A; Photos 10, 11 (leachate pond), and 15, 16 (sediment basin), Appendix B)

Looking northeast at northeast leachate pond. Erosion/excavation observed south of the pond rim. (Point 4, Appendix A)

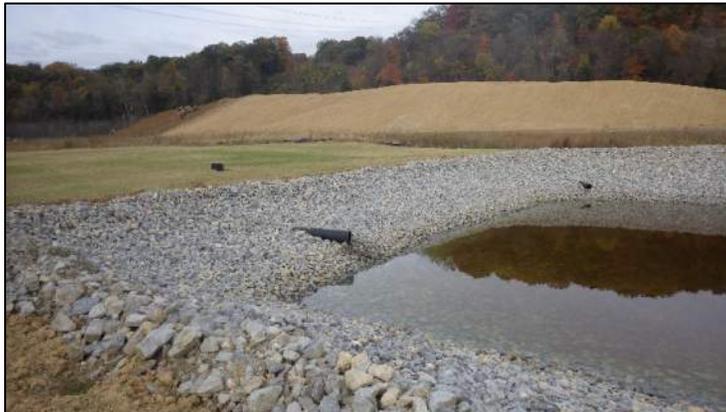
**Photo 11**

Looking northwest at northeast leachate pond. Topsoil stockpile in background. (Point 4, Appendix A)

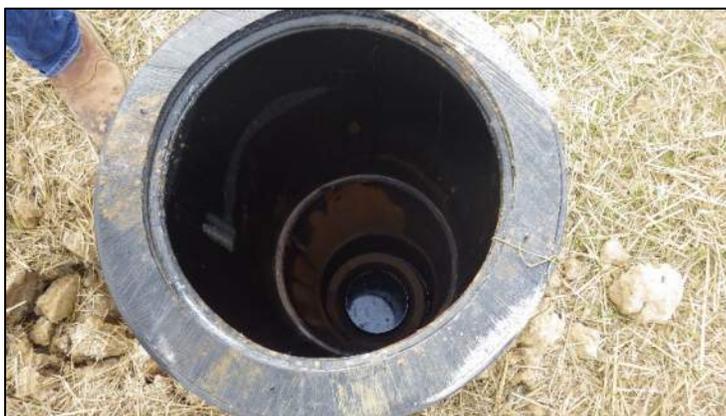
**Photo 12**

- A plastic standpipe was located west of the northeast leachate pond. Water was observed within the standpipe. (Point 5, Appendix A; Photo 12, Appendix B)

Plastic standpipe located west of the northeast leachate pond. (Point 5, Appendix A)

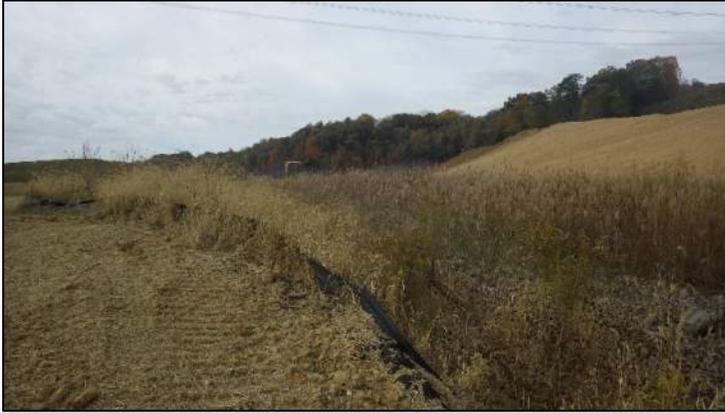
**Photo 13**

- Heavy vegetation, exposed soil channel edges, and failed silt fence were observed in the northern final cover stormwater channel. (Point 6 and 7, Appendix A; Photos 13-14, Appendix B)

Final cover stormwater channel north of the northeast leachate pond. Heavy vegetation in channel and failed silt fence (looking west). (Point 6, Appendix A)

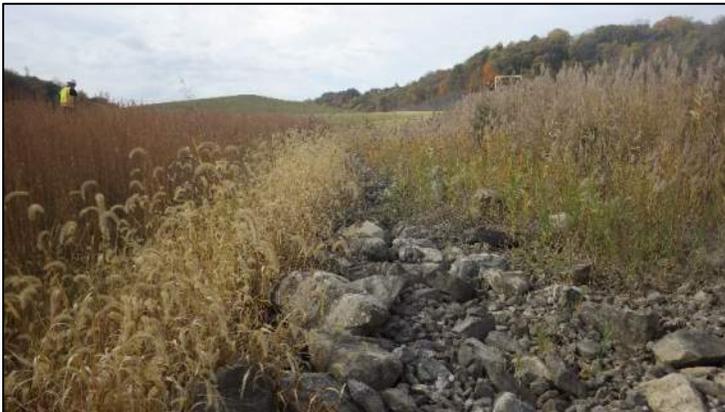
**Photo 14**

Looking west at final cover stormwater ditch located northwest of northeast leachate pond. Heavy vegetation in ditch. (Near Point 7, Appendix A)

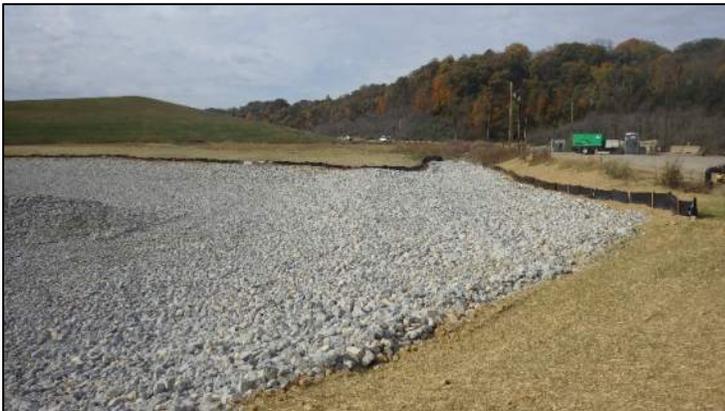
**Photo 15**

Newly constructed northeast sediment basin looking west at northeast side of the Type I landfill. (Point 7, Appendix A)

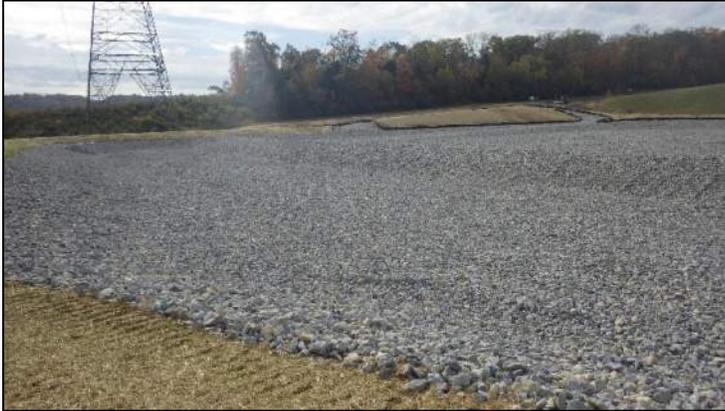
**Photo 16**  
Newly constructed northeast sediment basin looking south at southeast side of the Type I landfill. (Point 7, Appendix A)

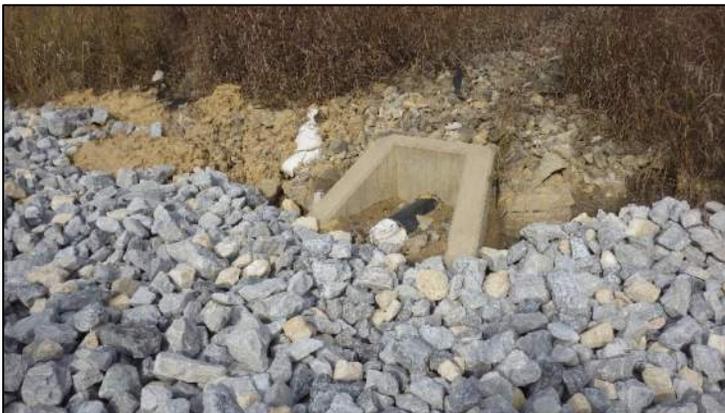
**Photo 17**  
Drainage pipe south of truck wash. Sediment buildup, erosion around the headwall, and low pipe invert. (Point 8, Appendix A)

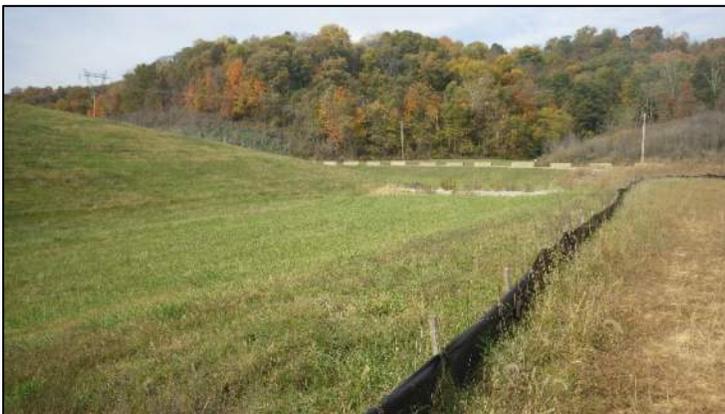
**Photo 18**  
Silt fence located east of the Type I landfill footprint and west of the northeast sediment basin. (Close to Point 7, Appendix A)

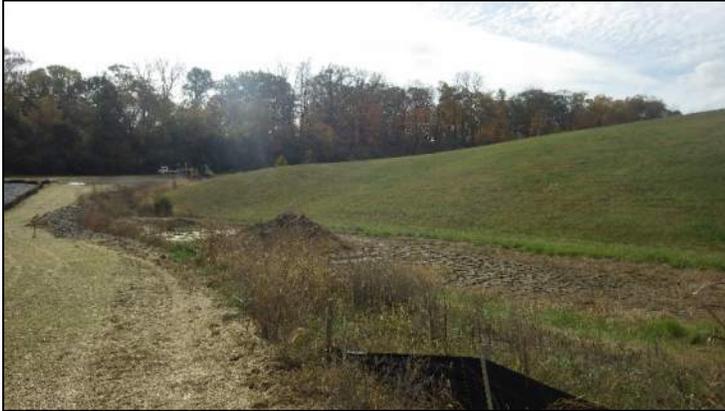
- A wet, soft area was noted at the toe of slope of the Type I landfill at the southeast corner. A soil stockpile was also located within the wet area. (Point 9, Appendix A; Photo 19, Appendix B)

**Photo 19**  
Wet, soft area and temporary soil stockpile located at the toe of slope of the Type I landfill at the southeast corner. (Point 9, Appendix A)

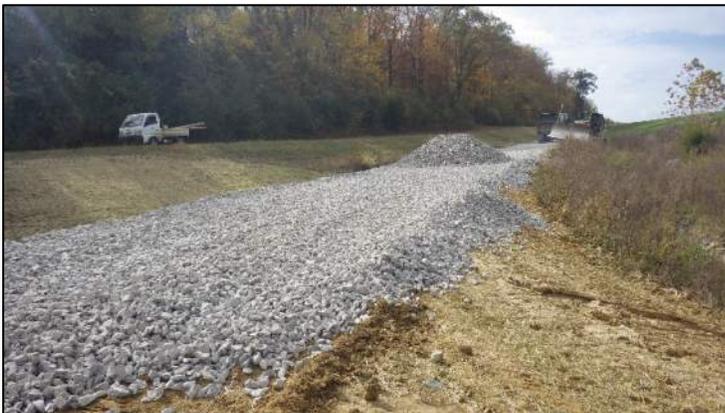
**Photo 20**  
Devil's Backbone access road improvements. Photo taken near southeast corner of Type I landfill, looking southwest.

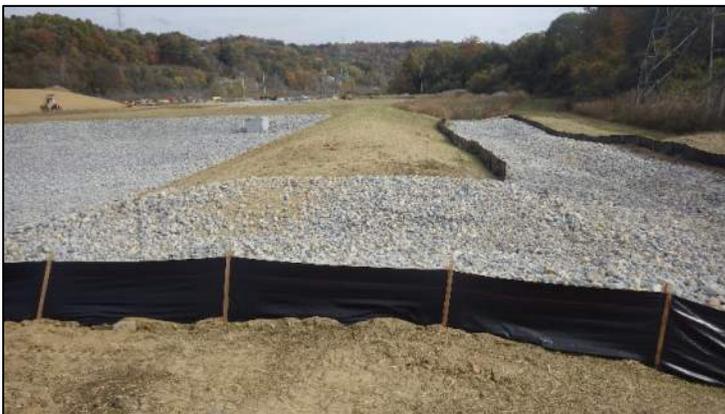
**Photo 21**  
Northeast sediment basin emergency spillway toward southern final cover stormwater channel. (Point 10, Appendix A)

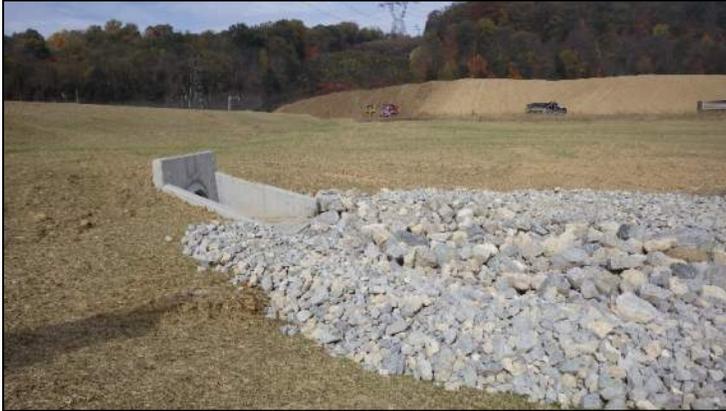
**Photo 22**

Looking northwest, downstream outlet headwall from the northeast sediment basin. (Point 11, Appendix A)

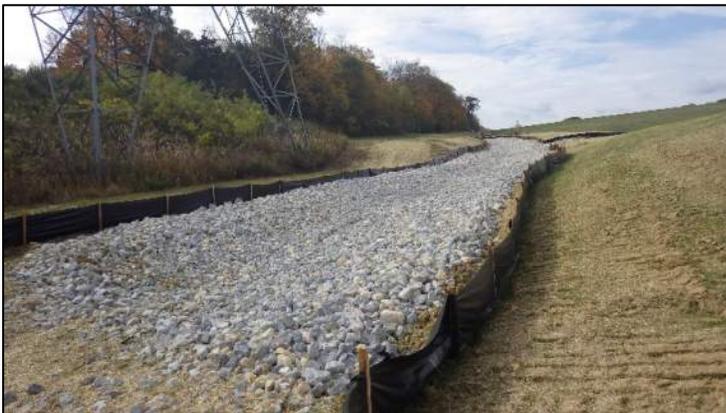
**Photo 23**

Southern final cover stormwater channel boundary between new riprap and vegetation. Northeast sediment basin emergency spillway in the background. (Point 12, Appendix A)

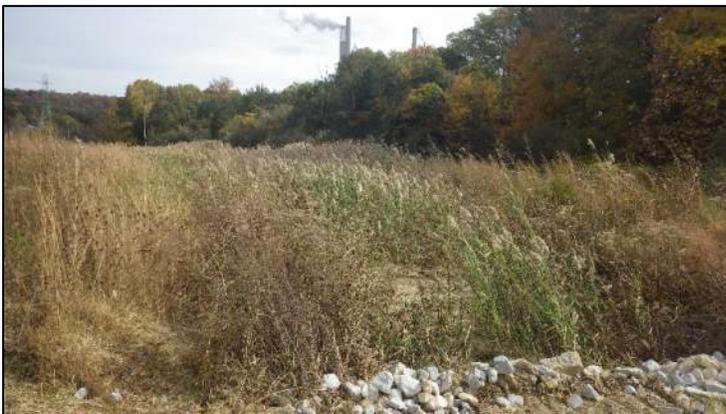
**Photo 24**

Heavy vegetation in southern final cover stormwater channel. (Point 13, Appendix A)

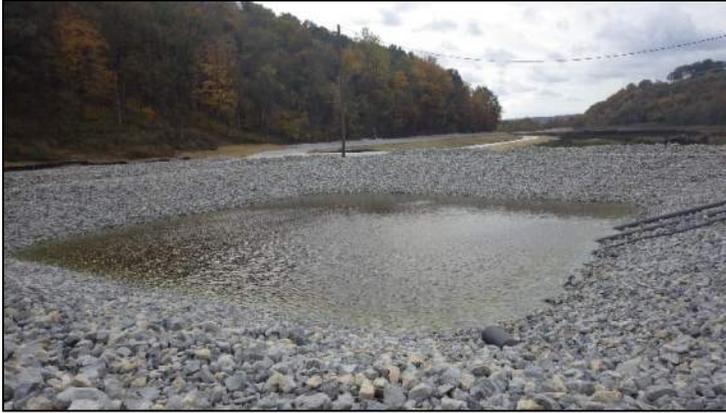
**Photo 25**

Looking south at the southwest leachate pond located in Phase 3 landfill footprint. (Point 14, Appendix A)

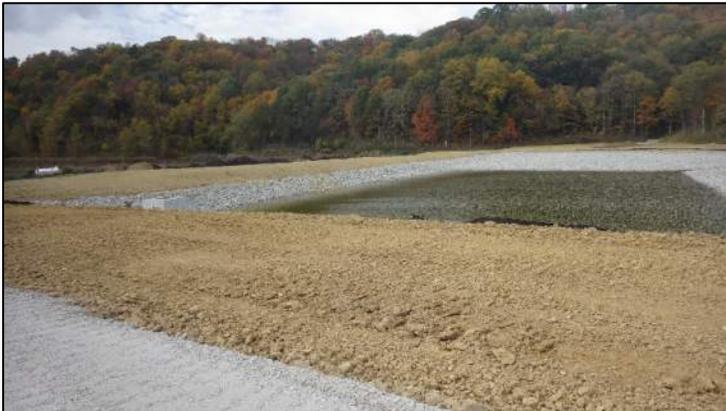
**Photo 26**

Looking west at southwest sediment basin. (Point 16, Appendix A)

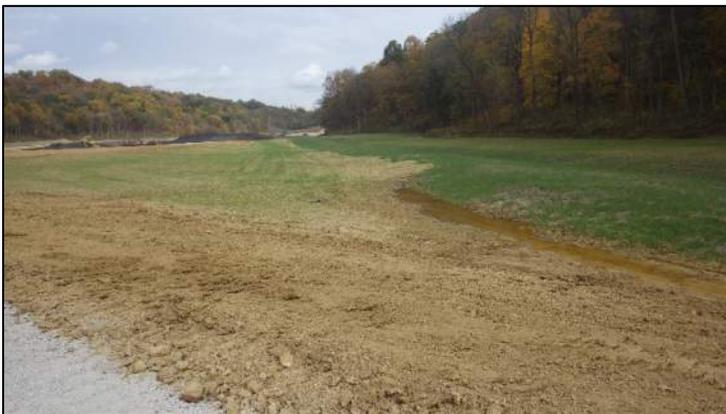
**Photo 27**

- A small amount of standing water was observed within the temporary cover area northeast of the southwest leachate pond. (Point 15, Attachment A; Photo 27, Attachment B)

Looking northeast at temporary cover adjacent to the stormwater drainage channel east of the southwest leachate pond. Standing water was observed. (Point 15, Appendix A)

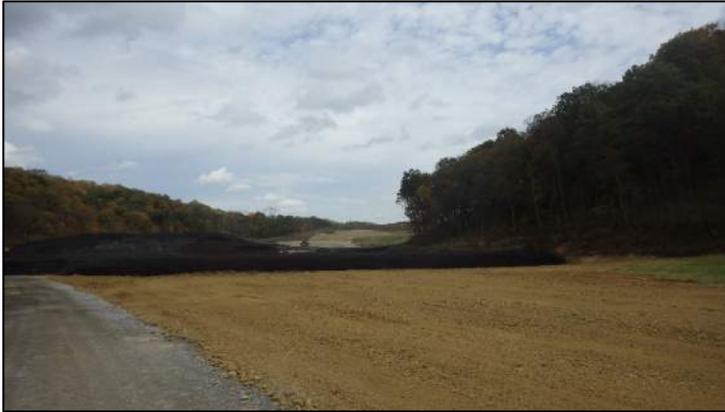
**Photo 28**

Construction stockpiles in Phase 2, looking north. Phase 2A structural fill placement in background. Temporary cover mulched and seeded in Phase 3.

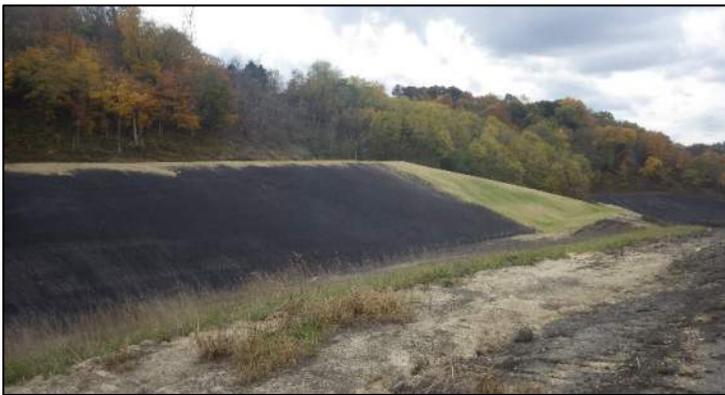
**Photo 29**

Subphase 1D with boiler slag temporary cover (prior to waste placement), looking south.

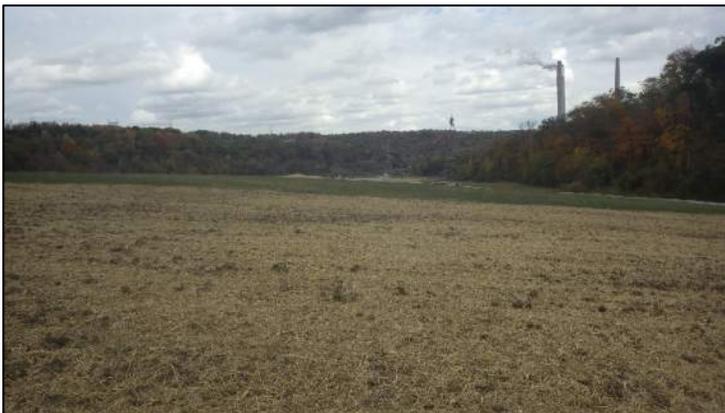
**Photo 30**

- Subphases 1C and 1B are near final CCR grades and have temporary cover placed. Boundaries of temporary cover were noted during the inspection (Points 18, 19, 21, 28, 29, and 30, Appendix A; Photos 30 and 35, Appendix B).

Crest of Subphases 1B and 1C. Temporary cover straw and seed at locations near grade. (Typical of Points 18,19, 21, 28, 29, and 30, Appendix A)

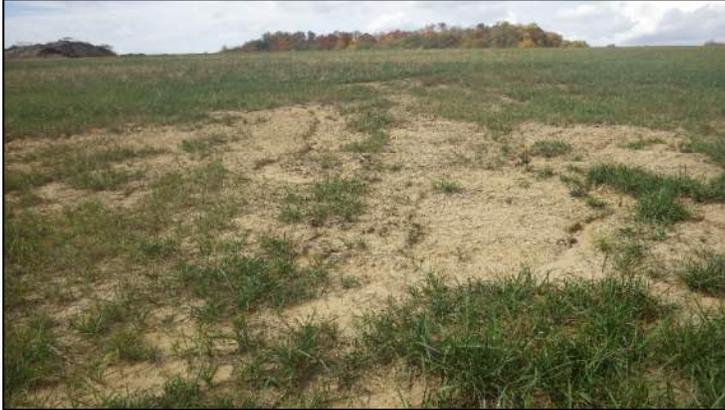
**Photo 31**  
Bare spot with erosion on top of Type I landfill. (Point 24, Appendix A)

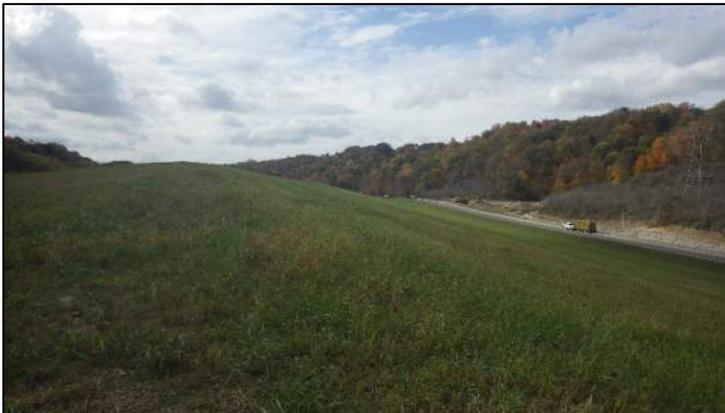
**Photo 32**  
Northern vegetated slope of Subphases 1A, 1B, and 1C, looking west. Paved haul road on right. (Point 23, Appendix A)

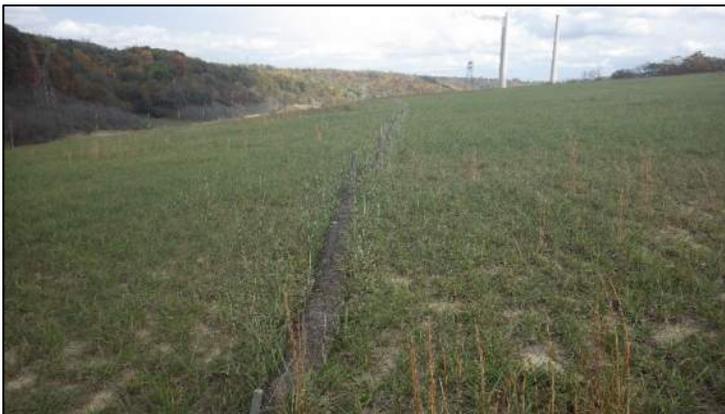
**Photo 33**  
Northern vegetated slope of Subphases 1A, 1B, and 1C, looking east. Sediment control sock in center. (Point 25, Appendix A)

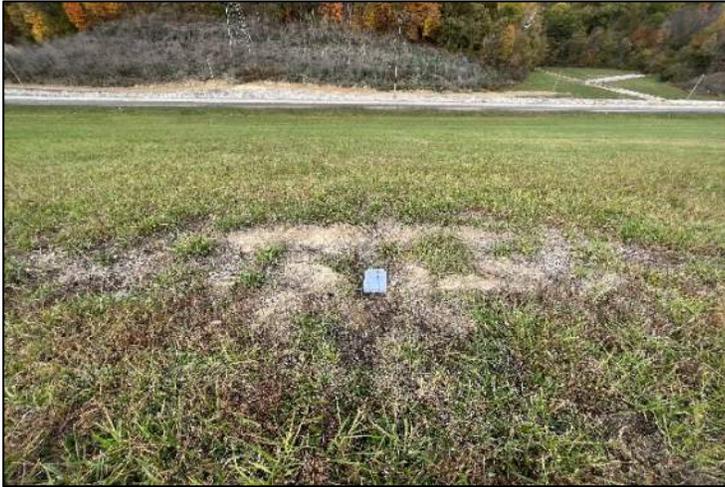
**Photo 34**

Typical minor ruts and erosion rills on northern slope of Type I landfill. (Points 27 and 31, Appendix A)

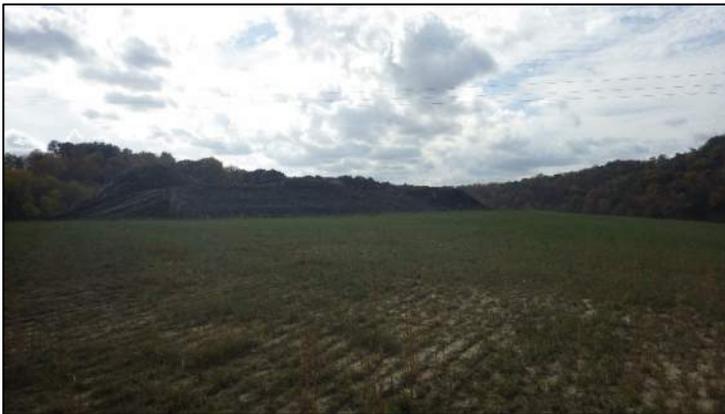
**Photo 35**

- CCRs were stockpiled within Subphase 1C. (Point 20, Appendix A; Photo 35, Appendix B)
- Woody vegetation was noted near the southeast corner of the landfill. (Point 22, Appendix A)

CCRs in active Phase 1 footprint. (Point 20, Appendix A)

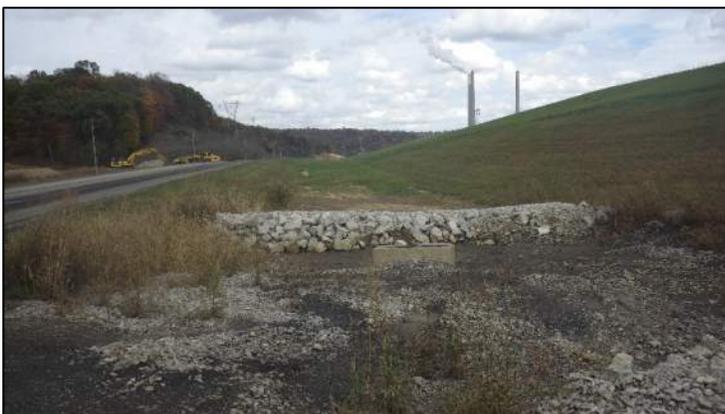
**Photo 36**

Looking northeast at check dam located on northwest side of Type I landfill. (Point 32, Appendix A)

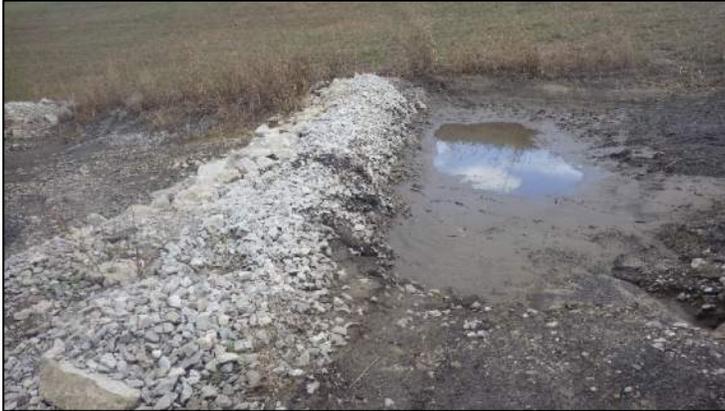
**Photo 37**

Looking southeast at check dam located on northwest side of Type I landfill. (Point 32, Appendix A)

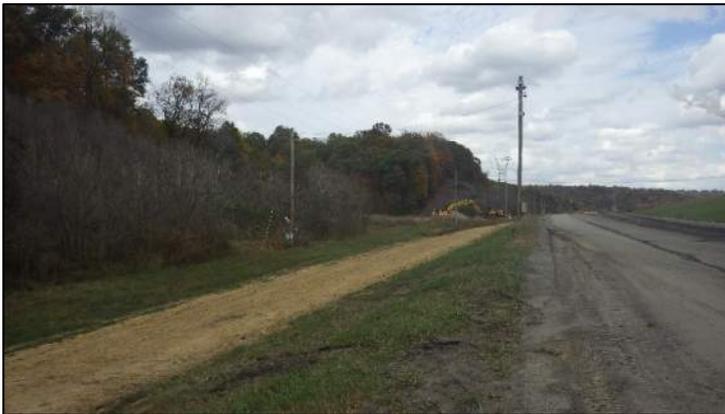
**Photo 38**

Newly constructed stormwater channel located on the north side of paved haul road. The ditch is not well defined in this area. (Point 36, Appendix A)

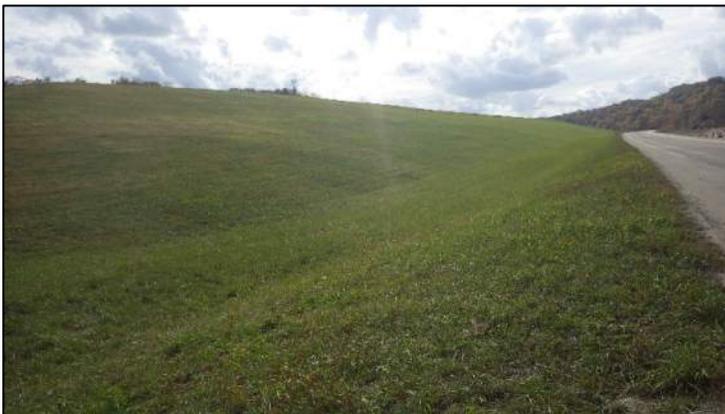
**Photo 39**

Northern vegetated slope of Type I landfill, looking southwest. (Point 34, Appendix A)
