2015 DAM AND DIKE INSPECTION REPORT

GERS-15-018

**CLIFTY CREEK PLANT
MADISON, INDIANA**

WEST BOTTOM ASH POND
FLY ASH POND
GERS-15-018
REVISION 0

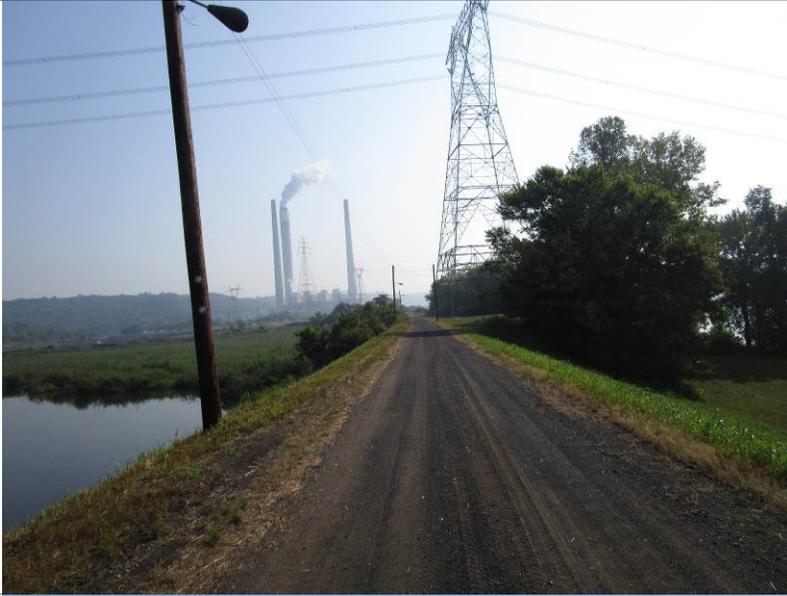
Photo No. 1

1. Photograph No. 1 illustrates a typical overview of the dike crest. The crest appears to be in good and stable condition. Signs of settlement, misalignment and cracking were not observed.

West Bottom Ash Pond Dike
From Crest Looking Northeast

Overview of Crest

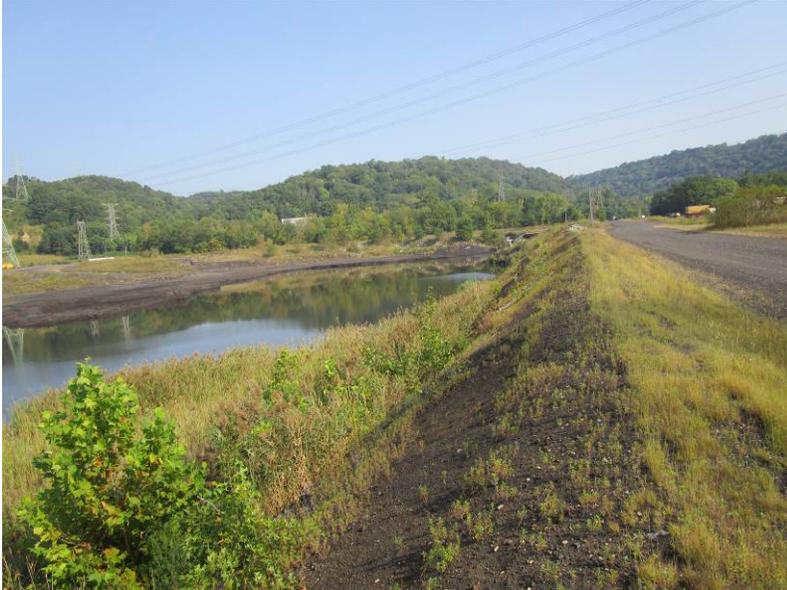
Photo No. 2

2. Photograph No. 2 and Photograph No. 3 illustrate the condition of the interior slopes at the settling end of the pond and the present extent of boiler slag buildup. The interior slope of the east dike at this end of the pond appeared to be in fair and stable condition. Photograph No. 3 shows an area of significant erosion on the interior slope.

West Bottom Ash Pond Dike –
Interior Slope at North End
Looking Toward Discharge Lines

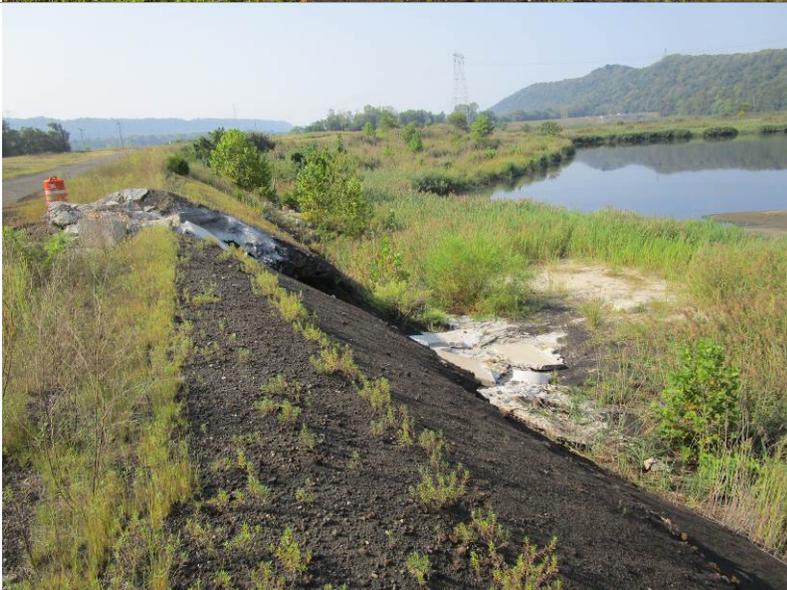
Photo No. 3

West Bottom Ash Pond Dike –
Interior Slope at North End
Looking South

Significant Erosion Caused By
Stormwater Runoff From
Roadway backfilled with concrete
debris

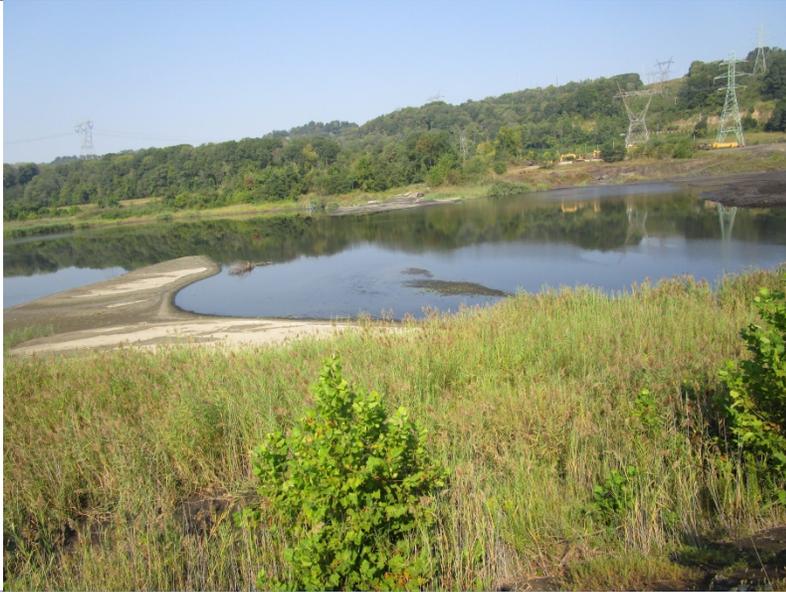
Photo No. 4

West Bottom Ash Pond – Near
North End of Interior Slope

General Overview

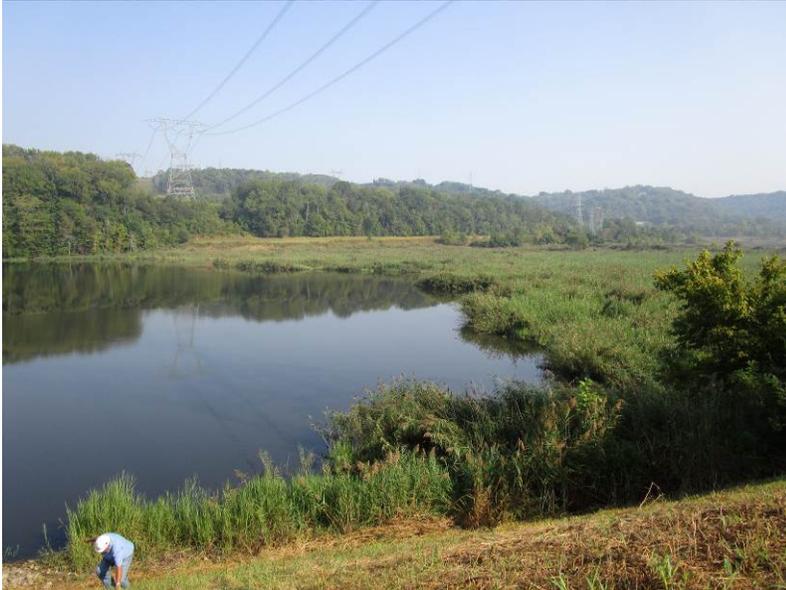
Photo No. 5

3. Photograph No. 5 provides an overview of the extent of the filtering vegetation within the clear water end of the pond. It was noted that the propagation of that filtering vegetation has not progressed to any significant extent since the last inspection.

West Bottom Ash Pond Interior
Adjacent To Transmission Tower
Looking North Across Pond

General Overview of Vegetation
Propagation

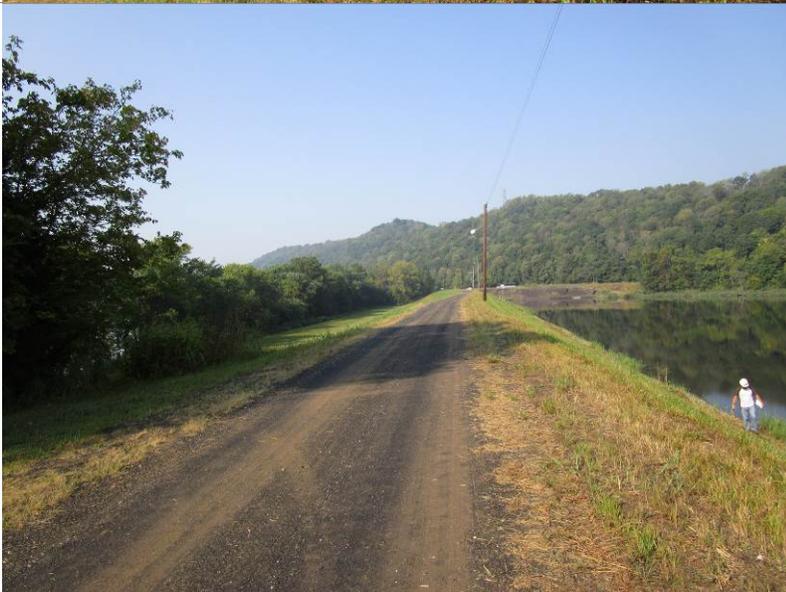
Photo No. 6

4. Photograph 6 through Photograph 9 show the general condition of the crest and the interior slope of the west end of the south dike.
5. Photograph No. 10 shows the overflow structure and the interior slopes of the dike.

West Bottom Ash Pond Dike –
Interior Slope From Near
Transmission Tower Looking
Southwest From Crest

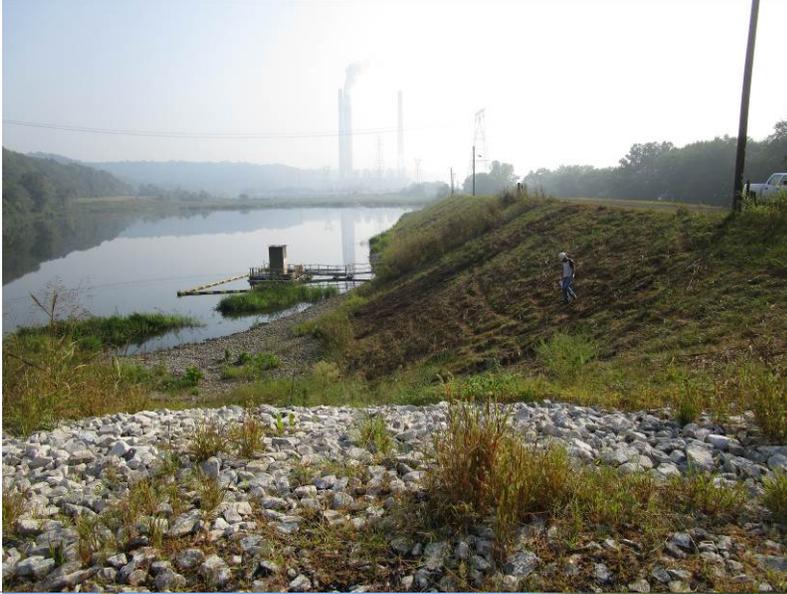
Photo No. 7

West Bottom Ash Pond Dike –
Interior Slope Looking Northeast
From Crest.

Overview of General Condition

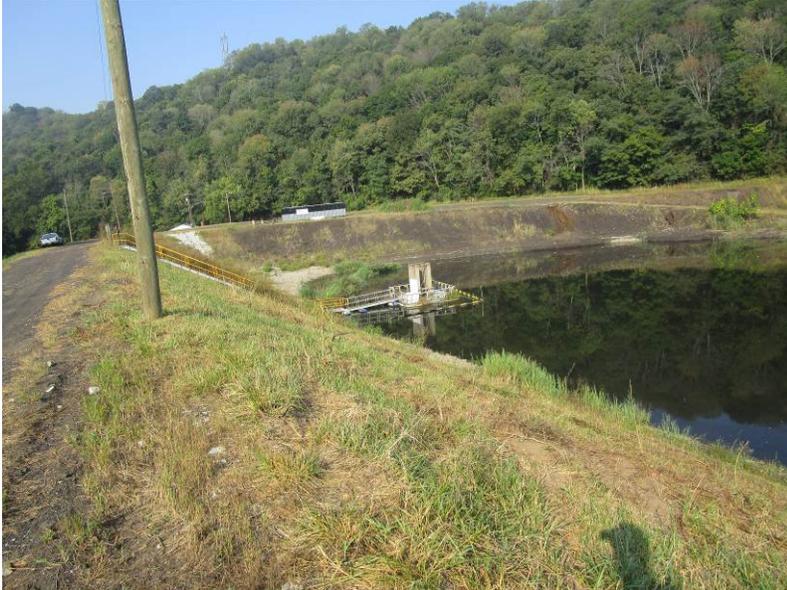
Photo No. 8

West Bottom Ash Pond Dike –
Interior Slope Looking West From
toe of slope

Overview of General Condition

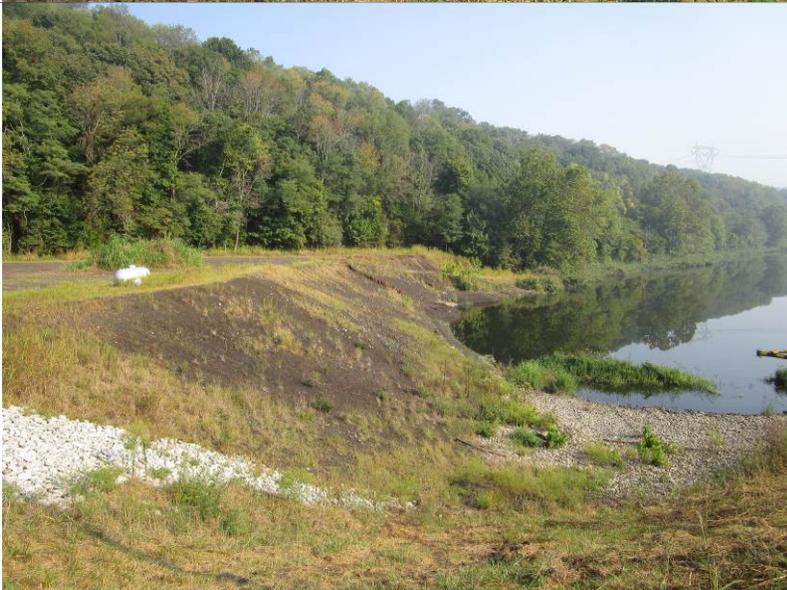
Photo No. 9

West Bottom Ash Pond Dike –
Interior Slope Looking Northeast
From Crest

Overview of General Condition

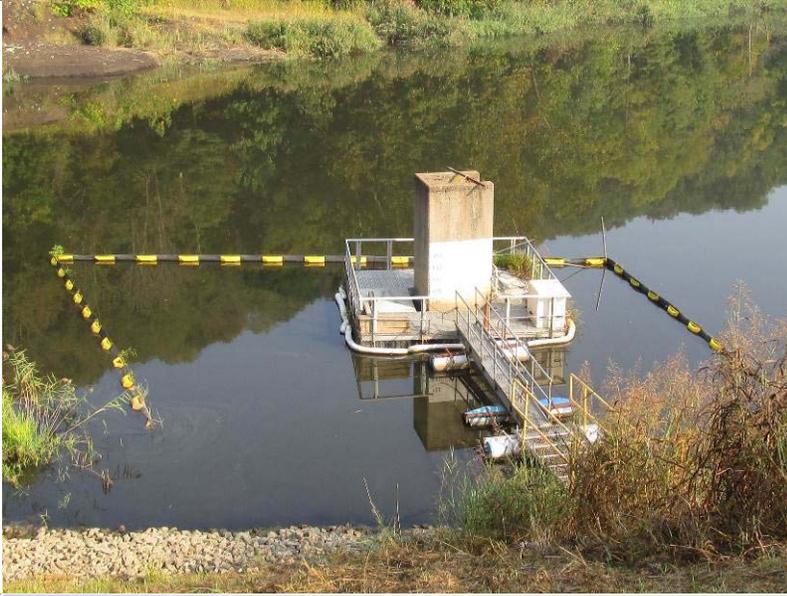
Photo No. 10

West Bottom Ash Pond Dike –
Interior Slope Looking Northwest
From Crest

Overview of General Condition

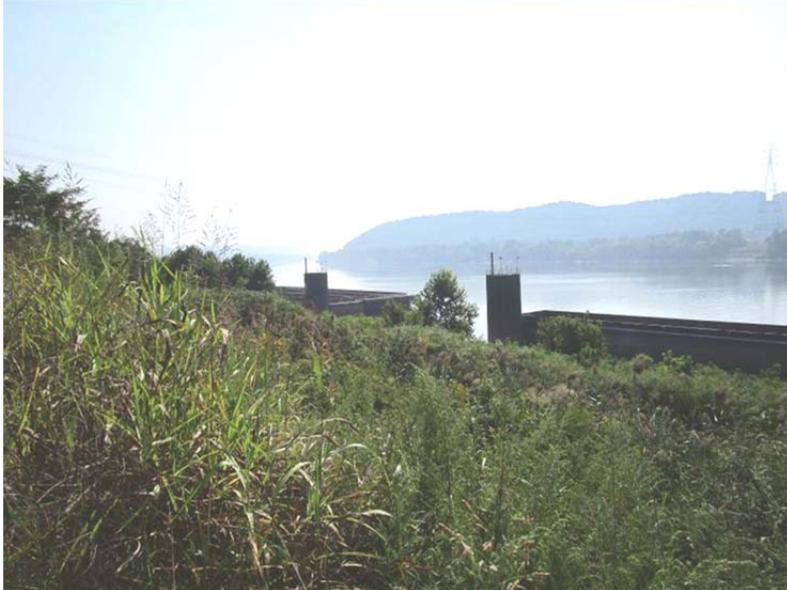
Photo No. 11

6. Photograph No. 11 and Photograph No. 12 show the excessive vegetation along the exterior slope at the northeast end of the dike.
7. Photograph No. 13, Photograph No. 14 and Photograph No. 15 show the general condition of the crest and the exterior slope of the west end of the south dike. No wet areas were noted during this inspection. The slope appeared in good and stable condition.

West Bottom Ash Pond Dike –
Exterior Slope From Crest
Looking East

Overview of Excessive Vegetation

1. Continue annual clearing and mowing of all dikes with vegetation control to prevent the growth of excessive woody plants and brush.
2. Continue removal of vegetation from within all stairways, including sufficient areas on either side of the stairs. Continue to remove all vegetation growing through and around all floating structures.
3. Continue following the requirements outlined in the AEPSC Dam and Dike Inspection and Maintenance Program Circular Letter and submit Quarterly Inspection Reports along with Instrumentation data to Mohammad Ajlouni within one month of the end of the quarter.

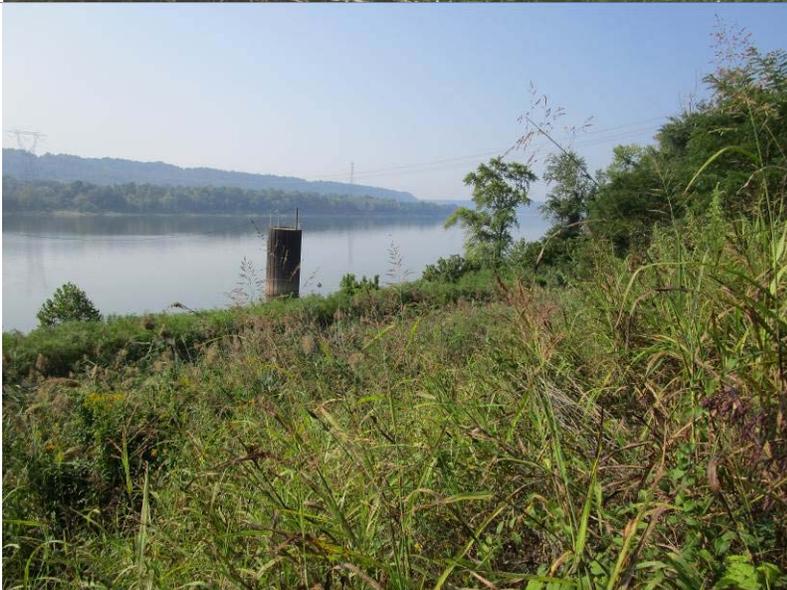
Photo No. 12

West Bottom Ash Pond Dike –
Exterior Slope From Crest
Looking Southwest

Overview of Excessive Vegetation

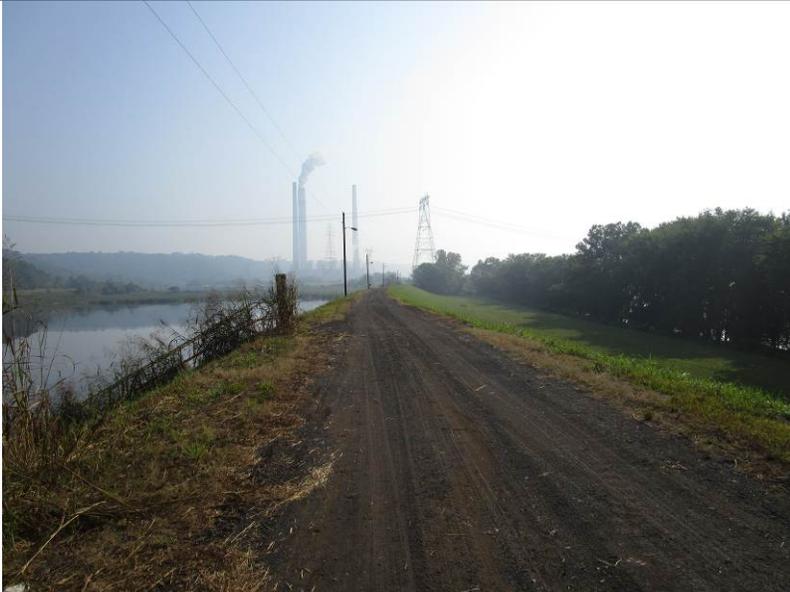
Photo No. 13
West Bottom Ash Pond Dike –
Crest From Top Looking
Northeast

General Condition

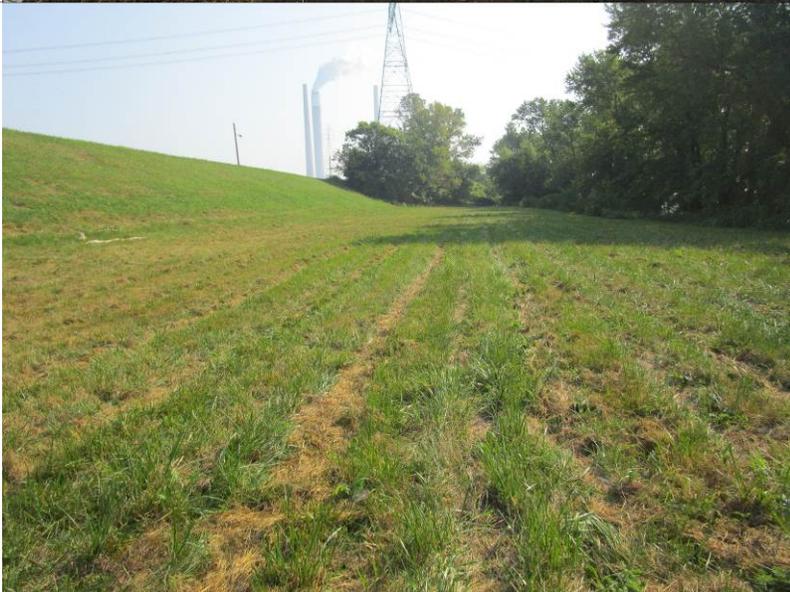
Photo No. 14
West Bottom Ash Pond Dike –
Exterior Slope From Toe Looking
East

Overview of Vegetation and
General Condition

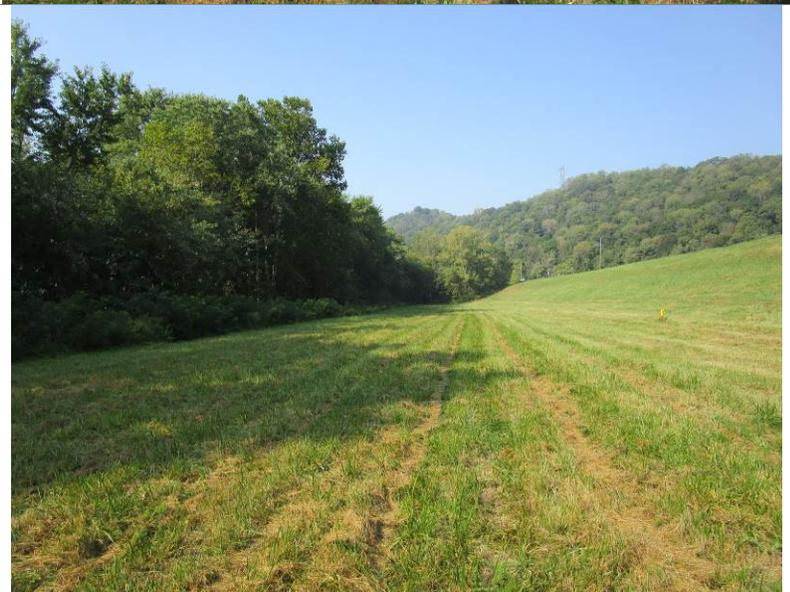
Photo No. 15
West Bottom Ash Pond Dike
Exterior Slope From Toe Looking
Southwest

Overview of Vegetation and
General Condition

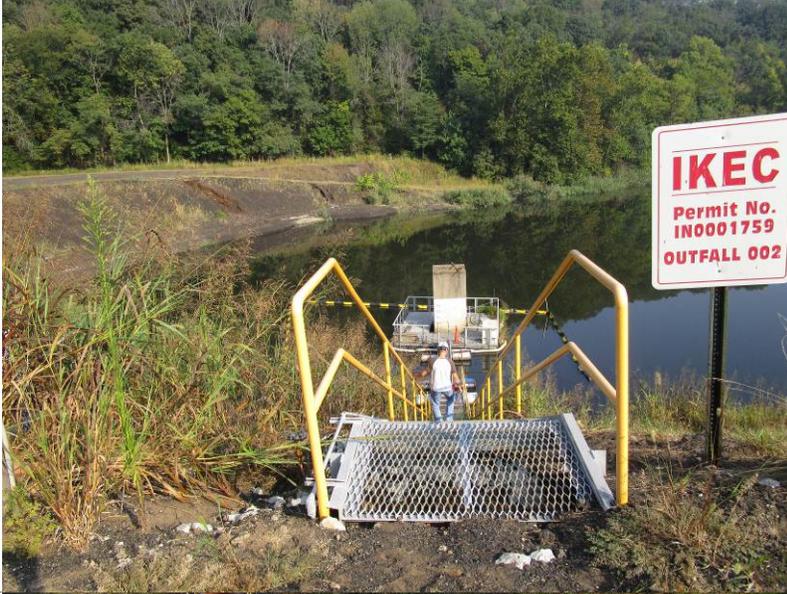
Photo No. 16

8. The overflow discharge structure walkway, railings, metal decking, and visible concrete were found to be in good, functional condition. Photographs No. 16, No.

West Bottom Ash Pond Principal Spillway Access Stairs and Decant Structure

Overview of General Condition

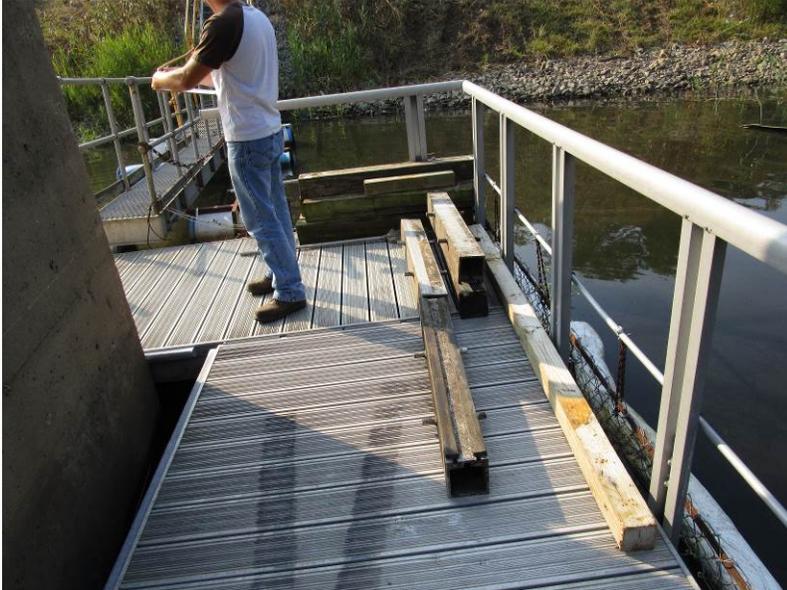
Photo No. 17

17, and No.18 illustrate the access metal walkway, metal deck, spare stop logs and interior of the overflow discharge structure.

West Bottom Ash Pond Principal Spillway Access Stairs and Decant Structure

Spare stop logs stacked next to the overflow structure.

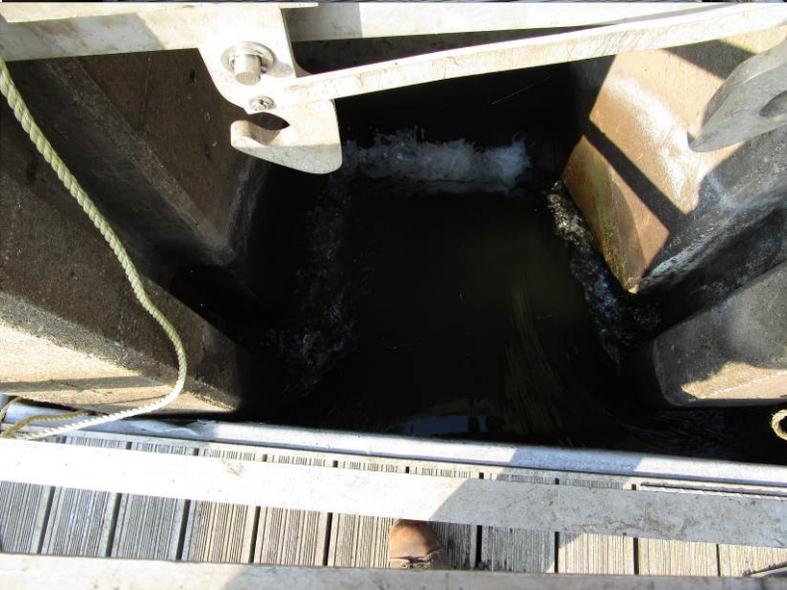
Photo No.18

West Bottom Ash Pond Principal Spillway Access Stairs and Decant Structure

Interior of the overflow discharge structure

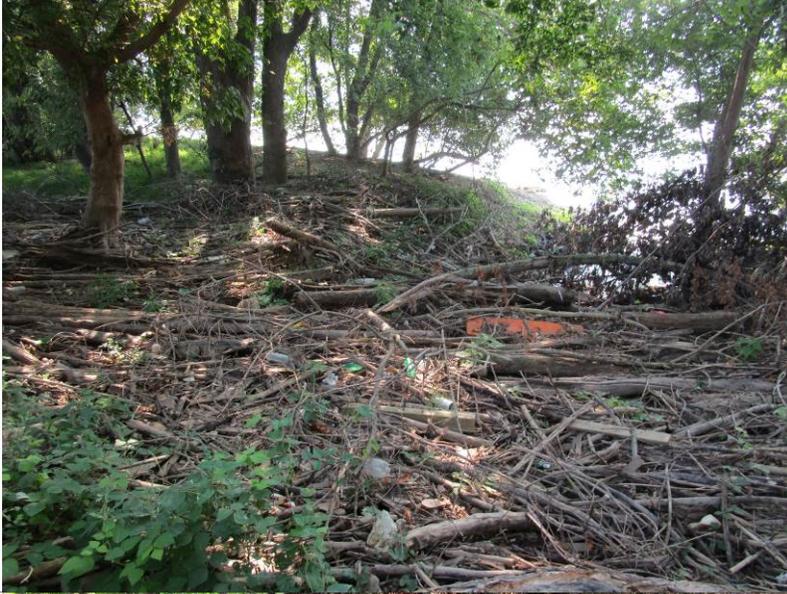
Photo No. 19

9. Photograph No. 19 shows the accumulation of significant wood derbies carried by the river during flooding events above the discharge pipe.
10. Photograph No. 20 Photograph No. 21 and Photograph No. 22 show the typical condition of the discharge pipe and outlet channel. Significant wood derbies carried by the river during flooding events. Erosion at the confluence of the channel and the river was consistent with the conditions observed in the past years. The channel and outlet pipe were observed to be in good condition and were unobstructed and flowing steadily.

West Bottom Ash Pond Principal Spillway Pipe Upstream of the Outlet Channel.

Significant wood debris carried by the river during flooding events

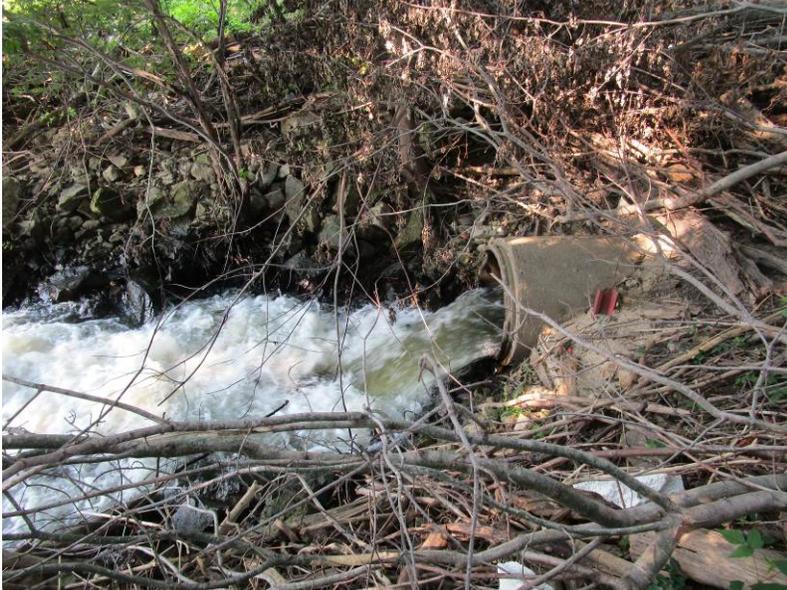
Photo No. 20

West Bottom Ash Pond Principal Spillway Pipe Discharge

General Condition of End of Pipe and Outlet Channel

Significant wood debris carried by the river during flooding events

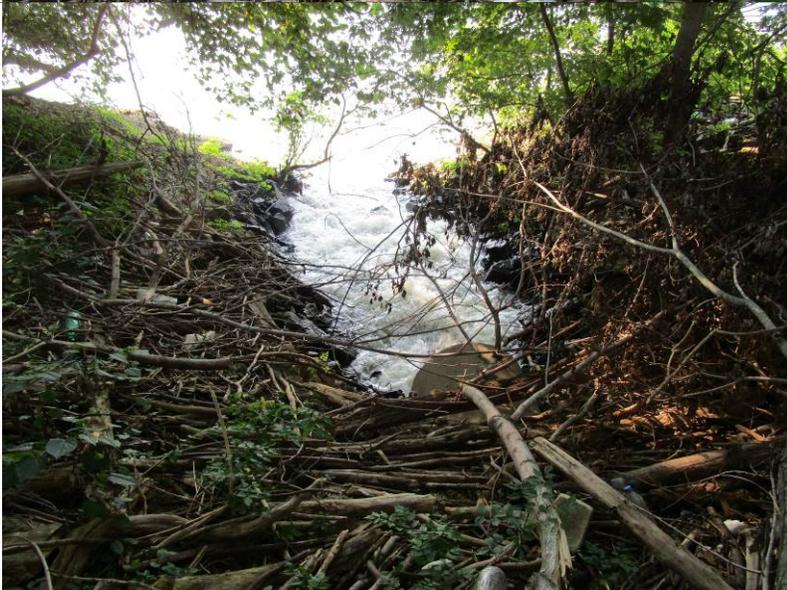
Photo No. 21

West Bottom Ash Pond Principal Spillway Pipe Discharge

General Condition of End of Pipe and Outlet Channel – Looking Toward River

Significant wood debris carried by the river during flooding events

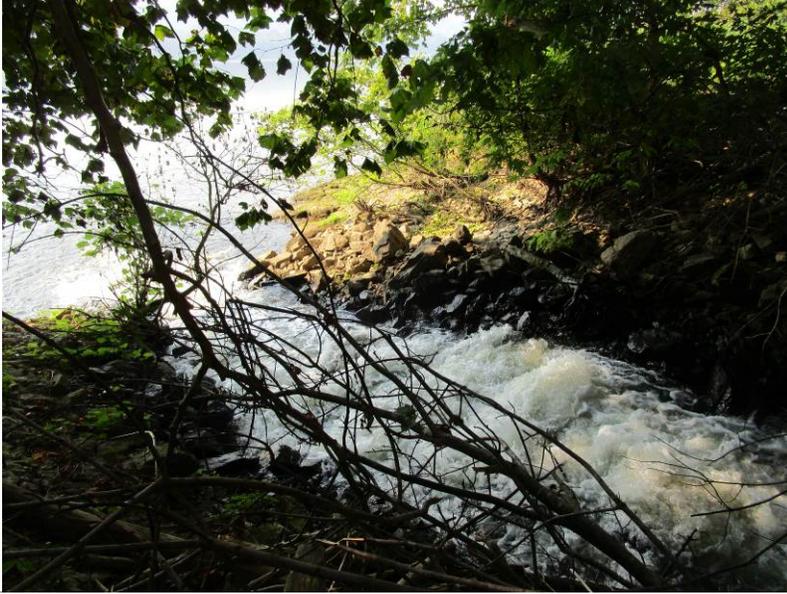
Photo No. 22

West Bottom Ash Pond Principal
Spillway Outlet Channel at
Confluence with Ohio River

Current Condition of Non-
Vegetated Slopes – No Significant
Change Since Last Inspection

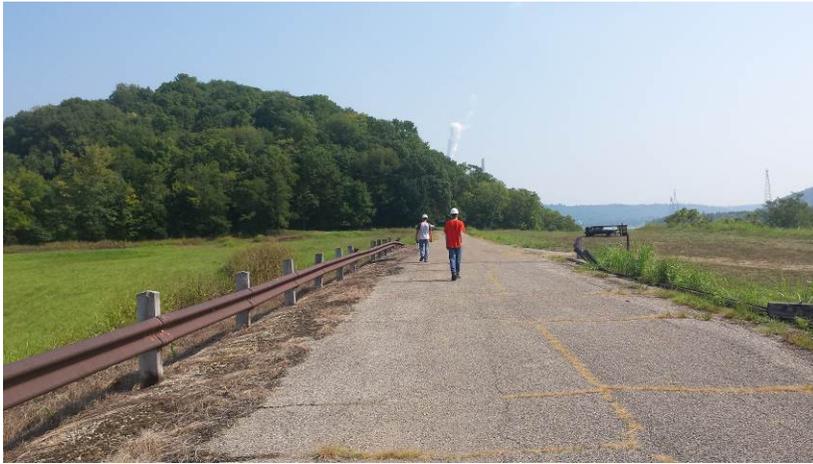
Photo No. 1

1. Photographs Nos. 1, 2 and 3 show the generally good condition of the crest of the dam. Signs of misalignment and settlement were not observed. Minor surface cracks in the pavement were observed. Those cracks are attributed to the age of the pavement and the effects from weathering.
2. Photographs Nos. 4, 5 and 6 provide overviews of the interior slope of the dam above the operating pool. Vegetation control is considered fair and erosion due to wave action was not observed. Overall the slope was found to be in good and stable condition.

Fly Ash Pond Dam From Crest
Looking Northeast Across Saddle
Dam

General Overview

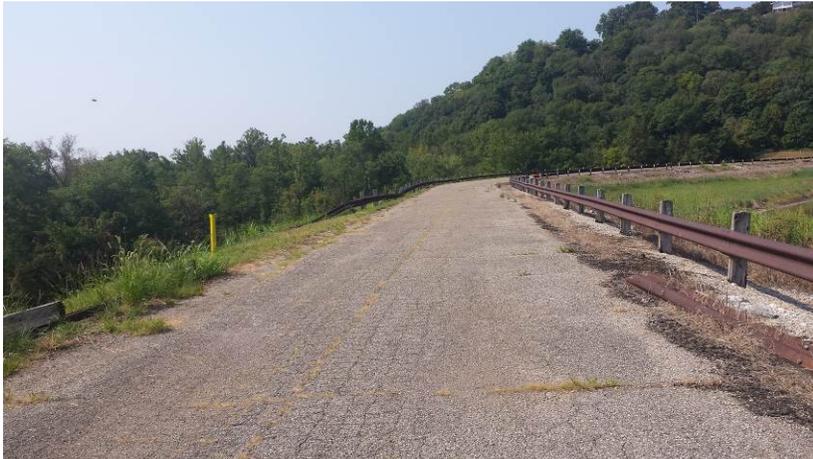
Photo No. 2

Fly Ash Pond Dam From Crest
Looking Southwest

General Overview

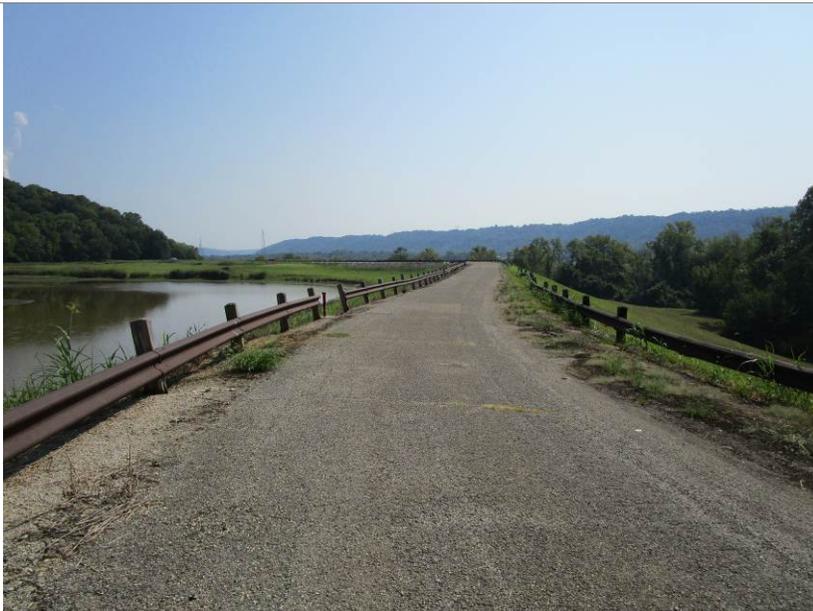
Photo No. 3

Fly Ash Pond Dam From Crest
Looking East

General Overview

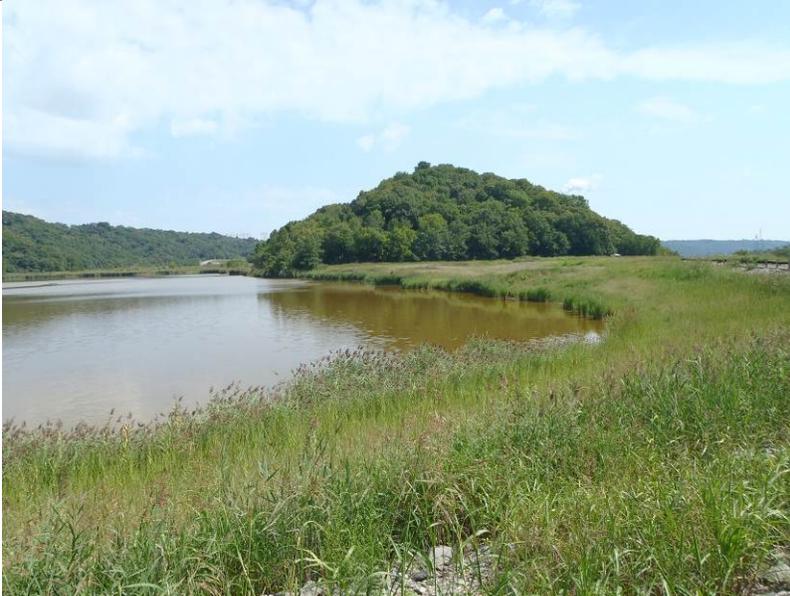
Photo No. 4

Fly Ash Pond Dam From Crest
Looking North

Overview of Current Operating
Pool and Vegetation Conditions
on Interior Slope Adjacent to
Saddle Dam

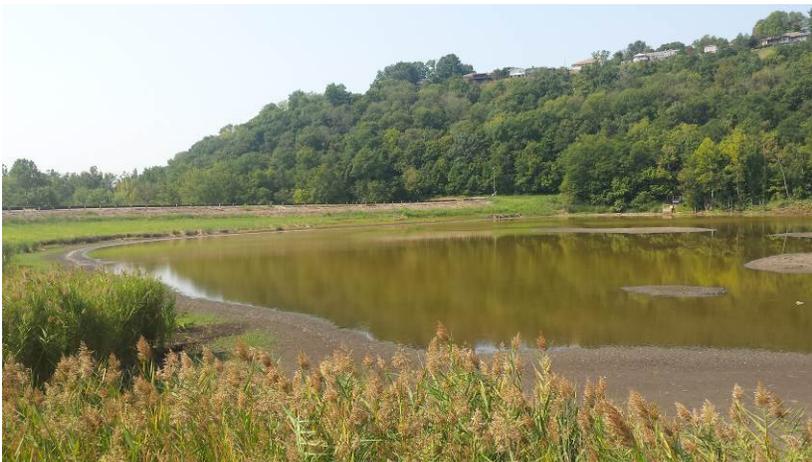
Photo No. 5

Fly Ash Pond Dam From Up
Stream Slope

Overview of Current Operating
Pool and Vegetation Conditions
on Interior Slope

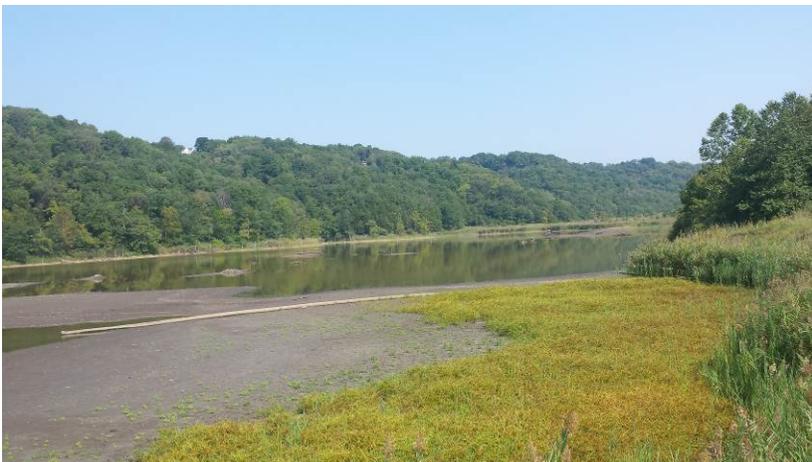
Photo No. 6

Fly Ash Pond Dam From Up
Stream Slope

Overview of Vegetation and
General Conditions

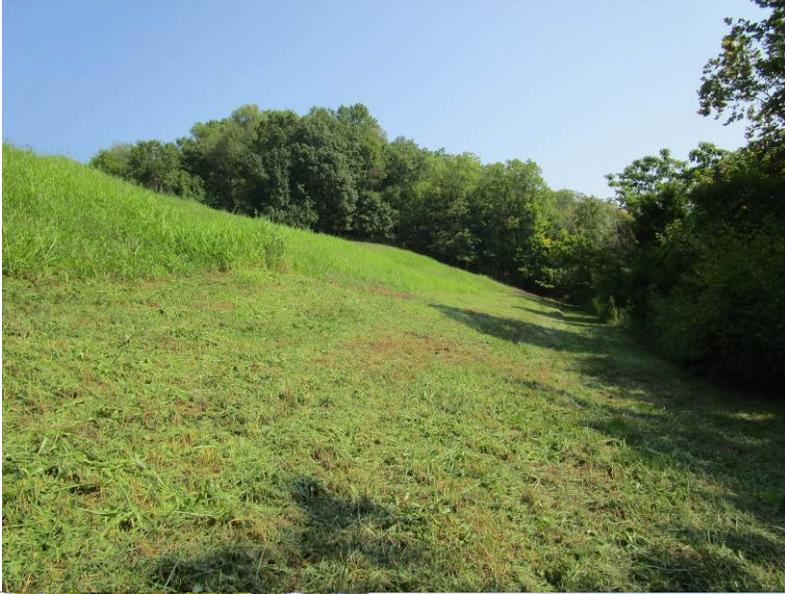
Photo No. 7

3. Photographs No's. 7 through 11 are all overviews of various areas of the exterior face of the dam as further described with each photograph. Throughout, vegetation control is acceptable. No visible change was observed from previous inspections. In general, the exterior slope appeared to be in good and stable condition.
4. Photograph No.12 is an overview of the principal spillway decant structure. Vegetation control was observed to be good. The decant structure appeared to be functioning properly and was free of obstructions.
5. Photographs Nos. 13 and 14 are overviews of the principal spillway outlet channel. The channel is not unobstructed with minimal flow at the time of the inspection.

Fly Ash Pond Dam From Roadway Leading to Crest Looking Northeast

Overview of Vegetation Management and General Condition

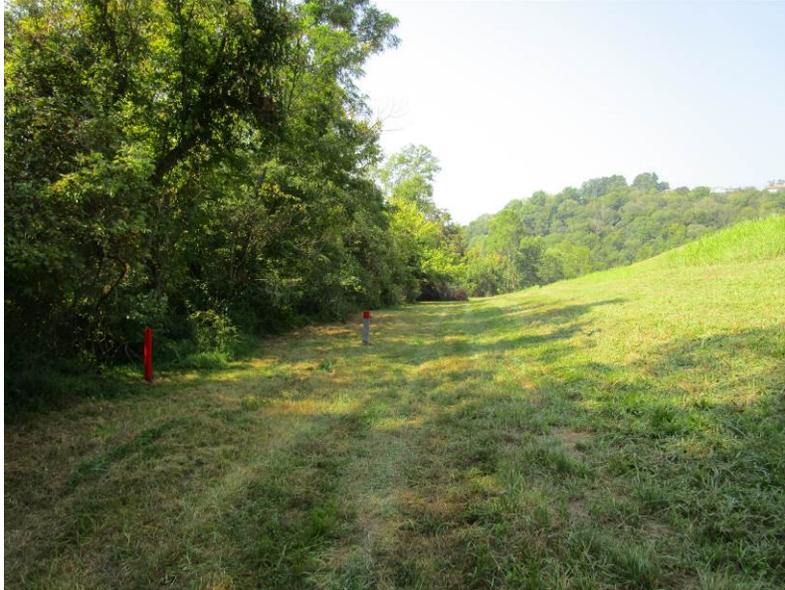
Photo No. 8

Fly Ash Pond Dam From Toe Slope Looking Southwest

Overview of Vegetation and General Conditions

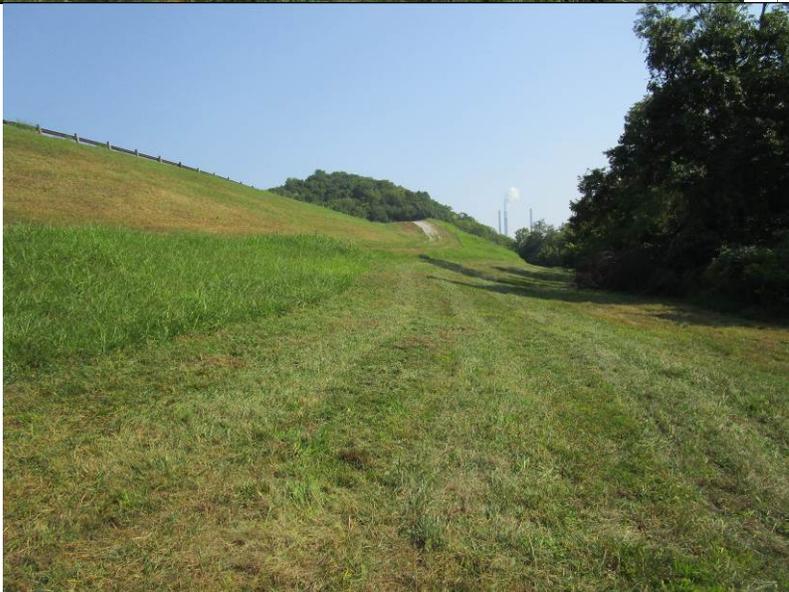
Photo No. 9

Fly Ash Pond Dam Adjacent To Toe of Slope Looking East

Overview of Vegetation and General Conditions

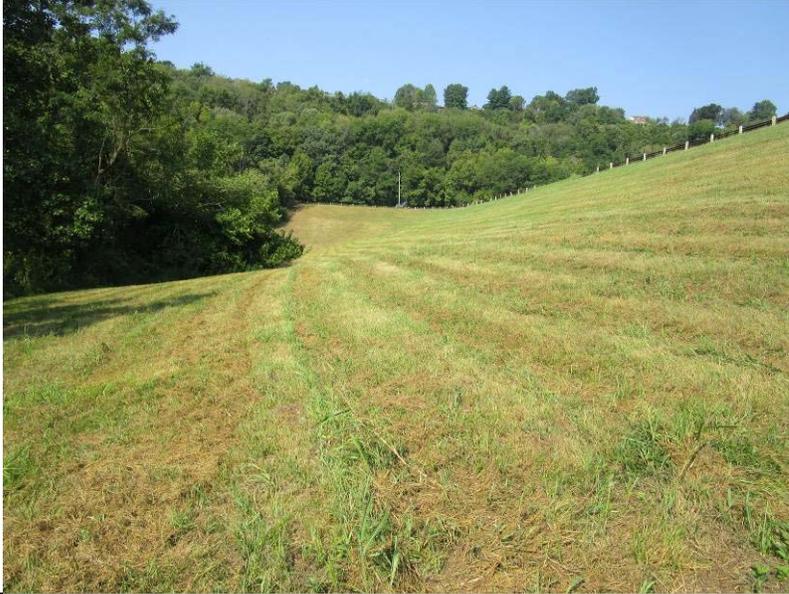
Photo No. 10

Fly Ash Pond Dam Adjacent To
Toe of Slope Looking Southwest

Overview of Vegetation and
General Conditions

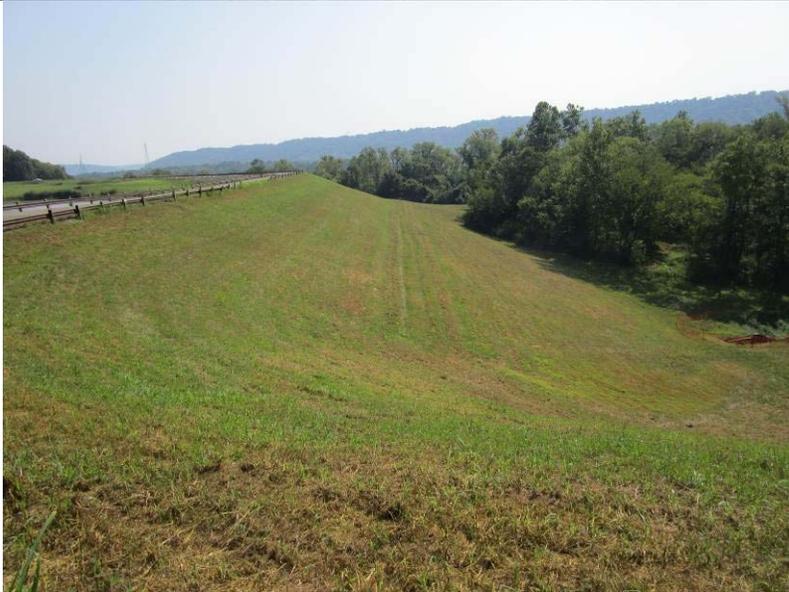
Photo No. 11

Fly Ash Pond Dam From Top of
Slope In Right Groin Looking
East

Overview of Vegetation and
General Conditions

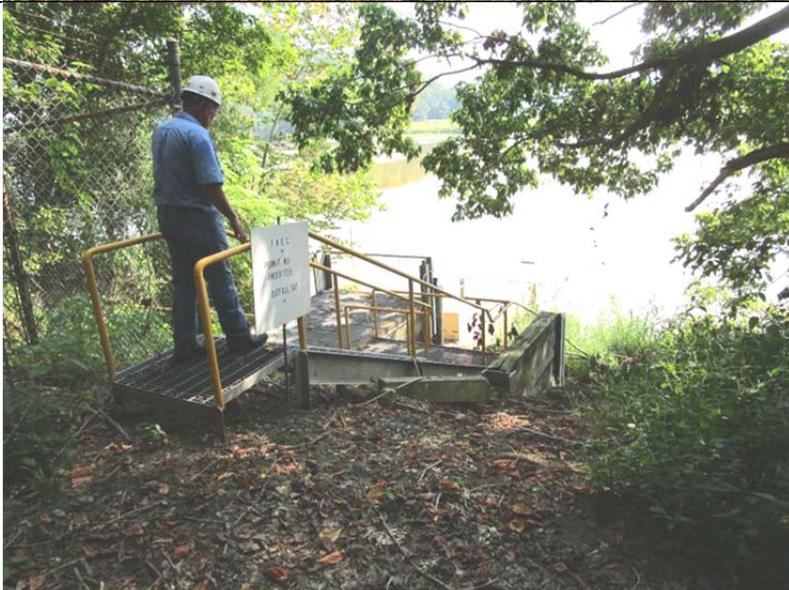
Photo No. 12

Fly Ash Pond Principal Spillway
Structure

General Overview

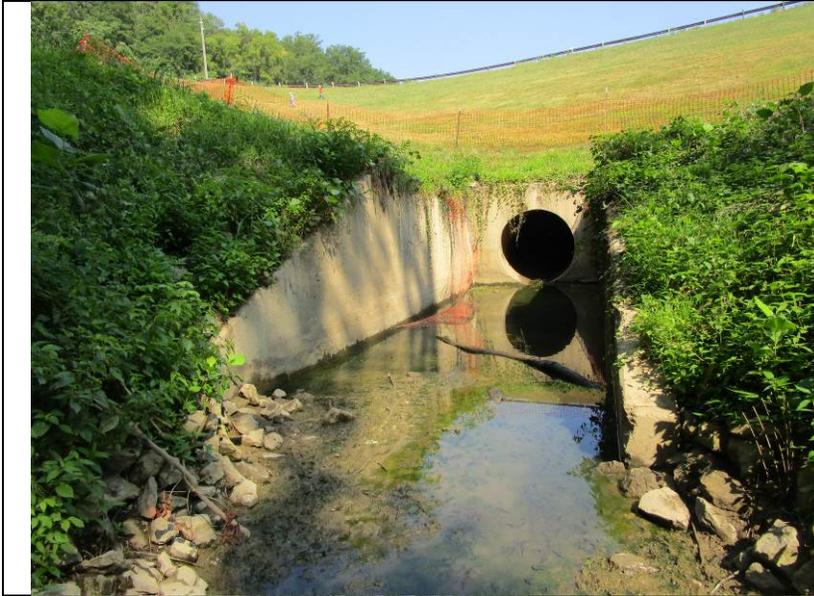
Photo No. 13

Fly Ash Pond Principal Spillway Outlet

General Overview –Backwater has been minimized since last inspection.

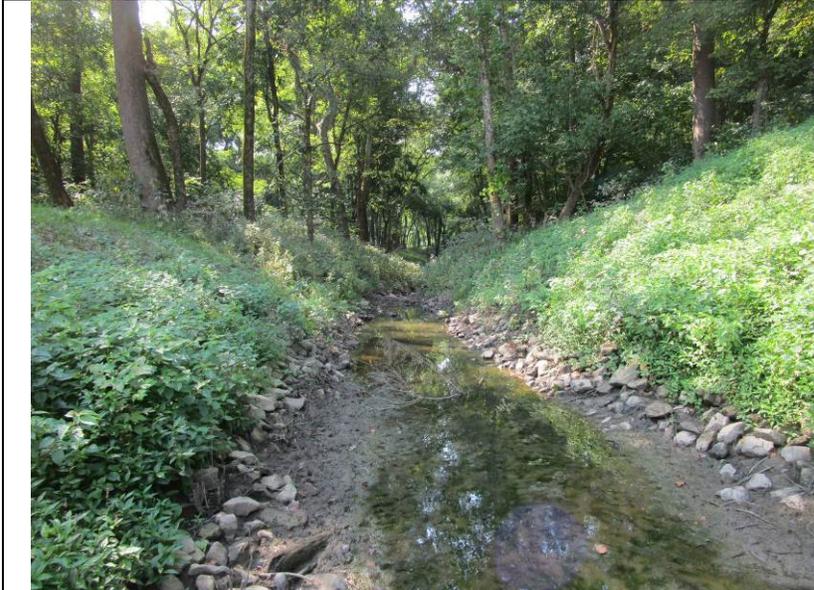
Photo No. 14

Fly Ash Pond Principal Spillway Outlet Channel Looking Downstream

General Overview
