**Re: Ohio Valley Electric Corporation  
Kyger Creek Station  
Notification of CCR Rule Information Posting  
Annual Certified CCR Dam and Dike (Surface Impoundment)  
Inspection Report Posting**

**2025 CCR Rule – Surface Impoundments  
Kyger Creek Dam/Dike Inspections**

Kyger Creek Generating Station  
Cheshire, Ohio  
Gallia County

January 19, 2026

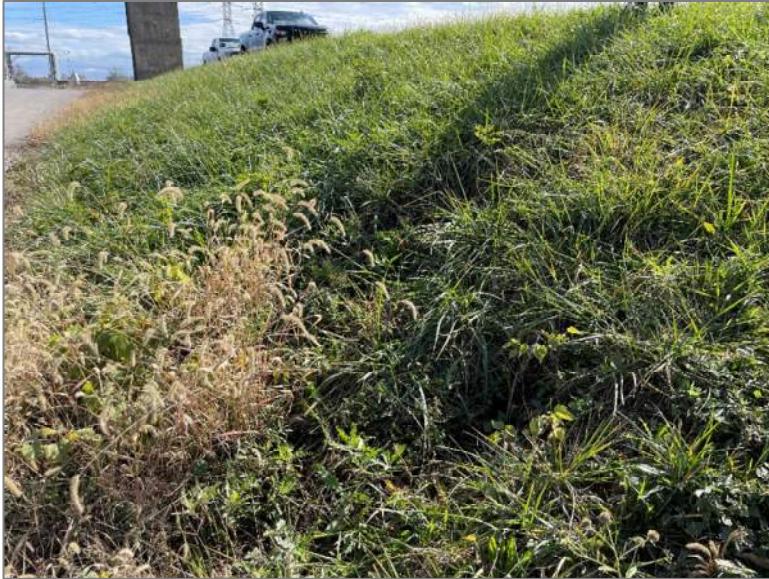
**Photo 1, Point 1**

- Surface erosion and erosion rills are noted, particularly as the material changes from the road surfacing to the grassy slopes near the crest along the perimeter embankment (Points 1, 3, and 4, Appendix A; Photos 1, 4, 5, 15, 17, 18, and 19, Appendix D).

LVWTS – Northwest Exterior  
Slope – Erosion gully near the  
toe.

- Reroute and repair erosion gullies as noted. Reseed barren areas noted on the exterior slope and establish uniform vegetation coverage in areas of need.

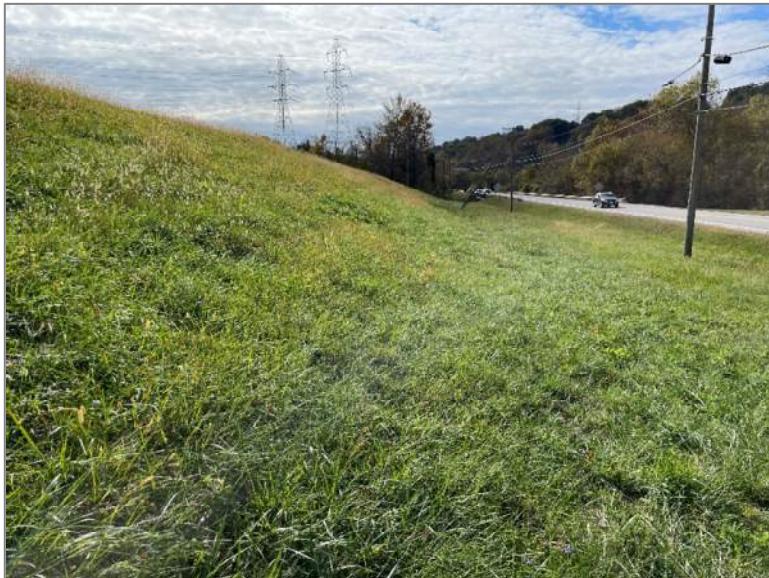
**Photo 2, Point 2**

- A minor depression or surface irregularity was noted mid-slope of the northwest exterior perimeter embankment (Point 2, Appendix A; Photo 2, Appendix D).

LVWTS – Northwest Exterior  
Slope – Minor depression mid-  
slope.

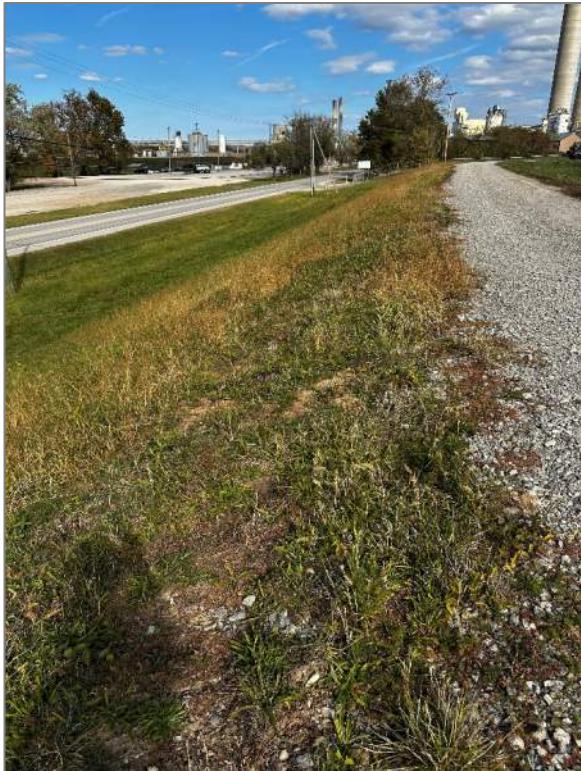
**Photo 3**

LVWTS – Northwest Exterior  
Slope – Surface erosion, bare  
spots near the crest.

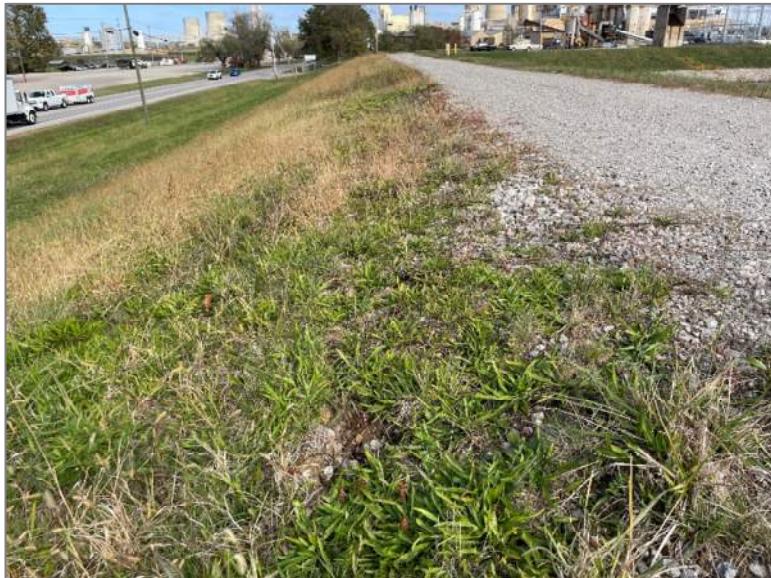
**Photo 4, Point 3**

LVWTS – Northwest Exterior  
Slope – Surface erosion, bare  
spots near the crest.

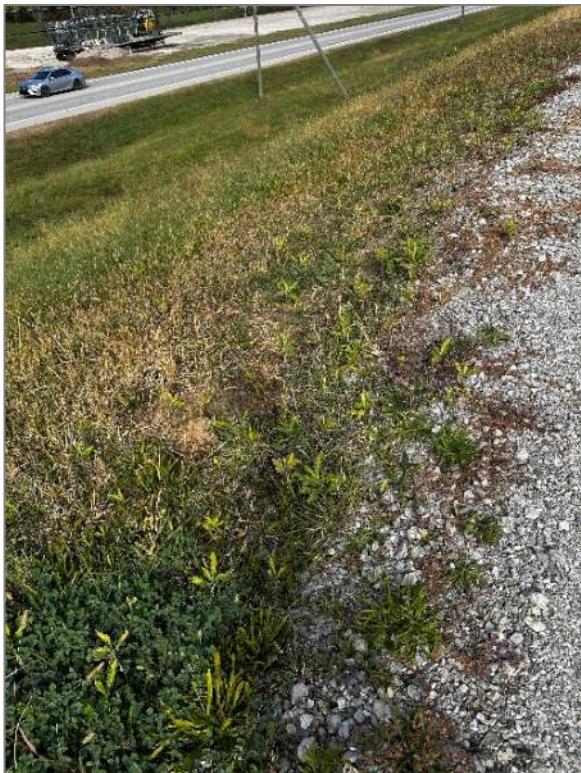
**Photo 5, Point 4**

LVWTS – Northwest Exterior Slope – Erosion gulley and bare area near the crest.

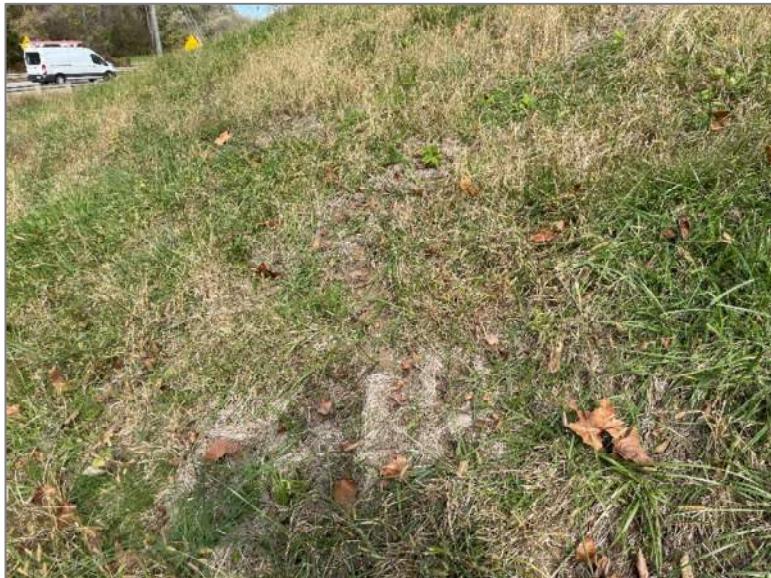
**Photo 6, Point 5**

- Vegetation is thin and areas of exposed earth were noted in areas along the perimeter embankment (Points 5, 6, and 9, Appendix A; Photos 6, 8, and 16, Appendix D). Some instances appear to be a result of tracked equipment traversing the slope.

LVWTS – West Exterior Slope – Equipment tracks, exposed earth.

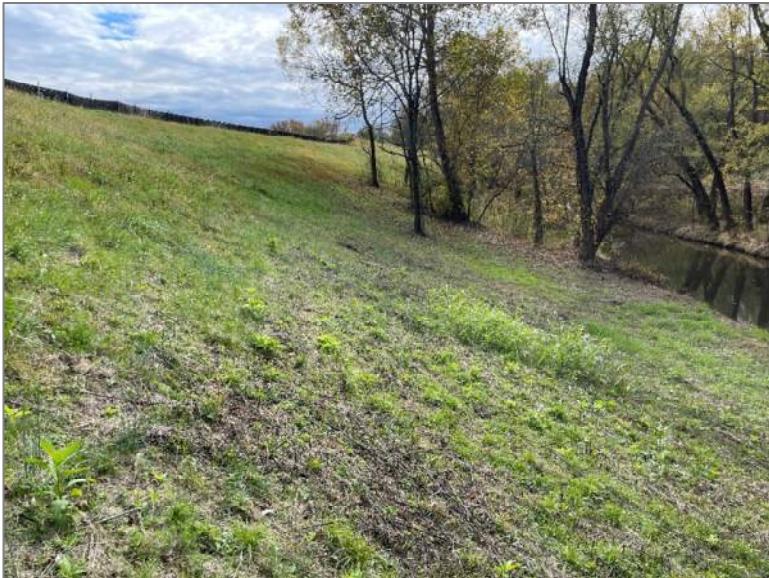
**Photo 7**

LVWTS – West Exterior Slope facing south, trees on slope between embankment and Kyger Creek.

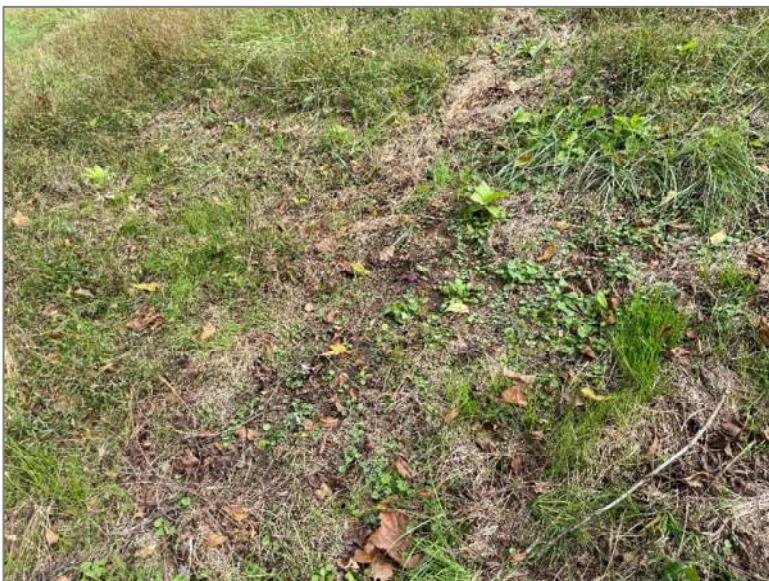
**Photo 8, Point 6**

Boiler Slag Pond – West Exterior Slope – Bare spot near the toe.

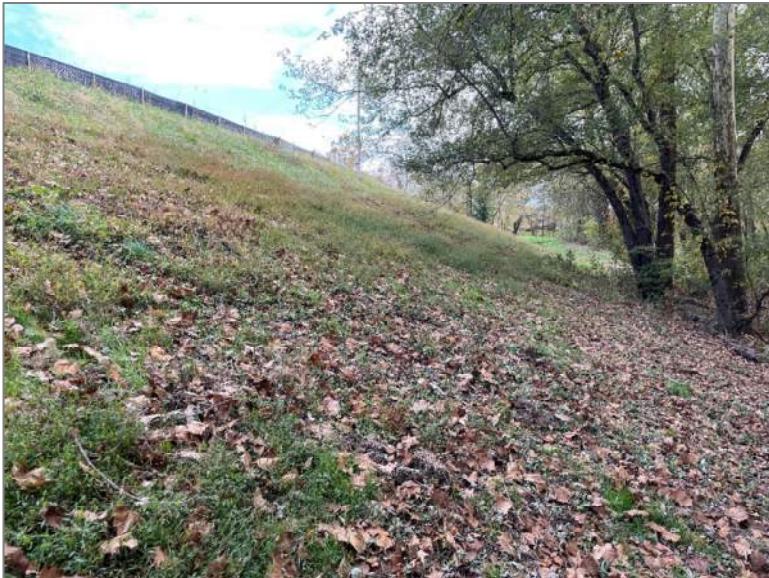
**Photo 9**

Clearwater Pond – Southwest  
Exterior Slope, facing southeast

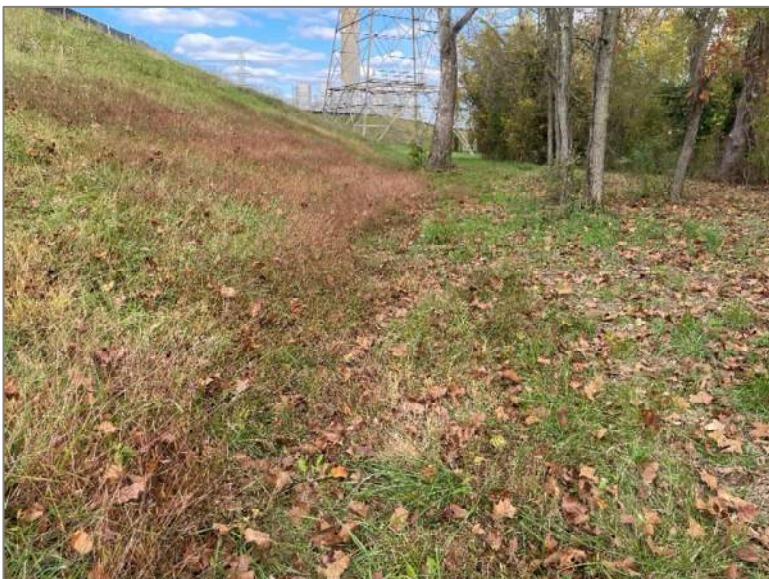
**Photo 10, Point 7**

- The exterior slopes are mowed, vegetated, and uniform along the northwest, southwest, and southeast perimeter of the clearwater pond (Photo 9, Appendix D).
- Trees and woody vegetation are growing along the toe of the embankment and Kyger Creek (Photo 9, Appendix D).
- The topography is difficult to discern along the exterior toe of the southeast perimeter. Water may pond at the toe following rain events. Ground was firm and no standing water was observed at the exterior toe (Point 7, Appendix A; Photo 10, Appendix D).

Clearwater Pond – Southeast  
Exterior Slope – Drainage  
direction at toe unclear.

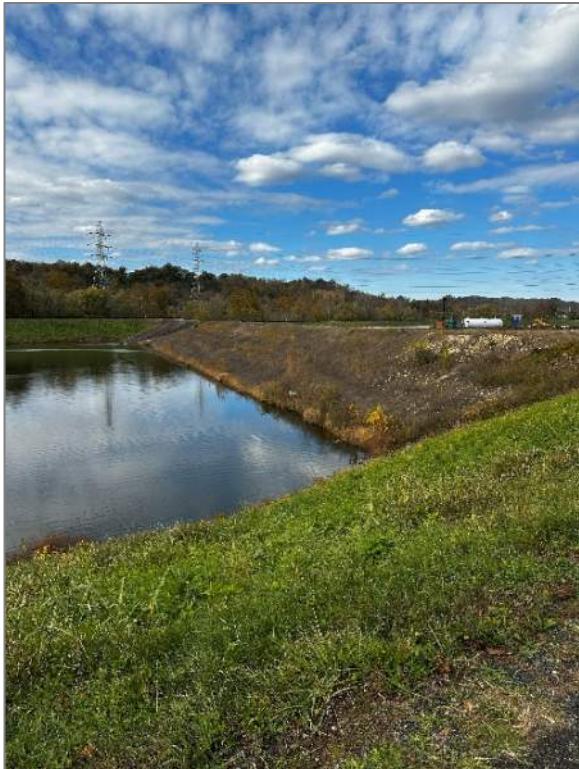
**Photo 11**

- Erosion rills were noted on both sides of the Splitter Dike near its crest and along the slopes of the dike (Point 12, Appendix A; Photos 11 through 14, Appendix D).

Clearwater Pond – Southwest slope of Splitter Dike facing northwest.

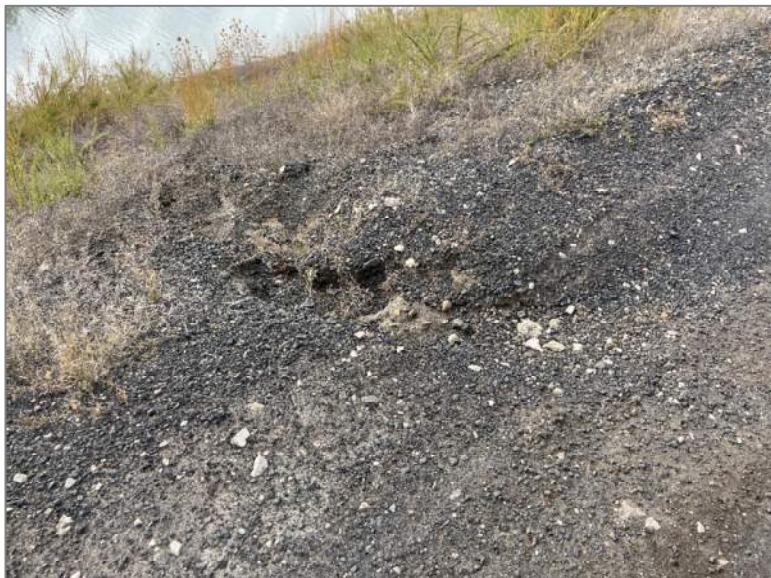
**Photo 12, Point 8**

Boiler Slag Pond – Southwest slope of Splitter Dike – Erosion gulley.

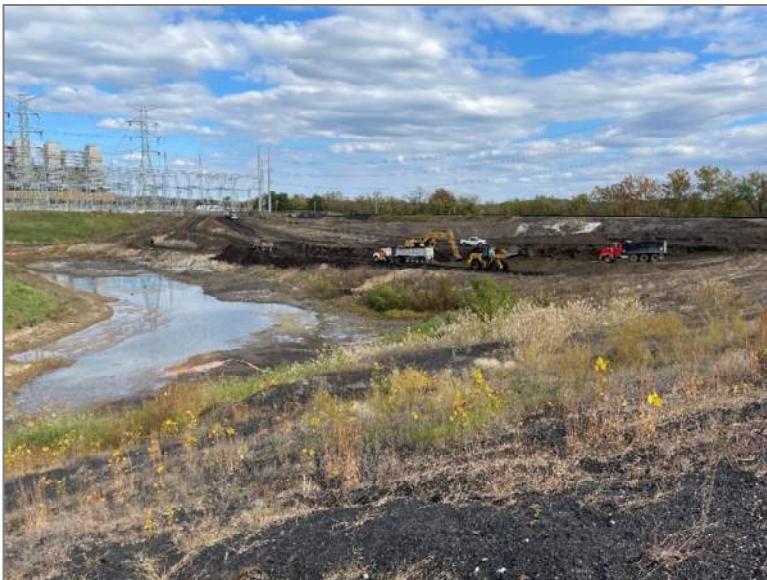
**Photo 13**

No operational flows were noted during the site visit into the boiler slag pond closure area. Ponded water was limited to an area at the toe of the LVWTS within the BSP closure area (Photo 13, Appendix D).

Boiler Slag Pond – Facing east from Splitter Dike – Closure by removal construction in progress.

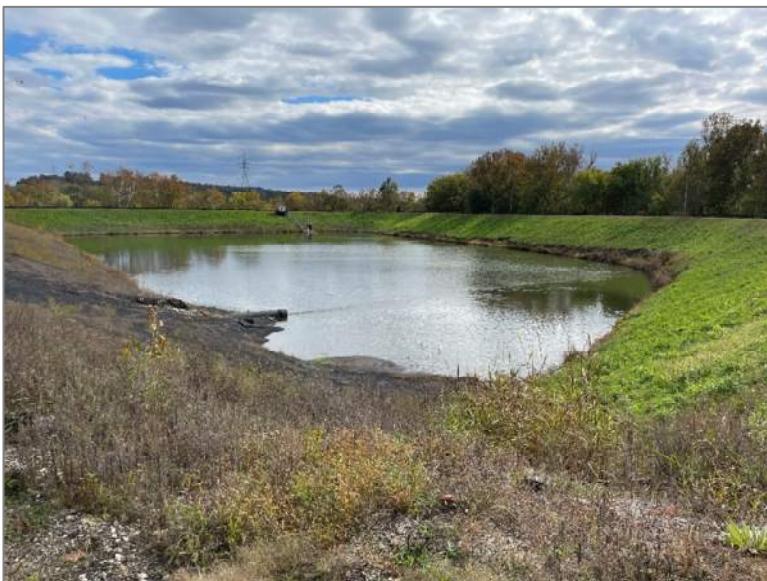
**Photo 14**

Clearwater Pond – Facing southeast from Splitter Dike

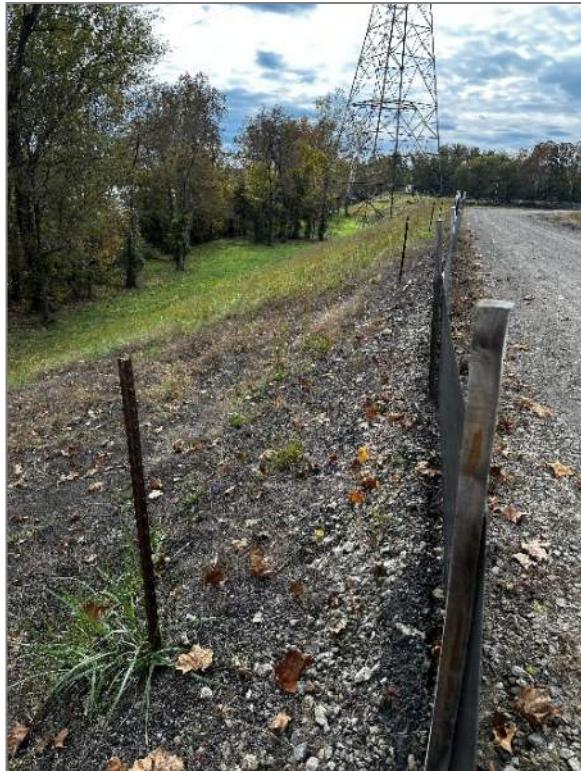
**Photo 15**  
Boiler Slag Pond – Southeast  
Exterior Slope – Erosion along  
the crest.

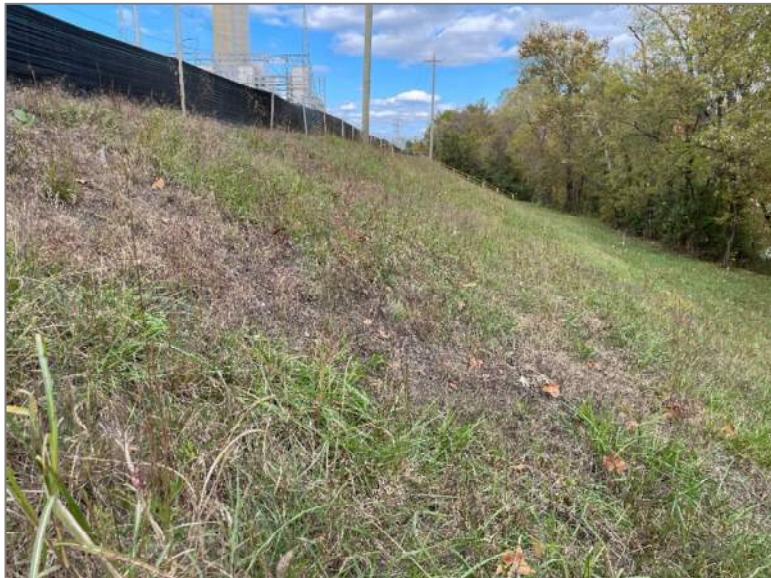
**Photo 16, Point 9**  
Boiler Slag Pond – Southeast  
Exterior Slope – Surface erosion  
on slope, bare spots.

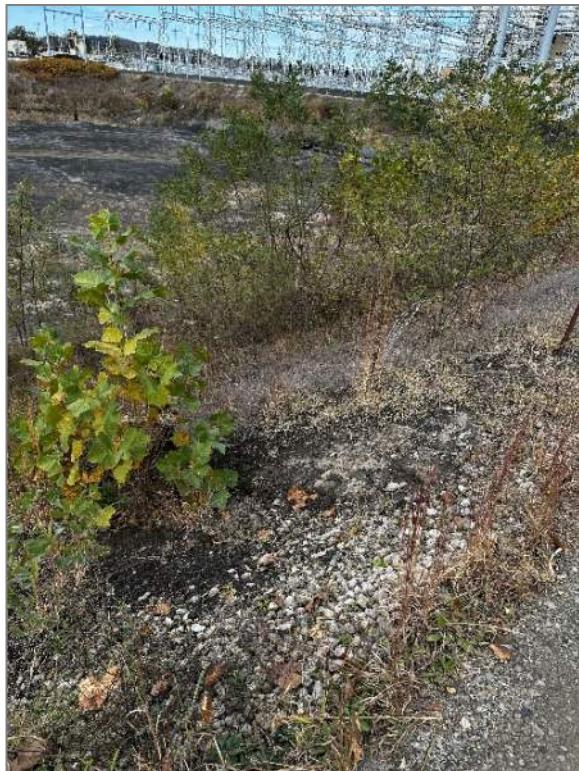
**Photo 17**  
Boiler Slag Pond – Southeast  
Interior Slope – Erosion along  
the crest.

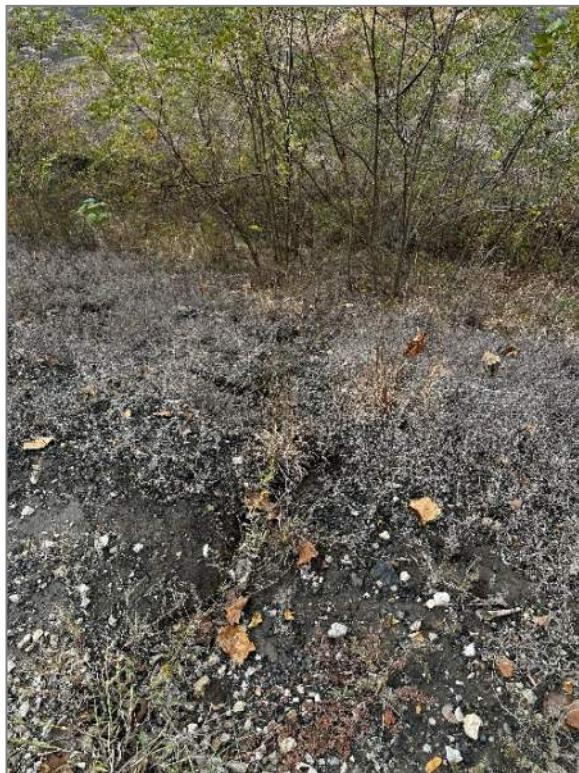
**Photo 18**  
Boiler Slag Pond – Southeast  
Interior Slope – Erosion gully  
near the crest.

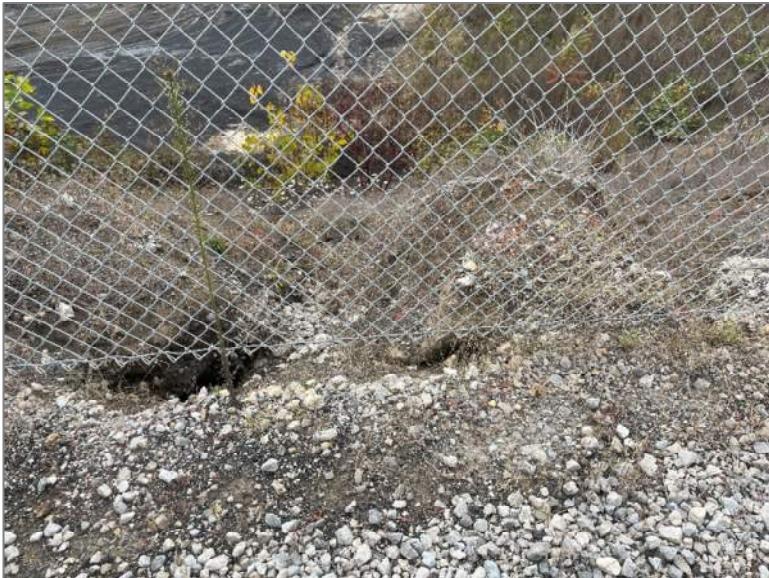
**Photo 19, Point 10**  
Boiler Slag Pond – Northeast  
Interior Slope – Erosion gully  
near the crest.

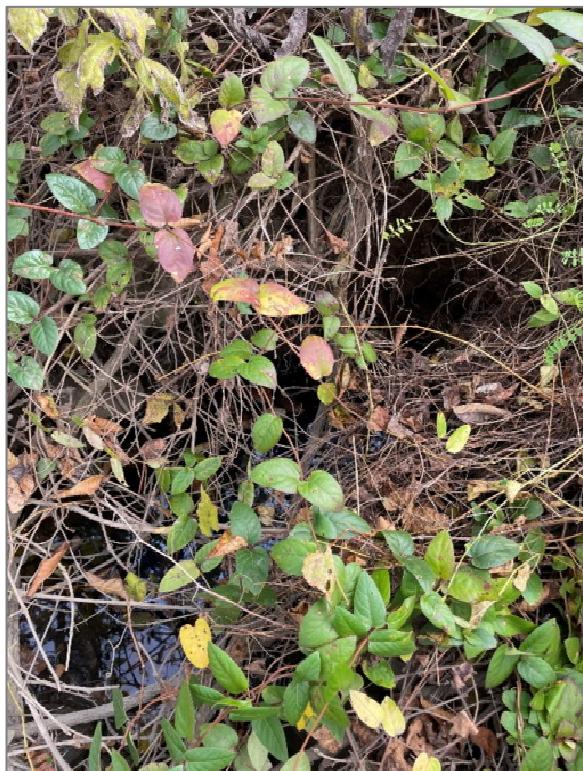
**Photo 22, Point 11**

- Surficial erosion and bare spots are observed at multiple locations along the exterior slope of the perimeter embankments (Points 11, 14, 15, 19, 21, 25, 26, and 27, Appendix A; Photos 22, 25, 26, 29, 31, 37, 38, and 39, Appendix D).

Northwest Exterior Slope –  
1-foot-deep erosion rill near toe

- Reroute and repair erosion gullies as noted. Reseed barren areas noted on the exterior slope and establish uniform vegetation coverage in areas of need.
- Backfill the documented animal burrows with compacted native soils or a mud-pack of soil and cement, ensuring all voids are filled and the entrance(s) are properly sealed.
- Repair the sloughing surface on the west corner of the pond near the access road.

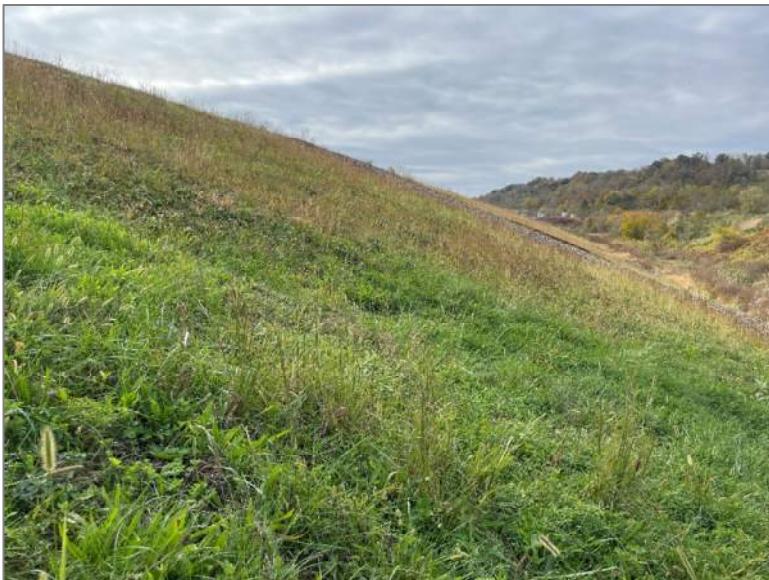
**Photo 23, Points 12-13**  
Northwest Exterior Slope –  
Depression in lower half of  
slope.

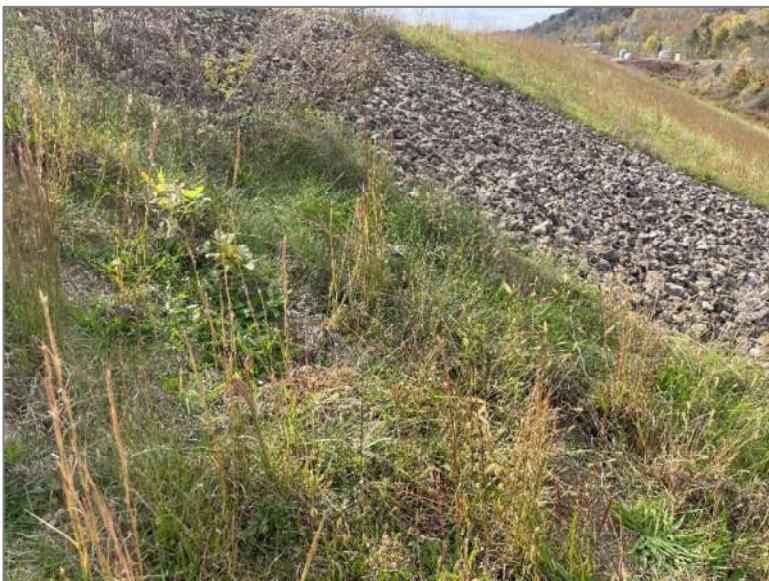
**Photo 26, Point 15**  
Northwest Exterior Slope –  
Surface erosion, bare spots.

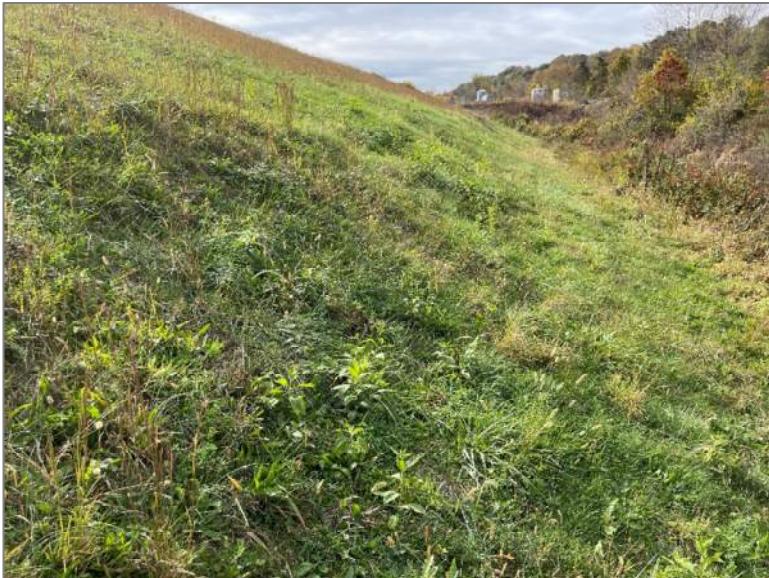
**Photo 27, Points 16-17**  
Northwest Exterior Slope –  
Depression in lower half of  
slope. Facing southwest.

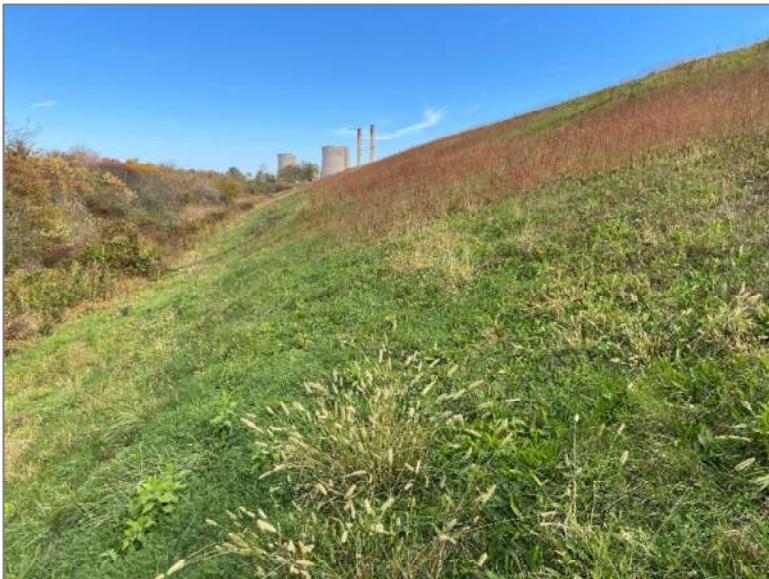
**Photo 28, Point 18**  
Northwest Exterior Slope –  
Depression in lower half of  
slope. Facing northeast.

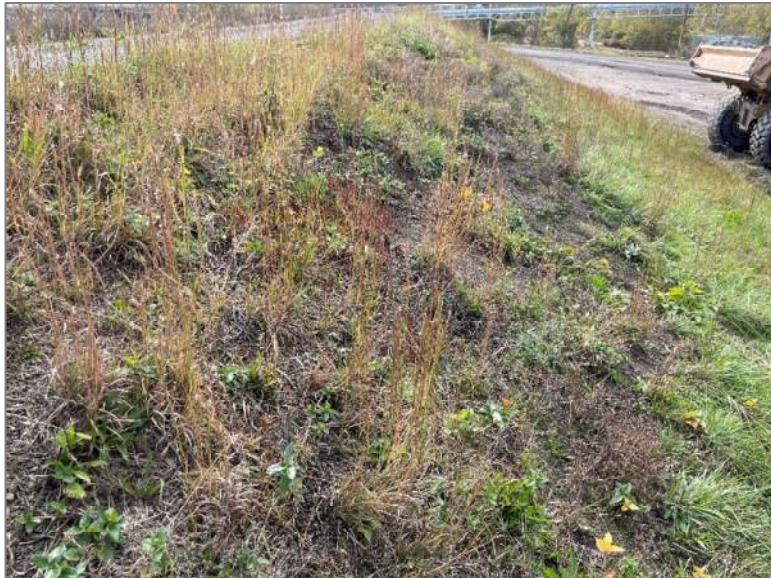
**Photo 29, Point 19**  
Northwest Exterior Slope –  
Surface erosion, bare spots.

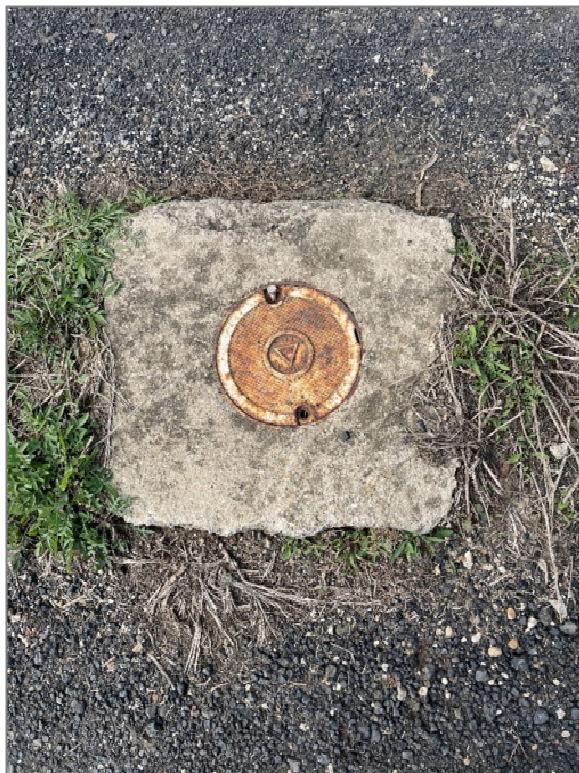
- Bolts are missing on the metal cover to a piezometer at the crest of the northwest embankment at the southern corner, potentially exposing the piezometer to moisture from the ground surface (Point 20 Appendix A; Photo 30, Appendix D).

**Photo 30, Point 20**  
Northwest Crest –  
Instrumentation well lid missing  
bolts.

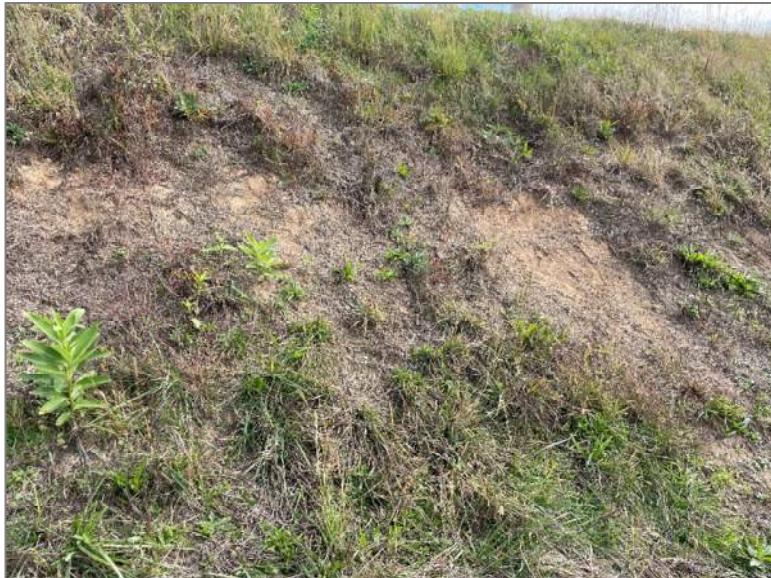
**Photo 31, Point 21**

West Exterior Slope – Surface erosion, bare spots at access ramp.

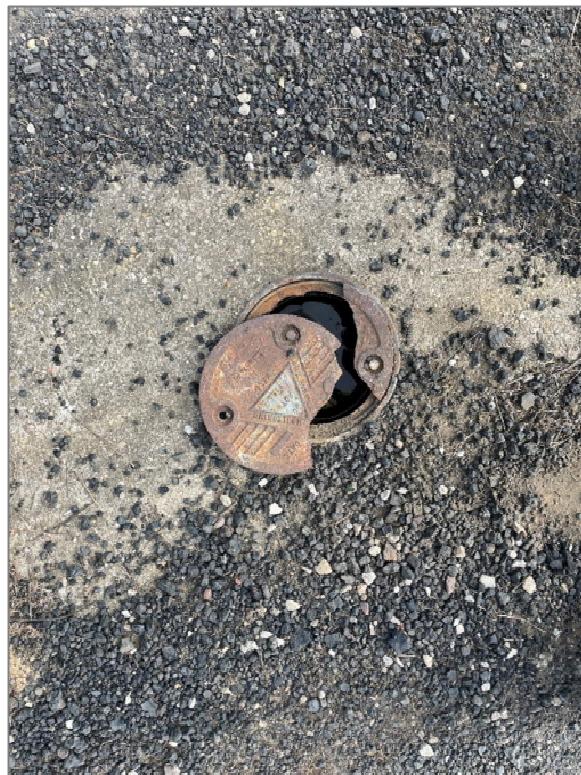
**Photo 32, Point 22**

- The ground surface metal cover to a piezometer at the crest of the perimeter embankment at the west corner has been damaged, exposing the piezometer to moisture from the ground surface (Point 22, Appendix A; Photo 32, Appendix D).

West Crest – Damaged well lid on instrumentation.

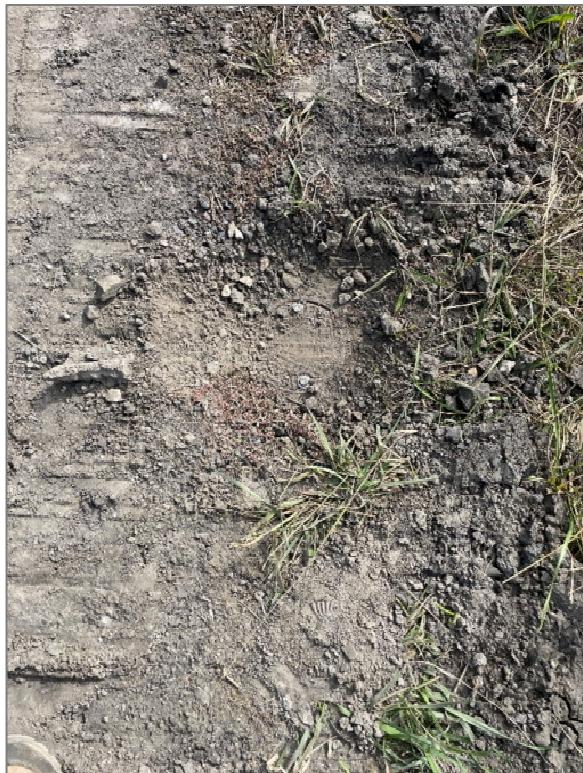
**Photo 33, Point 23**  
West Crest Slope – Well lid  
buried.

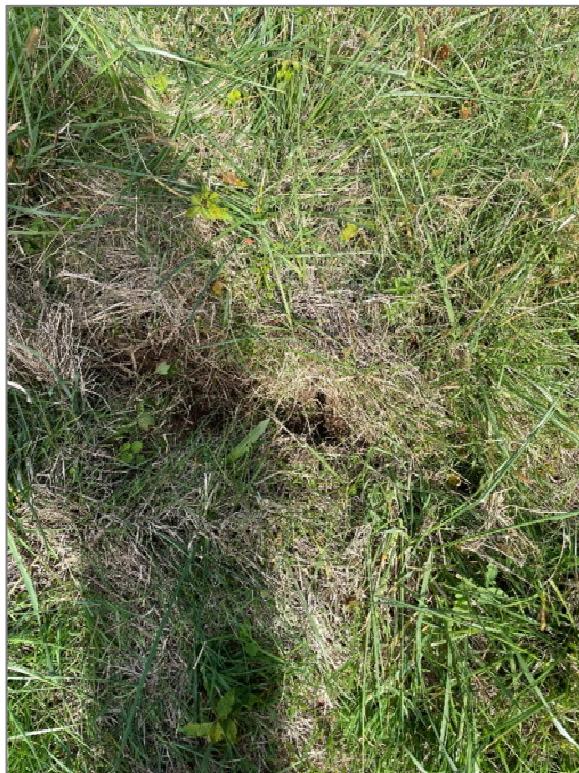
- Animal burrows are observed in the perimeter embankment surrounding the pond at two locations (Points 24 and 28, Appendix A; Photos 36 and 40, Appendix D).

**Photo 36, Point 24**  
Southeast Exterior Slope –  
Animal burrow.

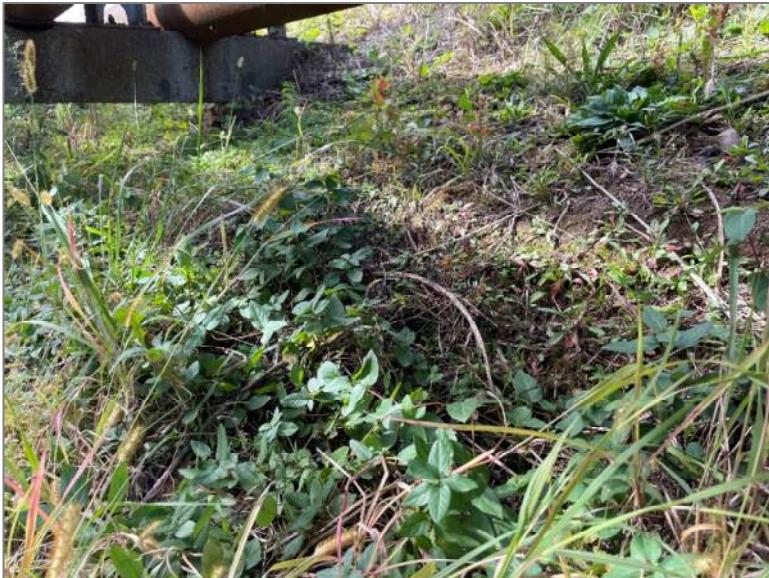
**Photo 37, Point 25**  
Southeast Exterior Slope –  
Erosion under pipes.

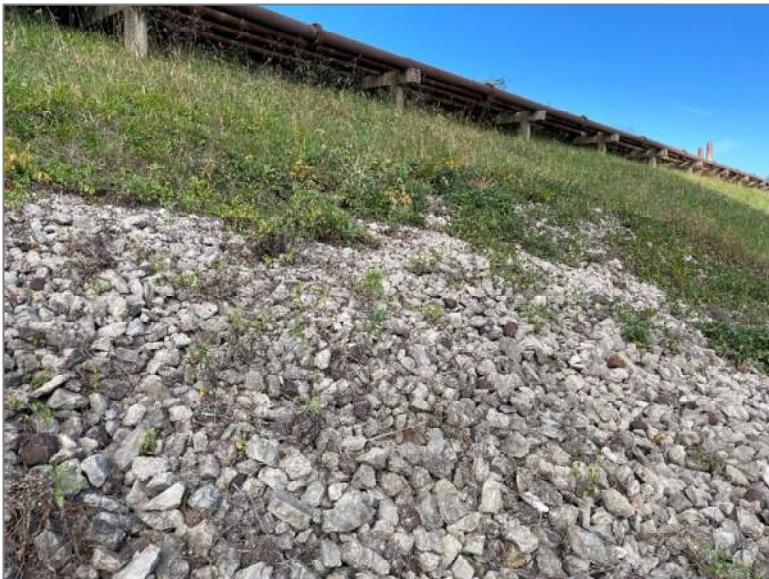
**Photo 38, Point 26**  
Southeast Exterior Slope –  
Surface erosion, bare spots.

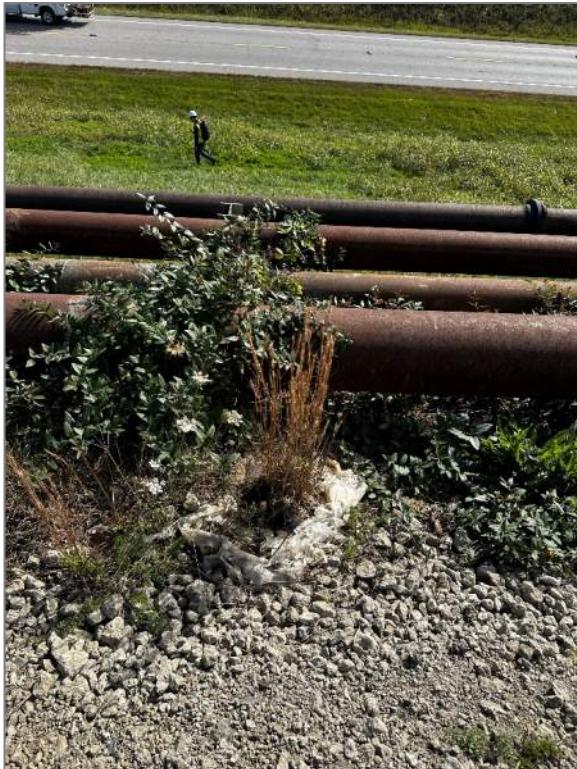
**Photo 39, Point 27**  
Southeast Exterior Slope –  
Erosion gully on crest and  
slope.

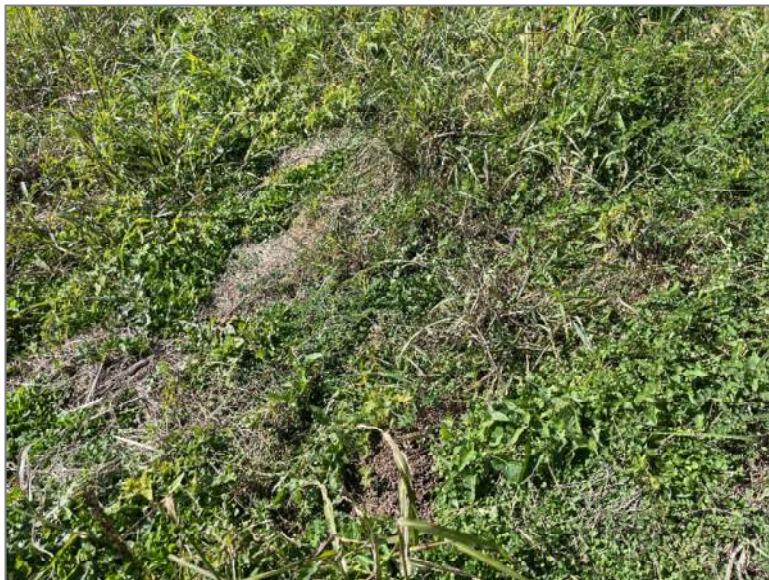
**Photo 40, Point 28**  
Southeast Exterior Slope –  
Animal burrow.

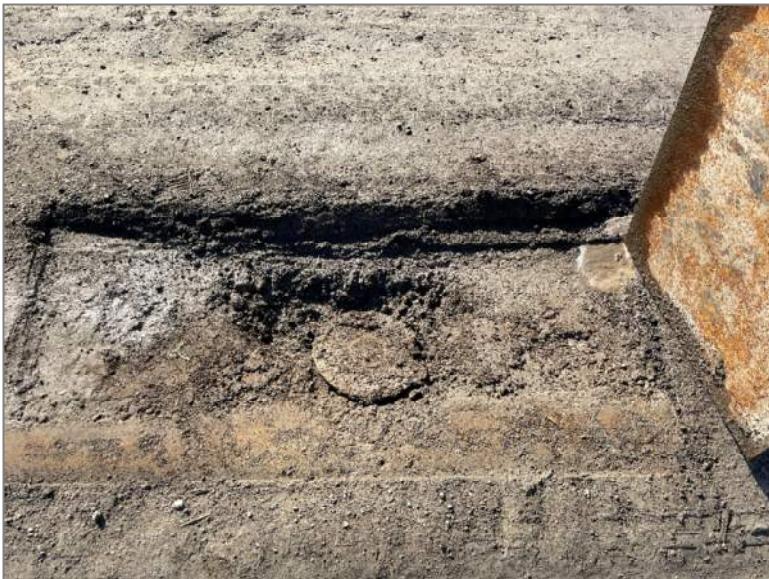
**Photo 42, Point 29**

- The splitter dike embankment shows no signs of rutting, erosion or instability (Photo 41, Appendix D).
- The ground surface metal cover to a piezometer at the crest of the splitter dike located under a steel plate appears to be damaged, exposing the piezometer to moisture from the ground surface (Point 29, Appendix A; Photo 42, Appendix D).

Splitter Dike Crest – Well lid  
under steel plate.
