**Re: Ohio Valley Electric Corporation
Kyger Creek Station's 2025 Annual CCR Landfill
Inspection Posting Notification**

**2025 CCR Rule - Landfill
Kyger Creek Landfill Inspection**

Kyger Creek Generating Station
Cheshire, Ohio
Gallia County

January 19, 2026

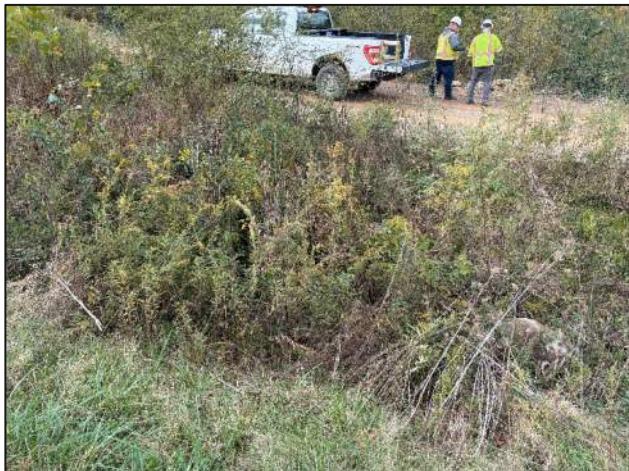
- Tall, dense vegetation along the south, west and northwest slopes prevented inspection of those slopes. The west slope of the embankment contains mature tree growth (Photos 3 and 5; Appendix B).
- A possible slip area near the historic slip was observed. Dense vegetation prohibited the extent of the slip from being observed. (Point 4; Appendix B).
- Two holes, possible animal burrows, approximately 6 inches diameter were observed on the crest of the west embankment (Points 2 and 3, Picture 4; Appendix B).
- Dense vegetation and sediment accumulation at the inlet and outlet of the headwalls inhibits flow of stormwater from the west side of Phase 1 to the south side of the West Sedimentation Pond (Point 1, Photos 1 and 2; Appendix B).

Photo 1 (Point 1) – dense vegetation at inlet of culvert leading to West Sedimentation Pond.

- Clear vegetation at the culvert headwall near the West Sedimentation Pond to maintain flow into the culverts.
- Backfill the documented animal burrows with compacted native soils or a mud-pack of soil and cement, ensuring all voids are filled and the entrance(s) are properly sealed.

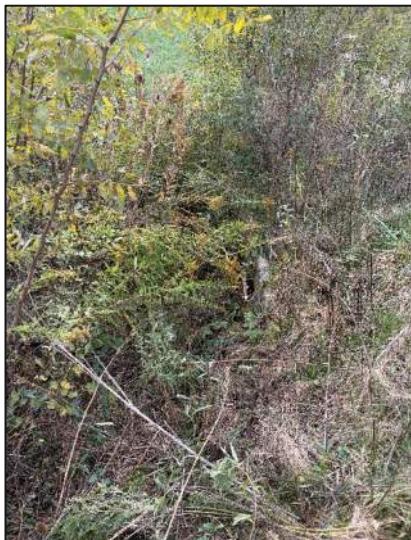
Photo 2 (Point 1) – dense vegetation at outlet of culvert leading to West Sedimentation Pond.

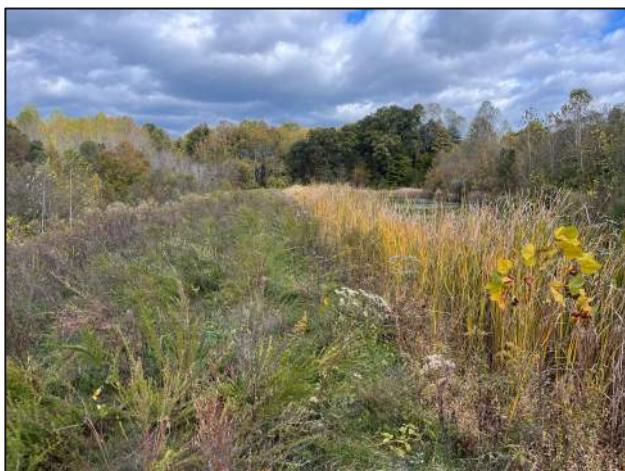
Photo 3 - West Sedimentation Pond – dense vegetation on crest and slope.

- The slopes around the West Sedimentation Pond should be mowed and maintained to allow for regular monitoring of possible instability in these areas. Trees on the west slope of the embankment should be removed.
- A possible separation of the crest on the south and east embankments of the Interim Leachate Collection Pond is occurring. These areas should be mowed, maintained, and routinely monitored to determine if a stability issue exists.

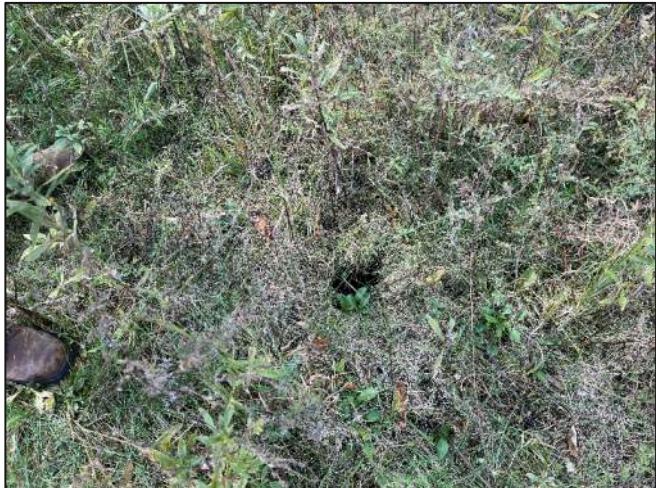
Photo 4 (Points 2 and 3) - West Sedimentation Pond – possible animal burrow.

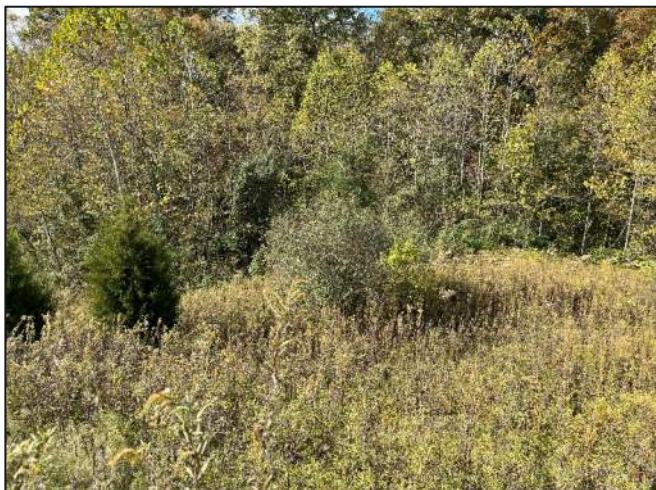
Photo 5 - West Sedimentation Pond – west exterior slope mature tree growth.

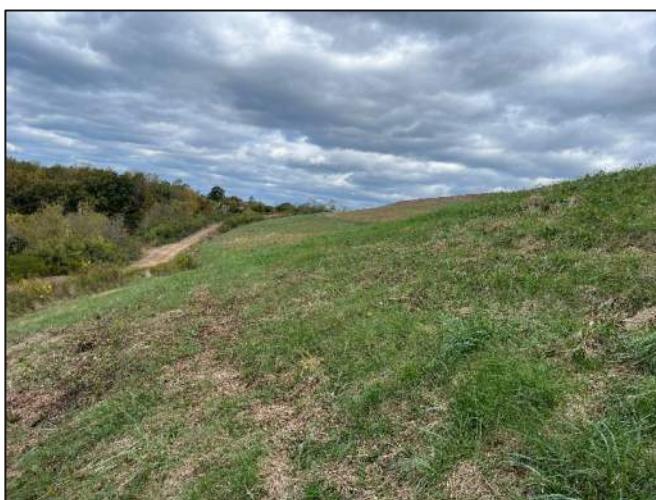
- The west and southwest temporary slopes are mowed, vegetated, and uniform. Slopes in these areas are estimated to be 3.7H:1V to 4.7H:1V (Points 6 through 8 and 22 through 23, Photos 6 through 8; Appendix B)
- Sparse vegetation cover was observed on the west slope near the West Sedimentation Pond upslope of the access road. Erosion and/or rutting is not present within this bare area (Point 5, Photo 8; Appendix B).
- CCR placement is in progress and thus there is no vegetation cover and grading in the active areas. The active areas were not observed due to construction vehicle activity.

Photo 6 (Points 6 and 7) - Phase 1 - west exterior slope, typical.

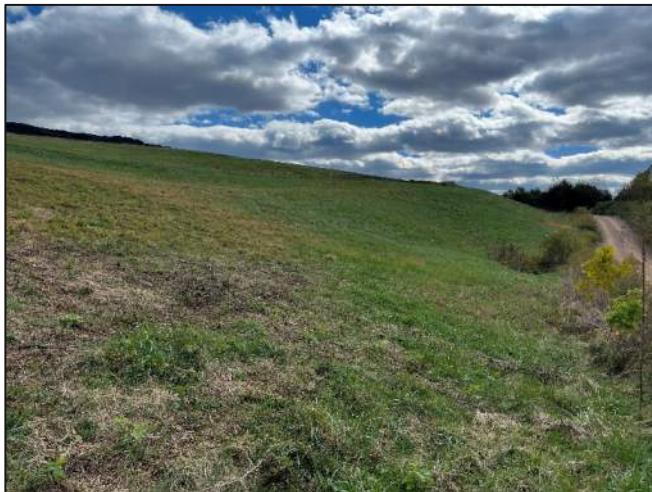
Photo 7 (Point 22) - Phase 1 -
west exterior slope, typical.

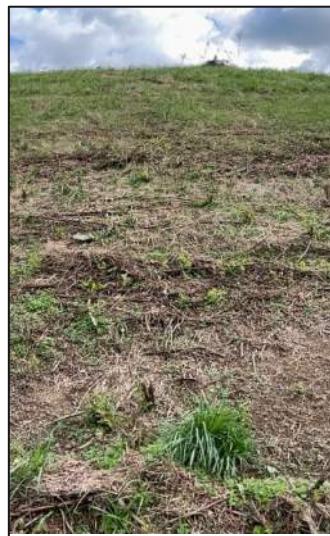
Photo 8 (Point 5) - Phase 1 –
west exterior slope sparse
vegetation.

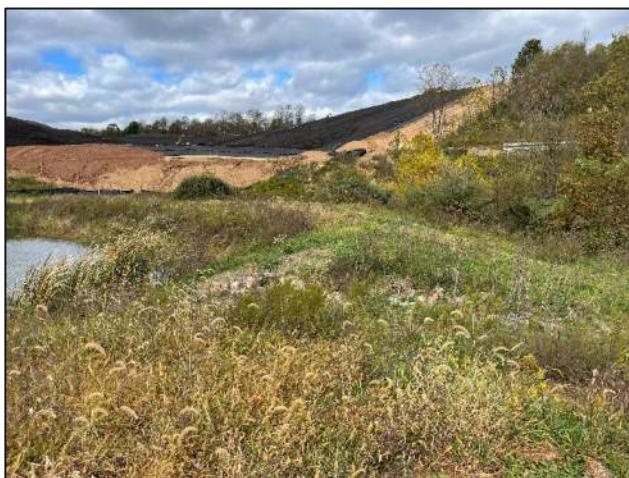
Photo 9 - Interim Leachate
Collection Pond – east crest
dense vegetation.

- Maintain the vegetation along the interior and exterior slopes of the Interim Leachate Collection Pond, West Sedimentation Pond, and the East Sedimentation Pond. Address the interior and exterior erosion as needed to maintain integrity of the ponds.
- Continue to conduct field surveys to measure current topography and compare to design geometry. Rergrade surface to conform to design if needed. Areas near final completion grade are recommended to be capped, closed, and vegetated. Further engineering evaluation of slope stability may be warranted, if deformations, steepened slopes, or sloughing indicate potential for significant instabilities.

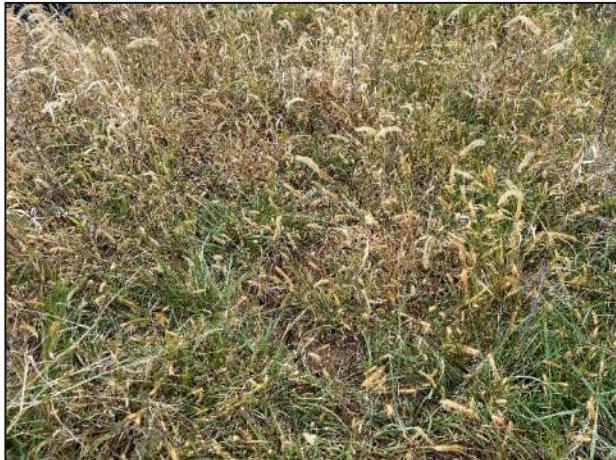
- The east interior slope appears to be separating from the crest and moving toward the pond, an observation consistent with the previous inspection (Points 9 through 12; Photos 10 through 11 and 13; Appendix B).

Photo 10 (Point 9) - Interim Leachate Collection Pond – east crest cracking.

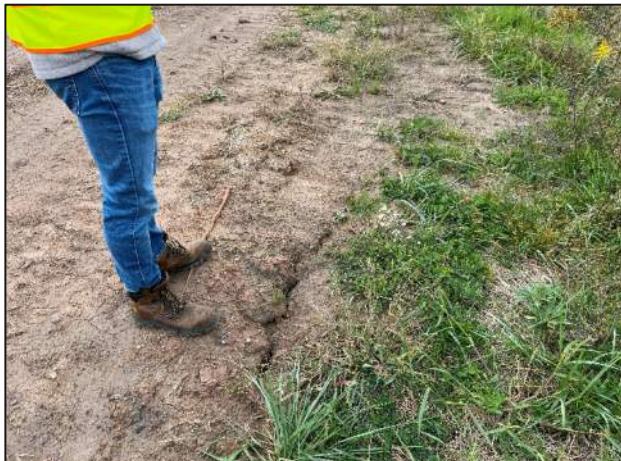
Photo 11 (Point 10) - Interim Leachate Collection Pond – crest cracking on southern end.

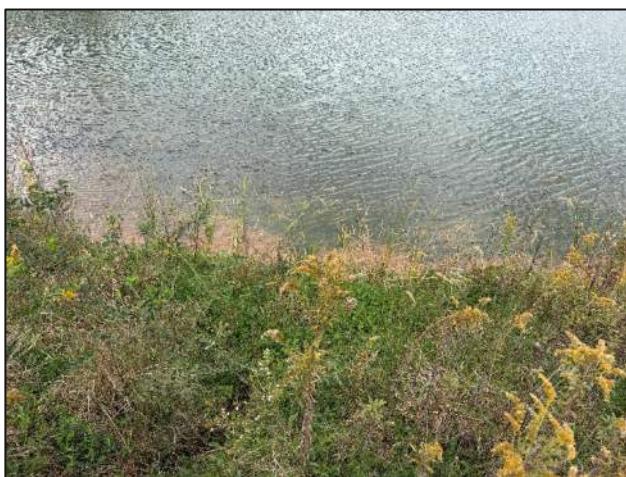
- Erosion of the interior slope at the southwest corner of the pond was observed at the outlet of the 12-inch reinforced concrete pipe (Point 12, Photo 12; Appendix B). Sediment buildup was observed and the geotextile fabric was exposed at the pipe's outlet (Point 13, Photo 14; Appendix B).

Photo 12 (Point 12) – Interim Leachate Collection Pond – erosion at toe of east interior slope.

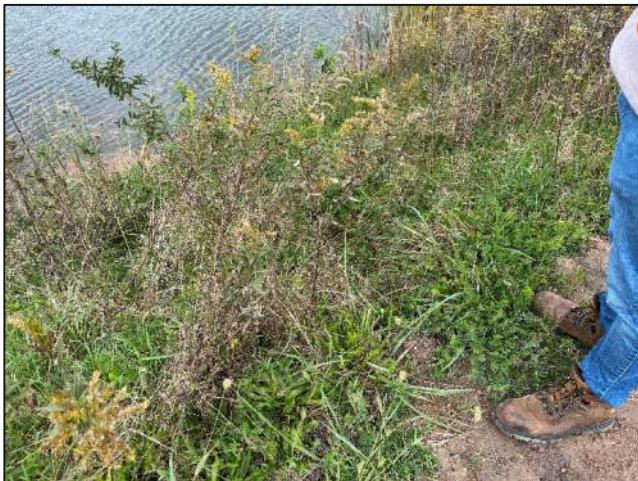
Photo 13 (Point 11) - Interim Leachate Collection Pond – crest cracking on southern end.

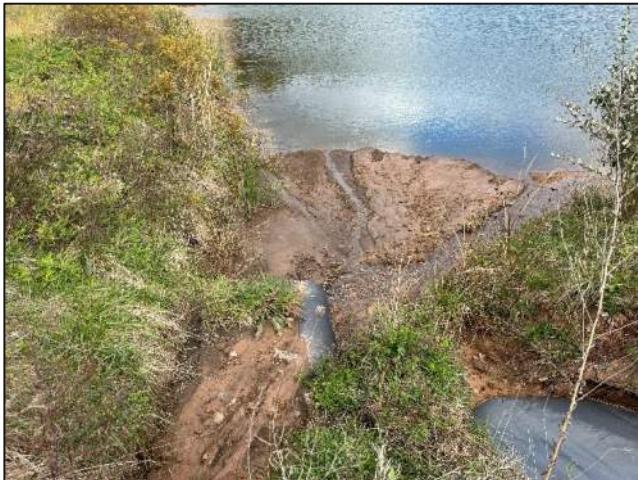
Photo 14 (Point 13) – Interim Leachate Collection Pond – south side sediment buildup at pipe outlet.

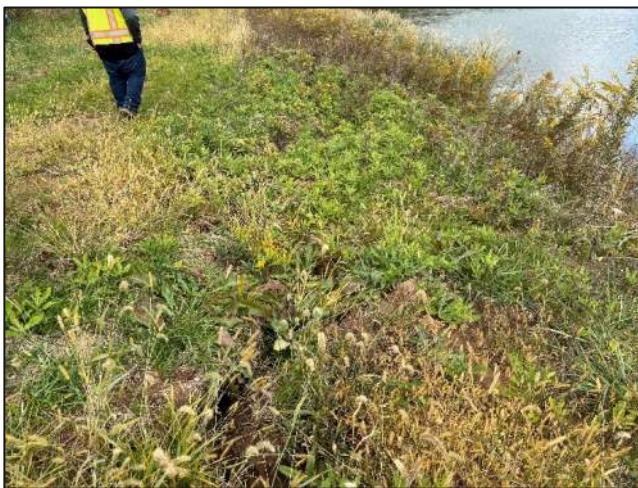
- The west interior slope has detached from the embankment and there is a large rift between the slope and detached portion. Separation was observed starting at its southwest corner (Point 14, Photo 15; Appendix B) and continuing along the slope to its northwest corner (Point 15, Photos 16 through 18; Appendix B).

Photo 15 (Point 14) – Interim Leachate Collection Pond – west side crest separation.

- The bottom portion of the west interior slope of the Interim Leachate Collection Pond has detached. This area should be inspected further to determine the cause. The slope should be regraded to conform to the design.
- The source of ponding at the bottom of the west slope of the Leachate Collection Pond should be investigated to determine if it is correlated to the recent floatation event.

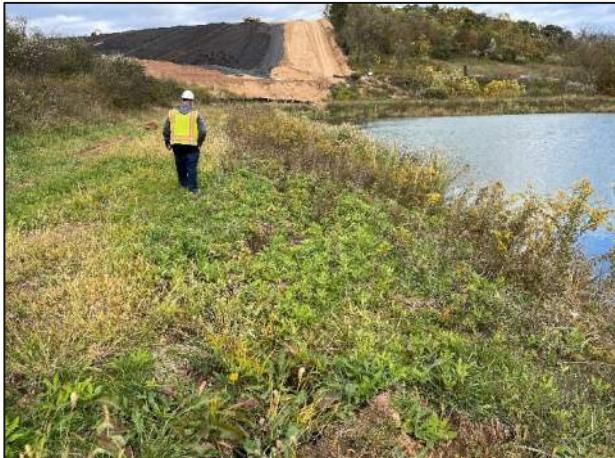
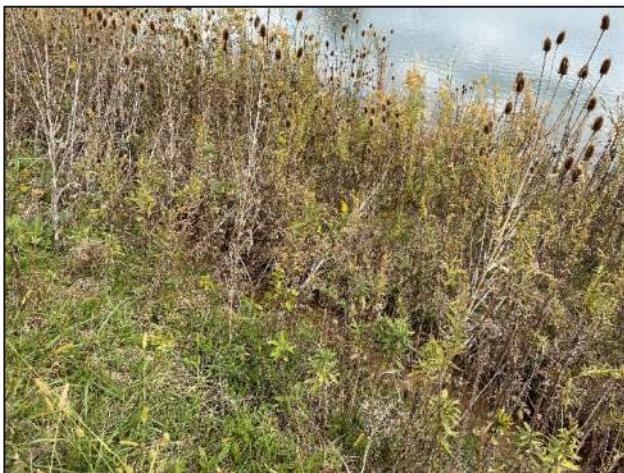
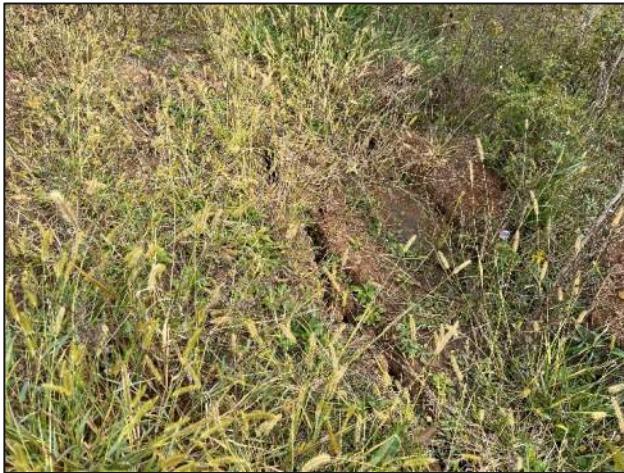
Photo 16 (Point 15) – Interim Leachate Collection Pond – west side crest separation.

Photo 17 (Point 15) - Interim Leachate Collection Pond – west side crest separation.

Photo 18 (Point 15) - Interim Leachate Collection Pond – west side crest separation.

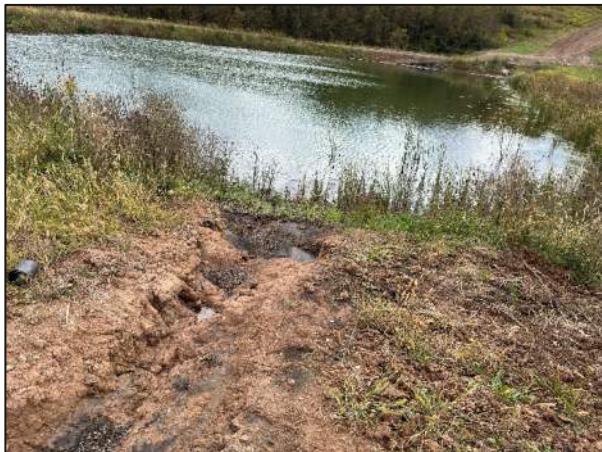
- Erosion was observed on the interior slope at the northwest corner of the pond. It appears the erosion was caused by surface runoff (Photo 19; Appendix B).
- Possible movement in the exterior slope on the south side of the pond was observed, but dense vegetation growth prevented detailed observations (Point 16; Photo 21; Appendix B).

Photo 19 – Interim Leachate Collection Pond – north side erosion.

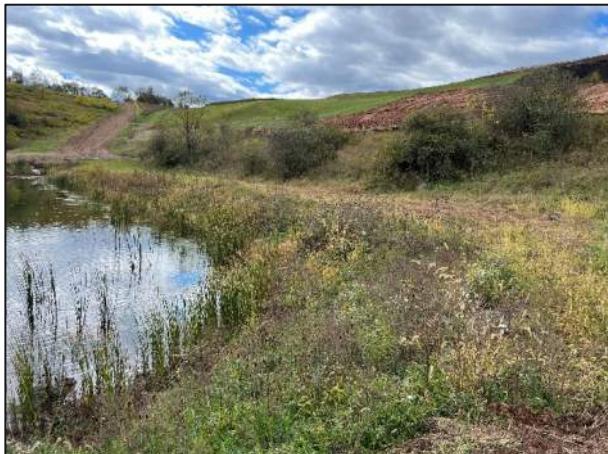
The Interim Leachate Collection Pond is part of Phase 1 construction activities (Photo 20; Appendix B). It manages leachate from the active CCR landfill. Observations made at the Interim Leachate Collection Pond include:

Photo 20 – Interim Leachate Collection Pond – west side, typical.

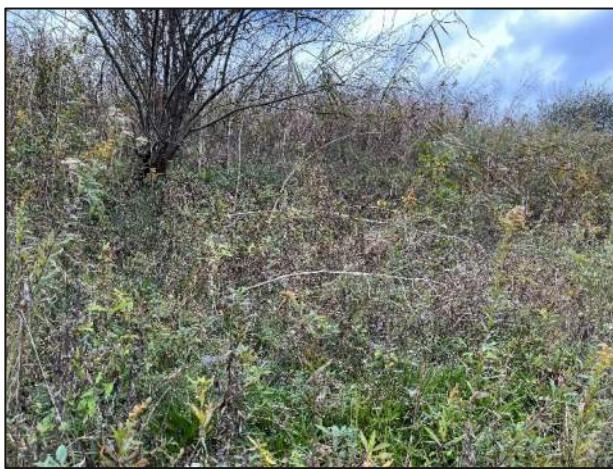
- Dense vegetation growth along the exterior slopes of the embankments surrounding the pond prohibited a thorough inspection of those slopes (Point 16, Photo 21; Appendix B).

Photo 21 (Point 16) - Interim Leachate Collection Pond – southeast exterior slope tree growth and dense vegetation.

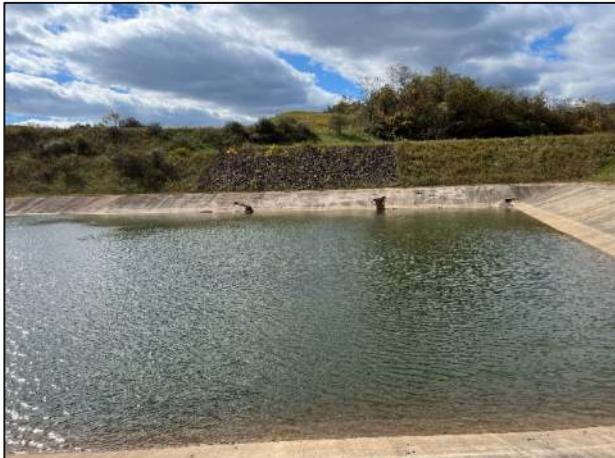
Photo 22 – Leachate Collection Pond – east crest looking west.

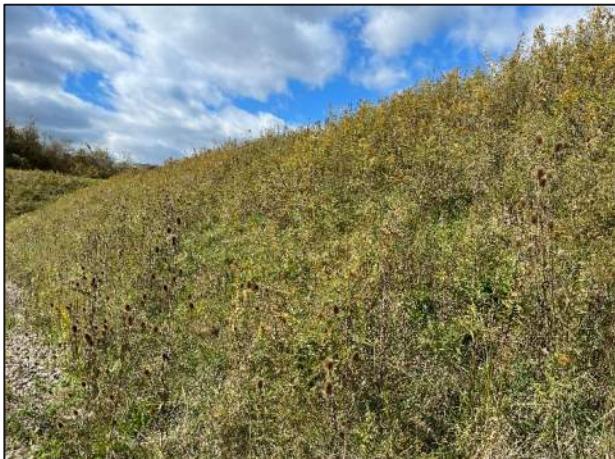
- Mature vegetation is present in the riprap patch on west slope (Point 18, Photo 29; Appendix B).
- Dense vegetation was present on the north interior slope that prohibited observations (Photos 23, 26, and 28; Appendix B).
- Water has pooled in the gravel at the base of the west slope (Points 19 and 20; Photos 29 and 30; Appendix B). OVEC noted that there was recently a bubble in the bottom of the leachate collection pond. Water in this area may be related to the float event.
- A small section of broken concrete was observed at the top of the concrete revetment in the northwest corner of the pond (Point 17, Photo 24; Appendix B).
- Tree growth was observed around the pond outlet on its south end (Point 21, Photo 31; Appendix B).

Photo 23 – Leachate Collection Pond – north interior slope dense vegetation.

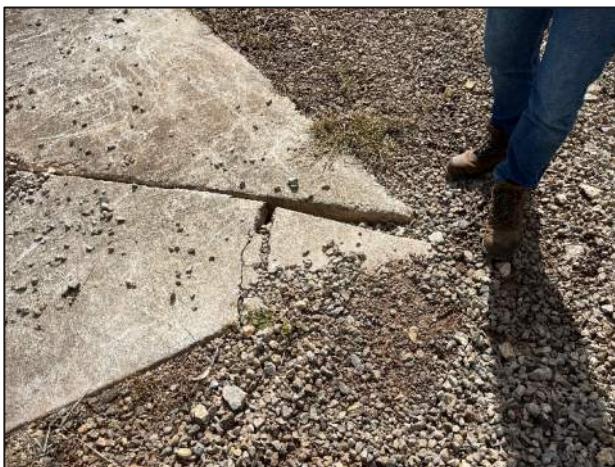
Photo 24 (Point 17) – Leachate Collection Pond – northwest concrete cracking.

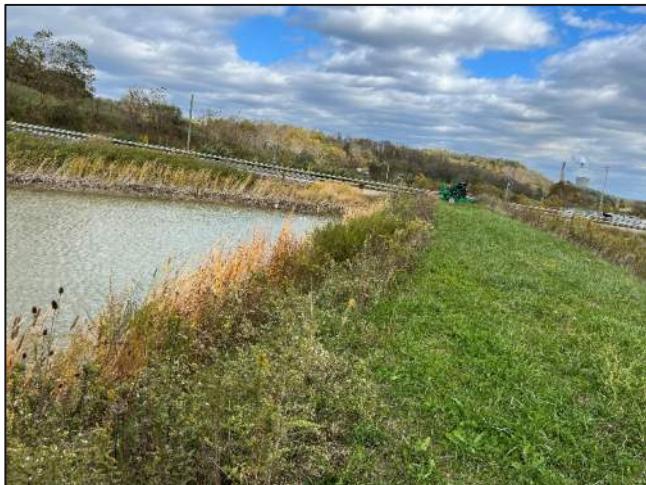
- Dense, woody vegetation obscured the interior slopes of the pond, which prevented a thorough inspection of those areas (Photos 25 and 27; Appendix B).

Photo 25 – East Sedimentation Pond – southeast interior slope dense vegetation.

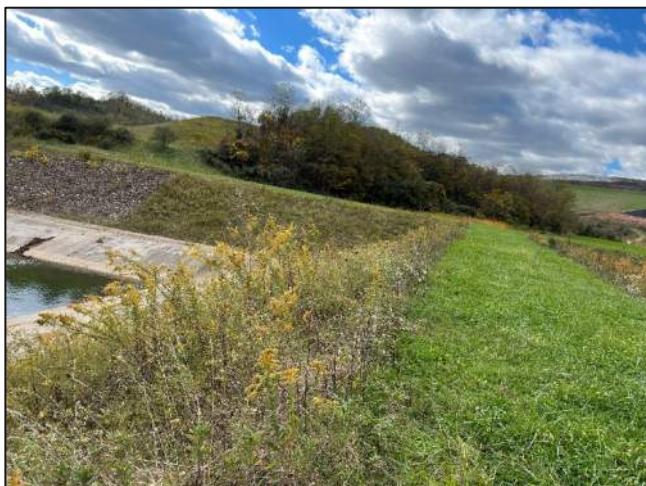
Photo 26 – Leachate Collection Pond – north interior slope dense vegetation.

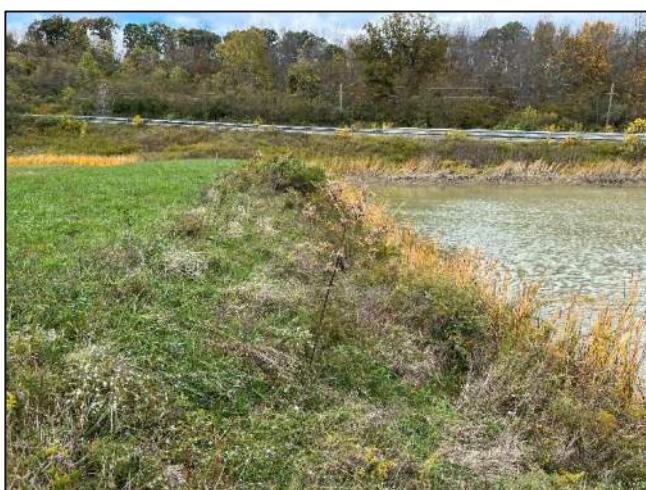
Photo 27 – East Sedimentation Pond – west interior slope dense vegetation.

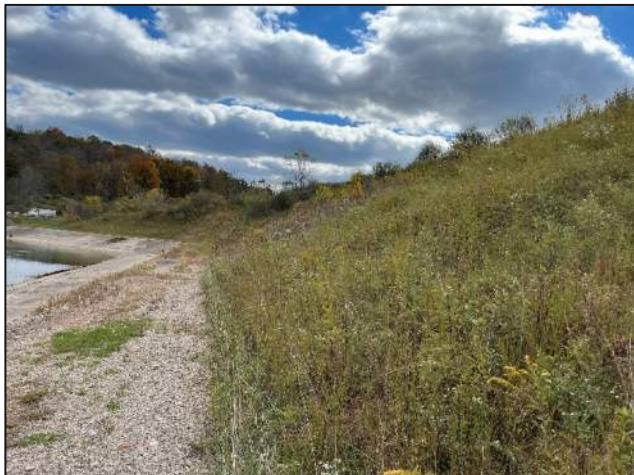
Photo 28 – Leachate Collection Pond – west interior slope dense vegetation.

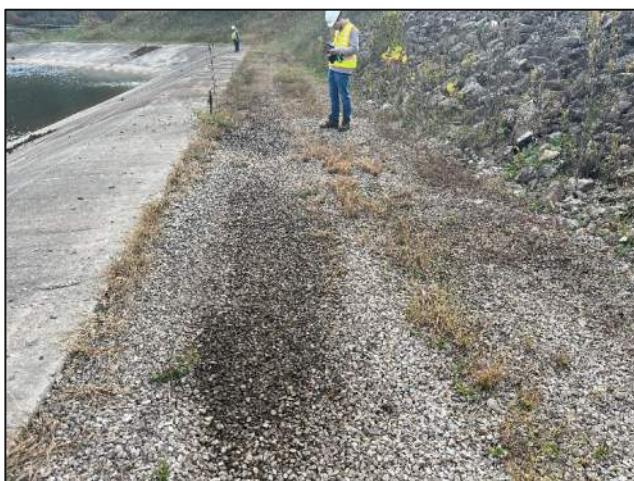
Photo 29 (Point 19) – Leachate Collection Pond – wet spot at toe of west interior slope.

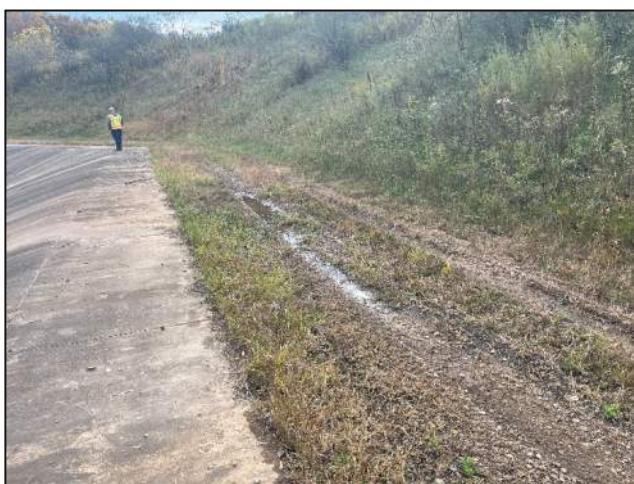
Photo 30 (Point 20) - Leachate Collection Pond – wet spot at toe of west interior slope.

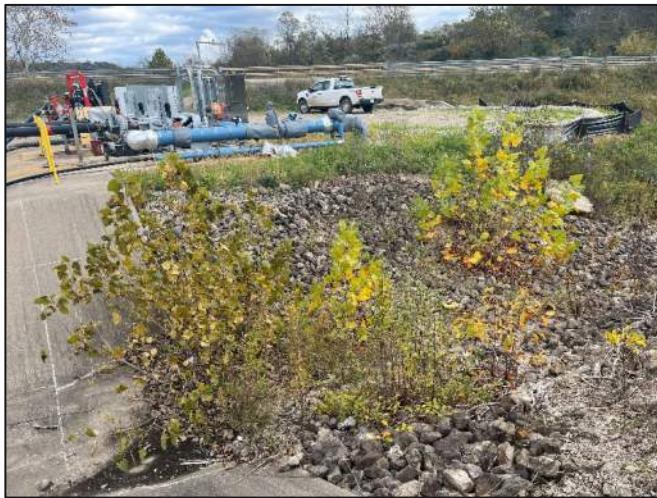
Photo 31 (Point 21) – Leachate Collection Pond – south slope vegetation growth in rip rap.
