**2024 CCR Rule – Surface Impoundments
Kyger Creek Dam/Dike Inspections**

Kyger Creek Generating Station
Cheshire, Ohio
Gallia County

January 19, 2025

Stantec Consulting Services Inc.
Cincinnati, Ohio

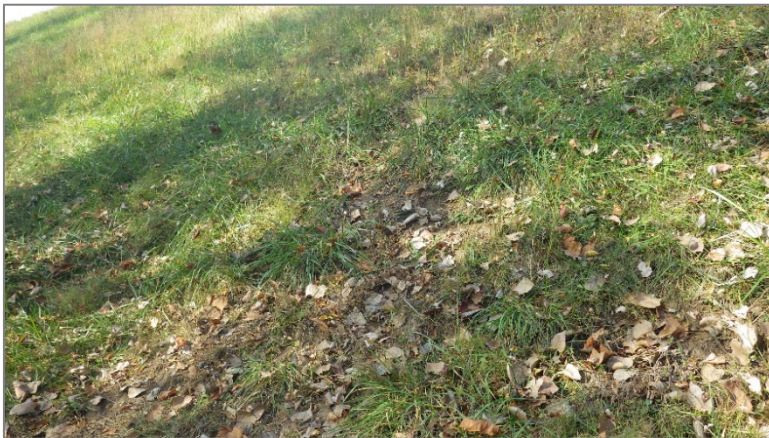
Photo 2, Point 2

Boiler Slag Pond – Southeast
Exterior Slope – Erosion gulley
near the crest.

- Regrade and repair erosion gullies as noted. Reseed barren areas noted on the exterior slope and establish uniform vegetation coverage in areas of need.
- Backfill the documented animal burrows with compacted native soils or a mud-pack of soil and cement, ensuring all voids are filled and the entrance(s) are properly sealed.

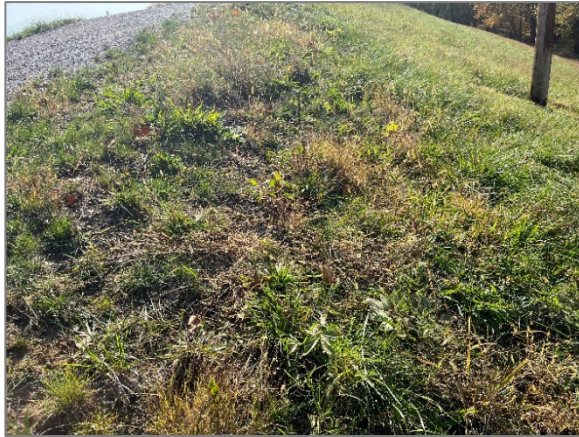
Photo 4, Point 4

Boiler Slag Pond – Southeast
Exterior Slope – Erosion gully
near the crest.

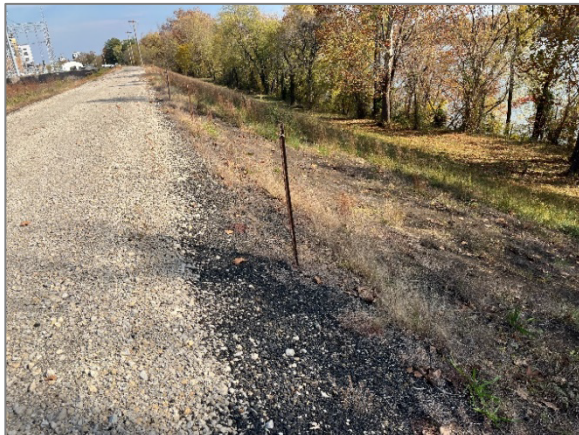
Photo 5, Point 5

Boiler Slag Pond – Southeast
Exterior Slope – Erosion gully
and bare area near the crest.

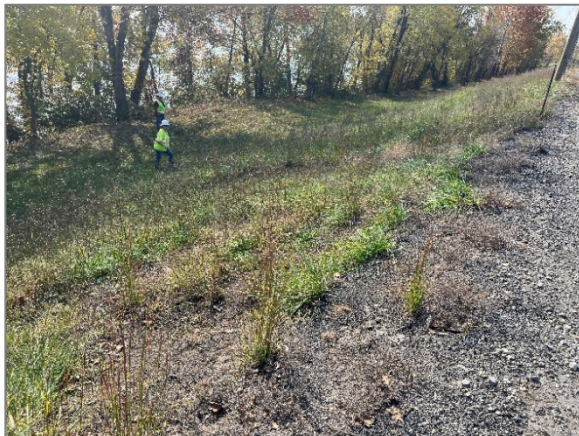
Photo 6, Point 6

Boiler Slag Pond – Southeast
Exterior Slope – Erosion gully
and bare area near the crest.

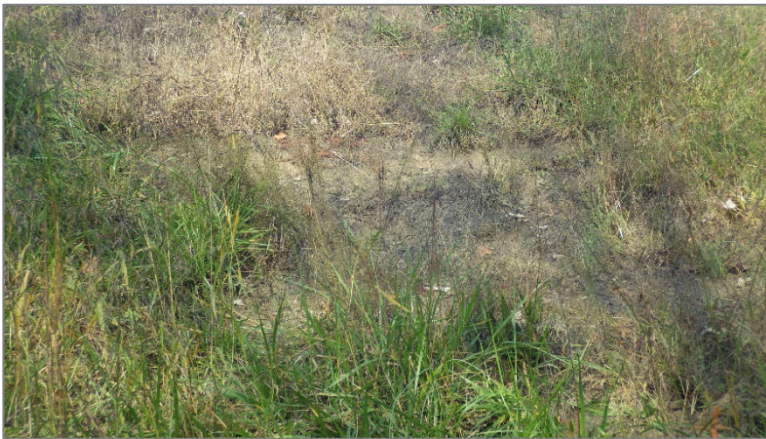
Photo 8, Point 8

Boiler Slag Pond – Southeast
Exterior Slope – Bare spot near
the toe.

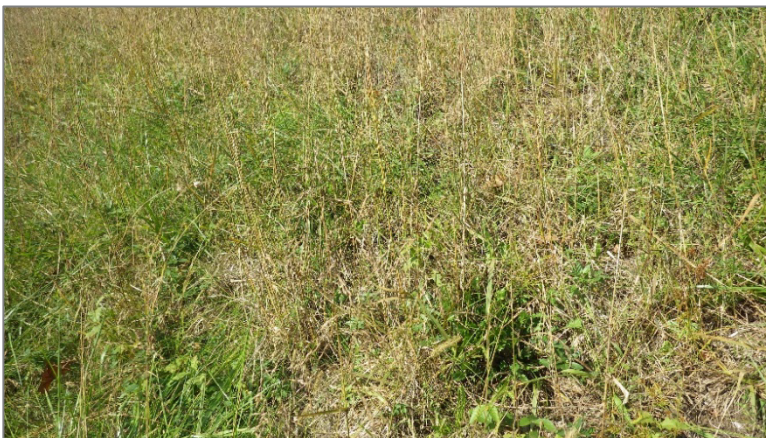
Photo 9, Point 9

Boiler Slag Pond – Southeast
Exterior Slope – Animal burrow
near the toe.

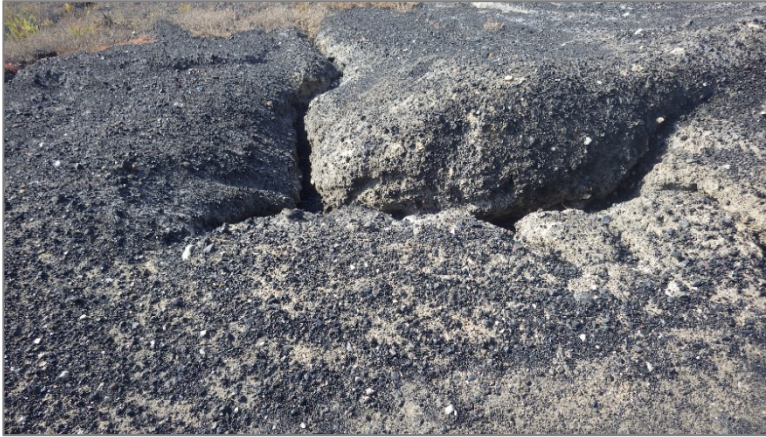
- Erosion rills were documented on both sides of the Splitter Dike near its crest and along the slopes of the dike (Points 11 and 13, Appendix A; Photos 11 and 13; Appendix D).
- Vegetation is thin and areas of exposed earth were noted in areas along the perimeter embankment (Points 5, 8, 18, 19, 21 through 25, Appendix A; Photos 5, 8, 18, 20, and 22; Appendix D).
- Animal burrows are observed in the perimeter embankment surrounding the pond (Points 9 and 10, Appendix A; Photos 9 and 10, Appendix D).
- Seepage was noted as the CCR dewatered within the BSP closure area. Flow was visible in three locations along the dike (Points 12 and 14, Appendix A; Photos 12 and 14, Appendix D).

Photo 13, Point 13
Boiler Slag Pond – Southwest
Divider Dike – Erosion gully at
the crest.

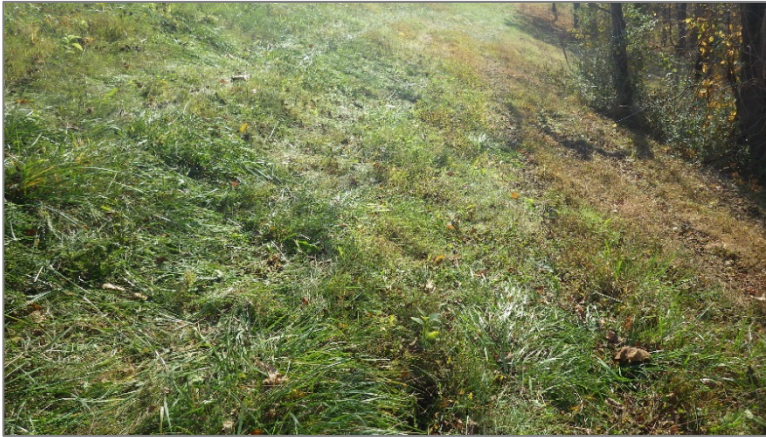
Photo 16, Point 16
Boiler Slag Pond – West Exterior
Slope – Erosion gully near the
crest.

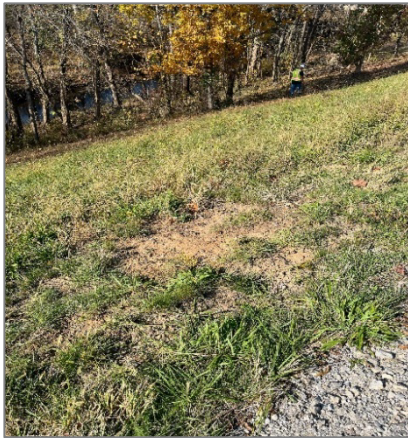
Photo 17, Point 17
LVWTS Secondary Basin – West
Exterior Slope – Erosion gully
near the crest.

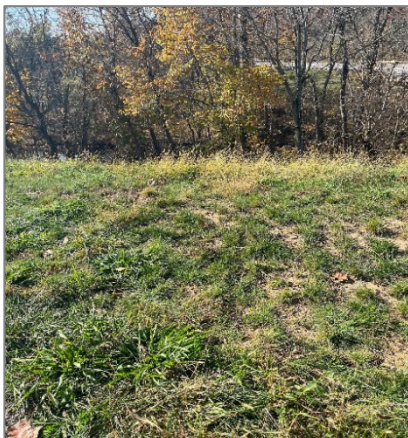
Photo 18, Point 18
LVWTS Secondary Basin – West
Exterior Slope – Bare spot near
the crest.

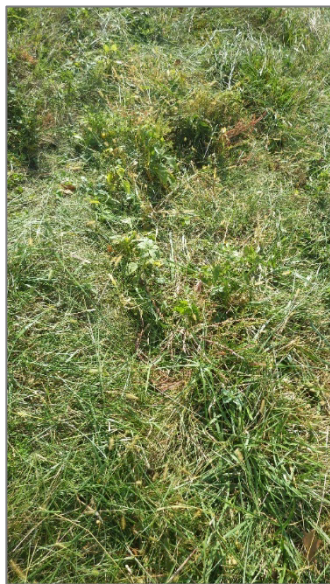
Photo 21, Point 20
LVWTS – West Exterior Slope –
Depression in the slope near
the toe.

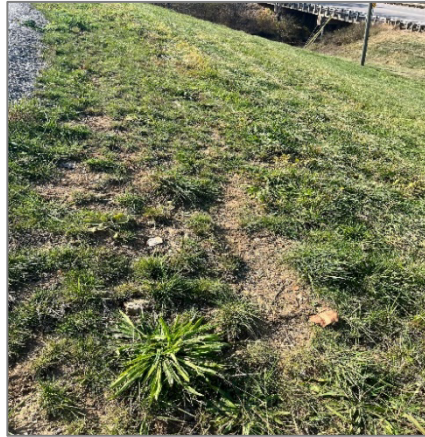
Photo 22, Point 21
LVWTS – West Exterior Slope –
Bare spot near the crest.

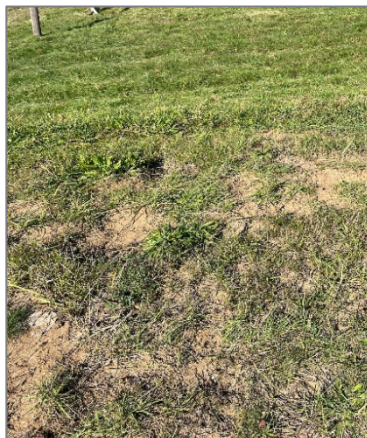
Photo 24, Point 23
LVWTS – West Exterior Slope-
Bare spot near the toe.

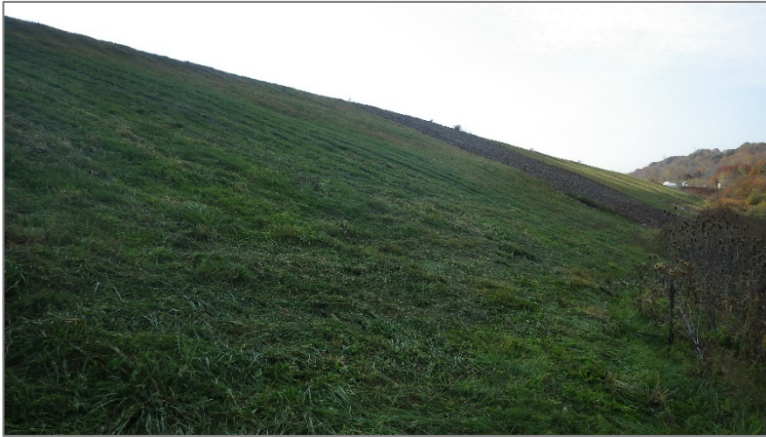
Photo 28, Point 27
Northwest Exterior Slope –
Depression in lower half of
slope.

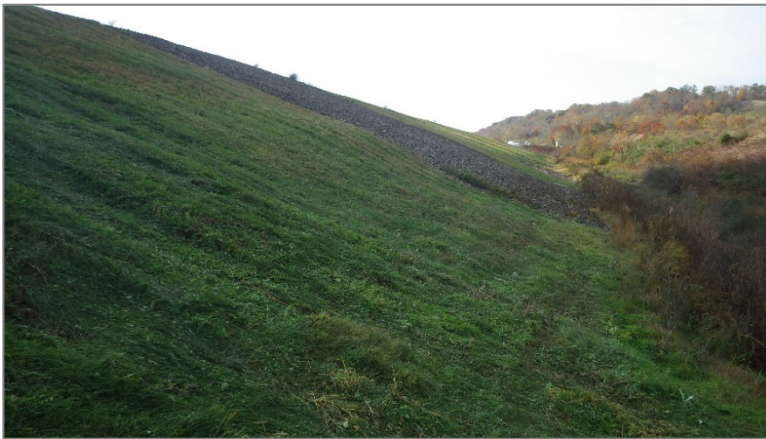
Photo 29, Point 28
Northwest Exterior Slope –
Depression in lower half of
slope.

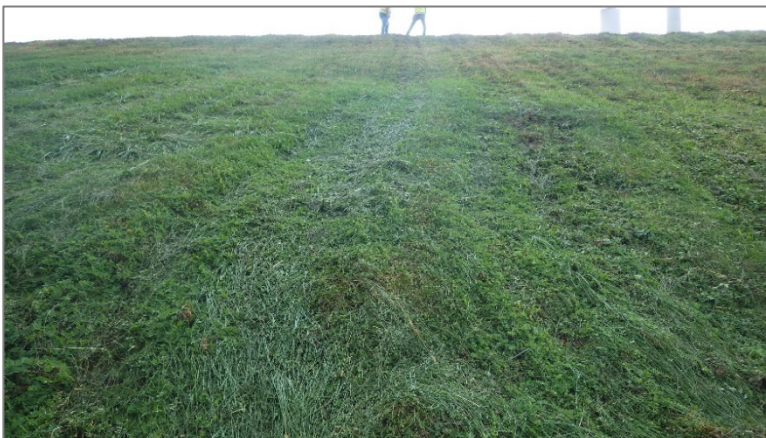
Photo 30, Point 29
Northwest Exterior Slope –
Depression in lower half of
slope.

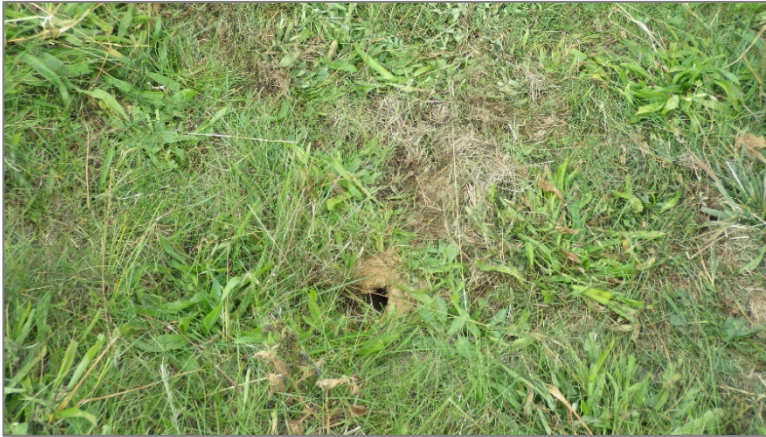
- Animal burrows are observed in the perimeter embankment surrounding the pond at two locations (Points 32 and 45, Appendix A; Photos 31 and 44, Appendix D).

Photo 31, Point 30
Northwest Exterior Slope –
Animal burrow near the toe.

- Regrade and repair erosion gullies as noted. Reseed barren areas noted on the exterior slope and establish uniform vegetation coverage in areas of need.
- Backfill the documented animal burrows with compacted native soils or a mud-pack of soil and cement, ensuring all voids are filled and the entrance(s) are properly sealed.
- Repair the sloughing surface on the west corner of the pond near the toe. Additionally, determine the cause of the small depressions on the southeast exterior slope and repair them as needed. Additional riprap rock in these areas may be necessary to protect the slope.

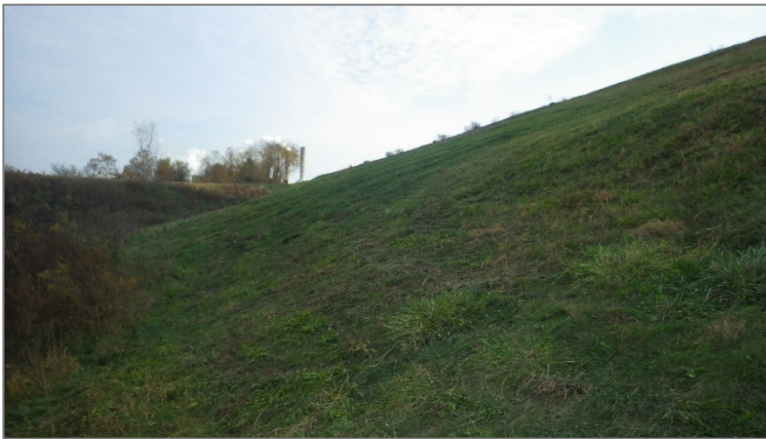
- No operational flow was evident at the time of the inspection at the inlet to the SFAP at the southeastern corner.
- Surficial erosion and bare spots are observed at multiple locations along the exterior slope of the perimeter embankments (Points 26, 33, 34, 41, and 42, Appendix A; Photos 25, 32, 33, 40, and 41, Appendix D).

Photo 32, Point 31
Northwest Exterior Slope – Bare
spot on the slope near mid-
height.

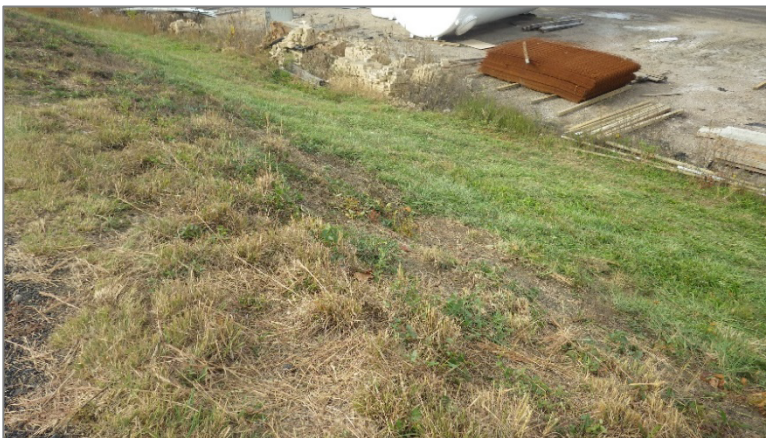
Photo 33, Point 32
West Exterior Slope – Bare spot
on slope near the crest.

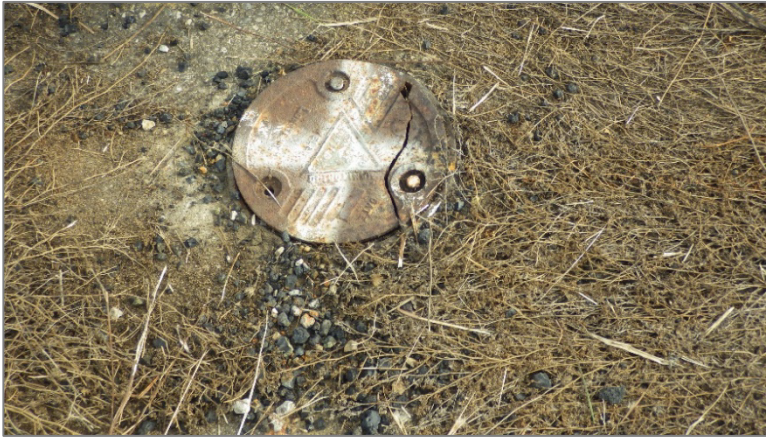
- The ground surface metal cover to a piezometer at the toe of the perimeter embankment at the west corner has been damaged, exposing the piezometer to moisture from the ground surface (Point 35, Appendix A; Photo 34, Appendix D).

Photo 34, Point 33
West Exterior Slope – Damaged
well lid on instrumentation.

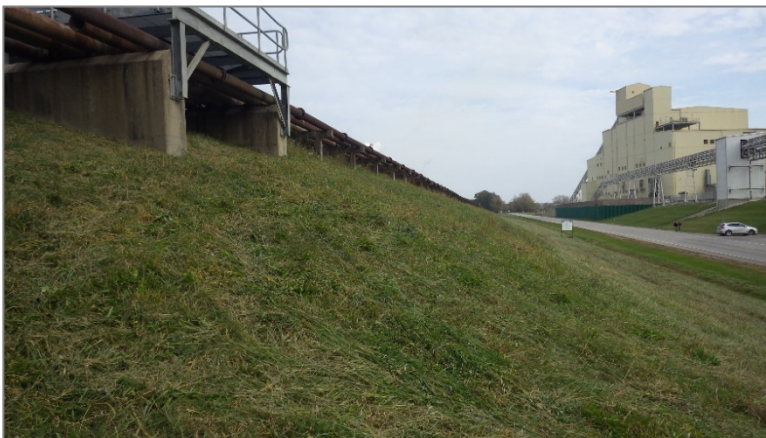
- Small-diameter surficial depressions are noted along the southeast exterior embankment (Points 37 and 39, Appendix A; Photos 36 and 38, Appendix D). An outward bow in the slope is also observed among these depressions (Point 40, Appendix A; Photo 39, Appendix D).

Photo 36, Point 35
Southeast Exterior Slope –
Depression at mid-height of the
slope.

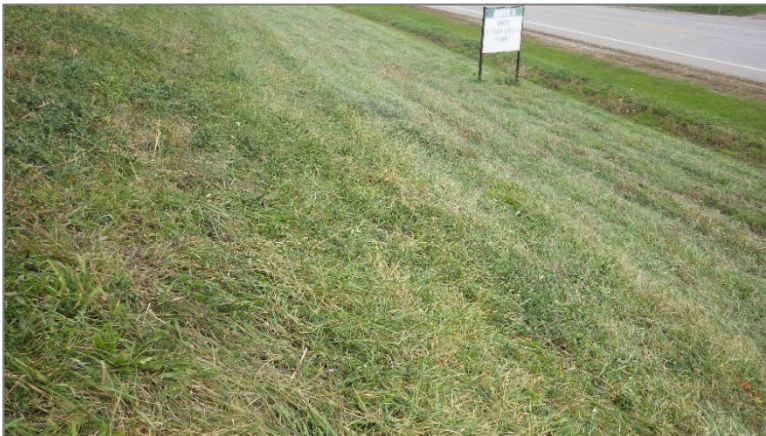
Photo 39, Point 38
Southeast Exterior Slope – Bow
in the slope at mid-height.

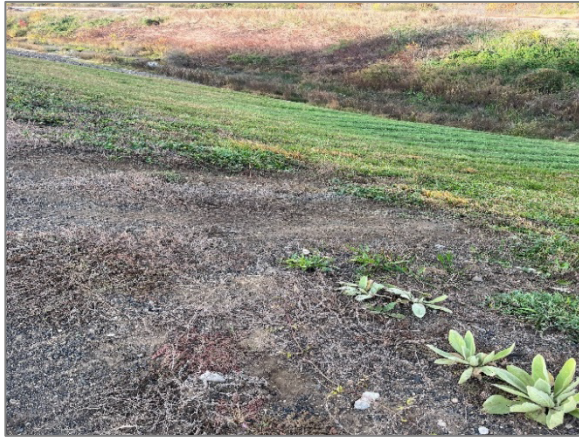
Photo 40, Point 39
Southeast Exterior Slope –
Erosion gully near the crest.

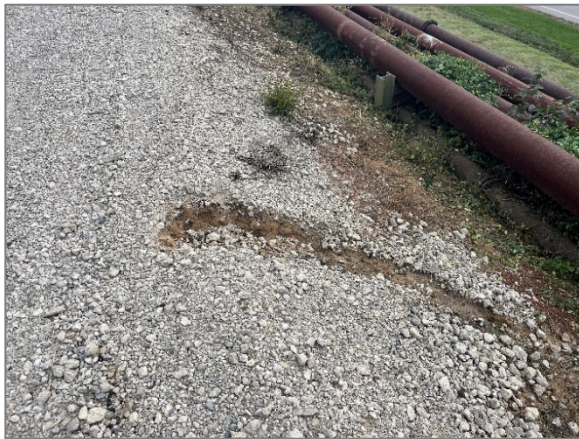
Photo 41, Point 40
Southeast Exterior Slope –
Erosion gully near the crest.

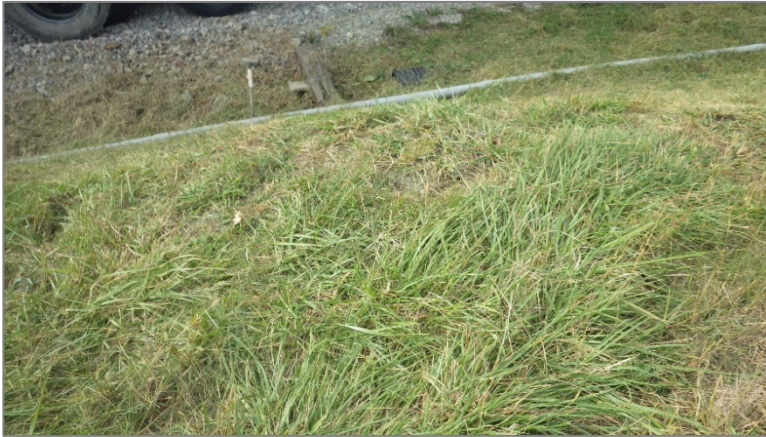
Photo 46, Point 45
Southwest Exterior Slope –
Slough on slope.
