**2025 CCR Rule – Surface Impoundments
Kyger Creek Dam/Dike Inspections**

Kyger Creek Generating Station
Cheshire, Ohio
Gallia County

January 19, 2026

Stantec Consulting Services Inc.
Cincinnati, Ohio

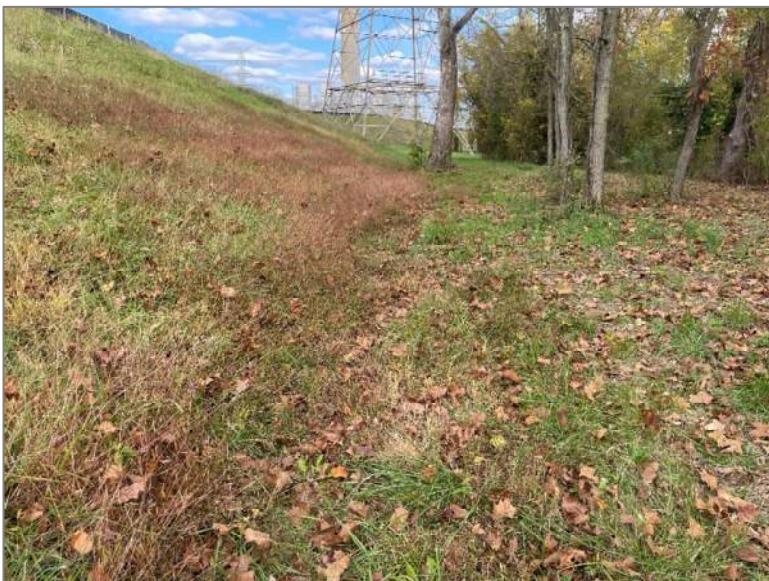
Photo 10, Point 7

- The exterior slopes are mowed, vegetated, and uniform along the northwest, southwest, and southeast perimeter of the clearwater pond (Photo 9, Appendix D).
- Trees and woody vegetation are growing along the toe of the embankment and Kyger Creek (Photo 9, Appendix D).
- The topography is difficult to discern along the exterior toe of the southeast perimeter. Water may pond at the toe following rain events. Ground was firm and no standing water was observed at the exterior toe (Point 7, Appendix A; Photo 10, Appendix D).

Clearwater Pond – Southeast
Exterior Slope – Drainage
direction at toe unclear.

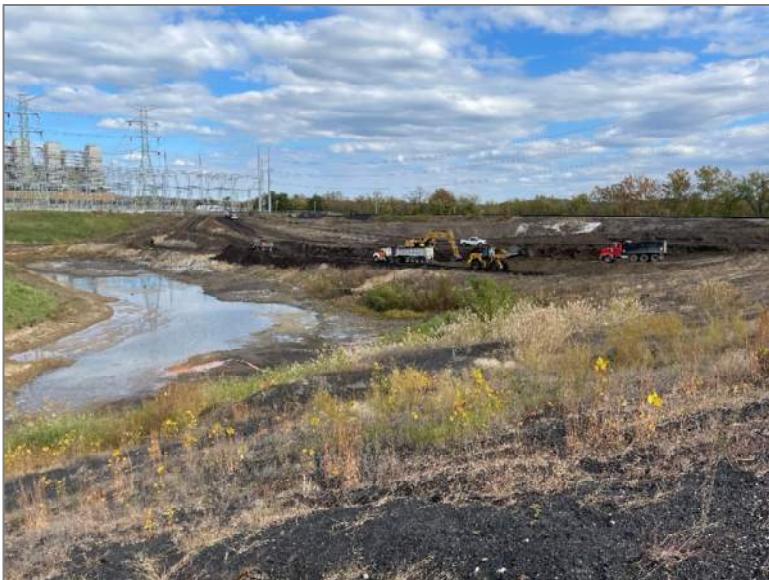
Photo 13

No operational flows were noted during the site visit into the boiler slag pond closure area. Ponded water was limited to an area at the toe of the LVWTS within the BSP closure area (Photo 13, Appendix D).

Boiler Slag Pond – Facing east from Splitter Dike – Closure by removal construction in progress.

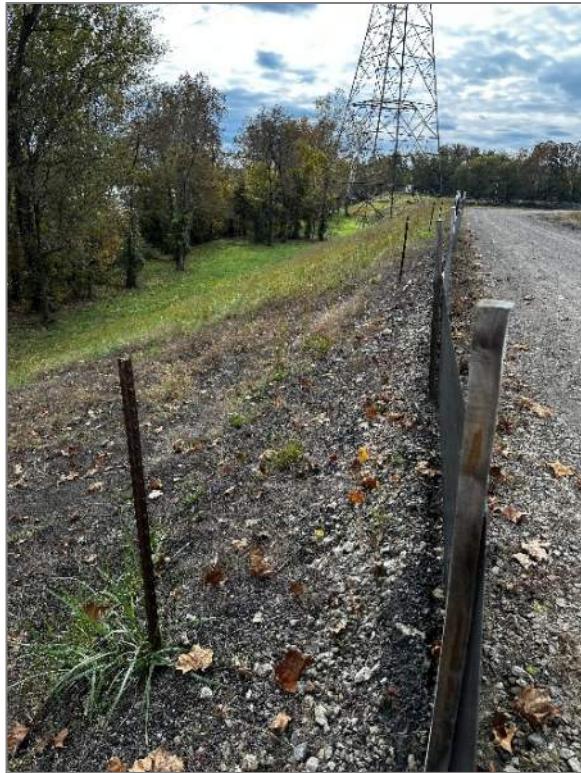
- Surface erosion and erosion rills are noted, particularly as the material changes from the road surfacing to the grassy slopes near the crest along the perimeter embankment (Points 1, 3, and 4, Appendix A; Photos 1, 4, 5, 15, 17, 18, and 19, Appendix D).

Photo 15
Boiler Slag Pond – Southeast
Exterior Slope – Erosion along
the crest.

- Reroute and repair erosion gullies as noted. Reseed barren areas noted on the exterior slope and establish uniform vegetation coverage in areas of need.

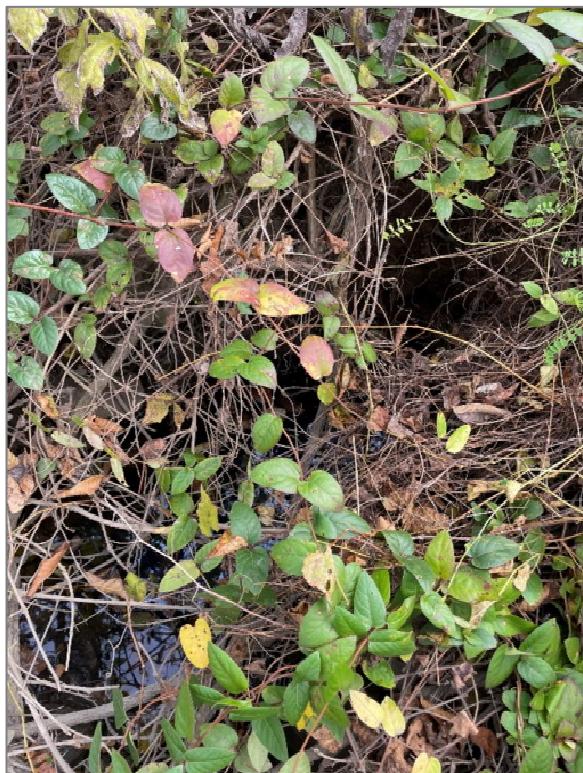
Photo 22, Point 11

- Surficial erosion and bare spots are observed at multiple locations along the exterior slope of the perimeter embankments (Points 11, 14, 15, 19, 21, 25, 26, and 27, Appendix A; Photos 22, 25, 26, 29, 31, 37, 38, and 39, Appendix D).

Northwest Exterior Slope –
1-foot-deep erosion rill near toe

- Reroute and repair erosion gullies as noted. Reseed barren areas noted on the exterior slope and establish uniform vegetation coverage in areas of need.
- Backfill the documented animal burrows with compacted native soils or a mud-pack of soil and cement, ensuring all voids are filled and the entrance(s) are properly sealed.
- Repair the sloughing surface on the west corner of the pond near the access road.

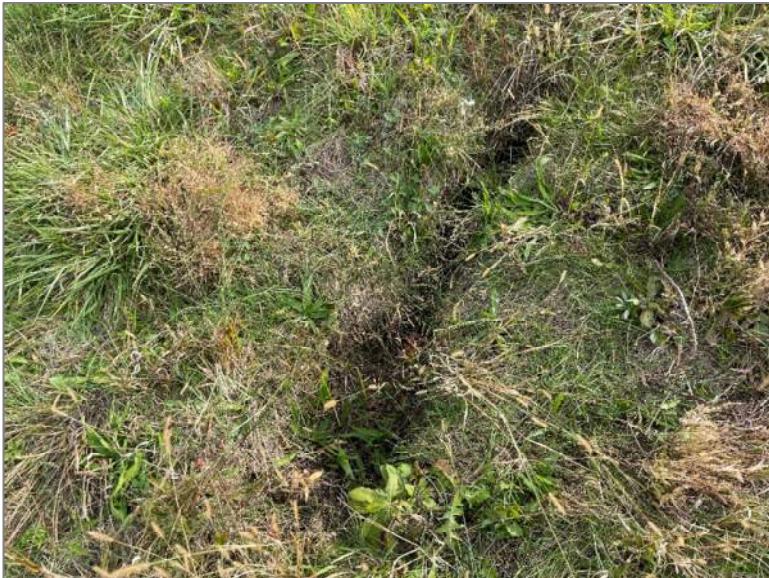
Photo 25, Point 14
Northwest Exterior Slope –
Erosion gulley, bare spots

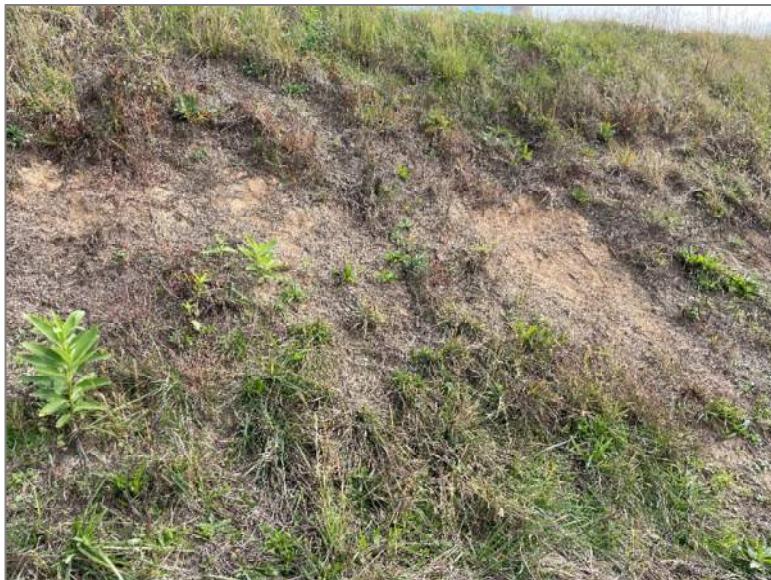
Photo 31, Point 21

West Exterior Slope – Surface erosion, bare spots at access ramp.

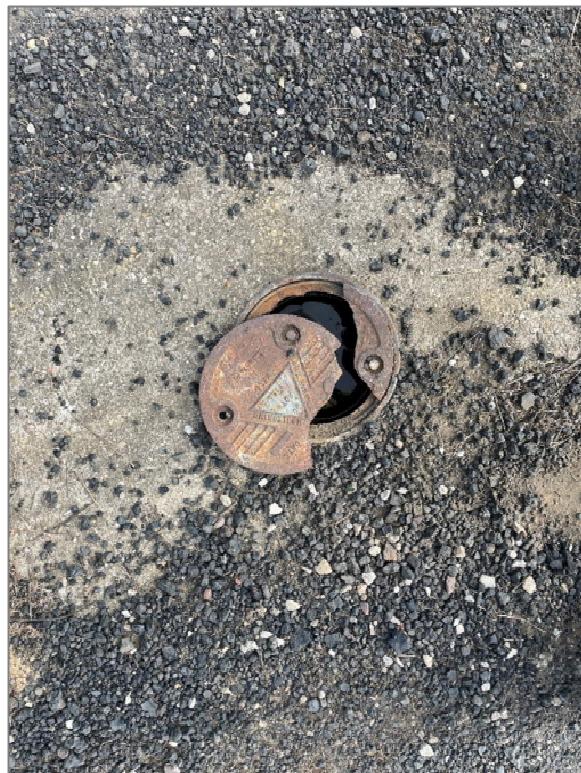
Photo 32, Point 22

- The ground surface metal cover to a piezometer at the crest of the perimeter embankment at the west corner has been damaged, exposing the piezometer to moisture from the ground surface (Point 22, Appendix A; Photo 32, Appendix D).

West Crest – Damaged well lid on instrumentation.

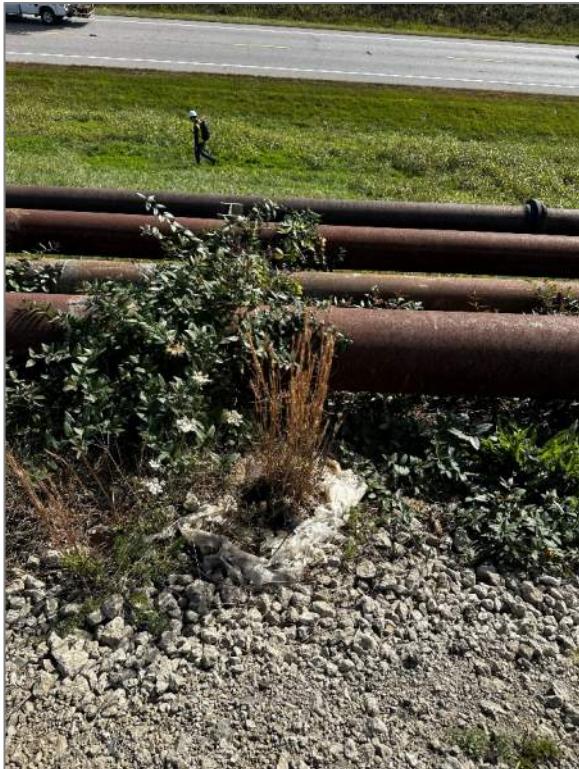
Photo 39, Point 27
Southeast Exterior Slope –
Erosion gully on crest and
slope.
