2018 ANNUAL DAM AND DIKE INSPECTION REPORT

**West Boiler Slag Pond
&
Landfill Runoff Collection Pond**

**CLIFTY CREEK PLANT
Indiana-Kentucky Electric Corporation
MADISON, INDIANA**

October 22, 2018

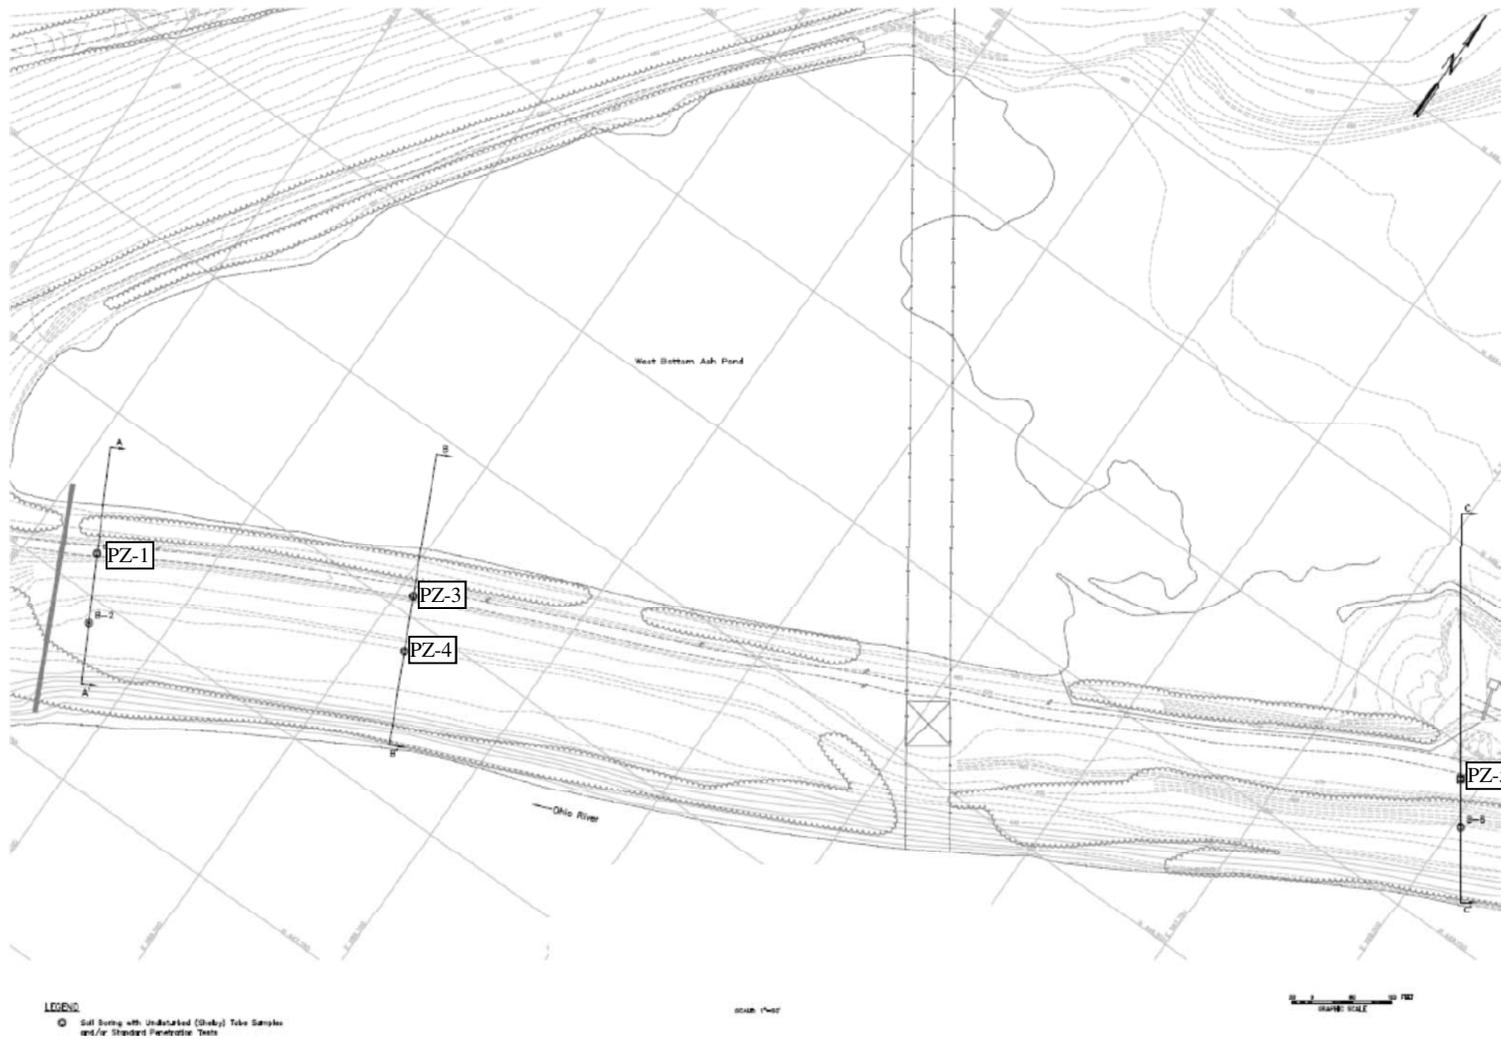
FIGURE 1. WEST BOILER SLAG POND INSTRUMENTS LOCATION PLAN

The location and type of instrumentation is shown on Figure 1. The results of the measurements of various piezometers since November 2015 are shown in Figure 2. The maximum recorded readings of each instrument since the previous annual inspection is shown in Table 1.

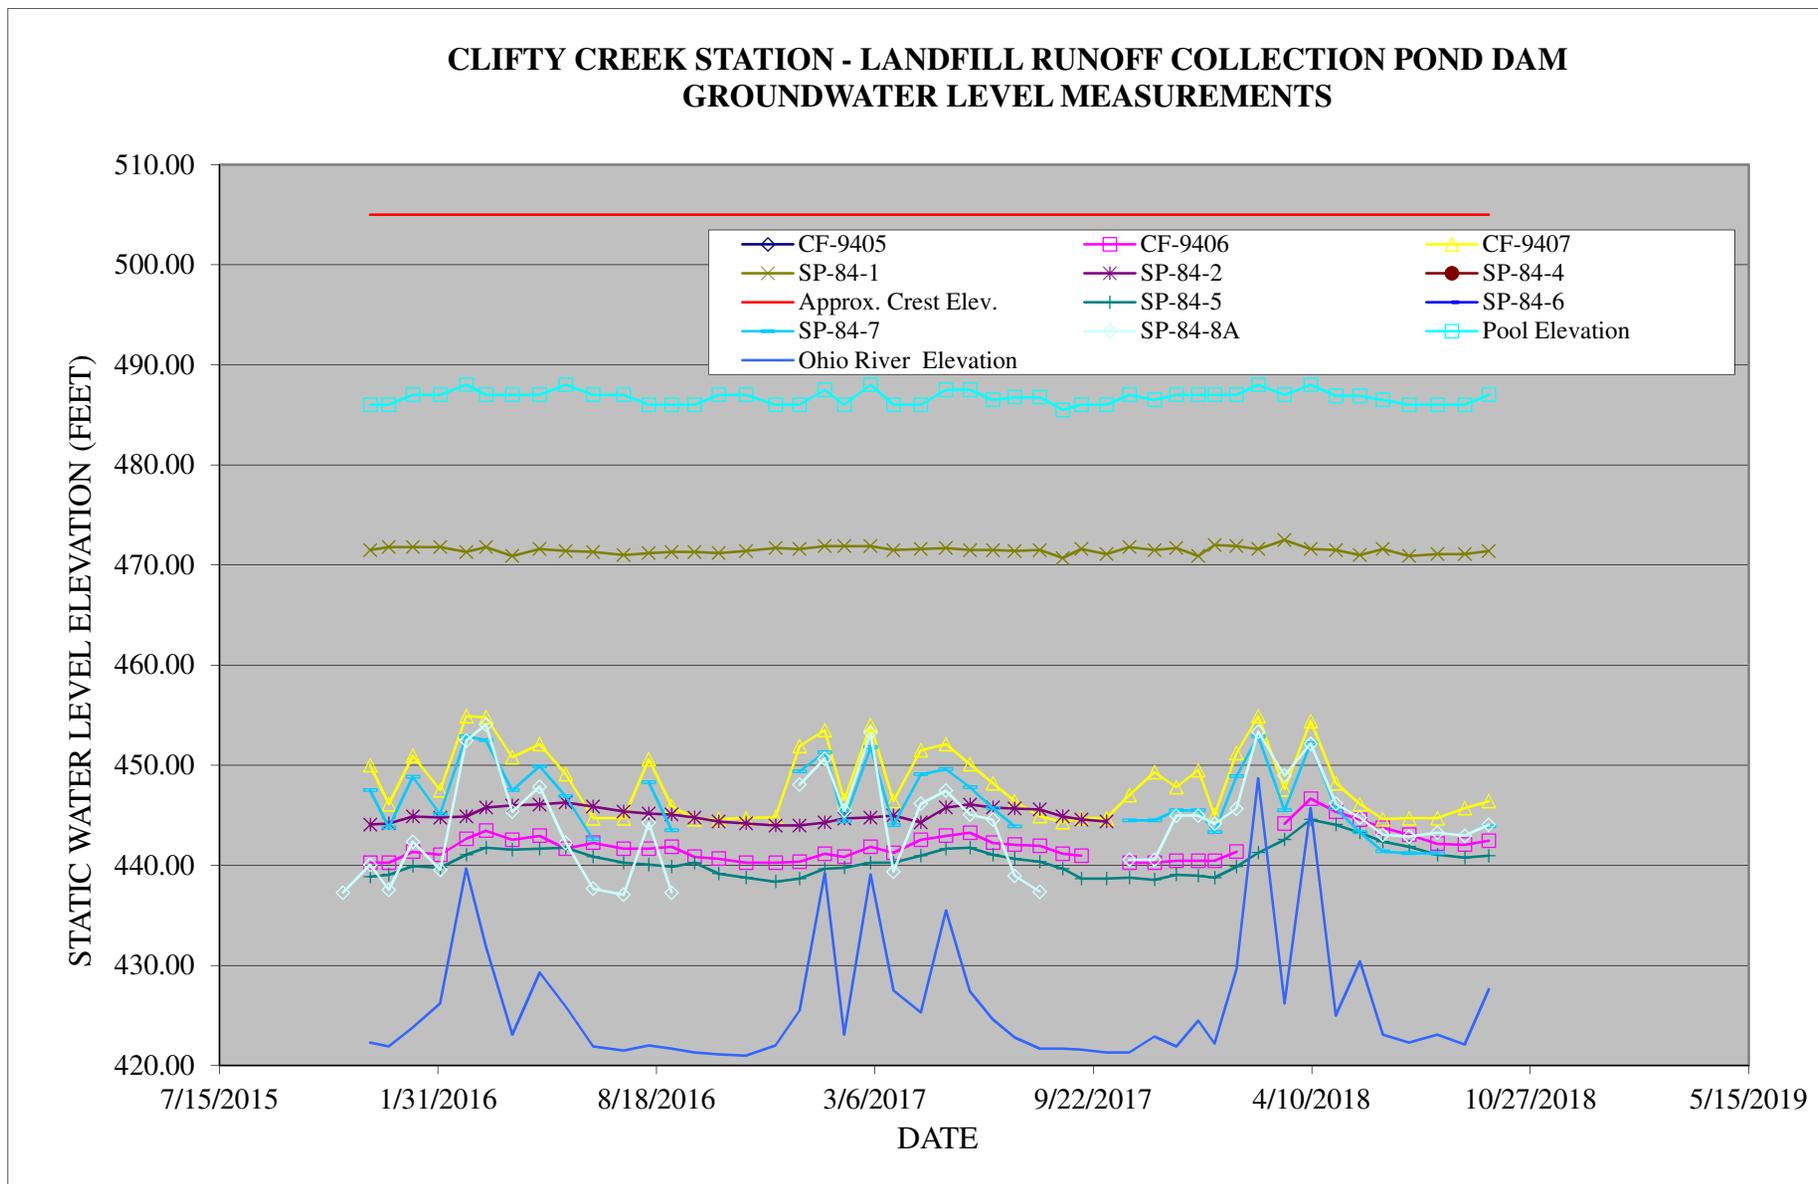
FIGURE 4. LANDFILL RUNOFF COLLECTION POND GROUNDWATER LEVEL MEASUREMENTS

The location and type of instrumentation is shown on Figure 3. The results of the measurements of various piezometers since November 2015 are shown in Figure 4. The maximum recorded readings of each instrument since the previous annual inspection is shown in Table 3 below.
