2019 ANNUAL DAM AND DIKE INSPECTION REPORT

**West Boiler Slag Pond
& Landfill Runoff Collection Pond**

**CLIFTY CREEK PLANT
Indiana-Kentucky Electric Corporation
MADISON, INDIANA**

Document ID: GERS-19-021

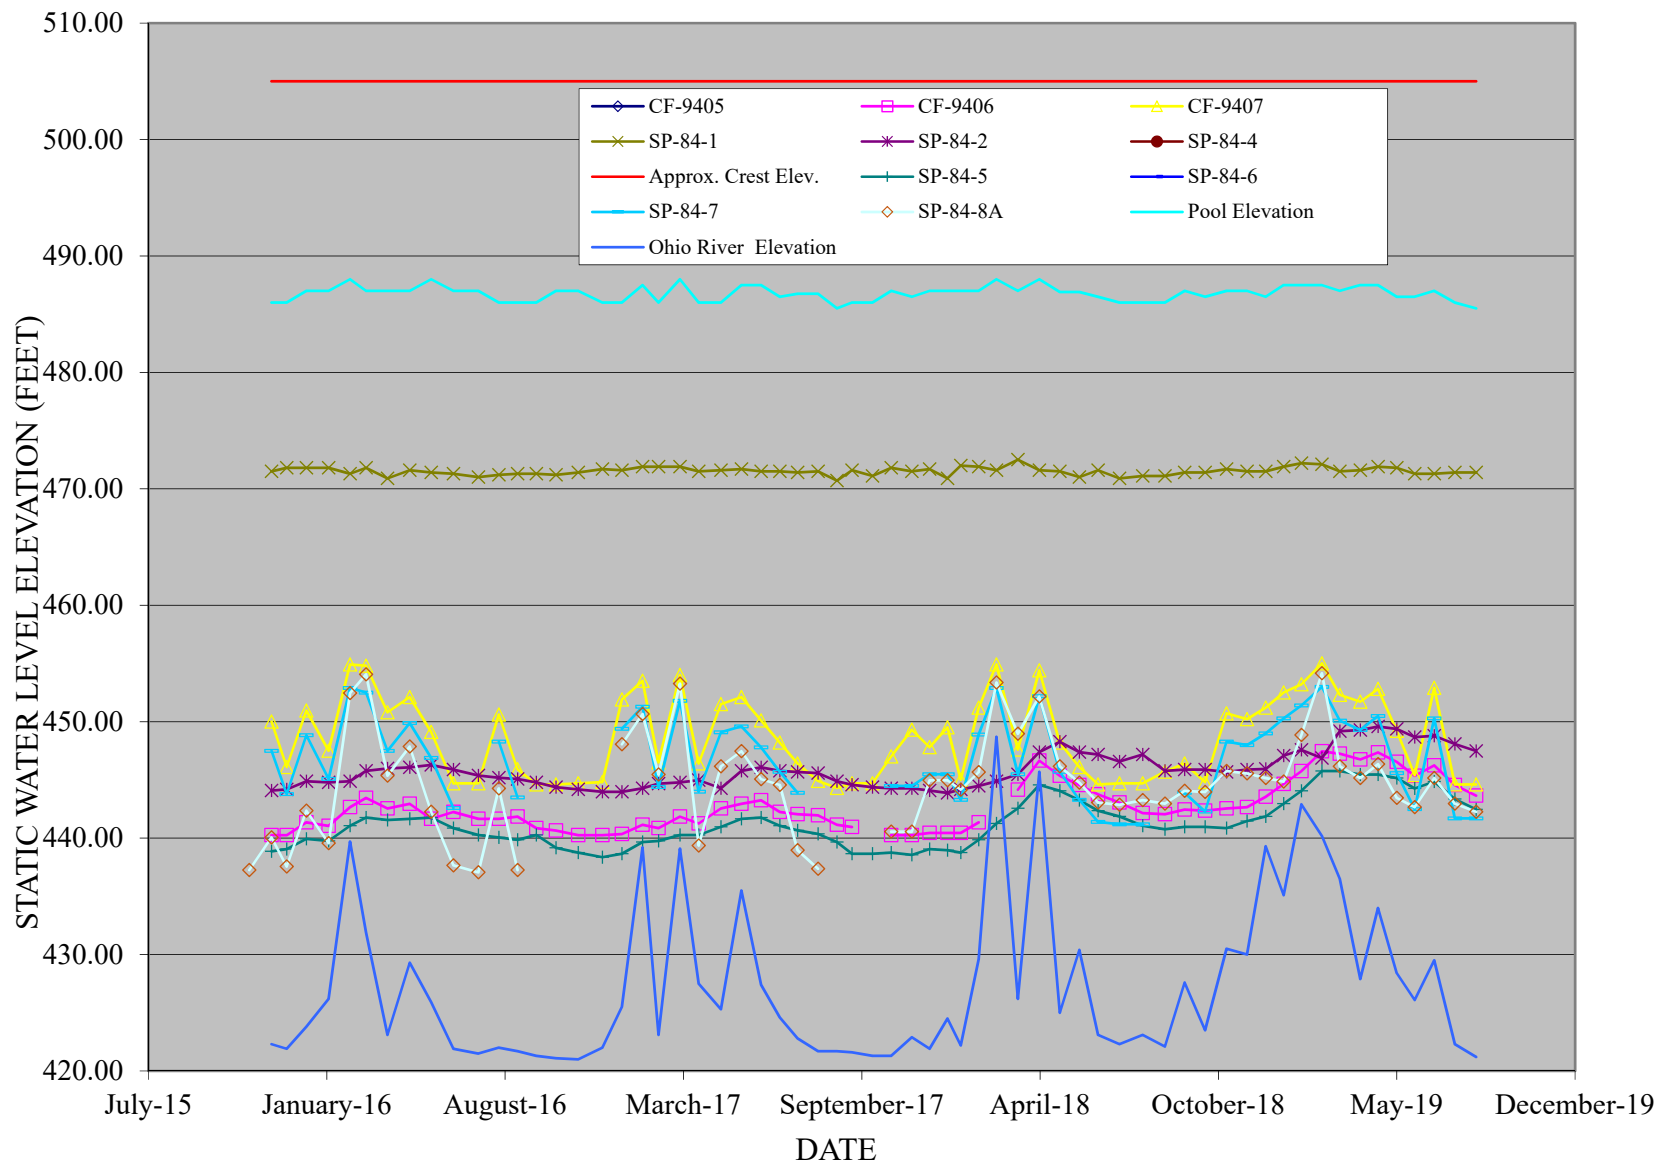
FIGURE 4. LANDFILL RUNOFF COLLECTION POND PIEZOMETERS MEASUREMENTS

The location and type of instrumentation is shown on Figure 3. The results of the measurements of various piezometers since November 2015 are shown in Figure 4. The maximum recorded readings of each instrument since the previous annual inspection is shown in Table 3 below.

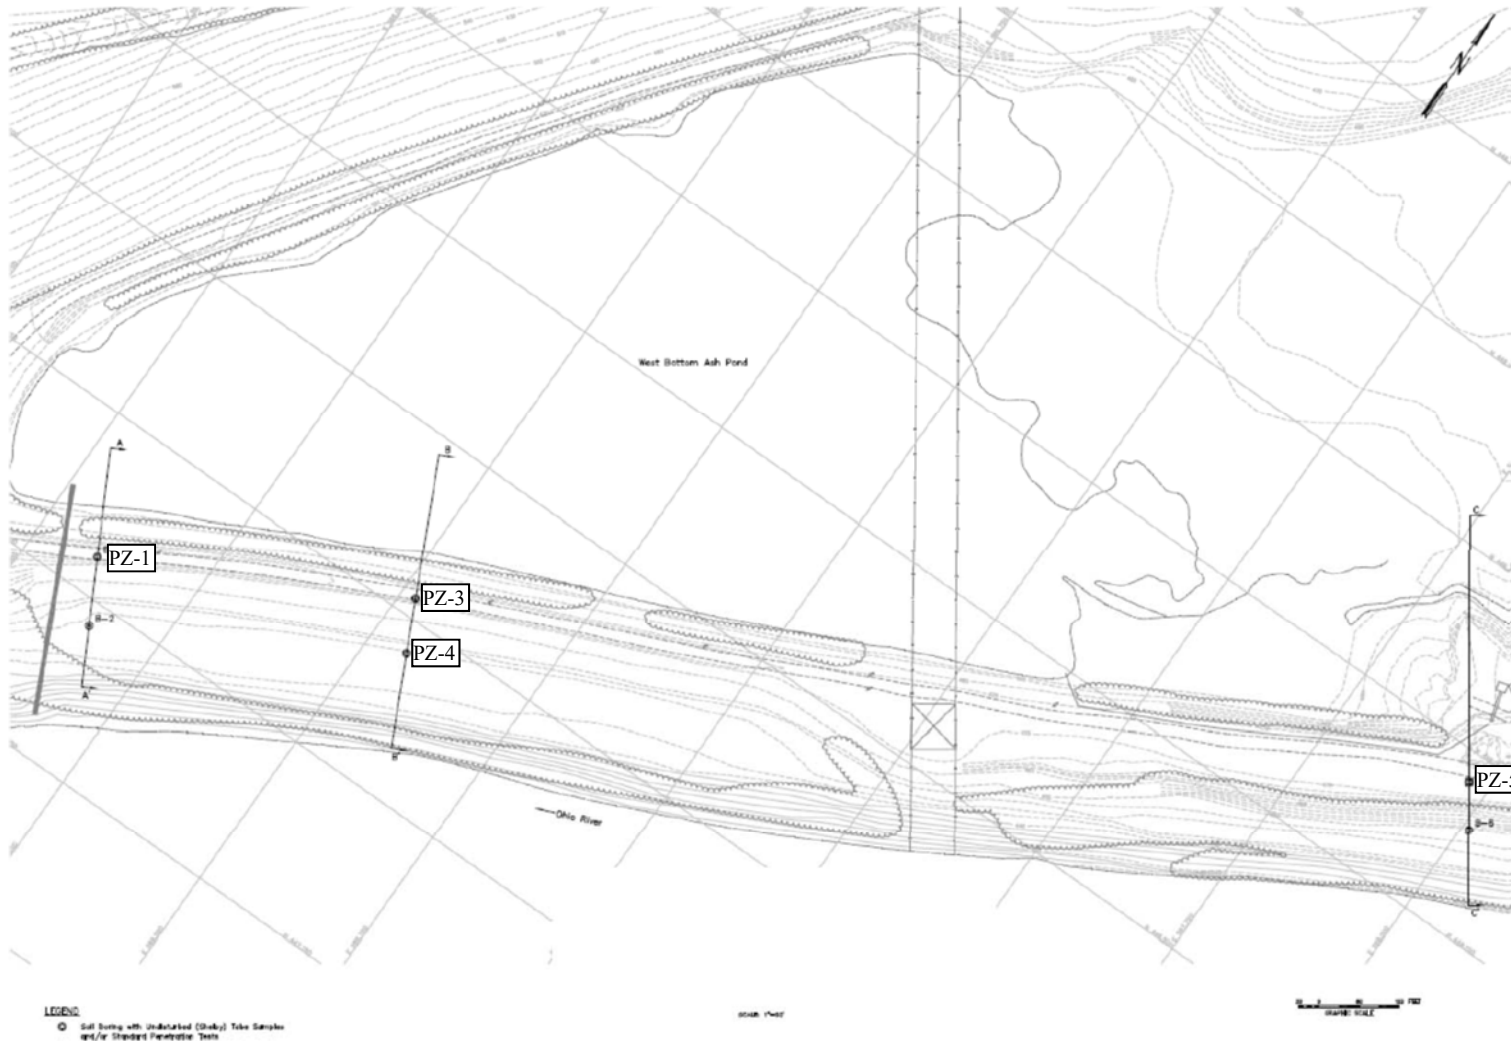
FIGURE 1. WEST BOILER SLAG POND PIEZOMETERS LOCATION PLAN

The WBSP (Figure 1) is located southwest of the station. It is formed by natural grade to the north, east, and west and an embankment dam on the south that runs along the bank of the Ohio River. The WBSP serves as a settling basin for sluiced bottom ash produced at the station and receives stormwater runoff from approximately 510 acres (Stantec, 2010a). The WBSP is used for the storage of bottom ash generated from all six generating Units. It consists of a single dike that is approximately 2,000 feet long and is approximately 35 feet high. The crest is at elevation 470.0 feet. The pond contains two primary areas: the eastern portion near the sluice pipes that is actively dredged for the recovery of material, and a western portion with minimal deposition or dredging activities. A vegetation delta separates the two areas acting as a natural filtering zone. The pond discharges to the Ohio River through a principal spillway at the southern edge of the impoundment.

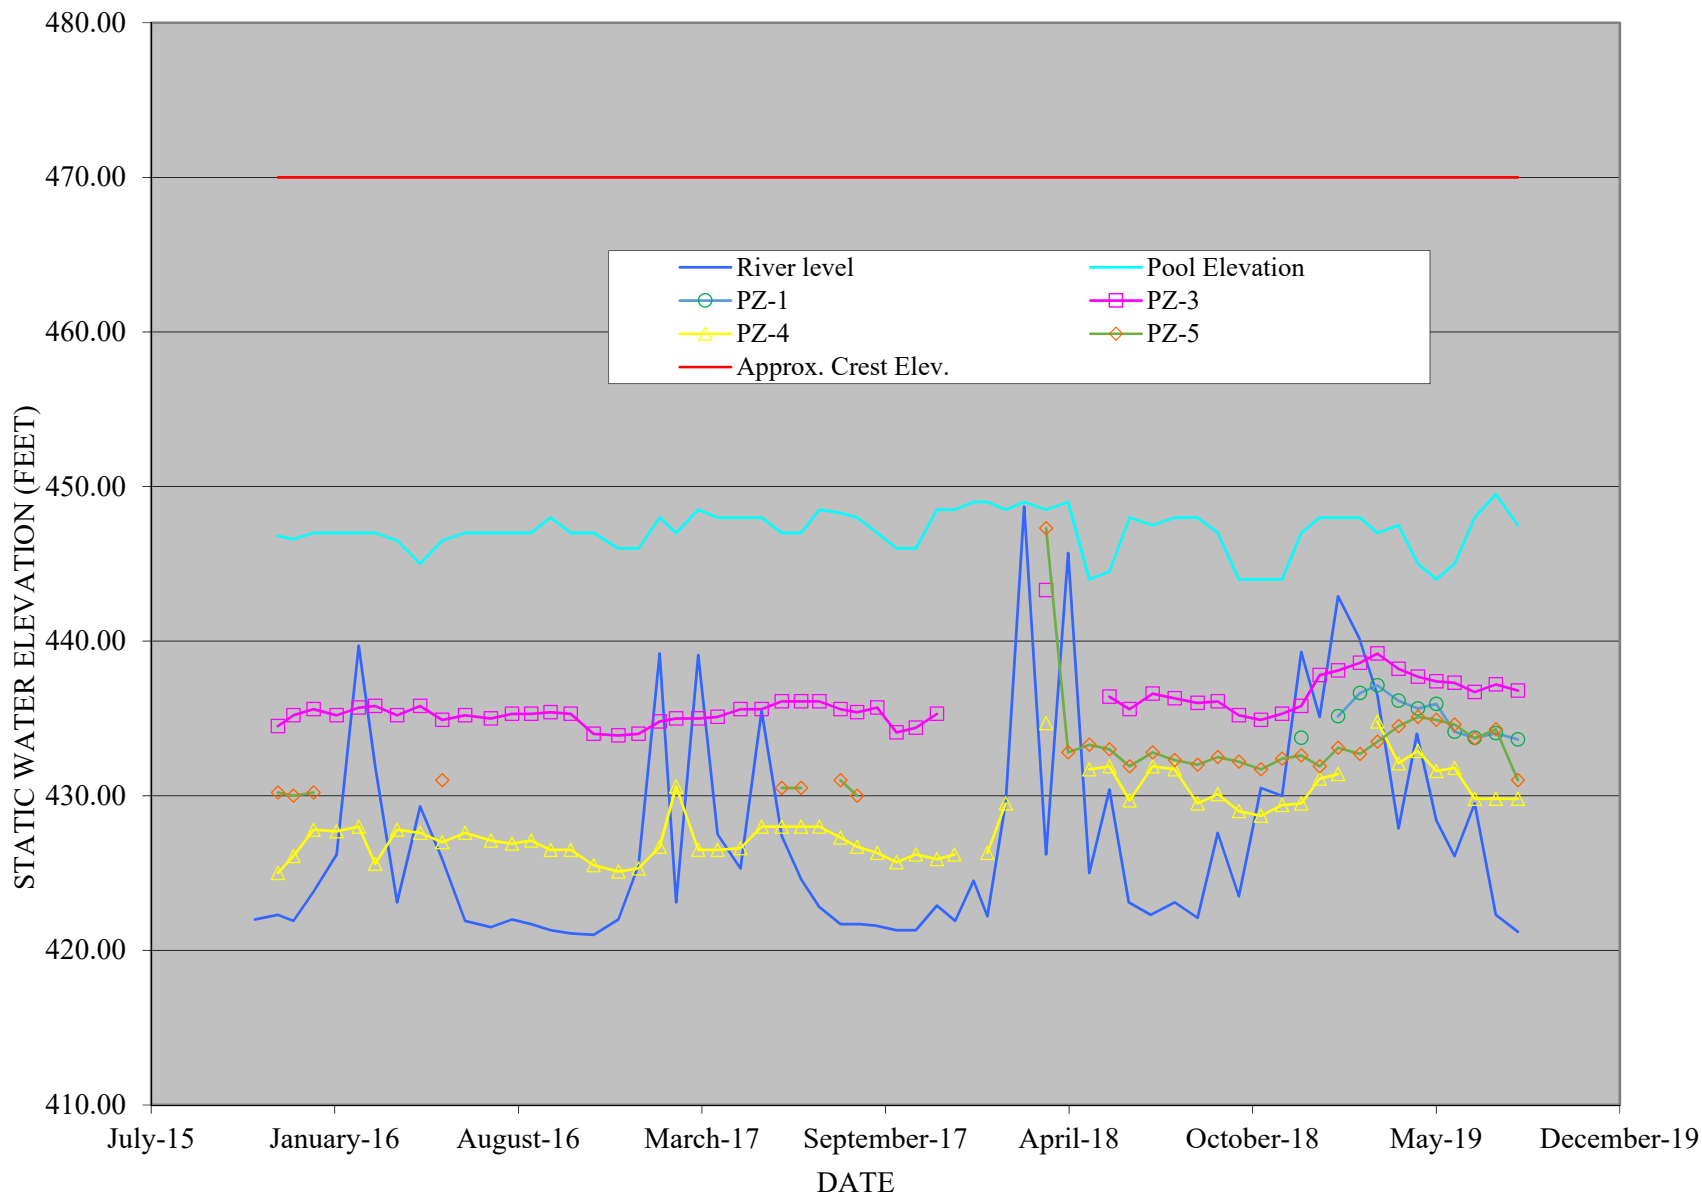
FIGURE 2. WEST BOILER SLAG POND PIEZOMETERS MEASUREMENTS

The location and type of instrumentation is shown on Figure 1. The results of the measurements of various piezometers since November 2015 are shown in Figure 2. The maximum recorded readings of each instrument since the previous annual inspection is shown in Table 1.
