2020 ANNUAL DAM AND DIKE INSPECTION REPORT

**West Boiler Slag Pond
& Landfill Runoff Collection Pond**

**CLIFTY CREEK PLANT
Indiana-Kentucky Electric Corporation
MADISON, INDIANA**

Document ID: GERS-20-041

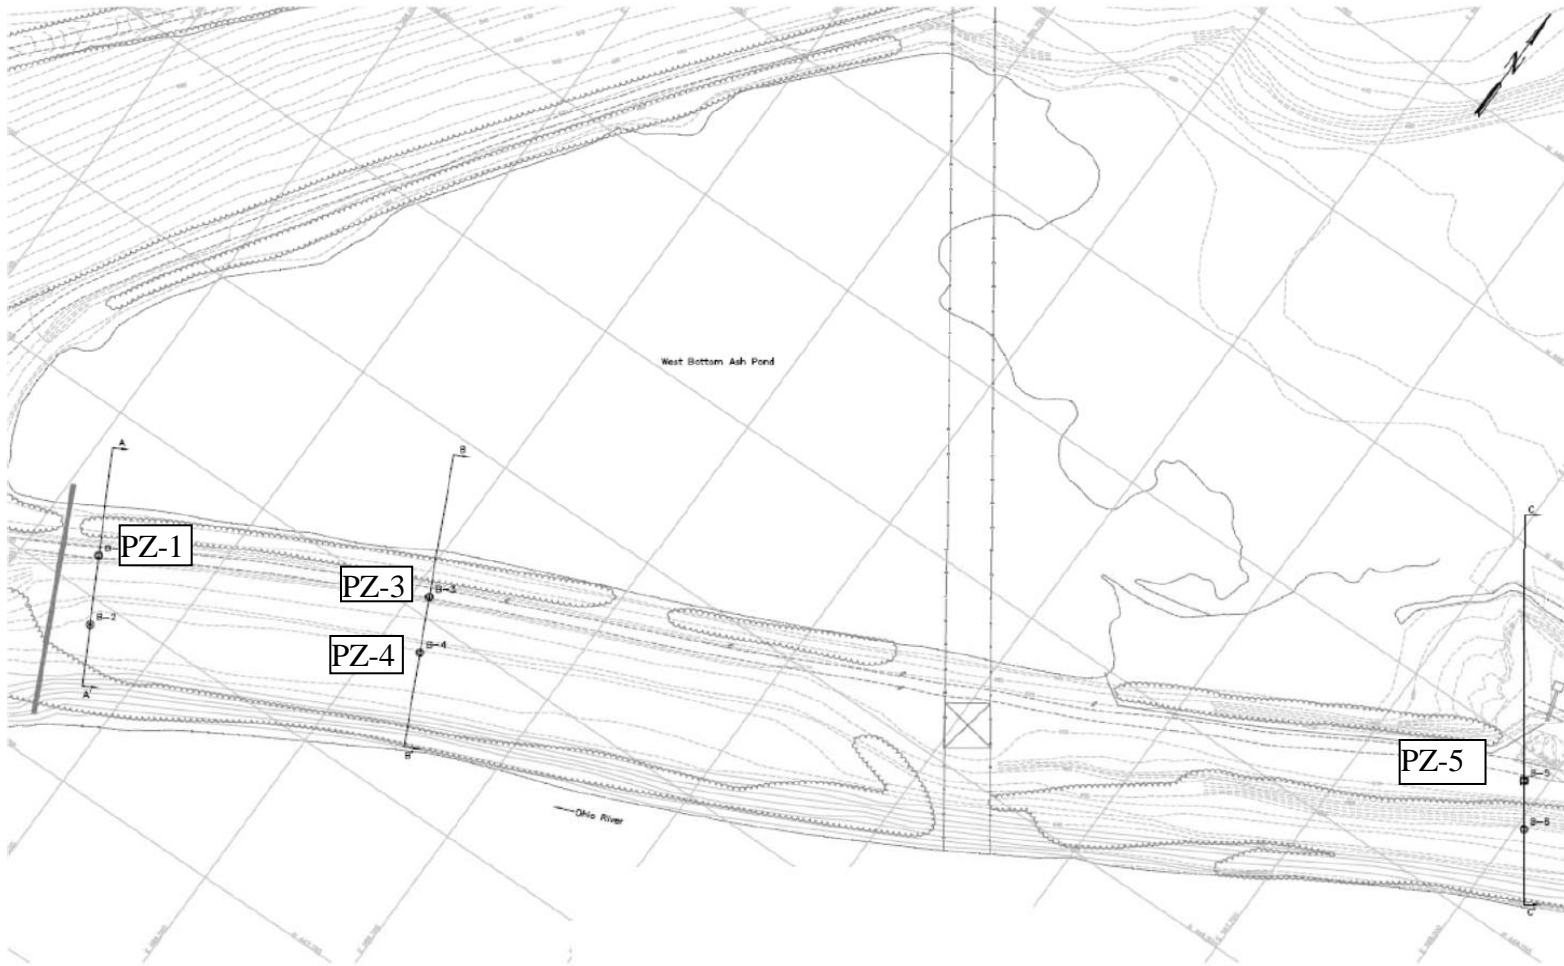
FIGURE 2 - WEST BOILER SLAG POND PIEZOMETERS LOCATION MAP.

The location and type of instrumentation are shown on Figure 2 in Appendix B. The results of the measurements of various piezometers since November 2015 are shown in Figure 3 at Appendix B. The maximum recorded readings of each instrument since the previous annual inspection is shown in Table 1.

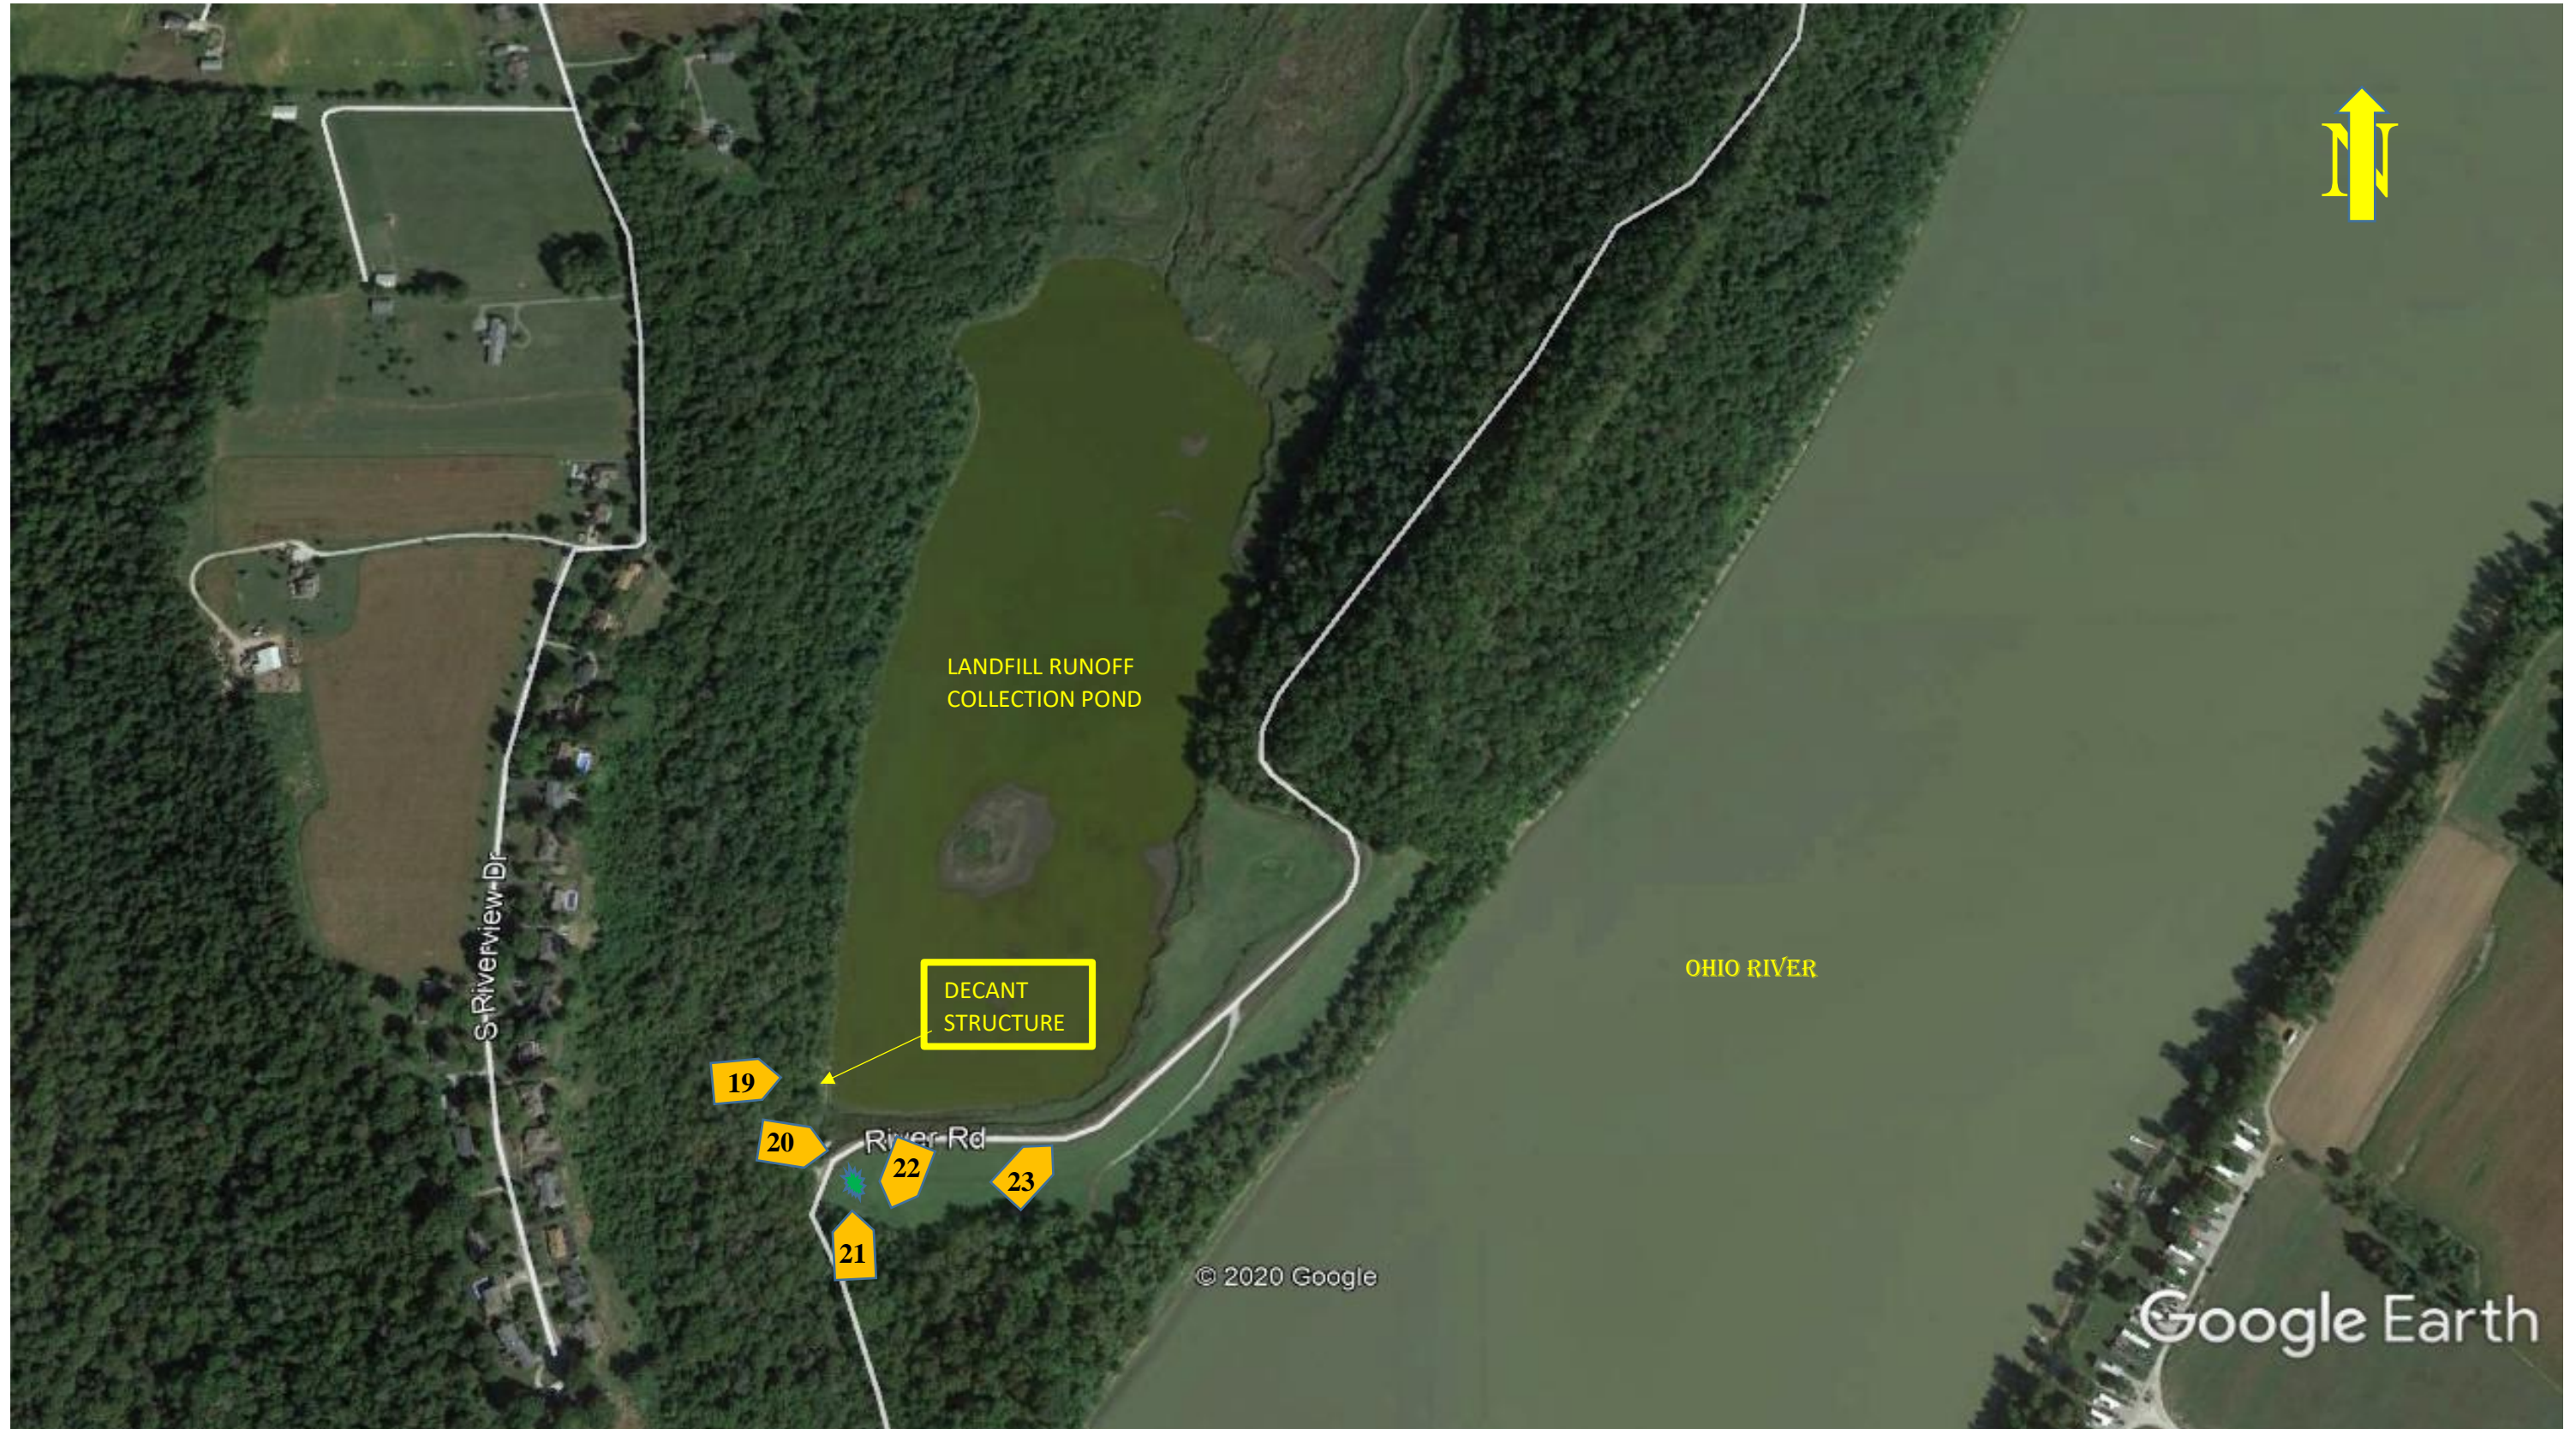
FIGURE 7 - Landfill Runoff Collection Pond Photographs Location Map
Clifty Creek Station, Madison, Indiana

Overall, the crest, interior slope and exterior slope is well vegetated and in stable condition. There were no apparent signs of new sloughing, depressions, areas of wetness, and seeps. Control of surface vegetation was considered satisfactory except along the outlet channel. The spillway outlet and discharge channel appear to have no obstructions, but the flow was minimal at the time of the inspection. Figure 7, illustrating photographs location and photographs are included Appendix C.
