2021 ANNUAL DAM AND DIKE INSPECTION REPORT

**West Boiler Slag Pond
& Landfill Runoff Collection Pond**

**CLIFTY CREEK PLANT
Indiana-Kentucky Electric Corporation
MADISON, INDIANA**

Document ID: GERS-22-002

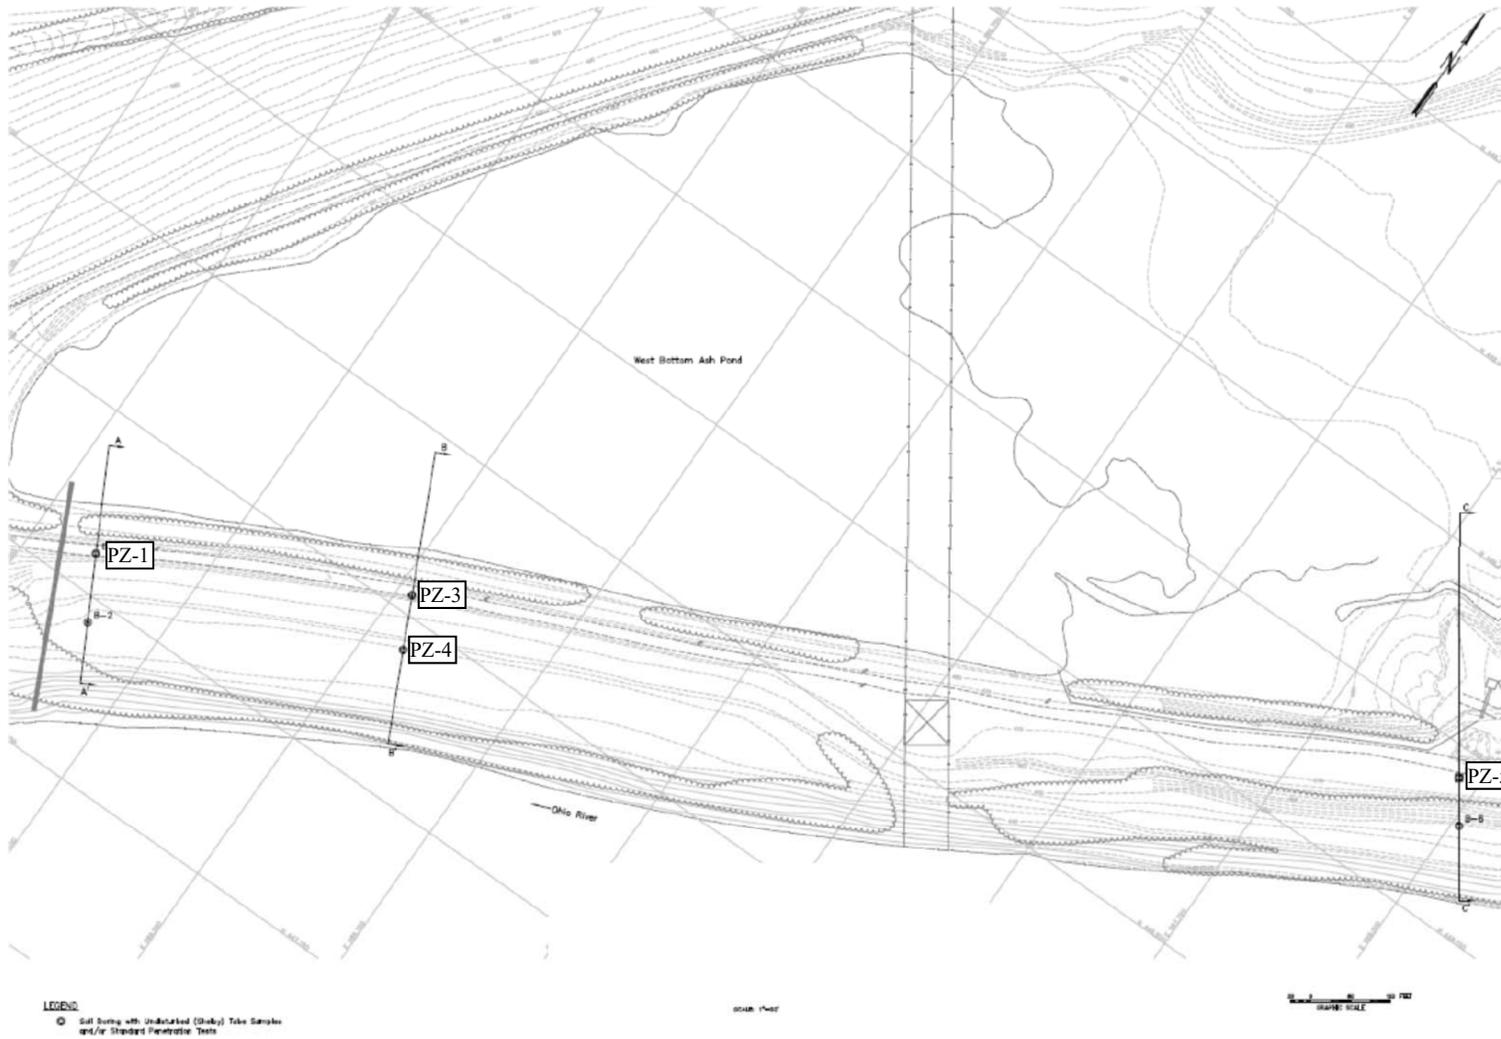
FIGURE 1. WEST BOILER SLAG POND PIEZOMETERS LOCATION PLAN

The location and type of instrumentation is shown on Figure 1. The results of the measurements of various piezometers since November 2015 are shown in Figure 2. The maximum recorded readings of each instrument since the previous annual inspection is shown in Table 1.

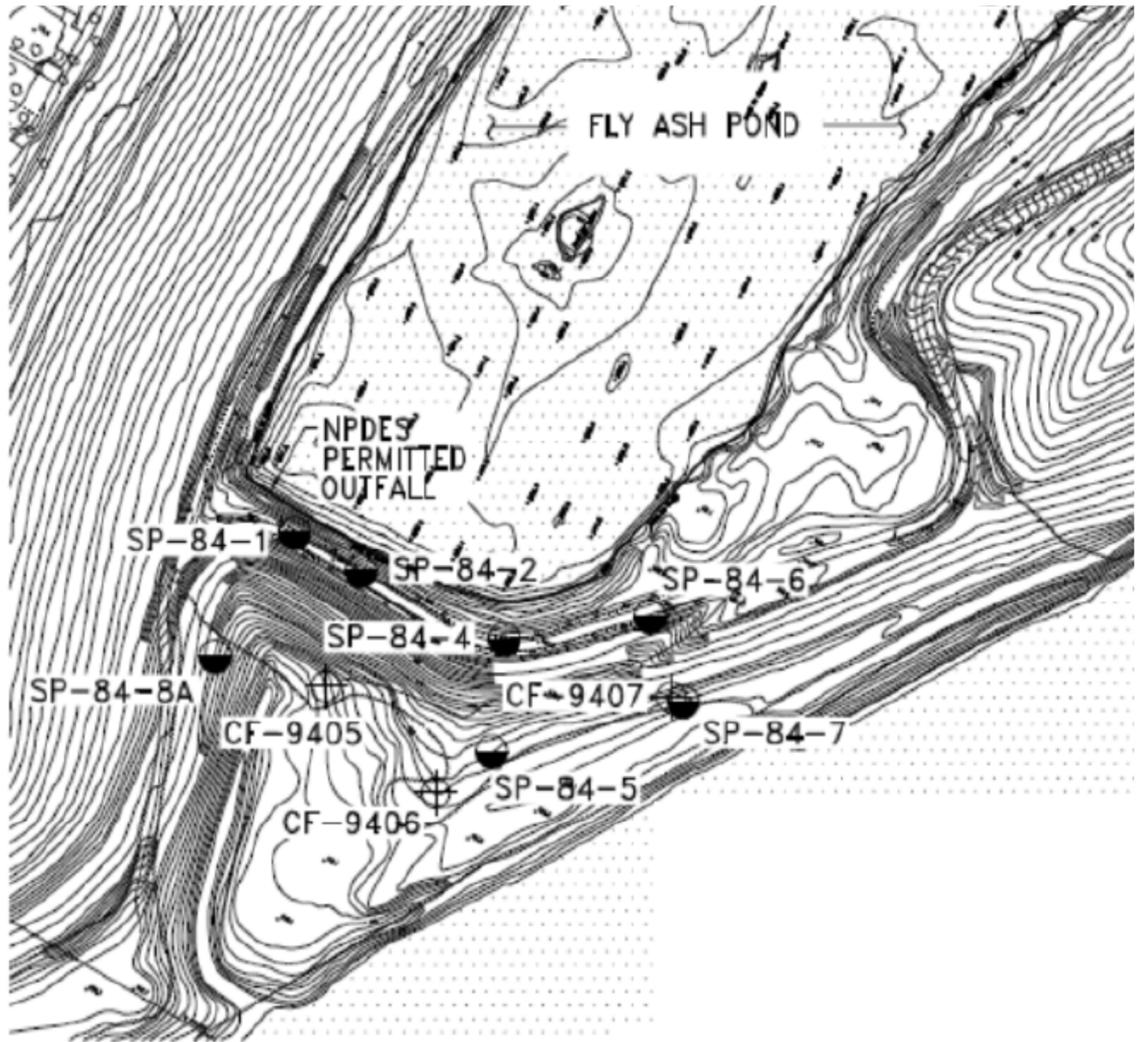
FIGURE 3. LANDFILL RUNOFF COLLECTION POND PIEZOMETERS LOCATION PLAN

The location and type of instrumentation is shown on Figure 3. The results of the measurements of various piezometers since November 2015 are shown in Figure 4. The maximum recorded readings of each instrument since the previous annual inspection is shown in Table 3 below.
