2021 ANNUAL DAM AND DIKE INSPECTION REPORT

**West Boiler Slag Pond
& Landfill Runoff Collection Pond**

**CLIFTY CREEK PLANT
Indiana-Kentucky Electric Corporation
MADISON, INDIANA**

GERS-21-080

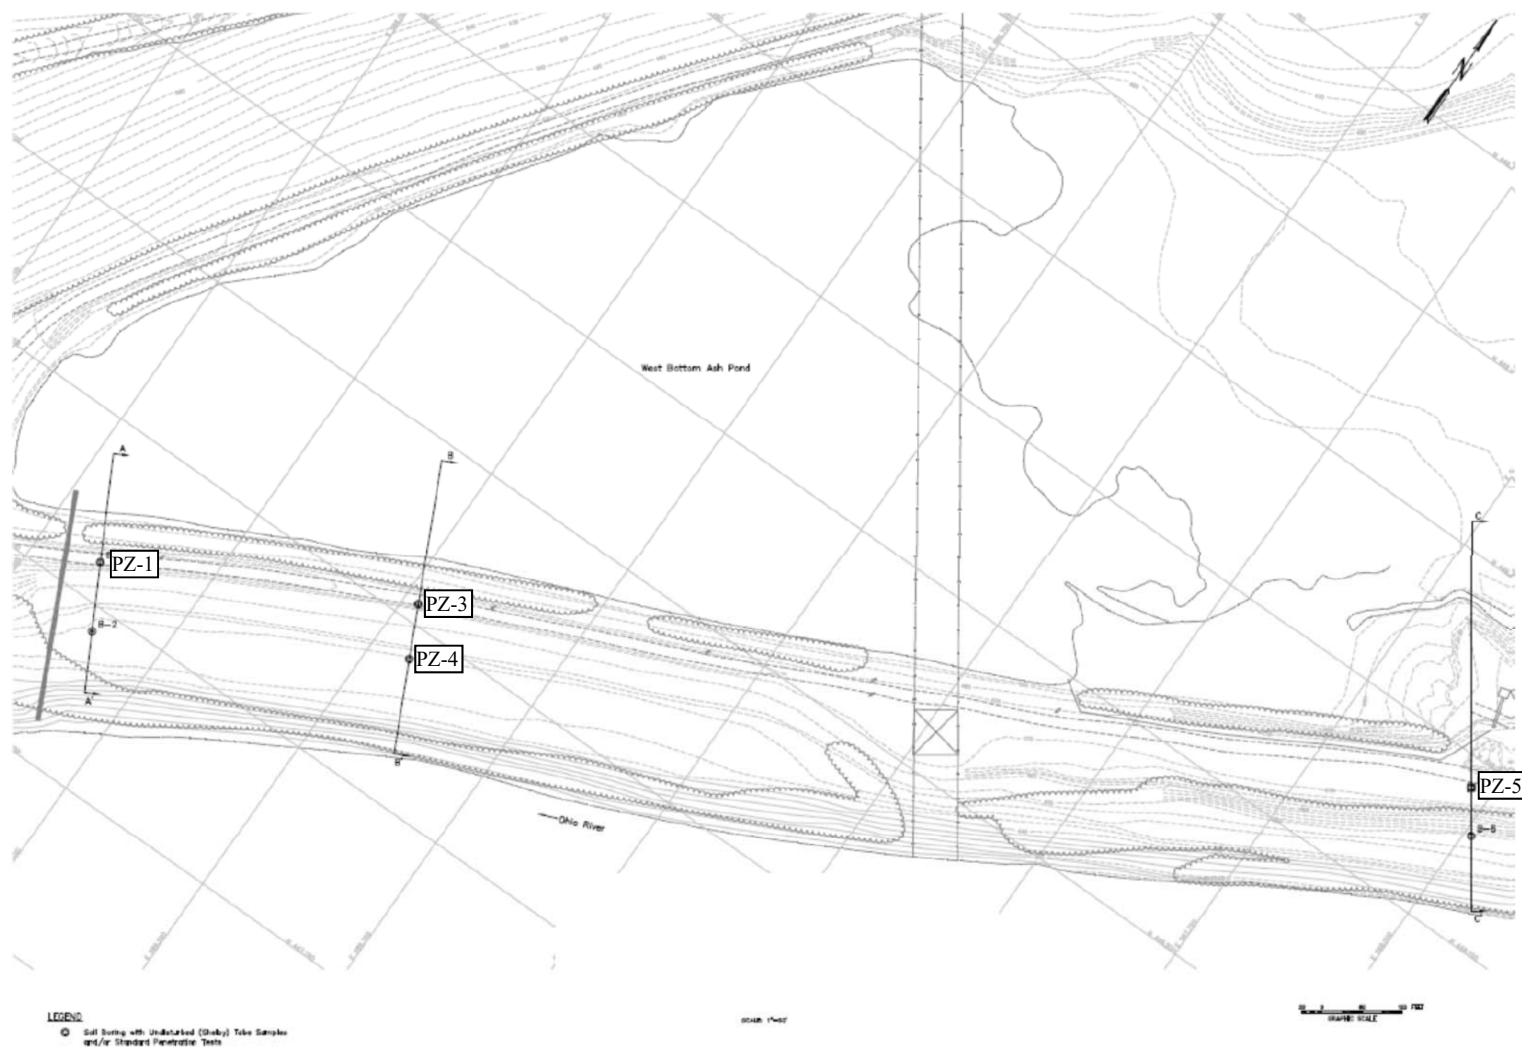
FIGURE 1. WEST BOILER SLAG POND PIEZOMETERS LOCATION PLAN

The location and type of instrumentation is shown on Figure 1. The results of the measurements of various piezometers since November 2015 are shown in Figure 2. The maximum recorded readings of each instrument since the previous annual inspection is shown in Table 1.

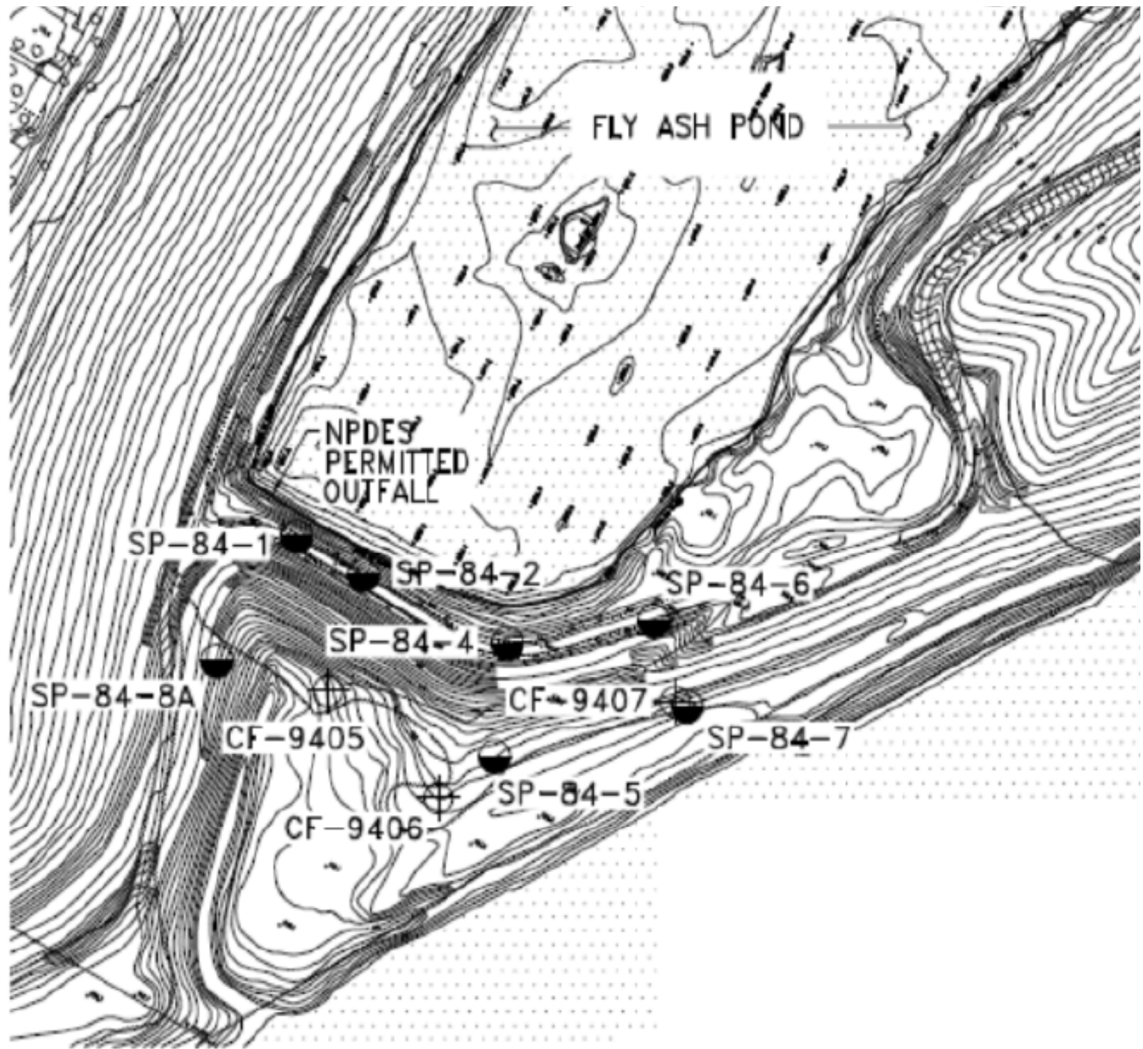
FIGURE 3. LANDFILL RUNOFF COLLECTION POND PIEZOMETERS LOCATION PLAN

The location and type of instrumentation is shown on Figure 3. The results of the measurements of various piezometers since November 2015 are shown in Figure 4. The maximum recorded readings of each instrument since the previous annual inspection is shown in Table 3 below.
