2022 ANNUAL DAM AND DIKE INSPECTION REPORT

**West Boiler Slag Pond
& Landfill Runoff Collection Pond**

**CLIFTY CREEK PLANT
Indiana-Kentucky Electric Corporation
MADISON, INDIANA**

Document ID: GERS-22-045

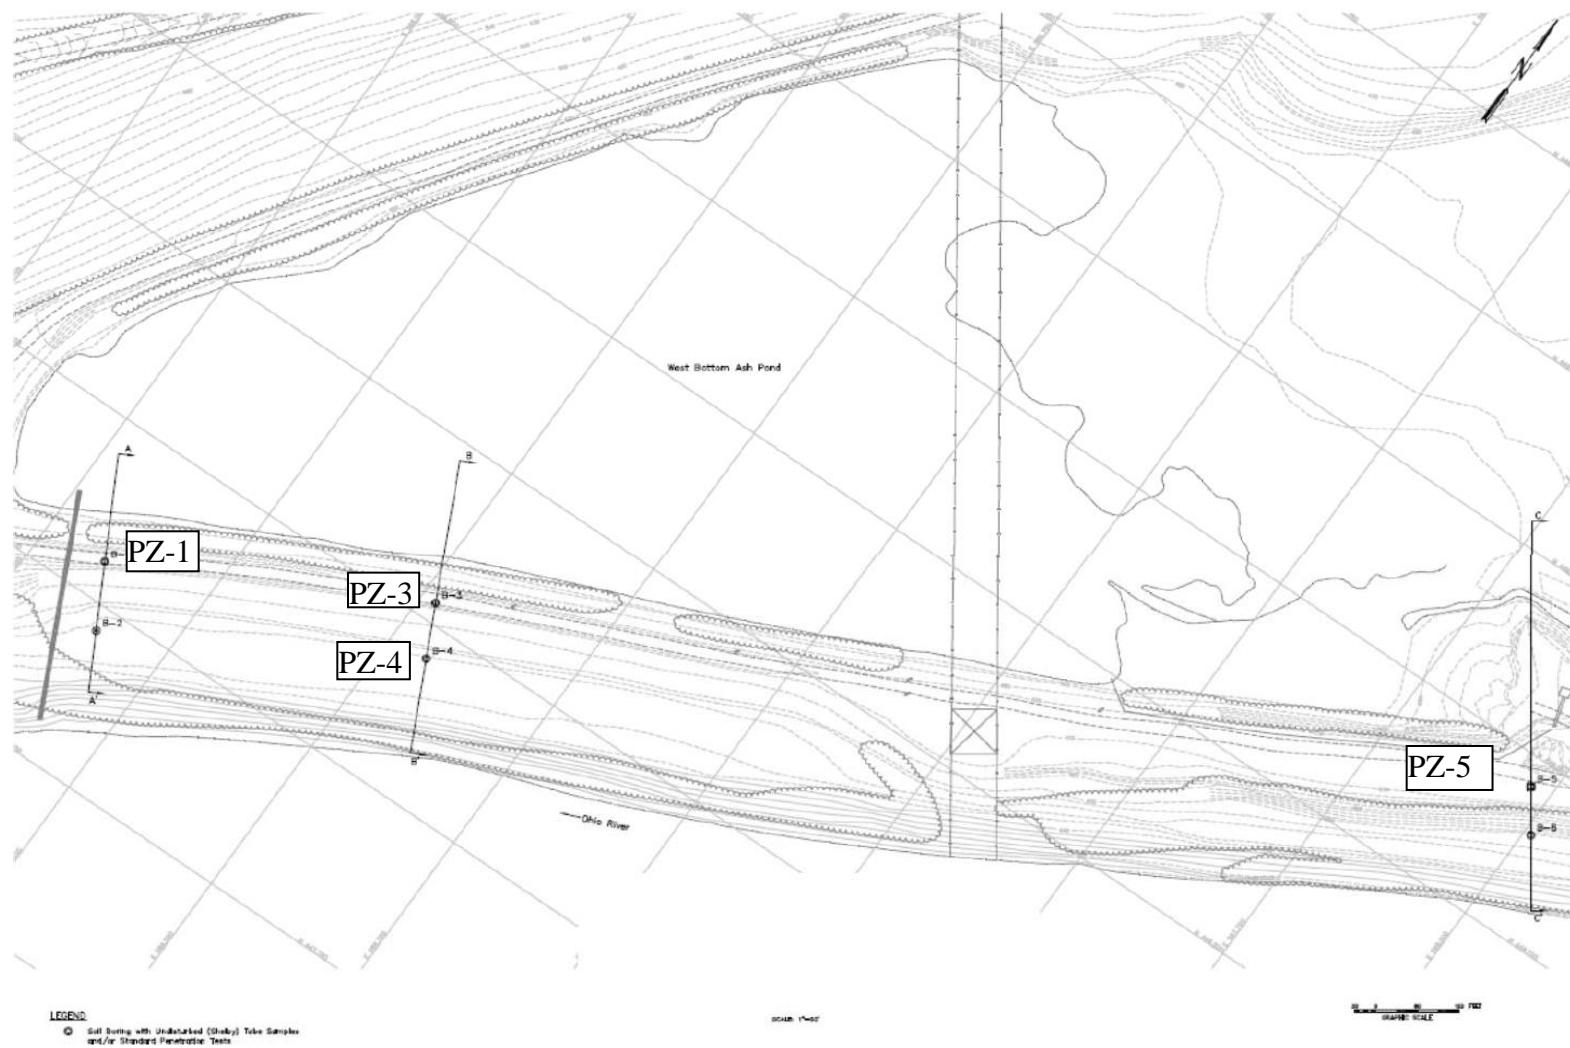
FIGURE 2 - WEST BOILER SLAG POND PIEZOMETERS LOCATION MAP

The location and type of instrumentation are shown on Figure 2. The results of the measurements of various piezometers since November 2015 are shown in Figure 3. The maximum recorded readings of each instrument since the previous annual inspection is shown in Table 1.

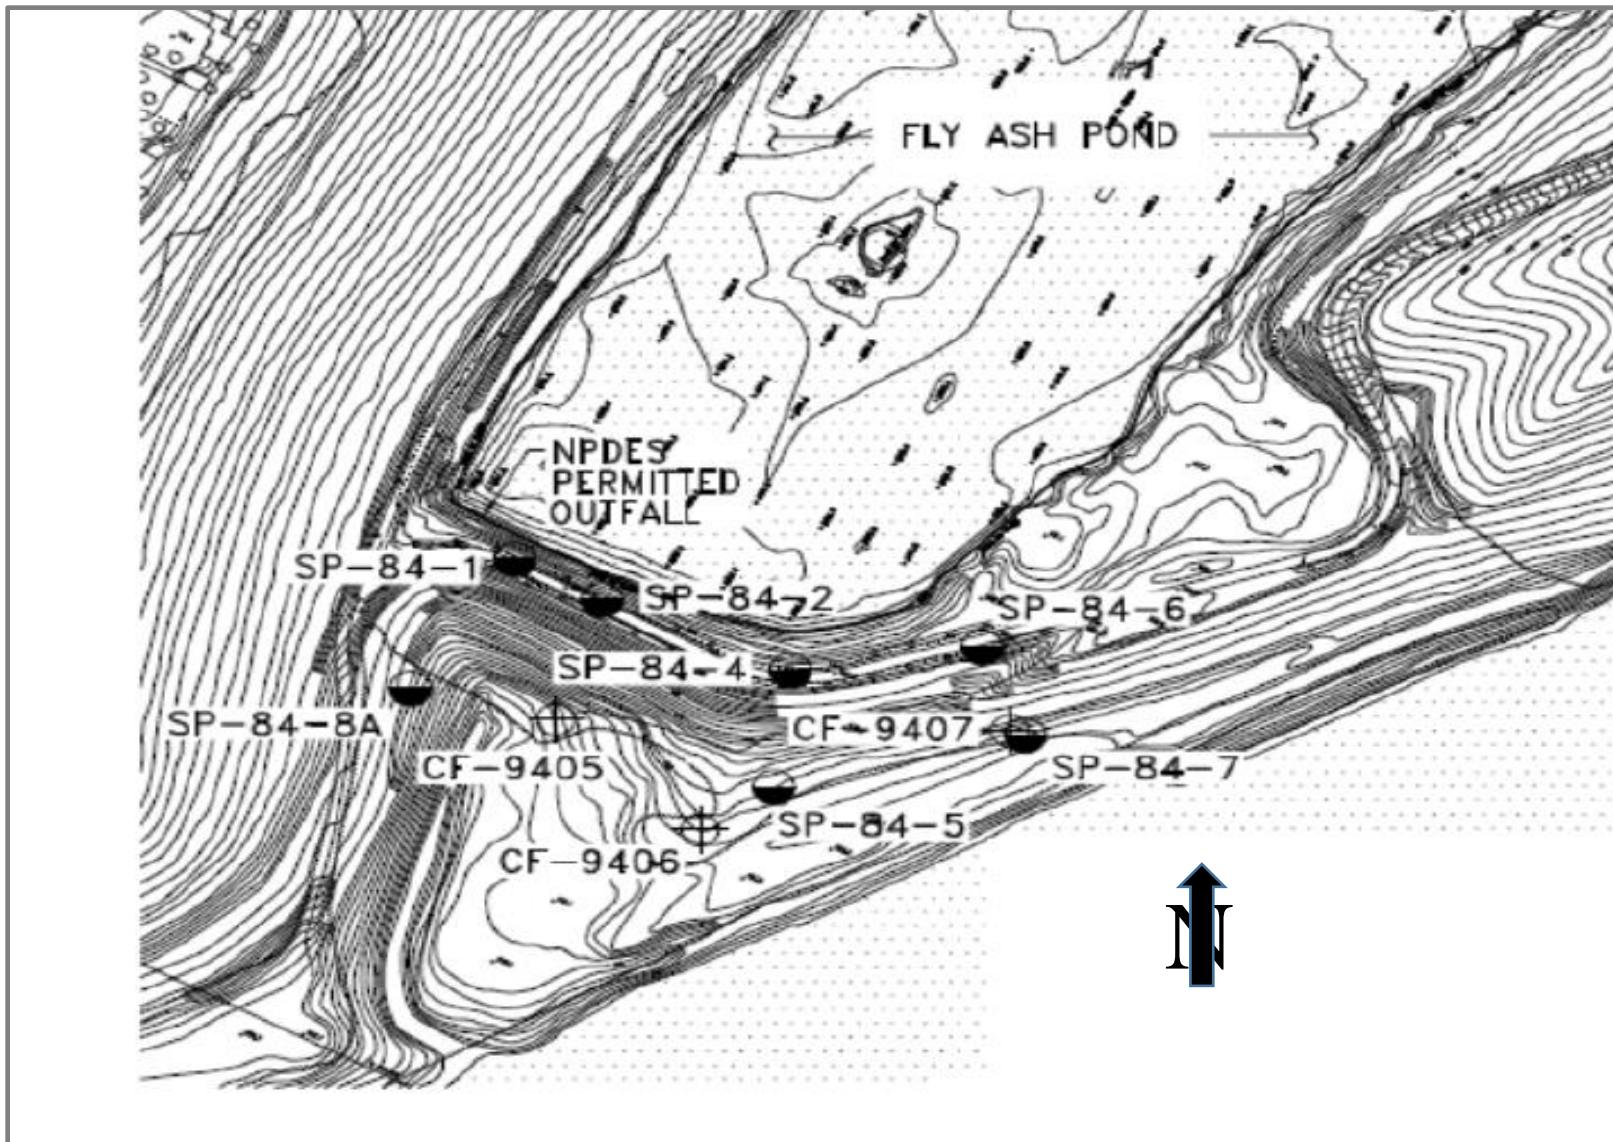
FIGURE 5 - LANDFILL RUNOFF COLLECTION POND PIEZOMETERS LOCATION MAP

There are piezometers and monitoring wells installed in and around the LRCP dam. The location and type of instrumentation is shown on Figure 5. The results of the measurements of various piezometers since November 2015 are shown in Figure 6. The maximum recorded readings of each instrument since the previous annual inspection is shown in Table 3 below.

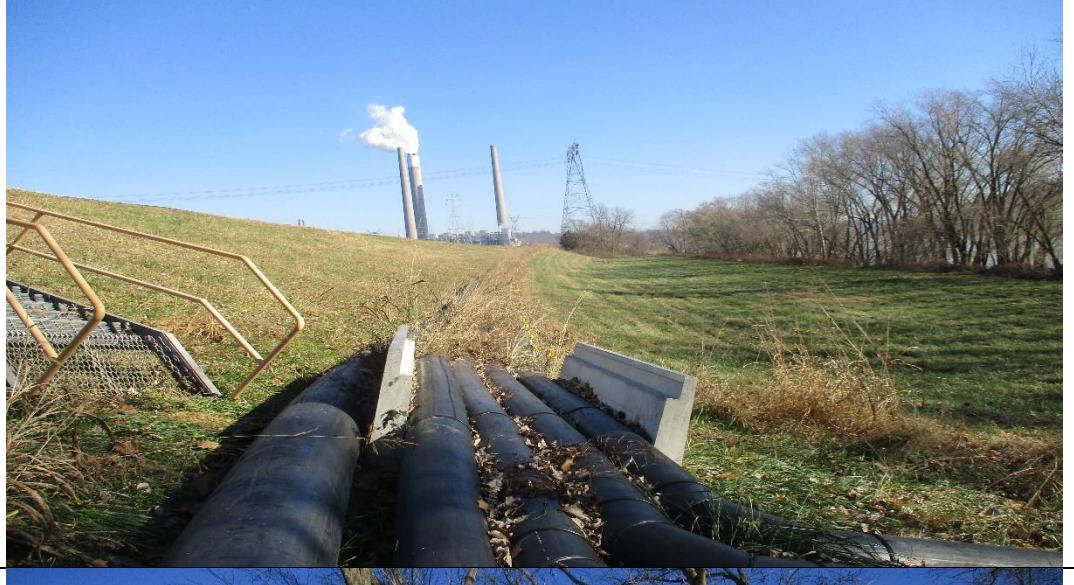
A photograph showing the interior slope of a dam. The slope is covered in dark, eroded soil. In the background, there is a flat, open field and industrial structures, including two tall smokestacks emitting white plumes of smoke. The sky is clear and blue.
<p>Photograph No. 5 Typical view of the exterior slope and discharge pipes leading to the outfall.</p>

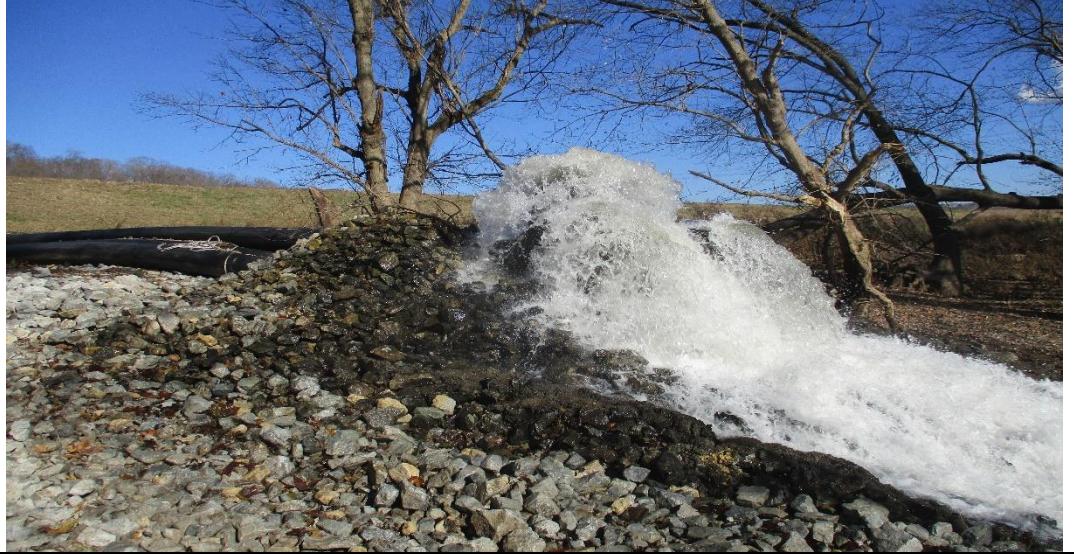
A photograph showing the exterior slope of a dam. In the foreground, several large, dark-colored discharge pipes are visible, some with concrete pipe supports. A metal railing is on the left. The slope is covered in grass and some bare ground. In the background, there are more industrial structures, including tall smokestacks, and a line of trees under a clear blue sky.
<p>Photograph No. 6 Typical exterior at the overflow discharge pipes outlet (south dike)</p>

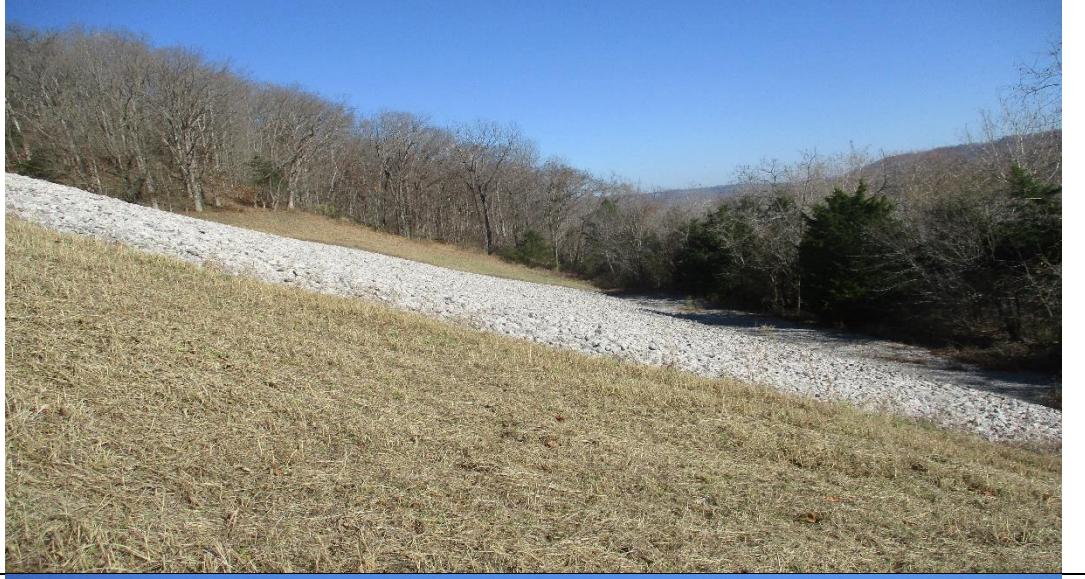
1. Photographs No. 17 and 18 illustrates the seepage control blanket previously installed. No visible seepage was observed during the inspection. The riprap cover was in good condition and no vegetation was seen protruding within the blanket.
2. Photographs No. 19 and 20 shows an overall view of the east exterior slope of the dam. Throughout exterior slope vegetation control was good and there were no signs of sloughing, erosion or instability. In general, the exterior slope appeared to be in satisfactory and stable condition.
3. A minor depression (Photograph No. 21) was encountered at the southeast area of the exterior slope along the toe. The access road from the crest of the dam to the toe area appeared in good condition (Photograph No. 22). Minor rutting along the sides were noticed (Photograph No. 23).

A photograph of a steep hillside. The upper portion is covered in dry, brown grass, while the lower slope and the base are covered in grey riprap stones. Bare trees line the top of the hill and the surrounding area.
<p>Photograph No. 19 View of the exterior slope and toe (looking north)</p>

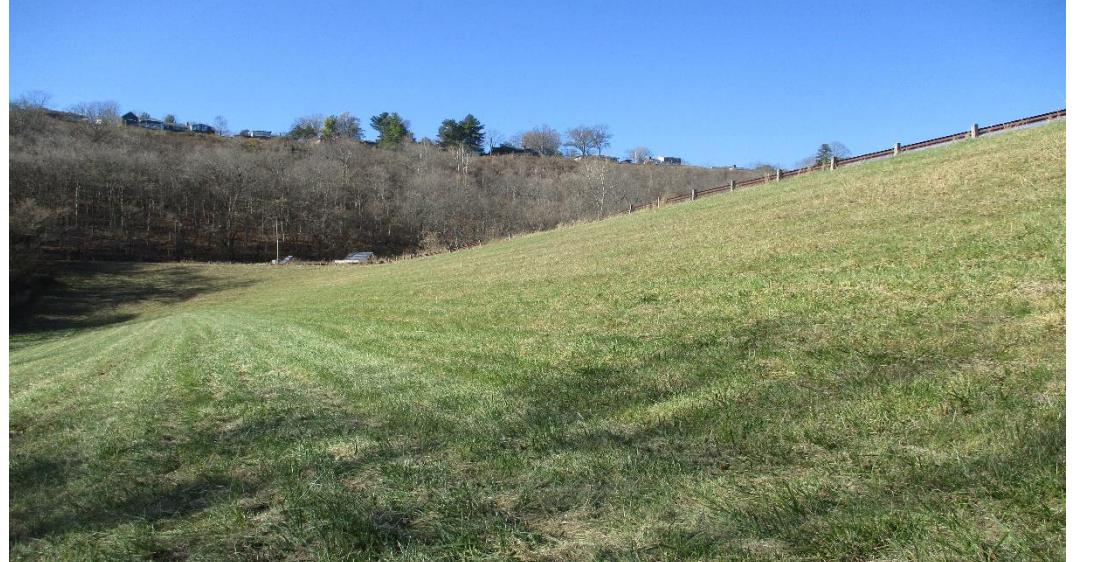
4. Photographs No. 24 and 25 illustrate south exterior slope of the dam. Throughout, vegetation control was adequate and there were no signs of sloughing, erosion or instability. No visible change was observed from previous inspections. In general, the exterior slope appeared to be in satisfactory and stable condition

A photograph showing a gravel path or dike with some minor erosion. The ground is covered in gravel and some sparse grass. A shadow of a person's head and shoulders is visible on the right side of the path.
<p>Photograph No. 24</p> <p>Exterior slope south side (looking west).</p>

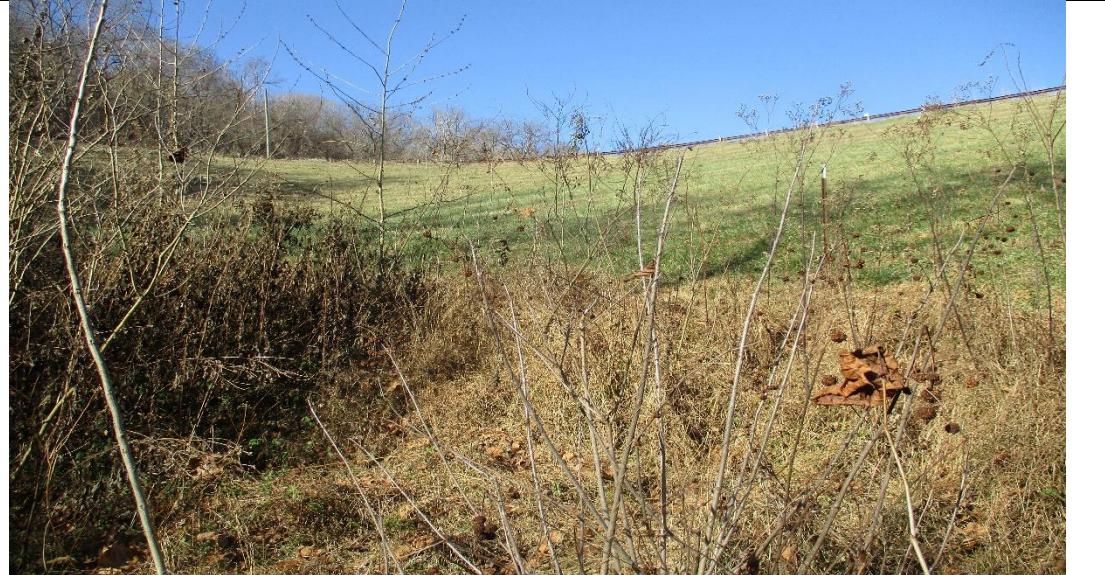
A photograph of a grassy hillside. The slope is relatively smooth and green. In the background, there is a line of trees and some buildings on a higher hill under a clear blue sky.
<p>Photograph No. 25</p> <p>View of the exterior slope south side.</p>
