**Re: Indiana-Kentucky Electric Corporation  
Clifty Creek Station's 2017 Annual Landfill Inspection**

**Reference: 2017 CCR Rule Inspection  
Annual Landfill Inspection  
Clifty Creek Generating Station  
Madison, Indiana**

**2017 CCR Rule Inspection  
Clifty Creek Landfill**

Clifty Creek Generating Station  
Madison, Indiana  
Jefferson County

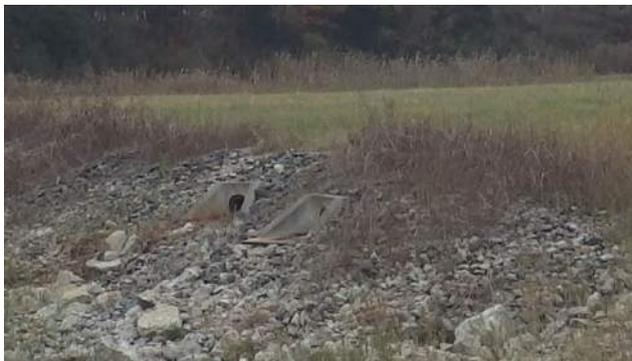
**Photo 11**

- Inspections near the leachate pipe outlet headwalls (Points 12 and 13, Appendix A; Photo 11, Appendix B) at the northeast corner of the Type III landfill resulted in the following observations:

Leachate pipe headwalls at northeast corner of Type III Landfill. See Points 12 and 13 in Appendix A. Photo looking southwest.

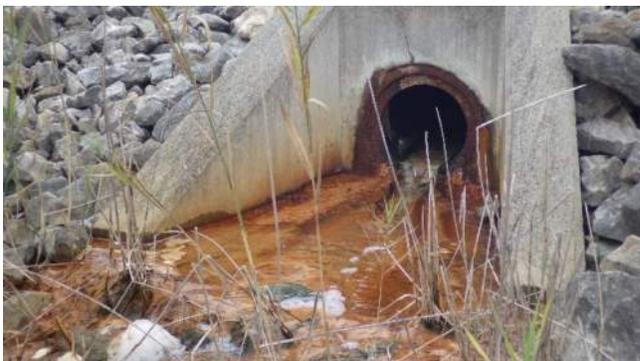
**Photo 12**

Southern leachate pipe headwall at northeast corner of Type III landfill. See Point 12 in Appendix A. Photo looking west.

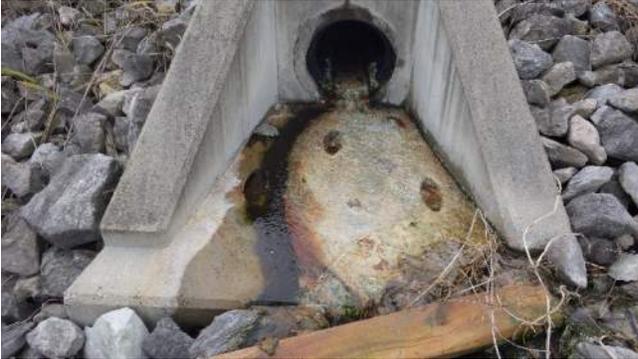
**Photo 13**

Northern leachate pipe headwall at northeast corner of Type III landfill. See Point 13 in Appendix A. Photo looking west.

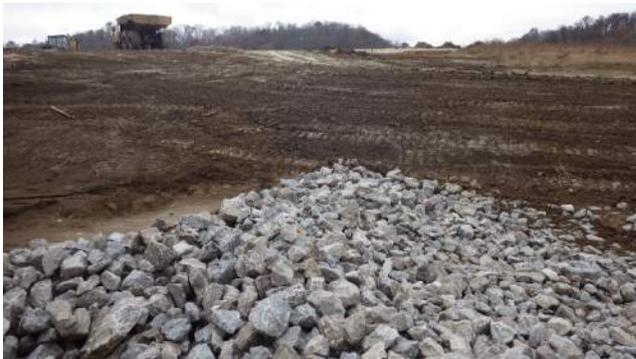
**Photo 20**

- The end of the currently placed temporary cover on the south side of Cell 1B2 was observed and marked in Appendix A as Point 26. The temporary cover limits are approximately 15 feet north of the stone-lined surface water channel (the end of which is marked as Point 27 in Appendix A; Photo 20 in Appendix B). An area of temporary cover extending about 40 feet further north feet was being regraded during the inspection (Point 26, Appendix A; Photo 19, Appendix B).

End of stone lining in surface channel on south side of landfill. See Point 27 in Appendix A. Photo looking northwest.

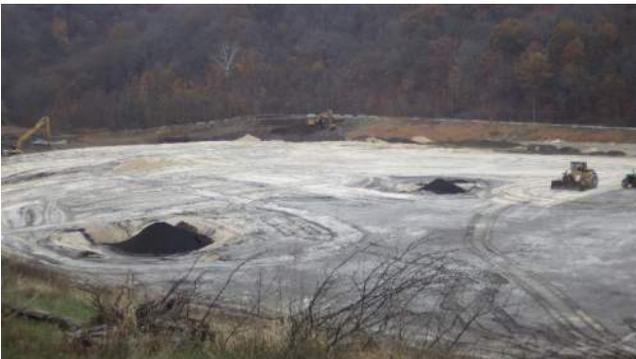
**Photo 21**

- Active waste placement was ongoing in Cells 1C based on the observation of gypsum stockpiles in the cell that were ready for spreading. Piles of bottom ash, used as chimney drains in the landfill, were visible and appeared to be properly spaced (Photo 21, Appendix B).

Active waste placement in Cell 1C. Gypsum placement with visible chimney drains, constructed via vertical piles of bottom ash. Photo looking northwest.

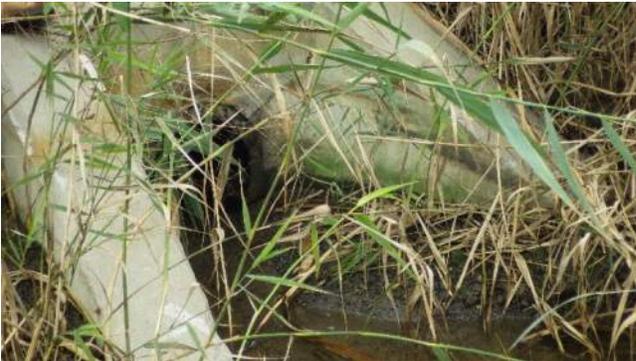
**Photo 32**

- The leachate pipe appeared unrestricted and actively flowing. Vegetation was maintained around the headwall to allow visual observation. (Point 28, Appendix A; Photo 32, Appendix B)

Leachate pipe outlet, west of Subphase 1C. See Point 28 in Appendix A.
