**Re: Indiana-Kentucky Electric Corporation**  
**Clifty Creek Station's 2020 Annual Landfill Inspection**

**Reference:** 2020 CCR Rule Inspection  
Annual Landfill Inspection  
Clifty Creek Generating Station  
Madison, Indiana

2020 CCR Rule Inspection  
Clifty Creek Landfill

Clifty Creek Generating Station  
Madison, Indiana  
Jefferson County

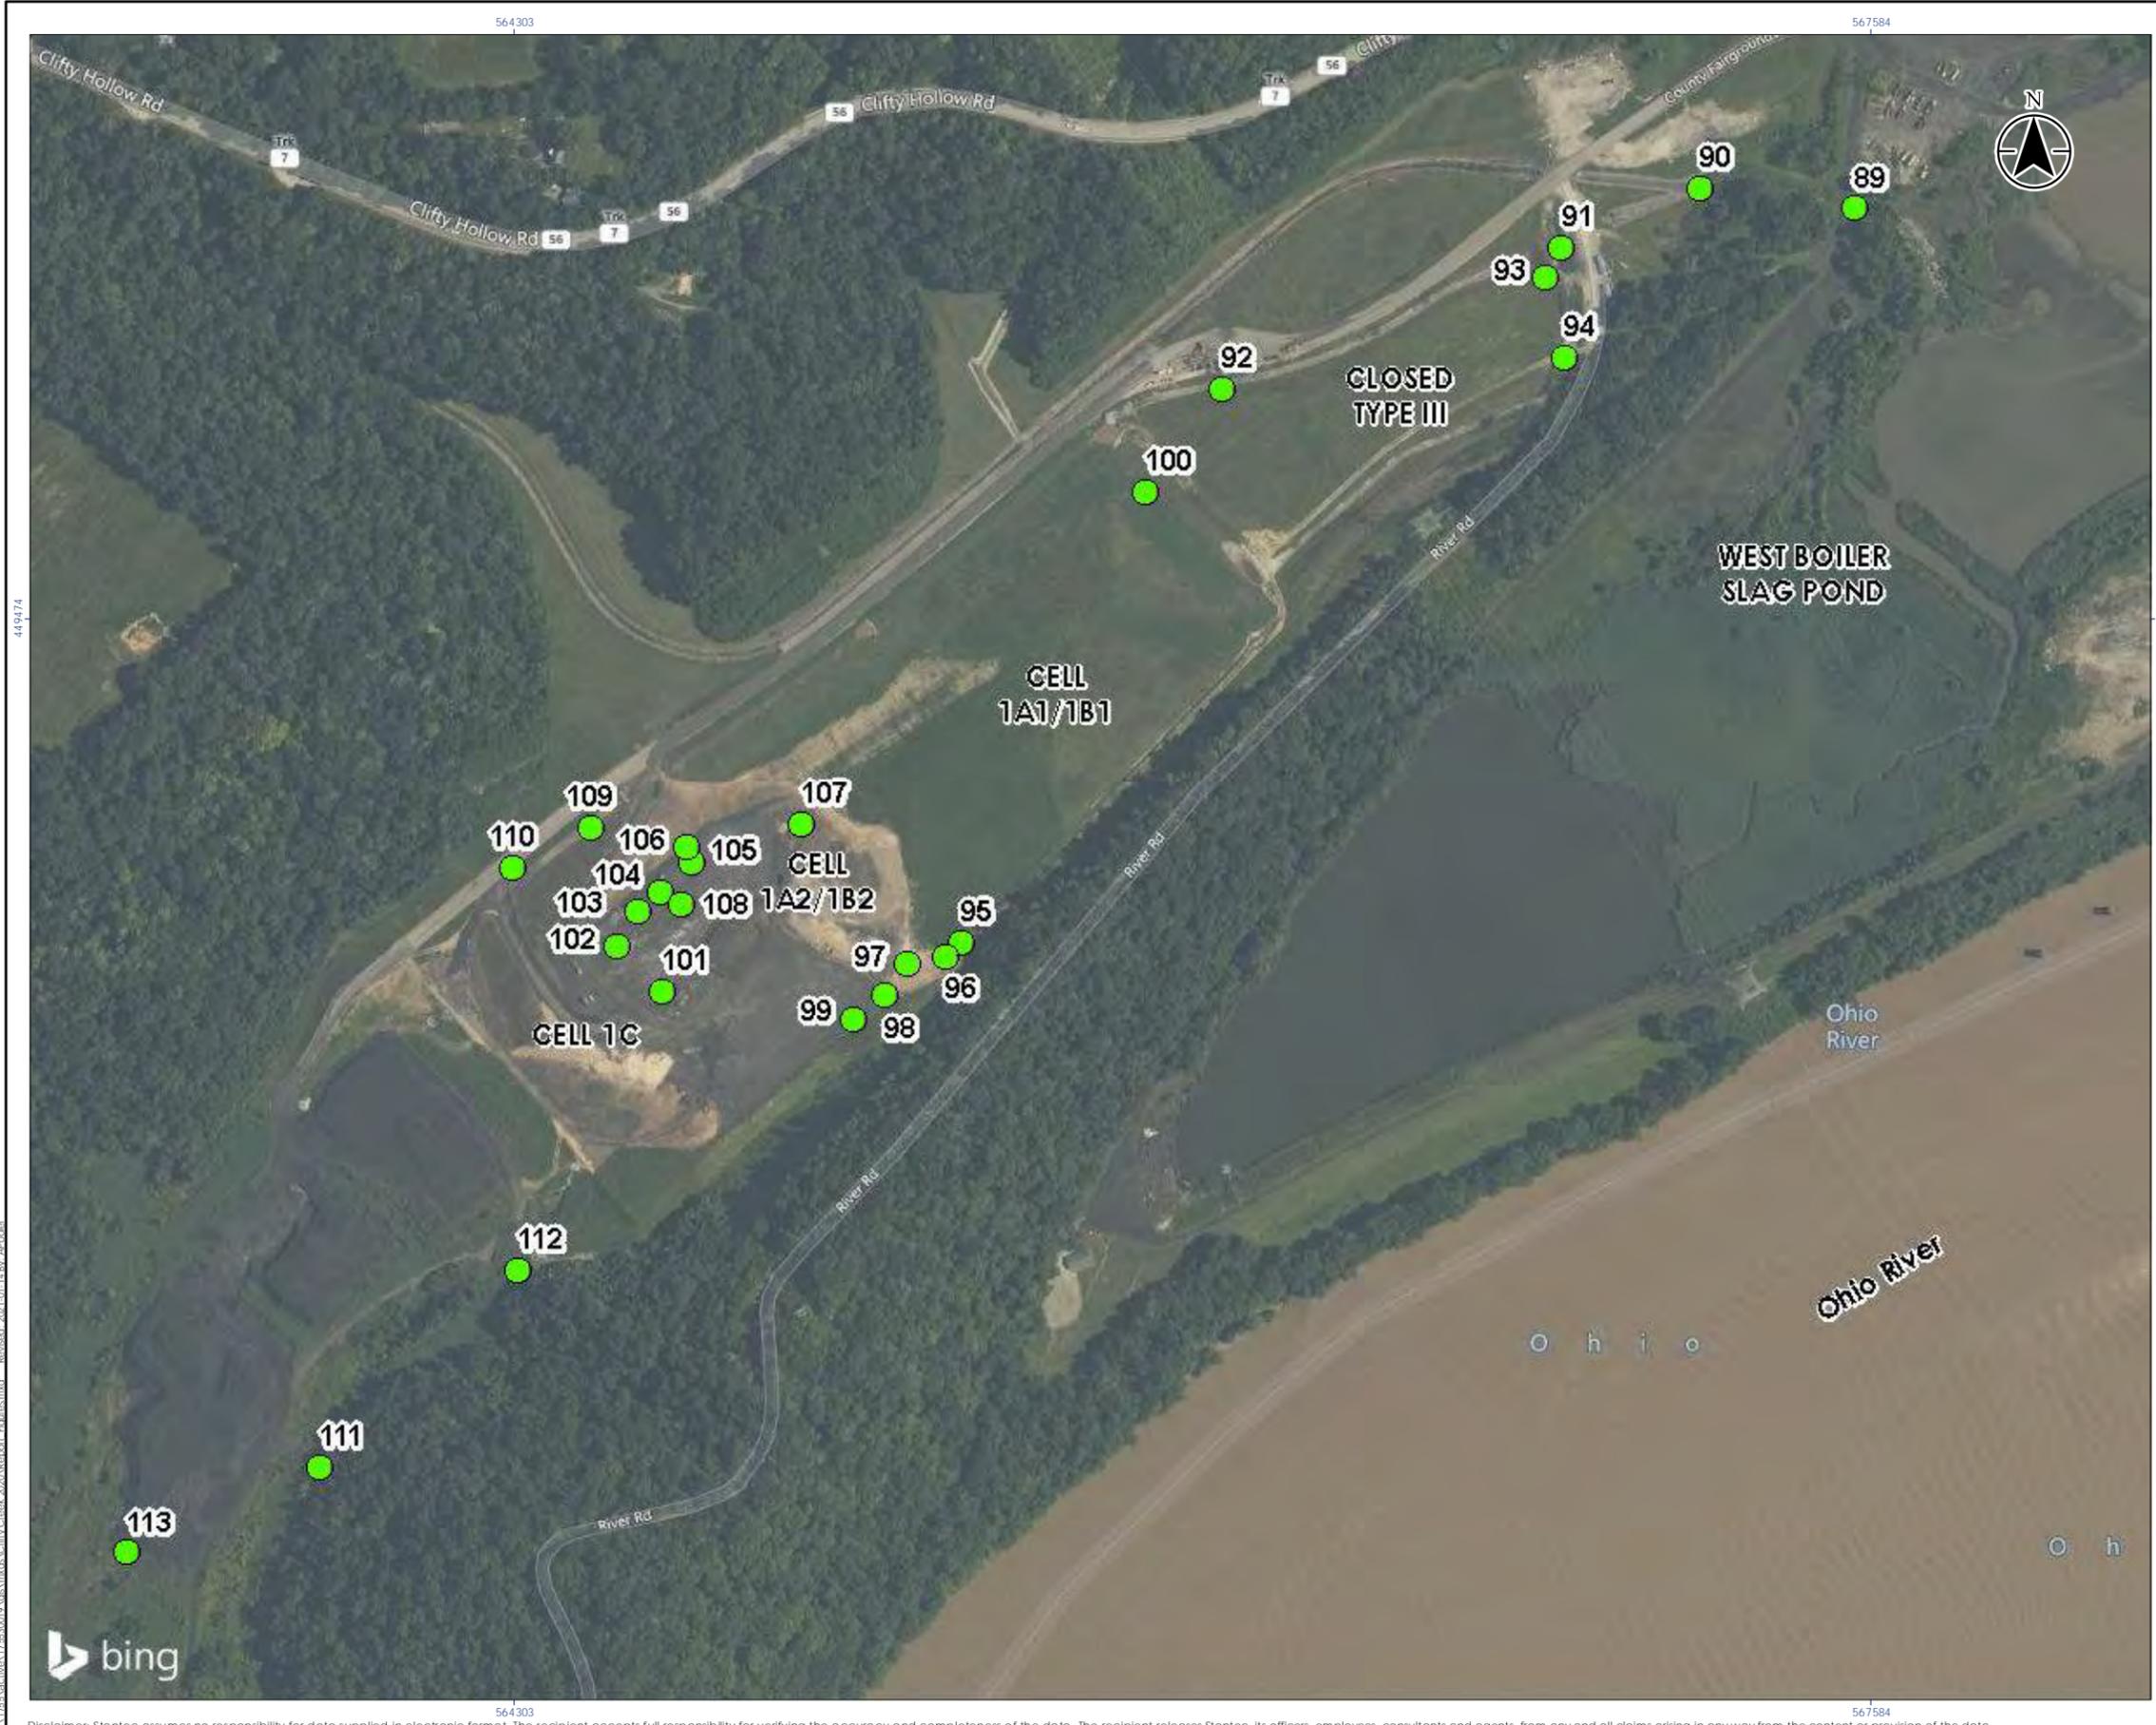
**APPENDIX A – PLAN VIEW AND TABLE OF  
INSPECTION LOCATIONS**

- The channel downstream of the east Conspan headwall is fairly clear of vegetation. Refer to Point 89, Appendix A and Photos 1-3, Appendix B.
- The channel upstream of the east Conspan headwall is fairly clear of vegetation to the next headwalls upstream (near the trailer area).
- The rock fill of the gabion mattress of the north stormwater channel near the confluence with the south channel was observed to be somewhat displaced and bulging beneath the wire gabion fabric (Point 90, Appendix A; Photos 4 and 5, Appendix B). The condition of this rock lining has not changed since 2019 and does not appear to impact functionality.

- Most rock check dams surrounding the landfill appear to be well maintained. Sediment was observed in a rock check dam on the north side of the landfill. (Point 109, Appendix A; Photo 17, Appendix B)

- Erosion rills and/or small animal burrows observed at the eastern toe of the landfill in 2019 have been repaired. (Point 100, Appendix A)
- Exposed CCR was observed on south side near top of landfill. (Point 95, Appendix A; Photo 8, Appendix B)

- A bare area was observed at edge of temporary vegetative cover. (Point 96, Appendix A; Photo 9, Appendix B)
- Active waste placement was ongoing in Cell 1C. Piles of bottom ash, used as chimney drains in the landfill, were visible. (Point 101, Appendix A; Photo 10, Appendix B)
